Project	291 Wallabout Street Site	Report No.	4
BCP Site	NYSDEC BCP SITE C224416	Date	05/06/2026
Location	291 Wallabout St	File No.	0211139
Client	291 Wallabout Realty LLC	Temperature	L: 60 H: 70
Contractor	Raptor Concrete LLC (Raptor)	Wind Direction	S to N, up to 30 mph
Weather	Cloudy	Personnel on Site	C. Jackson
Humidity	70%	Time on Site	6:30am – 5:45pm

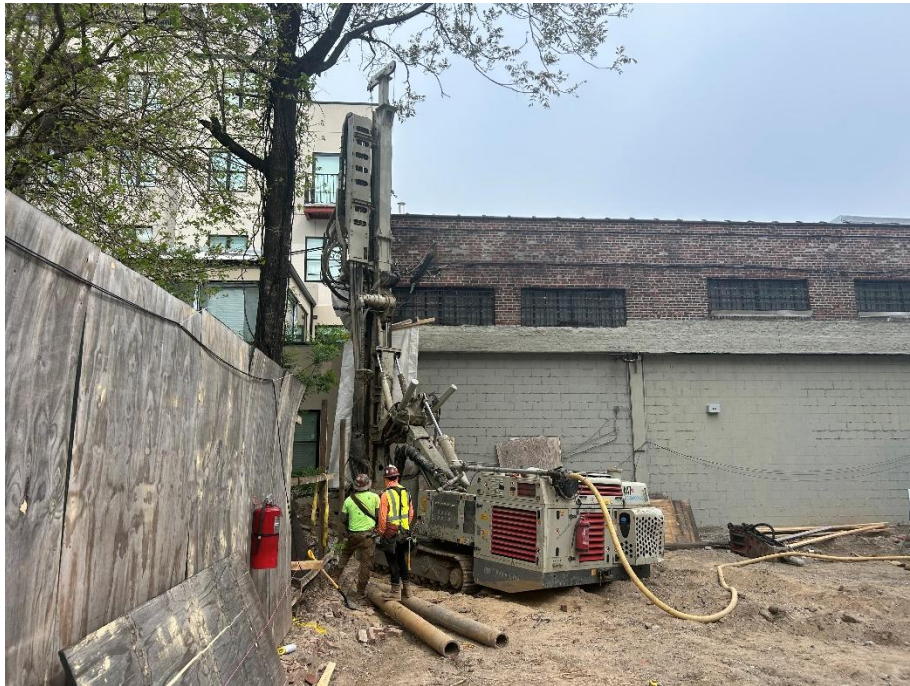
Photo 1: View of contractors installing soldier piles for SOE, facing north.

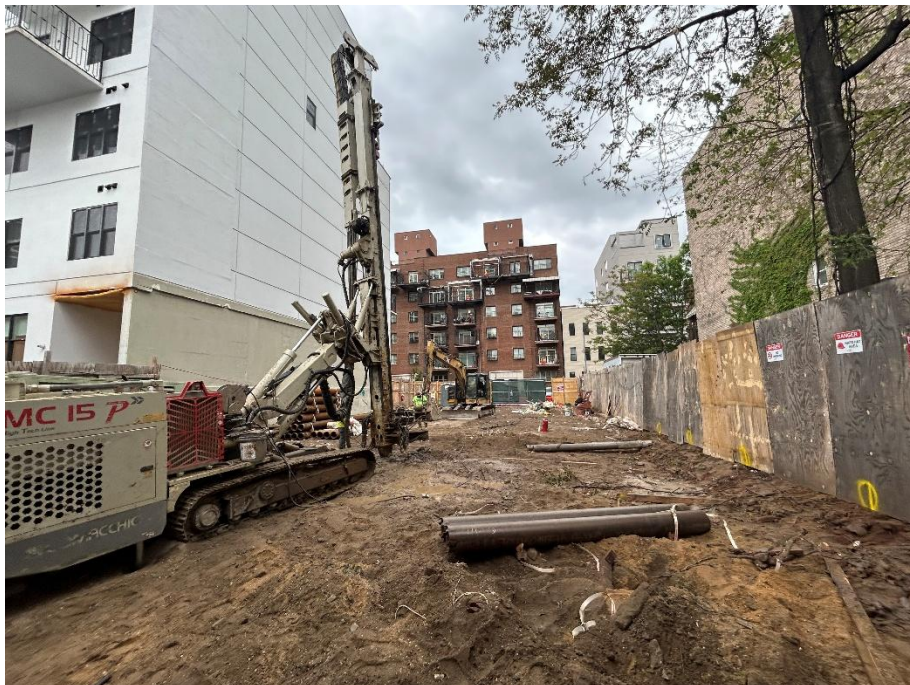
Photo 2: View of general site conditions at the end of the workday, facing south.
