# PHASE I ENVIRONMENTAL SITE ASSESSMENT

## VITAL BROOKLYN – SITES E, F, G, and H Brooklyn, New York

**Monadnock Development, LLC  
155 3<sup>rd</sup> Street  
Brooklyn, NY 11231**

**Langan Project No. 170655401**

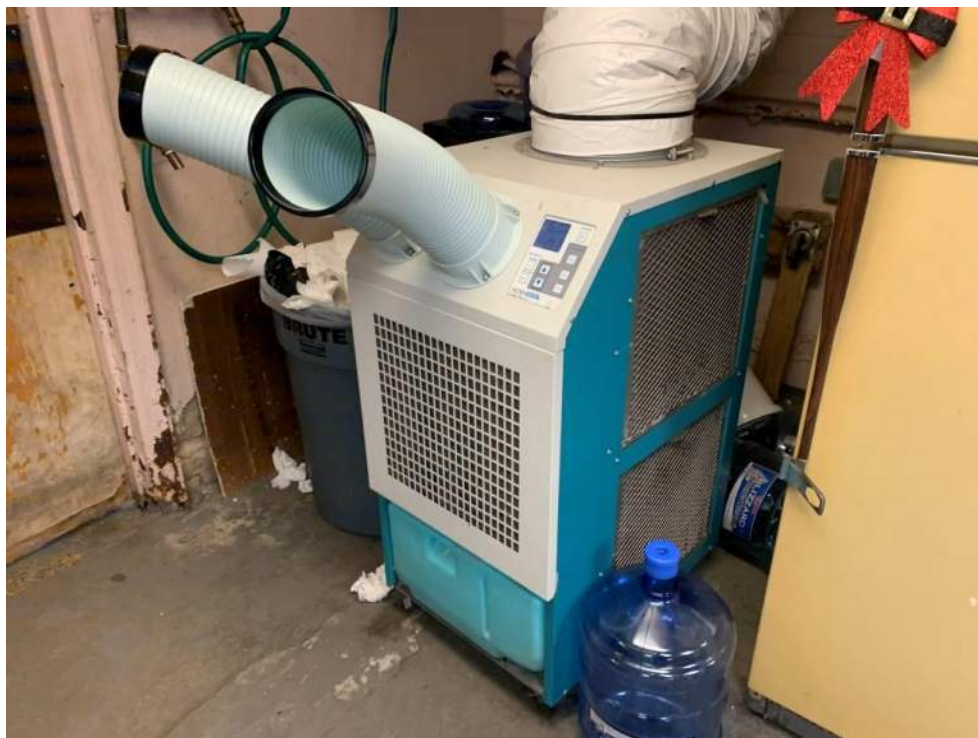
Photograph 3: View of portable air conditioning unit in partial cellar of the LeFrak building (facing east).

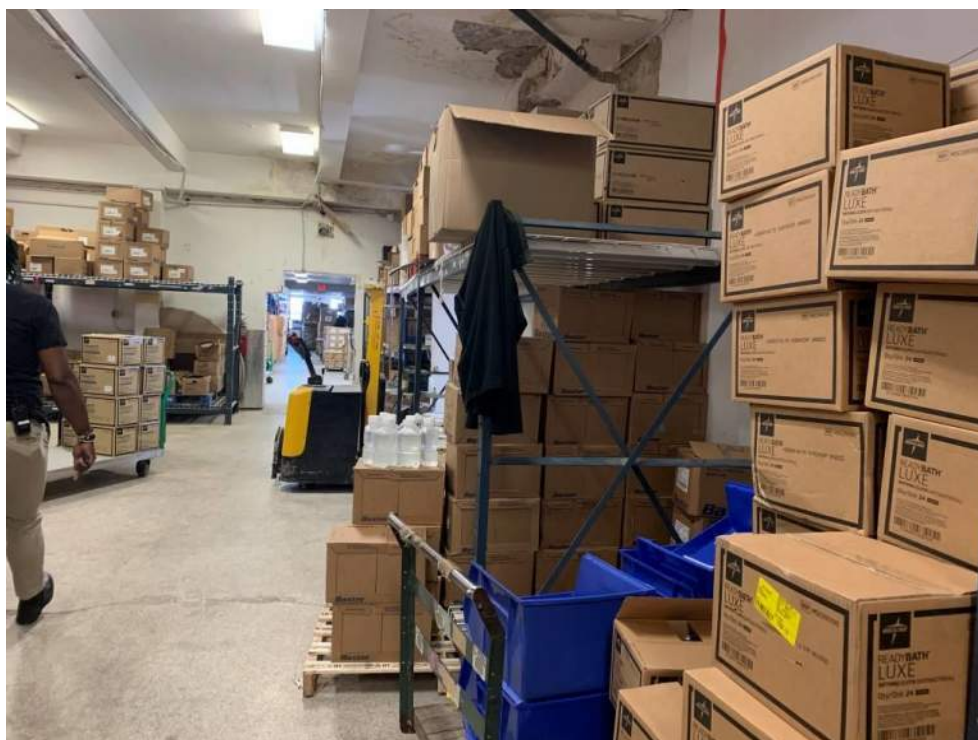
Photograph 4: General view of biomedical storage area on the third floors of the LeFrak and Blumberg buildings (facing west).

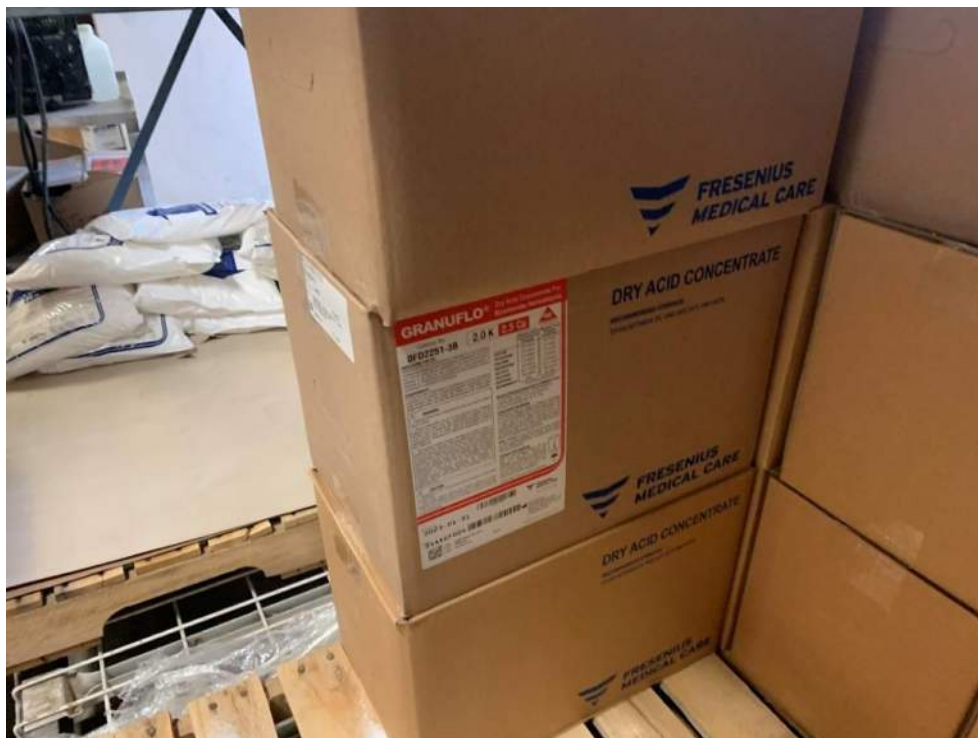
Photograph 5: View of dry acid concentrate in biomedical storage area on the third floor of the LeFrak building (facing northwest).

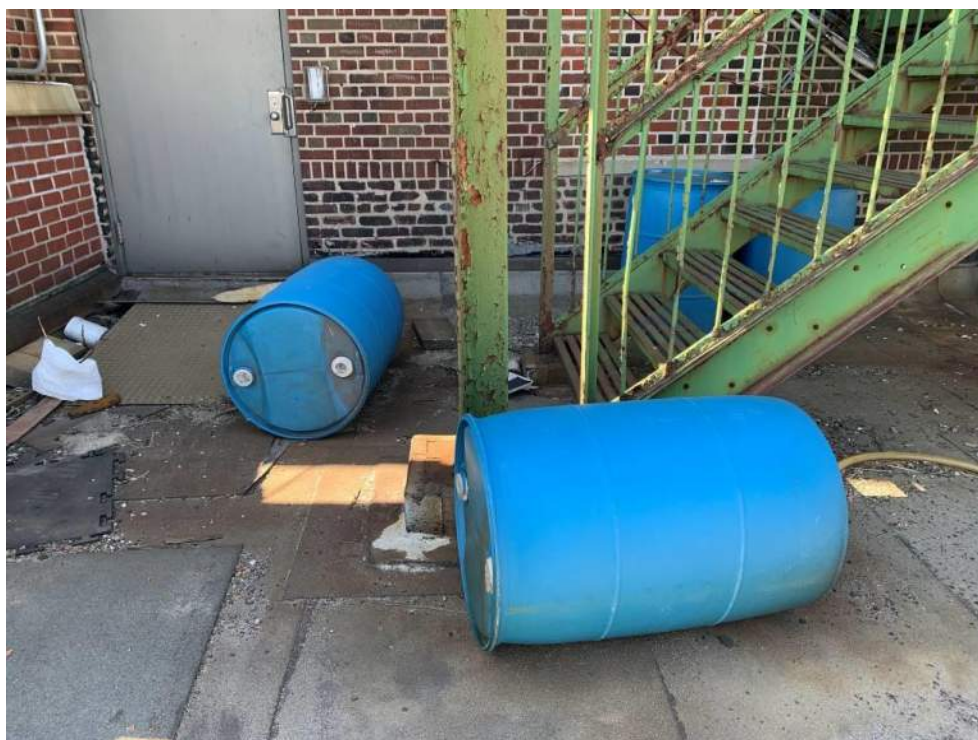
Photograph 6: View of plastic 55-gallon drums on the roof of the LeFrak building (facing west).

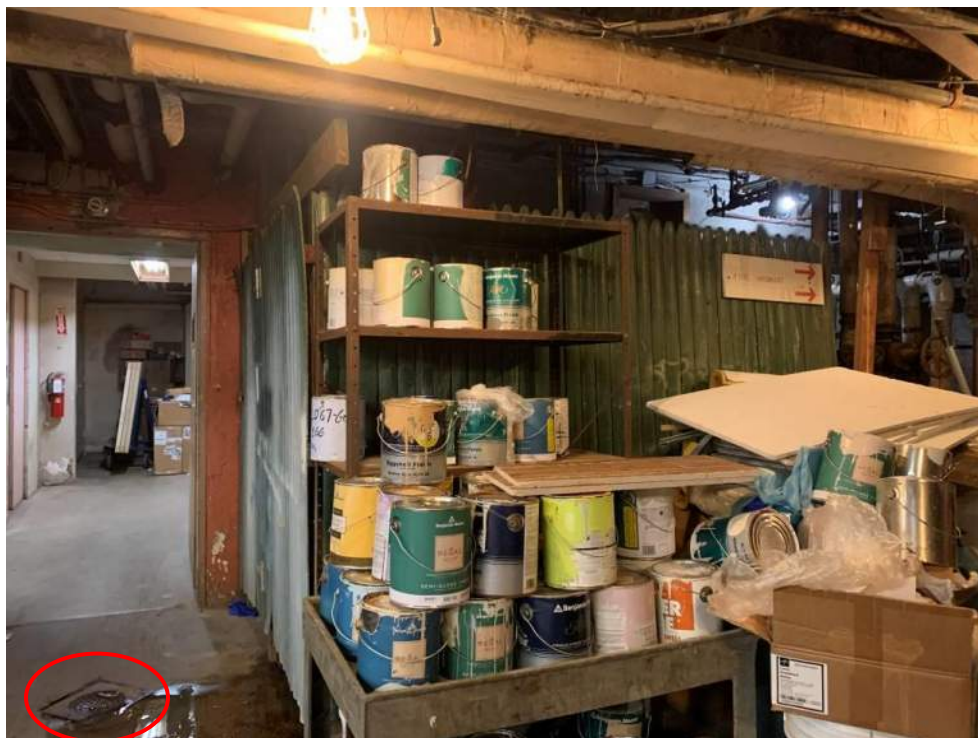
Photograph 9: View of paint storage and floor drain in maintenance area of Blumberg building cellar (facing northeast).

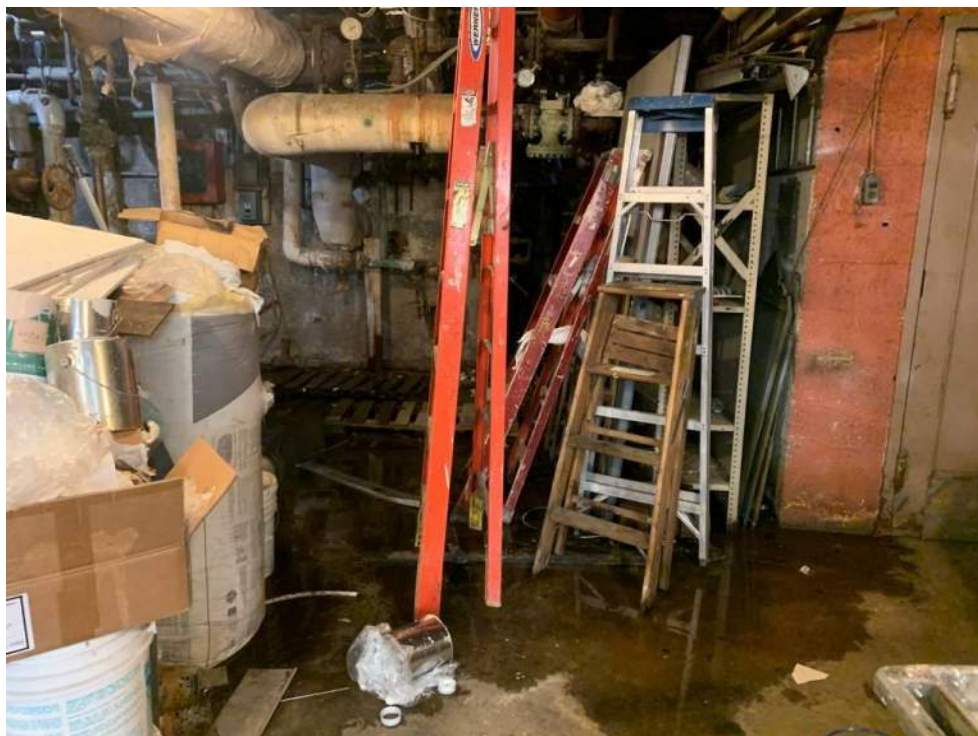
Photograph 10: View of standing water in maintenance area of Blumberg building cellar (facing east).

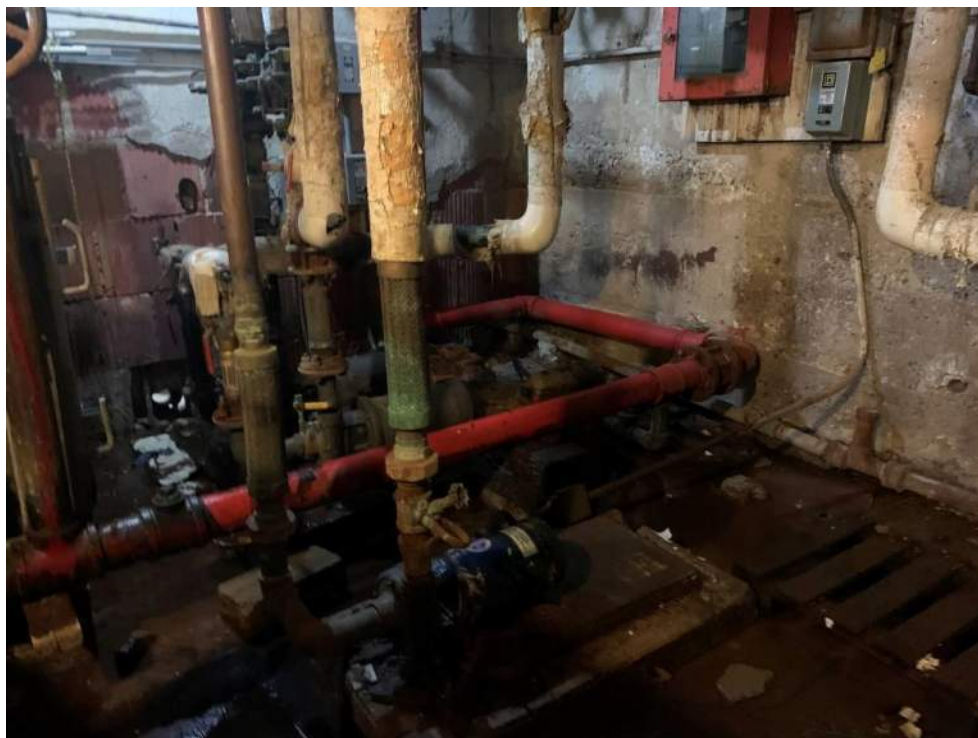
Photograph 11: View of leaking boiler in maintenance area of Blumberg building cellar (facing northeast).

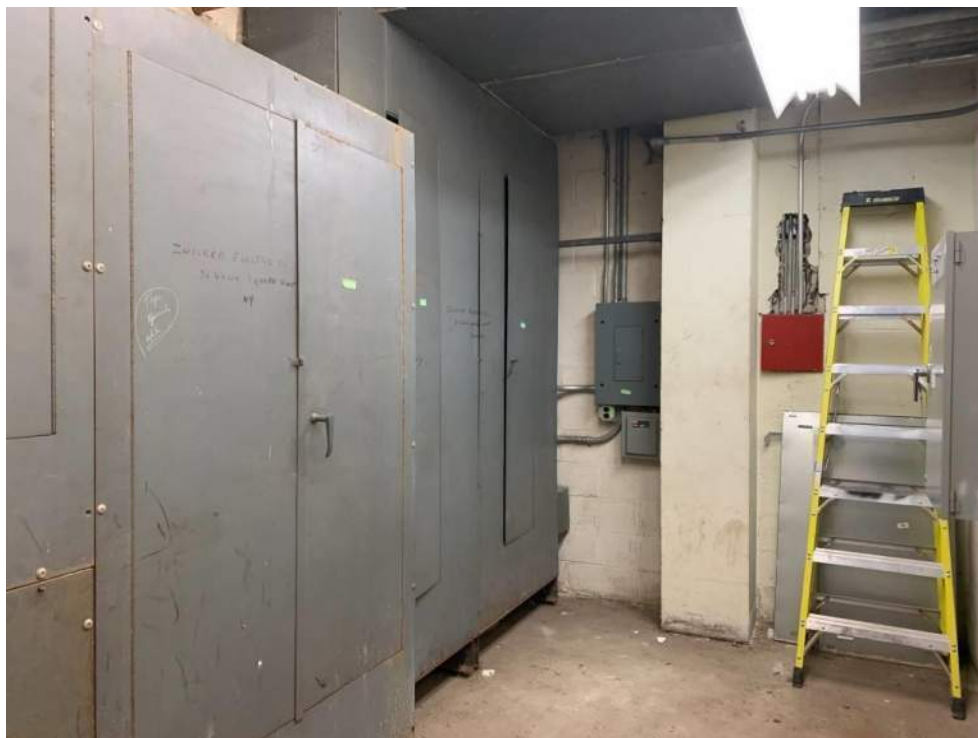
Photograph 19: View of electrical power boxes in cellar of the Masin building (facing north).

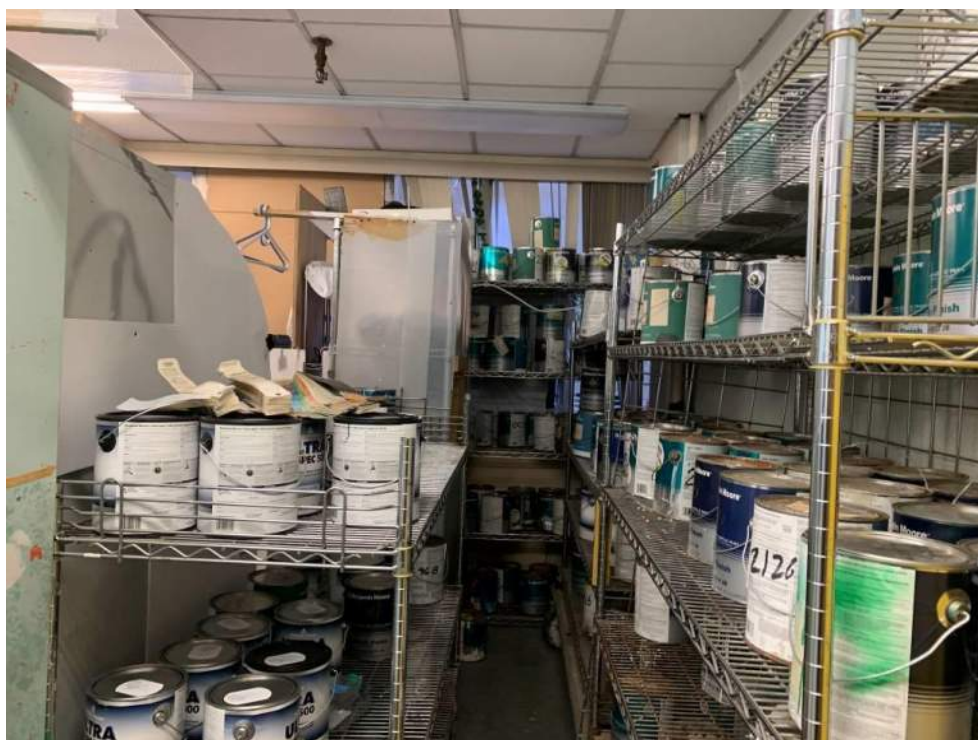
Photograph 20: View of paint storage room in cellar of the Masin building (facing south).

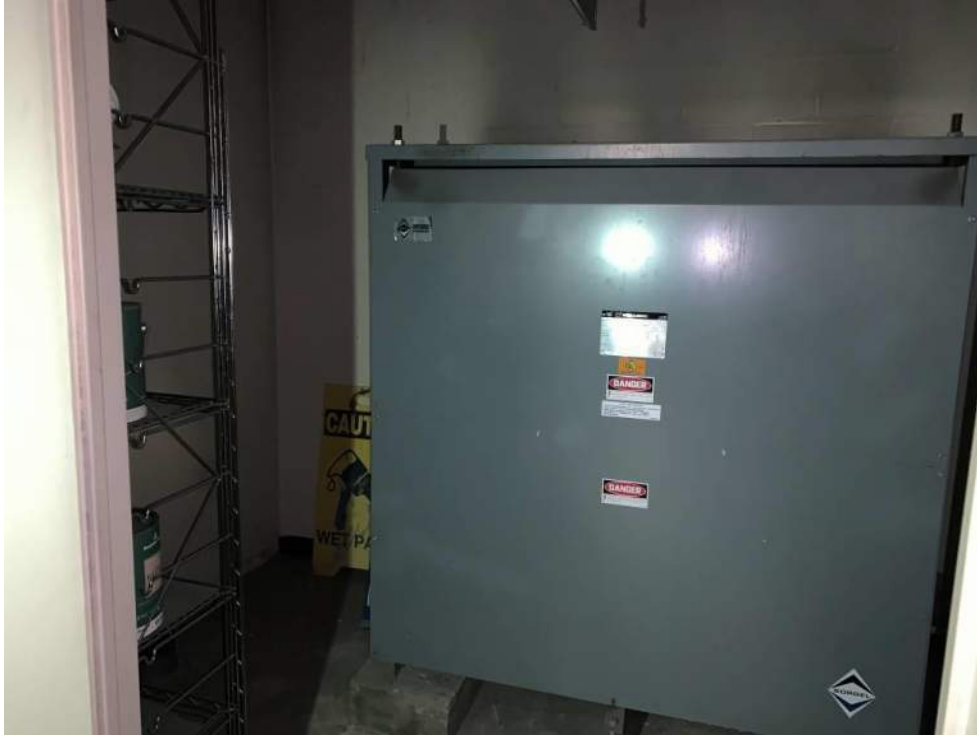
Photograph 21: View of a dry type transformer in cellar of the Masin building (facing east).

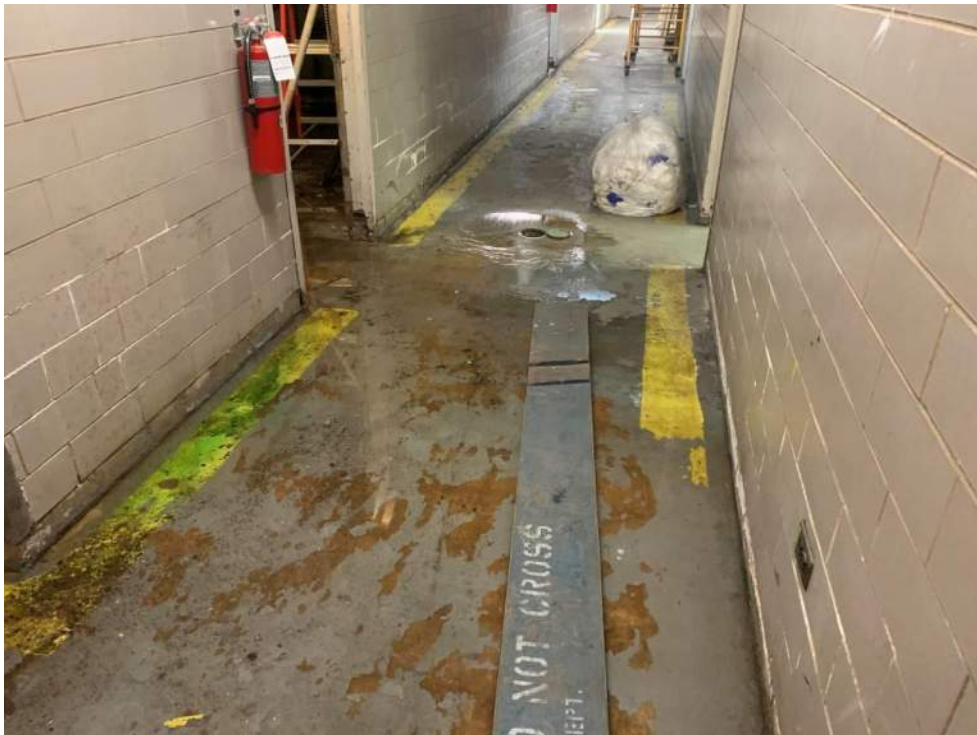
Photograph 22: View of leaking water from boiler room and floor drain in cellar of the Masin building (facing east).

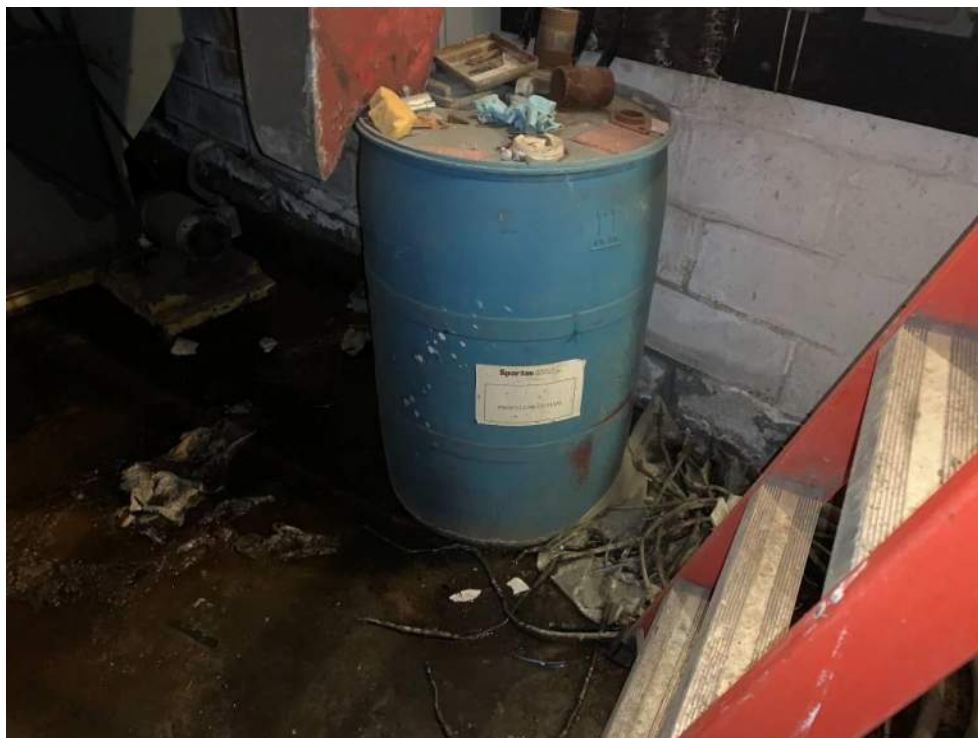
Photograph 23: View of plastic 55-gallon drum of propylene glycol in boiler room of Masin cellar (facing southeast).

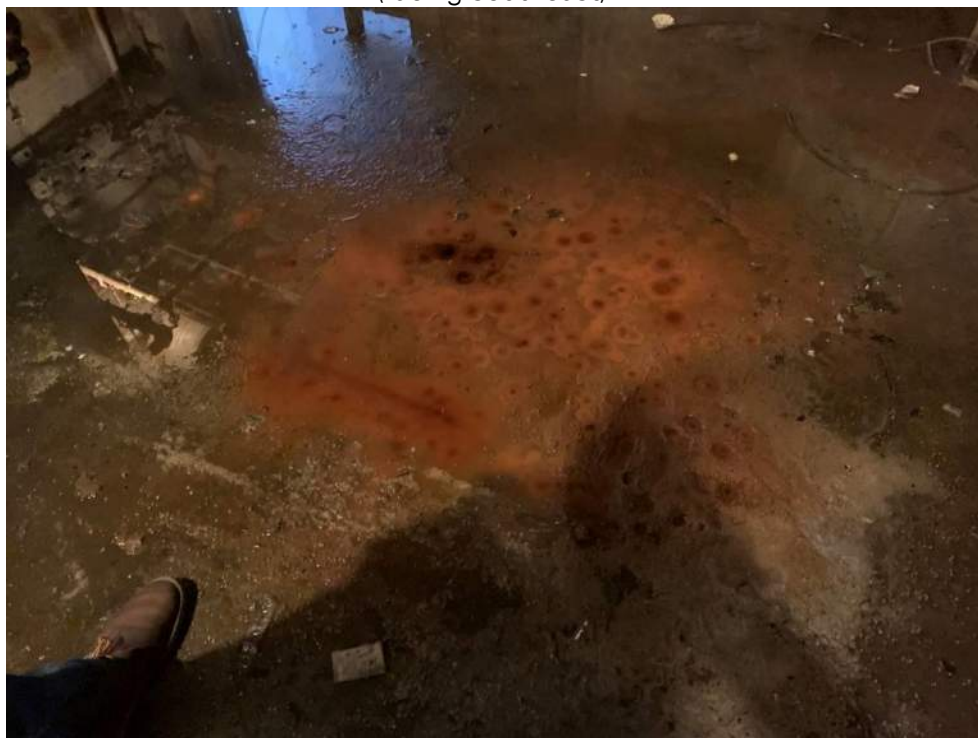
Photograph 24: View of rust-stained concrete and standing water in boiler room of Masin cellar (facing northwest).

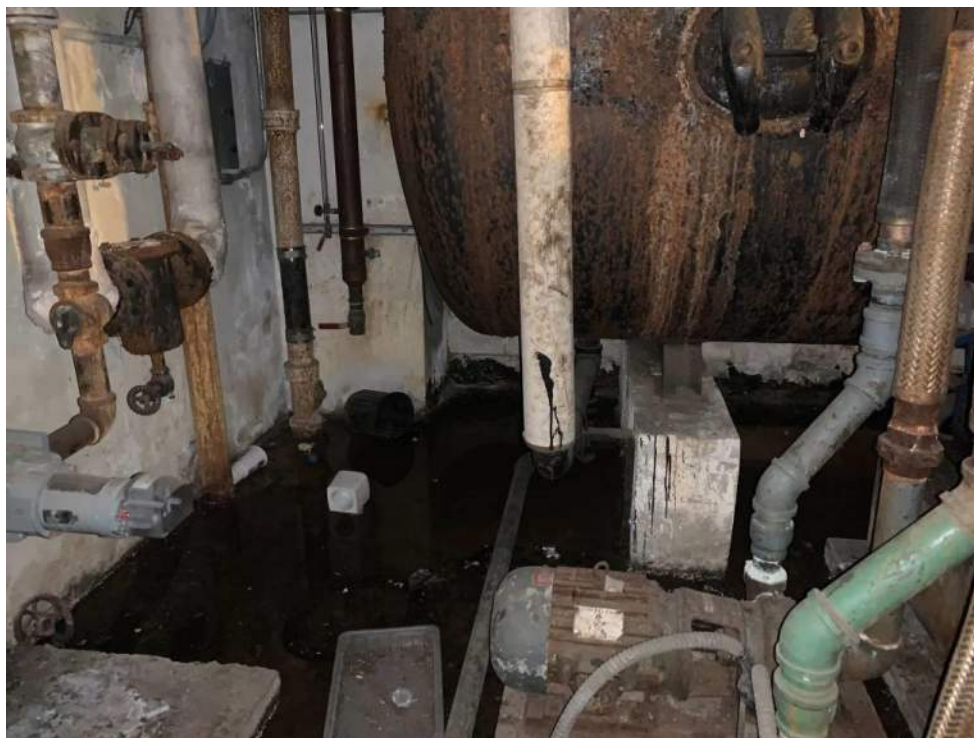
Photograph 25: View of hot water tank and standing water in boiler room of Masin cellar (facing east).

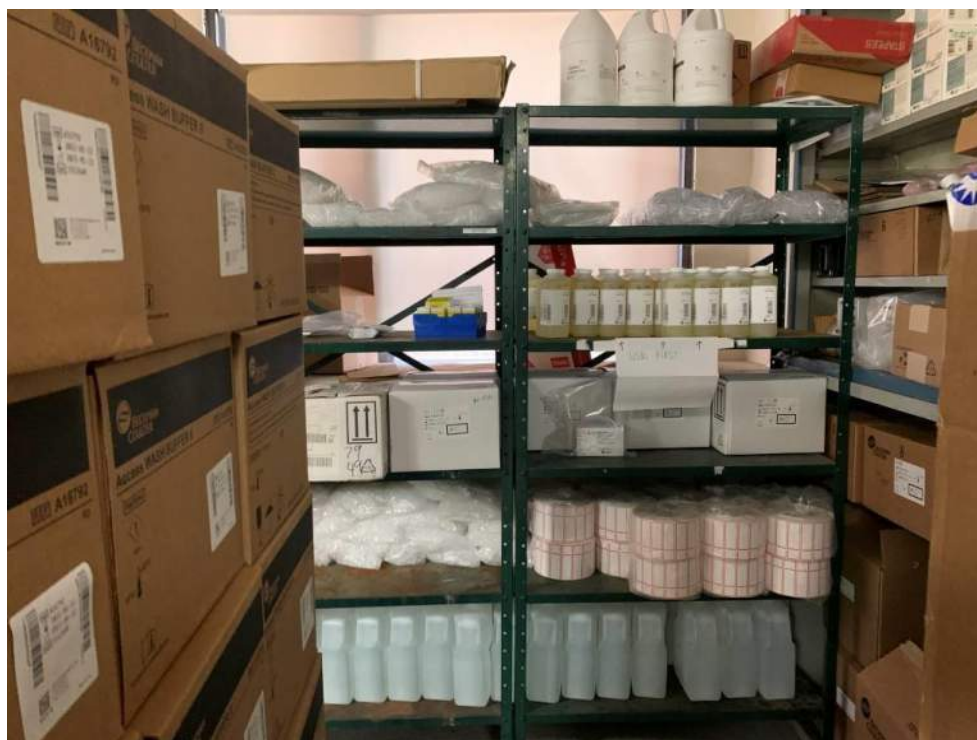
Photograph 26: View of chemical storage room on third floor of the Masin building (facing south).

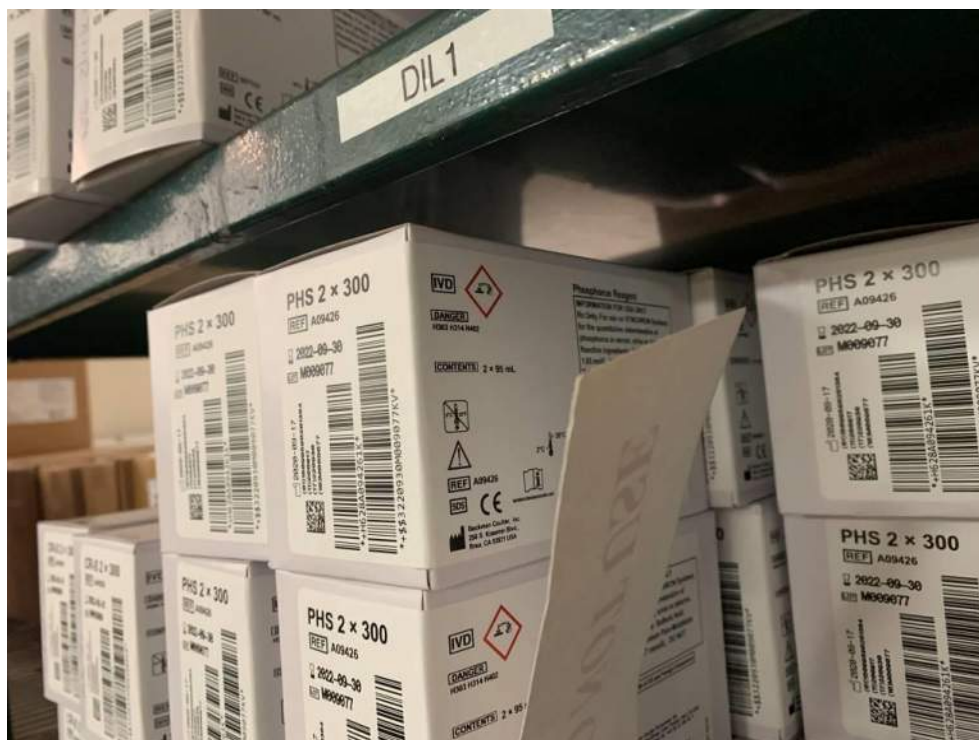
Photograph 27: View of phosphorous reagent in chemical storage room in the Masin building (facing northwest).

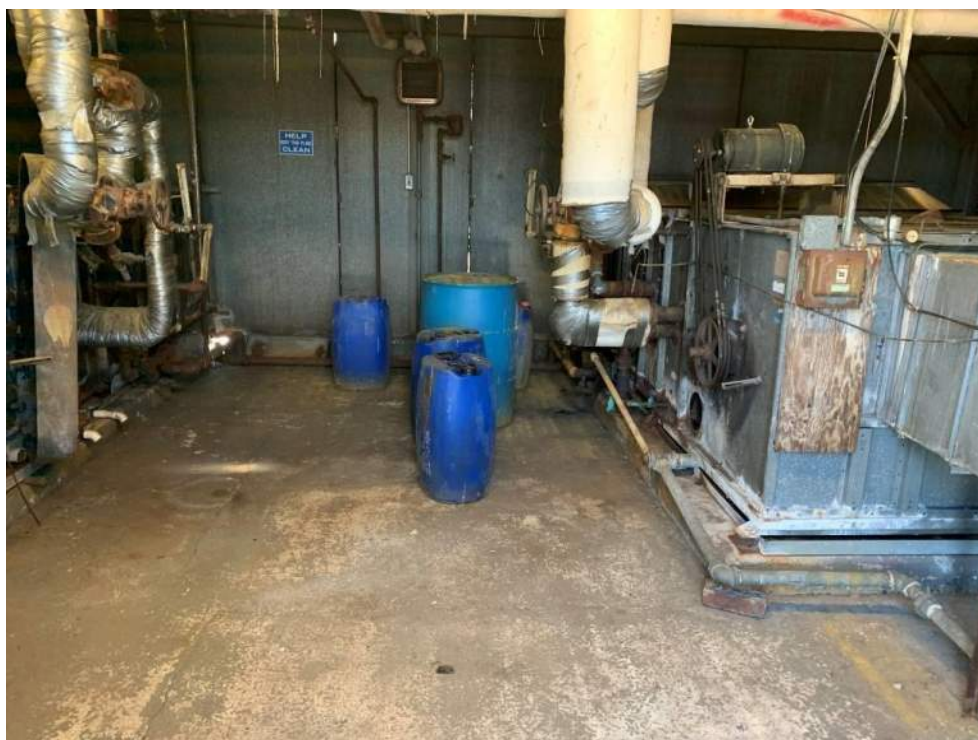
Photograph 32: View of plastic drums with unknown contents and HVAC system in maintenance area on roof of the Masin building (facing south).

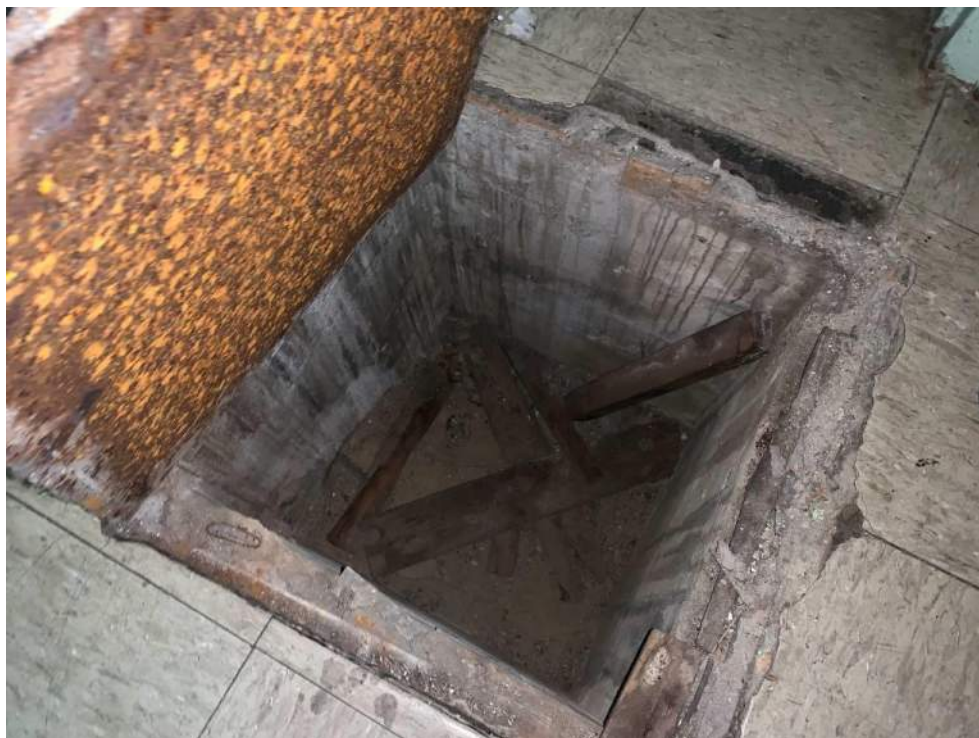
Photograph 34: View of sump pit in cellar of the Leviton building (facing west).

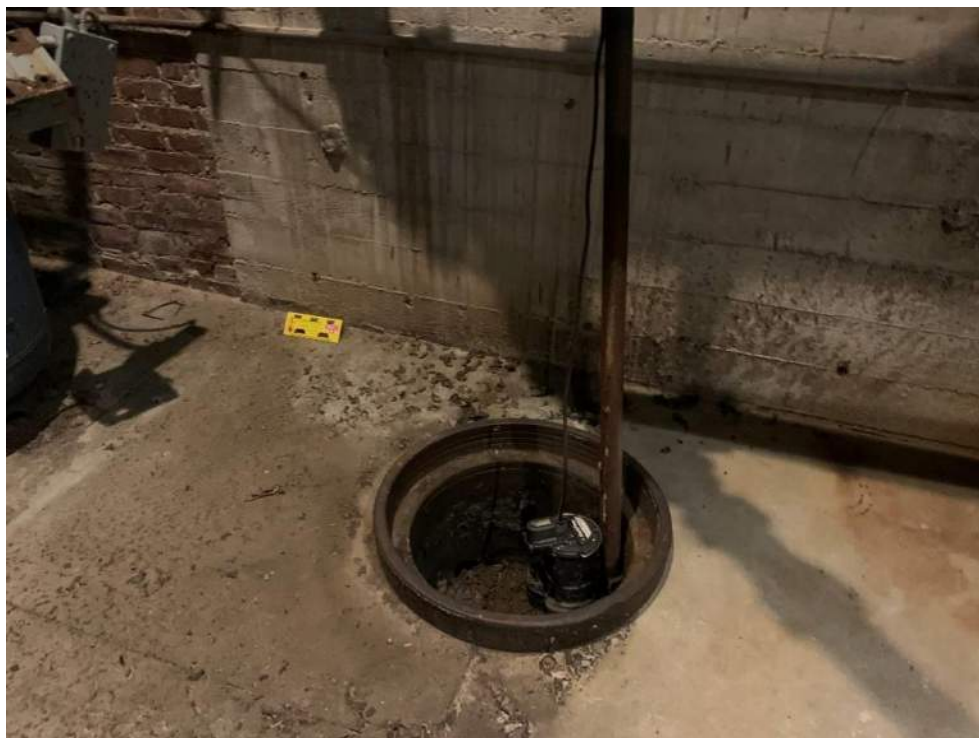
Photograph 36: View of sump in the boiler room of the Leviton cellar (facing east).

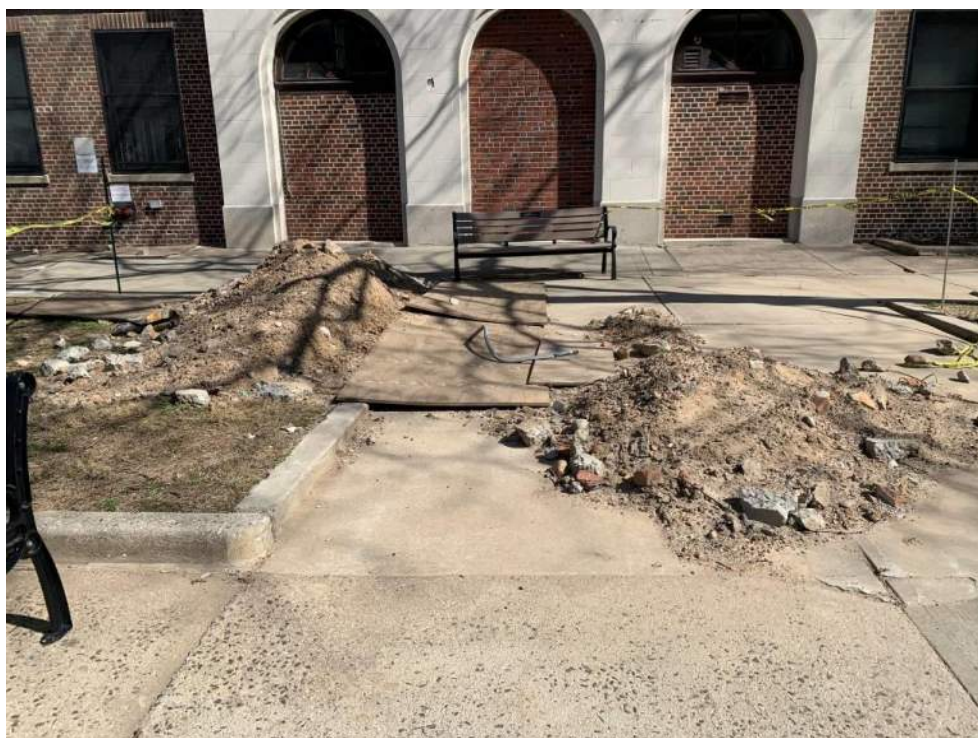
Fill was observed in stockpiles located near to where a buried steam pipe was previously repaired. Fill found in urban environments typically contains ash, demolition debris, and/or

Fill was observed in soil stockpiles in an excavated area during the site reconnaissance. Fill found in urban environments typically contains ash, demolition debris, and/or municipal waste products and may contain contaminants (e.g., semivolatile organic compounds [SVOCs] or metals) at concentrations above regulatory standards. The likely presence of fill at the Subject Property will require implementation of soil handling and management procedures during future site redevelopment to address excavation, re-use, handling, and off-site disposal, which may result in material cost to the User. As such, the presence of fill at the Subject Property is considered a BER.

Photograph 38: View of stockpiled soil in the courtyard outside of the Blumberg building (facing east).

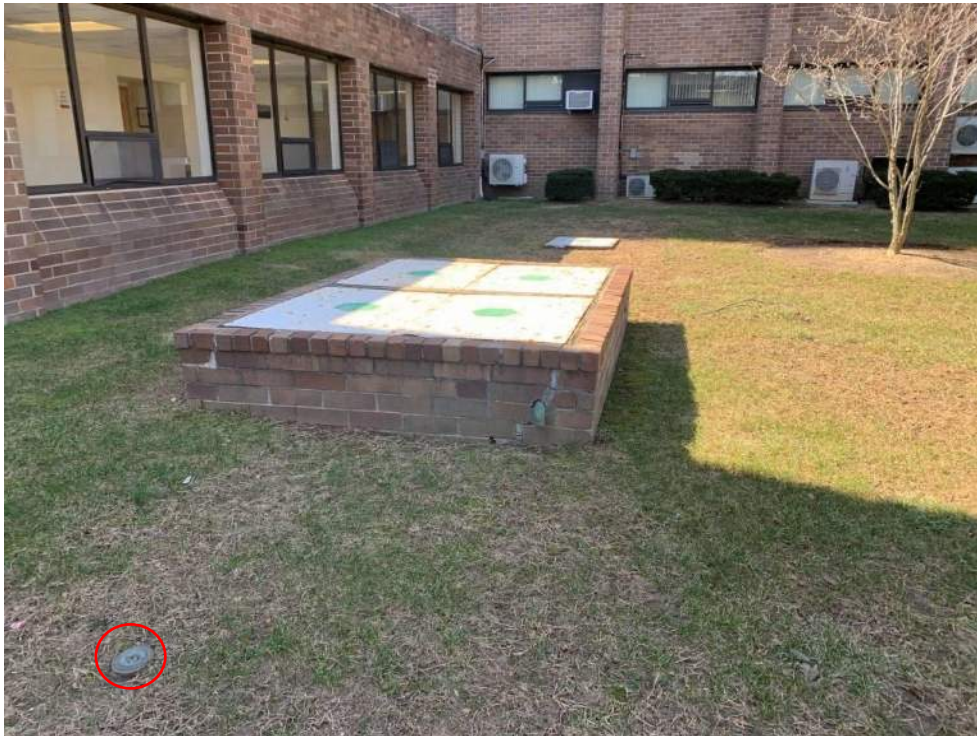
Photograph 41: View of 40,000 gallon No. 6 Fuel Oil underground storage tank (UST) vault and fill port on southern adjoining property in courtyard (facing west).

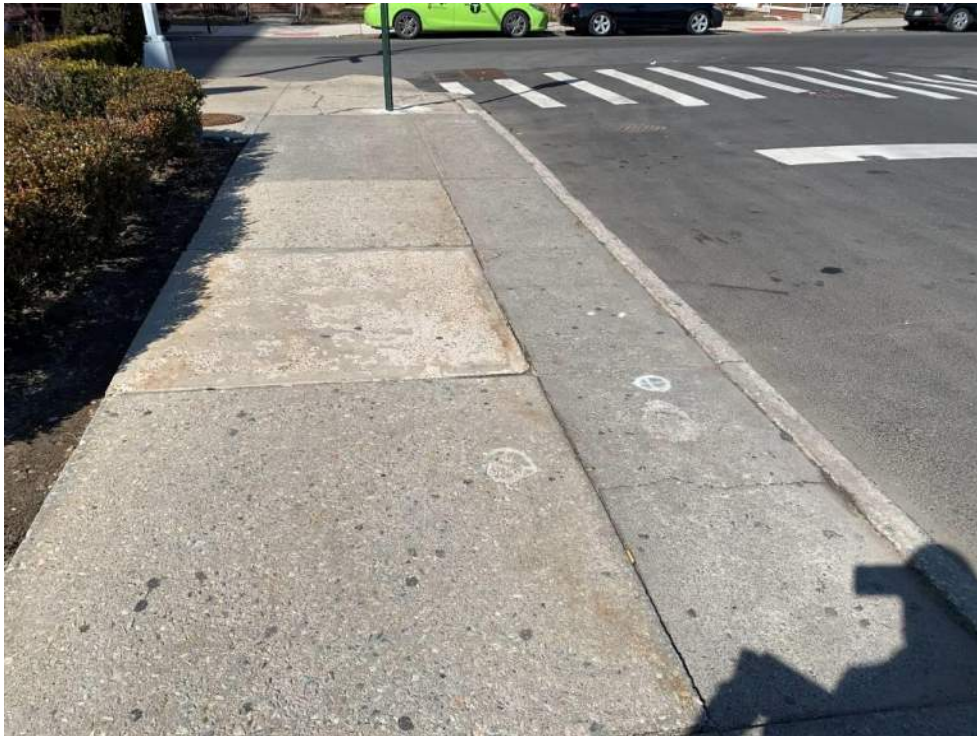
Photograph 43: View of patched concrete in potential borehole locations on sidewalk near the LeFrak building entrance (facing north).

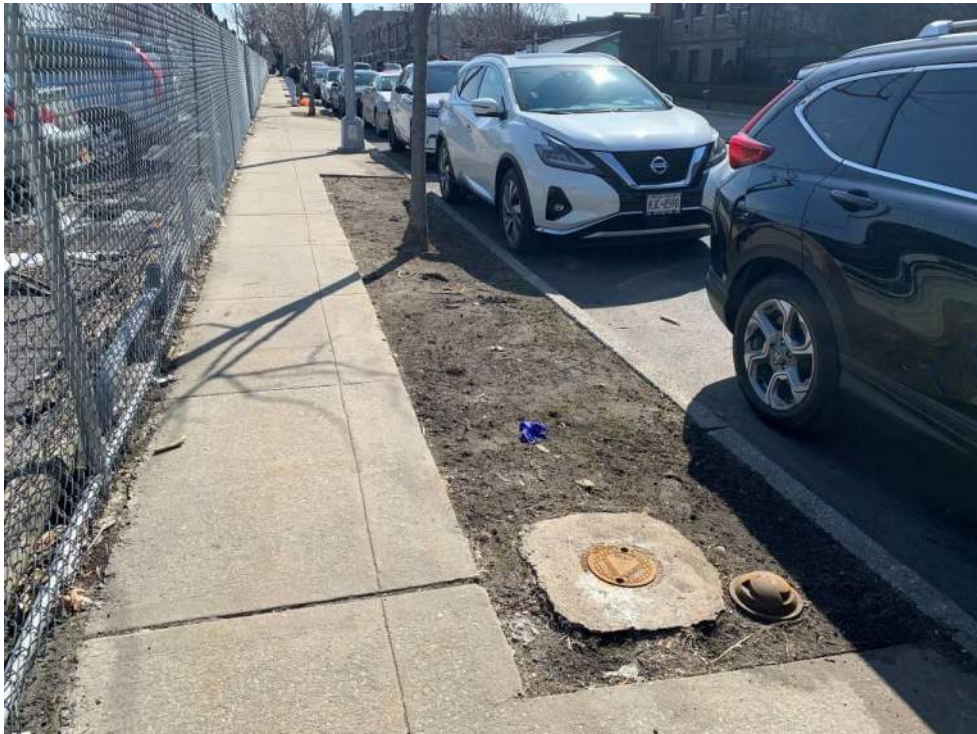
- Groundwater monitoring wells associated with an adjoining gasoline station spill were observed throughout the eastern part of the site (a.k.a Vital Brooklyn Parcel K).

Photograph 44: View of monitoring well on western-adjointing property sidewalk located west of the LeFrak building (facing south).

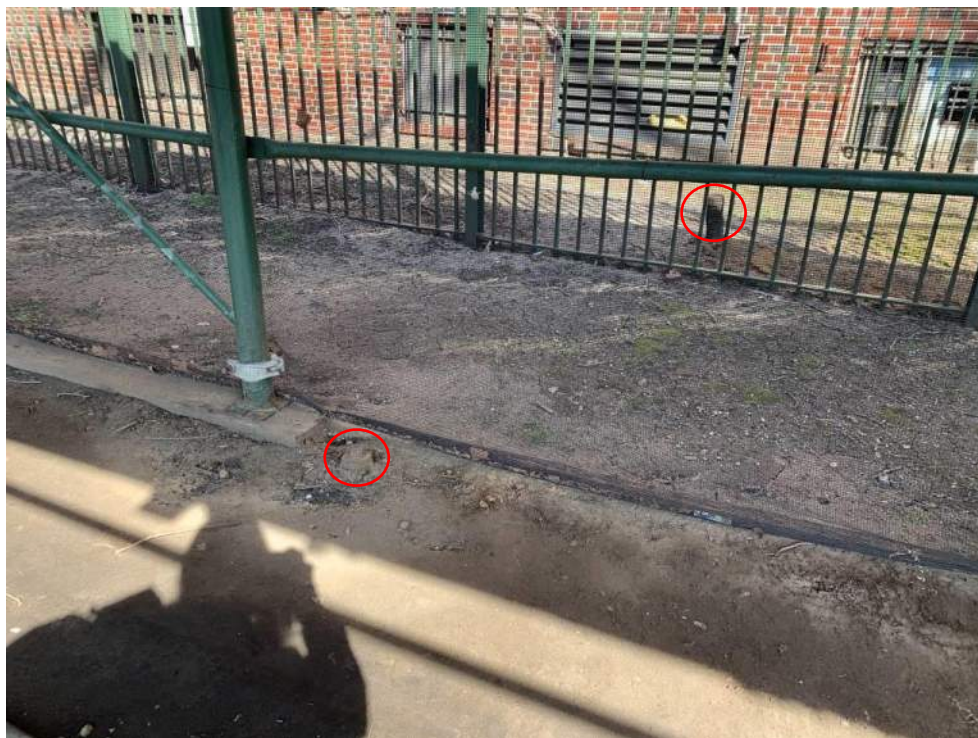
Photograph 47: View of fill port and vent pipe along Leviton exterior from Schenectady Avenue (facing northeast).
