# PHASE I ENVIRONMENTAL SITE ASSESSMENT

## VITAL BROOKLYN – SITES E, F, G, and H Brooklyn, New York

**January 14, 2022  
Langan Project No. 170655401**

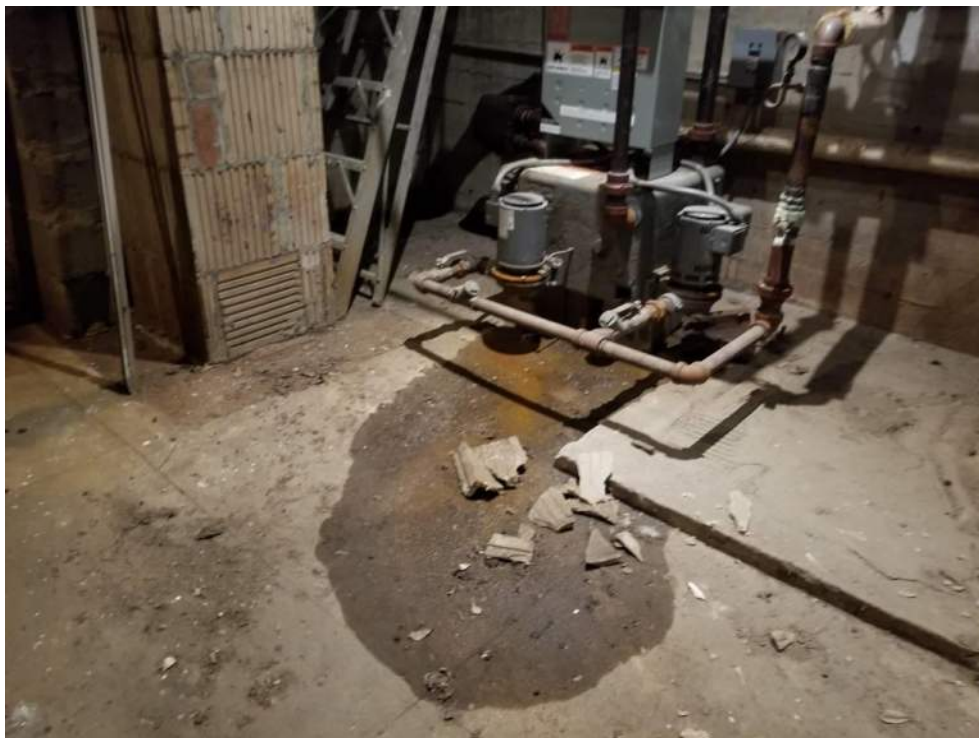
A damp concrete area was observed beneath a heating ventilation and air conditioning (HVAC) unit in the cellar of the Leviton building. Neither staining nor chemical odors were observed.

Photograph 7: View of water and rust staining beneath a pump in the cellar of the Leviton building (facing south).

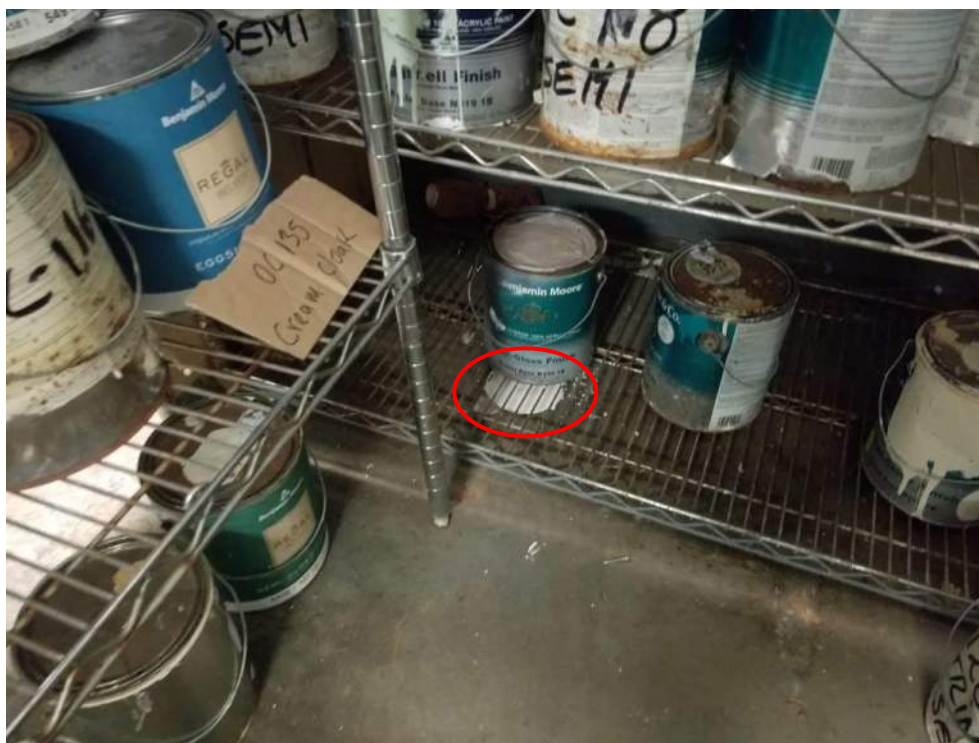
Three rooms in the cellar of the Masin building contained large quantities of paint in one- to five-gallon containers. Paint was observed on the floor beneath the paint storage area; however, these

releases were observed atop concrete in good condition, with no significant cracks or discontinuities.

Photograph 14: View of paint storage in the cellar of the Masin building and a release of paint atop the concrete slab (facing west).

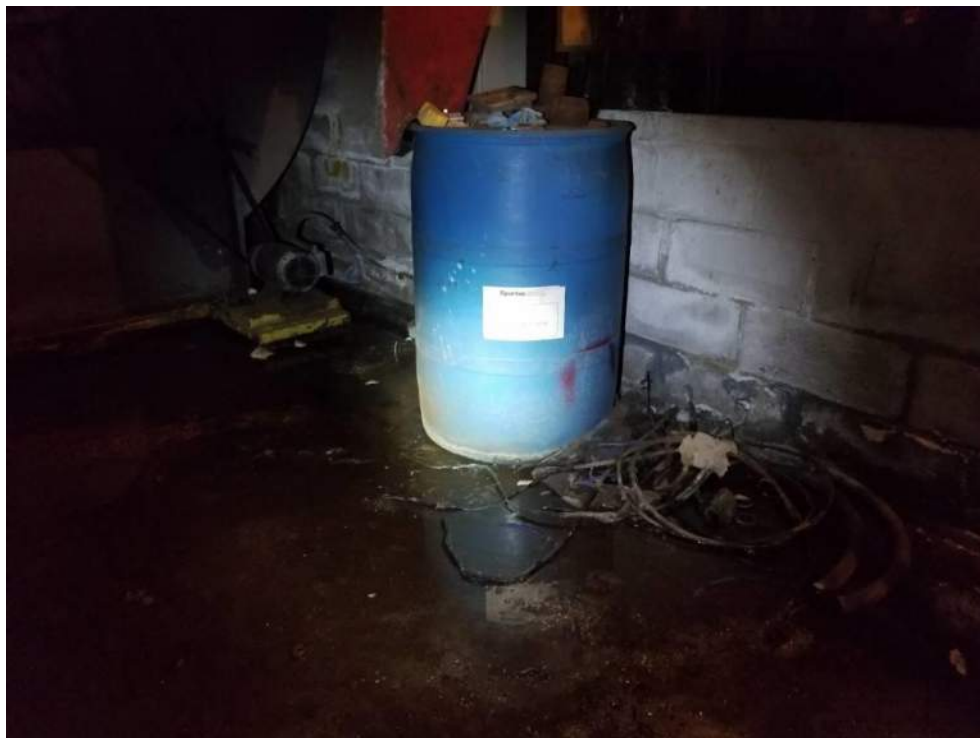
One 55-gallon plastic drum of propylene glycol was observed in the former boiler room in the cellar of the Masin building. The drum was staged on a concrete slab which appeared to be in good condition with no staining beneath or around the drum. Four 55-gallon plastic drums of unknown contents were observed staged atop intact roofing material outside the fire exit on the roof of the LeFrak building. One of the drums was positioned on its side; however, all of the drums appeared to be in good condition.

Photograph 19: View of plastic 55-gallon drum of propylene glycol in boiler room of Masin cellar (facing southeast).

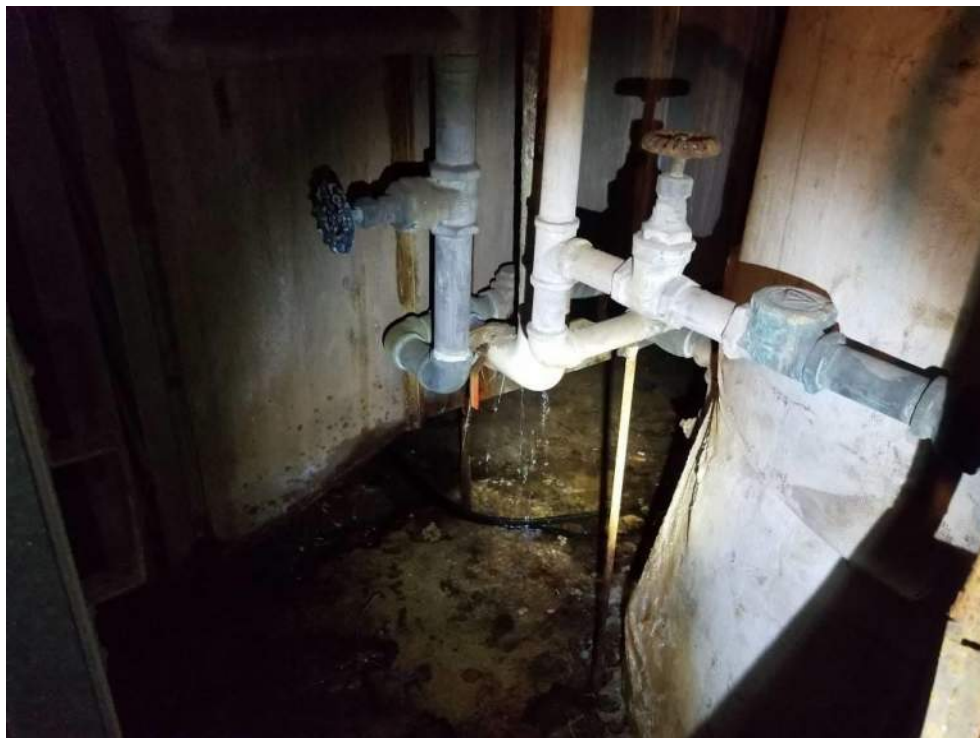
About 1- to 4- inches of standing water was observed in a utility room in the cellar of the Masin building. The water appeared to be leaking from piping attached to the hot water tank and precipitation entering through an open exterior door. Rust-like staining was observed on the concrete slab beneath the leaking pipes; however, neither odor nor evidence of a release of hazardous substances or petroleum were observed.

Photograph 21: View of leaking pipes in the former boiler room in the cellar of the Masin building (facing north).

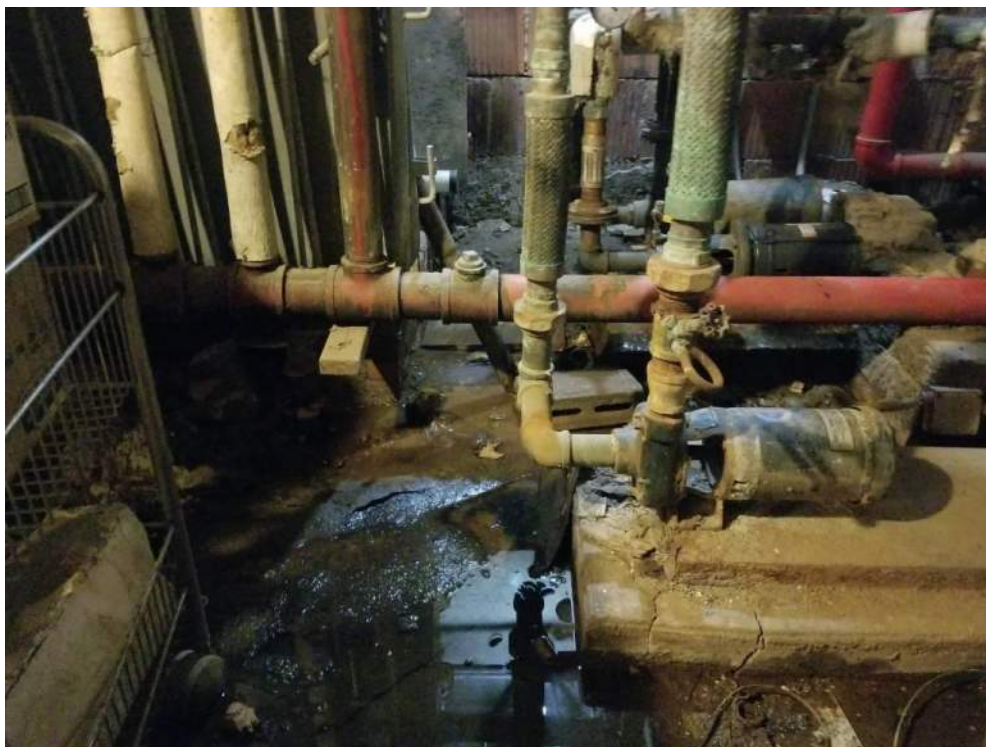
Standing water was observed within the maintenance area in the cellar of the Blumberg building near a hot water tank which appeared to have leaking pipes. Neither staining nor chemical odors were observed.

Photograph 22: View of leaking boiler in maintenance area of Blumberg building cellar (facing south).

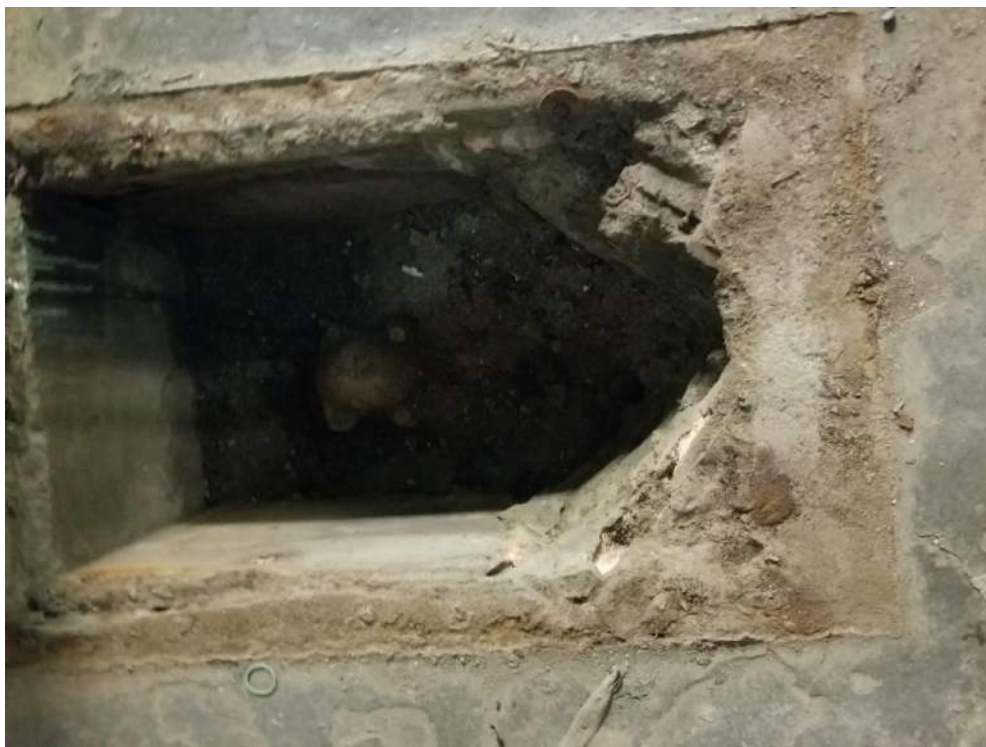
A sewage cleanout pit was observed in the cellar of the Leviton building. The pit was observed to be dry and the sides constructed on concrete; however, soil and debris prevented inspection of the base of the pit.

Photograph 23: View of sewer cleanout pit in the cellar of the Blumberg building (facing south).

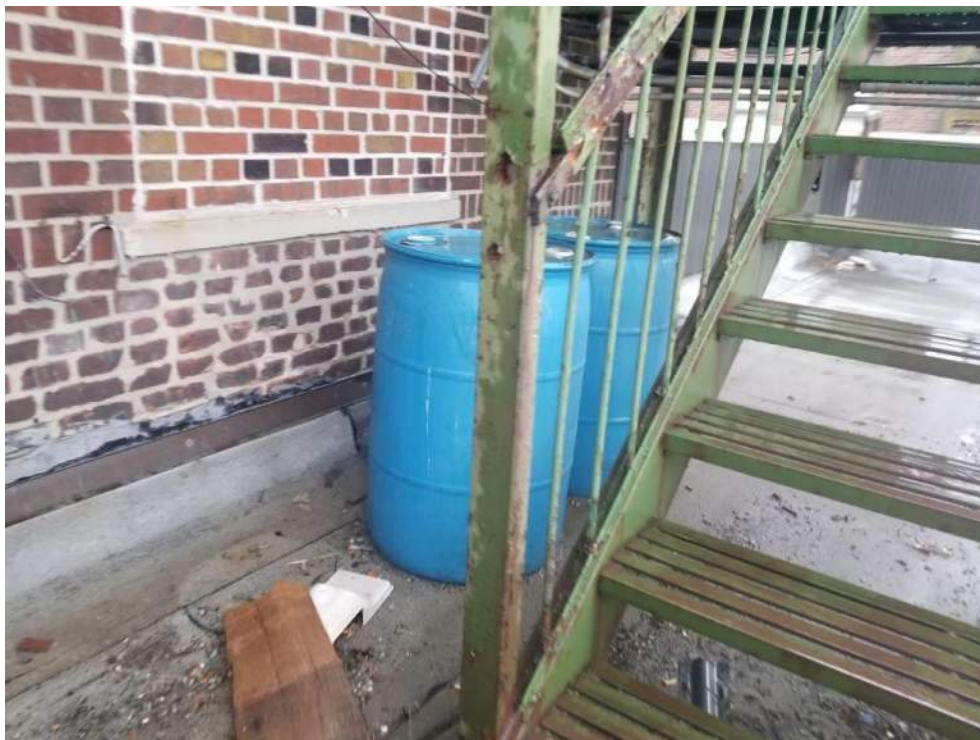
Photograph 27: View of two unlabeled plastic 55-gallon drums on the roof of the LeFrak building (facing north).

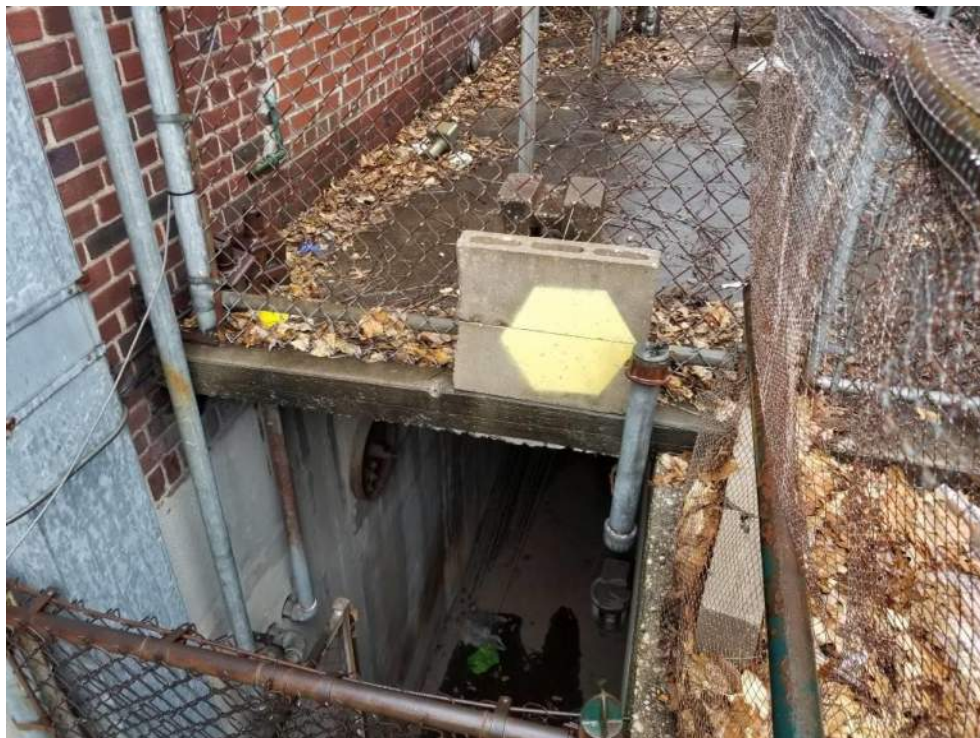
Photograph 31: View of a diesel tank fill port on the southeastern adjoining building (facing north).

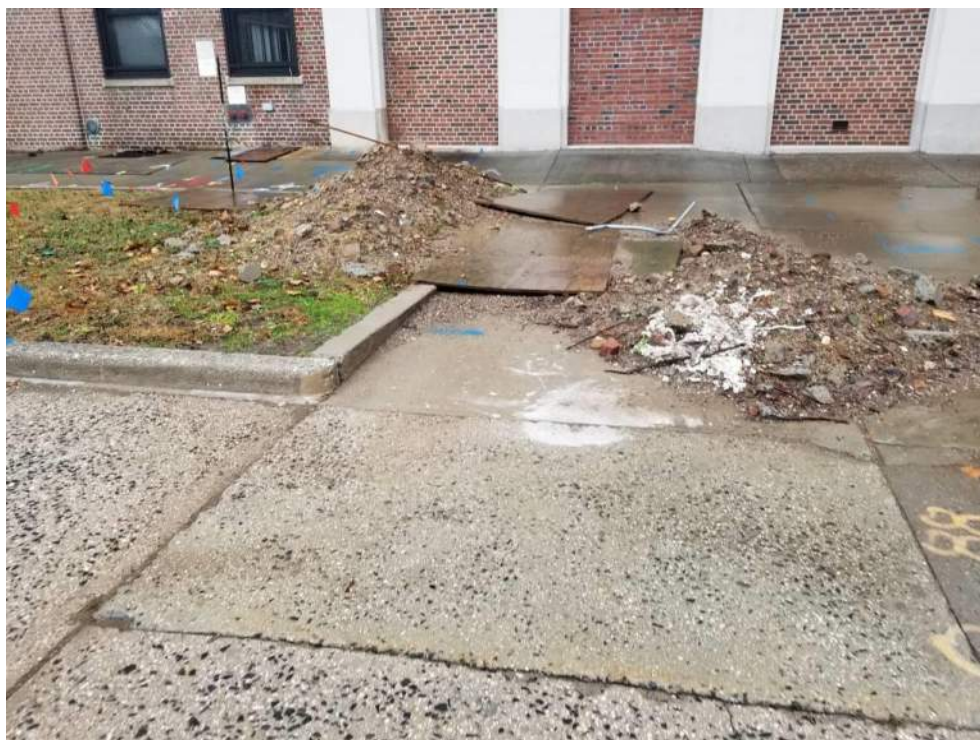
Photograph 33: View of stockpiled soil in the courtyard outside of the Blumberg building (facing east).

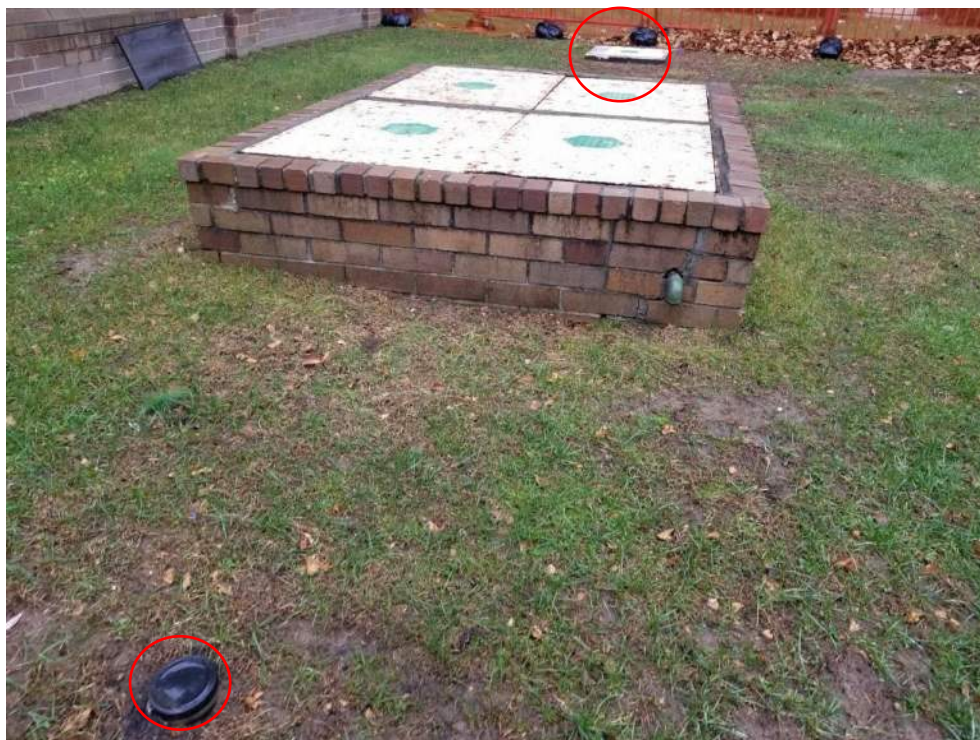
Photograph 35: View of 40,000 gallon No. 6 Fuel Oil underground storage tank (UST) vault and fill port and access hatch on southern adjoining property in courtyard (facing west).
