Re: Corrective Measures Implementation
River Place II
New York, New York
Langan Project No.: 170040901

Langan Engineering, Environmental, Surveying and Landscape Architecture, D.P.C. (Langan) prepared this Corrective Measures Implementation Memorandum to summarize mitigation of water intrusion observed in isolated areas of the boiler room and the oil tank room at River Place II (the site) in Manhattan, New York. The site is owned by River Place II, LLC (the owner) and is improved with a 59-story, high-rise residential apartment building with two cellar levels. The site was remediated under the New York State Department of Environmental Conservation (NYSDEC) Brownfield Cleanup Program (BCP Site C231012) and is managed under the July 2006 Site Management Plan (SMP). This Memorandum provides a brief site background, summary of site observations, and description of the corrective measures implemented.

Corrective Measures Implementation
River Place II
New York, New York
Langan Project No.: 170040901
January 29, 2016 - Page 2 of 4

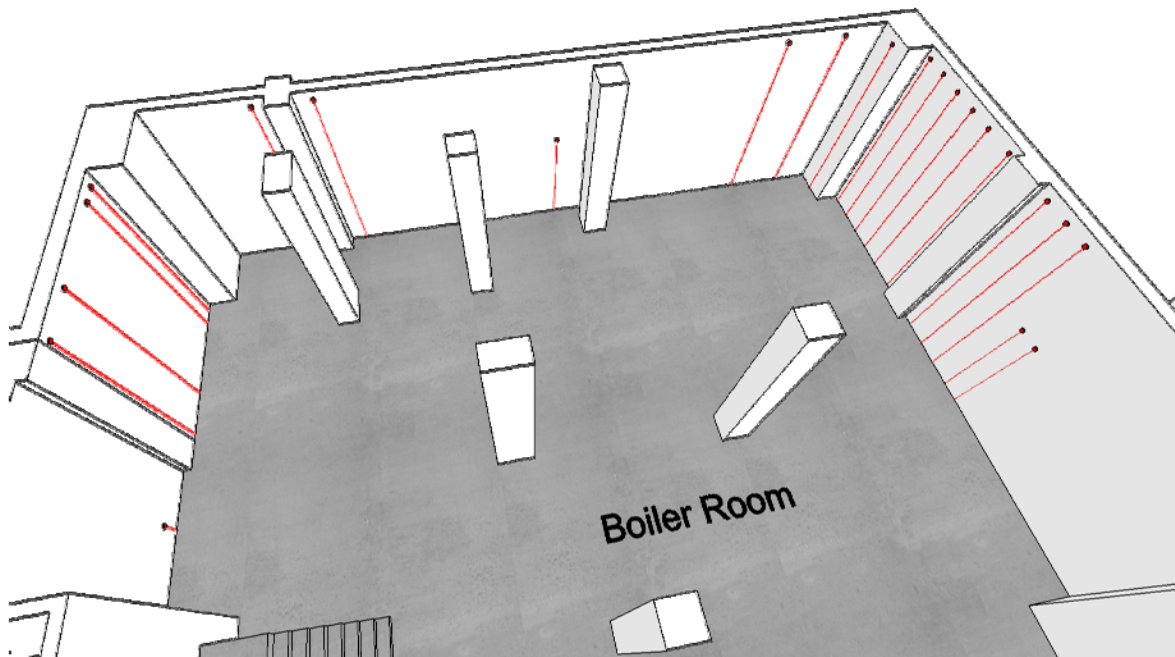
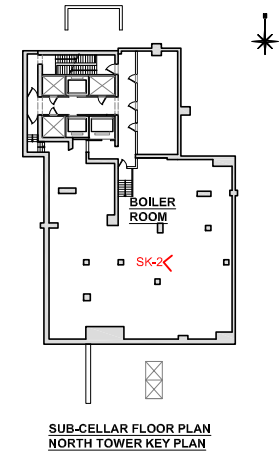
SHEET: SK-1

TITLE: AREA OF SUB-CELLAR LEAKAGE

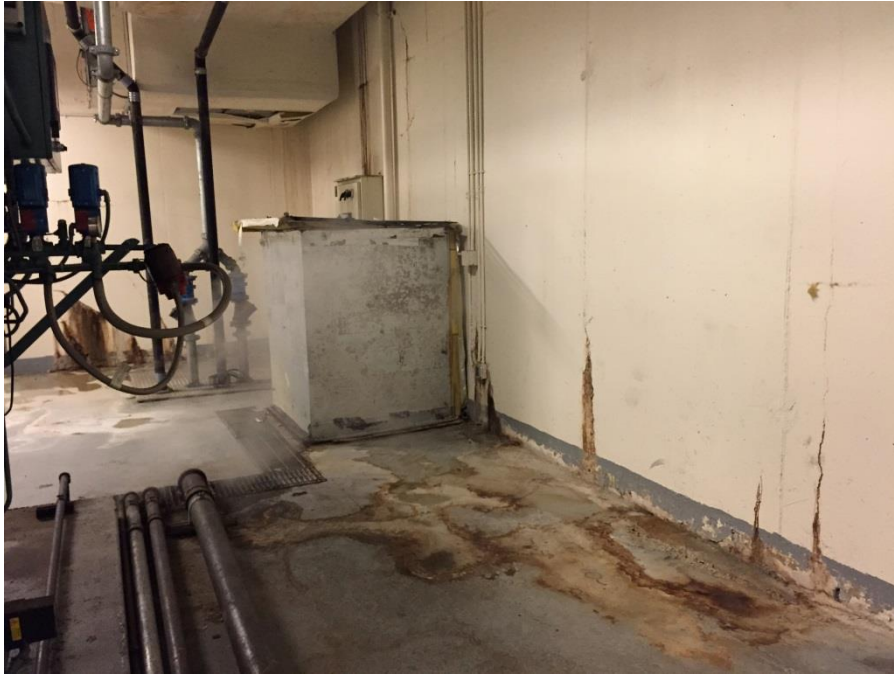
Photograph 1: View of leaks in sub cellar (8/6/15).

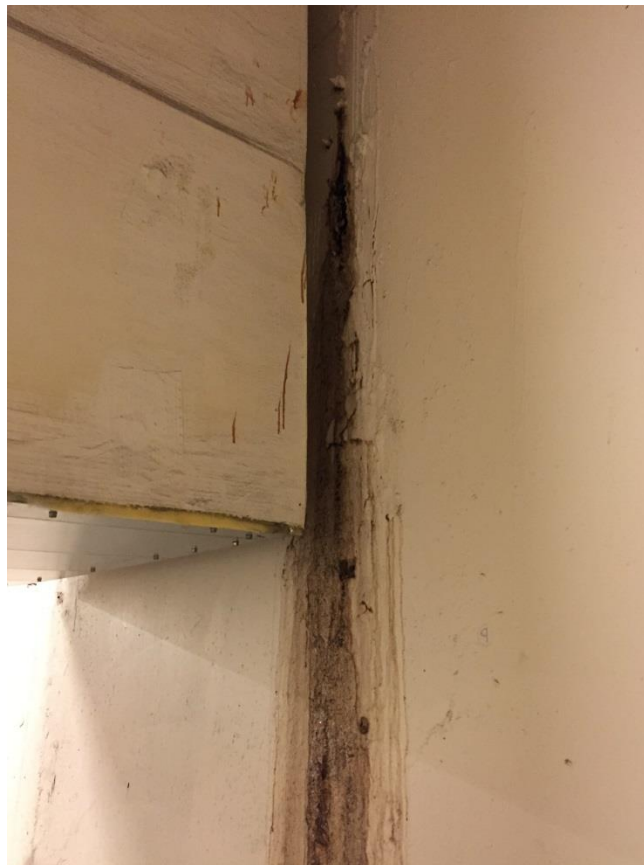
Photograph 2: View of leaks in sub cellar (8/6/15).

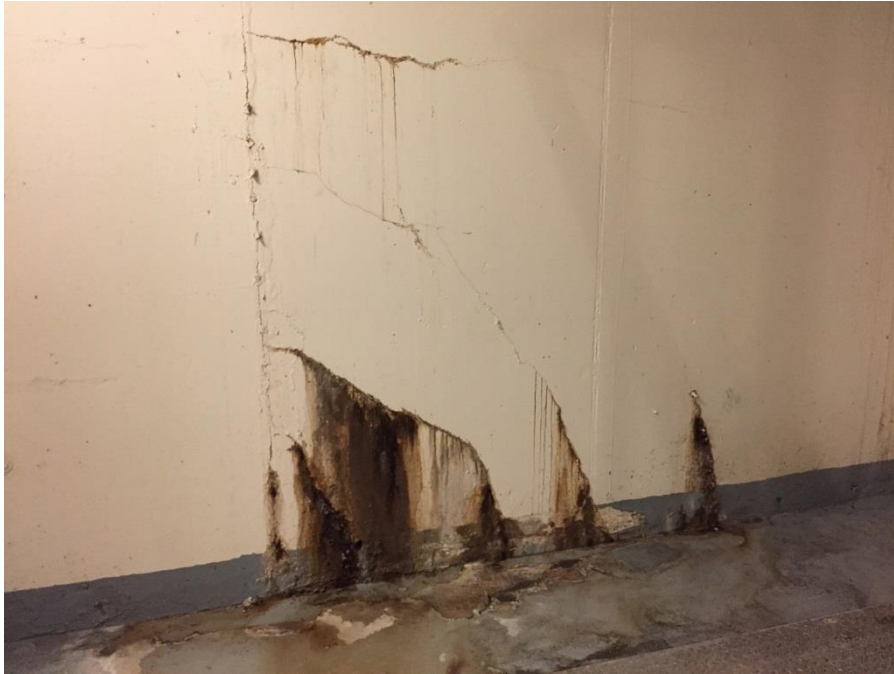
Photograph 3: View of leaks in sub cellar (8/6/15).

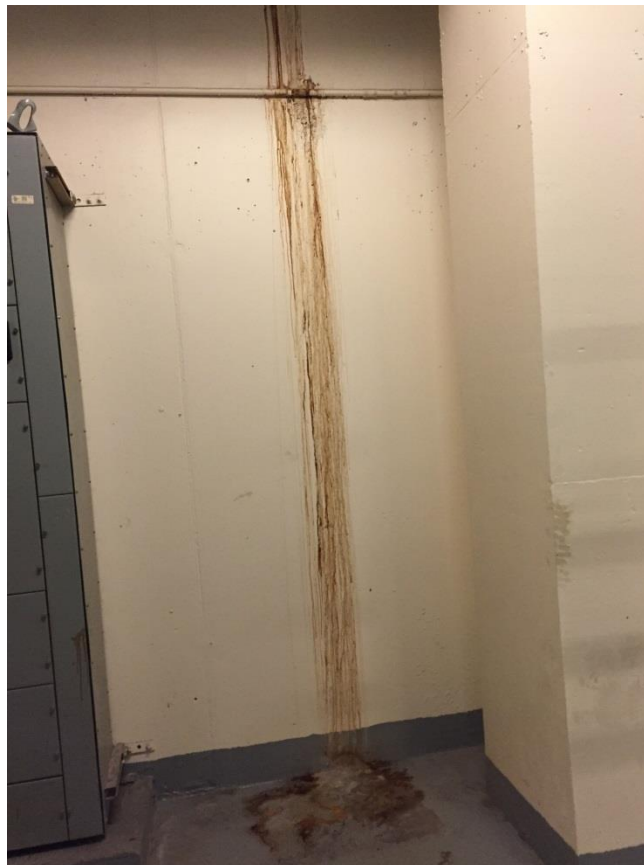
Photograph 4: View of leaks in sub cellar (8/6/15).

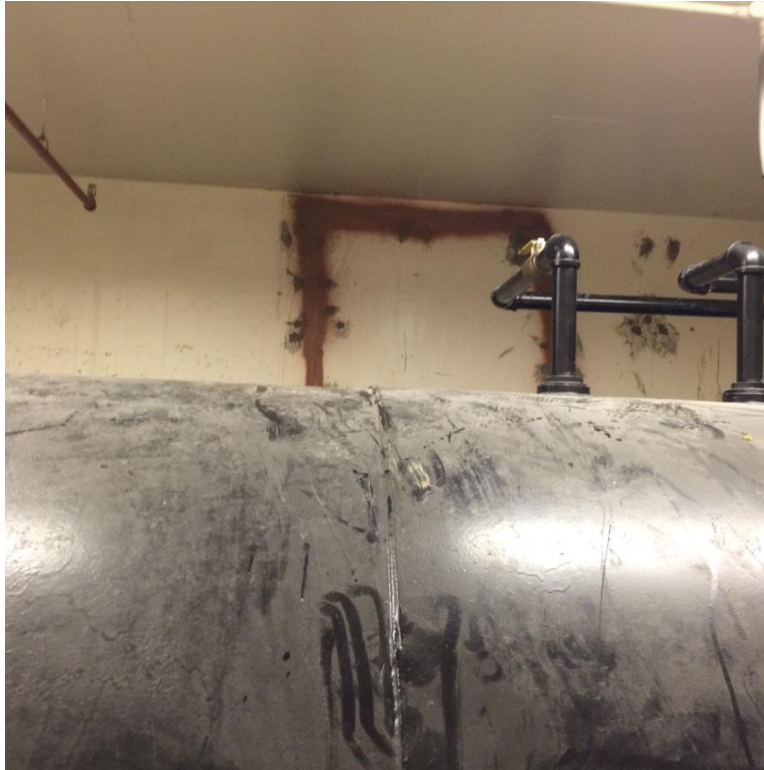
Photograph 5: View of sealed cracks in oil tank room, marked with bronze paint (12/2/15).

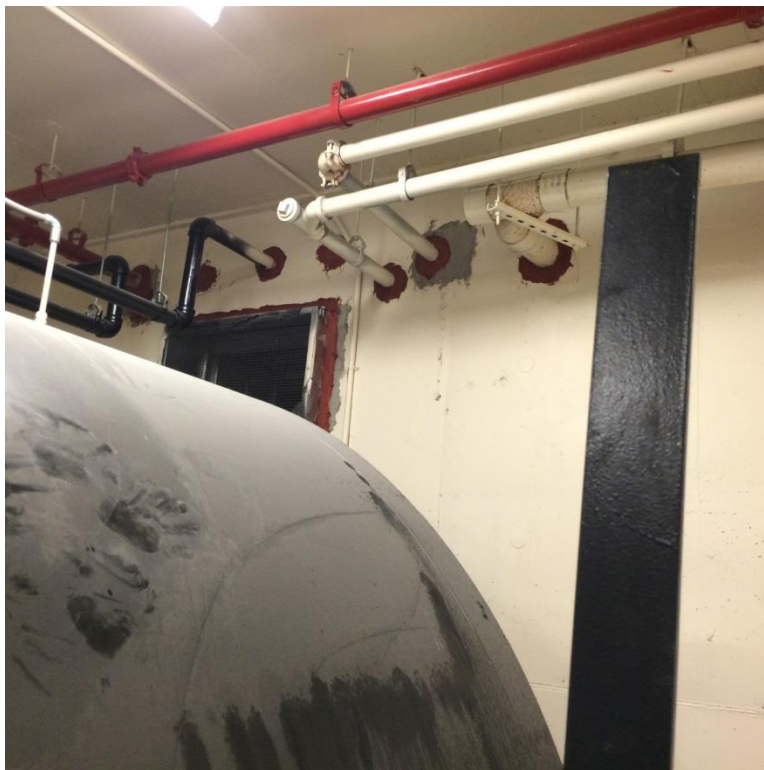
Photograph 6: View of sealed piping penetrations in oil tank room (12/2/2015).

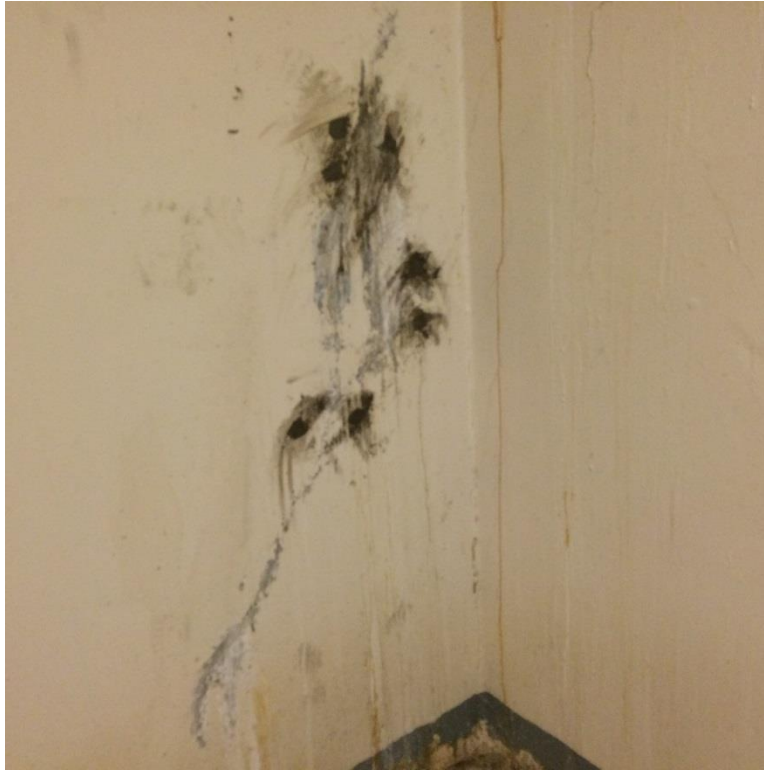
Photograph 7: View of sealed crack in sub cellar (12/2/15).

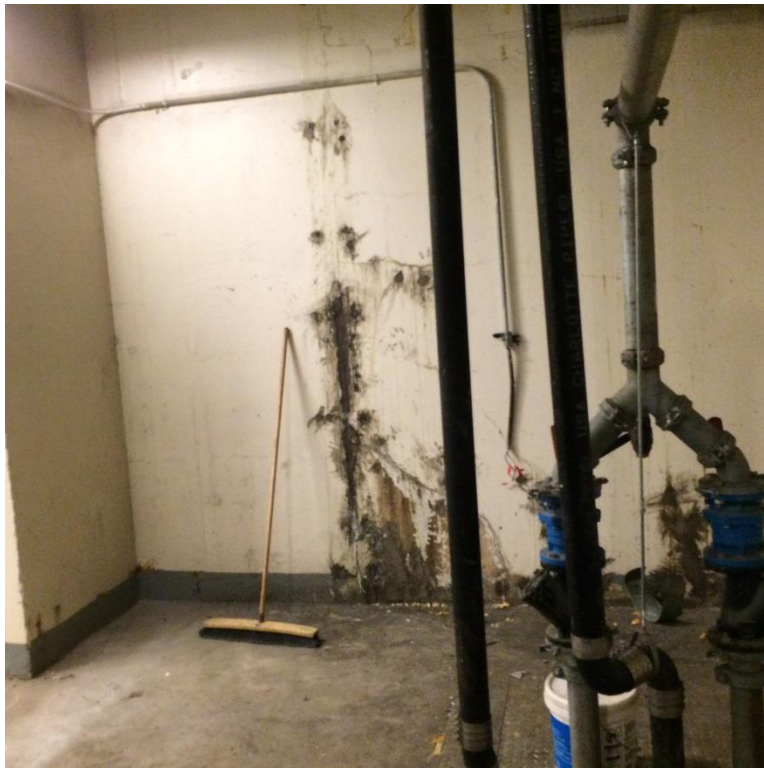
Photograph 8: View of sealed crack in sub cellar (12/2/15).

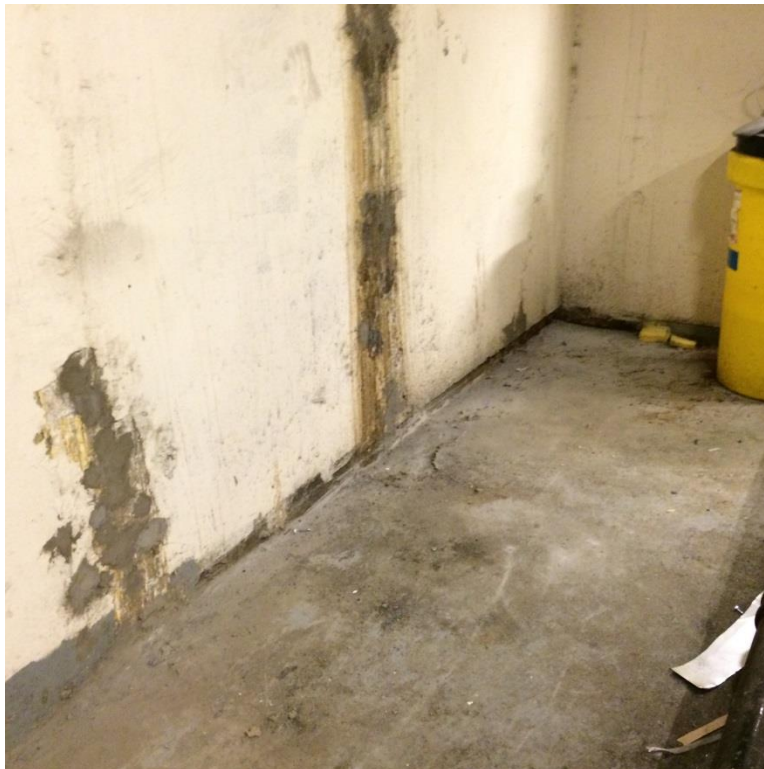
Photograph 9: View of sealed crack in sub cellar (12/2/15).

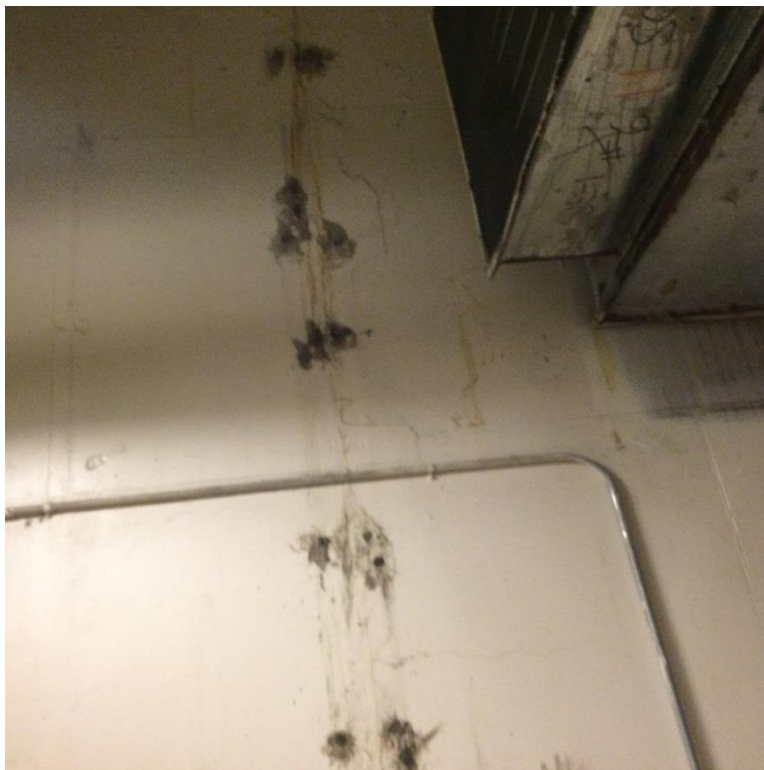
Photograph 10: View of sealed crack in sub cellar.

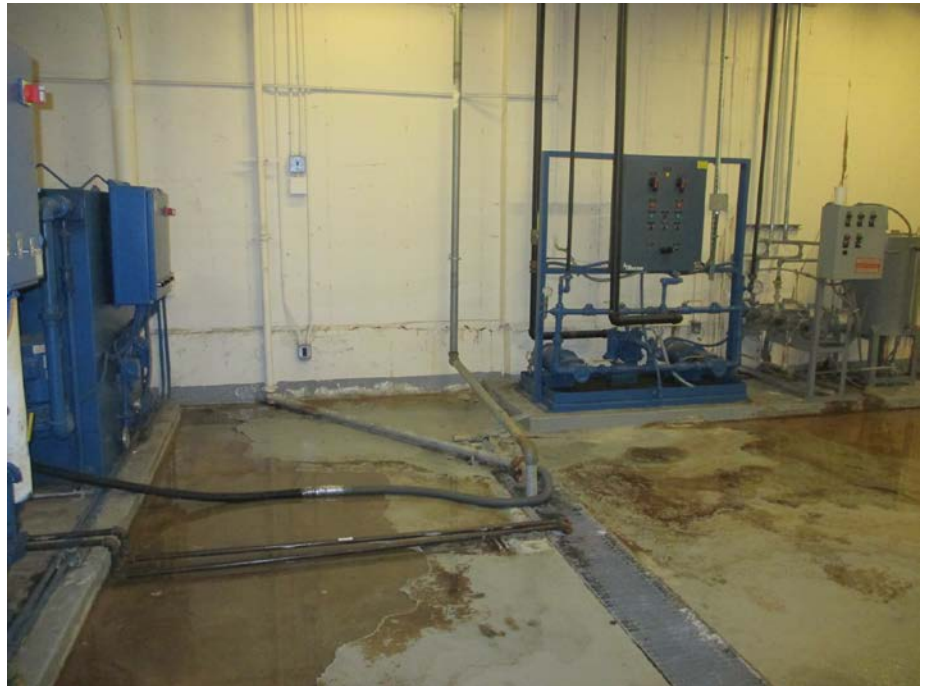
Photographs #1 and #2

Overview of the north wall at the Boiler Room where water intrusion was a persistent issue, showing standing water typical over most of the floor of this room. Water present has a sulfuric odor.

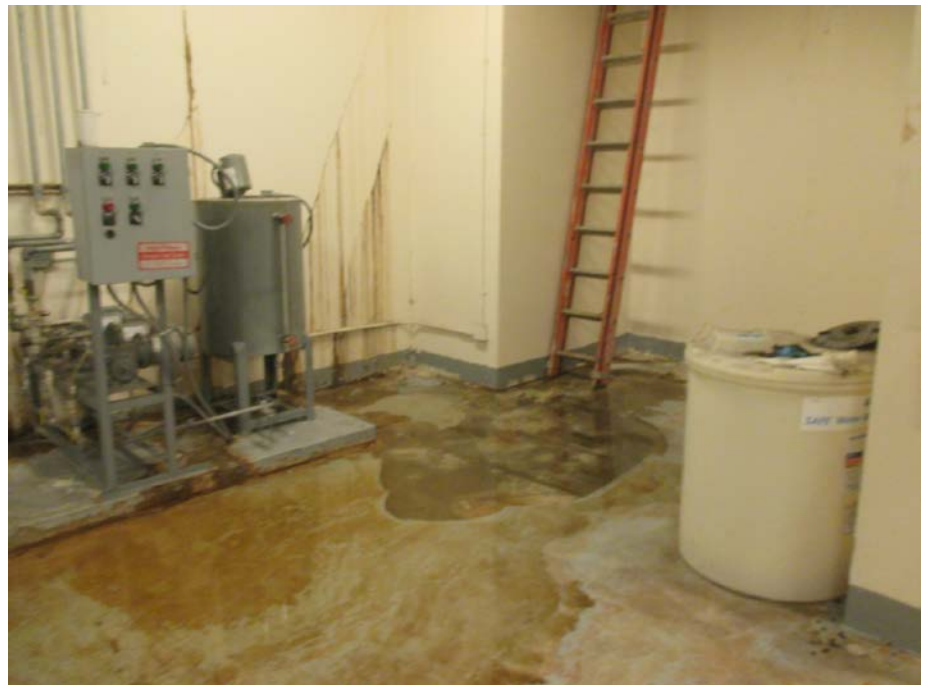
Active Water leakage through crack in the foundation wall, as well as at the base of the wall at a cold joint and previous injection ports.

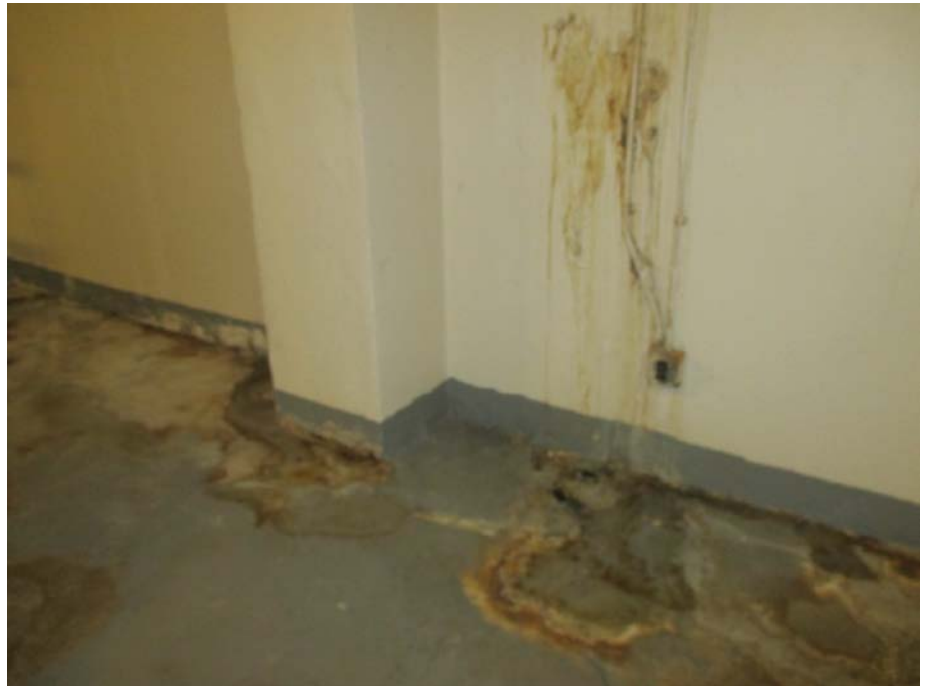
Sub-cellar Level
Boiler Room
East Wall

Overview of water staining and
intrusion of water at the floor of the
room.

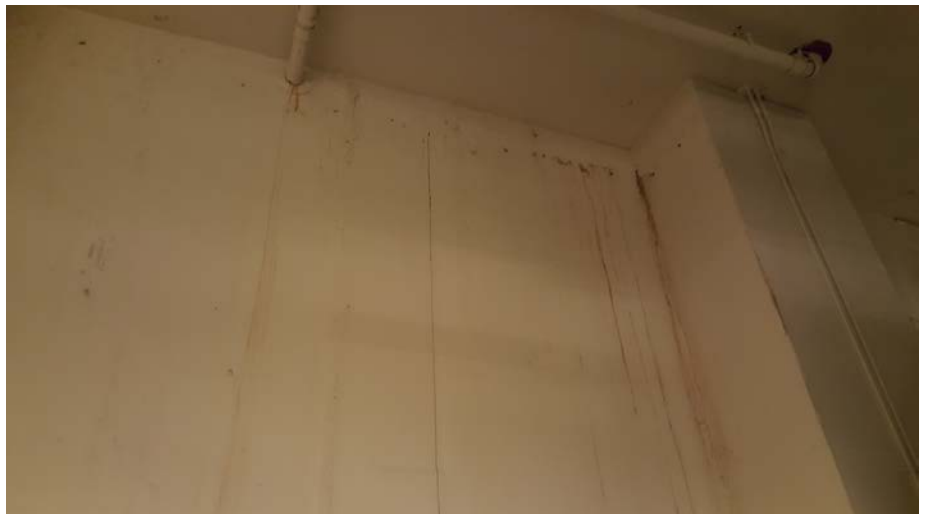
Overview of water infiltration
observed at a cold joint (wall-to-
ceiling transition) at the south wall
following heavy rain. CGI was
instructed to inject at this cold joint,
in addition to the original scope of
work.

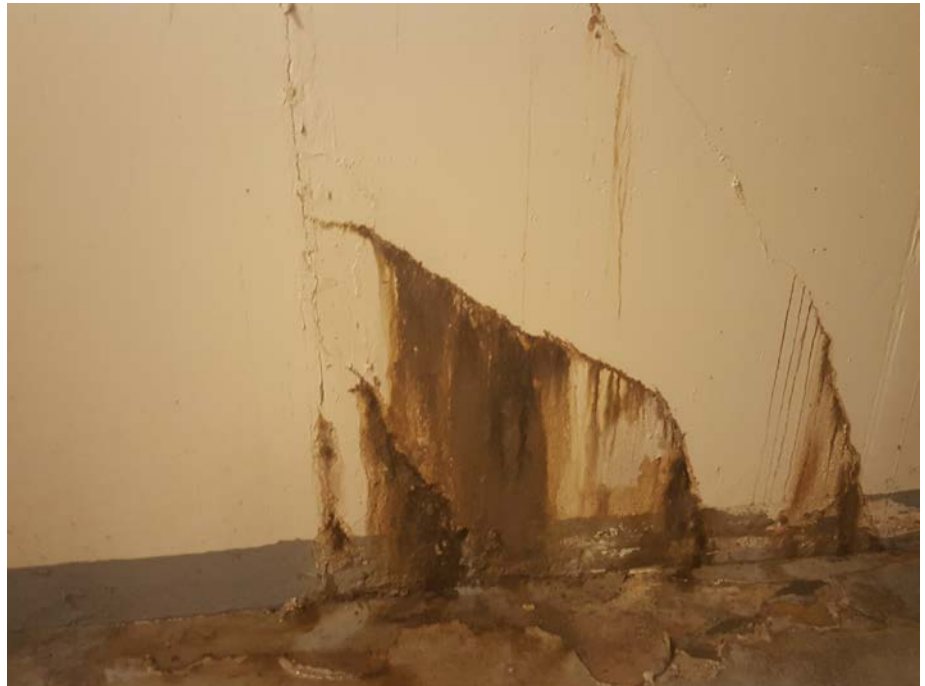
Southwest corner of Boiler Room:
Overview of actively leaking cracks
marked out for gel injection and
patching of ports with cement.

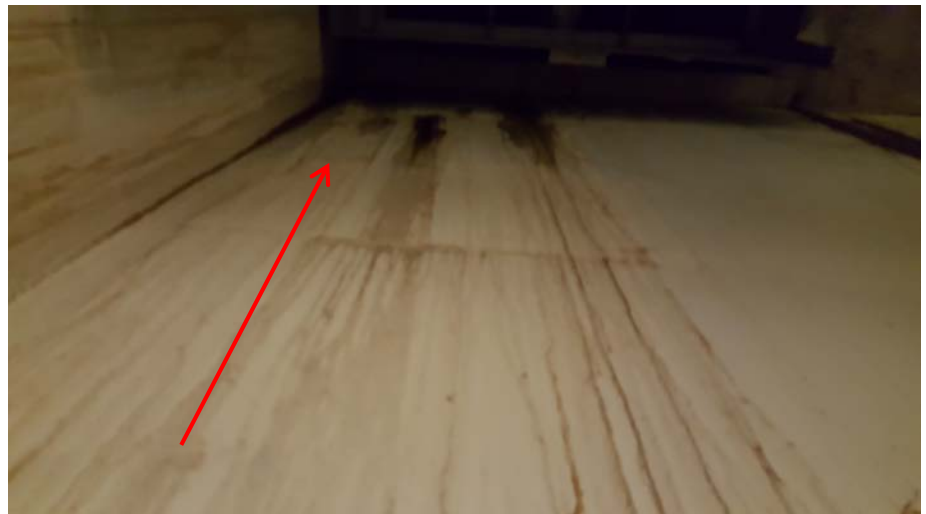
Overview of actively leaking
cracks observed following removal
of ductwork at the southwest
corner of the Boiler Room.

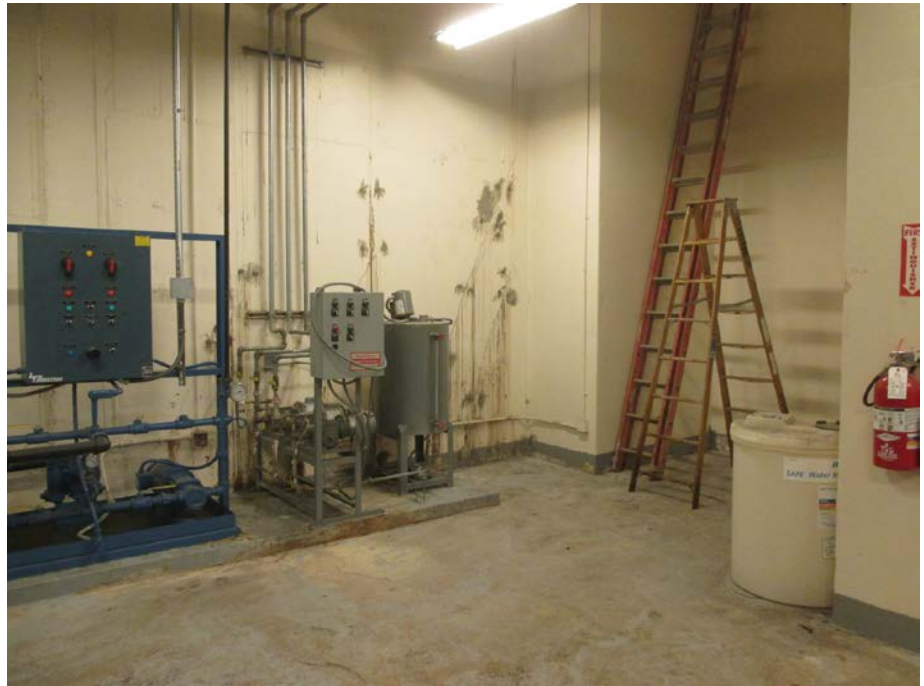
North Wall of Boiler Room:
Overview of completed gel injection
and patching of ports with cement.

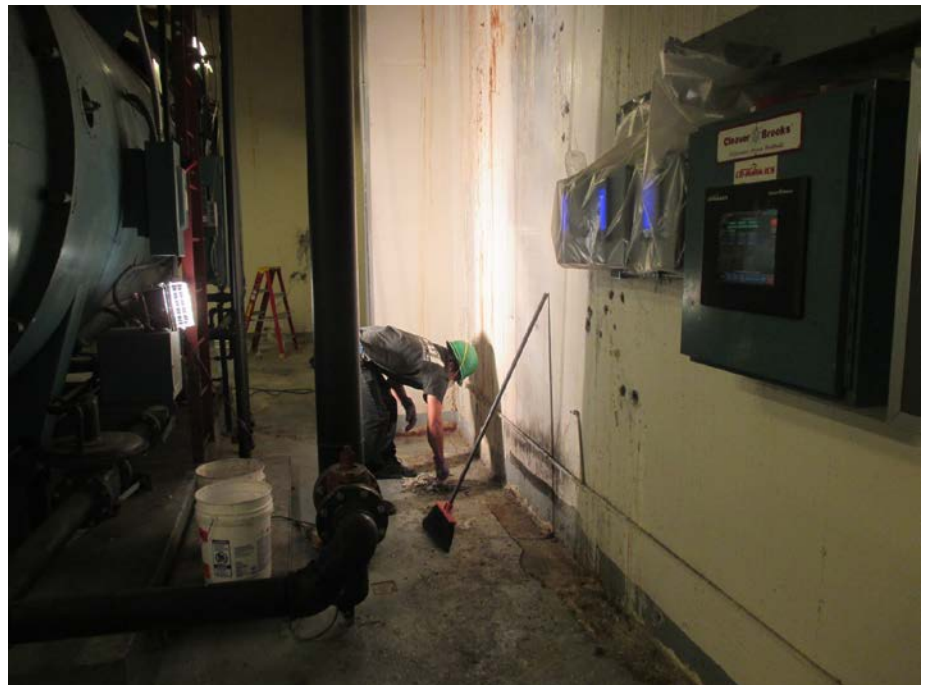
Overview of Contractor performing
concrete gel injection at the East
wall.

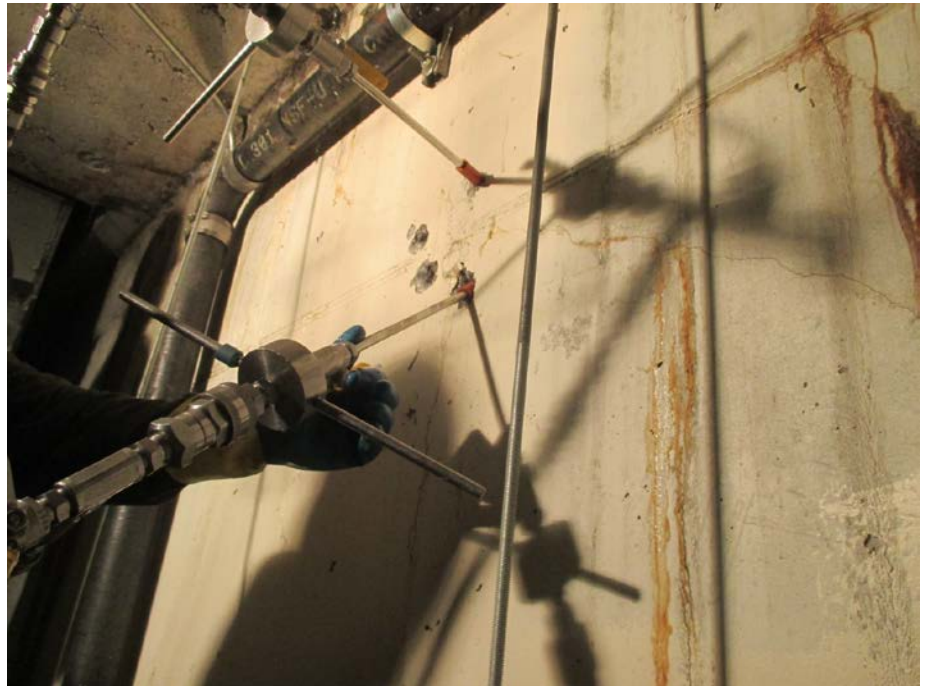
Close-up of the Contractor performing concrete gel injection at the West wall. The pressurized injection of water into the cracks resulted in the passage of water from the actively leaking cracks to adjacent deficiencies (hairline cracking, abandoned ports). CGI expanded the scope of work in this area per CANY direction.

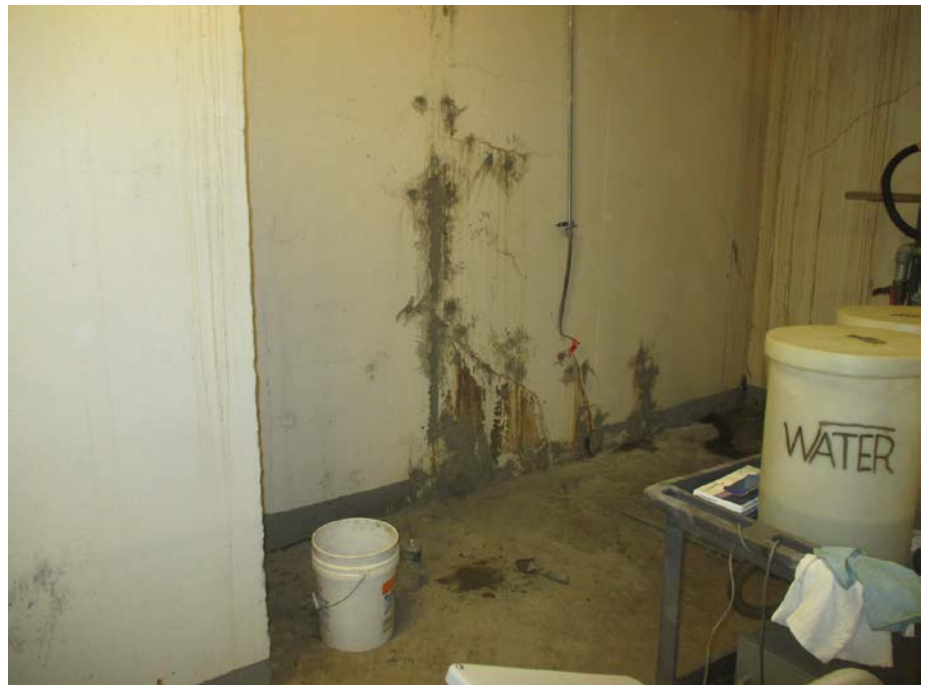
Overview of completed concrete gel injection and patching of old ports performed at the south wall of the Boiler room.

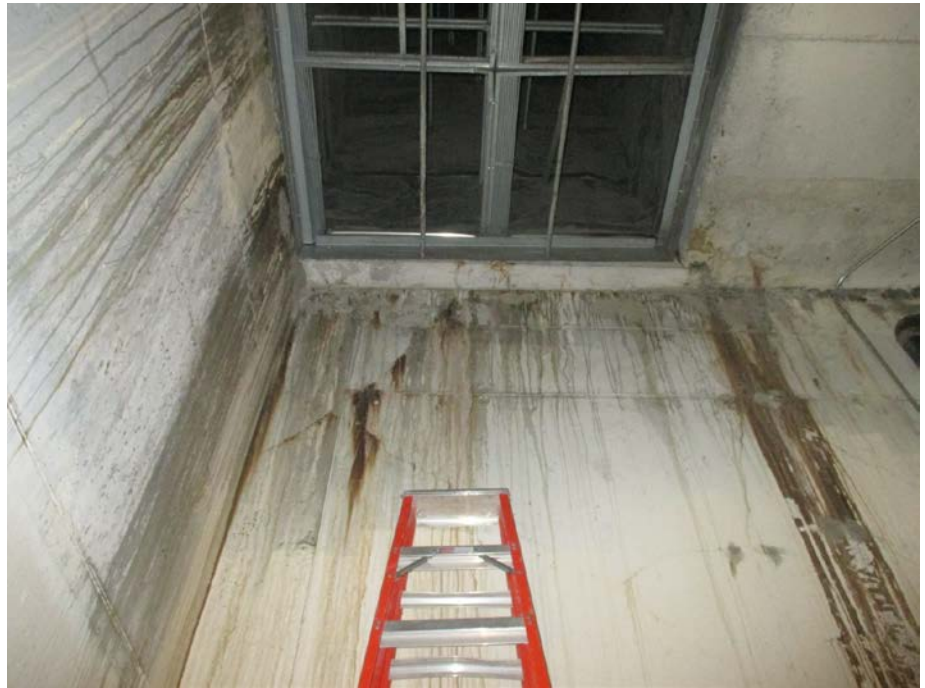
Overview of completed concrete gel injection and patching of old ports performed at the west wall of the Boiler room (southwest corner).

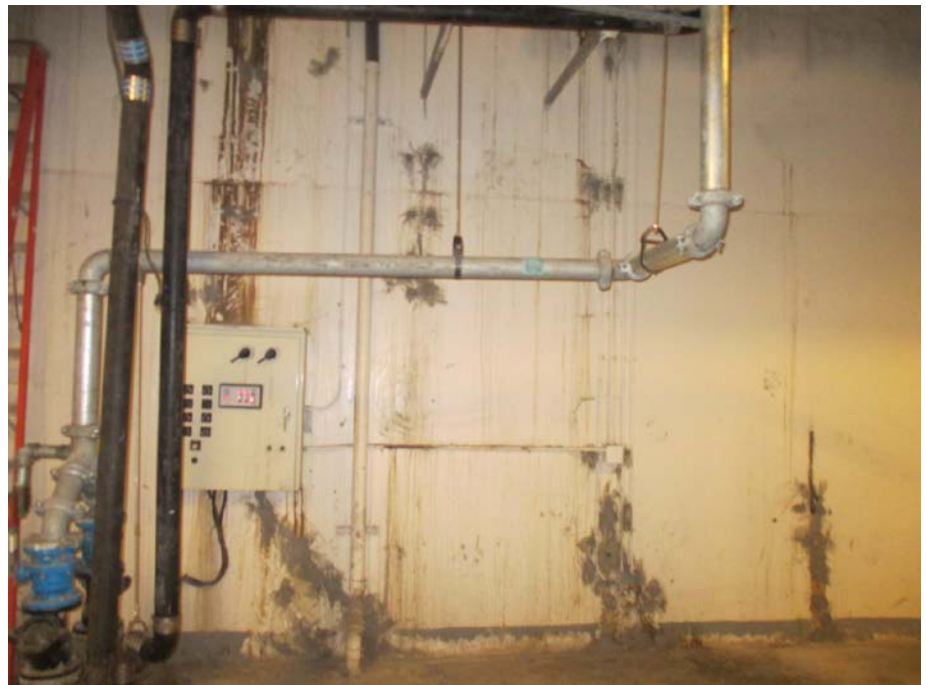
Photograph showing completed CGI application and patching of ports along side of the actively leaking cracks at the west wall of the Boiler Room.

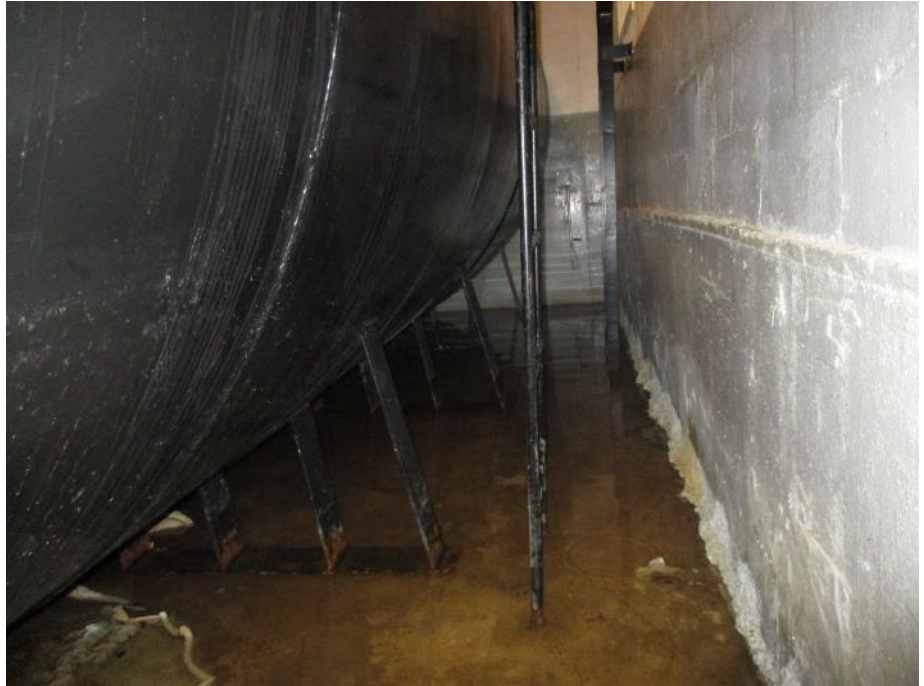
Photographs #1 and #2

Overview of the SE corner of the tank room showing standing water typical over most of the floor of this room. Water present has a sulfuric odor.

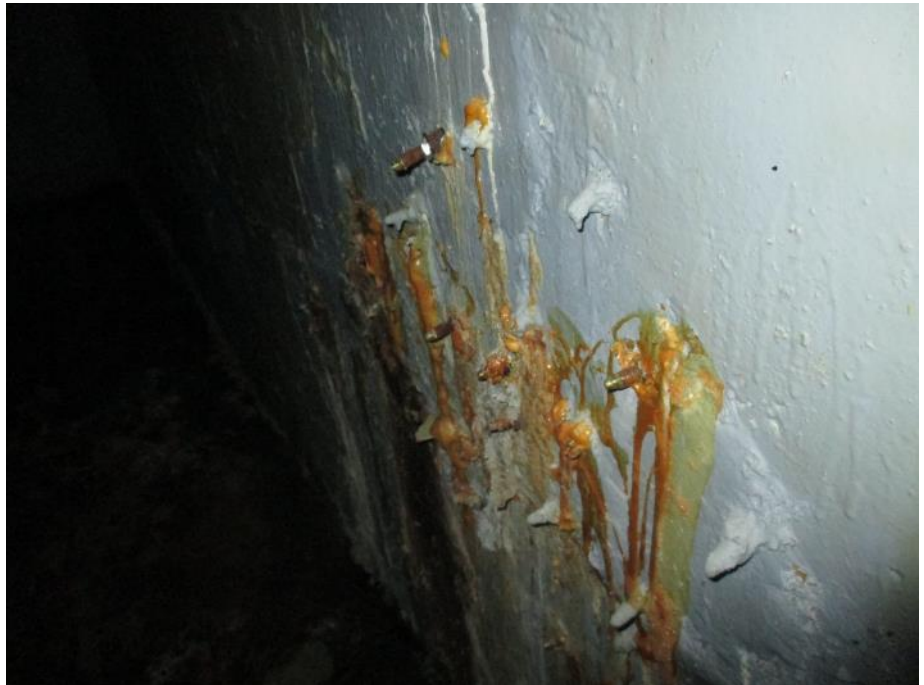
Active Water leakage at the base of the wall at a cold joint and previous injection ports.

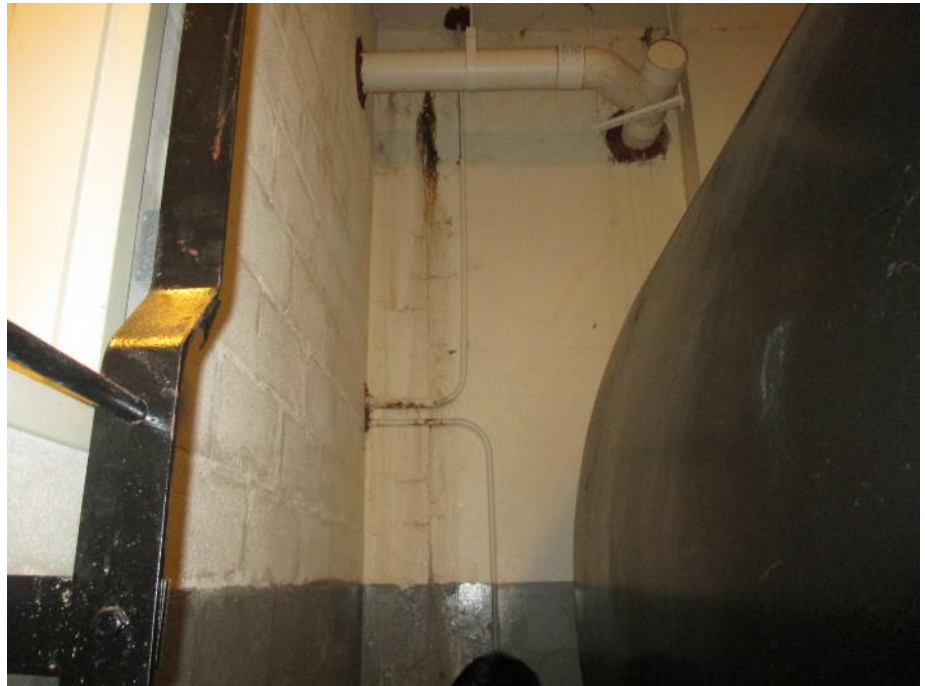
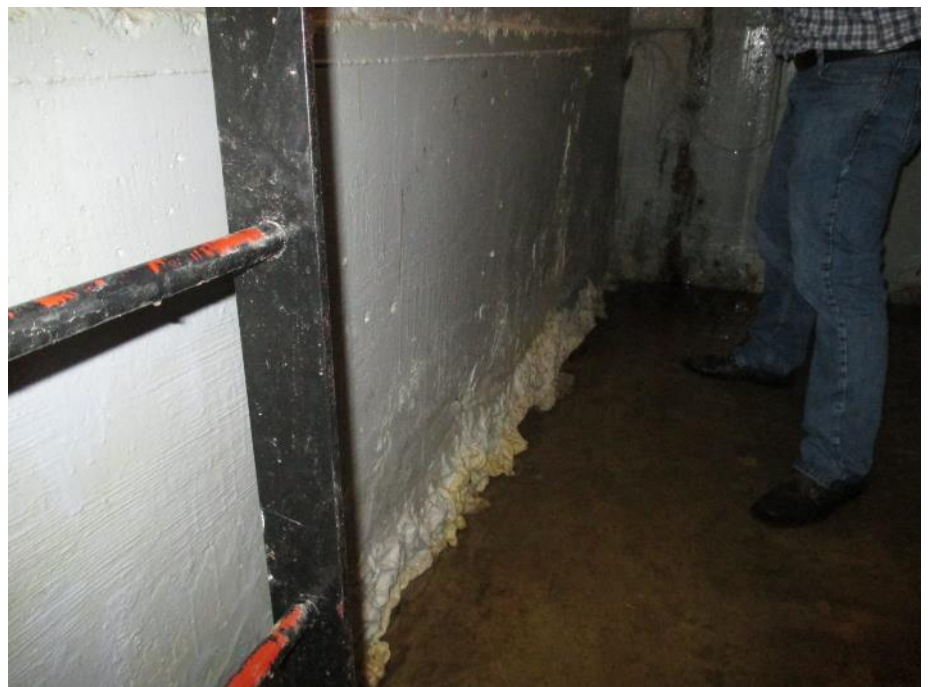
Photographs #3 and #4:

Indications of water entry through
cold-joint and ports at the head of
the wall and active leakage at
cracks in the base of the
foundation wall

Note: There is rough-finished
parging material at the head of this
section of wall, possibly part of an
earlier waterproofing repair.

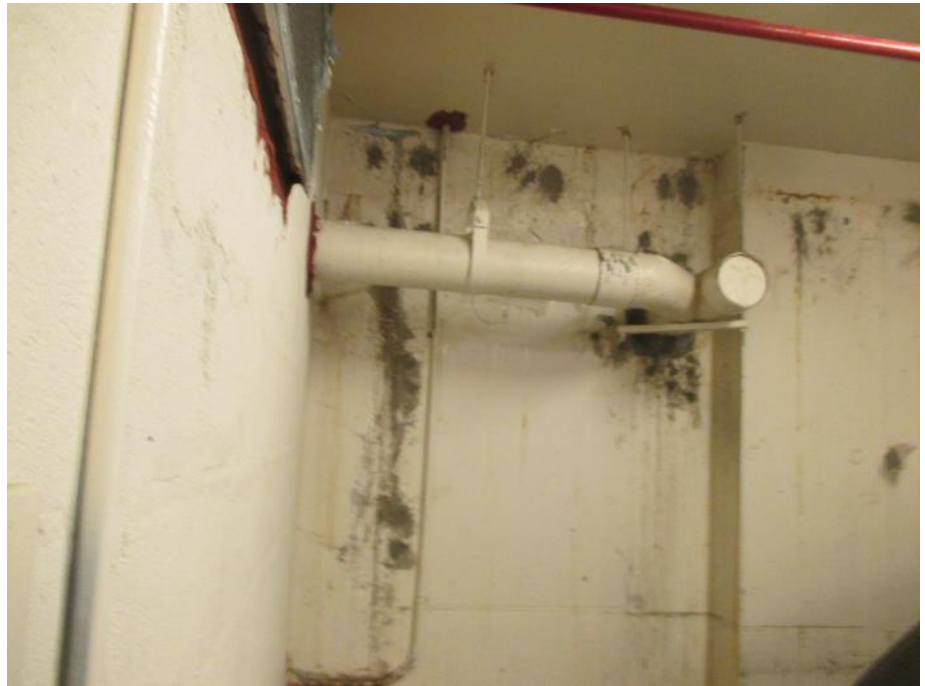
Northwest corner of Oil Tank Room: Overview of completed gel injection and patching of ports with cement.

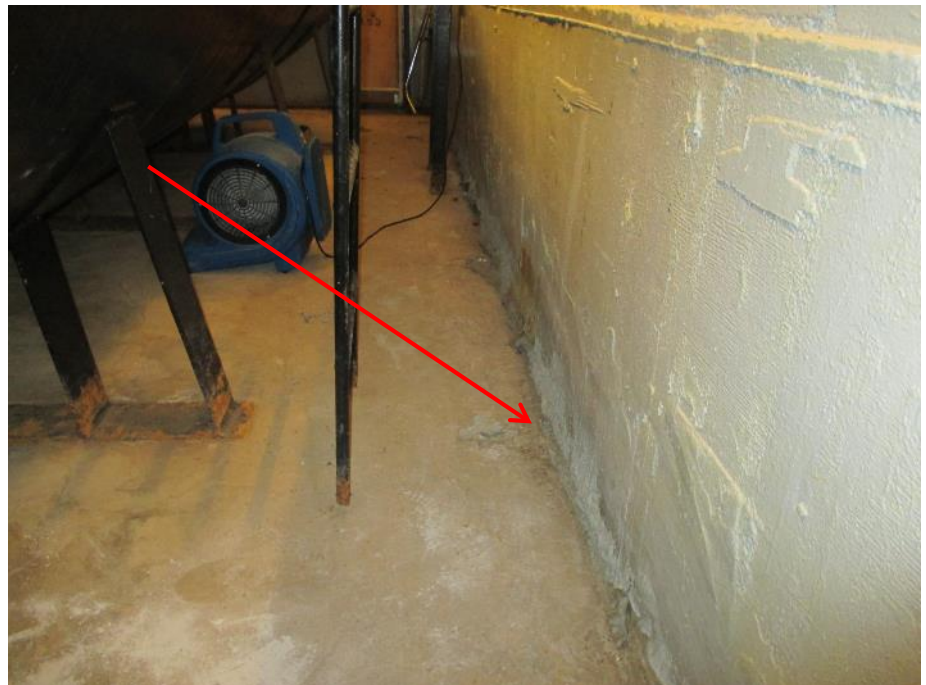
Typical cold joint injection completed at the base of the west wall of the Oil Tank Room.

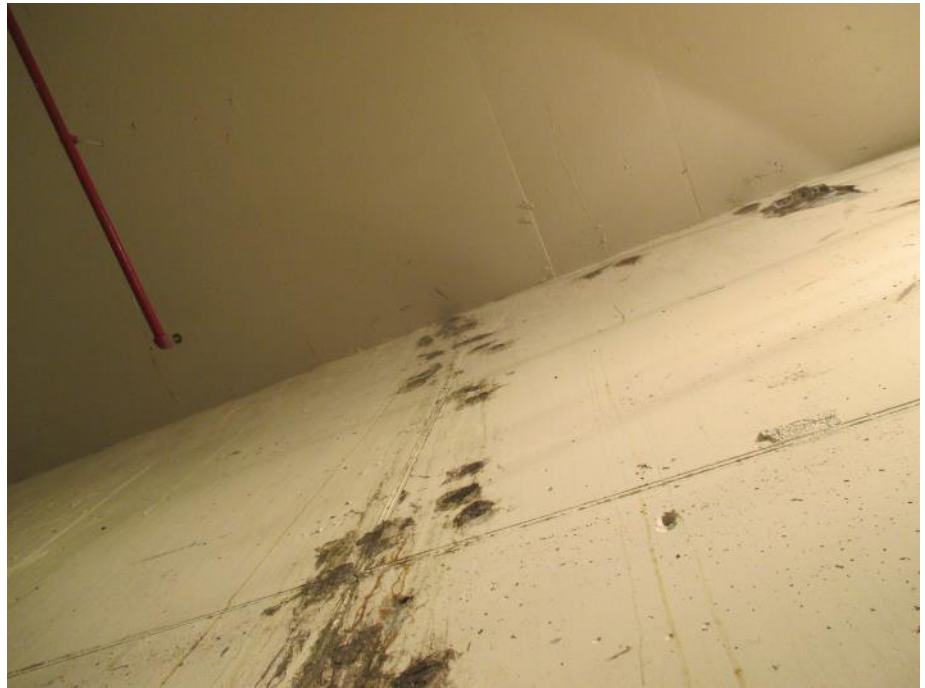
East Wall of Oil Tank Room:
Overview of completed gel injection
and patching of ports with cement.

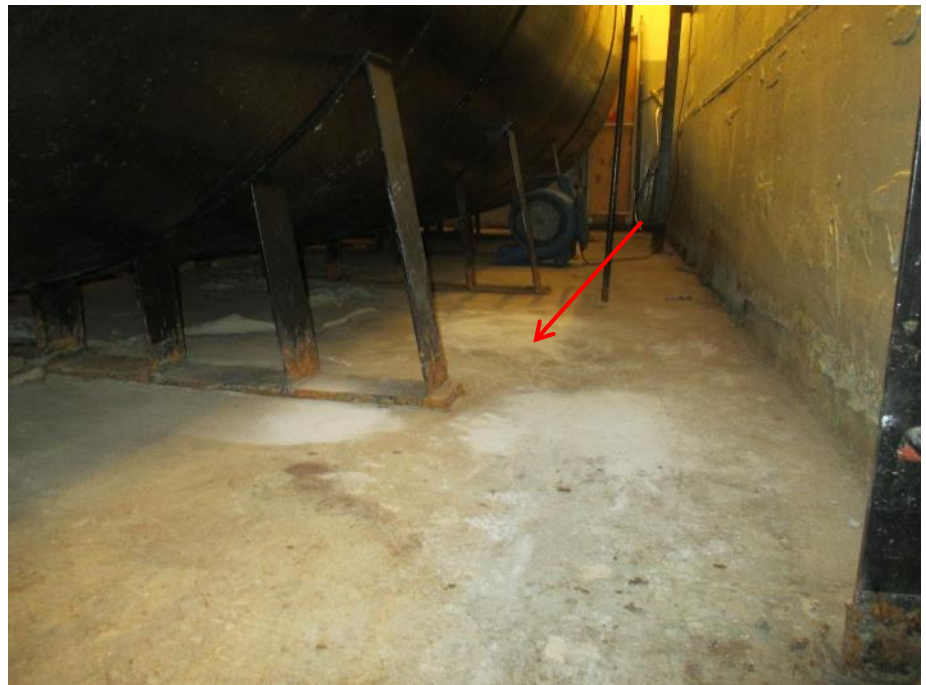
Overview of the Oil Tank room
floor following completion of the
concrete gel injection application at
the north, west and east walls.

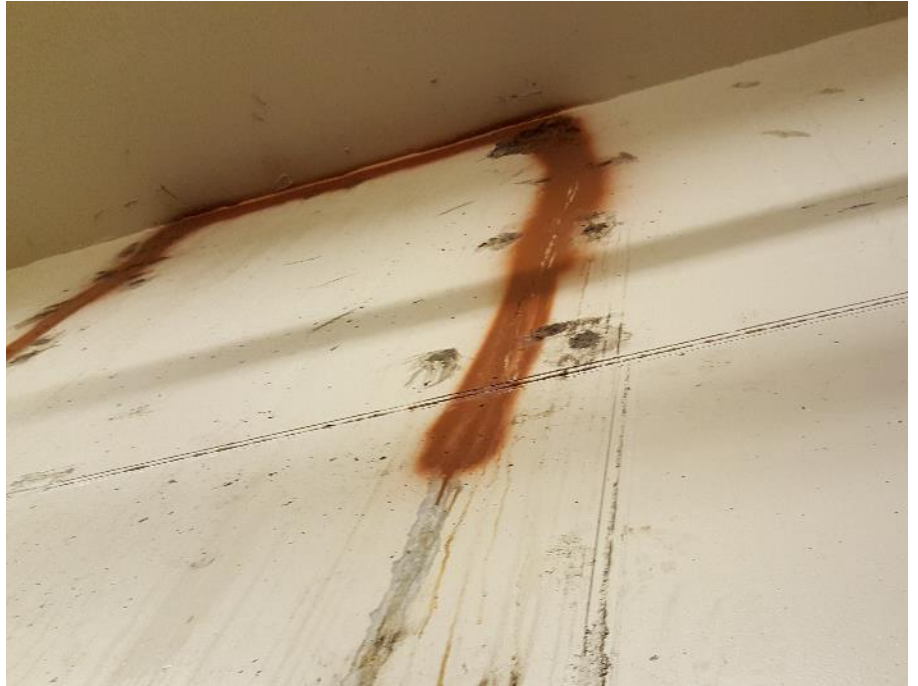
East Wall of Oil Tank Room:
Overview of completed gel injection
and patching of ports with cement
and marked with bronze spray
paint.

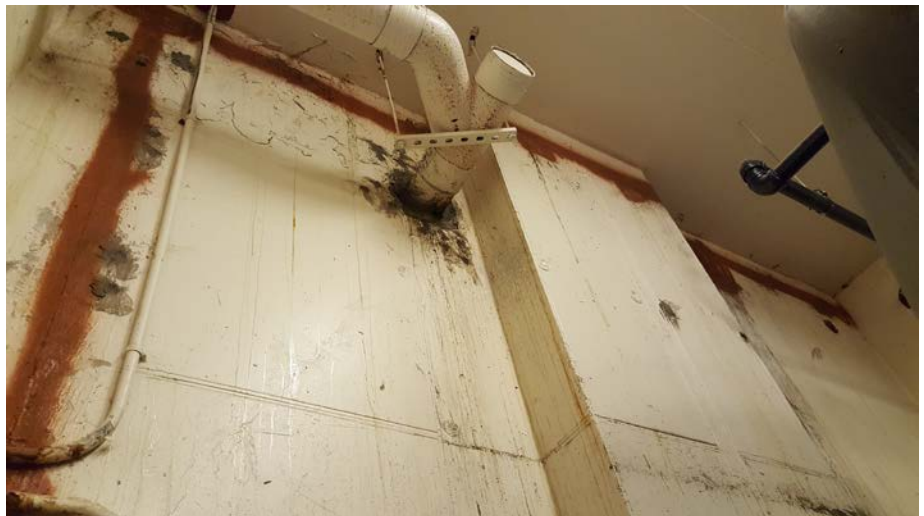
Overview of completed concrete
gel injection and patching of old
ports performed at the north wall of
the oil tank room. The Contractor
used spray paint to mark locations
repaired.

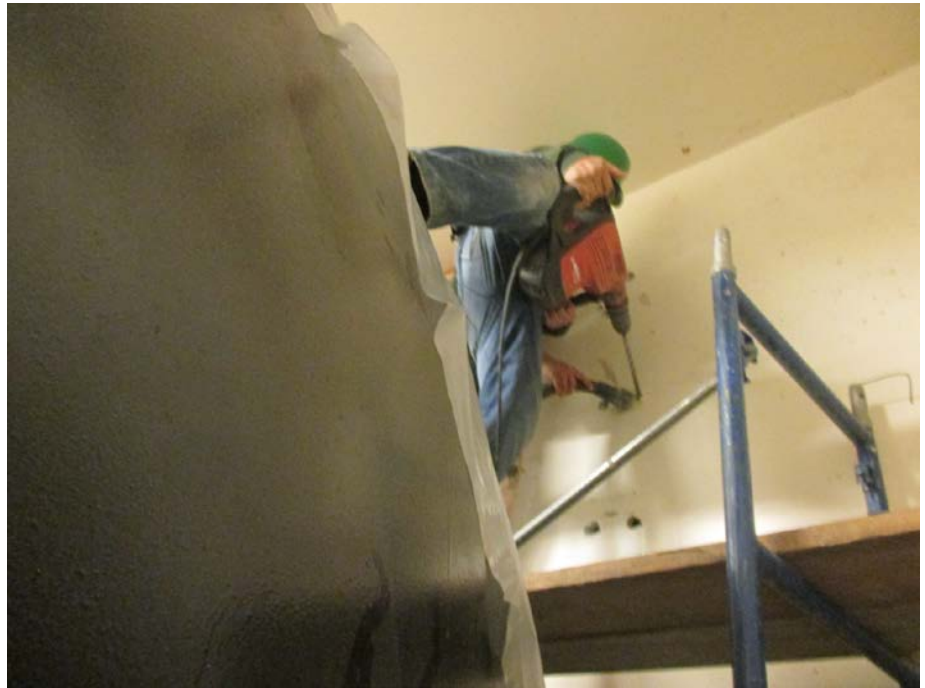
Overview of Contractor drilling into the east wall of the oil tank room in preparation for the gel injection application at an active leak location. The Contractor drilled into the wall approximately 9" at either side of the observed crack, removed debris with a vacuum (pictured) and water prior to injection of the hydrophilic resin (Aqua Loc Resin LV).

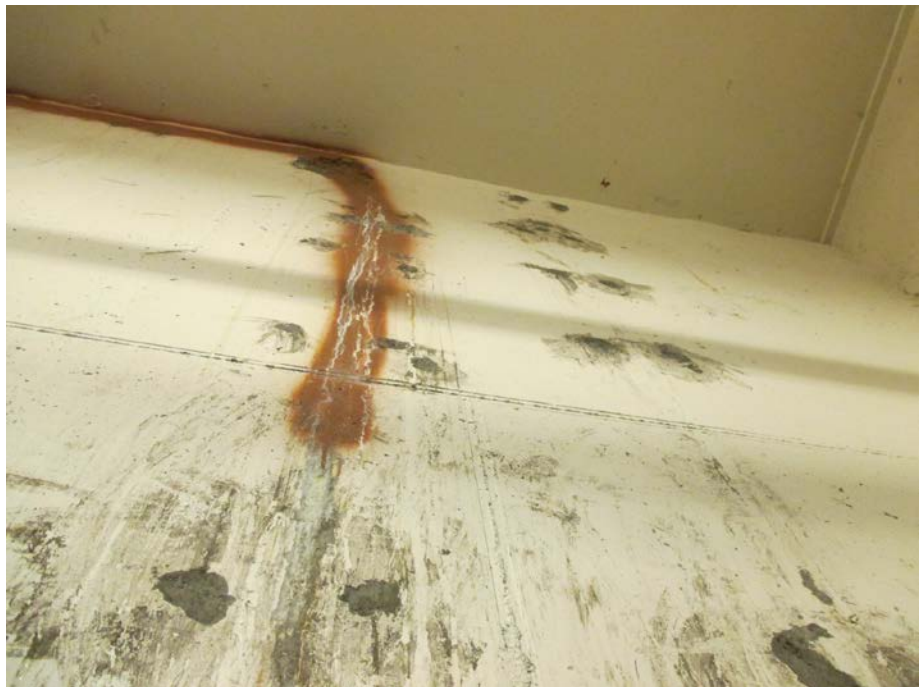
Photograph showing completed CGI application and patching of ports along side of the actively leaking cracks at the east wall of the oil tank room.
