Re: West 19<sup>th</sup> Street Development Site

NYSDEC BCP Site No. C231017

Certification of Institutional Controls/Engineering Controls

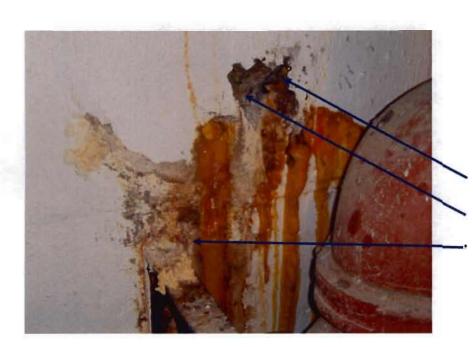
### Photo 2

- We observed active water infiltration above the bolt penetration for the railing in the gas-meter room (X=170, Y=200). We also observed nearby grout injection ports and grout staining on the wall near the railing's termination. This area was injection grouted in January 2008 (Photo 2).
- We observed active water infiltration at the foundation wall-to-slab interface (joint) in the corner of the telephone room (X=180, Y=200). We noted that the pool of water contained sandy sediment mixed with the water (Photo 3).

Active water infiltration in the gas meter room.

We recommend that these repairs be implemented in accordance with the grout injection technique described in OMP. Per your request, we will visit the building during the implementation of these recommended repairs, and again after the repairs are completed to observe the repair effectiveness.

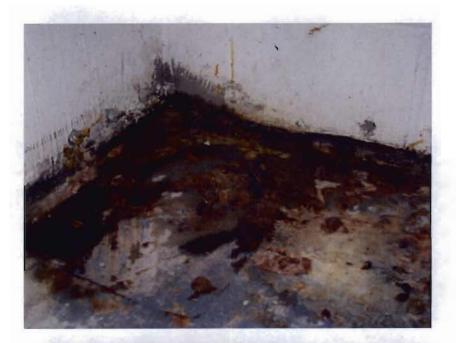
### Photo 3

Active water infiltration at the wall-to-slab interface in the telephone room. The wall at the left is the foundation wall, and the wall at the right is an interior partition wall.

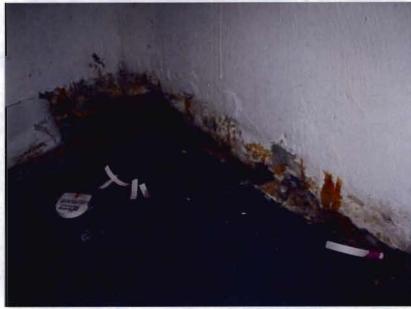
### Photo 4

- We found active water infiltration at the far northeast corner of the building in the water meter room (X=40, Y=200). We removed the vinyl baseboard and felt that the foundation wall-to-slab interface was wet along both the west and north elevations. We observed previous grout injection ports in the surrounding area (Photo 4).

Active water infiltration at the wall-to-slab interface at the northwest corner of the building.

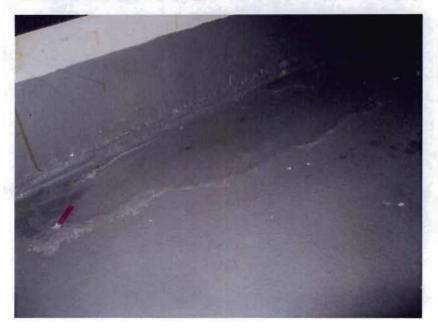
### Photo 5

- We observed active water infiltration and standing water on the foundation slab along the west foundation wall in the car parking area. We noted that the water infiltration occurred at the foundation floor-to-wall interface and extended intermittently over approximately 25 ft from (X=80, Y=90) to (X=90, Y=70). We observed previous grout injection ports in the surrounding area (Photo 5).

Active water infiltration at the wall-to-slab interface along the west elevation of the garage.

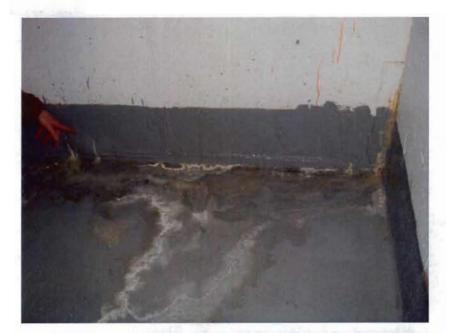
### Photo 6

- At the fan room at the east side of the building, we noted active water entry at the foundation slab-to-wall interface. The leak occurred along the north wall (X=240, Y=100) (Photos 6 and 7).

Active water infiltration in the fan room, located in the northeast corner of the site.

Hand points to blistered paint, which we show partially removed in Photo 7)

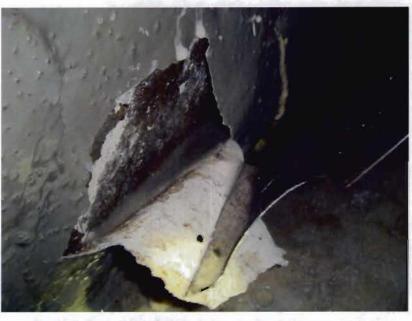
### Photo 7

Water behind the blistered paint shown in Photo 6.

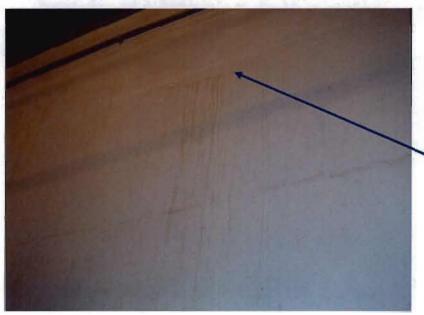
### Photo 8

- In the fuel tank room, at the east foundation wall (X=200, Y=180), we noted a crack with assumed water staining running down from it. At the crack, which was located about 10 ft above the slab, we observed no nearby grout injection ports (Photo 8).
- We observed a crack with efflorescence and staining in the north foundation wall of the mechanical room (X=130, Y=200). The crack was located about 5ft above the slab and there were no grout injection ports in the vicinity (Photo 9).

Horizontal crack in the east foundation wall of the fuel room.

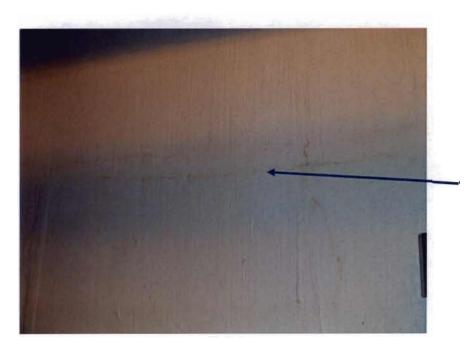
Photo 9

Horizontal crack in the north foundation wall inside the storage room.
