West 19th Street Development Site NYSDEC BCP Site No. C231017

Certification of Institutional Controls/Engineering Controls

Project 110043 - Walkthrough Inspection and Repair Observations

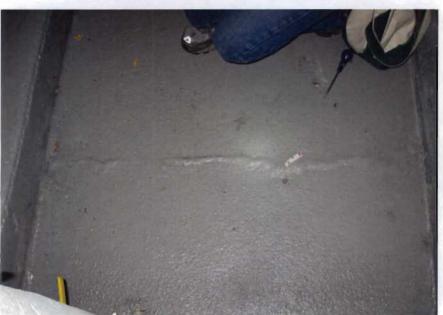
Photo 2

We observed water infiltration at the slab in the mechanical room on the east side of the building (X=210, Y=90). We observed a line of blistered traffic deck coating, approximately 2-1/2 ft long. We opened a small section of the blister and found moisture under the traffic-deck coating (Photo 2).

Crack previously repaired with grout injection. Opening the blister revealed wet grout repair foam.

Per the OMP, only cracks where the water is discharging through the crack are required to be repaired, while cracks with suspect water infiltration are required to be monitored. In lieu of monitoring, we recommend that the active water infiltration we observed this year at the slab in the mechanical room on the east side of the building (X=210, Y=90) be repaired using the grout injection technique described in the OMP as part of best maintenance practice.

- We observed grout injection repairs on the slab in the mechanical room (X=210, Y=90).
 The technicians injected grout into three ports along the line of a blister below the traffic deck coating. The technicians pumped grout until grout material pushed out of the crack (Photo 9).

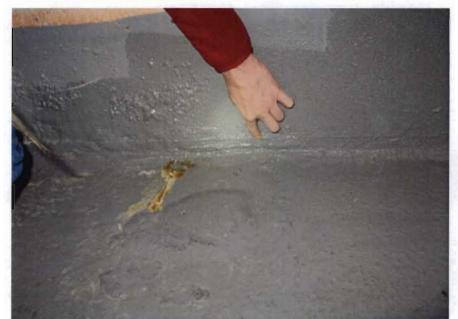
Photo 3

In the mechanical room on the east side of the building, we noted water infiltration at the slab-to-wall interface (X=210, Y=100) at the north elevation along approximately 4 ft of wall (Photo 3). We noted water trapped behind the traffic deck coating at the base of the wall.

Active water infiltration at the wall-to-slab interface in the mechanical room on the east side of the building.

Per the OMP, only cracks where the water is discharging through the crack are required to be repaired. This year, we recommended that all four locations listed above in Section 3.3 (including leaks at slab-to-wall interface and grout injection ports, as well as areas of stain growth) be repaired using the grout injection technique described in the OMP.

- We observed grout injection repairs at the slab-to-wall interface in the mechanical room (X=210, Y=100). The technicians drilled and pumped fort ports along the base of the foundation wall until grout material surfaced (Photo 10).

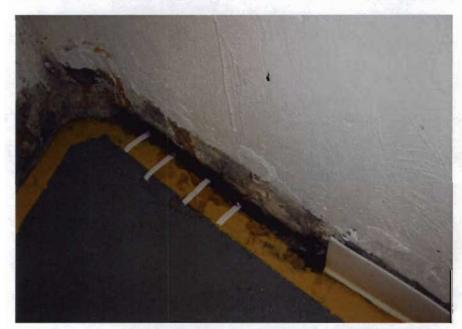
Photo 4

- We found active water infiltration at the far northwest corner of the building in the water meter room (X=40, Y=200). We removed the vinyl baseboard and felt that the foundation slab-to-wall interface was wet along about 2 ft of the north elevation (Photo 4). On 11 February 2011, this area was dry. This area had been previously grout injected under our observation on 26 March 2009. During our 2010 walkthrough, we did not observe any signs of water infiltration. We observed that the amount of water infiltration is less than that of two years ago.

Active water infiltration at the wall-to-slab interface at the northwest corner of the water meter room.

The paper strips in the photo are water-finding paper, which turn magenta when wet.

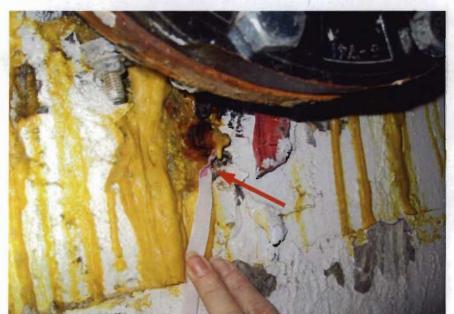
Photo 5

- We noted water infiltration near a pipe penetration along the south wall of the fan room (X=240, Y=20). We found water infiltration at a grout injection port just below a pipe penetration (Photo 6). On 11 February 2011, this location was dry. The grout injection in this location had been performed prior to 24 August 2007. Between 24 August 2007 and 3 February 2011, we did not observe water infiltration at this location during our annual walkthrough inspections.

Active water infiltration at a pipe penetration on the south wall of the fan room.

The paper strip in the photo is water-finding paper, which turn magenta when wet (arrow).

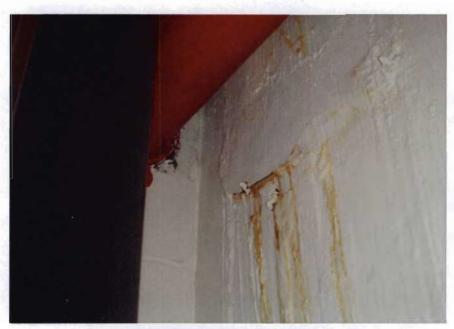
Photo 6 2010 Photo

Water staining at gas meter room.

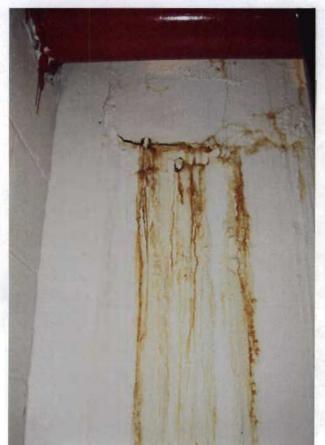
Photo 7 2011 Photo

• We noted additional brown staining on the north wall of the gas meter room (X=165, Y=200). We found this location to be dry on both 3 February 2011 and 11 February 2011. Our comparison of photos taken on 21 January 2010 and 3 February 2011 shows a greater extent of stains at the wall and along the crack (Photos 6 and 7). The grout injection in this area was performed prior to 24 August 2007.

Water staining at gas meter room. Additional staining along crack lines and on wall.

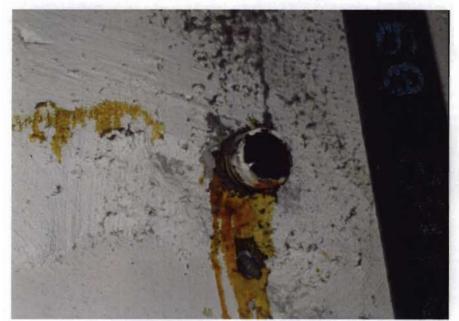
Photo 8

On 3 February 2011, a member of the maintenance staff informed us that he had seen water on the floor of the mechanical room (X=210, Y=100), and thought it flowed in from a pipe penetration (Photo 8). We observed that the area around the penetration, as well as the wall and floor directly below the penetration, were dry and free of water stains. We observed that the area on the fall and floor below the pipe were covered with grout injection material. On 24 January 2008, we had observed technicians seal this pipe penetration and grout inject the annulus between the hose and the surrounding concrete. During subsequent annual walkthrough inspections, we did not observe signs of water infiltration at this location.

We did not recommend repairing the pipe penetration at the mechanical room (X=210, Y=100). We found no indication of water infiltration in this location. The reported water observed by the maintenance staff member may have been the residual grout injection material.

Pipe penetration at north wall of the mechanical room.

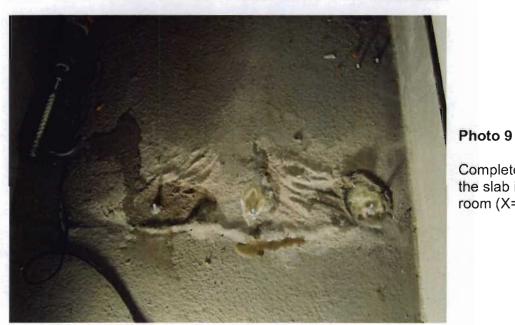
Completed grout injection at the slab in the mechanical room (X=210, Y=90).

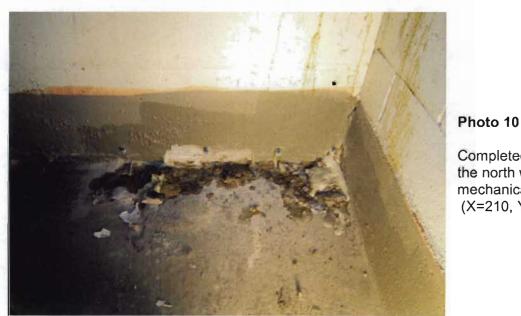
Completed grout injection at the north wall of the mechanical room (X=210, Y=100).

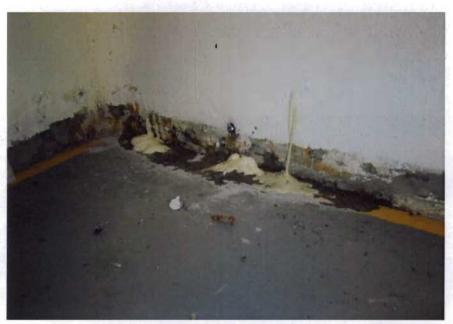
Photo 11

Completed grout injection in the water meter room (X=40, Y=200).

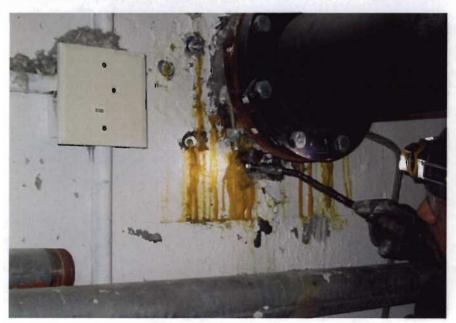
Photo 12

In progress grout injection repair in the fan room (X=240, Y=20).

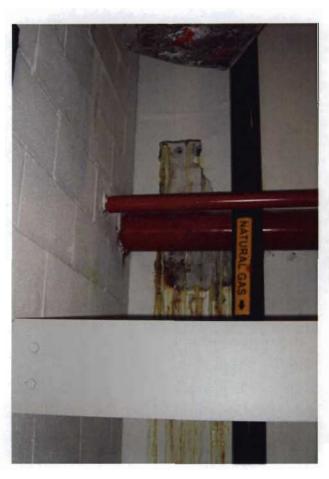
Photo 13

Completed grout injection repair at the north wall of the fan room (X=165, Y=200).
