Re: West 19<sup>th</sup> Street Development Site  
NYSDEC BCP Site No. C231017  
Certification of Institutional Controls/Engineering Controls

Walkthrough Inspection and Repair Observations, prepared by Simson Gumpertz & Heger,  
dated March 8, 2012

Project 120115.00 – Walkthrough Inspection and Repair Observations  
West 19th Street Development Site  
528 West 19th Street, New York, NY

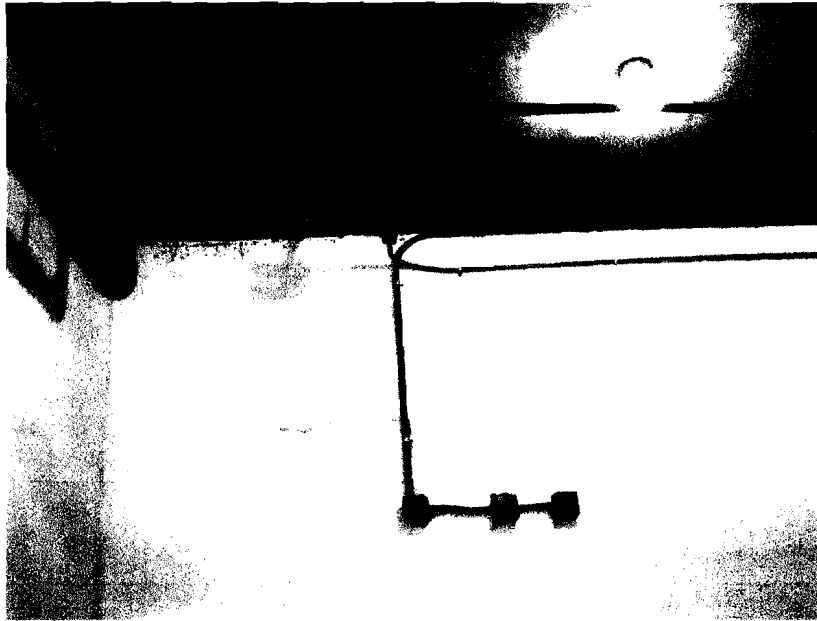
**Photo 18**

2011 photo of staining on  
east wall of oil tank room  
X=200, Y=190.
