Re: West 19<sup>th</sup> Street Development Site  
NYSDEC BCP Site No. C231017  
Certification of Institutional Controls/Engineering Controls

**PERIODIC REVIEW REPORT**

**For the Property Located at**  
**West 19<sup>th</sup> Street Development Site, New York, NY**

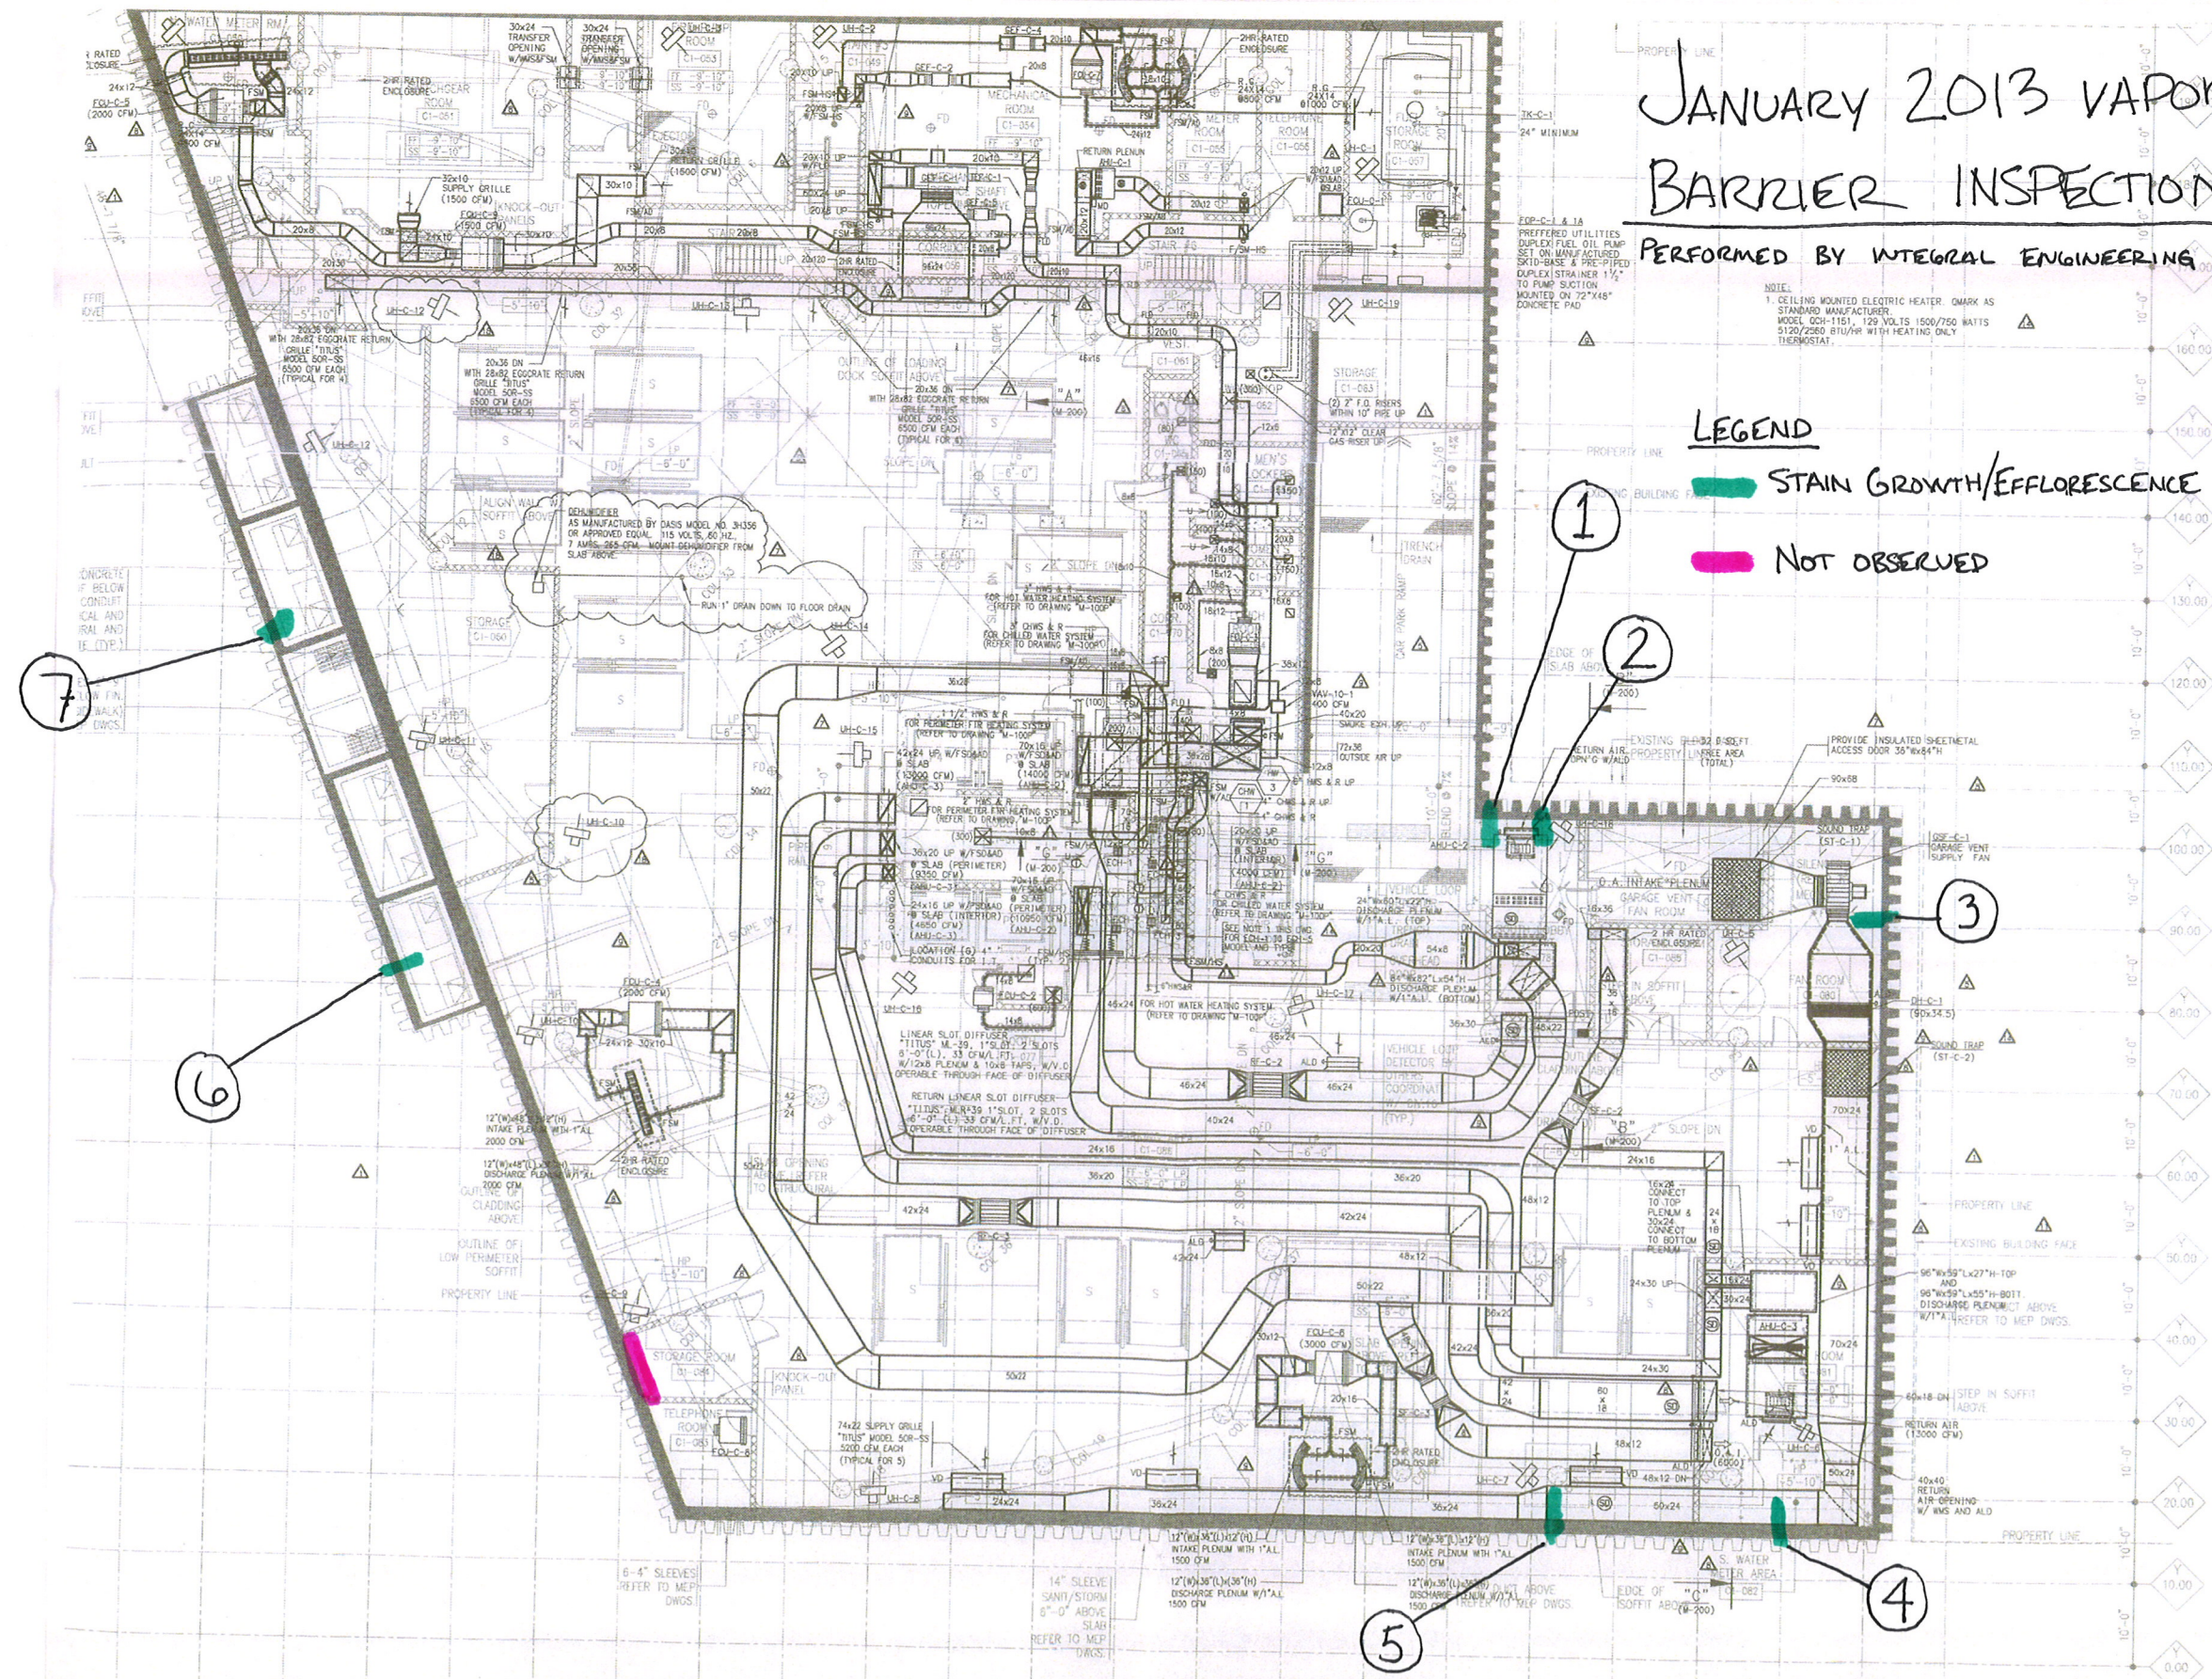
Figure 1. Vapor Barrier Repair Locations

During the inspection, Integral Engineering observed isolated instances of active water infiltration, predominantly near the slab-wall interface locations. Also observed were several isolated areas with evidence of previous water infiltration, such as stain growth, sediment deposits, and efflorescence build-up.

All repairs related to the recommendations were performed by Starbrite Waterproofing on March 12 and 13, 2013, under the observation of Integral Engineering. All areas slotted for repairs were grout injected following the OMP guidelines.

The locations of all repairs are shown in plan view (by number) in Figure 1. Pictures of the repairs can be found in Appendix B.

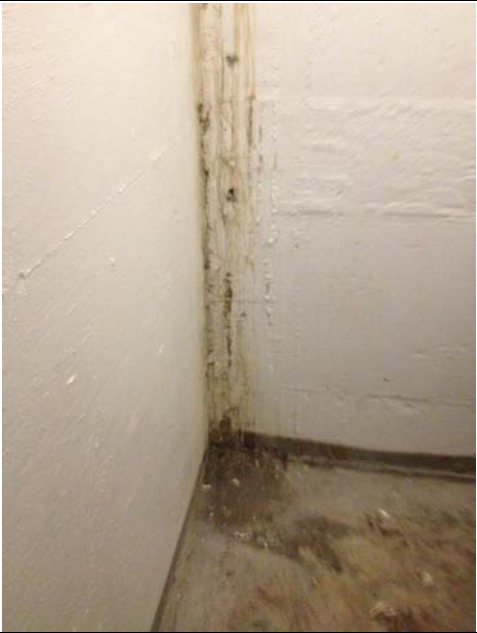
- Location 1 – An active water infiltration was found at the intersection of two walls near the floor. The building manager informed Integral Engineering that leaking was visible from the crack during rain events. The location had evidence of previous repairs.
- Location 7 – An active water infiltration was found along the West foundation wall near the floor. The area surrounding the crack was found to contain moisture during the inspection.

Location 1 – Before repair.				Location 1 – After repair.

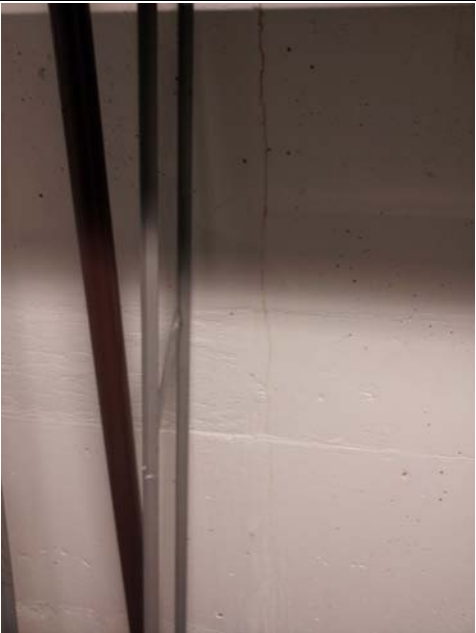
- Location 2 – Staining was observed on the North foundation wall surrounding a small hairline crack.
- Location 3 – Efflorescence build-up was observed on the East foundation wall was near the floor. Evidence of previous repairs was noted.
- Location 4 – A small hairline crack was observed running vertically along the South foundation wall.
- Location 5 – Staining was observed around the area of a previous repair done in 2012.

Location 2 – Before repair.				Location 2 – After repair.

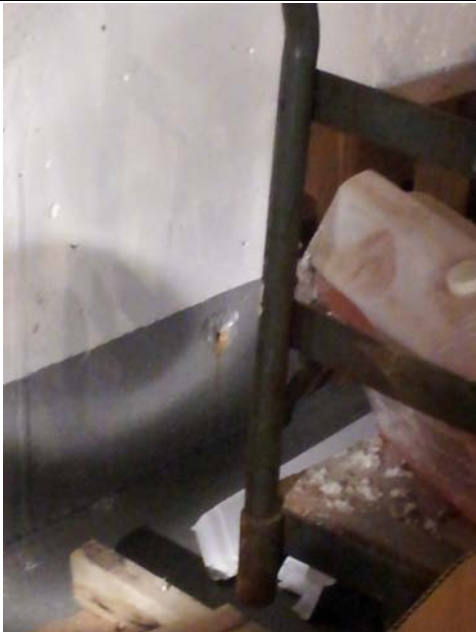
Location 3 – Before repair.

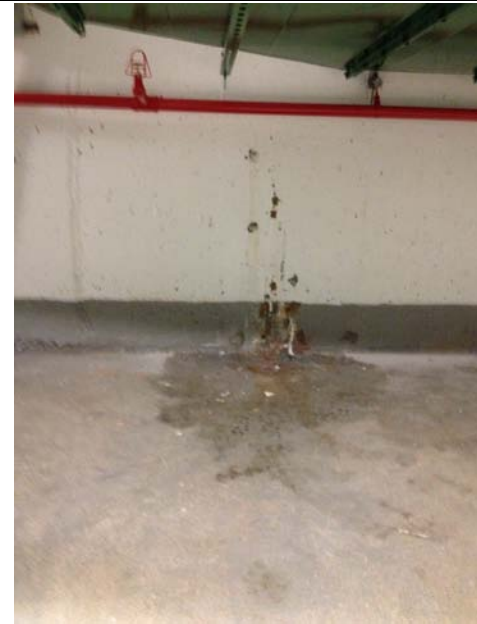
Location 3 – After repair.

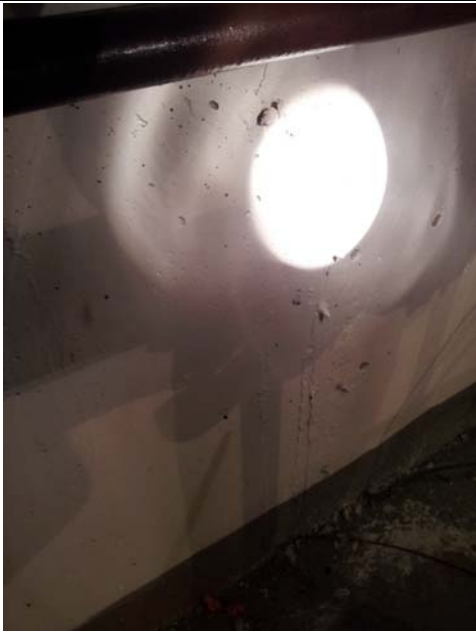
Location 4 – Before repair.

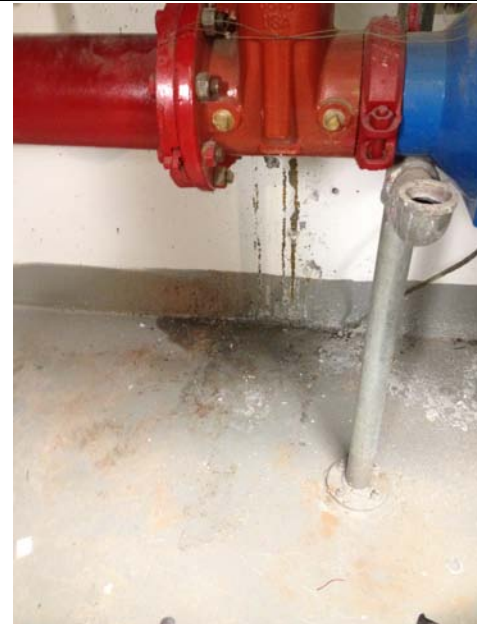
Location 4 – After repair.

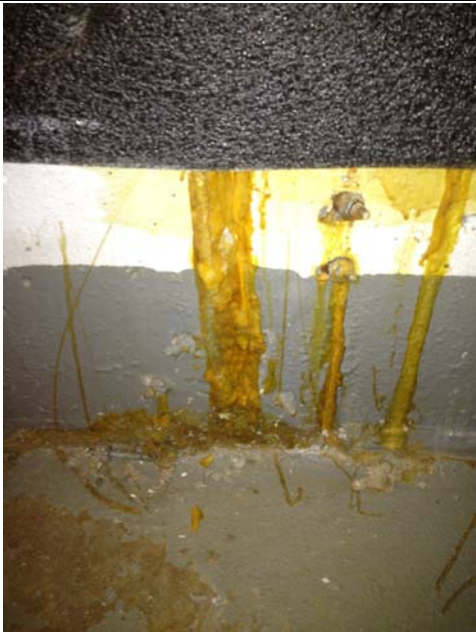
Location 5 – Before repair.

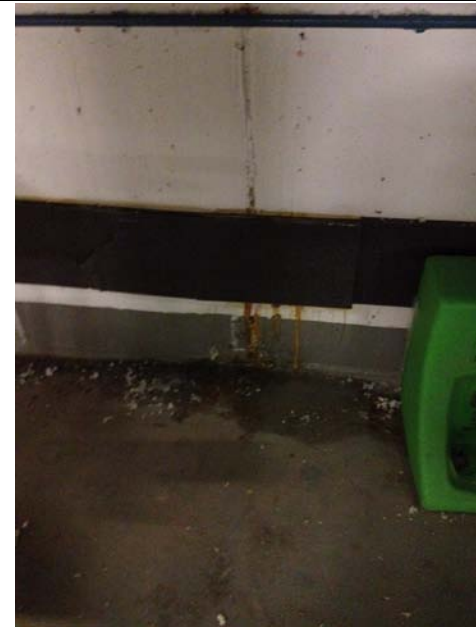
Location 5 – After repair.

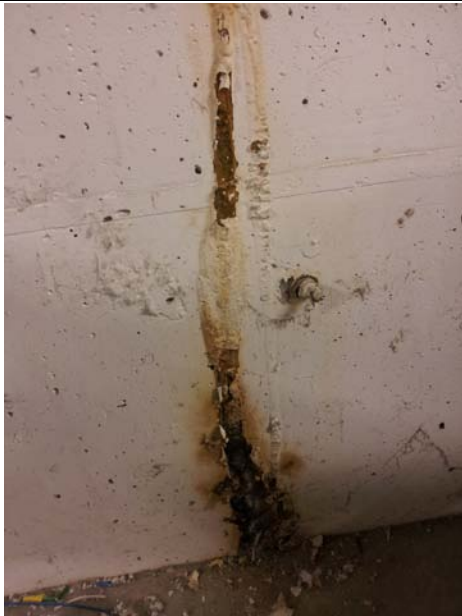
Location 7 – Before repair.

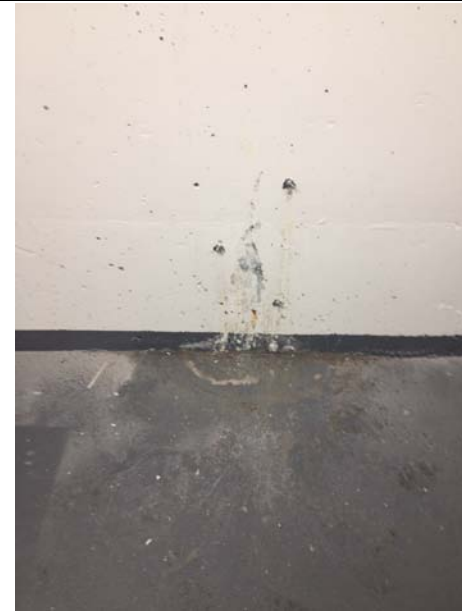
Location 7 – After repair.
