PERIODIC REVIEW REPORT

**For the Property Located at
West 19th Street Development Site, New York, NY**

Prepared for
IAC/InterActiveCorp
550 West 18th Street
New York, NY 10011

March 13, 2014

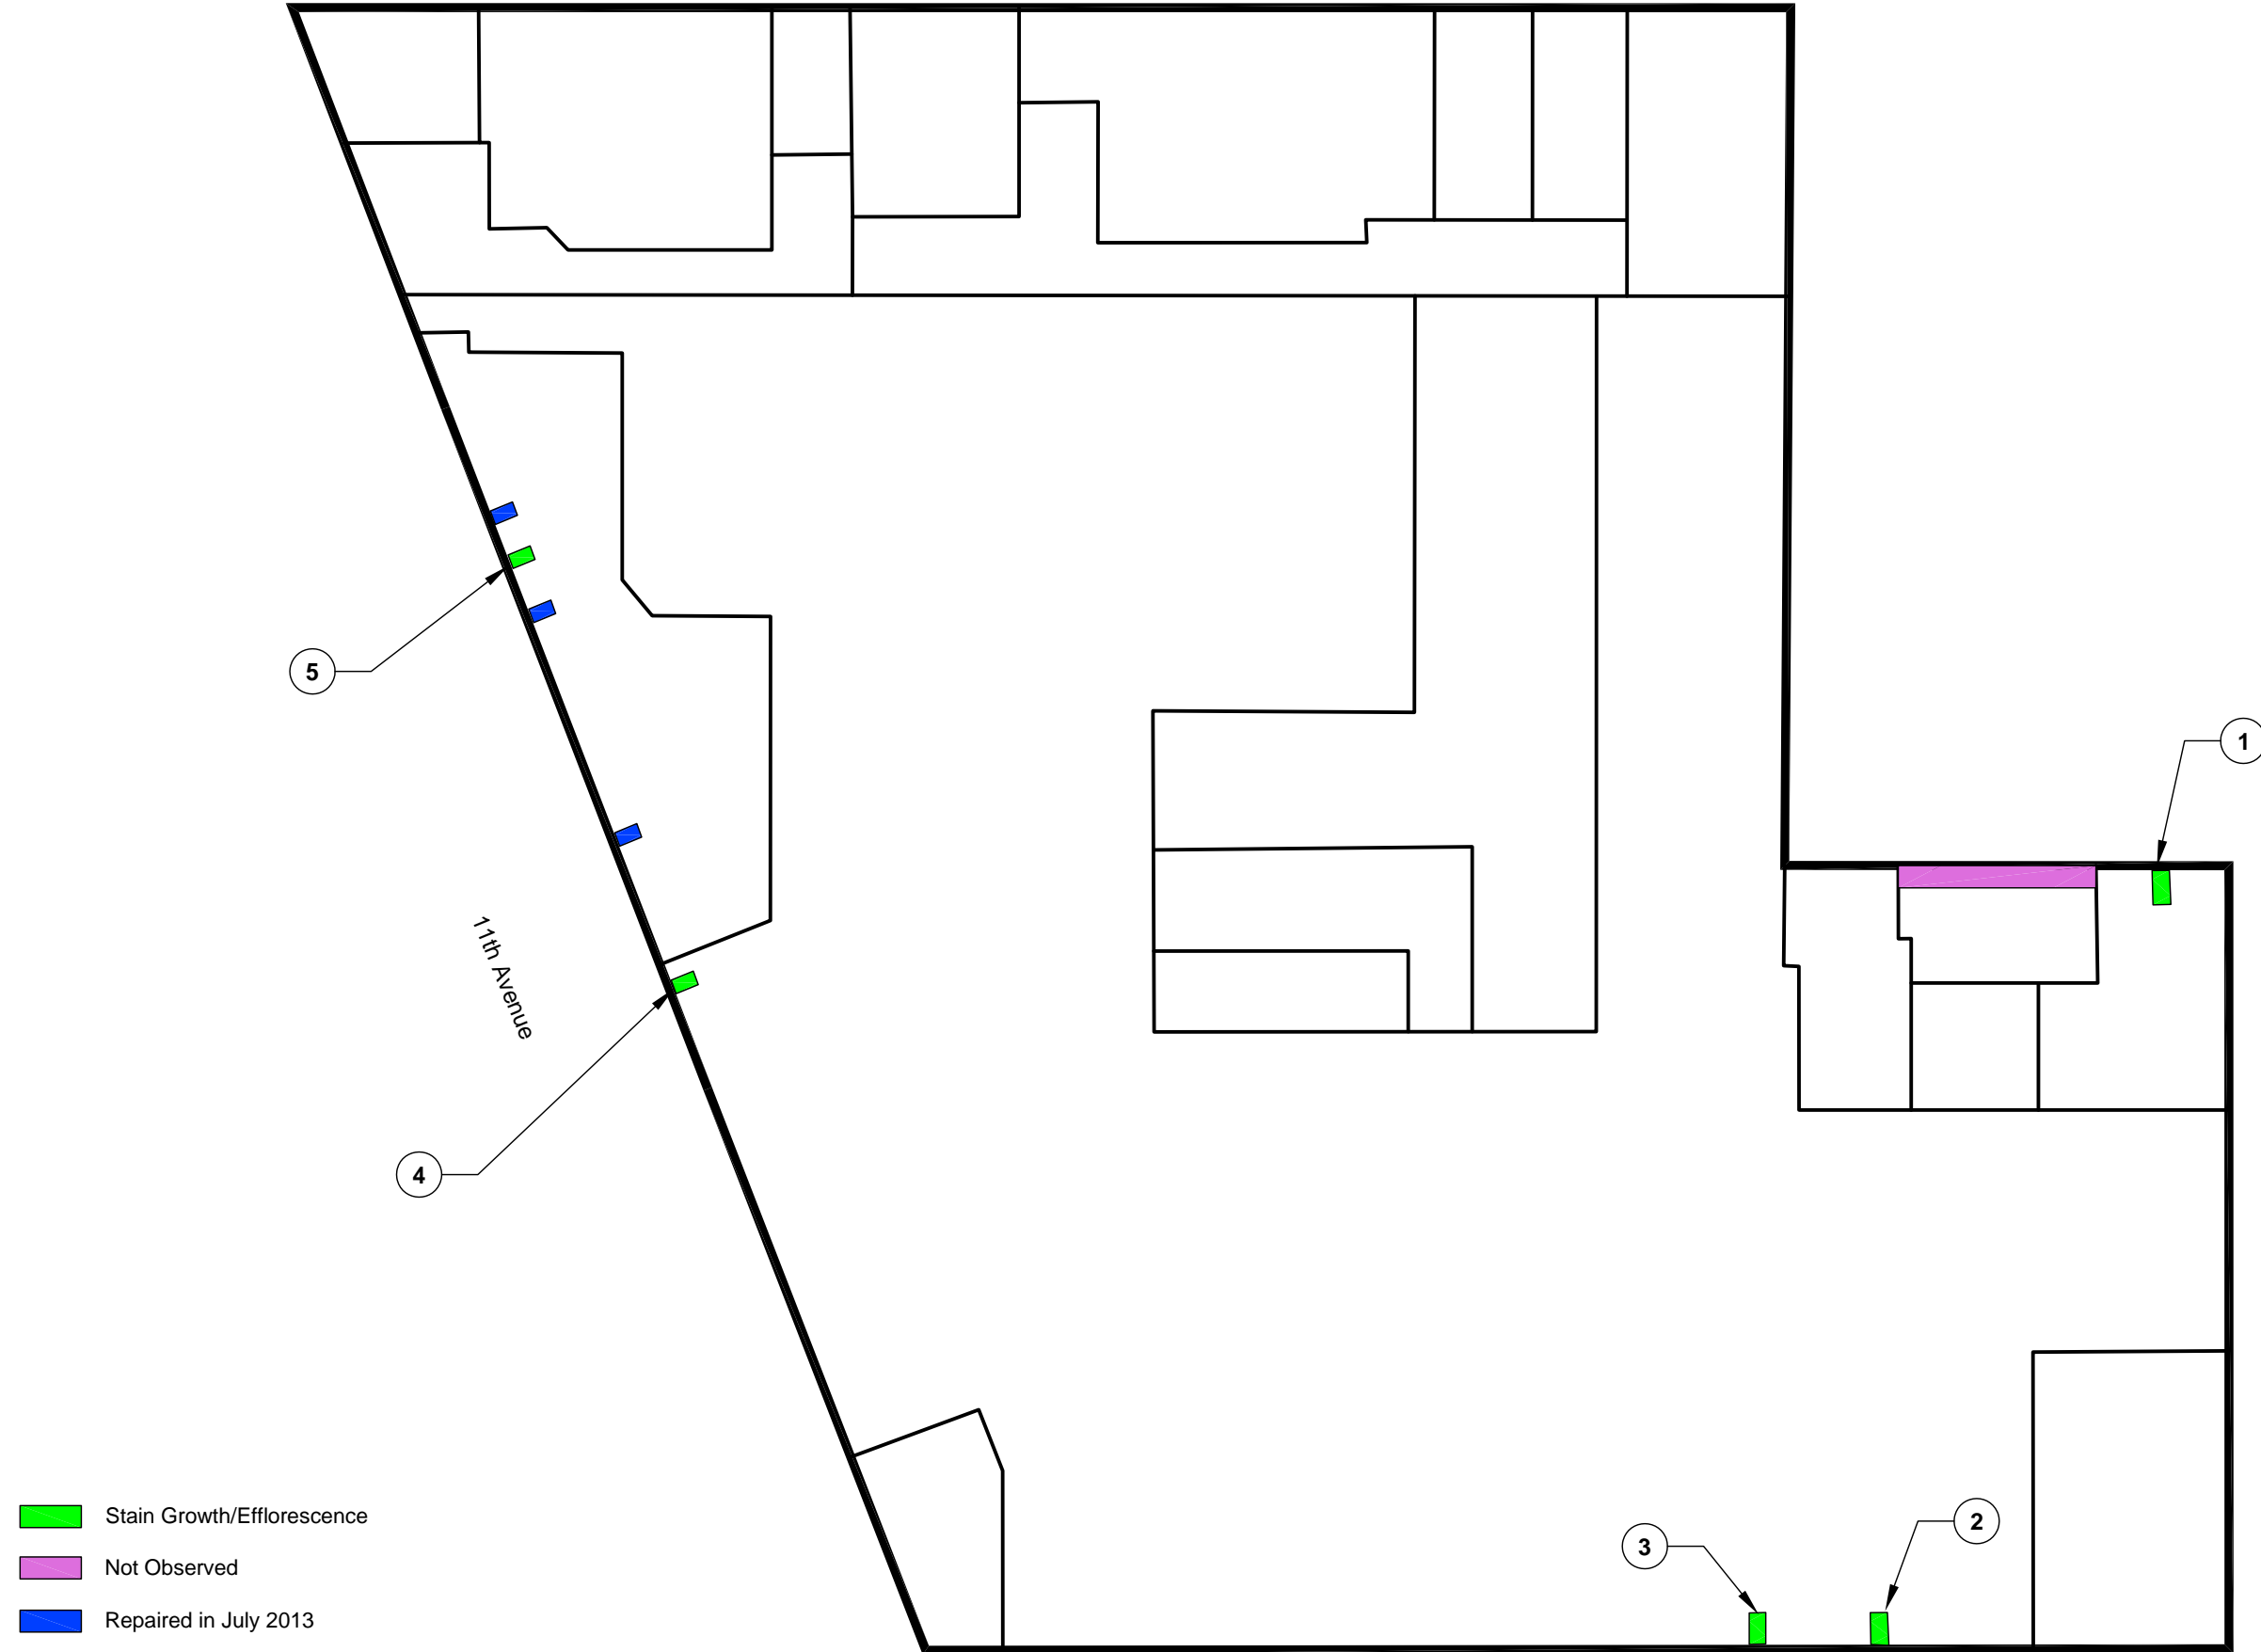
Figure 1. Vapor Barrier Repair Locations

During the inspection, Integral Engineering observed isolated instances of active water infiltration, predominantly near the slab-wall interface locations (see Figure 1). Also observed

¹ One small section of the foundation wall was not inspected (see Figure 1) as it was inaccessible.

The locations of all repairs are shown in plan view (by number) in Figure 1. Pictures of the repairs can be found in Appendix B.

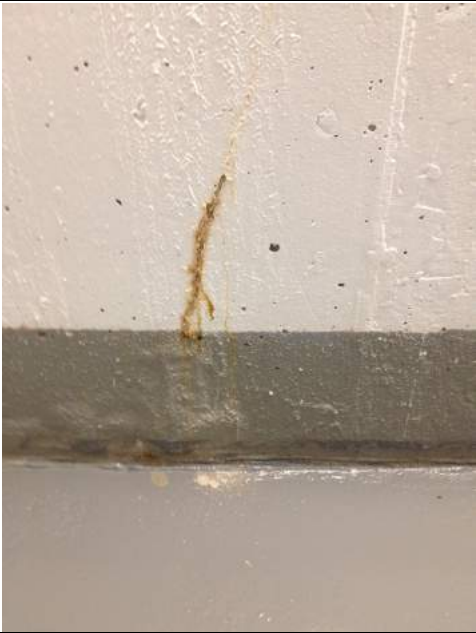
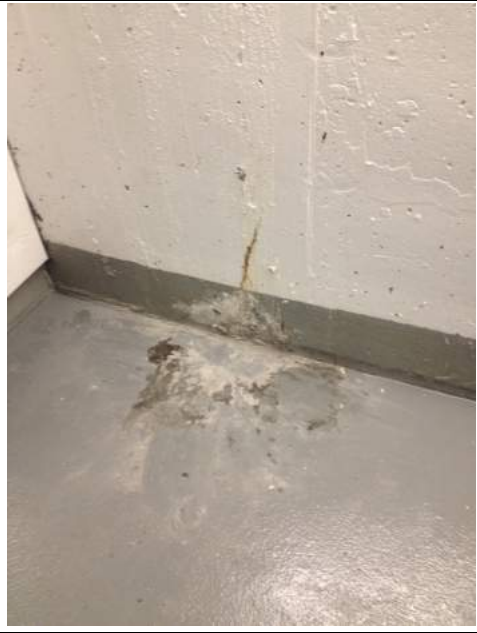
- Location 1 – A small hairline crack was observed running vertically along the North foundation wall. Efflorescence build-up was observed.
- Location 2 – Efflorescence build-up was observed on the South foundation wall near the floor. Evidence of previous repairs was noted.

| Location 1 – Before repair. | | | | | Location 1 – After repair. | |

All repairs related to the 2014 recommendations were performed by Starbrite Waterproofing on February 28, 2014, under the observation of Integral Engineering. All areas slotted for repairs were grout injected following the OMP guidelines.

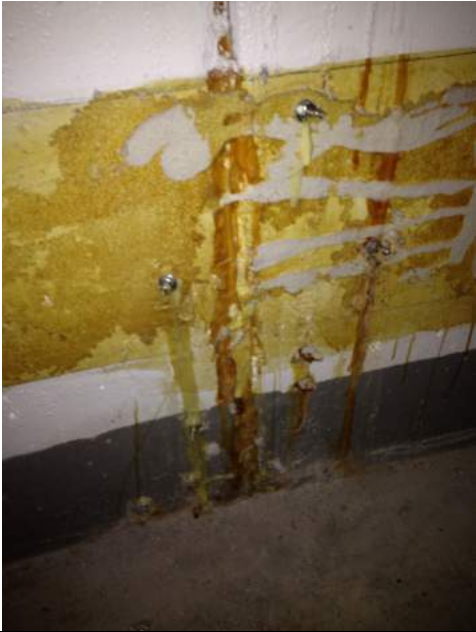
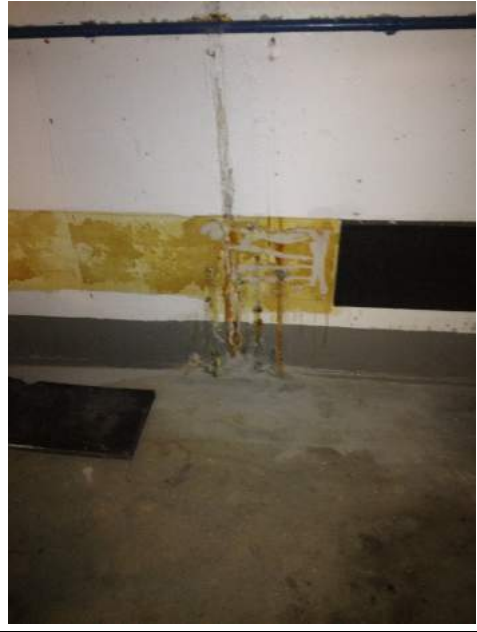
| Location 2 – Before repair. | | | | | Location 2 – After repair. | |

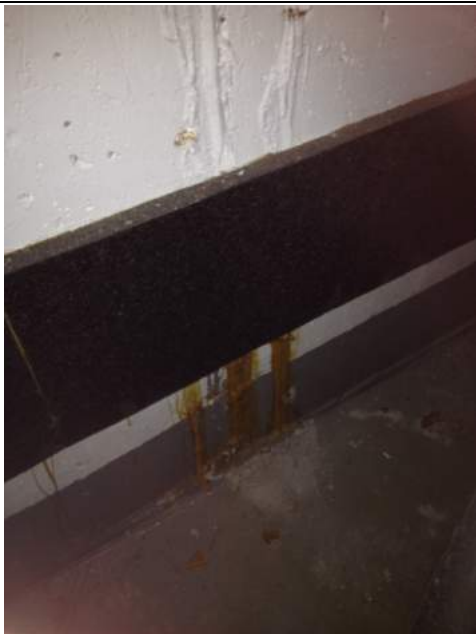
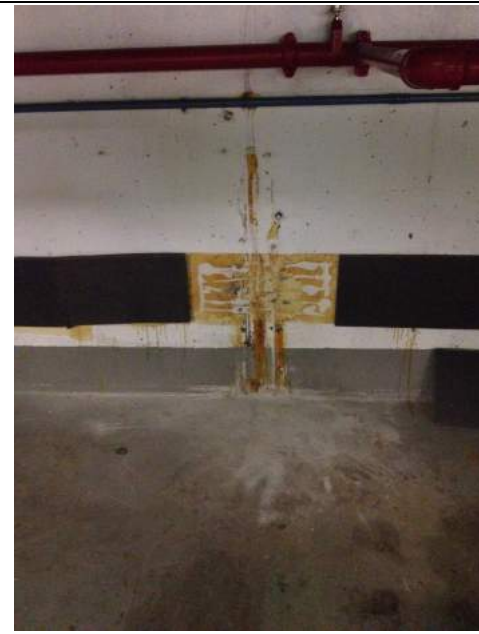
- Location 3 – An active water infiltration was found along the South foundation wall near the floor. The area surrounding the crack was found to contain moisture during the inspection.
- Location 4 – An active water infiltration was found along the West foundation wall near the floor. The area surrounding the crack was found to contain moisture during the inspection.
- Location 5 – An active water infiltration was found along the West foundation wall near the floor. Staining and some moisture were found during the inspection.

Location 3 - Before repair.

Location 3 - After repair.

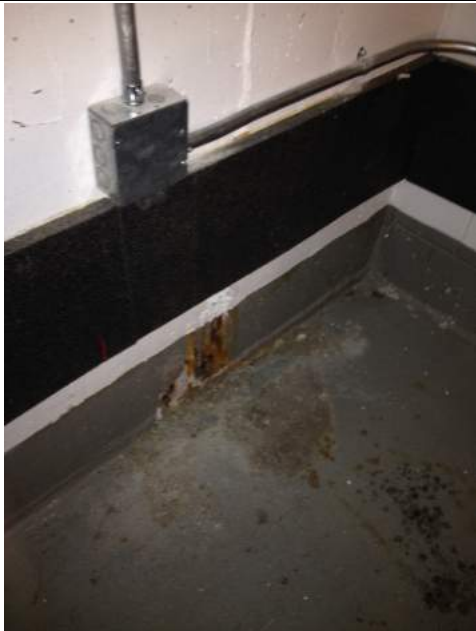
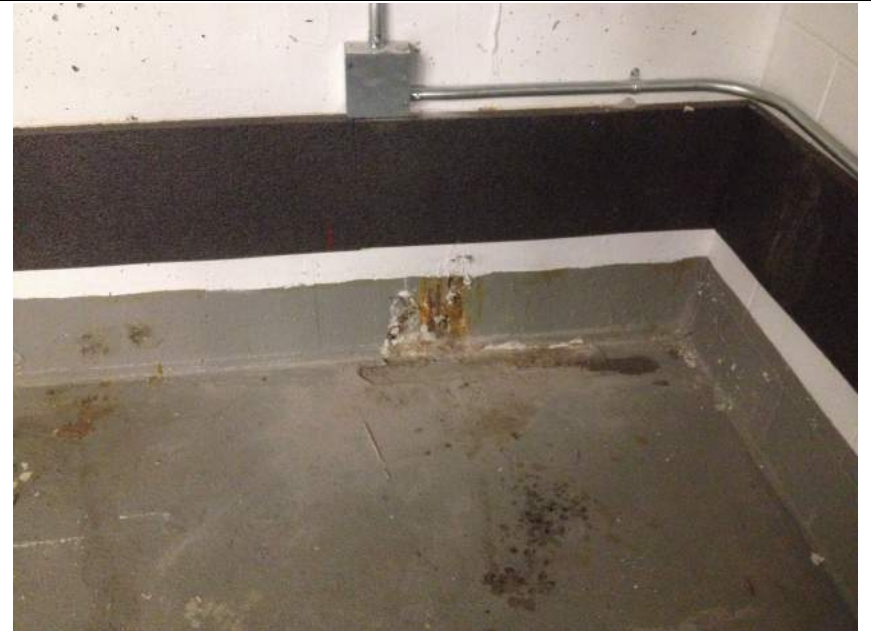
Location 4 - Before repair.

Location 4 - After repair.

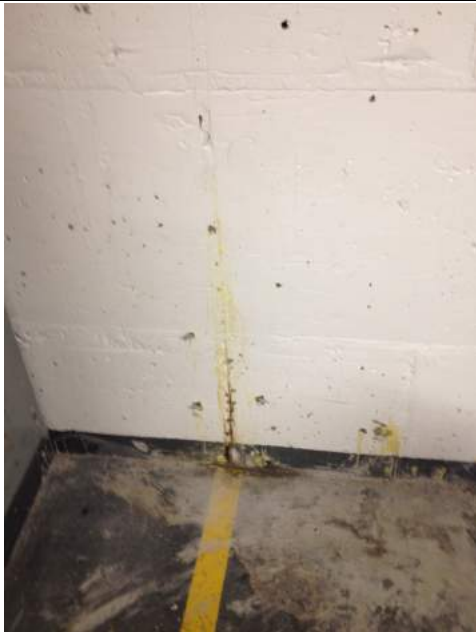
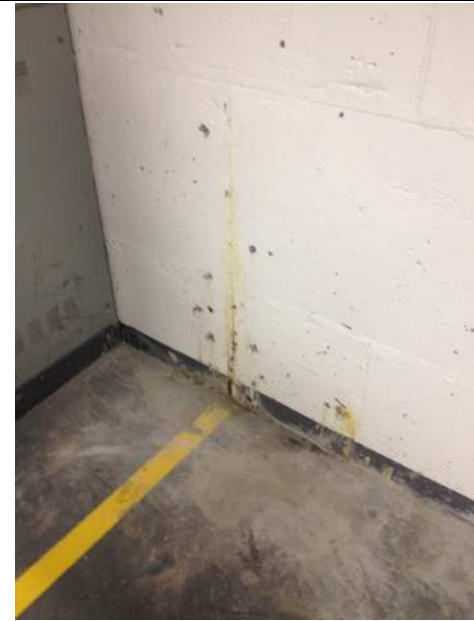
Location 5 – Before repair.

Location 5 – After repair.
