**PERIODIC REVIEW REPORT**

**For the Property Located at**  
**West 19<sup>th</sup> Street Development Site, New York, NY**

March 12, 2015

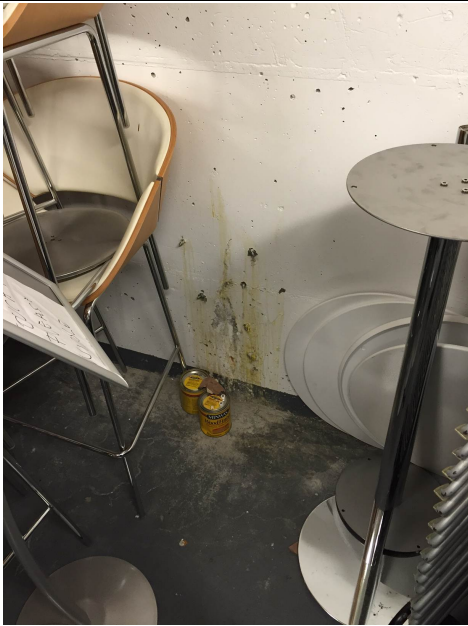
- Location 1 – Evidence of active water infiltration was found along the west foundation wall near the floor. The area surrounding the crack contained moisture during the inspection.

Location 1 – Before repair.

Per the OMP, only cracks where the water is actively discharging through the crack are required to be repaired, and suspected breaches in the barrier-layer system should be monitored. However, upon completion of the 2015 inspection, Integral recommended that both locations listed above in Section 5.1.2.2 and 5.1.2.1 be repaired using the grout injection technique described in the OMP.

The repair of the two locations identified by the 2015 inspection was performed by Starbrite Waterproofing on February 13, 2015, under the observation of Integral. The areas were grout injected following the OMP guidelines.

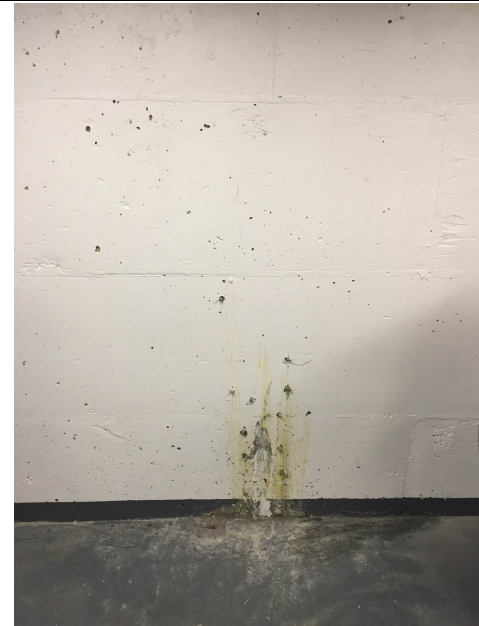
Location 1 – After repair.

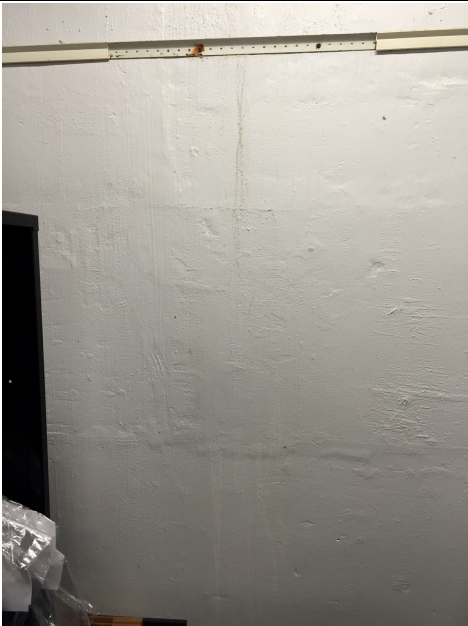
- Location 2 – A small hairline crack with efflorescence build-up was observed running vertically along the north foundation wall.

Location 2 – Before repair.

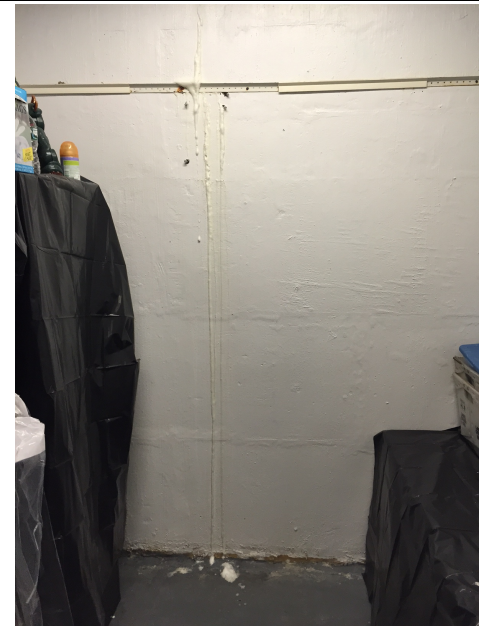
Location 2 – After repair.
