PERIODIC REVIEW REPORT

**For the Property Located at
West 19th Street Development Site, New York, NY**

March 13, 2017

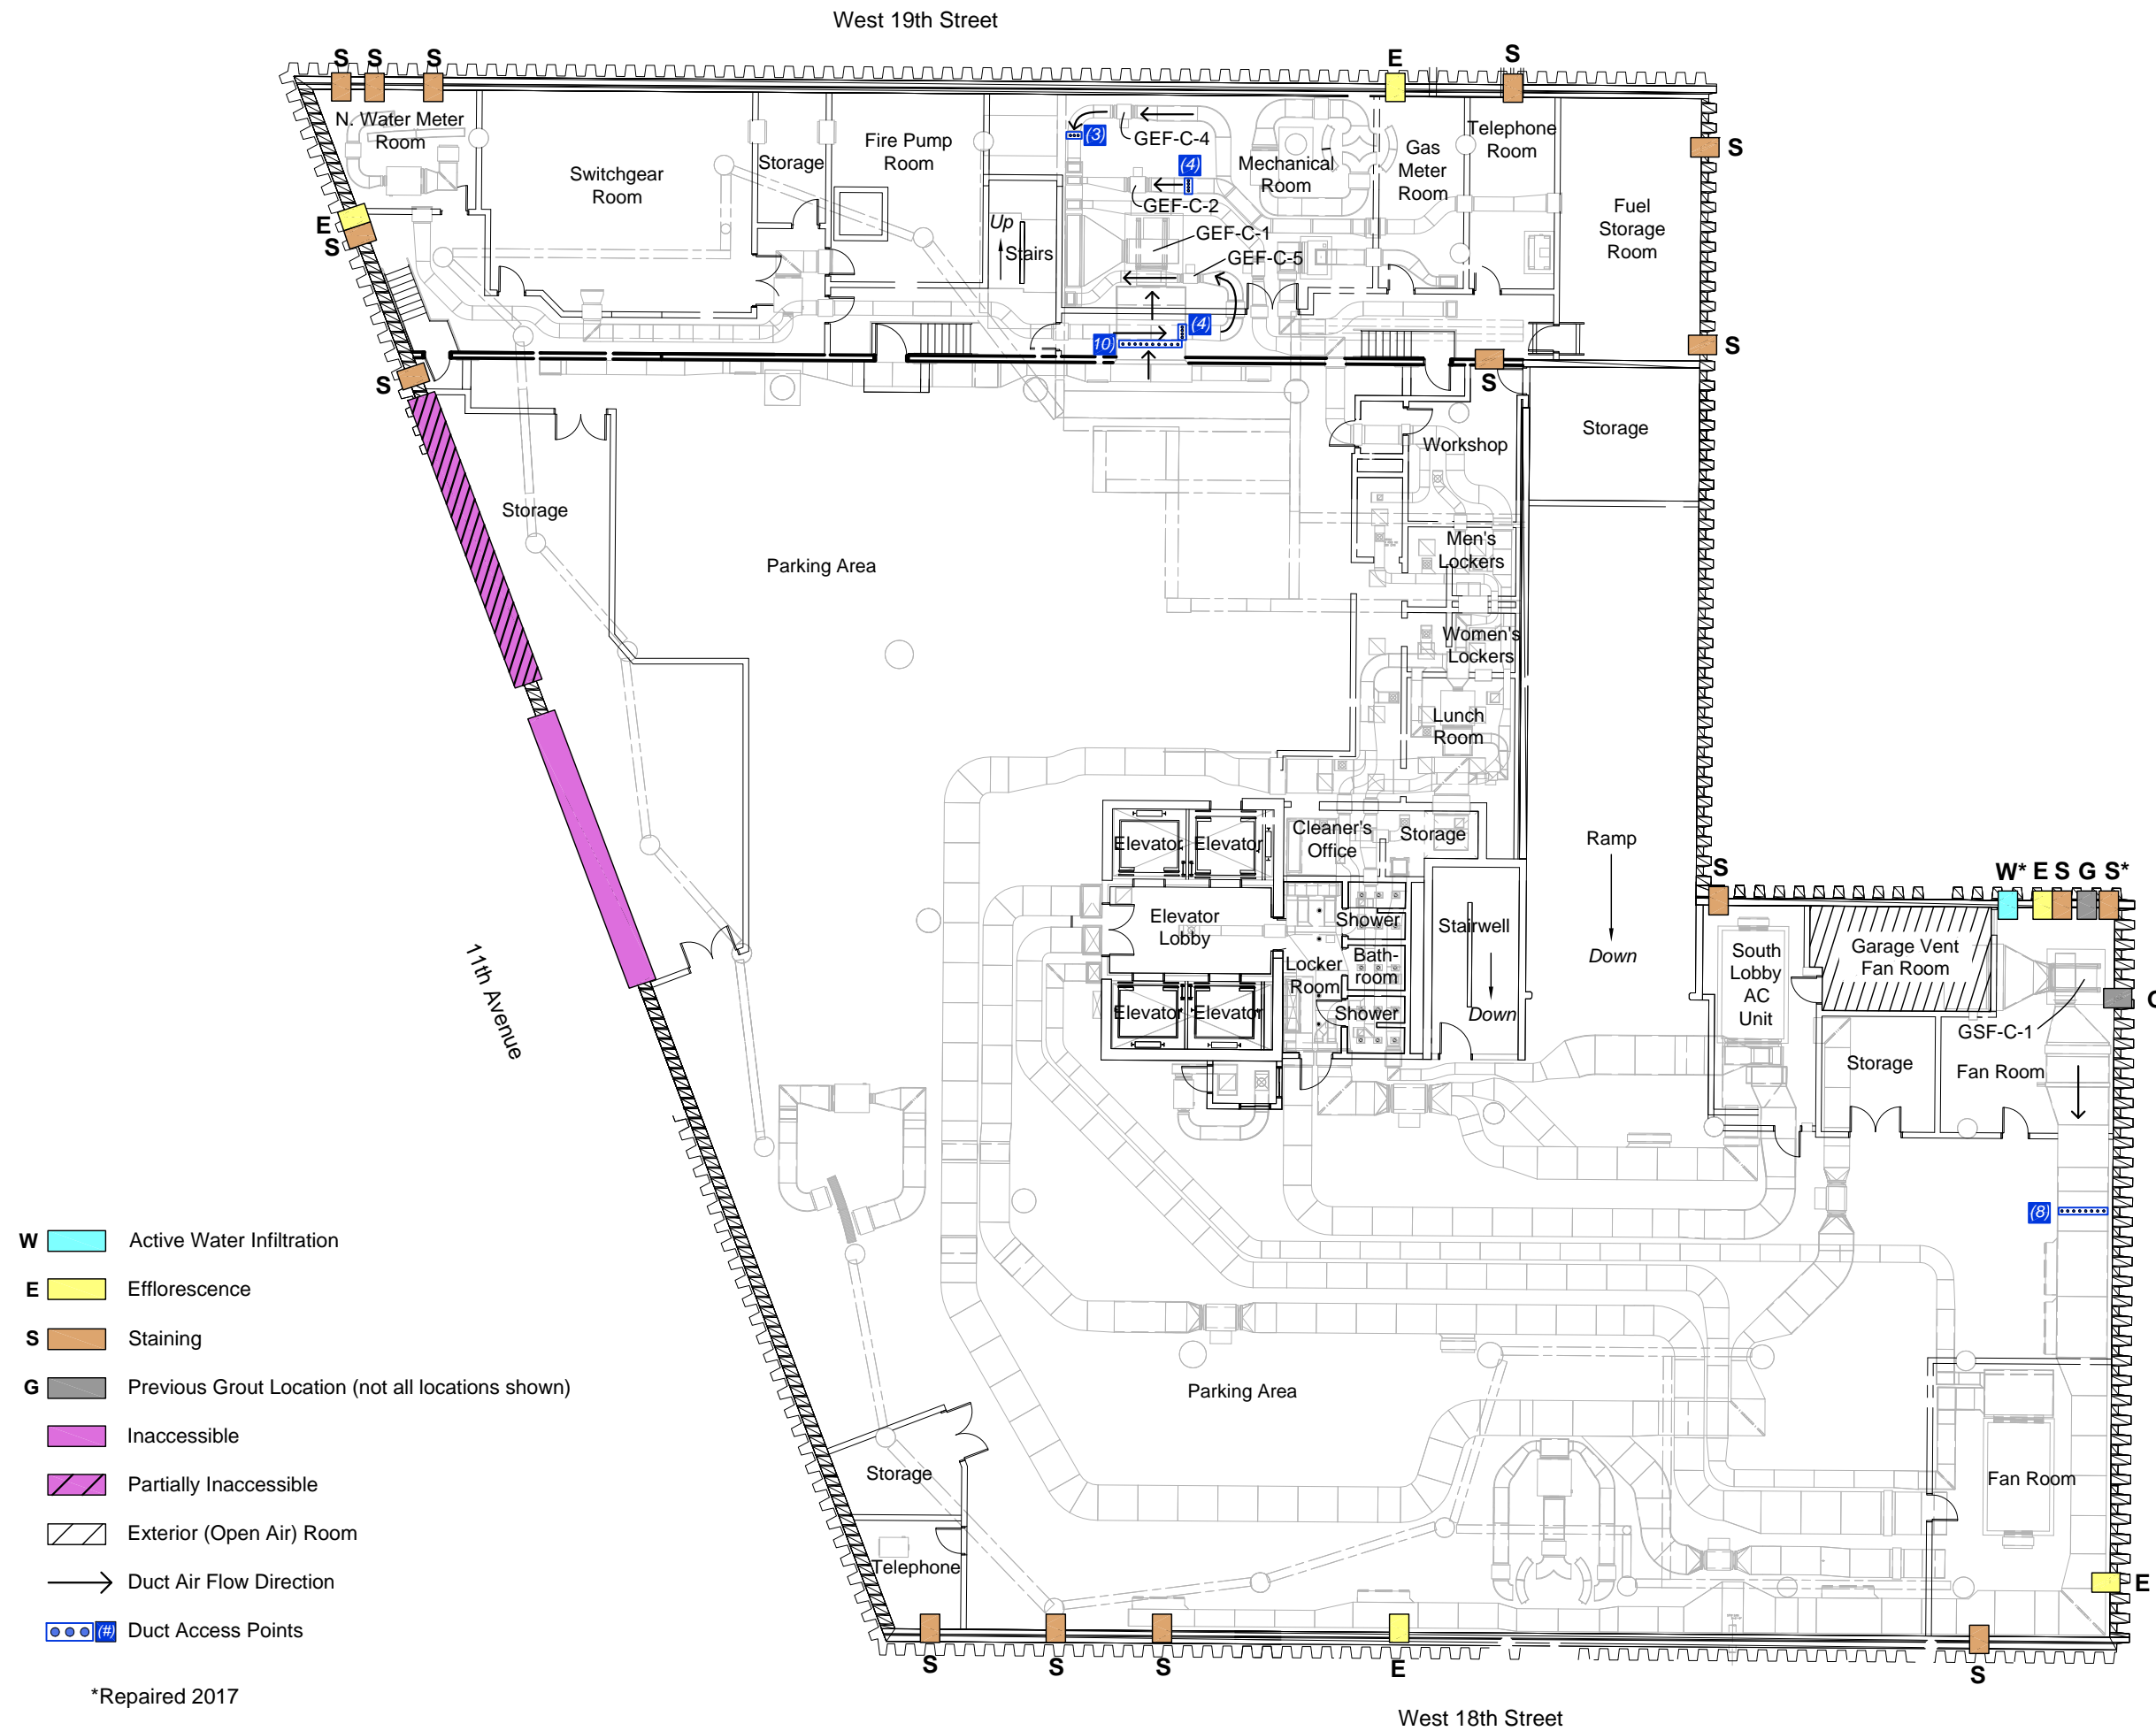
FIGURE 1

During the inspection, Integral observed one isolated instance of active water infiltration in the eastern Fan Room. Integral also observed historical evidence of staining or efflorescence (but

not active) at various locations around the perimeter foundation wall. See Figure 1 for the locations of these observations.

BARRIER LAYER REPAIRS LOCATIONS

The repair of the one location identified by the 2017 inspection was performed by Starbrite on February 28, 2017, under the observation of Integral. The areas were grout injected following the OMP guidelines.

The location of the repair made during this reporting period is shown in plan view on Figure 1. Pictures of the repair can be found in Appendix C.

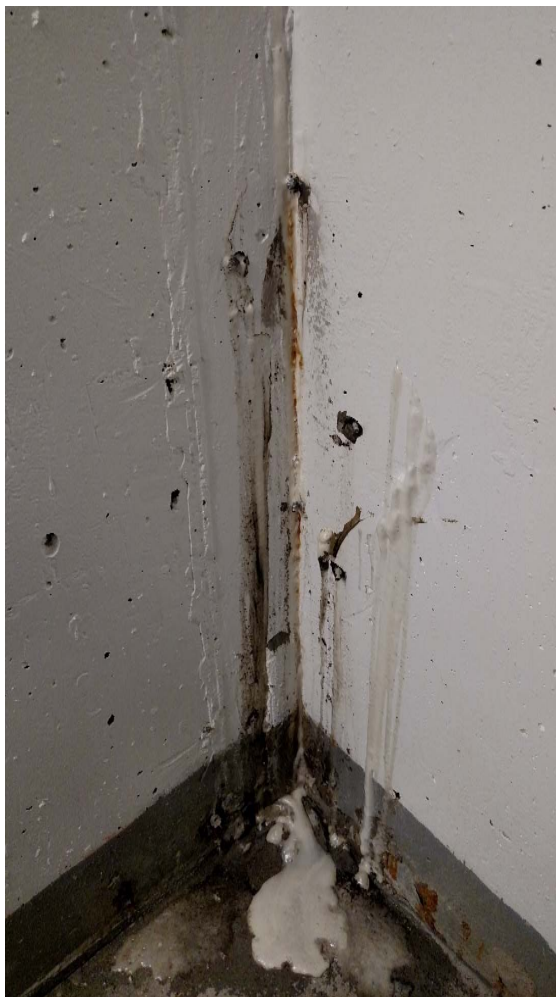
² Integral also had grout injected near an area of historical staining in the same room.

Photograph 1. Grout Repair in Stained Area (Northeast Corner of Fan Room)

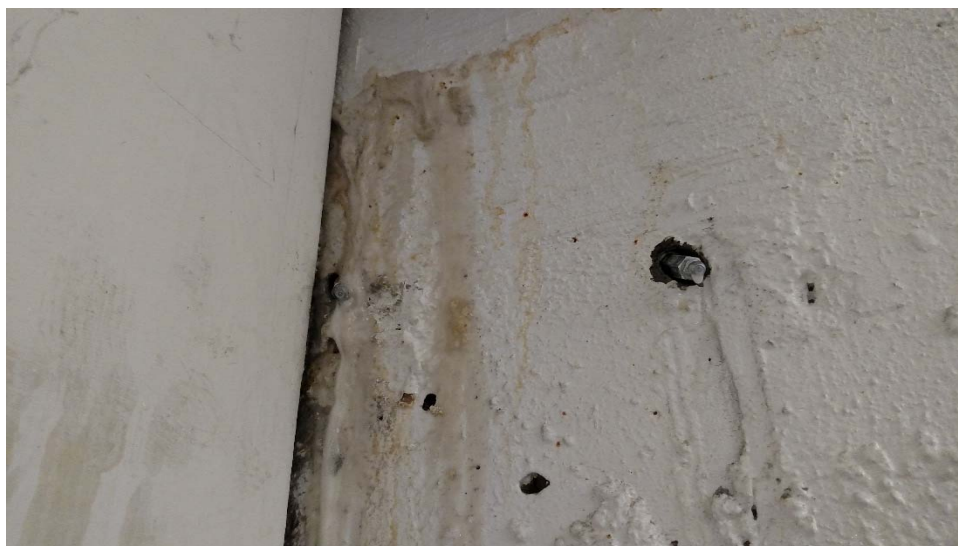
Photograph 2. Grout Repair in Area of Water Infiltration (Fan Room)

Per the OMP, only cracks where the water is actively discharging through the crack are required to be repaired, and suspected breaches in the barrier-layer system should be monitored. Accordingly, upon completion of the 2017 inspection, Integral recommended that the one active water infiltration location listed in Section 5.1.2 above be repaired² using the grout injection technique described in the OMP.
