PERIODIC REVIEW REPORT

**For the Property Located at
West 19th Street Development Site, New York, NY**

Prepared for
IAC/InterActiveCorp
550 West 18th Street
New York, NY 10011

March 16, 2018

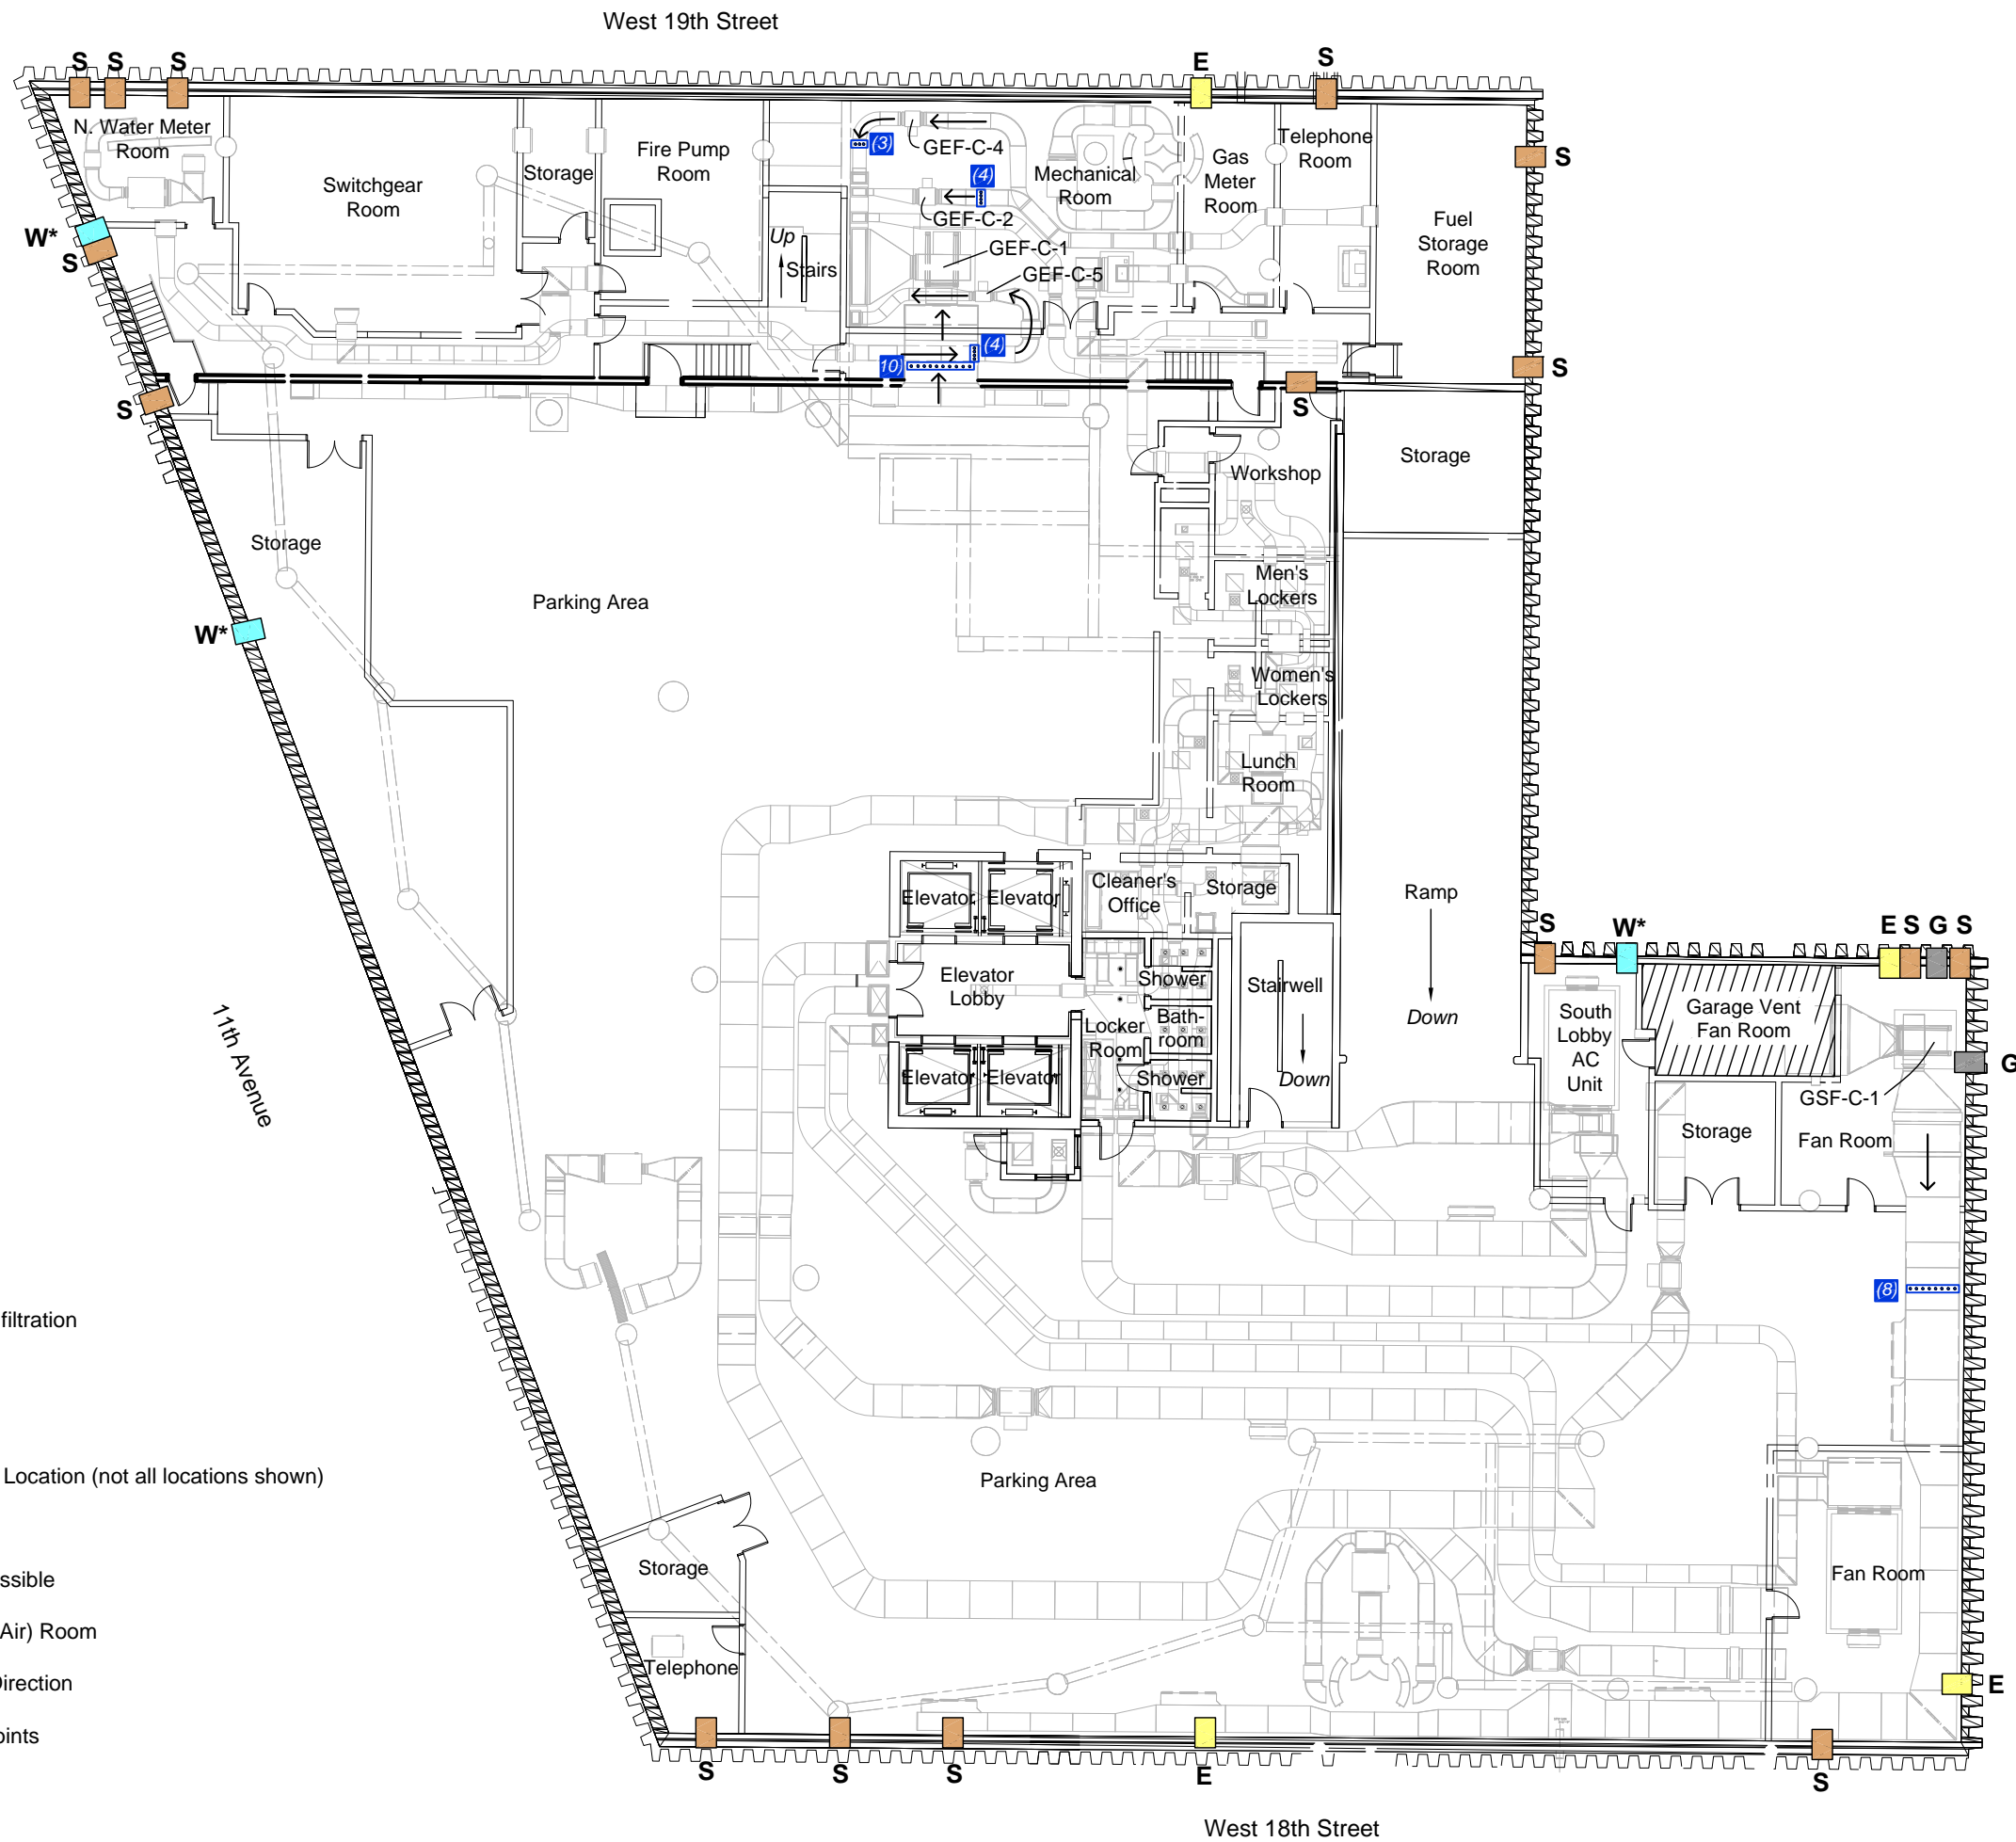
FIGURE 1

During the inspection, Integral observed three instances of active water infiltration. There was one instance each in the following areas: the eastern Fan Room, western Store Room, and the stairwell located in the northwest corner of the building. Integral also observed historical evidence of staining or efflorescence (but not active water infiltration) at various locations around the perimeter foundation wall. See Figure 1 for the locations of these observations.

VAPOR BARRIER OBSERVATIONS & REPAIR

*Repaired 2018

The location of the repairs made during this reporting period is shown in plan view on Figure 1. Pictures of the repairs can be found in Appendix D.

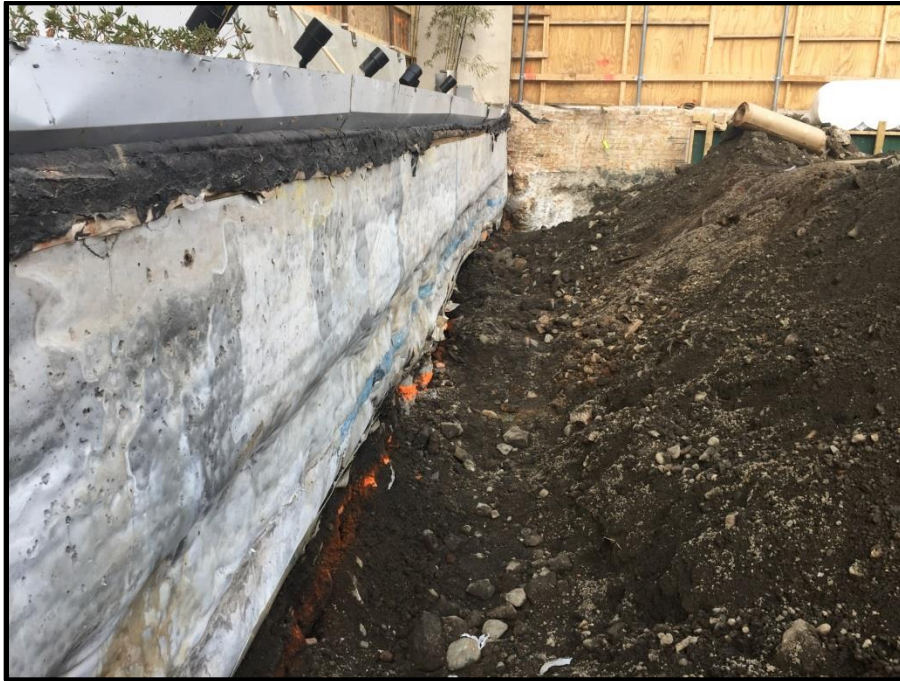
Photo 1: West wall of IAC building prior to beginning waterproofing work (facing northwest)

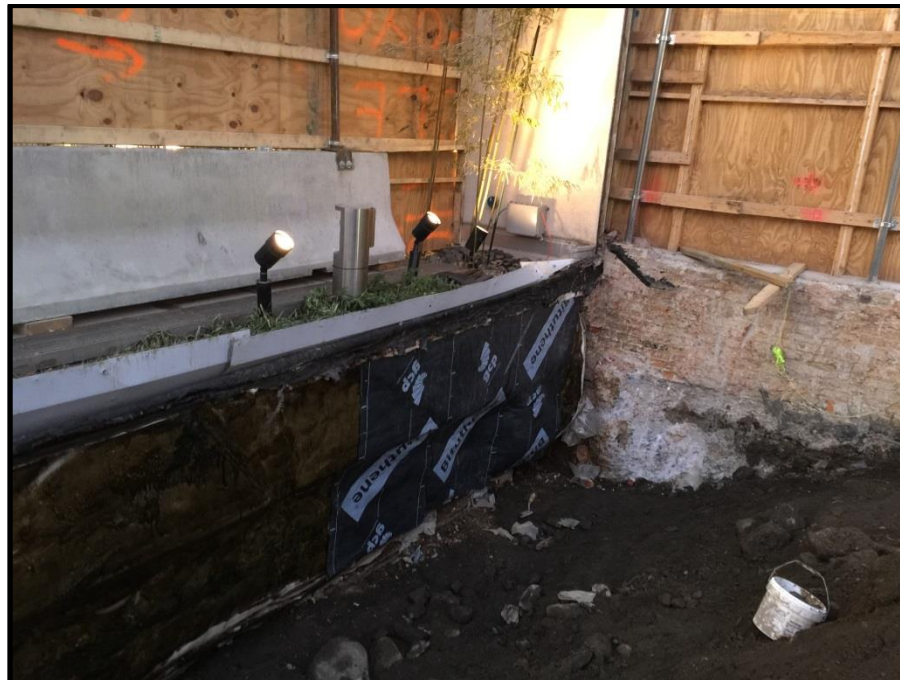
Photo 2: End of waterproofing work for the day (facing northwest).

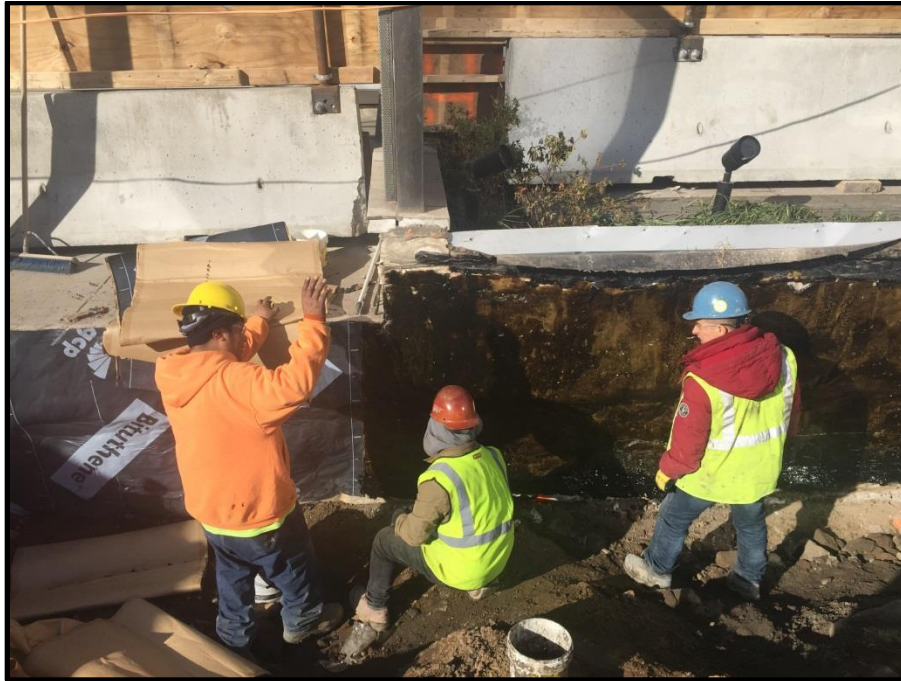
Photo 1: Contractor installing Bituthene membrane over the west wall (facing west)

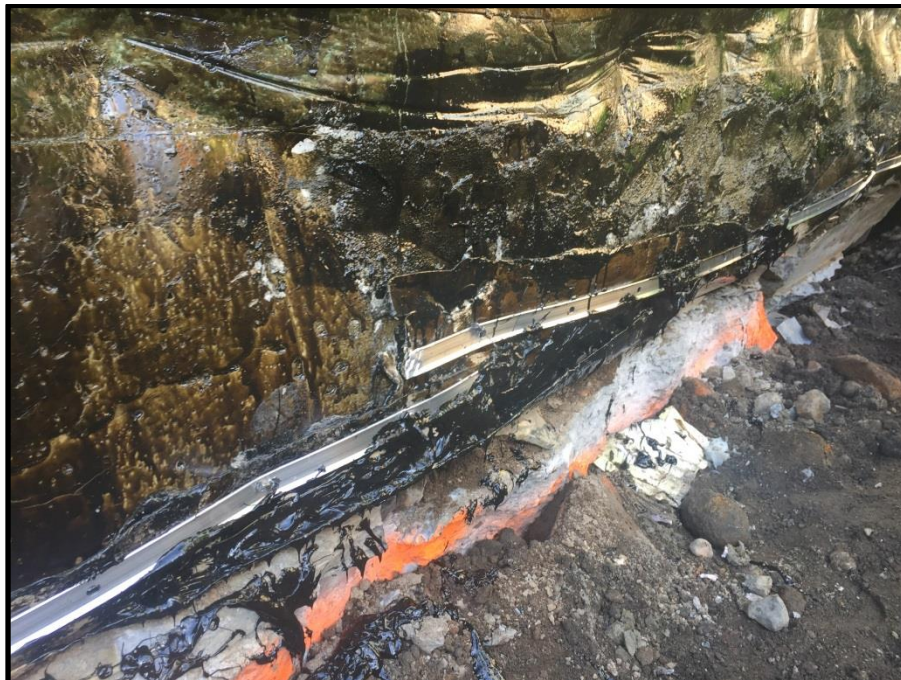
Photo 2: View of Preprufe termination at the bottom of the wall

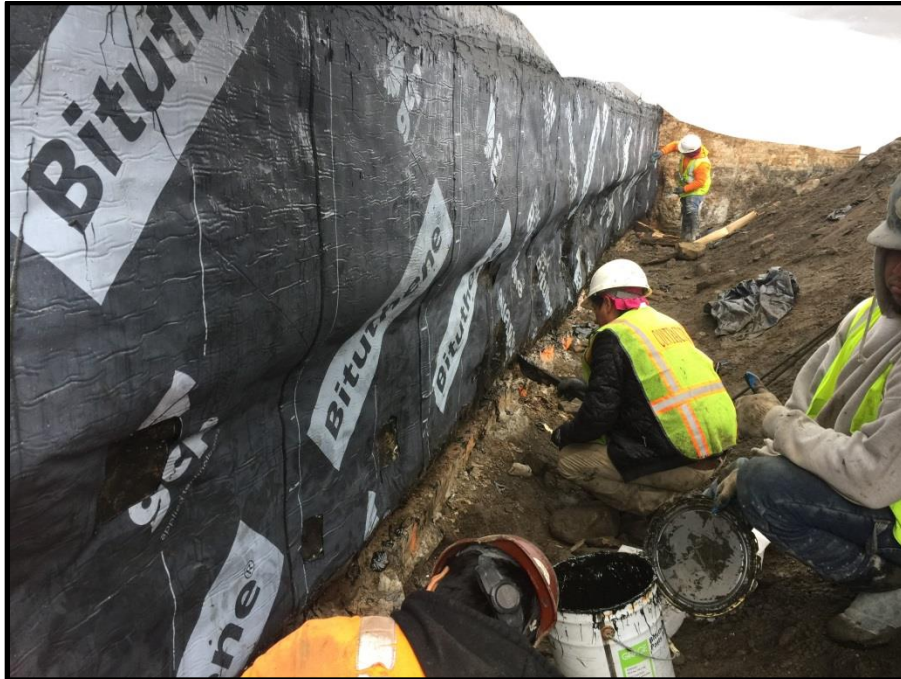
Photo 1: Contractor repairing the Bituthene membrane along the west wall (facing north)

The contractor applied LM over the Preprufe-Bituthene 3000 overlap at the bottom of the wall. The contractor started installing termination bars at the top of the wall. Langan, MRCE, and Related, identified locations where the Bituthene membrane did not adhere properly to the wall; these areas were delineated for repair.

Contractor applied LM over the top termination bar and repaired the poorly adhered areas. Contractor installed Hydroduct (prefabricated drainage panels) over the Bituthene membrane.

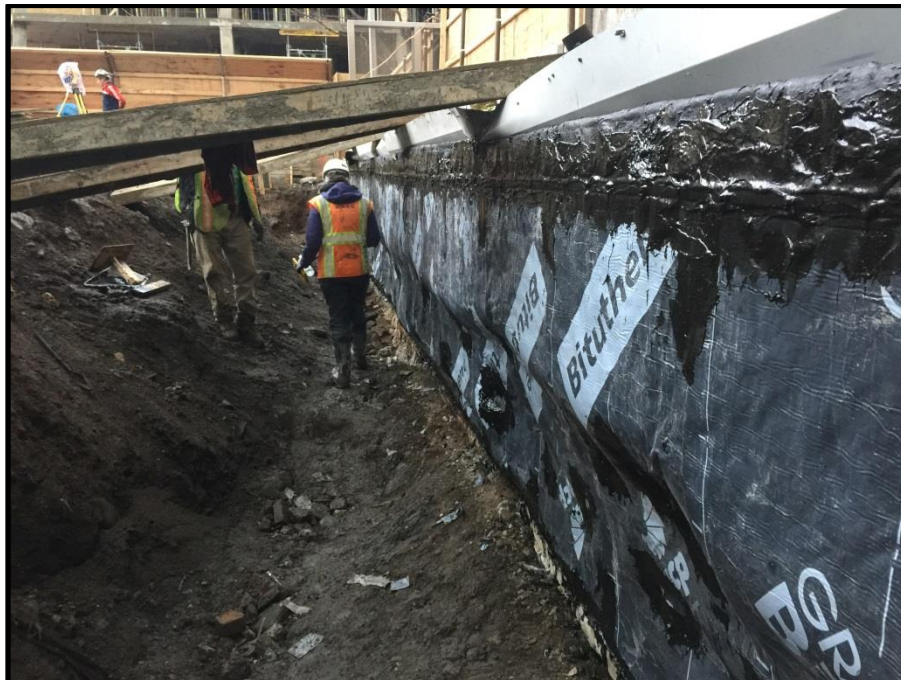
Photo 2: MRCE engineer inspecting completed waterproofing (facing south)

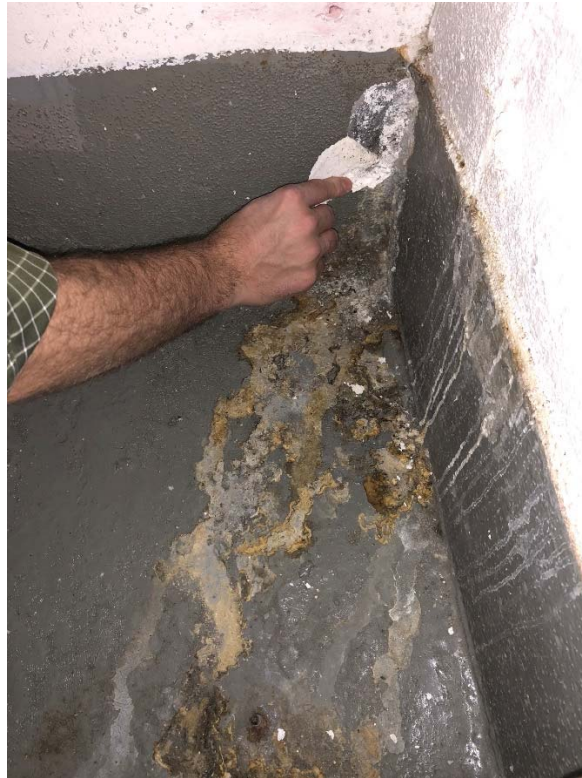
Photograph 1. Water infiltration and dried grout in northeast corner of South Lobby AC Room

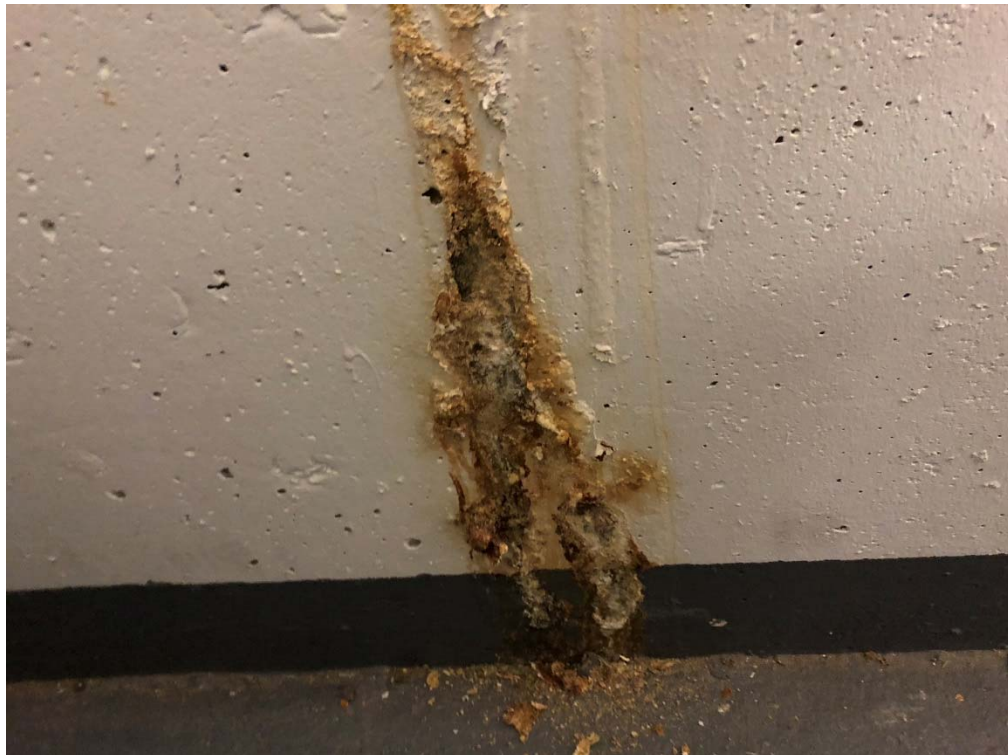
Photograph 2. Water infiltration in Storage Room

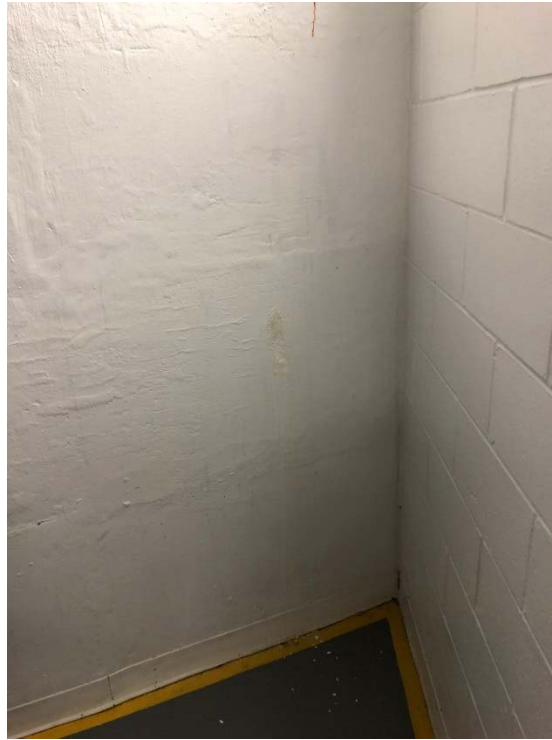
Photograph 3. Water infiltration in northwest basement stairwell

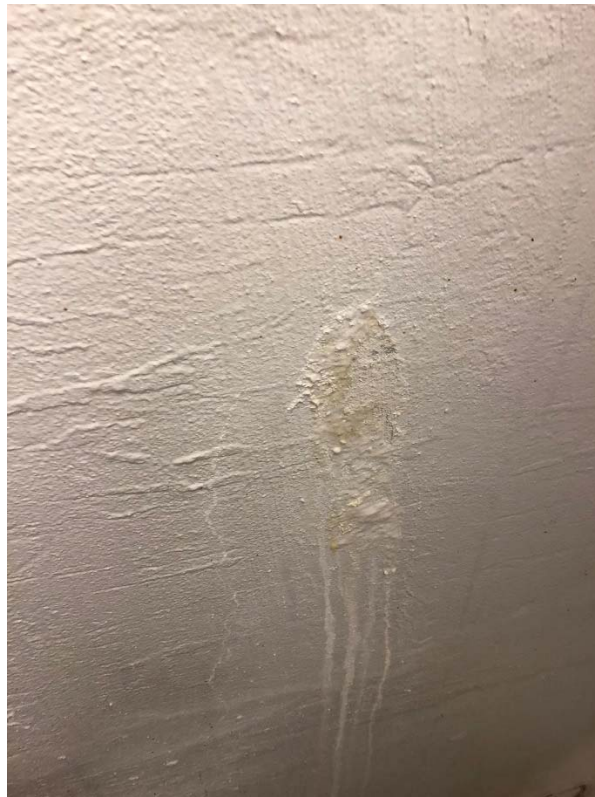
Photograph 4. Water infiltration in northwest basement stairwell (same area as Photo 3, closer picture to show damage detail)

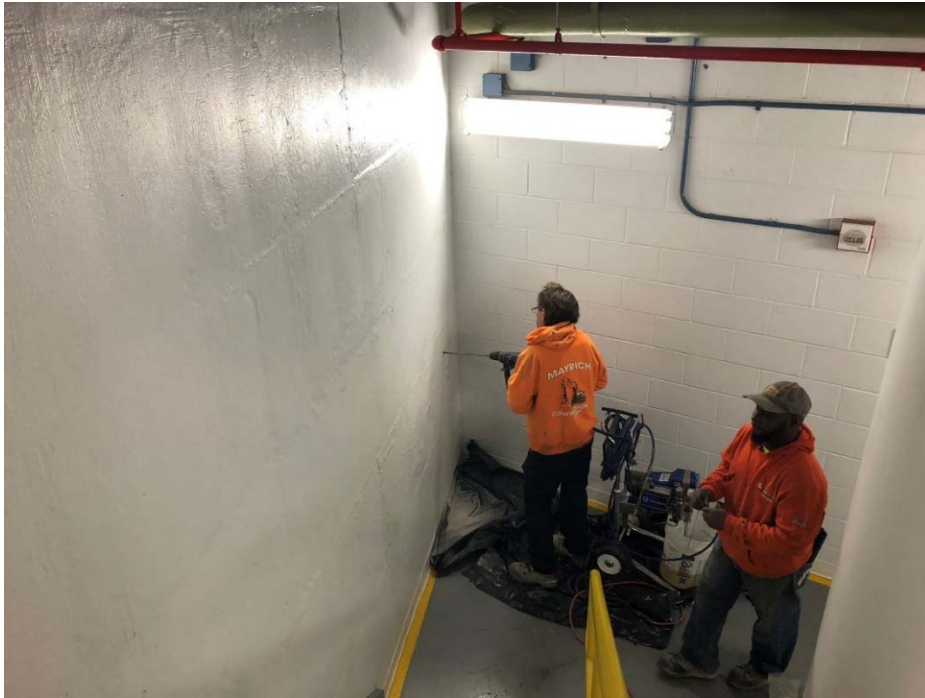
Photograph 1. Contractor drilling holes in the foundation wall for grout injection (northwest corner of building stairwell)

The repair of the three locations identified by the 2018 inspection was performed by Starbrite on March 2, 2018, under the observation of Integral. The areas were grout injected following the OMP guidelines.

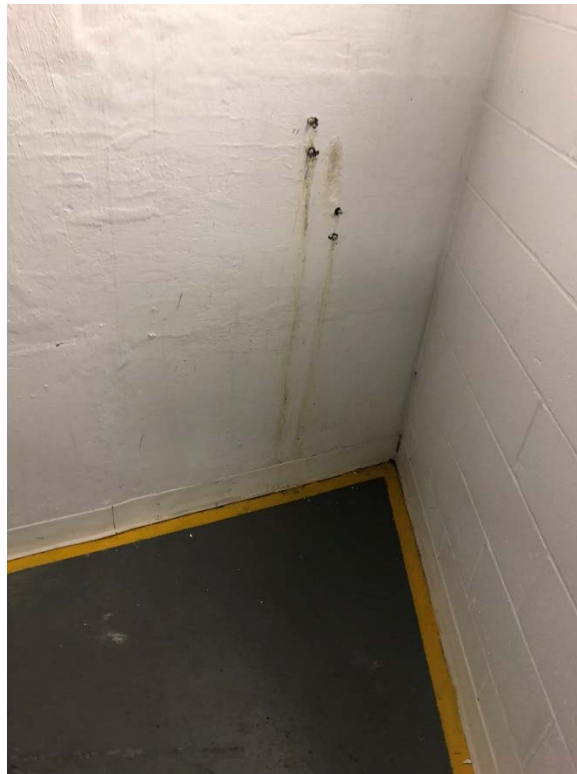
Photograph 2. Contractor injected grout into 4 points in the northwest corner of the building stairwell

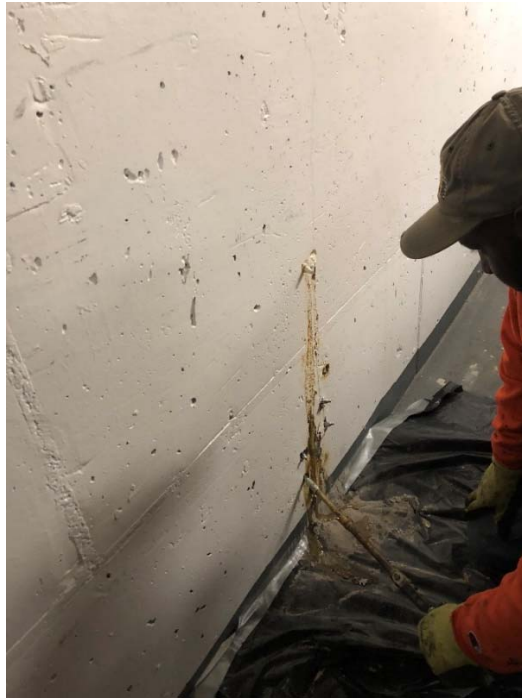
Photograph 3. Contractor injecting grout into points to seal the foundation vapor barrier (western building perimeter in Storage Room)

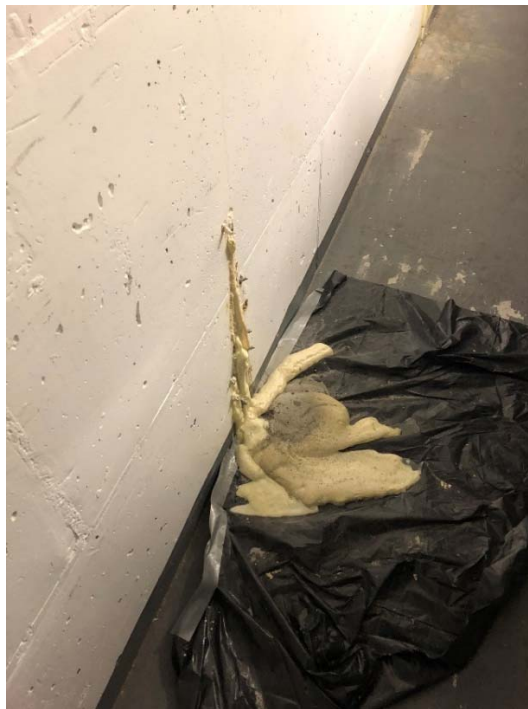
Photograph 4. Injected grout is seeping out of the injection points as it sets (western building perimeter in Storage Room)
