PERIODIC REVIEW REPORT

**For the Property Located at
West 19th Street Development Site, New York, NY**

March 13, 2019

**IAC/InterActive Corp.
Inspection & Repair Photos
Site Photographs from February 2019**

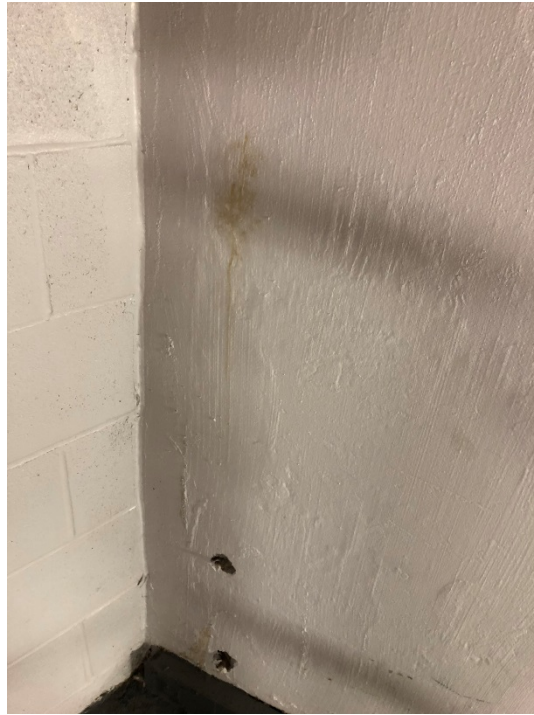
reporting period in the stairwell located at the northwest corner of the building. Integral did observe historical evidence of staining or efflorescence (but not active water infiltration) at various locations around the perimeter foundation wall. See Figure 1 for the locations of these observations.

Photograph 1. New Evidence of Active Water Infiltration on Foundation Wall in Northwest Stairwell (February 7, 2019)

Upon completion of the 2019 inspection, Integral recommended that the observed area of active water infiltration and the fire main penetration leak location listed in Section 5.1.2 above be repaired using the grout injection technique described in the OMP.

The repair of the two locations identified by the 2019 inspection was performed by Starbrite on February 21, 2019, under the observation of Integral. The areas were grout-injected following the OMP guidelines.

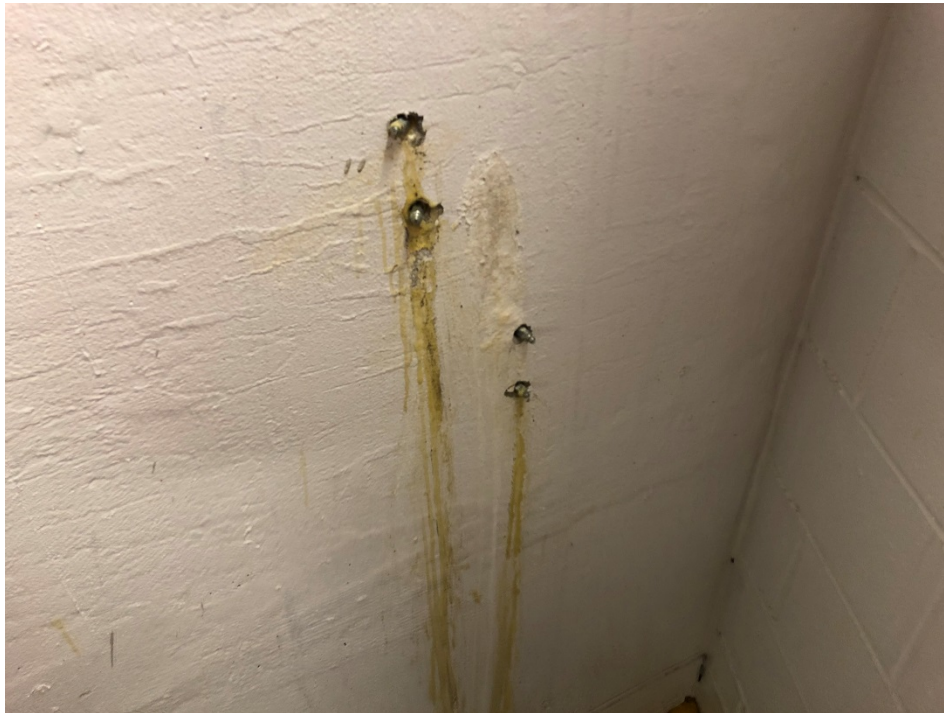
In March 2018, three locations with evidence of water infiltration were repaired with grout injection. Integral inspected these locations during the 2019 inspection and found that they remained effective in terms of preventing water infiltration.

Photograph 2. 2018 Grout Injection Location (February 7, 2019)

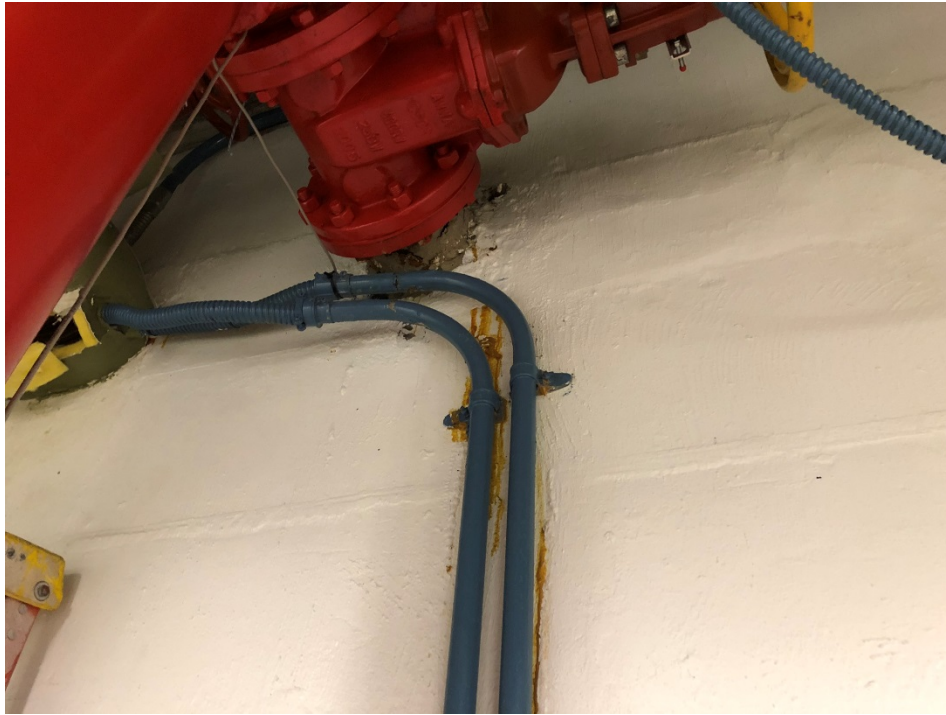
During the inspection, Tom Casey, the IAC Building Engineer, told Integral that water entered the foundation wall penetration of the fire main pipe in the North Water Meter Room for several days after a large rain event in 2018. This area was not actively discharging at the time of Integral's inspection. Integral observed one instance of active water infiltration during this

Photograph 3. Leaking Fire Main Pipe Penetration (February 7, 2019)

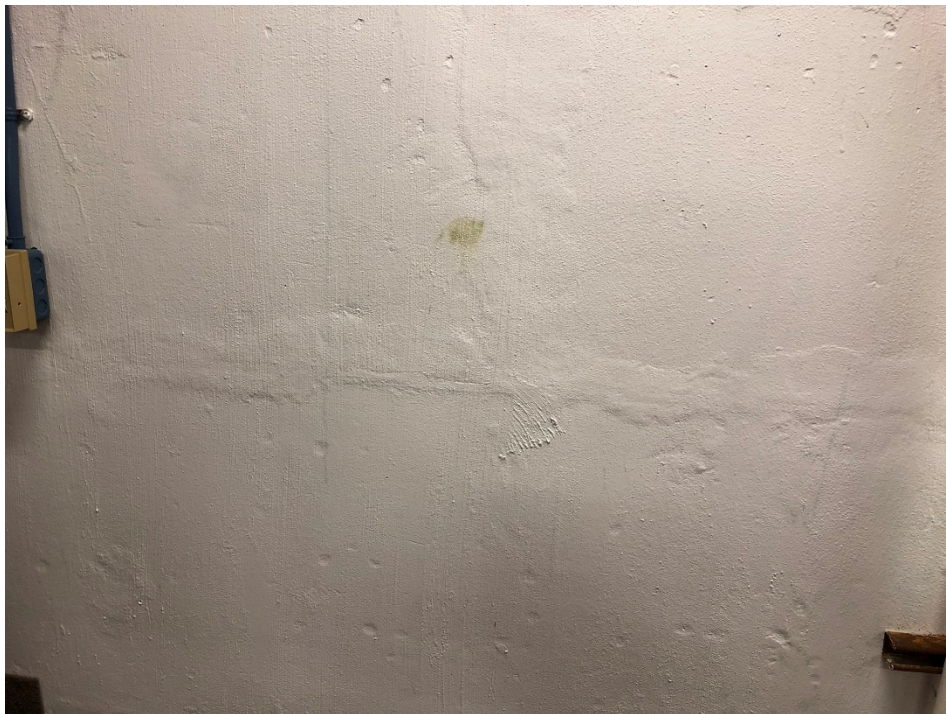
Photograph 4. New Foundation Wall Stain in Fire Pump Room (February 7, 2019)

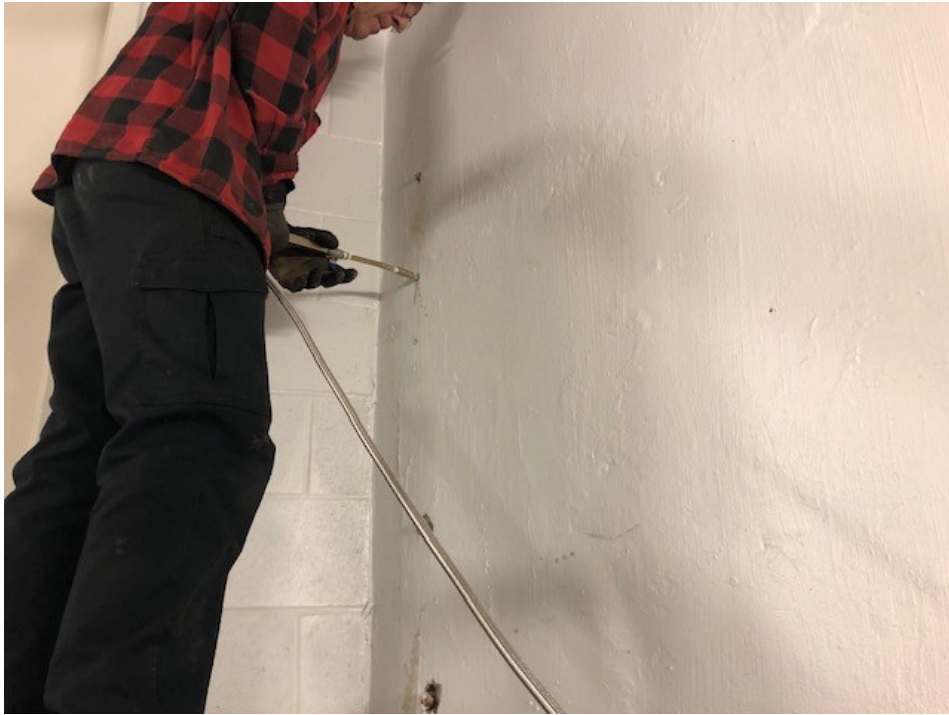
Photograph 5. Grout Injection around Water Infiltration Stain in Northwest Stairwell (February 21, 2019)

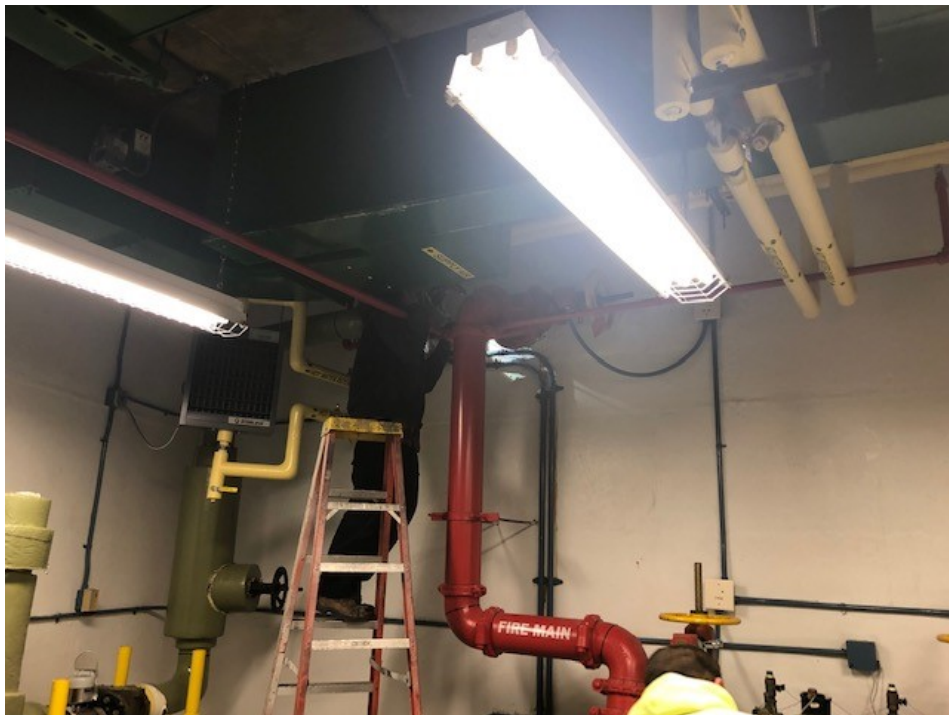
Photograph 6. Starbrite Drilling Holes for Grout Injection around Fire Main Pipe Penetration in Foundation (February 21, 2019)

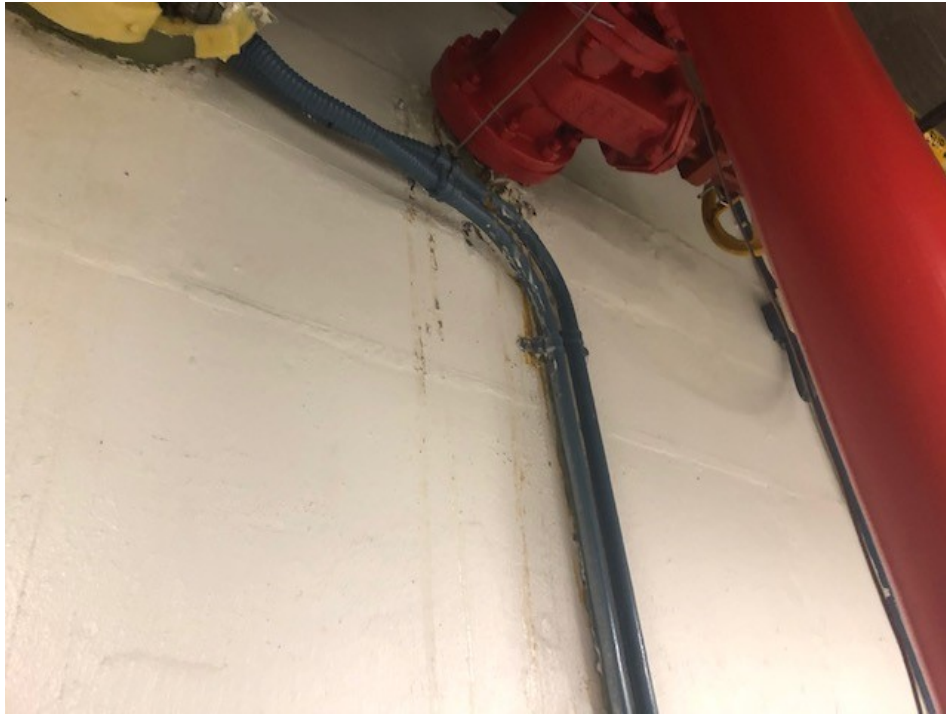
Photograph 7. Fire Main Pipe Penetration in Foundation Wall after Grout Injection (February 21, 2019)

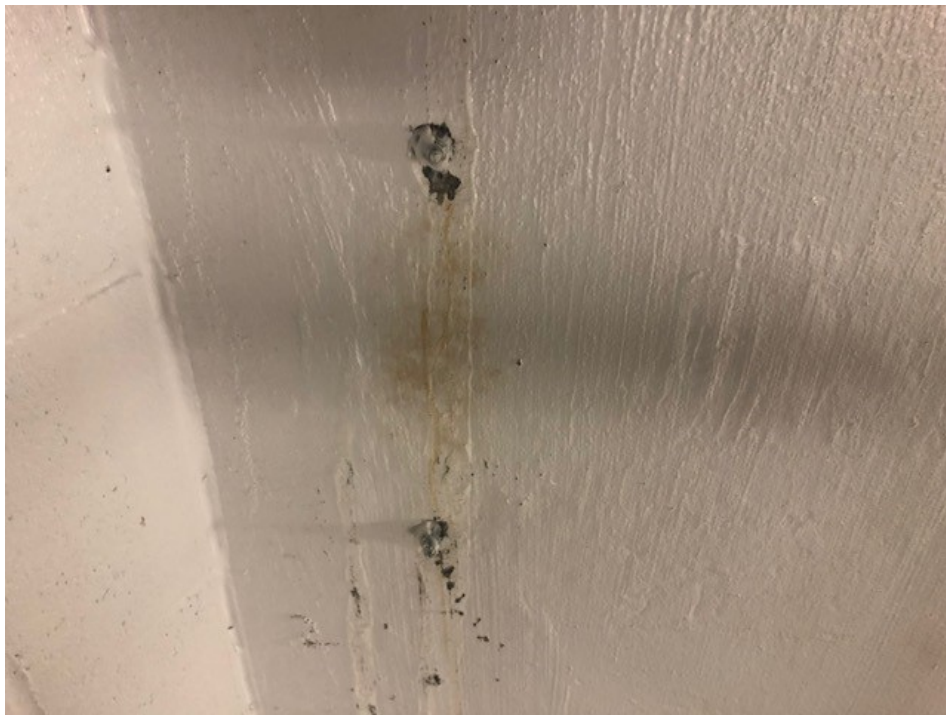
Photograph 8. Water Infiltration Stain in Northwest Stairwell after Grout Injection (February 21, 2019)
