PERIODIC REVIEW REPORT

**For the Property Located at
West 19th Street Development Site, New York, NY**

Prepared for
IAC/InterActiveCorp
550 West 18th Street
New York, NY 10011

March 11, 2021

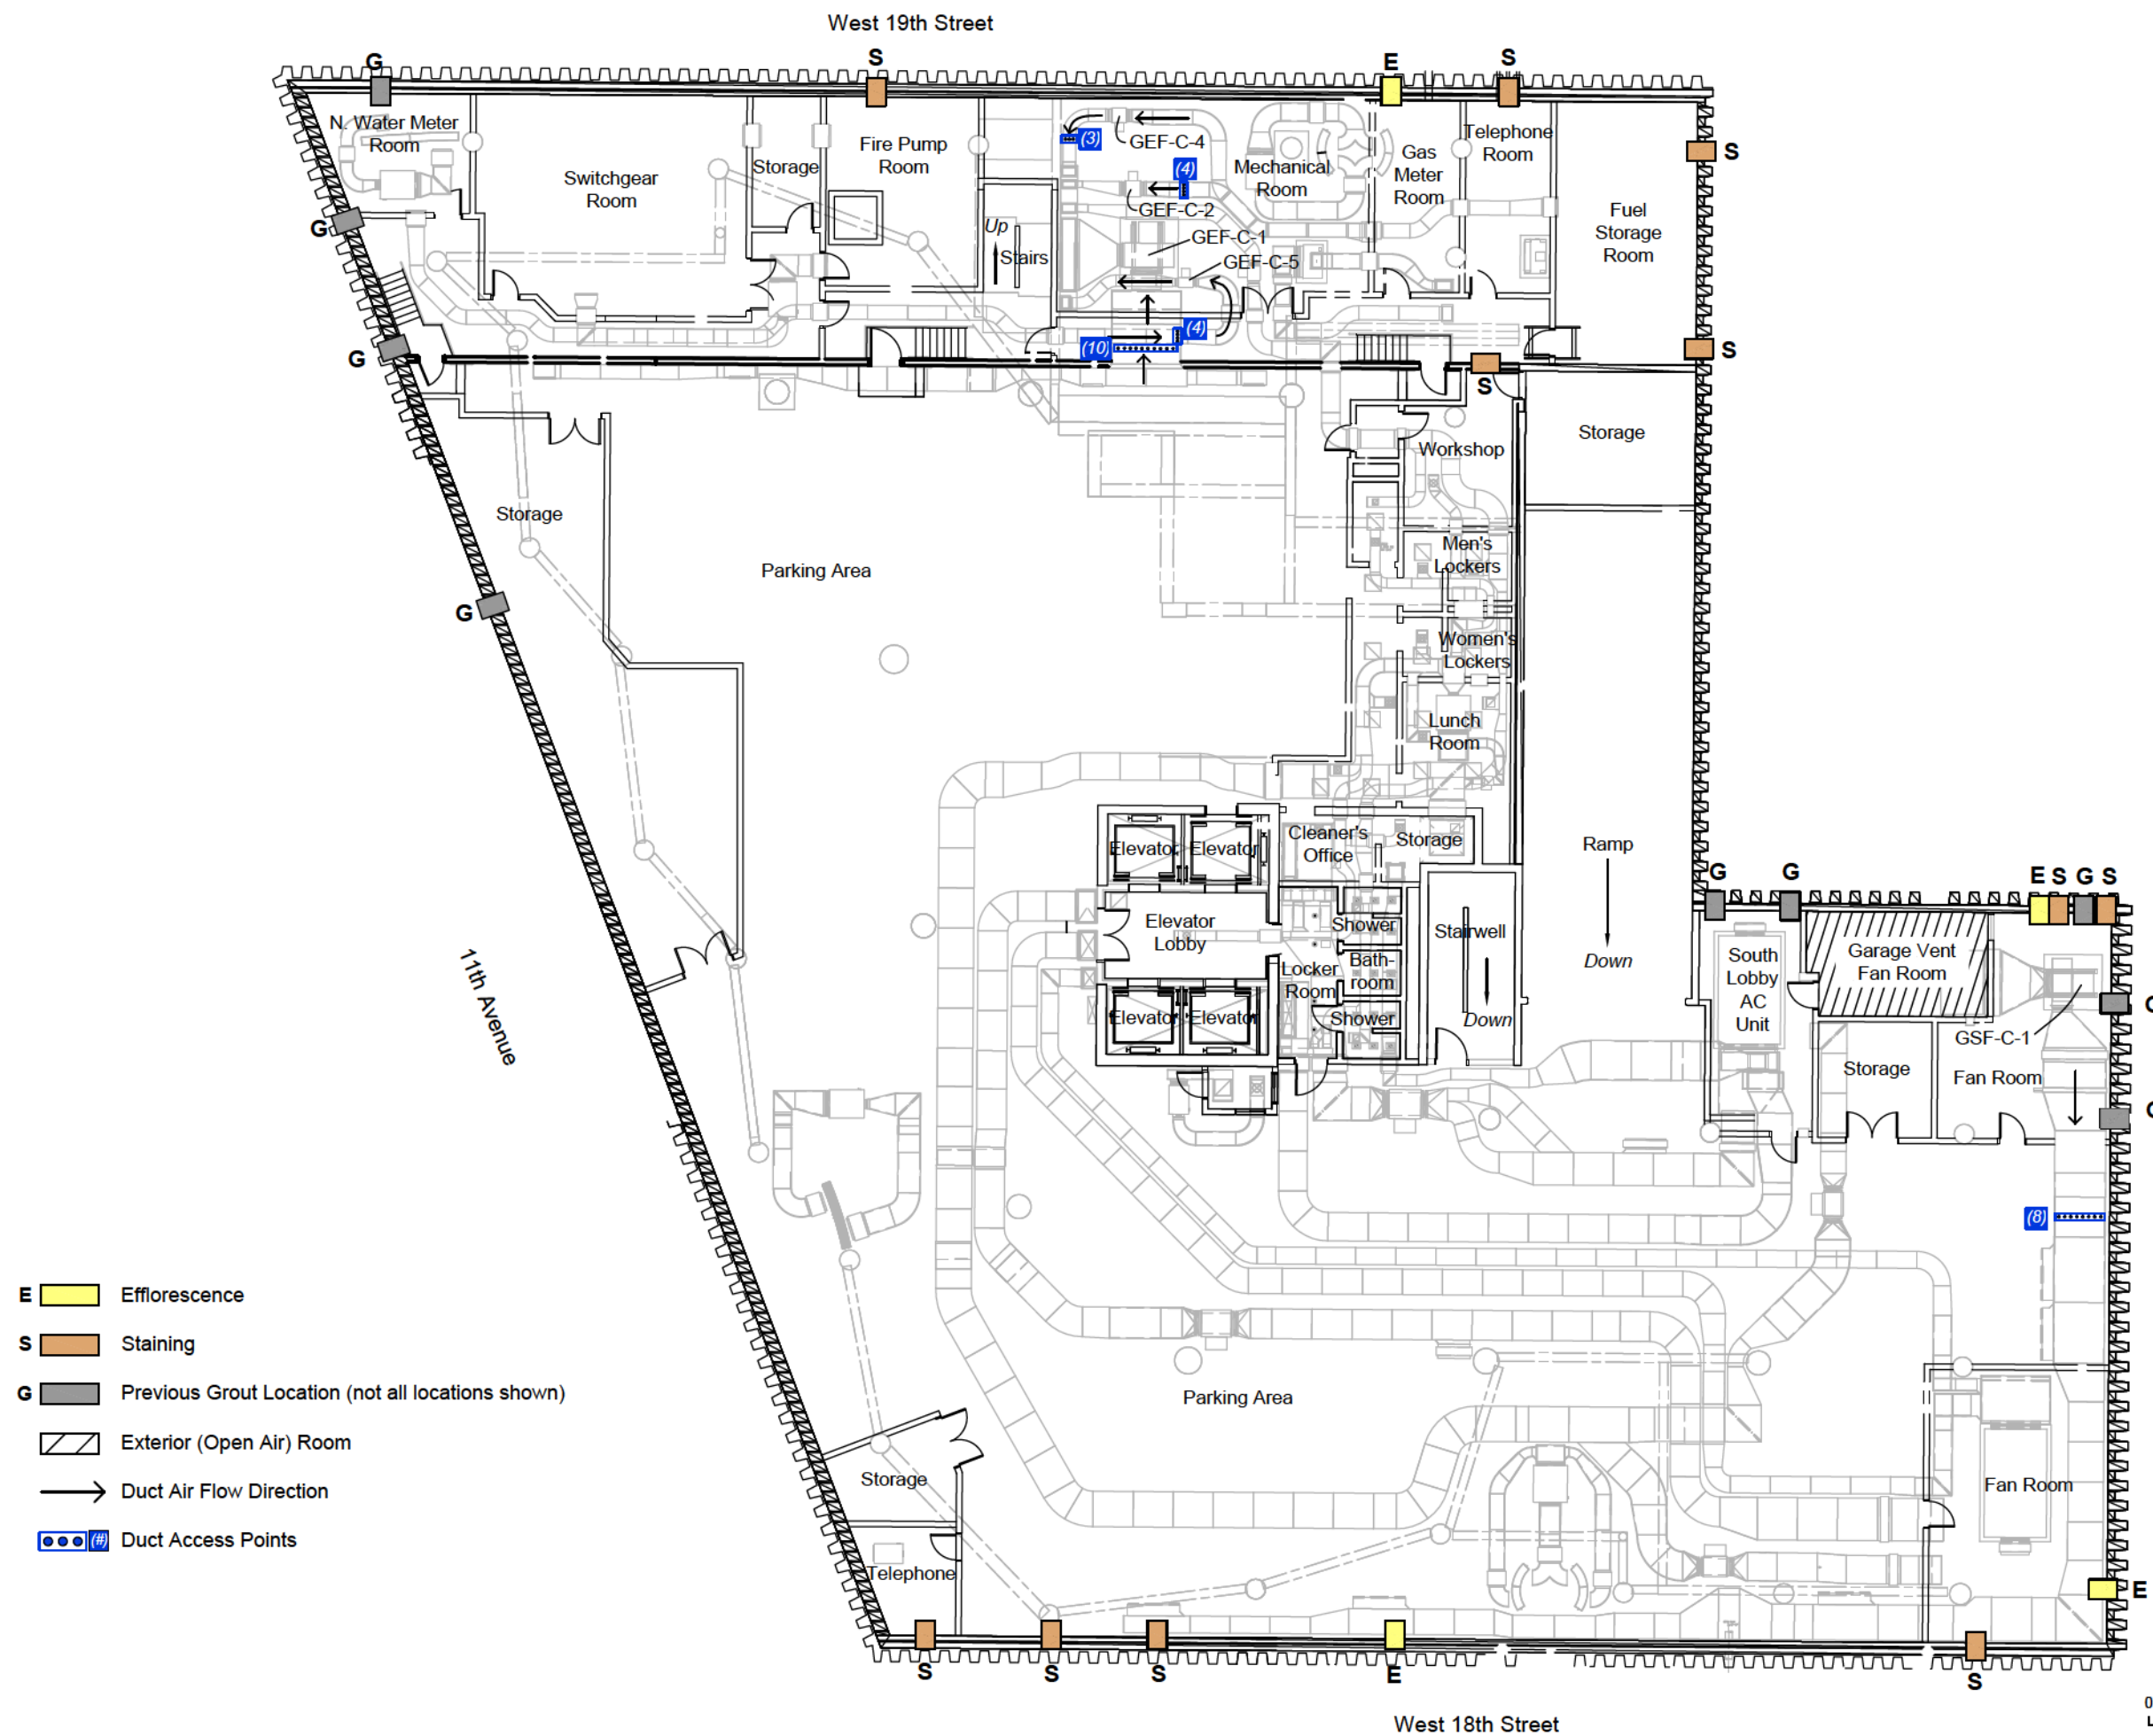
FIGURE 1

During the inspection, Integral did not observe instances of active water infiltration. Integral did observe historical evidence of staining or efflorescence (but not active water infiltration) at various locations along the perimeter foundation wall (Figure 1).

Upon completion of the 2021 visit, Integral recommends no repairs because there are no observed areas of active water infiltration.

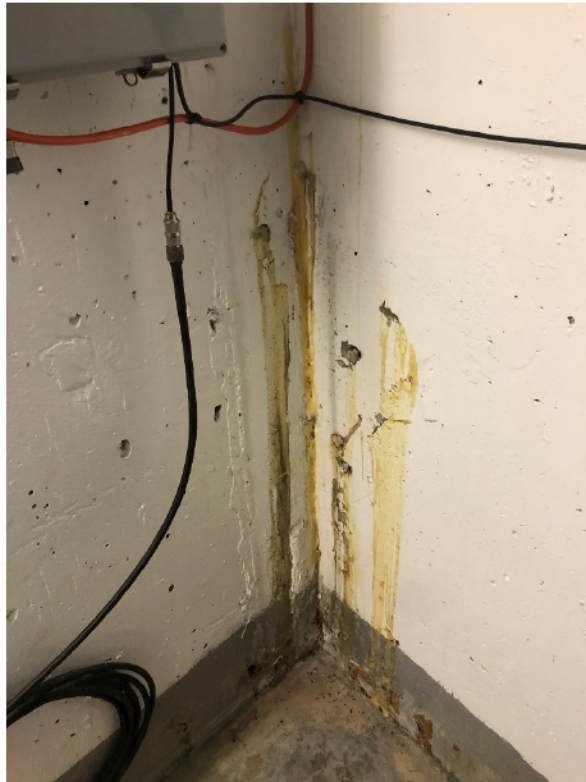
In July 2020, two locations with evidence of water infiltration were repaired with grout injection. Integral observed these locations during the 2021 visit and found that they remained effective in terms of preventing water infiltration.

Photograph 1. Previous Grout Injection from 2020 in South Lobby AC Room (January 19, 2021)

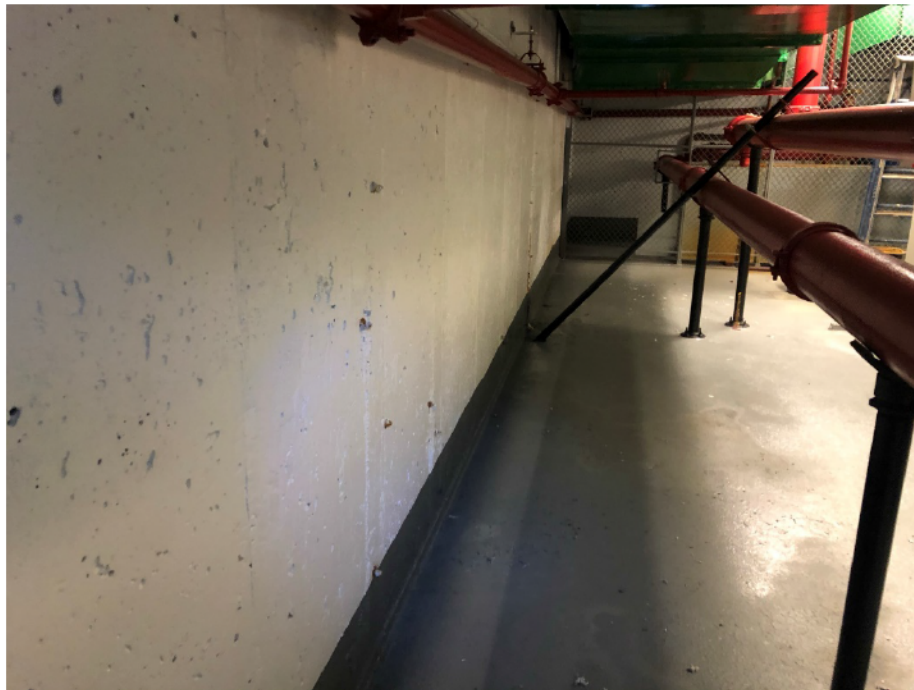
Photograph 2. Previous Grout Injection from 2020 in Fan Room (January 19, 2021)

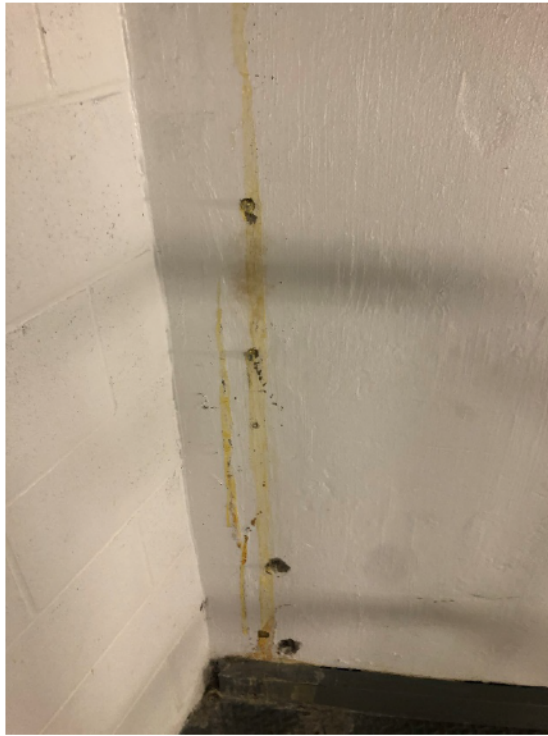
Photograph 3. Previous Grout Injection from 2019 in Northwest Stairwell (January 19, 2021)

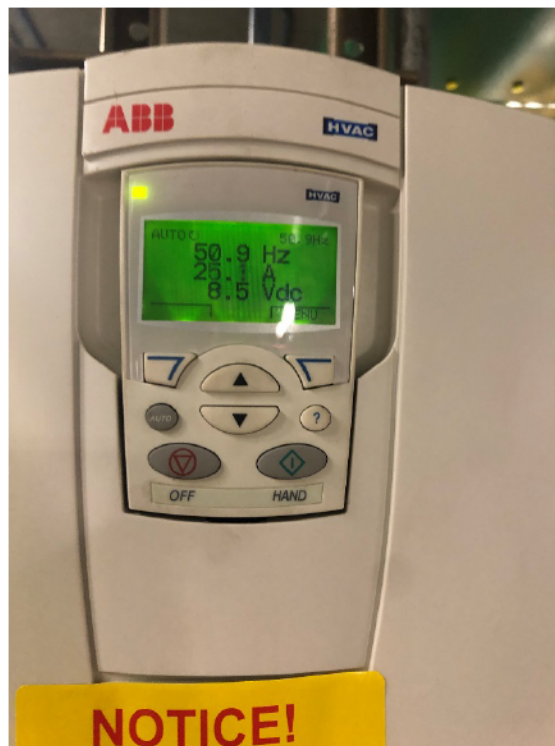
Photograph 4. GEF:C1 HVAC System Interface (January 19, 2021)
