# PERIODIC REVIEW REPORT

**For the Property Located at  
West 19<sup>th</sup> Street Development Site, New York, NY**

*Prepared for*  
**IAC/InterActiveCorp**  
550 West 18<sup>th</sup> Street  
New York, NY 10011

March 14, 2022

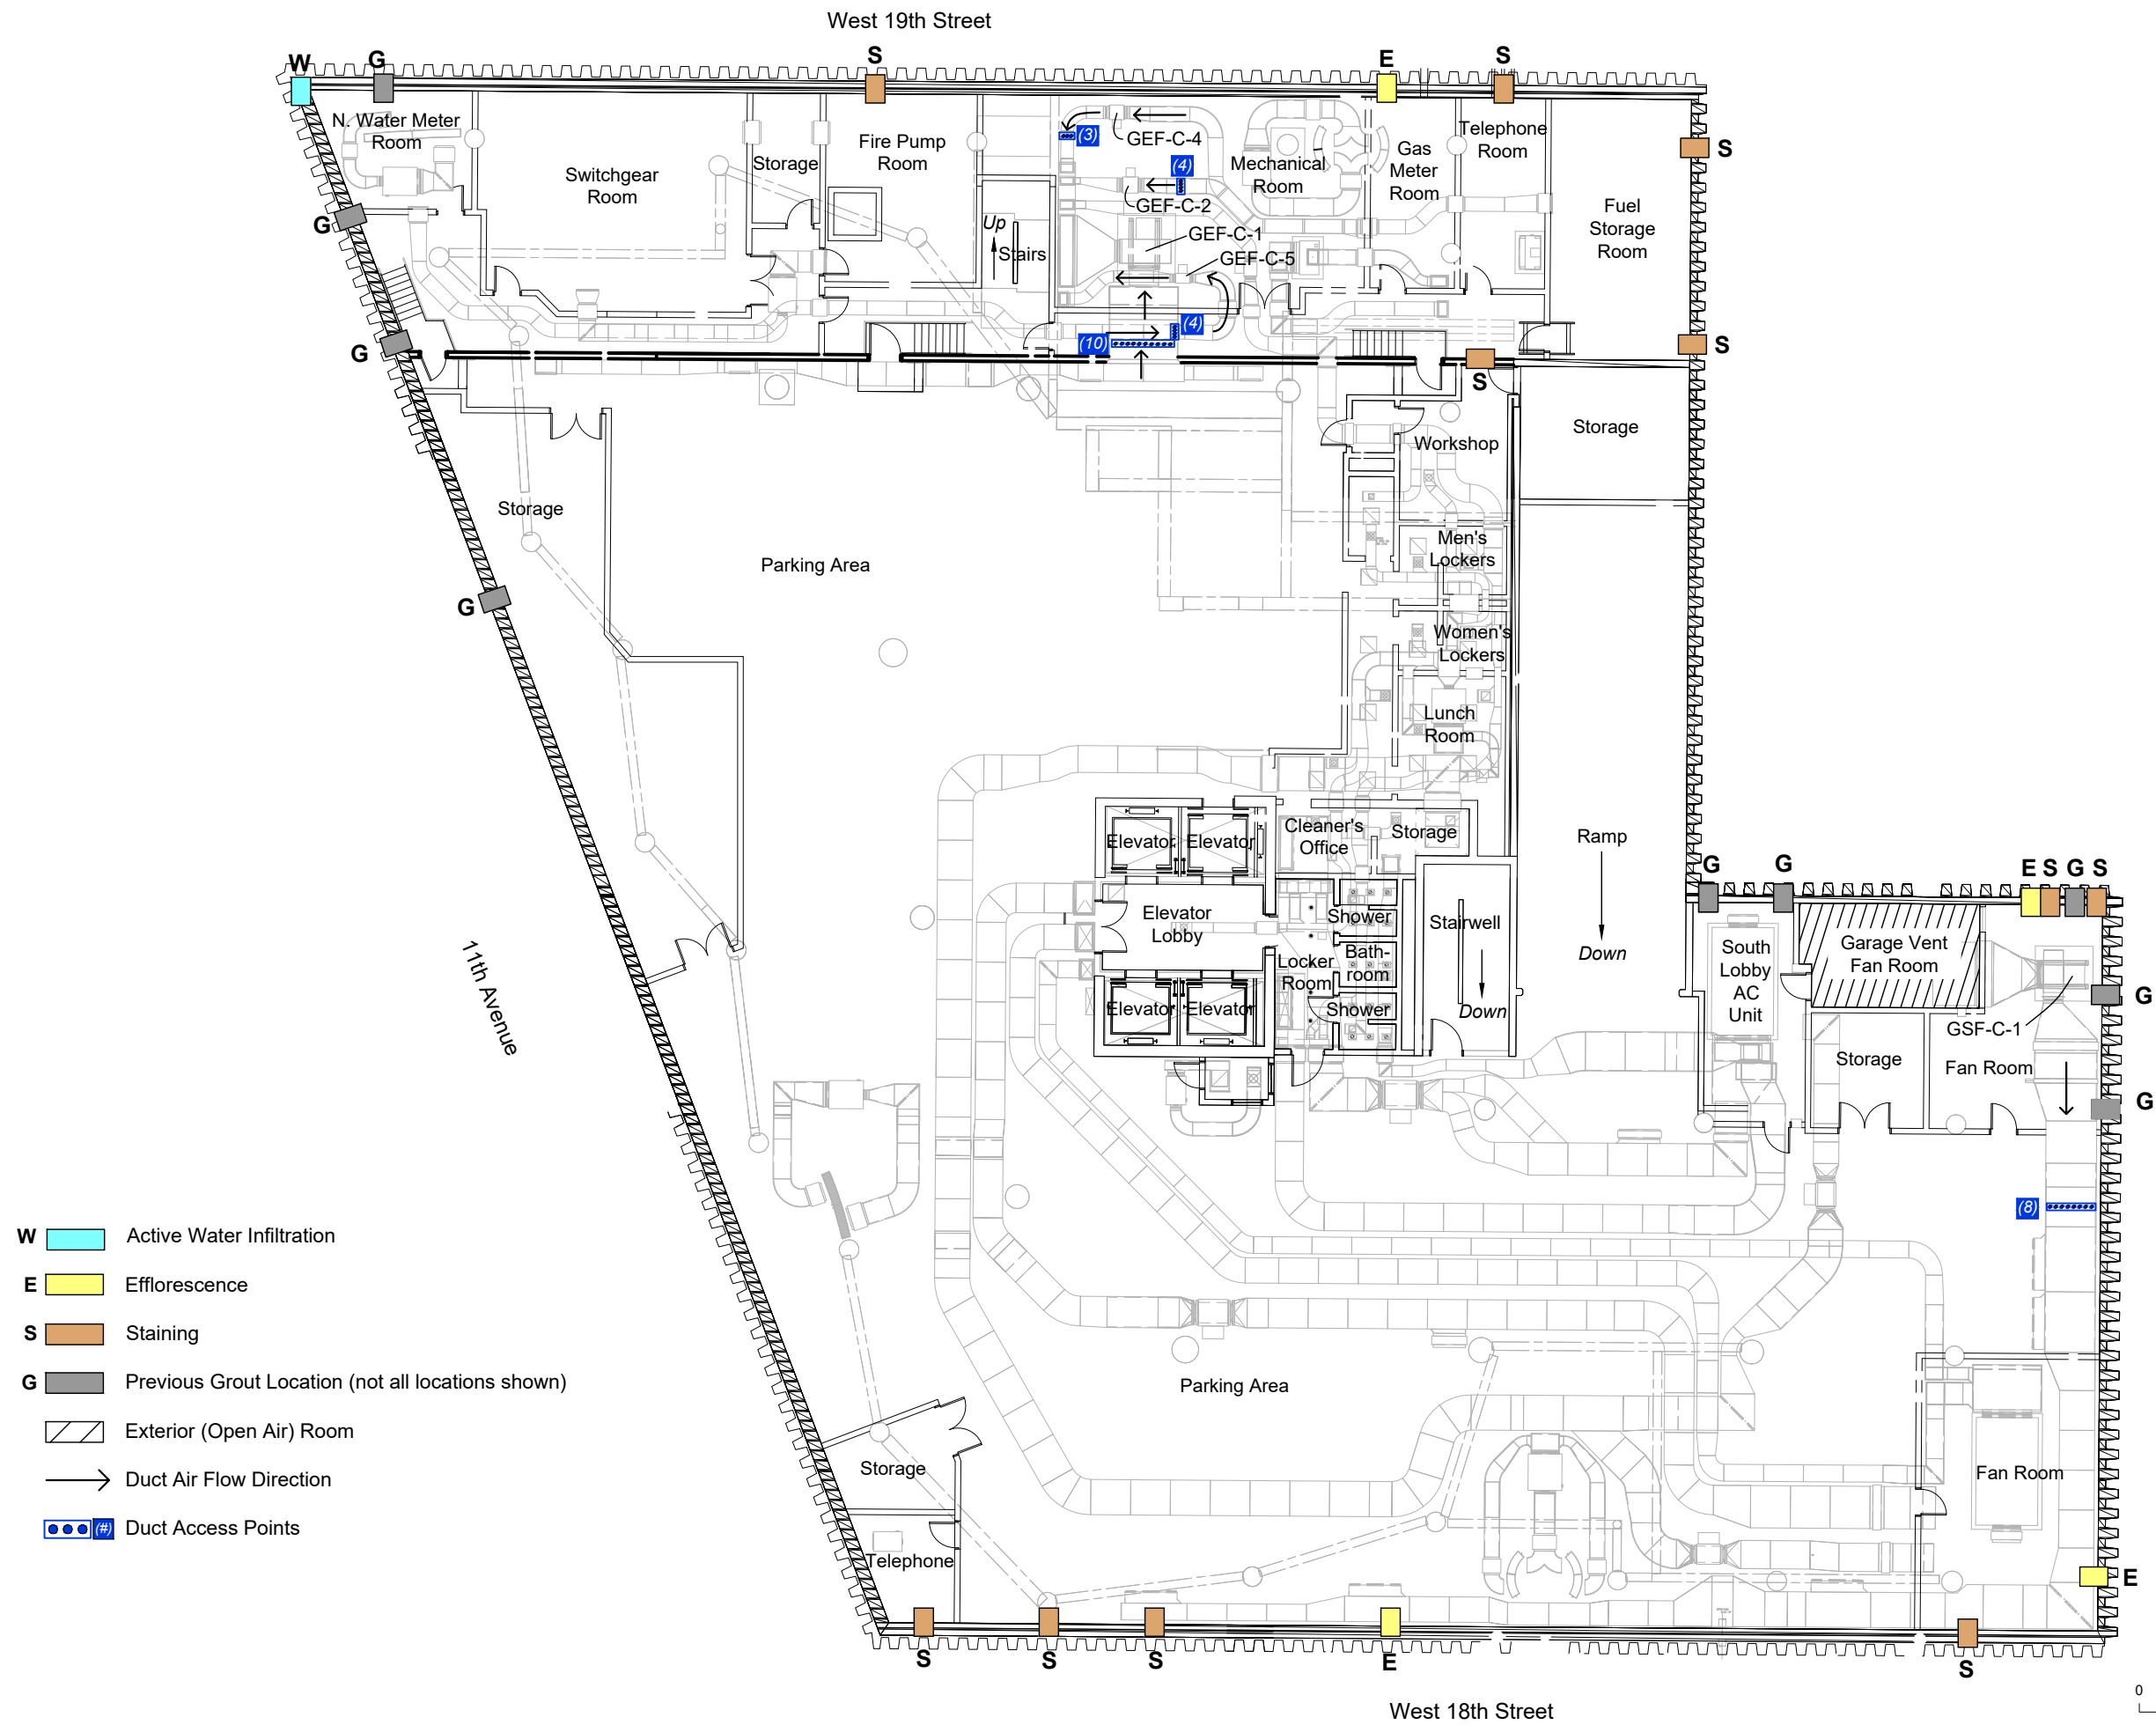
## VAPOR BARRIER OBSERVATIONS

During the inspection, Tom Casey, the IAC Building Engineer, told Integral that water entered the cold joint where the floor slab meets the north and west walls of the building in the corner of the North Water Meter Room and he has often observed water or dampness in this corner over the past year. Integral did not observe active water infiltration at this location during the inspection, but water staining on the floor was evident. Integral did observe historical evidence

of staining or efflorescence (but not active water infiltration) at various locations along the perimeter foundation wall. See Figure 1 for the locations of these observations.

The location of the repair made during this reporting period is shown in plan view on Figure 1 (shows as "Active Water Infiltration" in the N. Water Meter Room). Photographs of the repair can be found in Appendix C.

Upon completion of the February 2022 visit, Integral recommended that the noted area of water infiltration listed in Section 6.2 above be repaired using the grout injection technique described in the OMP.

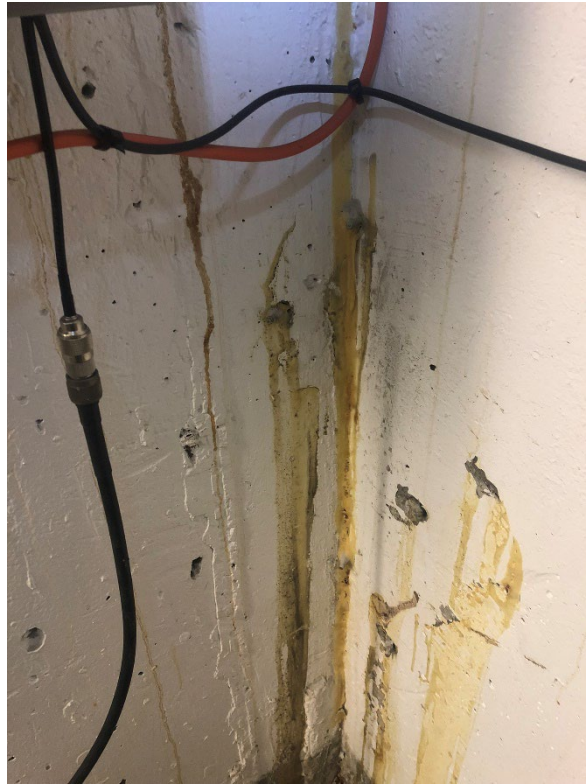
Photograph 1. Previous Grout Injection from 2020 in South Lobby AC Room (February 9, 2022).

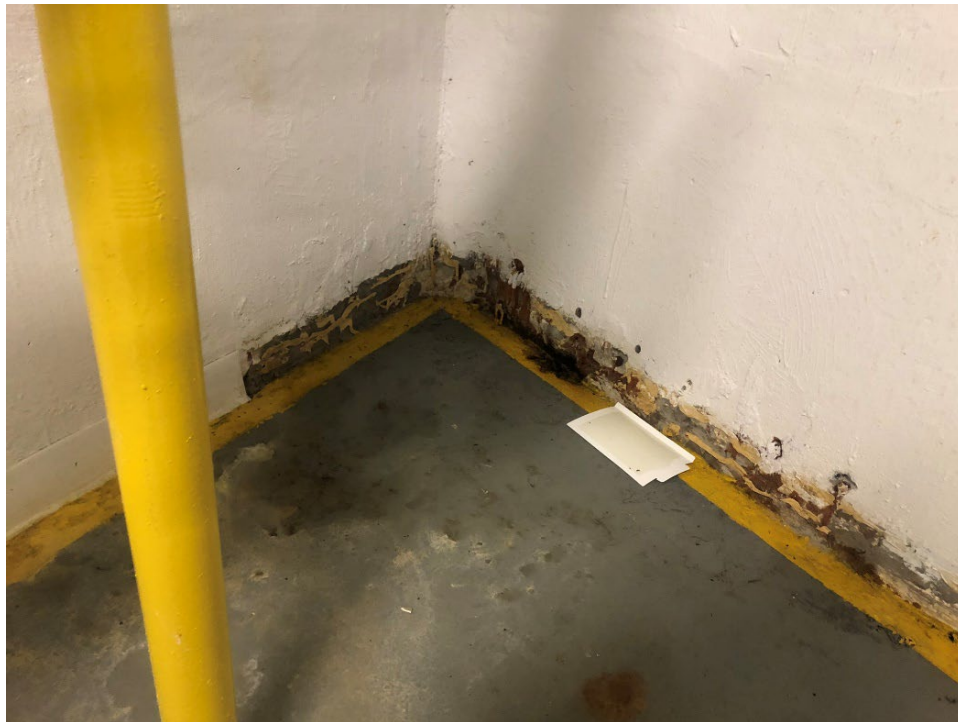
Photograph 2. Corner of Building in North Water Meter Room with Evidence of Water Infiltration (February 9, 2022).

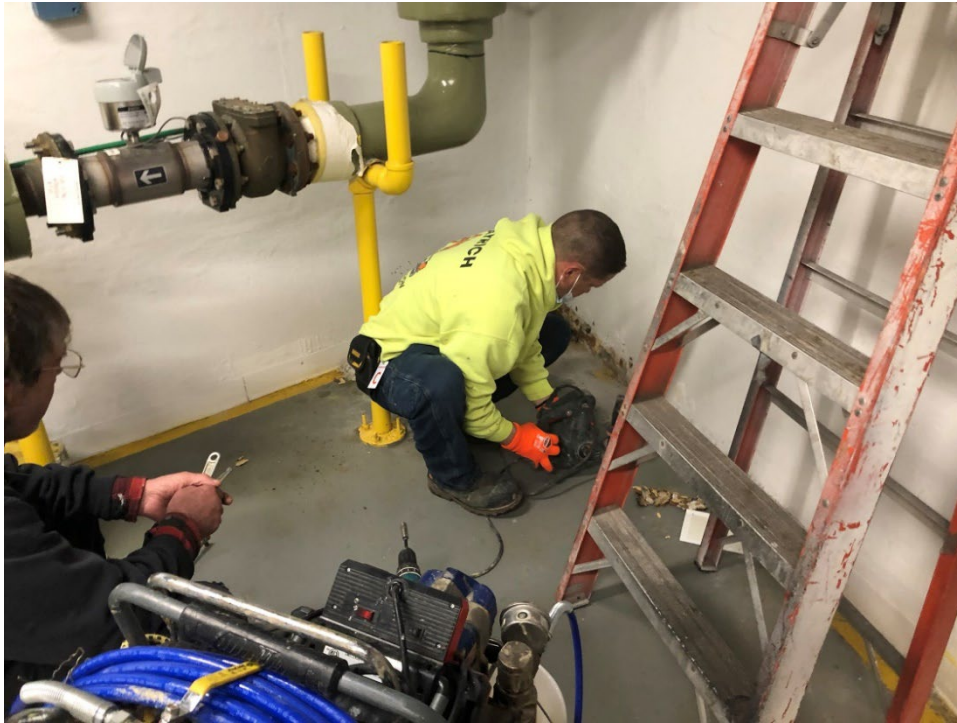
Photograph 3. Grout Injection in Corner of North Water Meter Room (March 10, 2022).

The repair of the location identified in the 2022 inspection was performed by Starbrite on March 10, 2022, under the observation of Integral. The area was grout-injected following the OMP guidelines.

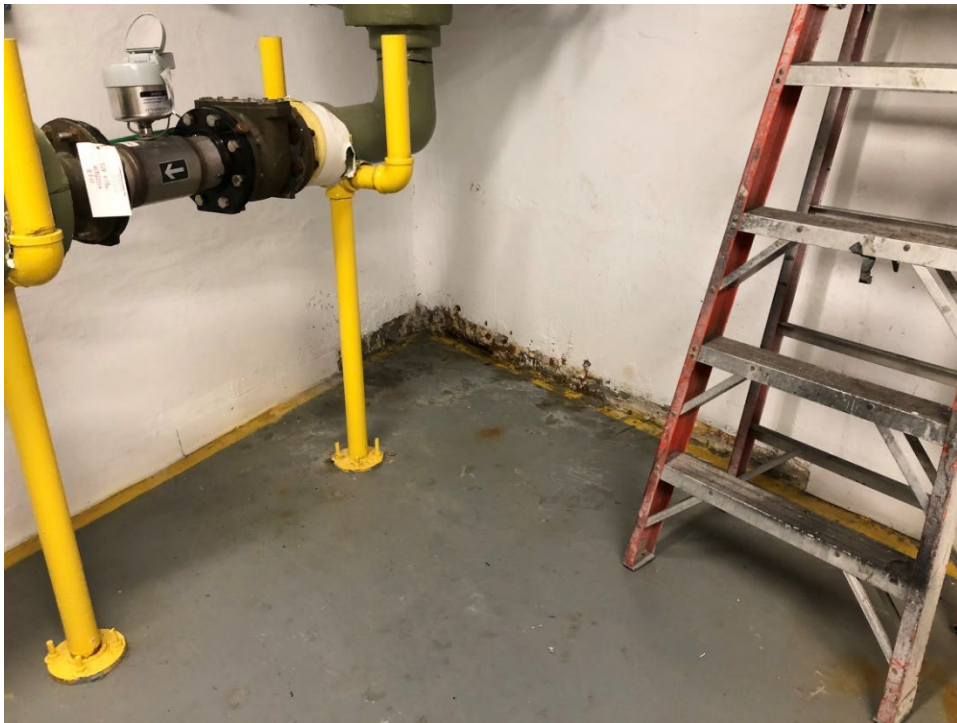
Photograph 4. Completed and Cleaned Grout Injection Location in North Water Meter Room (March 10, 2022).
