# **PERIODIC REVIEW REPORT**

**For the Property Located at  
West 19<sup>th</sup> Street Development Site, New York, NY**

*Prepared for*  
**HTRF Ventures, LLC**  
555 West 18<sup>th</sup> Street  
New York, NY 10011

March 13, 2025

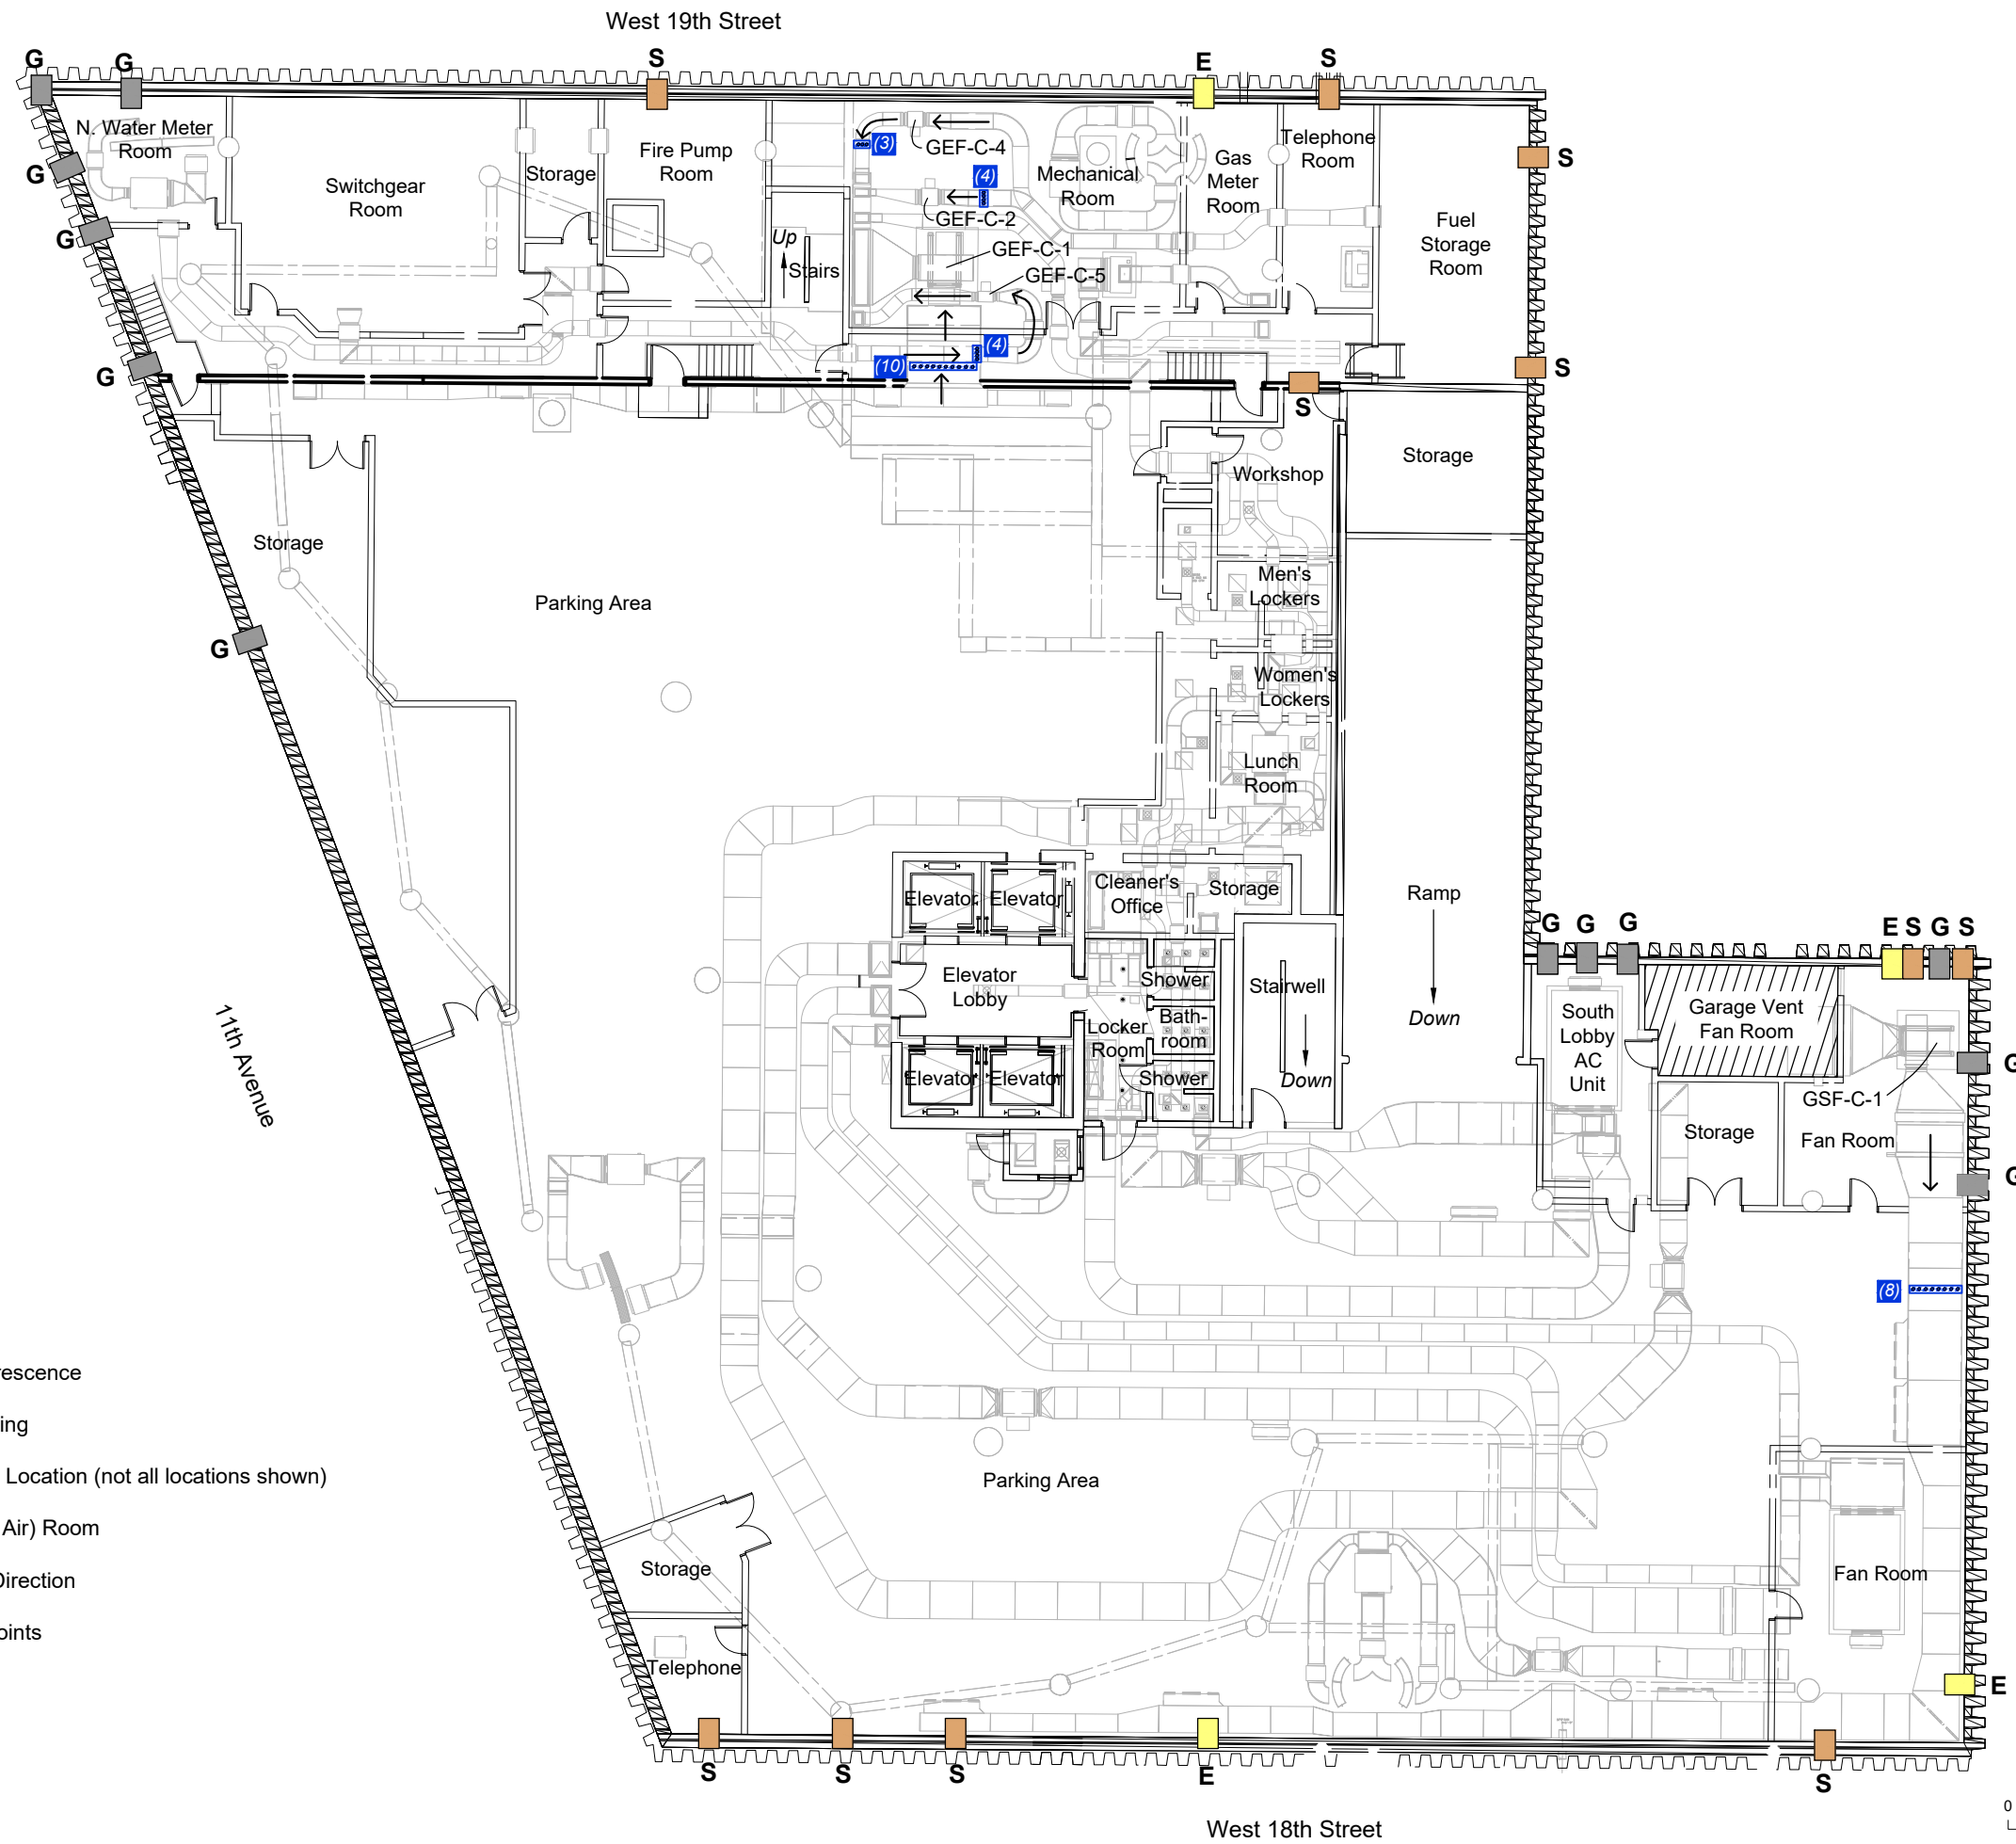
## VAPOR BARRIER OBSERVATIONS

As part of the 2025 certification process, a representative of Integral Engineering, P.C. (Integral), visited the Site on January 24, 2025, to inspect the perimeter foundation walls and the foundation slab. Integral did not observe any evidence of water infiltration in the basement foundation walls. As a result, Integral does not recommend any grout injection repairs this year. Locations of grout injection repairs from previous years can be seen in Figure 1.

Integral observed historical evidence of staining or efflorescence (but not active water infiltration) at various locations along the perimeter foundation wall. See Figure 1 for the locations of these past observations.

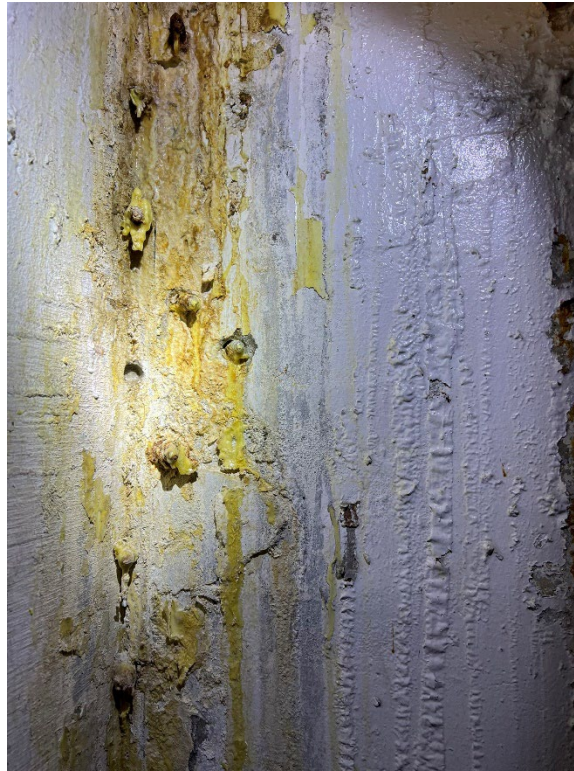
In February 2024, one location with evidence of water infiltration was repaired with hydro active grout injection, in accordance with Appendix A to the OMP. Integral observed this location during the 2025 visit and found that it remained effective in terms of preventing water infiltration.

Photograph 1. Closeup of Previous Grout Injection from 2024 in South Lobby AC Unit Room (January 24, 2025).

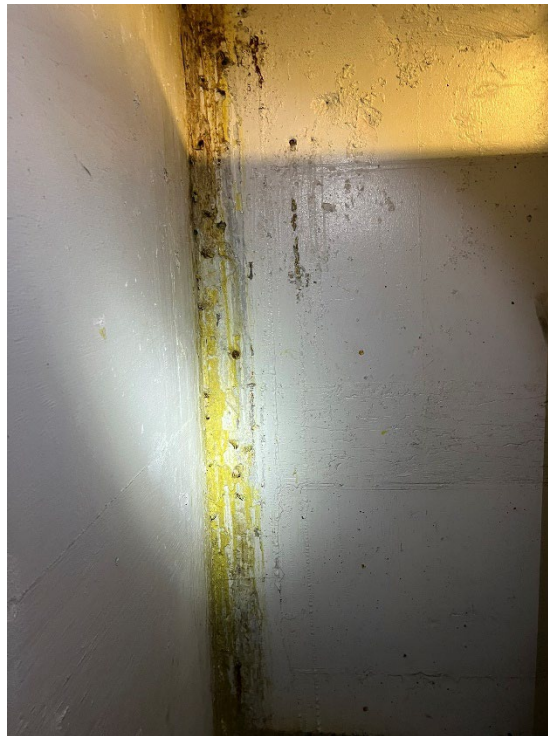
Photograph 2. Previous Grout Injection from 2024 in South Lobby AC Unit Room (January 24, 2025).

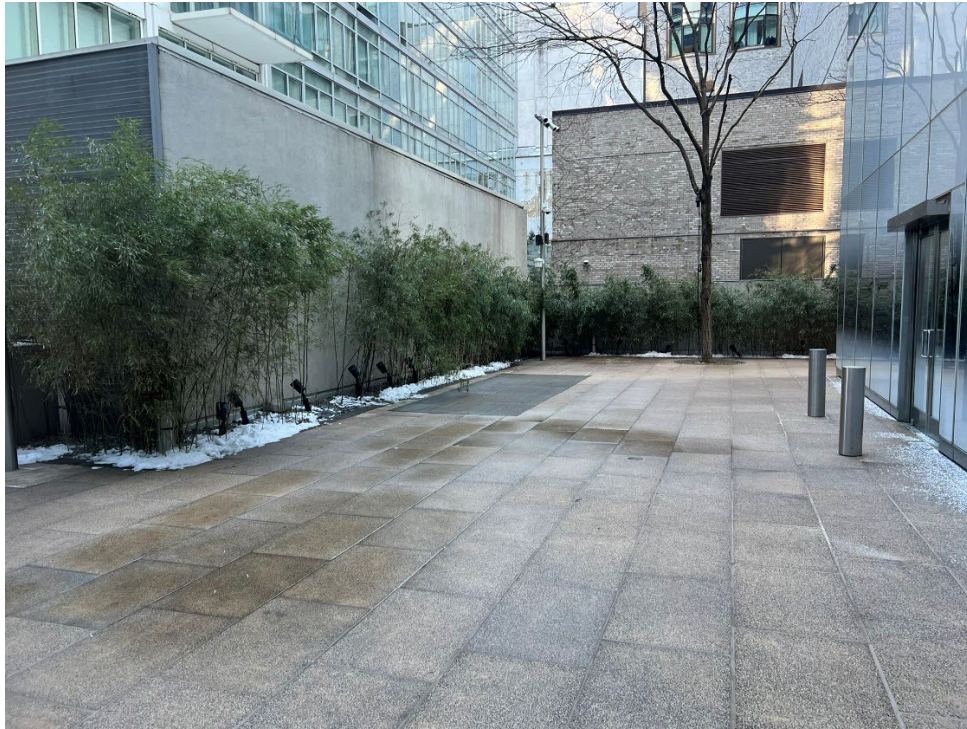
Photograph 3. Outdoor Area above Garage Vent Fan Room Showing Metal Grate Flooring and Vegetation (January 24, 2025).

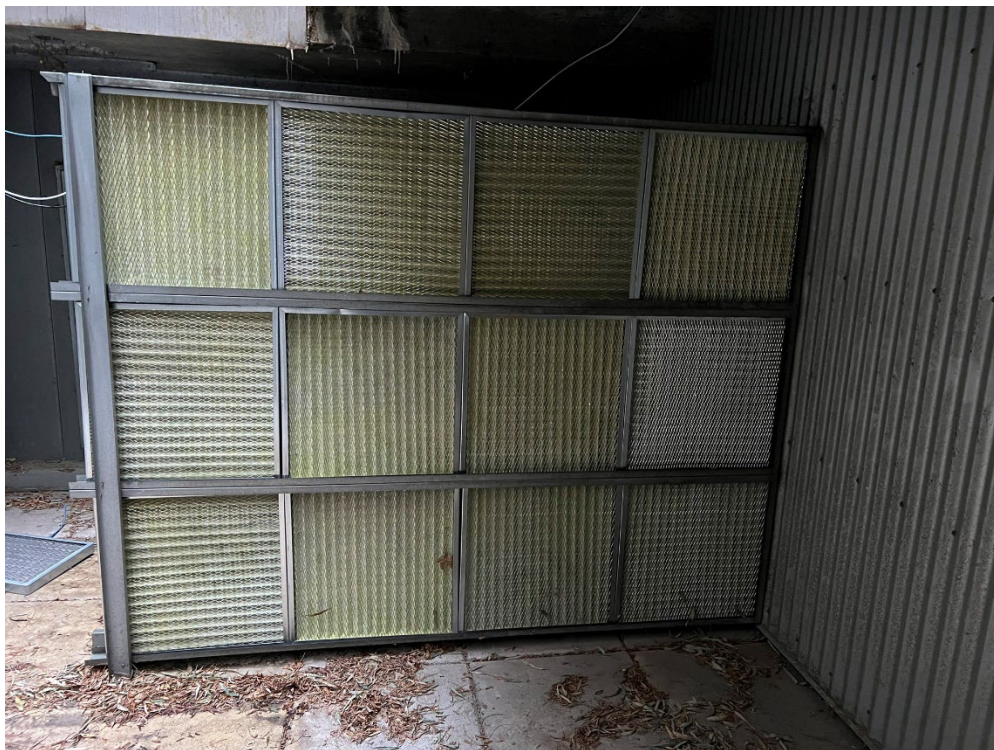
The IAC Building Engineer stated that IAC has increased the filter replacement schedule for the GSF-C-1 intake vents from biannually to quarterly in order to better match the intake and exhaust of the basement air handling system and be able to run them at higher airflow. The filters were changed the morning of January 24, 2025, before Integral's evaluation. The new filters can be seen in the photo log (Appendix B).

Photograph 4. GSF-C-1 New Intake Filters (January 24, 2025).

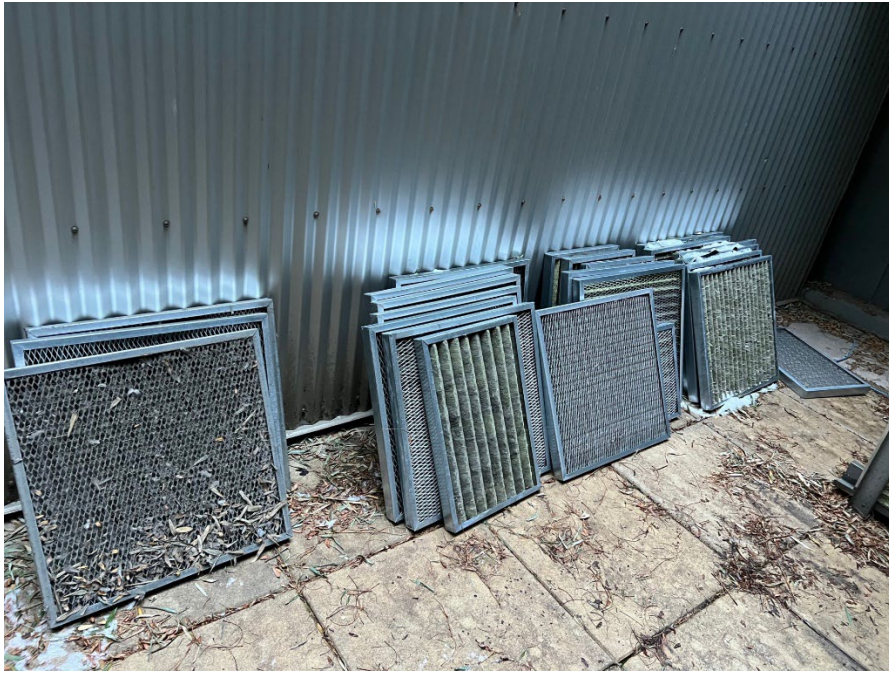
Photograph 5. Used and Replaced GSF-C-1 Air Filters (January 24, 2025).

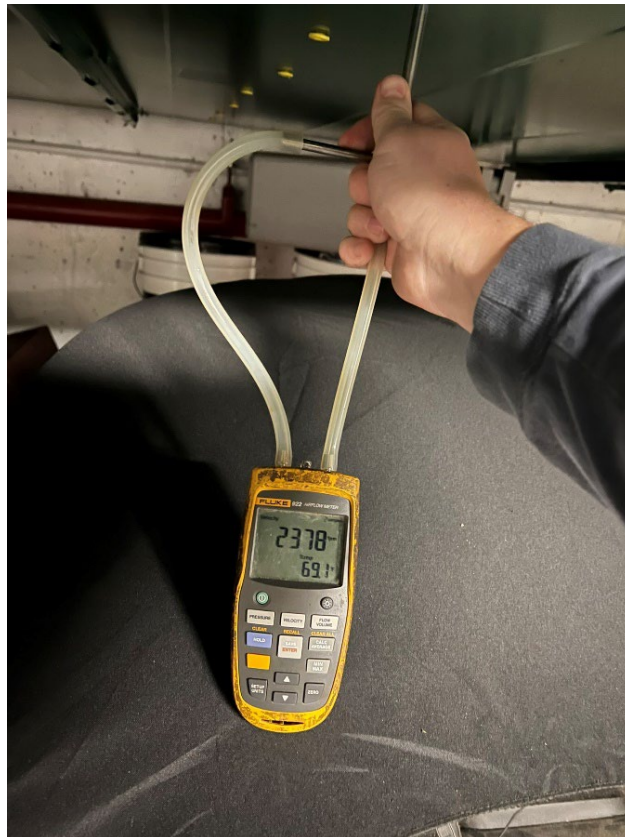
Photograph 6. Manometer and Pitot Tube Monitoring Equipment Measuring Air Velocity in GSF-C-1 Air Duct (January 24, 2025).

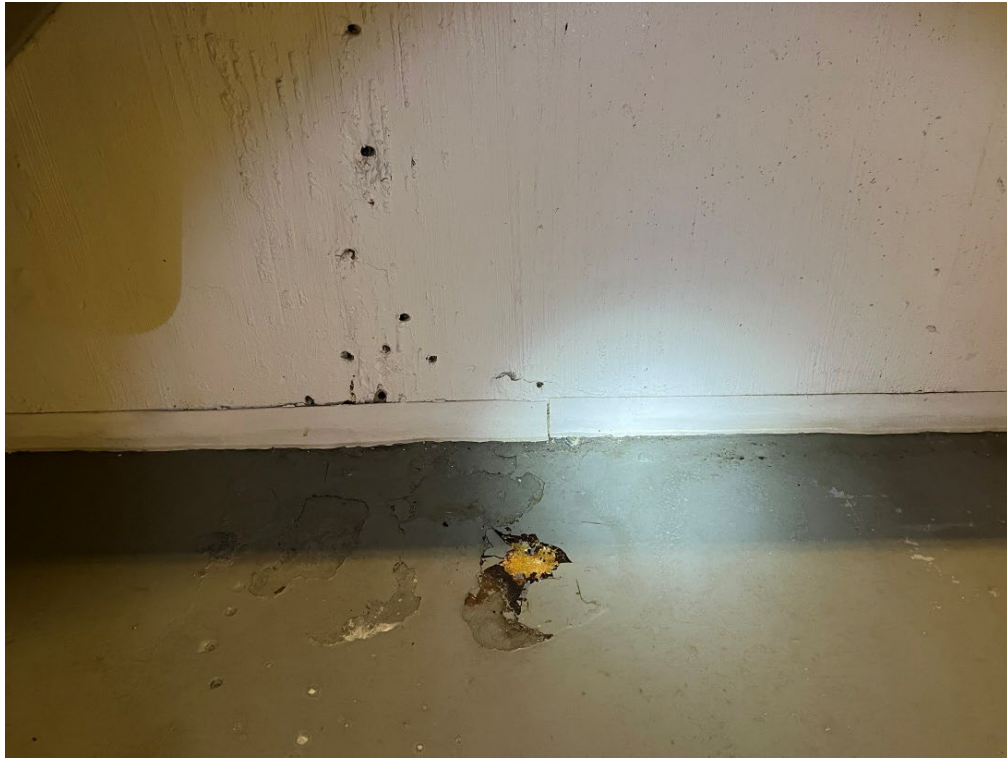
Minor cracking, consistent with observations from previous inspections, was noted in the floor paint underneath the central stairs in the north hallway due to grout injection in a nearby wall. Cracking was noted in the floor paint in the Switch Gear Room and the building manager believes this was due to installation of new large pieces of equipment which were dragged on the floor. No cracks in the concrete slab underneath the floor paint was noted. Integral believes the cracking is surficial damage and is not causing any vapor intrusion.

Photograph 7. Cracking in Floor Paint in North Hallway due to Grout Injection in Foundation Wall Above. (January 24, 2025).

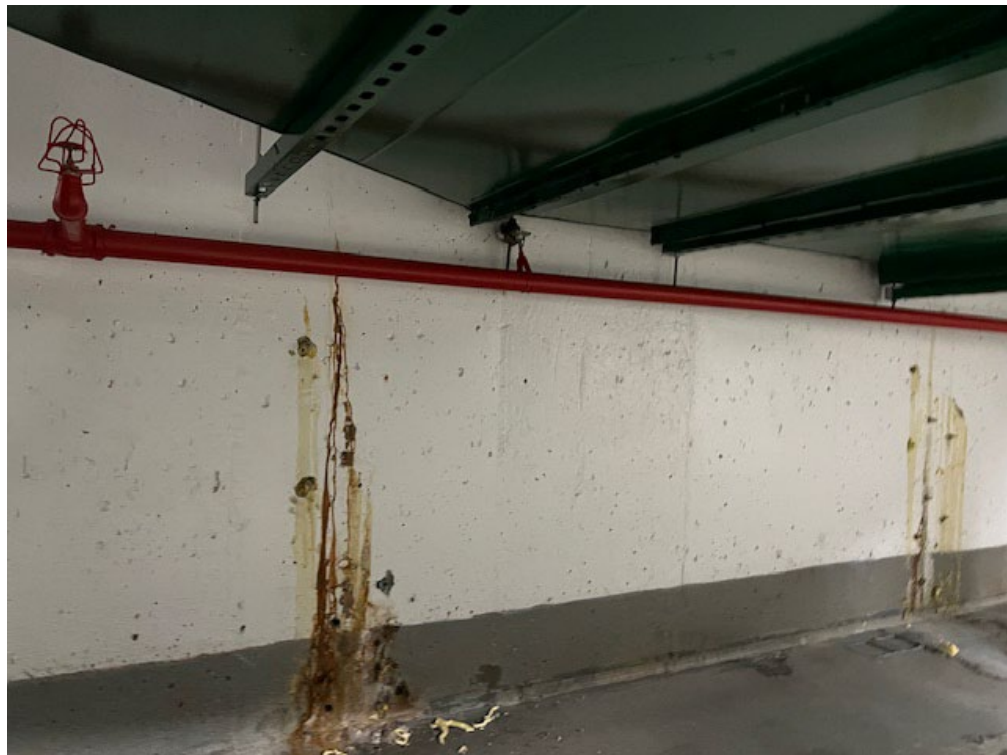
Photograph 8. Historical Staining and Previous Grout Injection Locations in South Fan Room (January 24, 2025).
