# **APPENDIX R**

## **PHOTO LOG OF SITE WORK**

1. Photo log of site work from June 2005 to February 2006

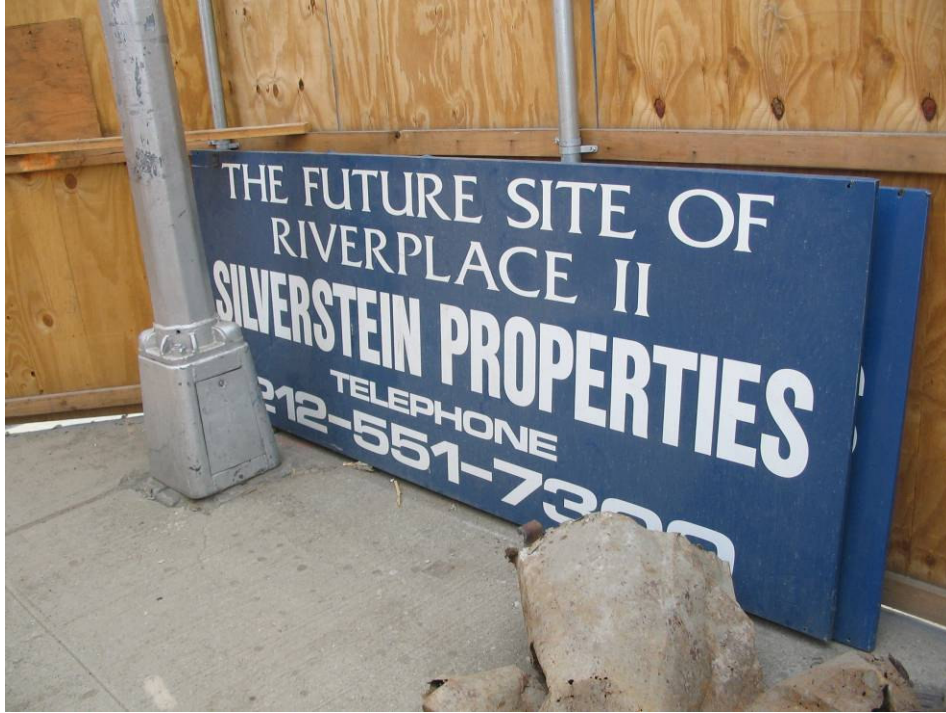
**Photograph No. 1: Welcome to the Future Site of River Place II.**

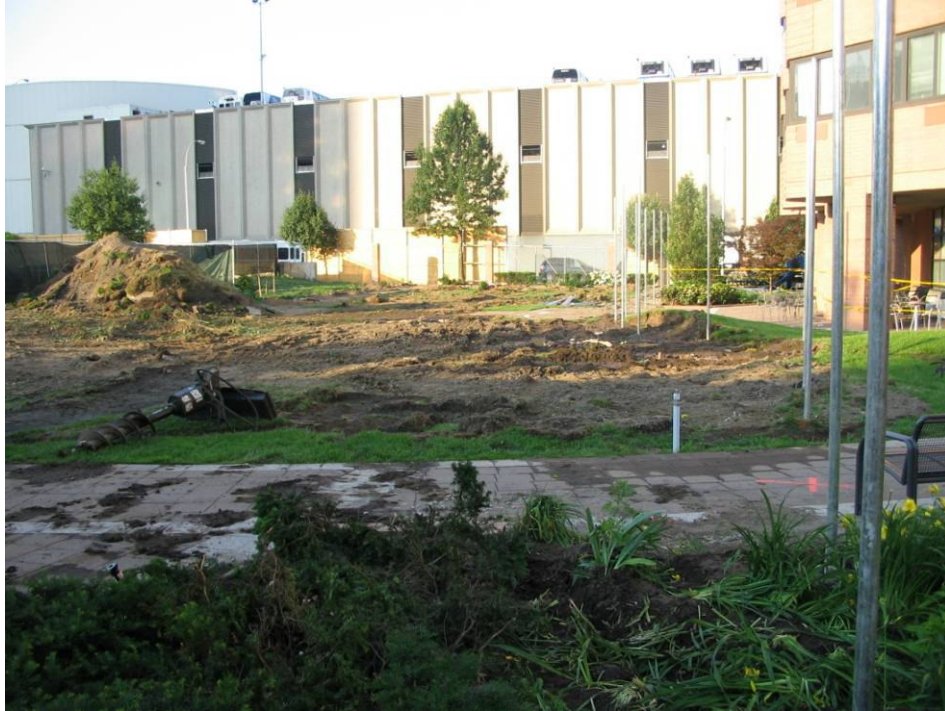
**Photograph No. 3: June 2005 - View of park area (view south). Note poles to be used for support of blue perimeter wall.**

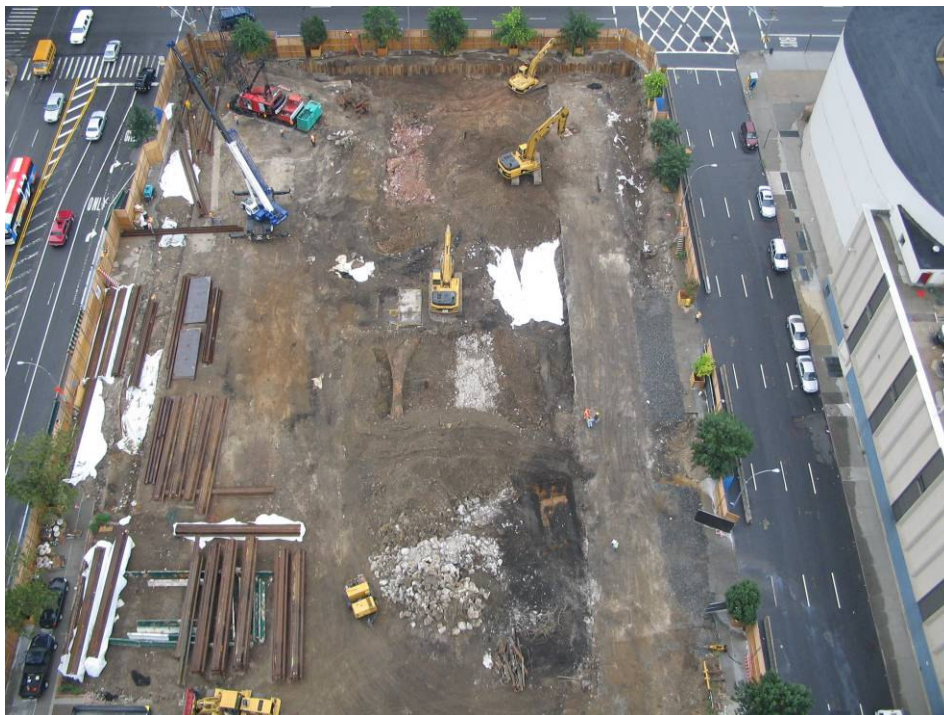
**Photograph No. 10: July 25, 2005 - Aerial view of site (view east) from RiverPlace I 32<sup>nd</sup> floor observation deck.**

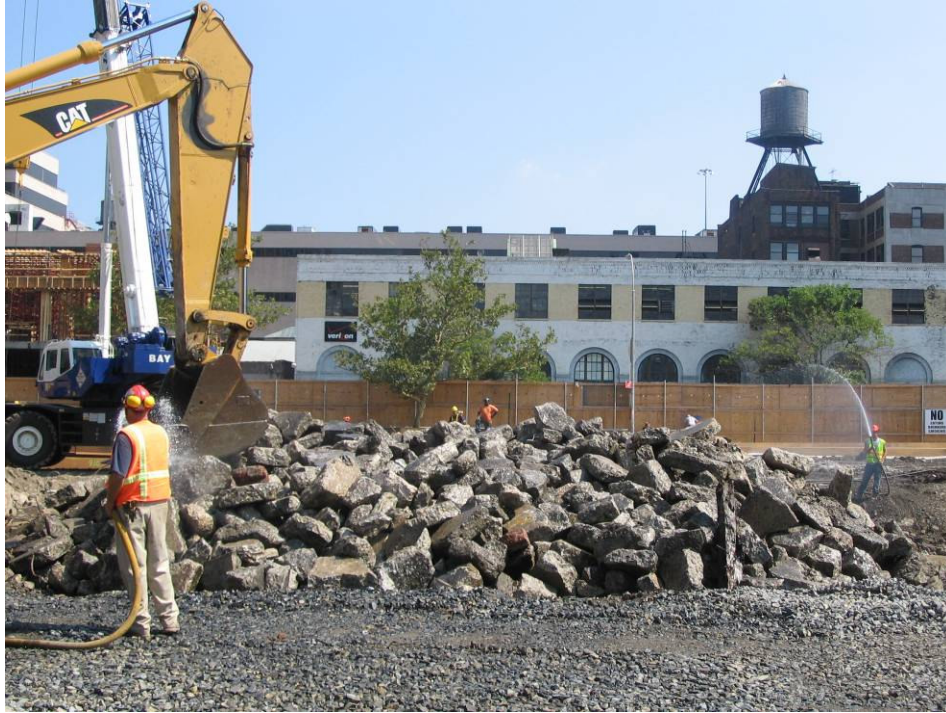
**Photograph No. 11: August 2005 - Stockpile of C&D material being wetted down to minimize generation of dust.**

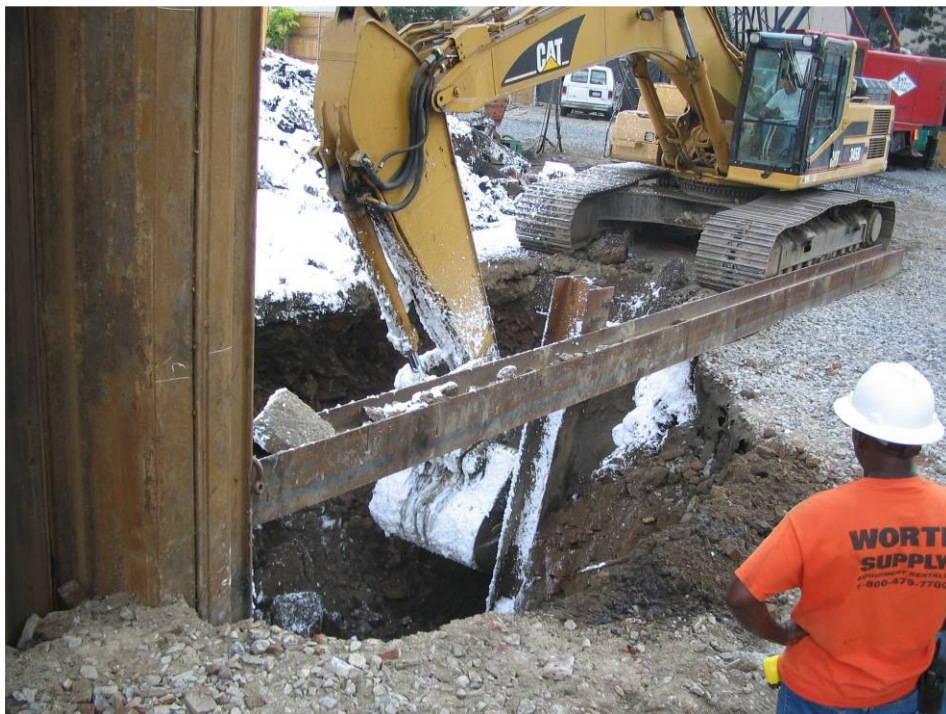
**Photograph No. 12: August 2005 - Pre-excavation trenching to facilitate installation of sheeting.**

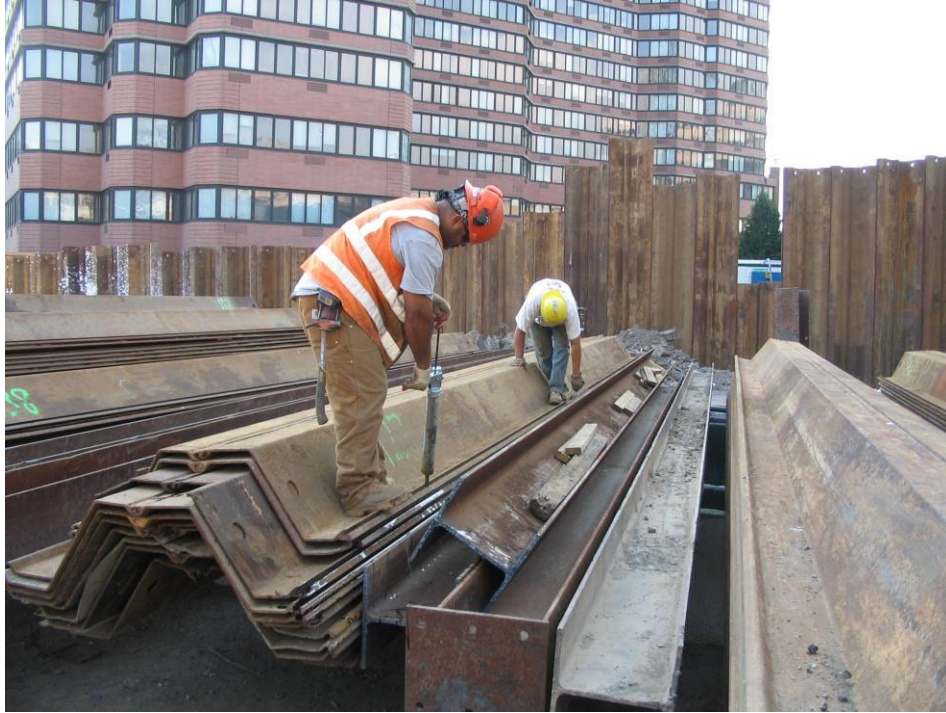
**Photograph No. 13: August 2005 - Preparing sheeting sections with Adeka Ultra Seal A-50 waterproof sealant.**

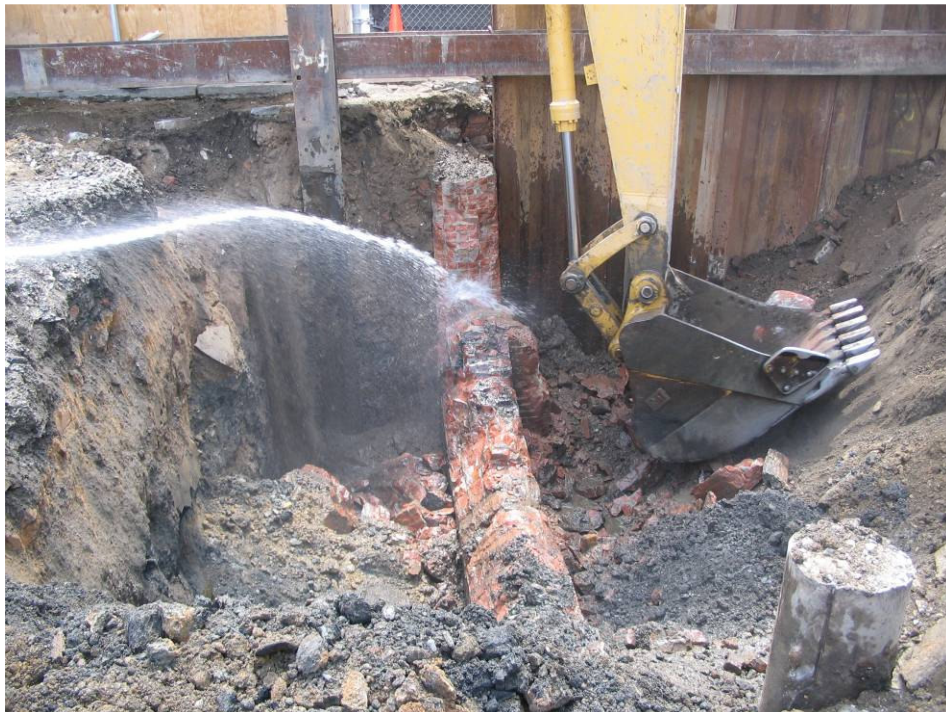
**Photograph No. 14: August 6, 2005 - Exposed section of MGP holder wall being excavated and simultaneously wetted down to suppress generation of dust.**

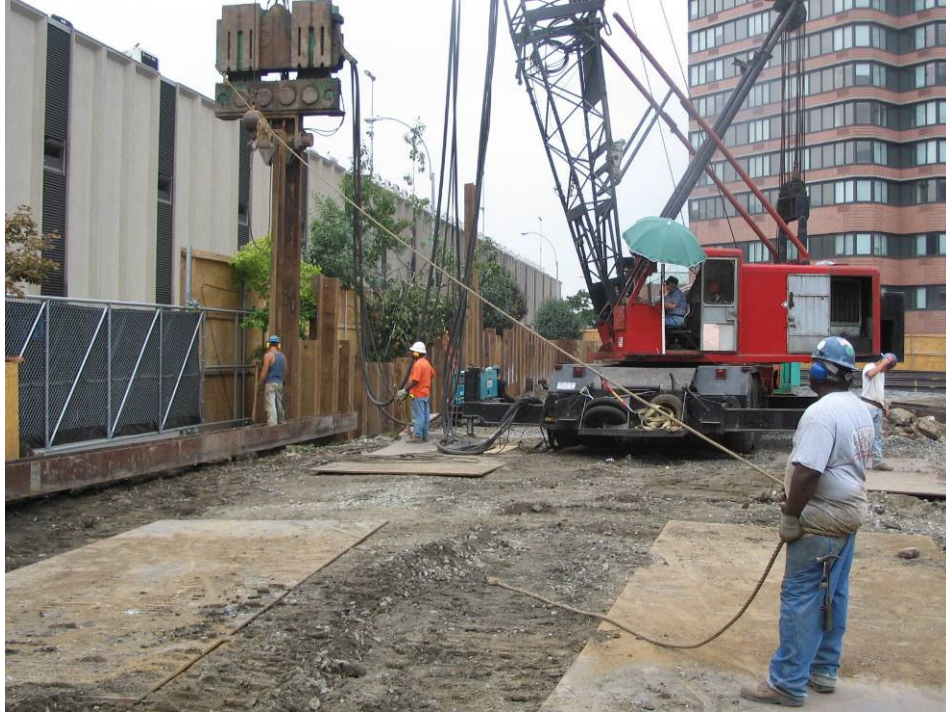
**Photograph No. 15: August 9, 2005 - Sheet piling installation occurring in southwest corner of Site and proceeding towards the east.**

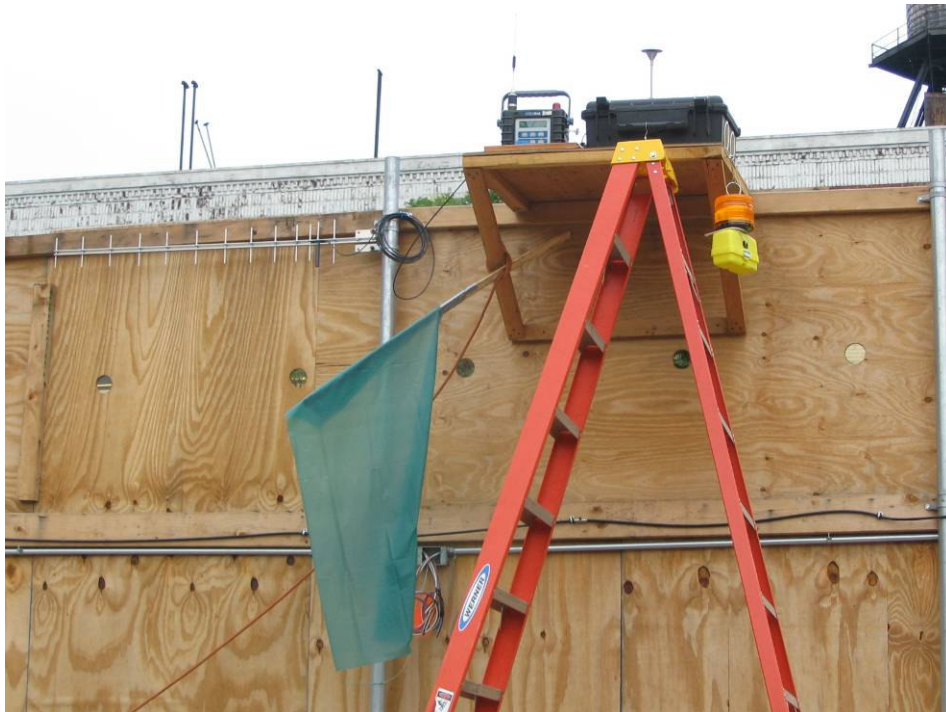
**Photograph No. 16: View of typical Air Monitoring Station and telemetry with colored flag indicating current action level (green; VOCs < 3.7 ppm and particulates < 113 ug/m<sup>3</sup>).**

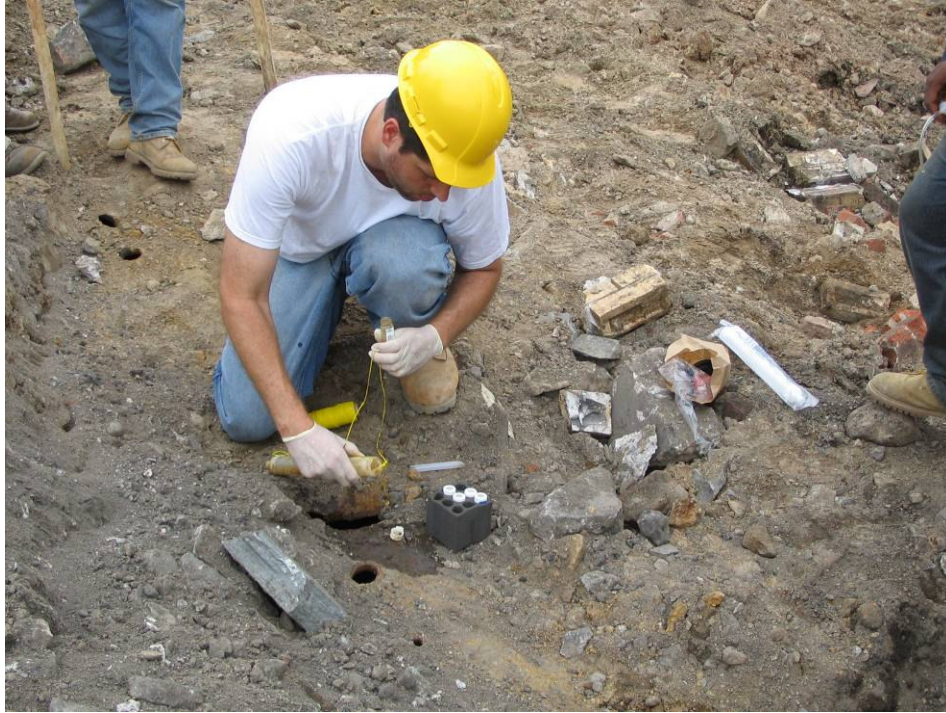
**Photograph No. 17: August 9, 2005 - Collecting sample of contents from UST discovered in northeast portion of Site.**

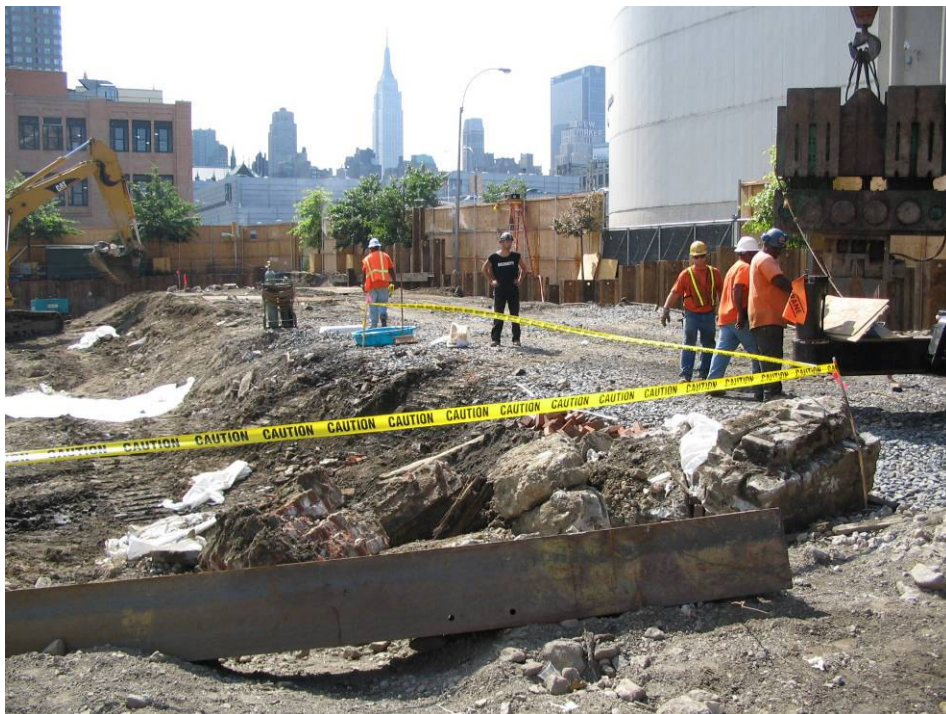
**Photograph No. 18: August 10, 2005 - An early version of zone demarcation using caution tape (view towards southeast). Note decontamination pools present at zone boundary.**

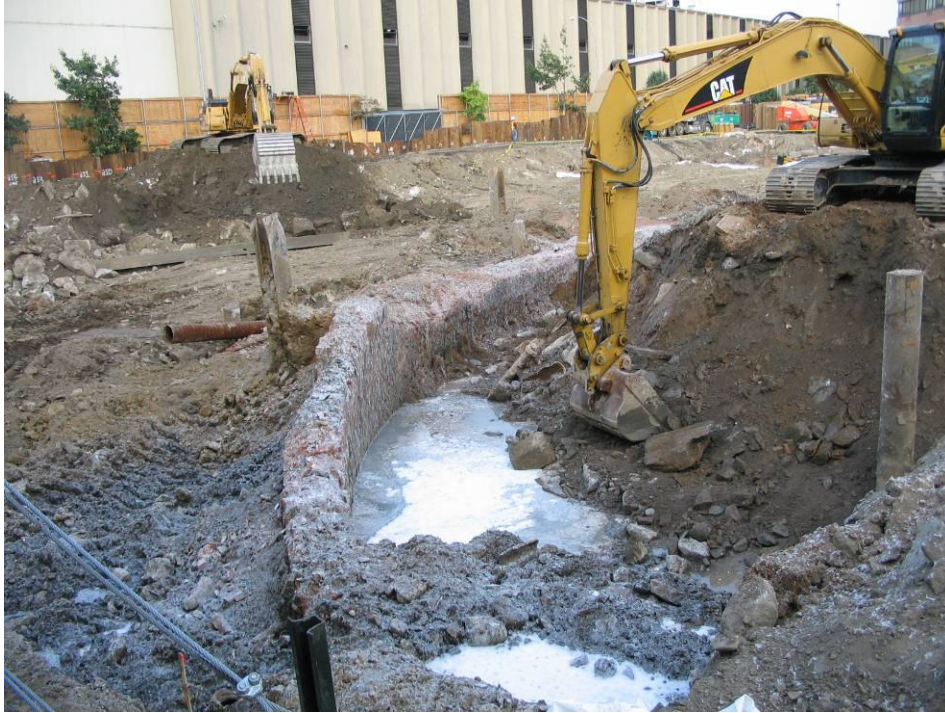
**Photograph No. 19: August 12, 2005 - View of exposed section of northeast MGP holder wall (view southwest).**

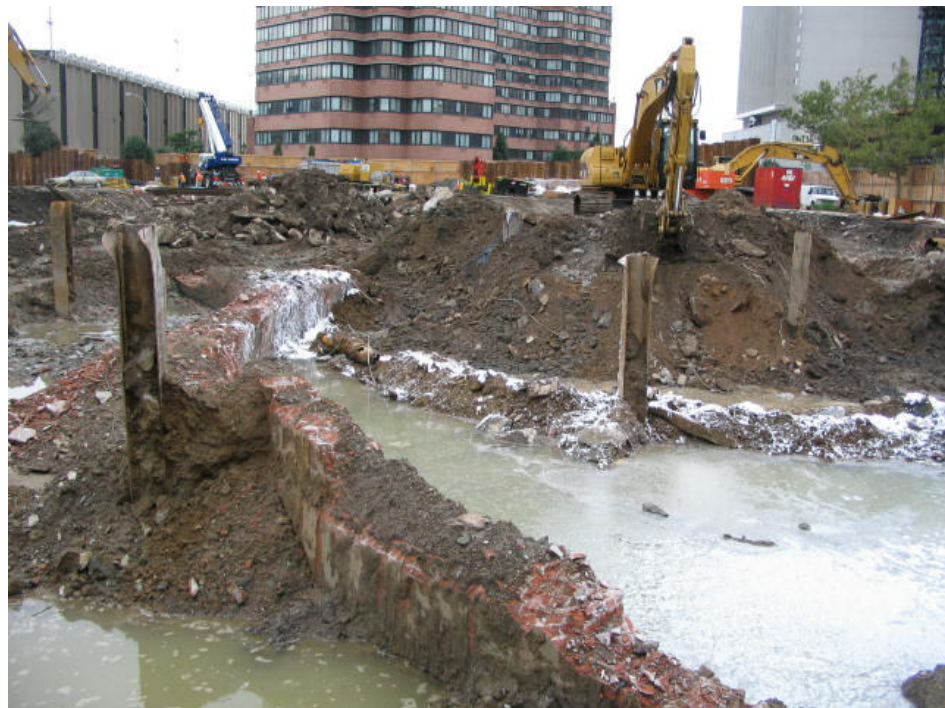
**Photograph No. 20: August 15, 2005 - View of exposed section of northeast MGP holder wall (view west). Note surface water accumulation and/or exposed groundwater.**

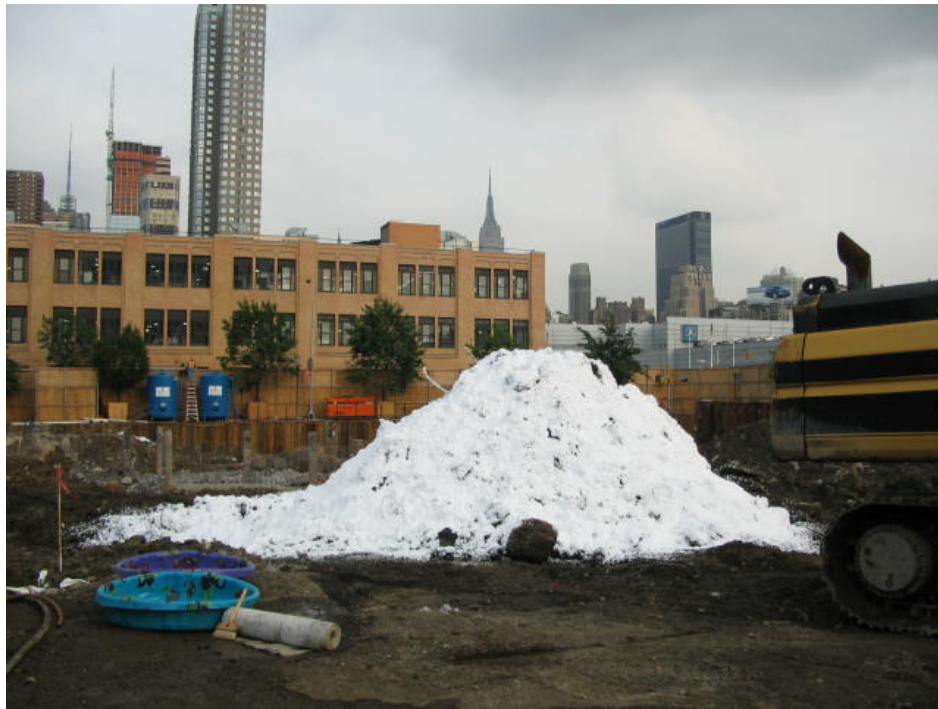
**Photograph No. 25: August 2005 - Typical view of foam odor suppressant covering temporary stockpile.**

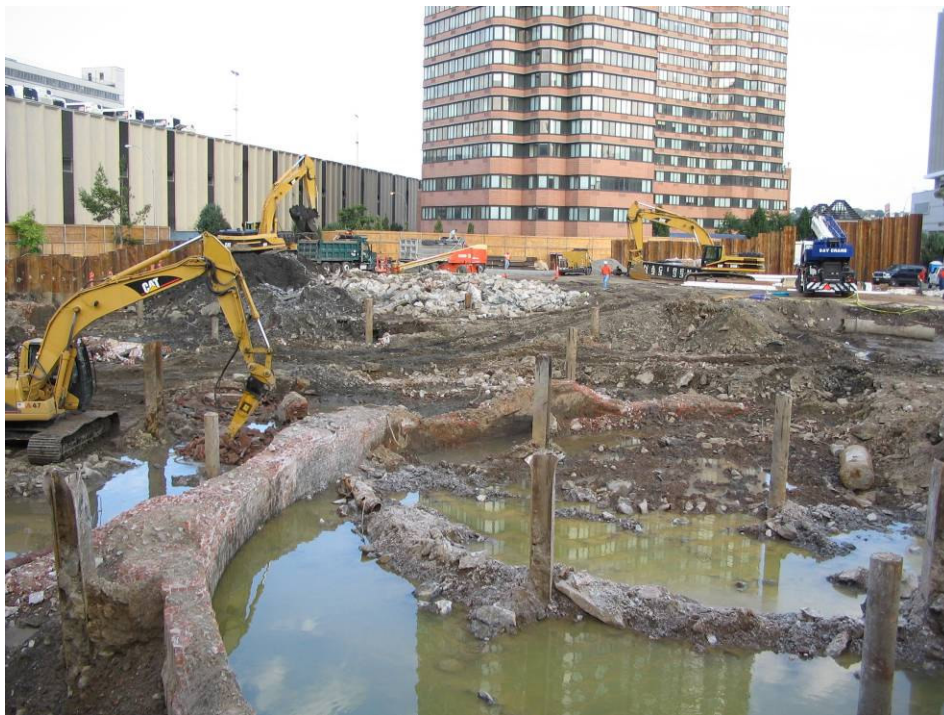
**Photograph No. 26: August 18, 2005 - View of excavation showing exposed northeast MGP holder wall, various H-piles and concrete filled pipe piles (view west).**

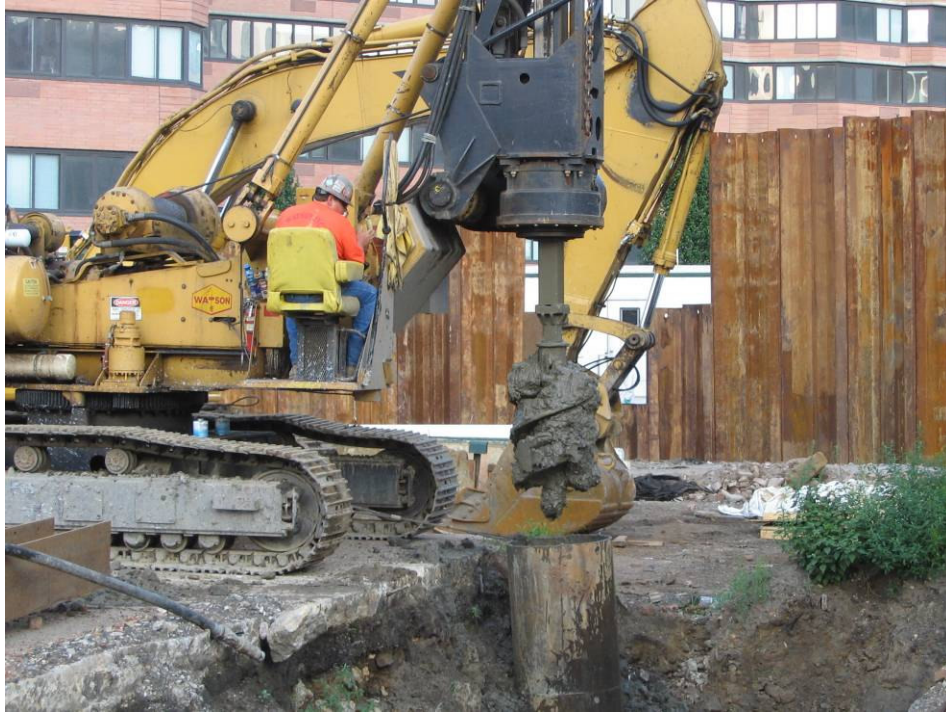
**Photograph No. 27: August 18, 2005 - Moretrench's Watson 3-1678 track mounted drill rig advancing borehole for northwestern dewatering well (Well #4).**

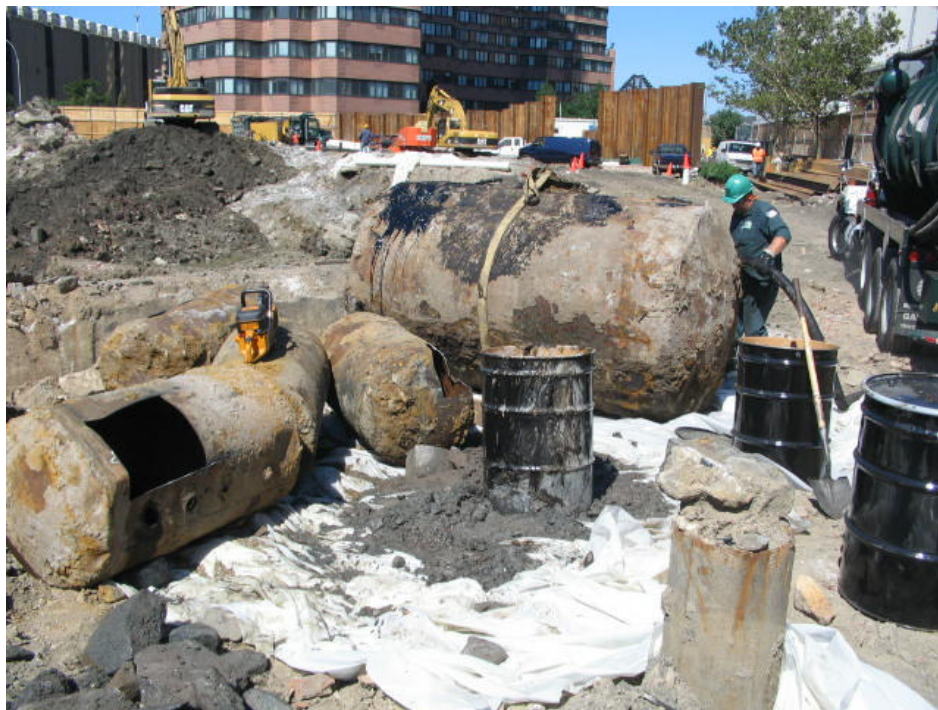
**Photograph No. 28: August 25, 2005 – Additional USTs discovered in northeast portion of Site having contents vacuumed out and cleaned for decommissioning.**

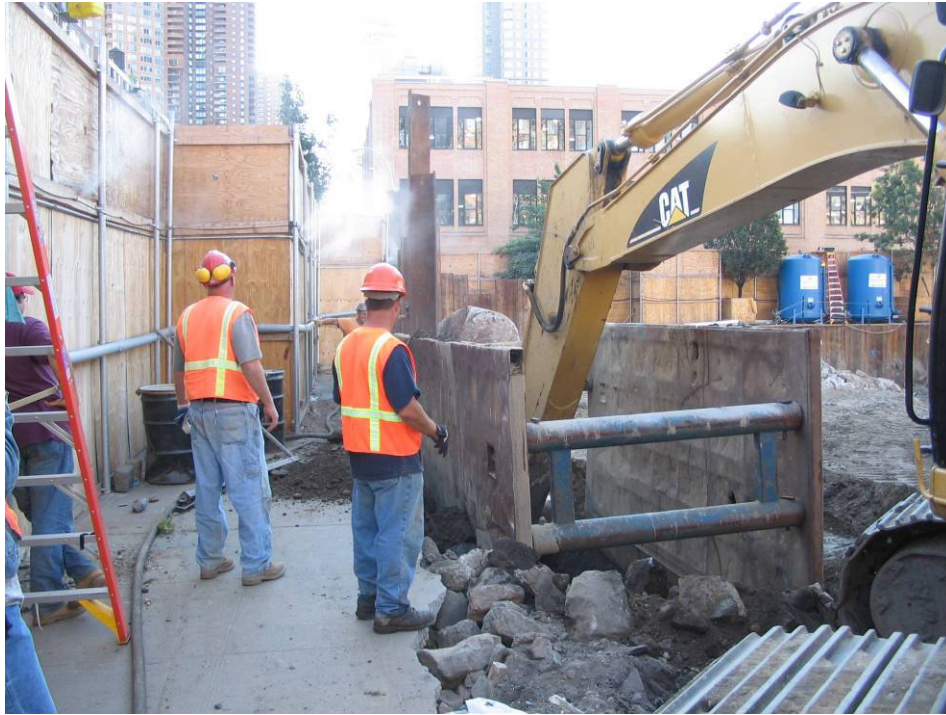
**Photograph No. 39: September 10, 2005 - Trench box excavation in progress along northern site perimeter (view east).**

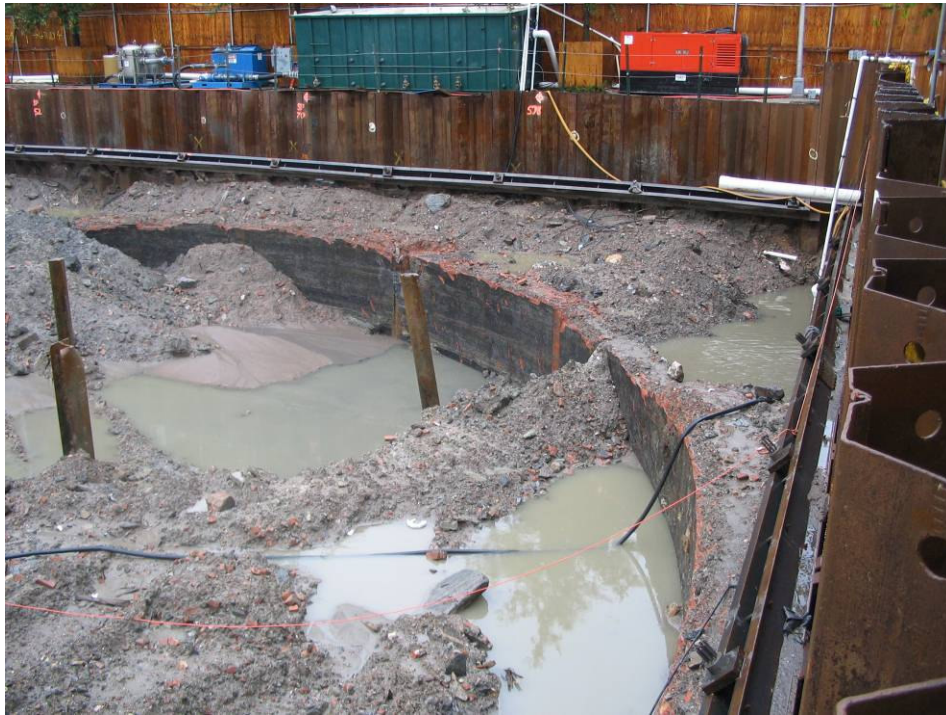
**Photograph No. 59: October 14, 2005 - View of surface water accumulation within northeast MGP holder wall remnants. Note presence of hoses and sump pumps used to assist in dewatering efforts.**

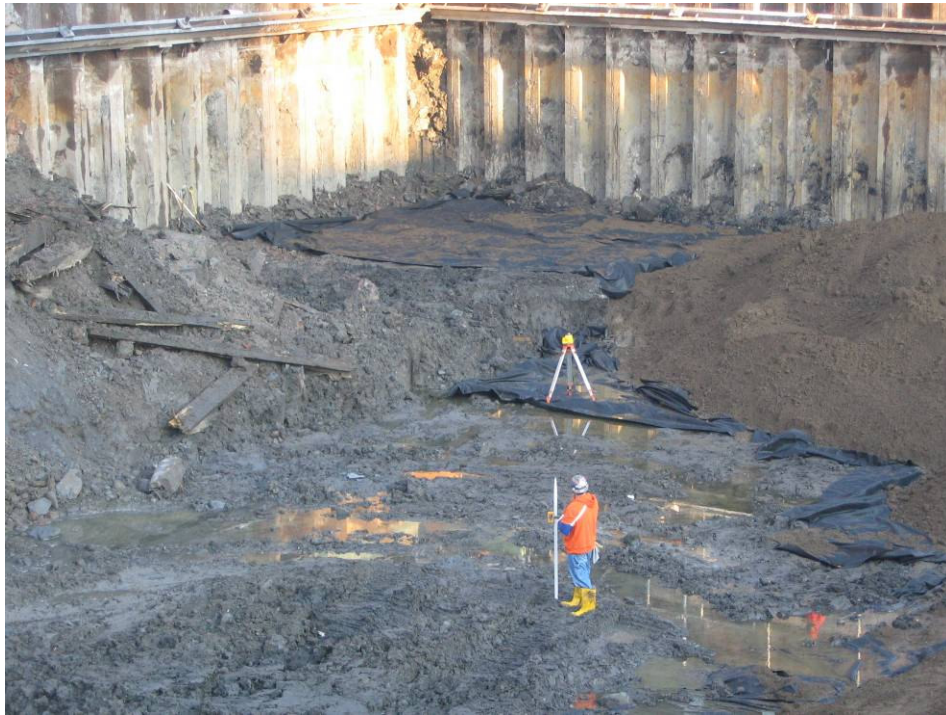
**Photograph No. 102: January 27, 2006 – Excavating the former Purifying House foundation (view south-southwest).**

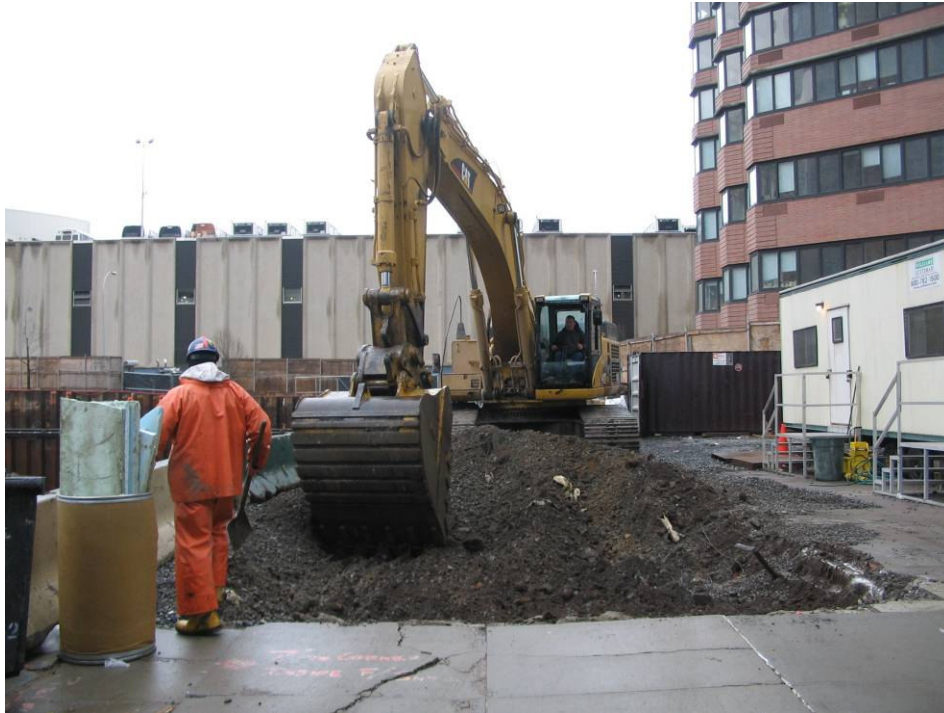
**Photograph No. 106: February 2, 2006 - The last bit of MGP material to be excavated. View is of southwest corner of Site looking towards the northwest.**
