Harlem Park
1800 Park Avenue
New York, NY

NYSDEC BCP Site No. C231041

PERIODIC REVIEW REPORT

Reporting Period: February 25, 2022 to February 24, 2025

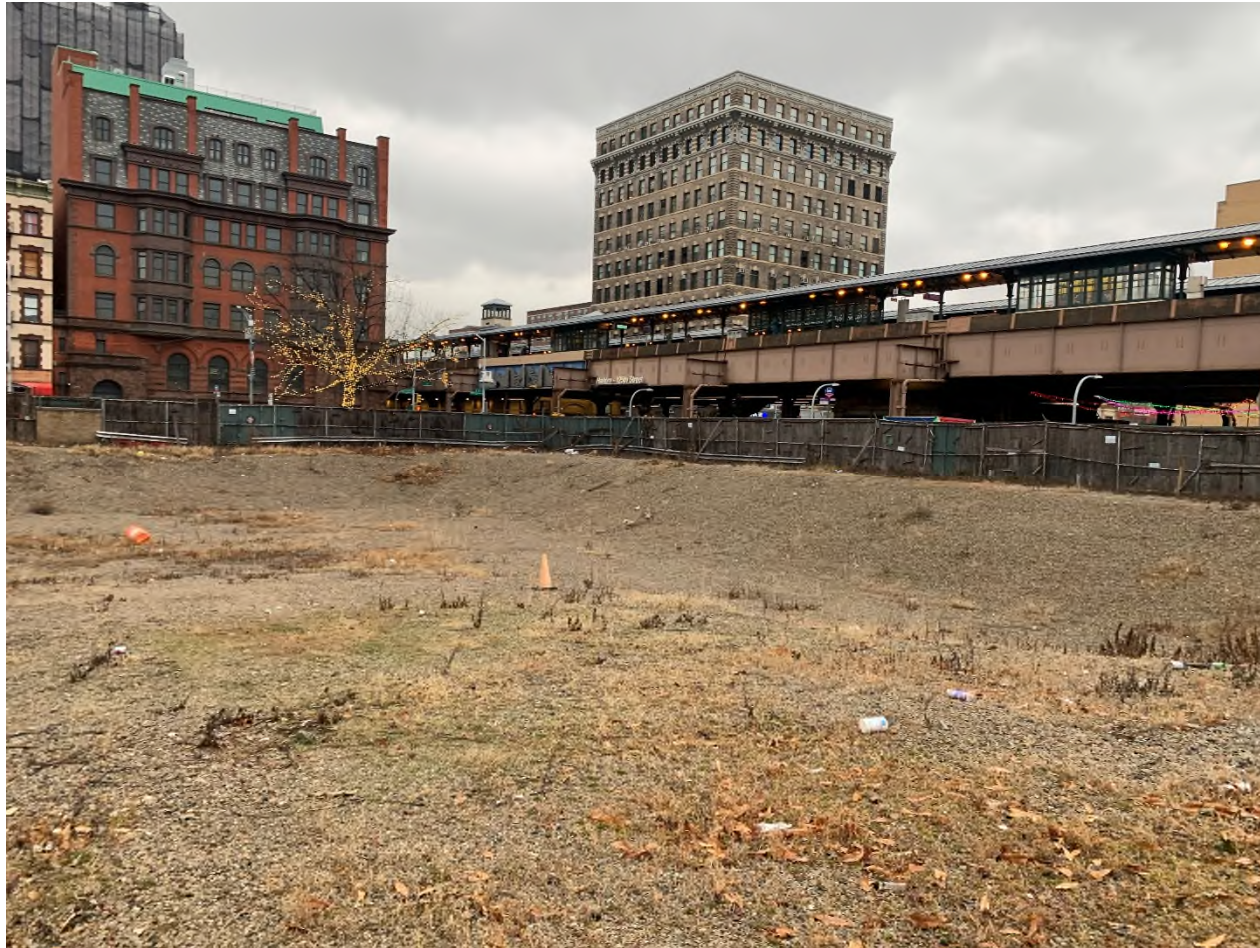
Photo 1: Temporary cover system, facing northeast toward Park Avenue and 125th Street (January 13, 2023)

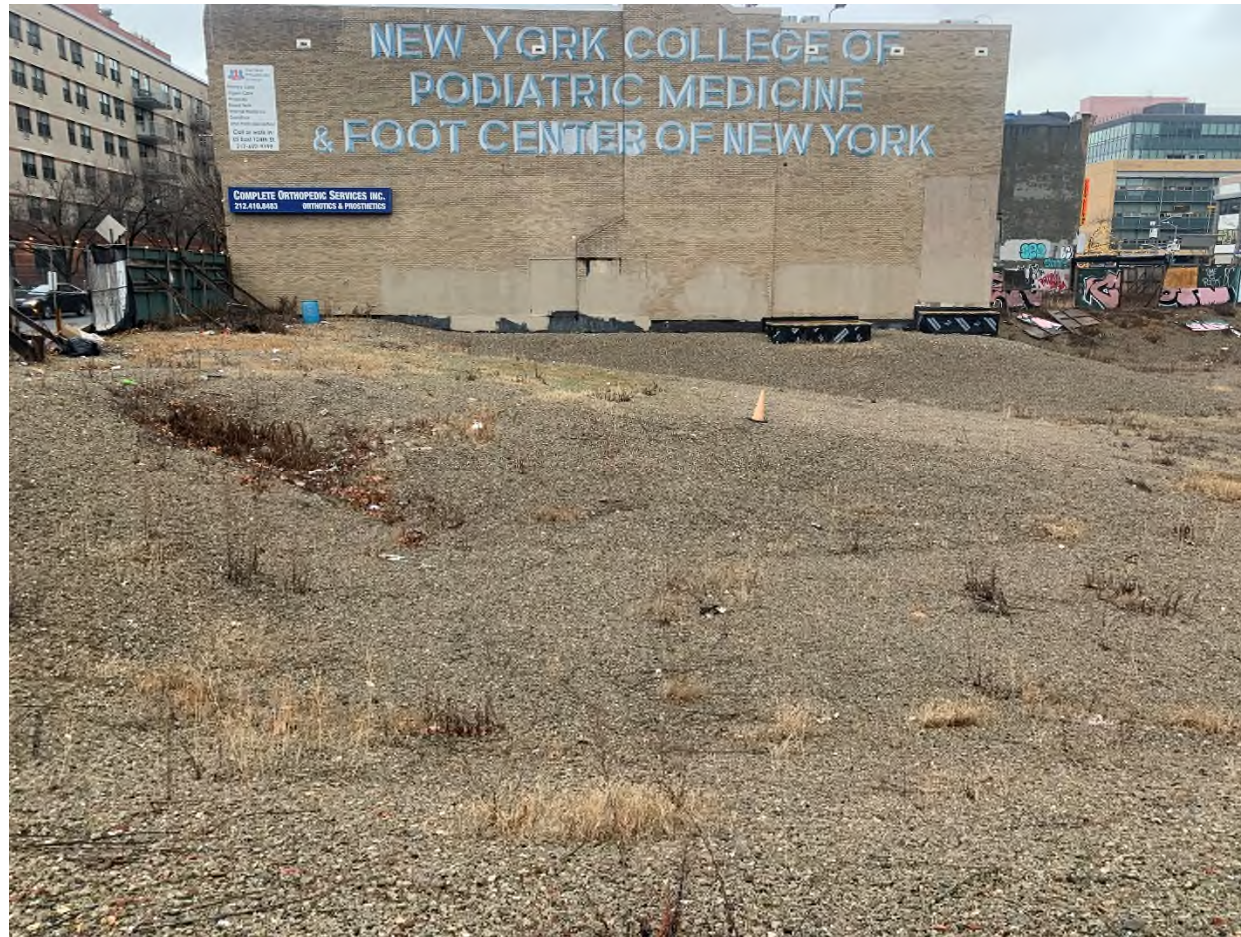
Photo 2: Temporary cover system, facing west toward Madison Avenue (January 13, 2023)

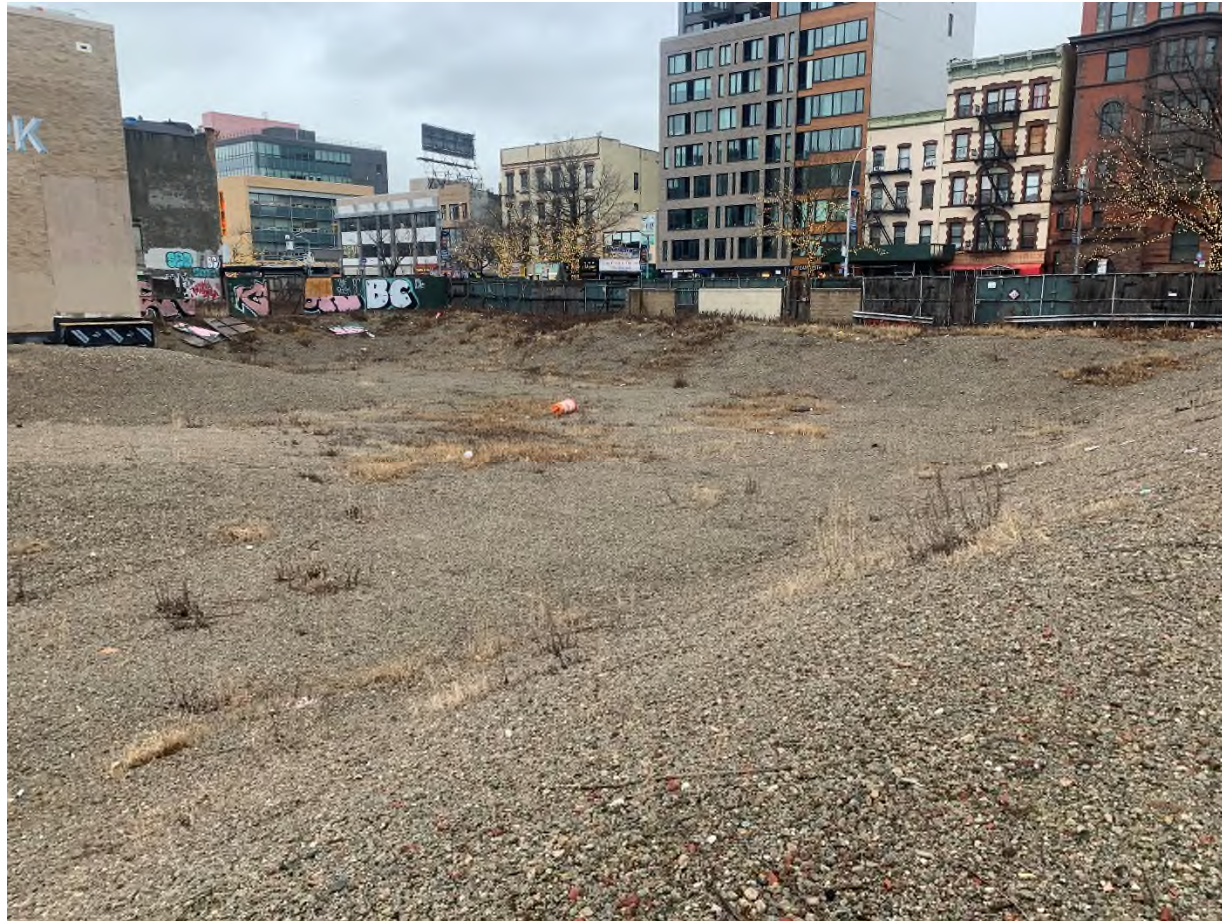
Photo 3: Temporary cover system, facing northwest toward Madison Avenue and 125th Street (January 13, 2023)

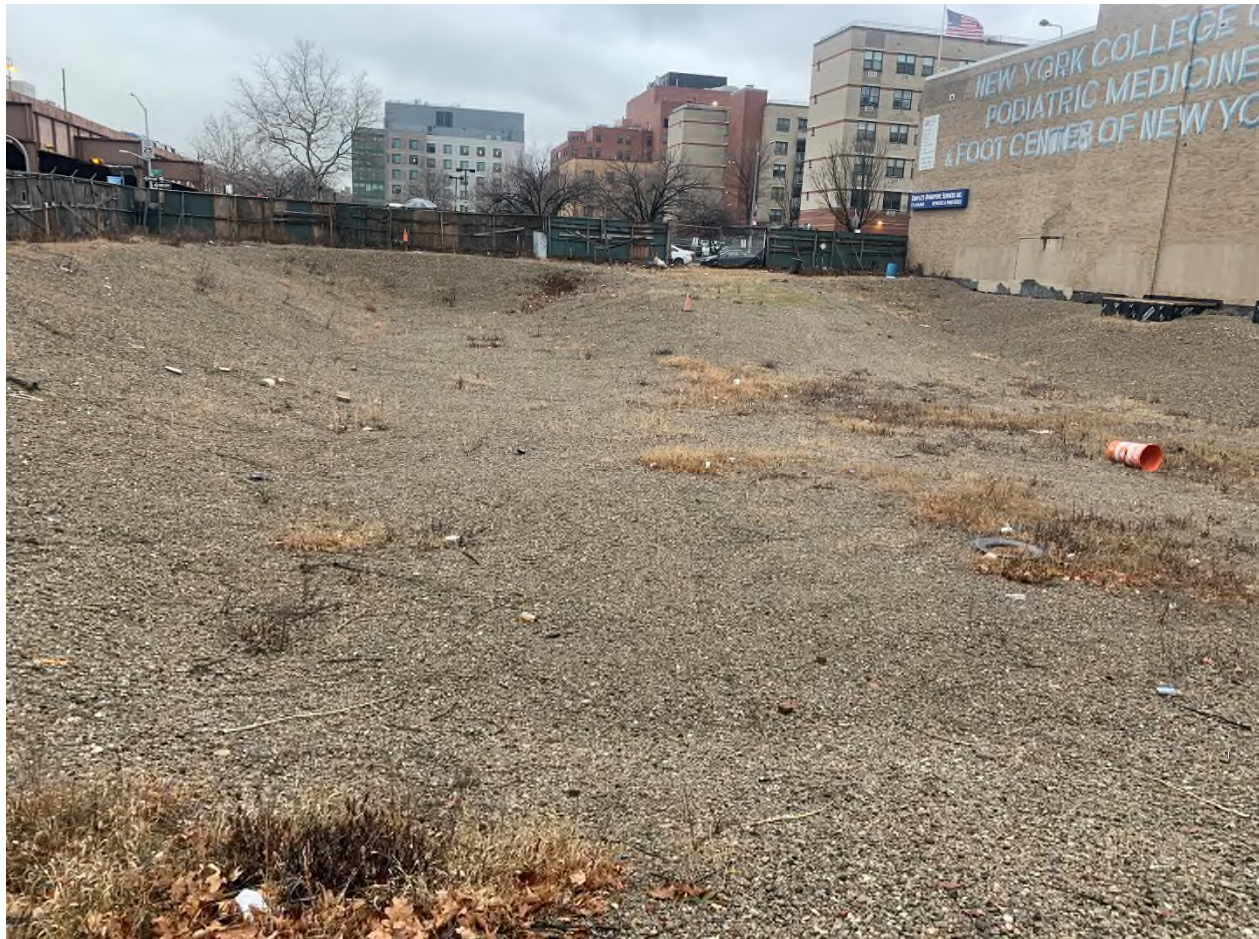
Photo 4: Temporary cover system and ramp, facing south toward 124th Street (January 13, 2023)

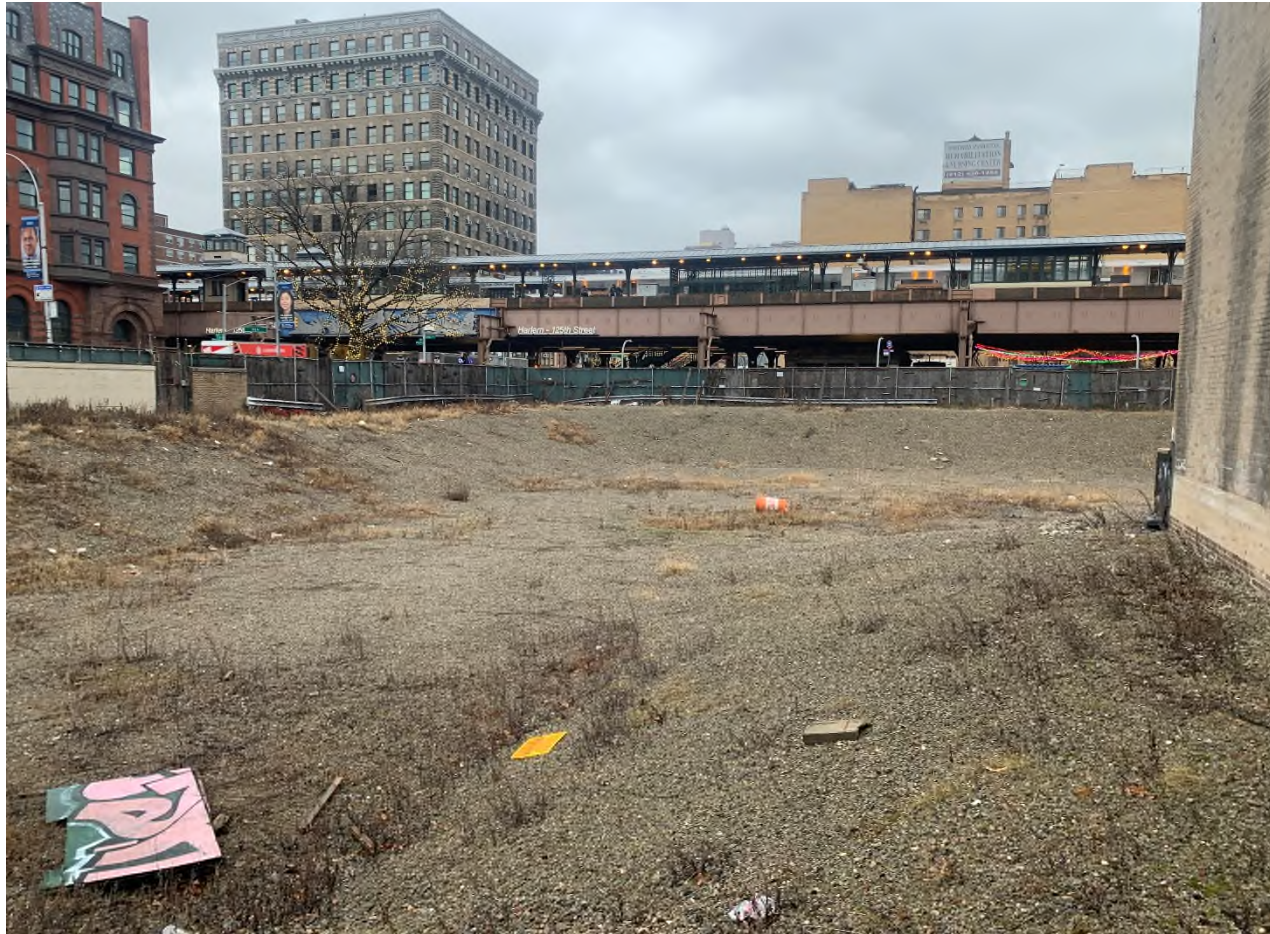
Photo 5: Temporary cover system, facing east toward Park Avenue (January 13, 2023)

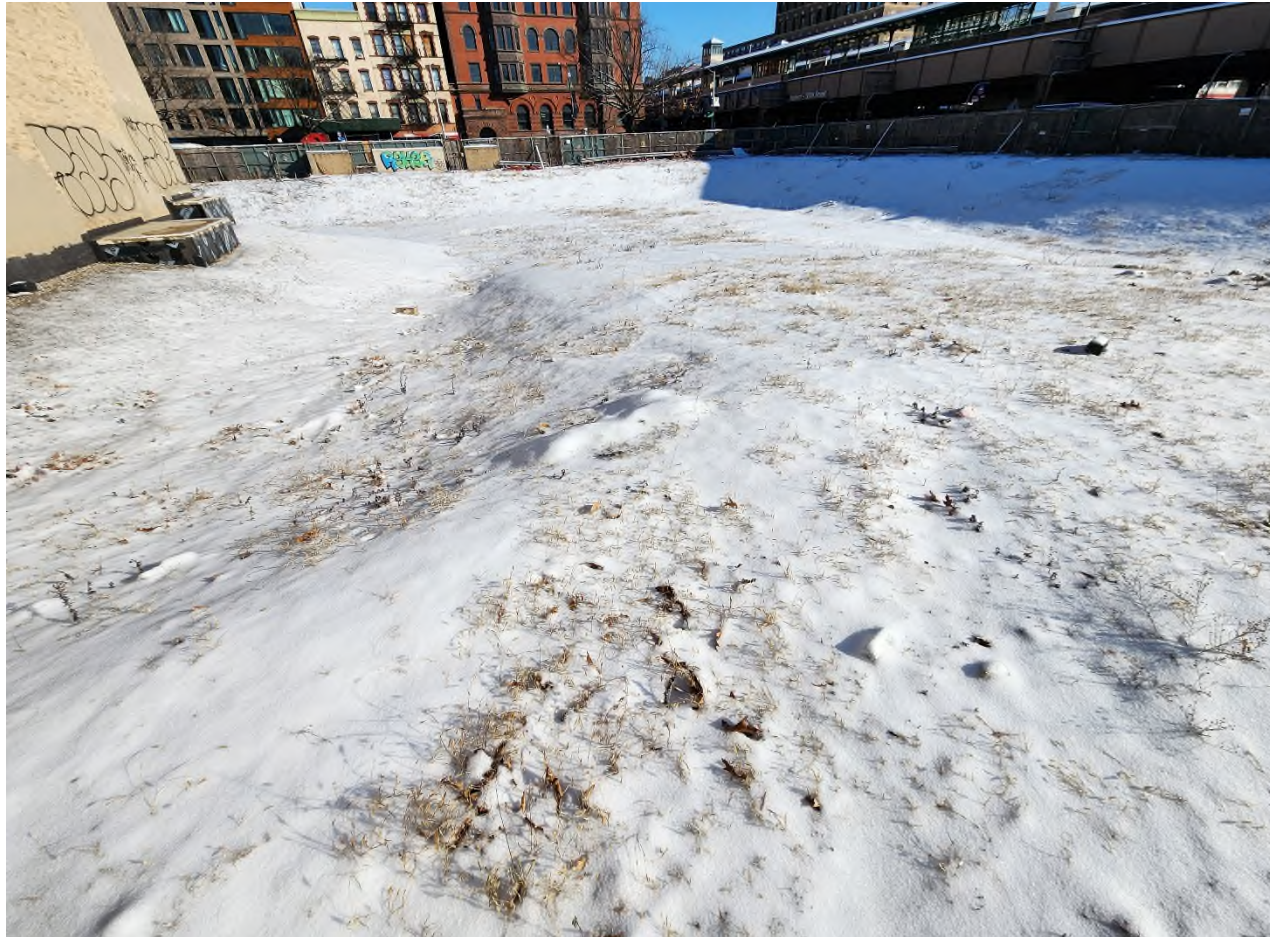
Photo 6: Temporary cover system, facing northeast toward Park Avenue and 125th Street (January 17, 2024)

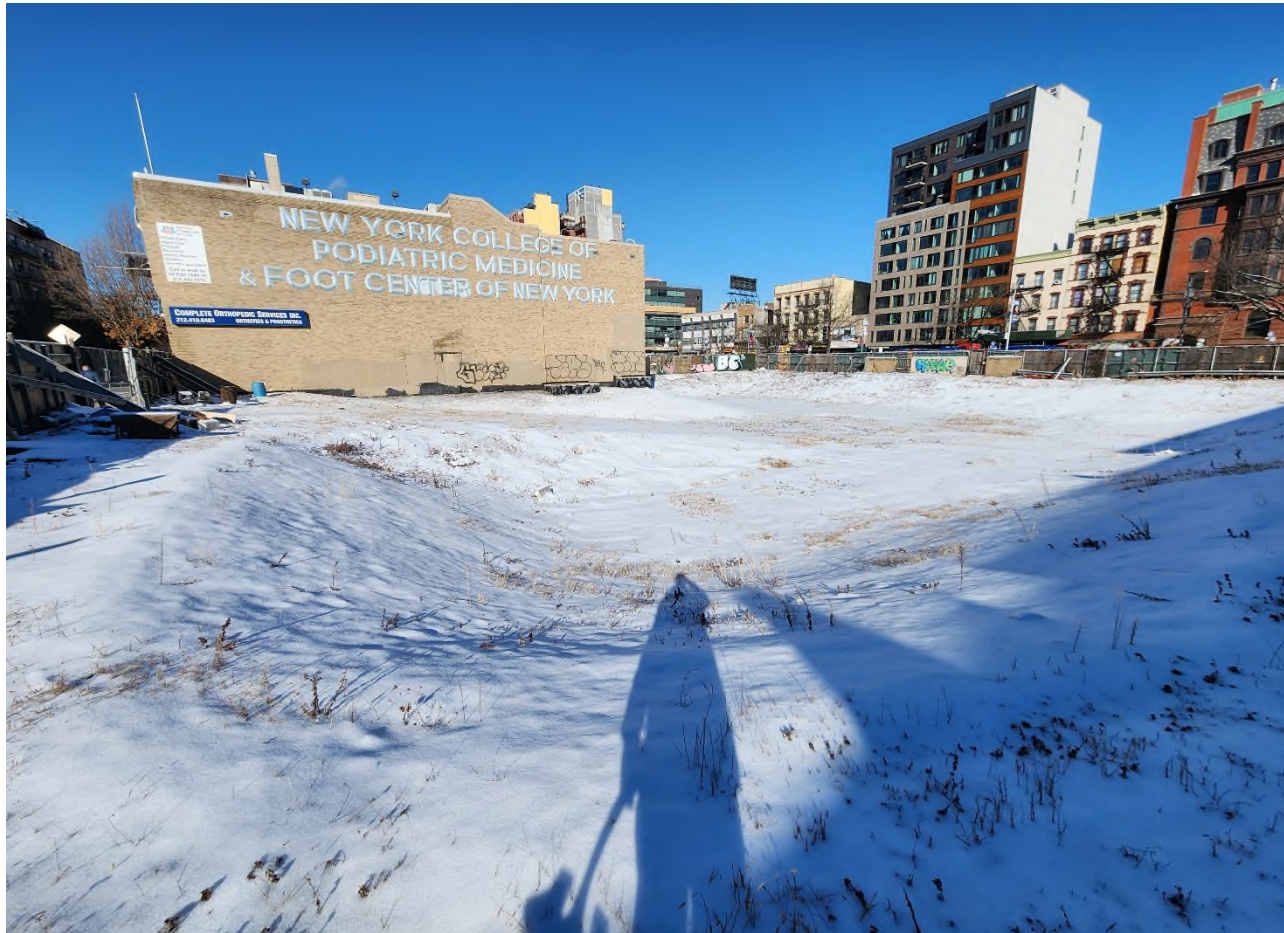
Photo 7: Temporary cover system, facing northwest toward Madison Avenue and 125th Street (January 17, 2024)

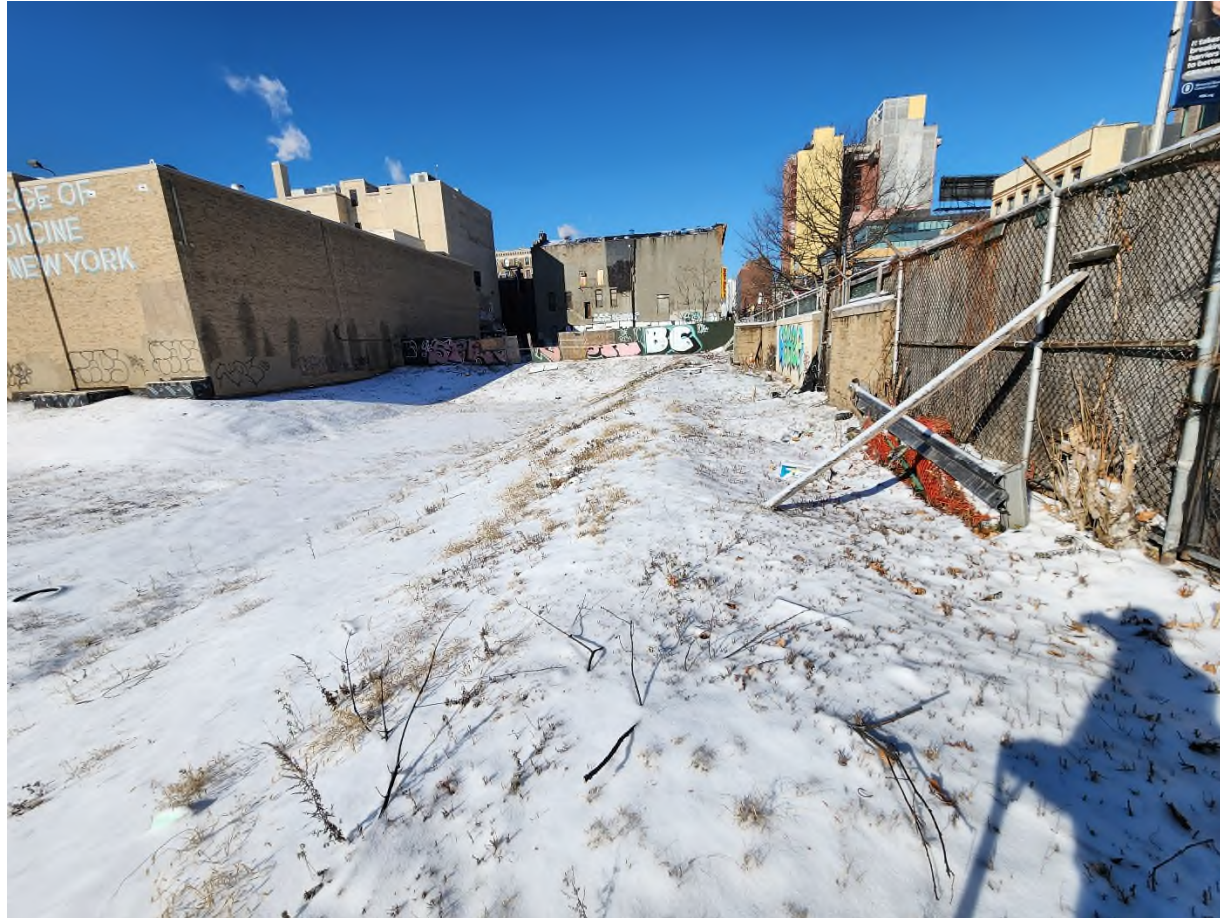
Photo 8: View of temporary cover system facing west from the corner of Park Avenue and East 125th Street (January 17, 2024)

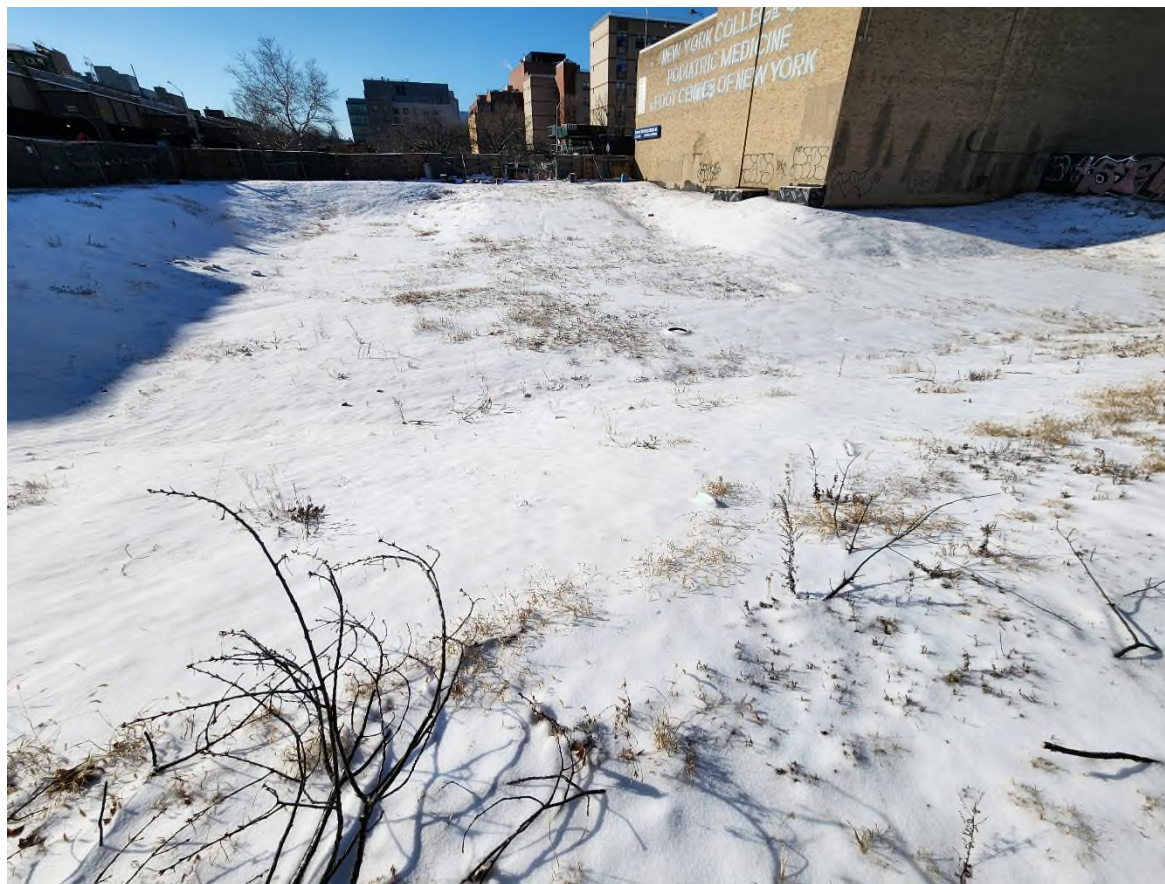
Photo 9: Temporary cover system and ramp, facing south toward 124th Street (January 17, 2024)

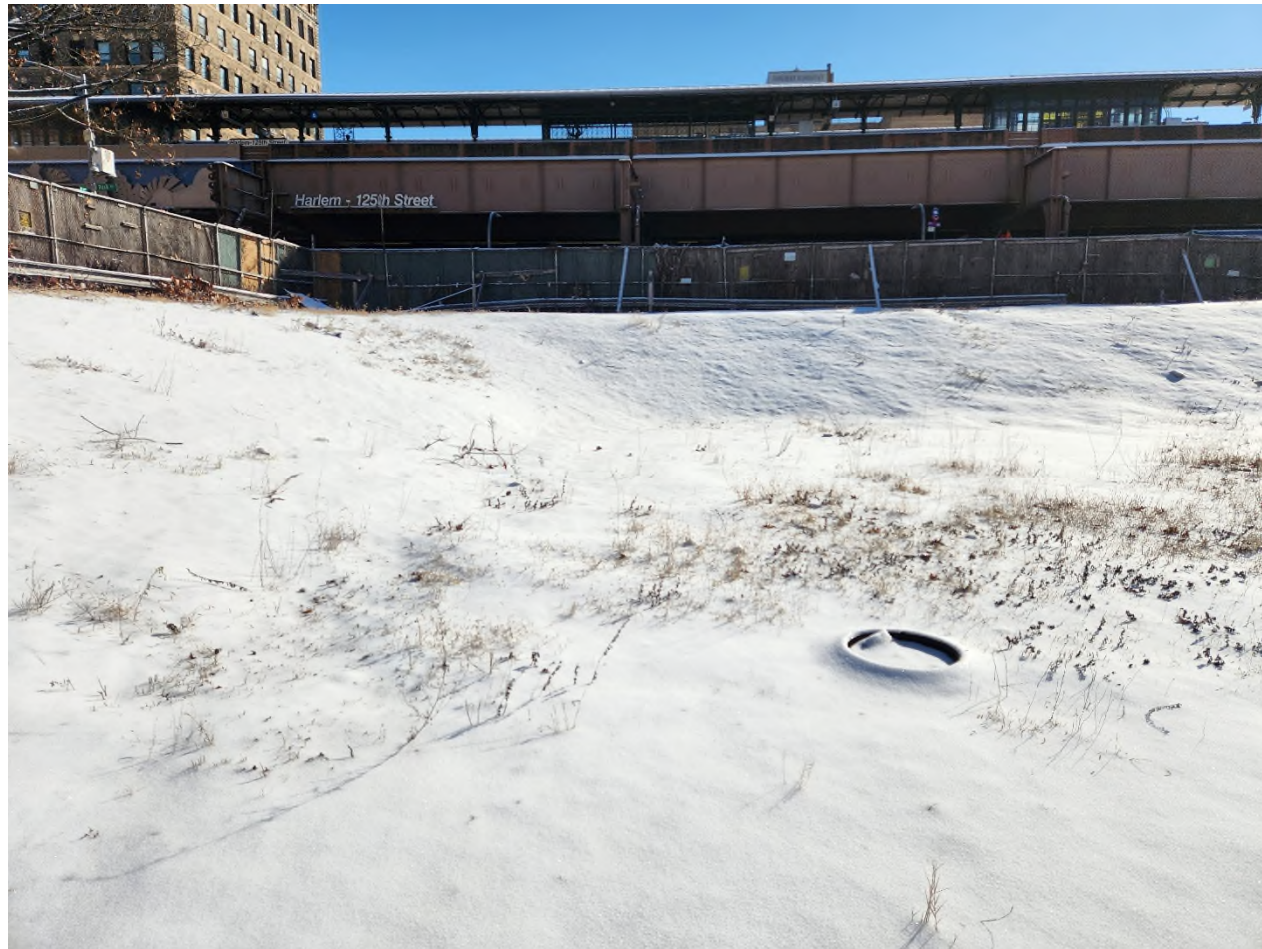
Photo 10: Temporary cover system, facing east toward Park Avenue (January 17, 2024)

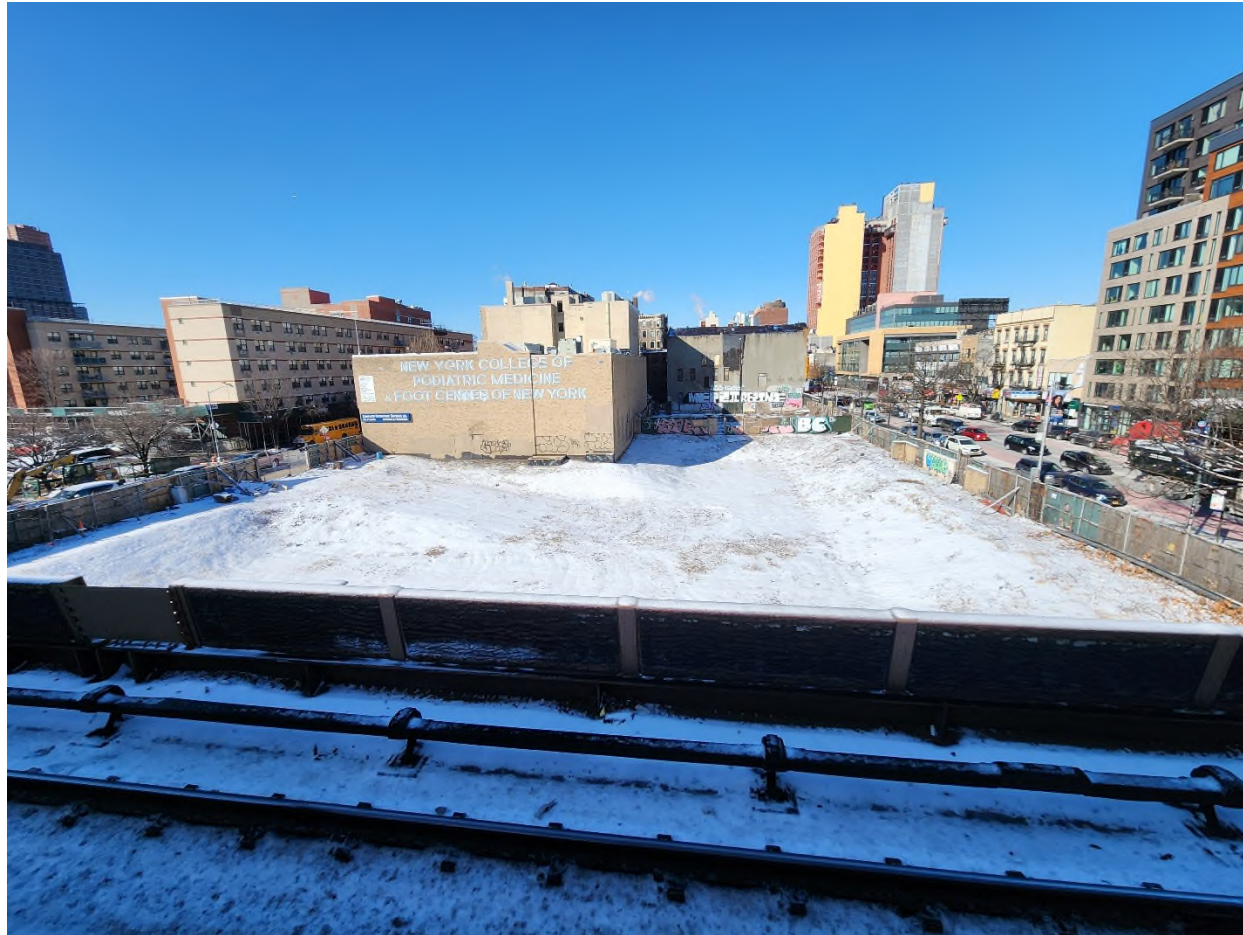
Photo 11: View of the Site from Metro-North 125th Street Station platform, facing west (January 17, 2024)

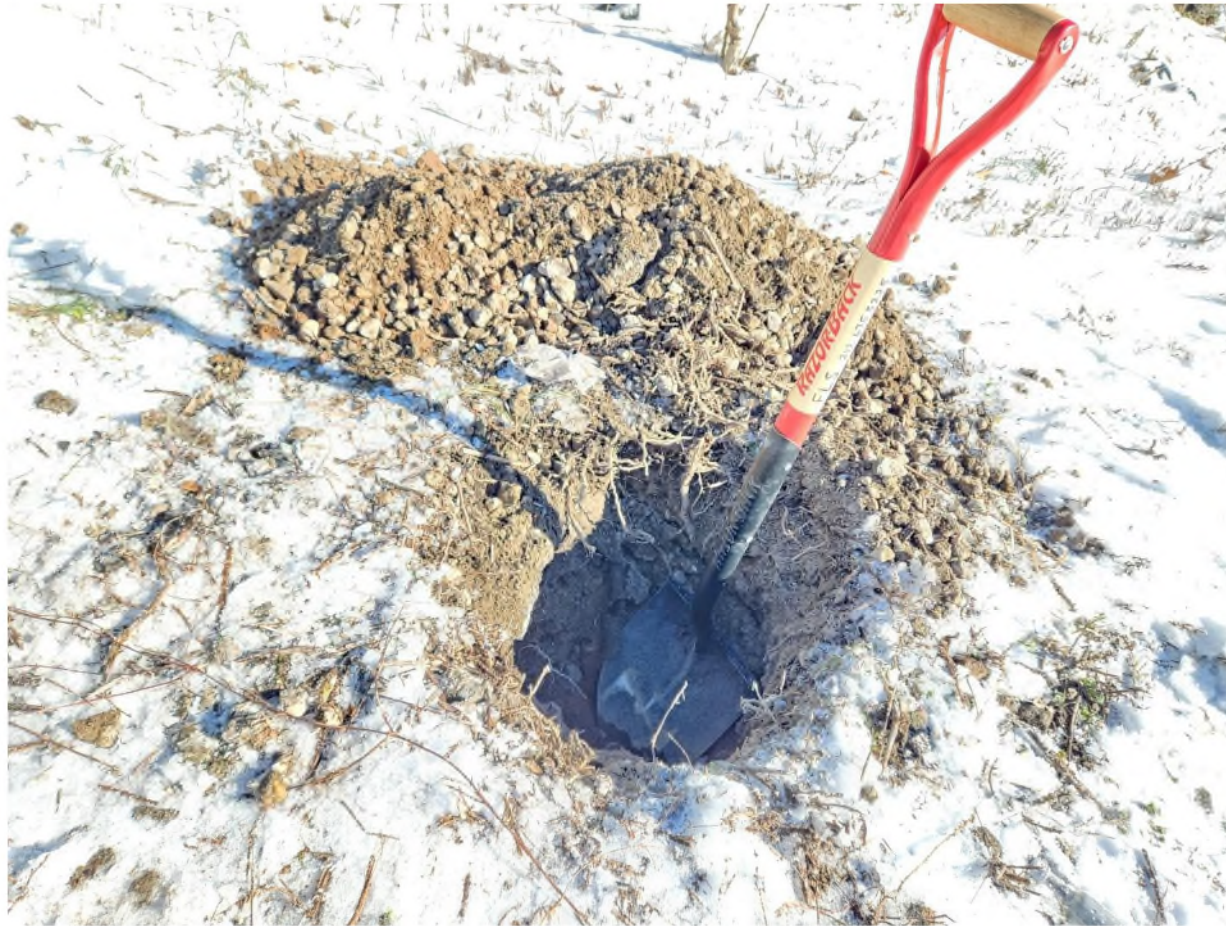
For confirmation that the cover system has remained at the established depth, a two (2) foot deep test pit was dug into the RCA cover system near the northern border of the Site. After the depth was measured, this hole was backfilled. The RCA was found to be two (2) feet deep as intended, although some dirt and vegetation were found to be sparingly mixed into the RCA. It is believed that this organic material has simply been deposited over time through natural events such as rainfall and animal activity, and is not indicative of contaminated soil breakthrough of the cover system.

Photo 12: 2 ft. Test Pit to confirm RCA depth (January 17, 2024)

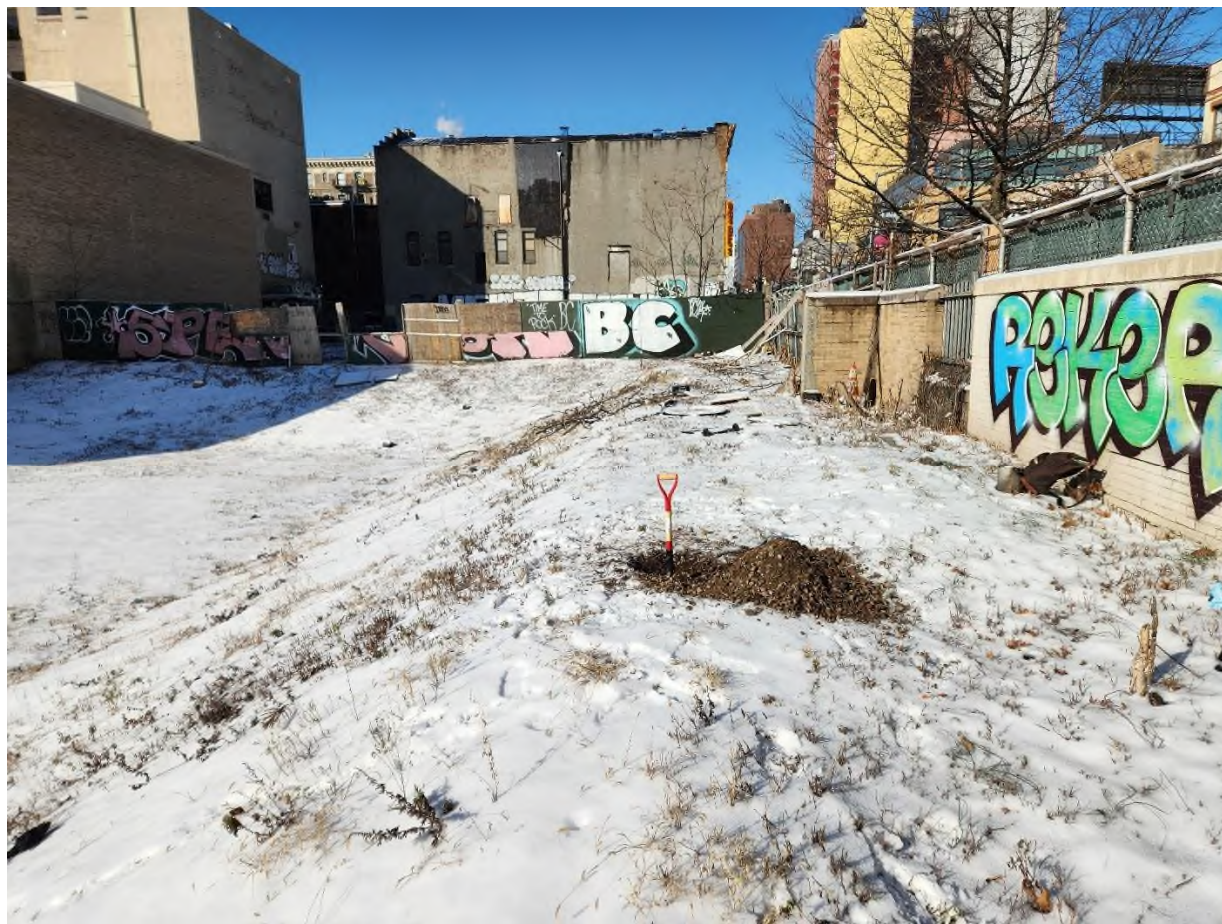
Photo 13: Temporary cover system with Test Pit to confirm RCA depth, facing west toward Madison Avenue (January 17, 2024)

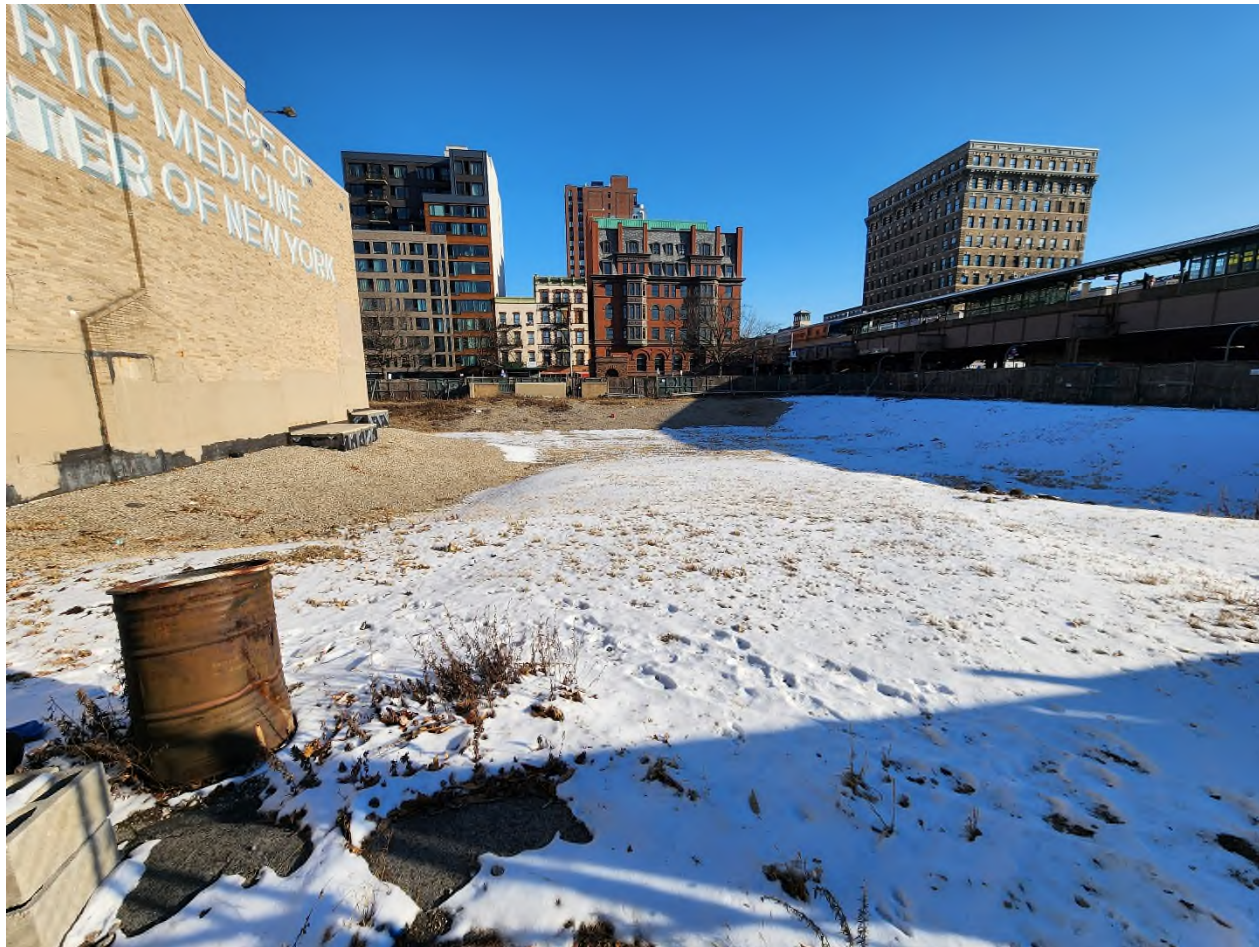
Photo 14: Temporary cover system, facing north toward 125th Street (January 24, 2025)

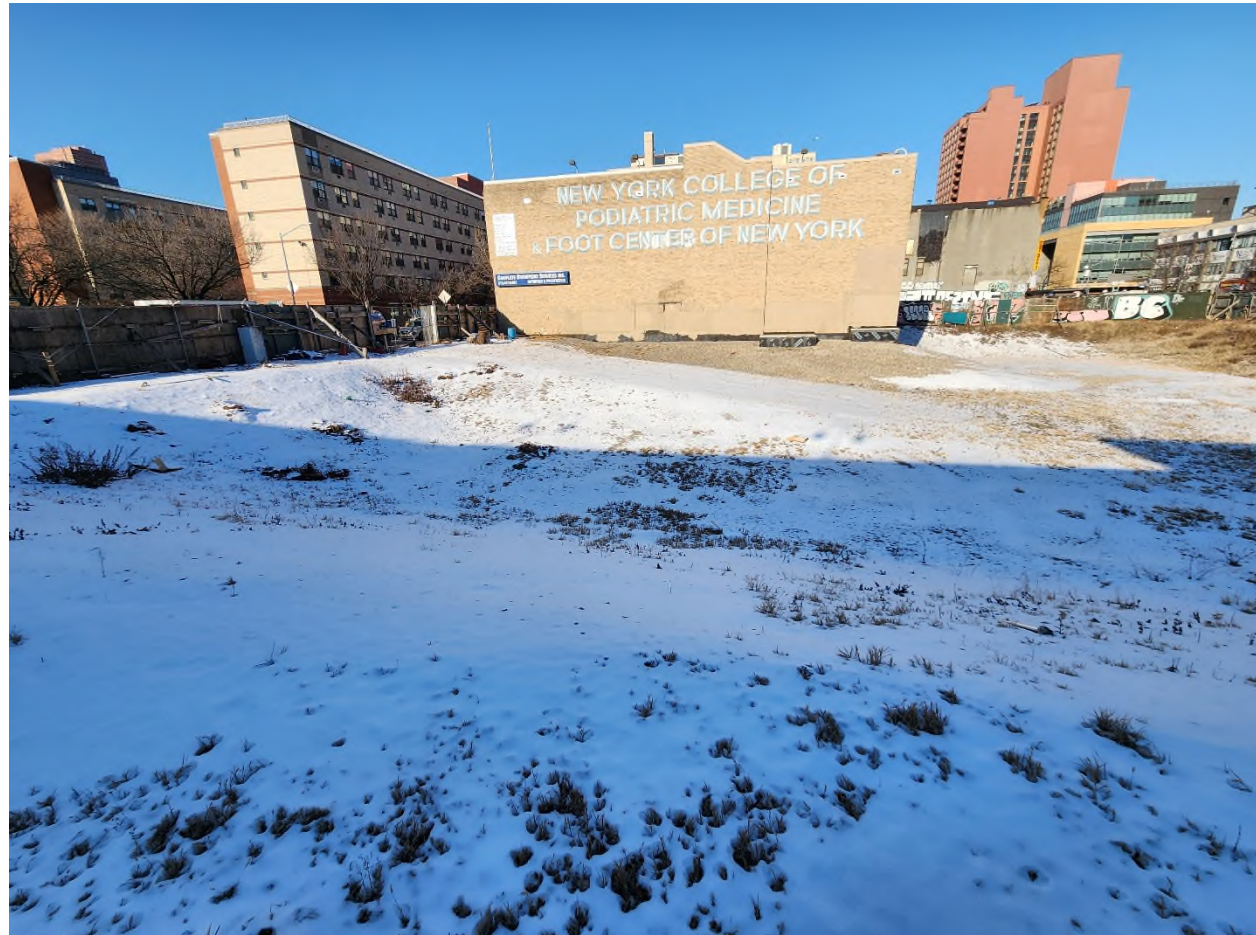
Photo 15: Temporary cover system, facing west toward Madison Avenue (January 24, 2025)

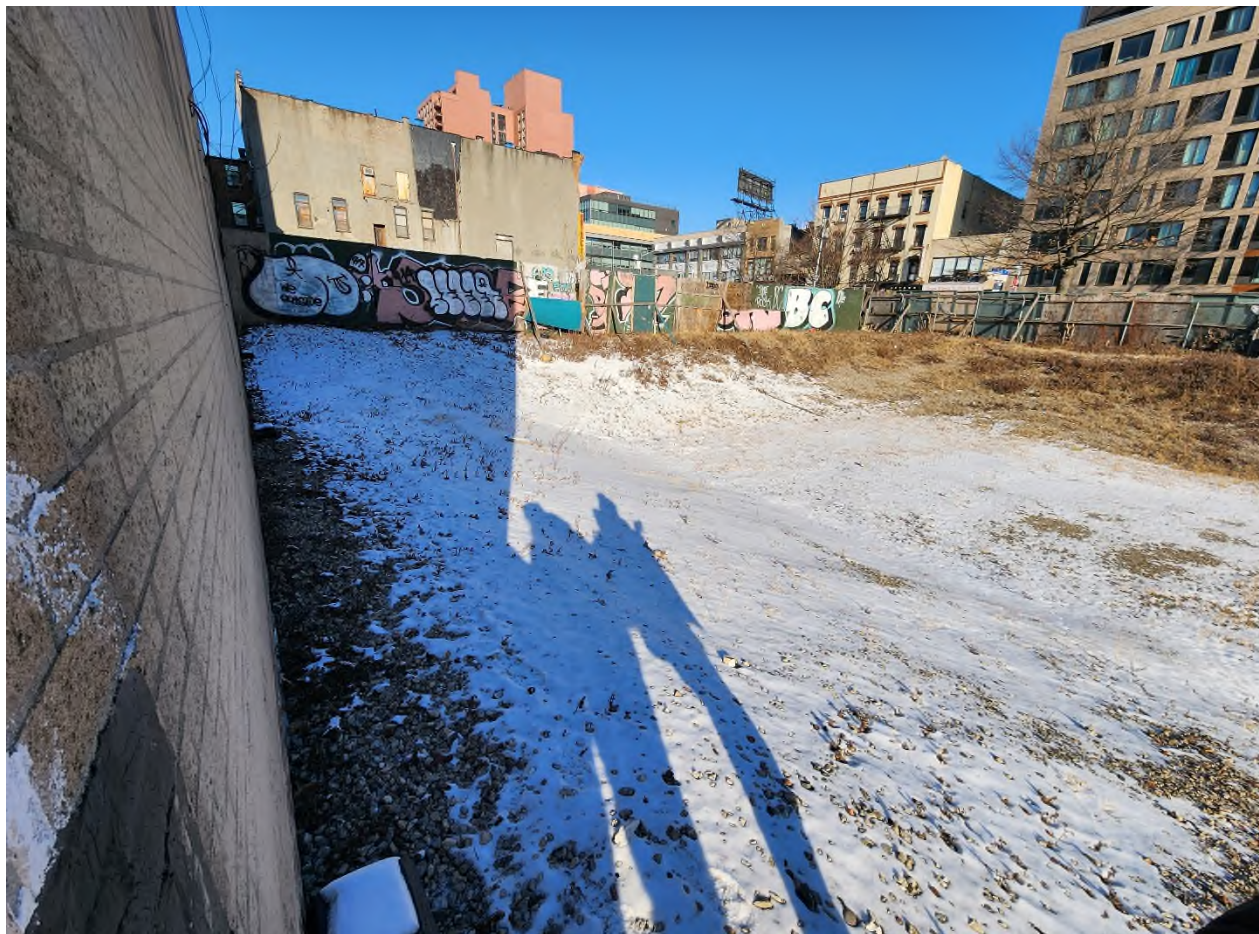
Photo 16: View of the western portion of the temporary cover system, facing northwest toward Madison Avenue and 125th Street (January 24, 2025)

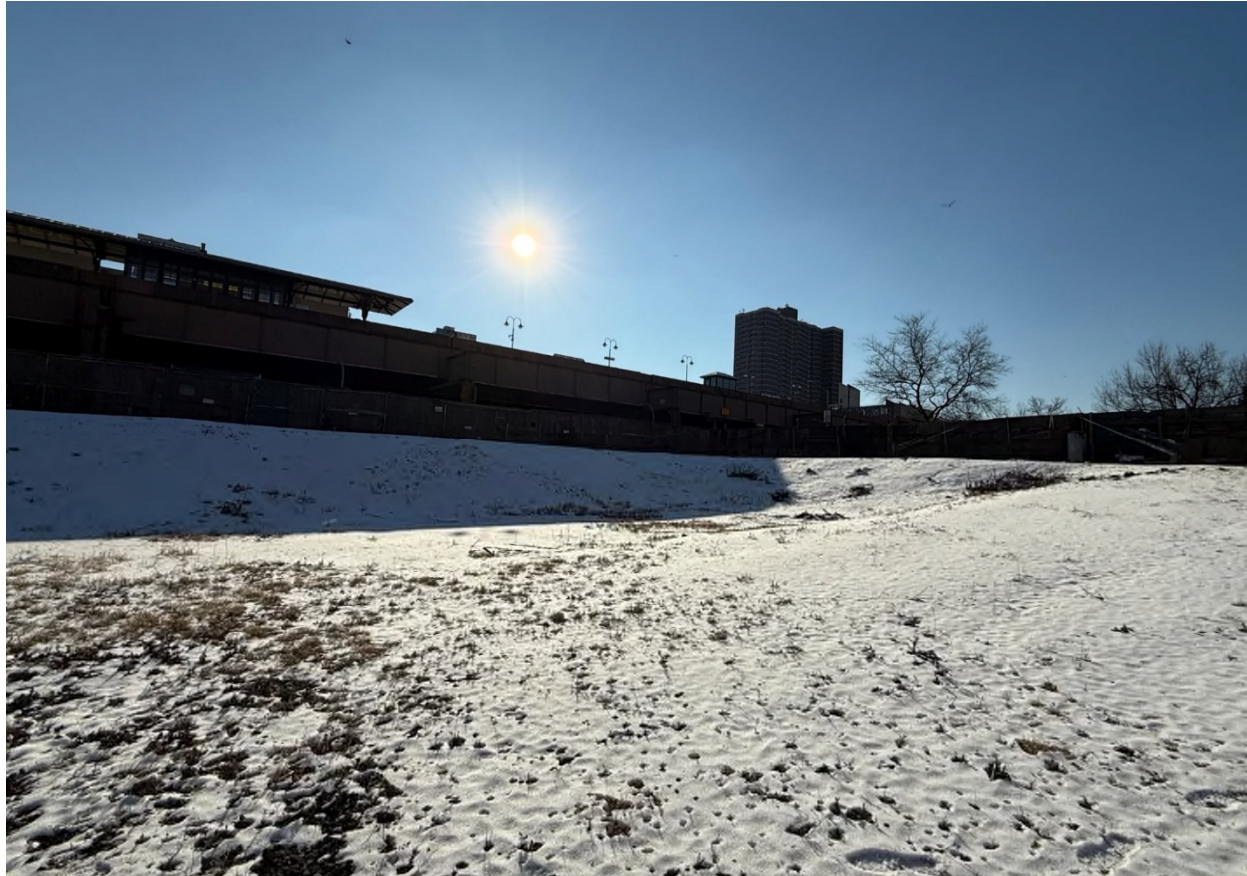
Photo 17: Temporary cover system and ramp, facing southeast toward Park Avenue and 124th Street (January 24, 2025)

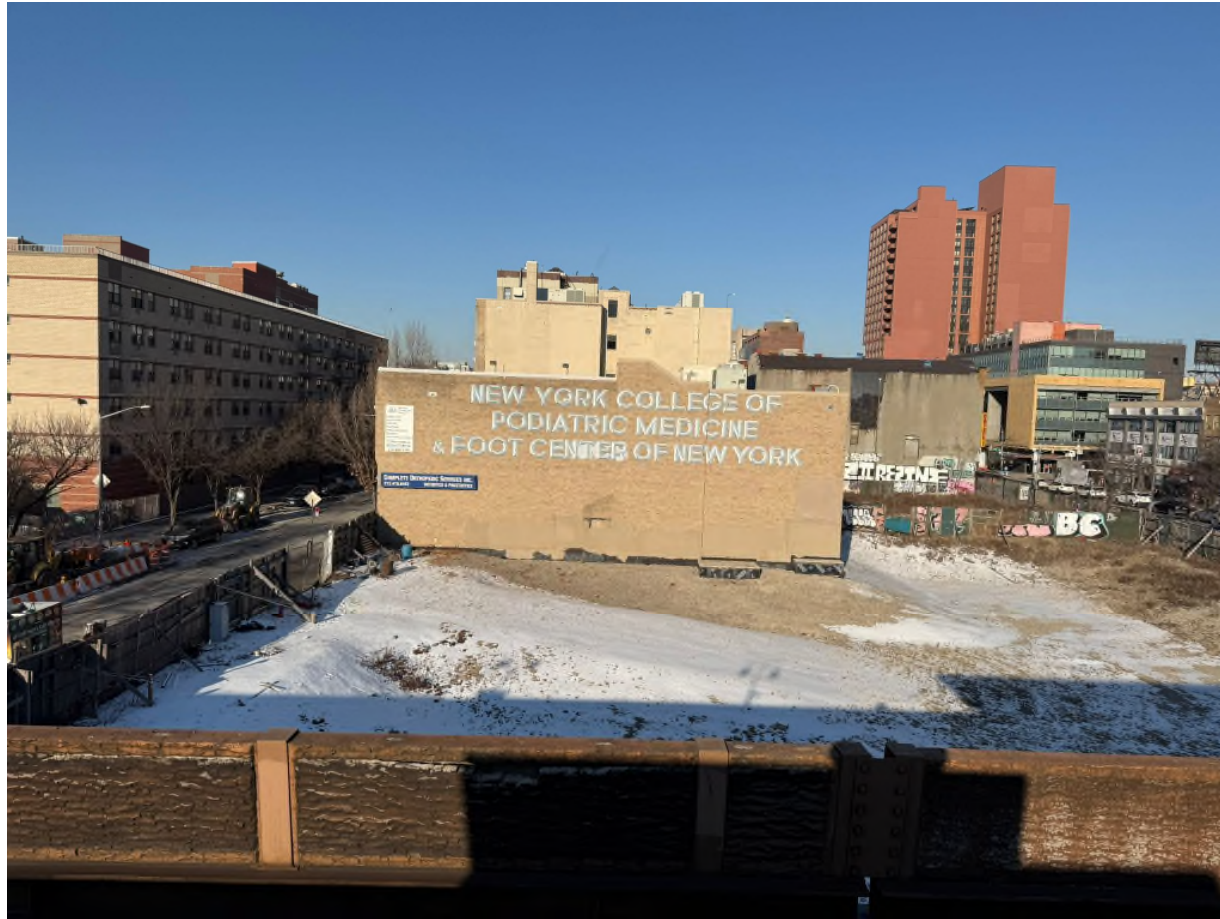
Photo 18: View of the Site from Metro-North 125th Street Station platform, facing west (January 24, 2025)
