Appendix H

Photograph Log

**West 34th Street
New York, New York
BCP Site #C231049**

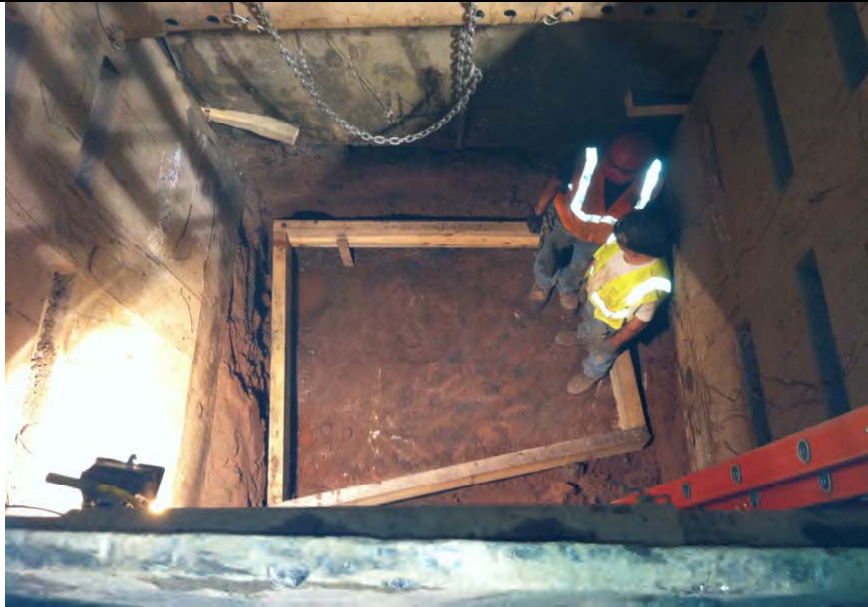
1. Phase III, Area "D" excavated down to bedrock.

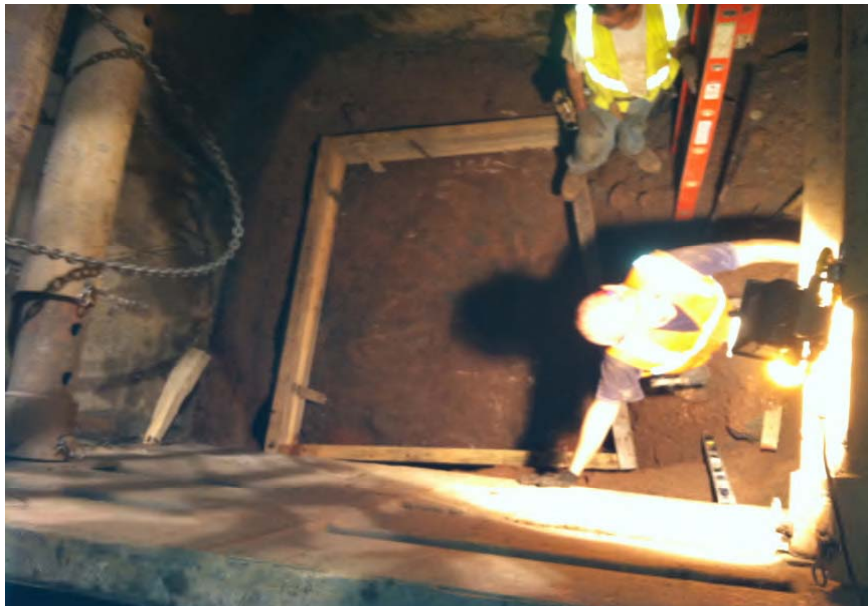
2. Phase III, Area "D" excavated down to bedrock.

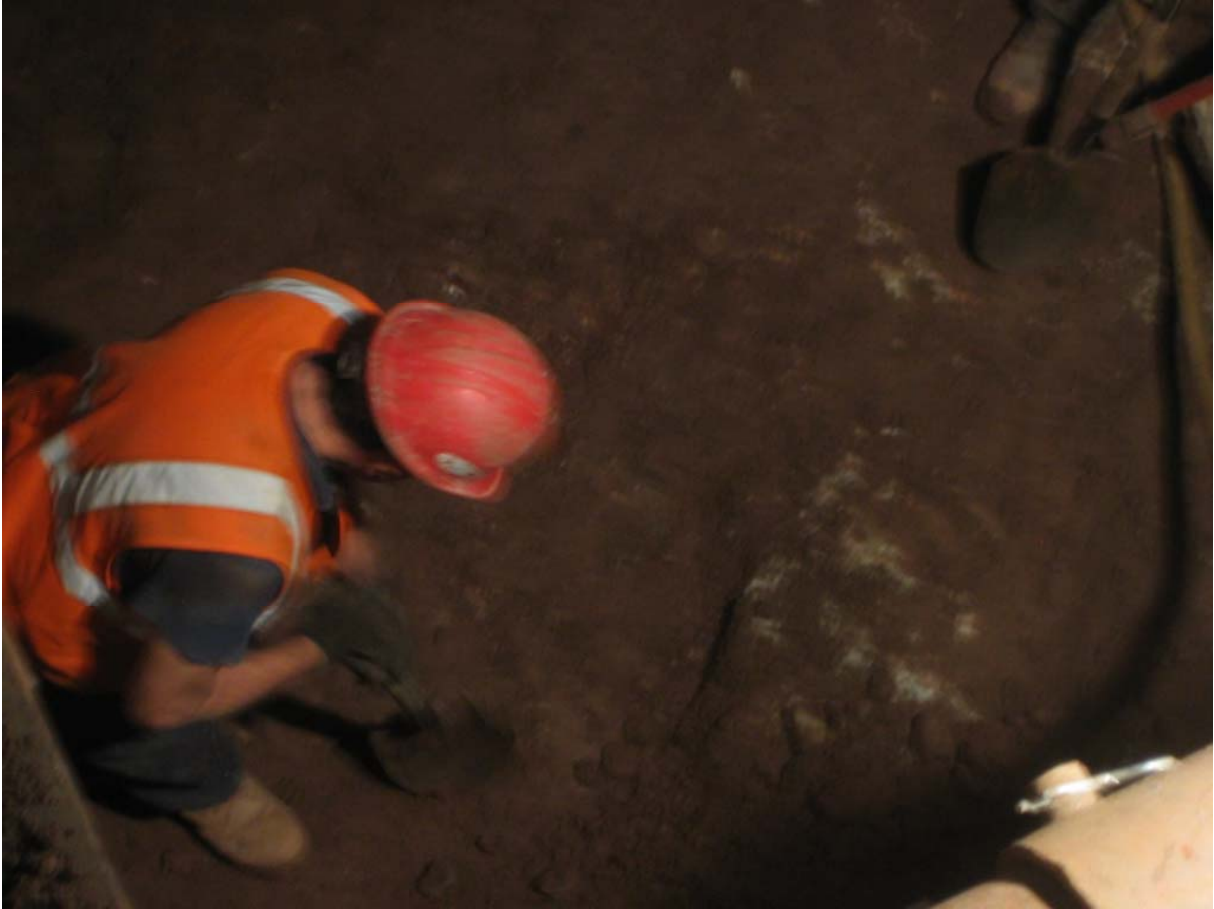
1. Area "B" excavated down to bedrock

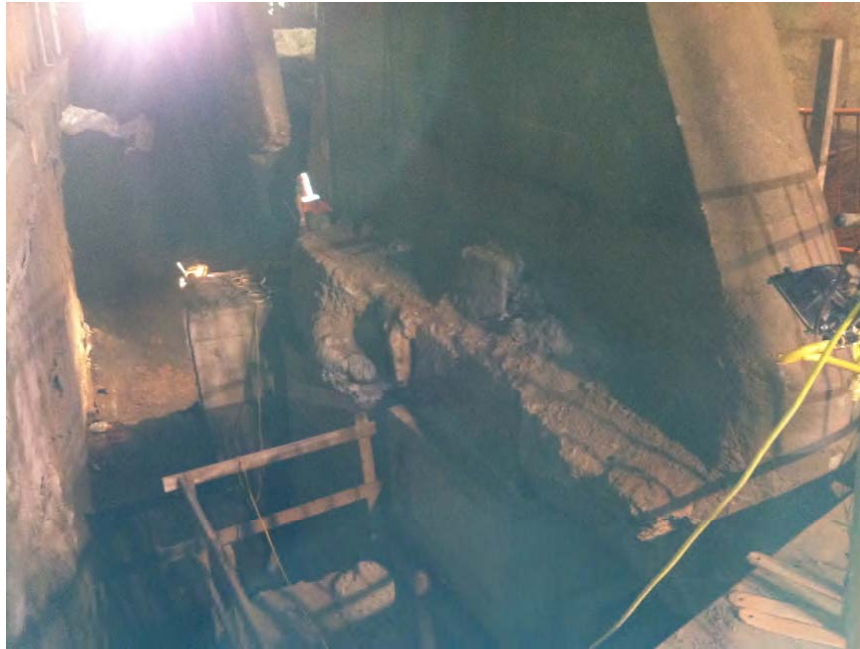
1. Excavation of the remaining sections of Phase #2

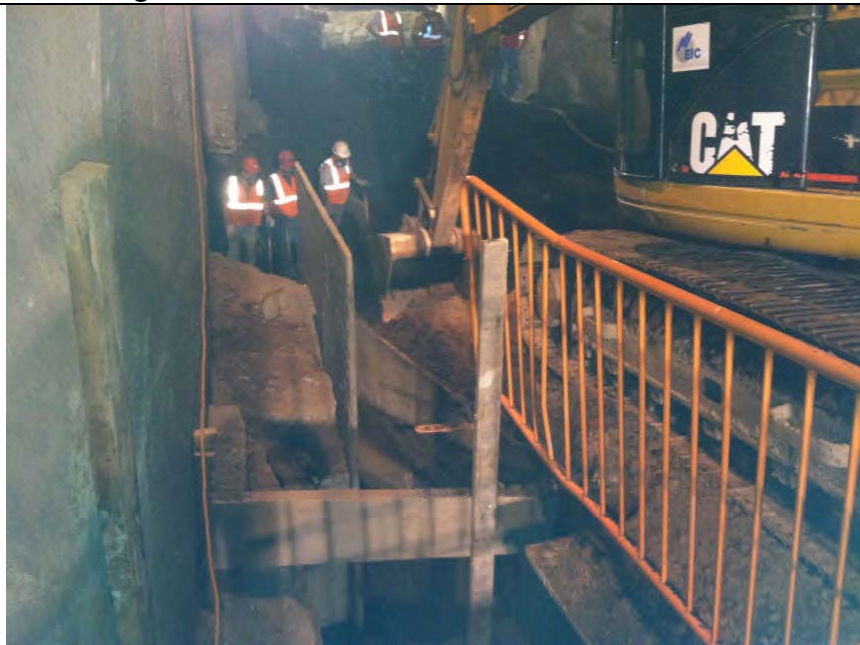
2. Excavation of the remaining sections of Phase #2

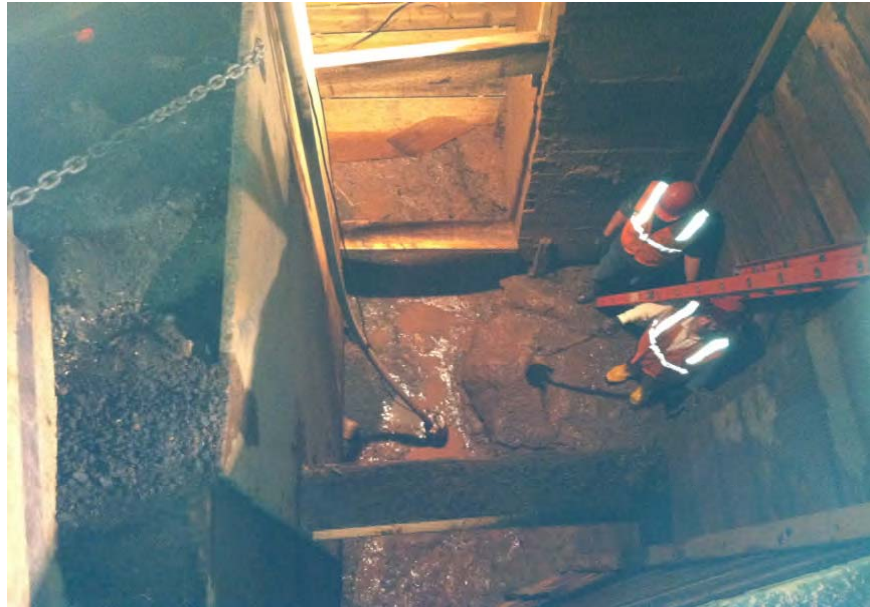
1. Phase II area excavated and cleaned to bedrock.

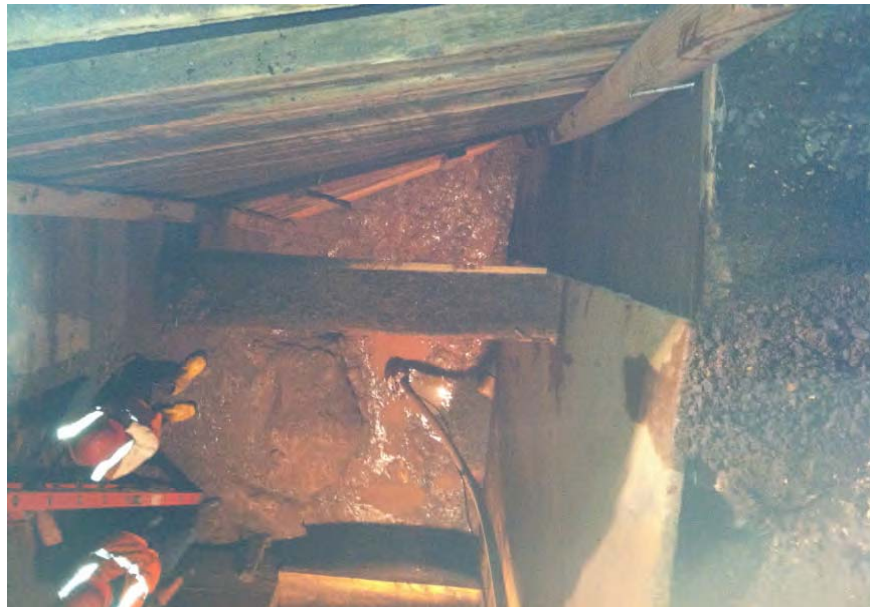
2. Phase II area excavated and cleaned to bedrock.

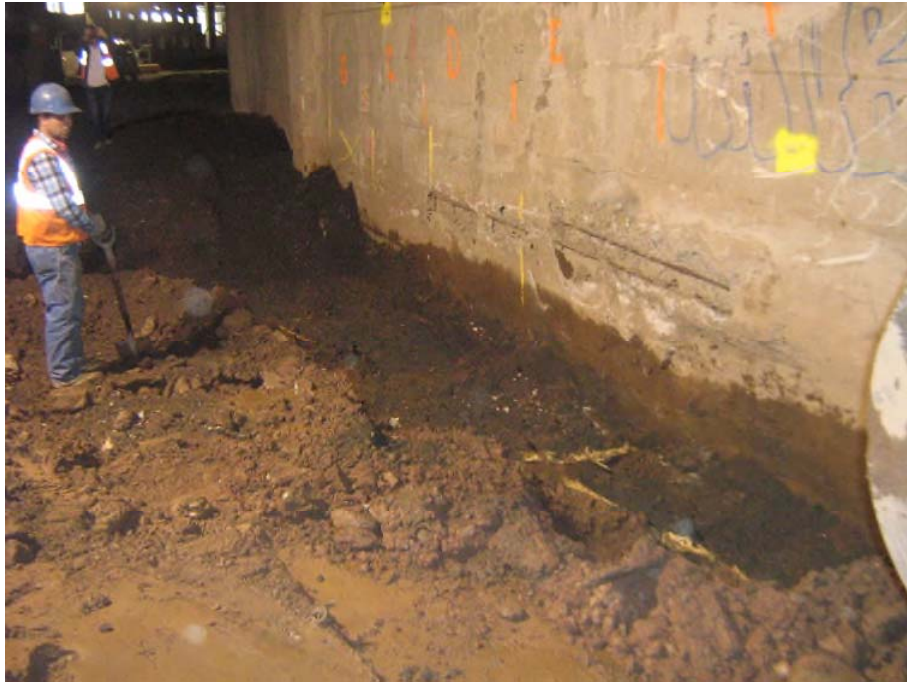
1. Excavation to clean backfill in Phase III and removal of plastic sheeting liner protecting backfill.

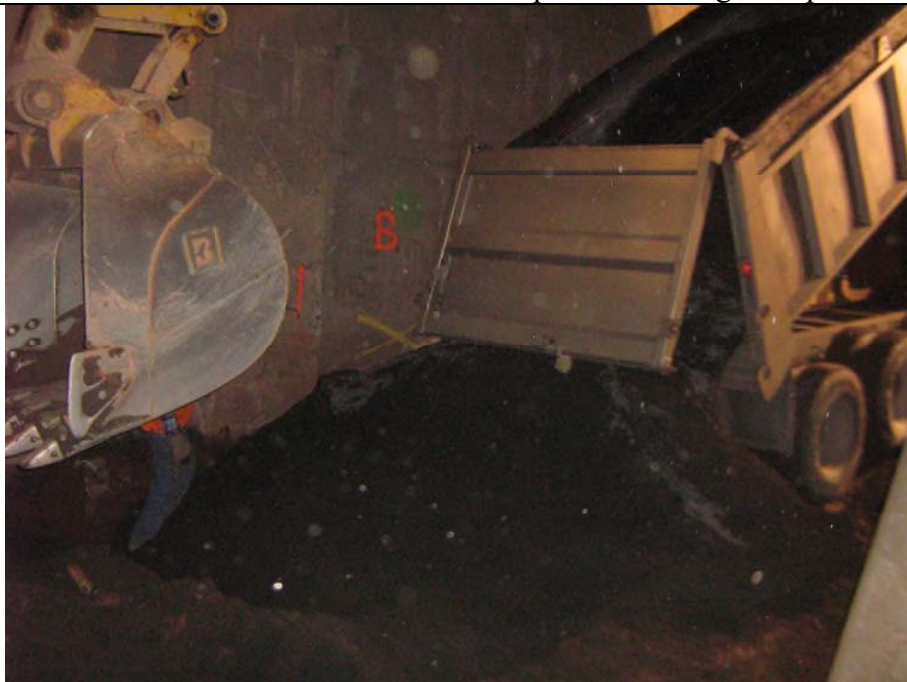
2. Backfilling Phase III area to grade.

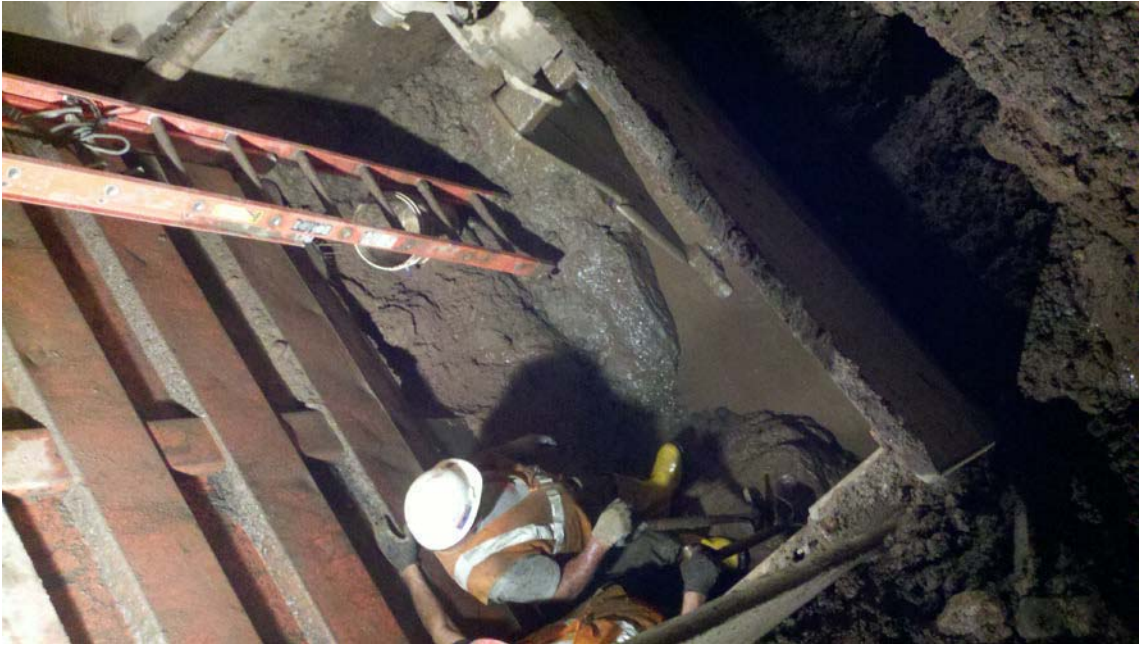
1. Pier # 2 Excavation

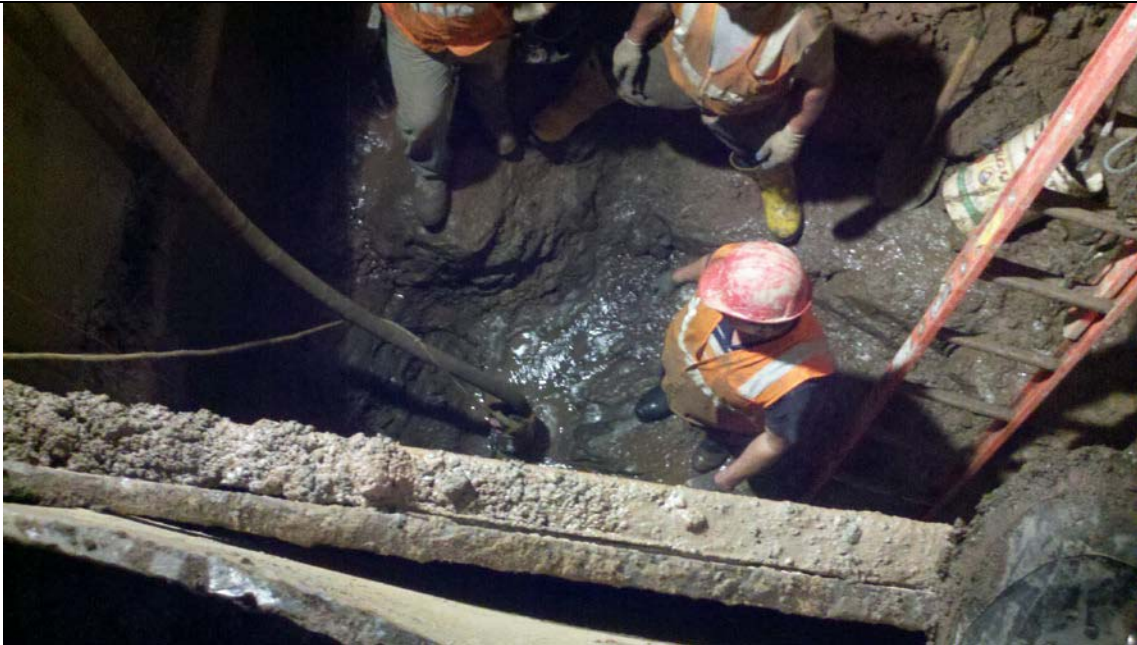
2. Pier #2 Exposed bedrock

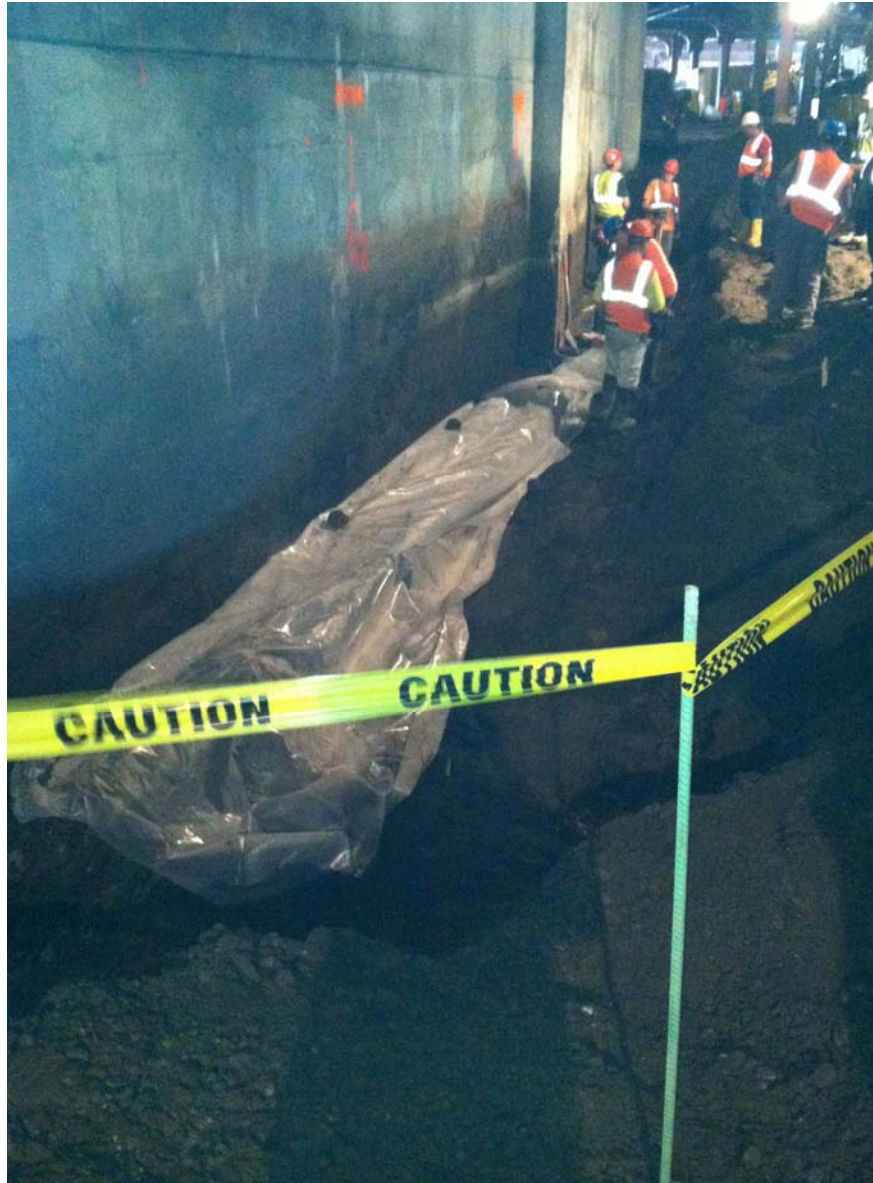
Excavation to reveal the extent of the pipe.

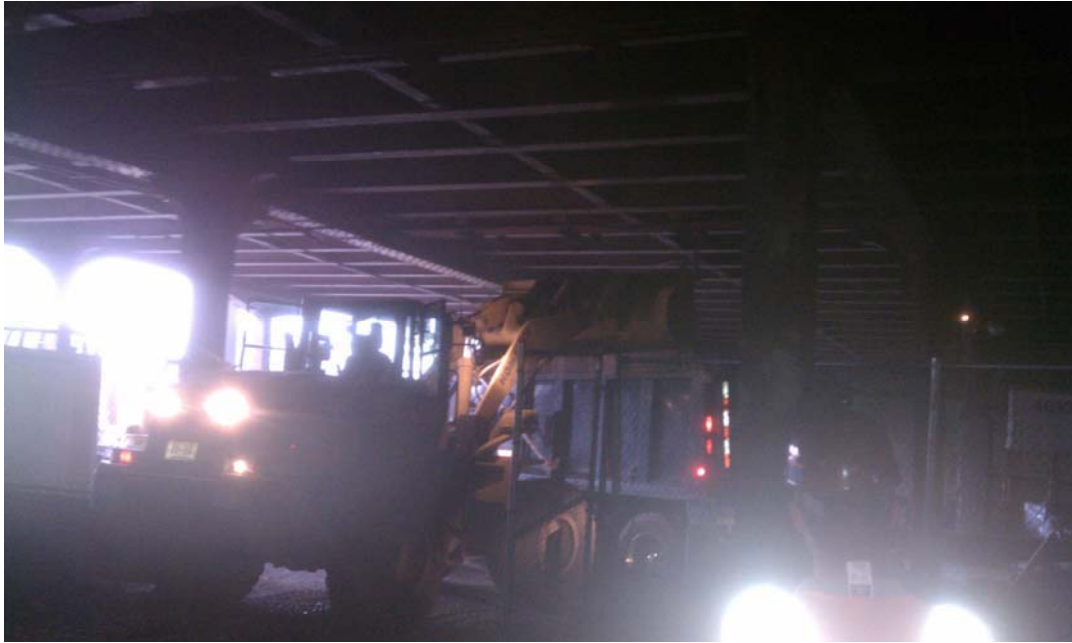
1. 16 truckloads of soil were exported to Lincoln Park West Landfill Facility in New Jersey

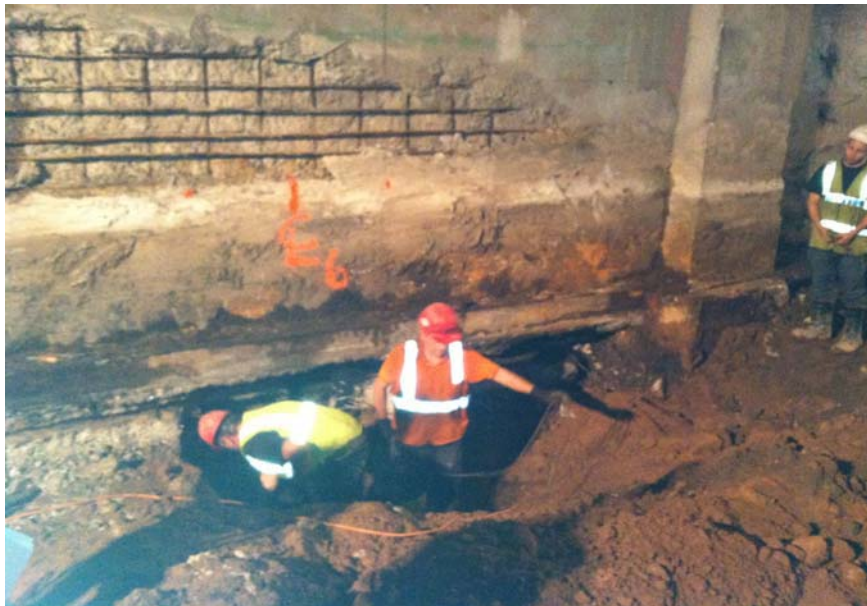
2. The excavation continued by hand-digging.

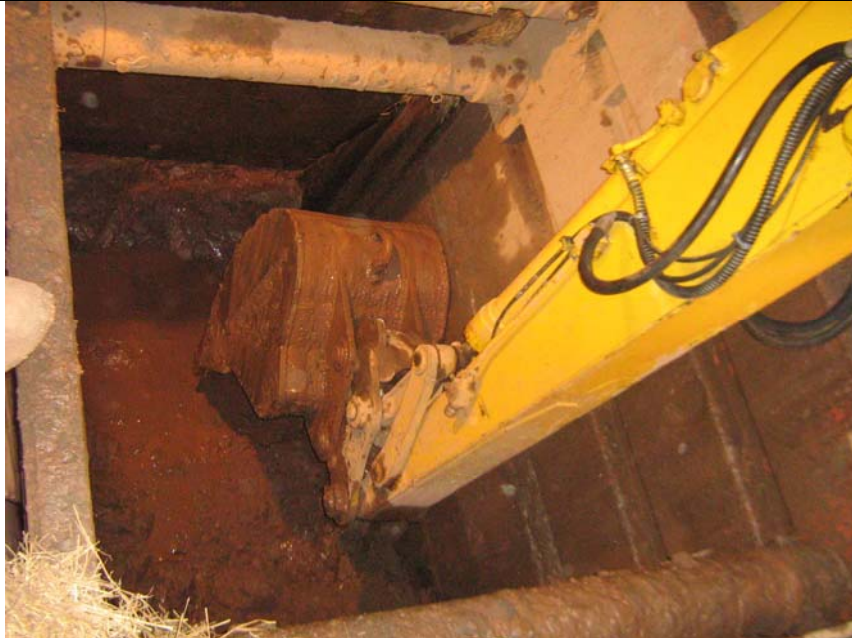
2. Pier #2 Continued excavation of Pier #11 (eventually halted to re-shore excavation and dewater)

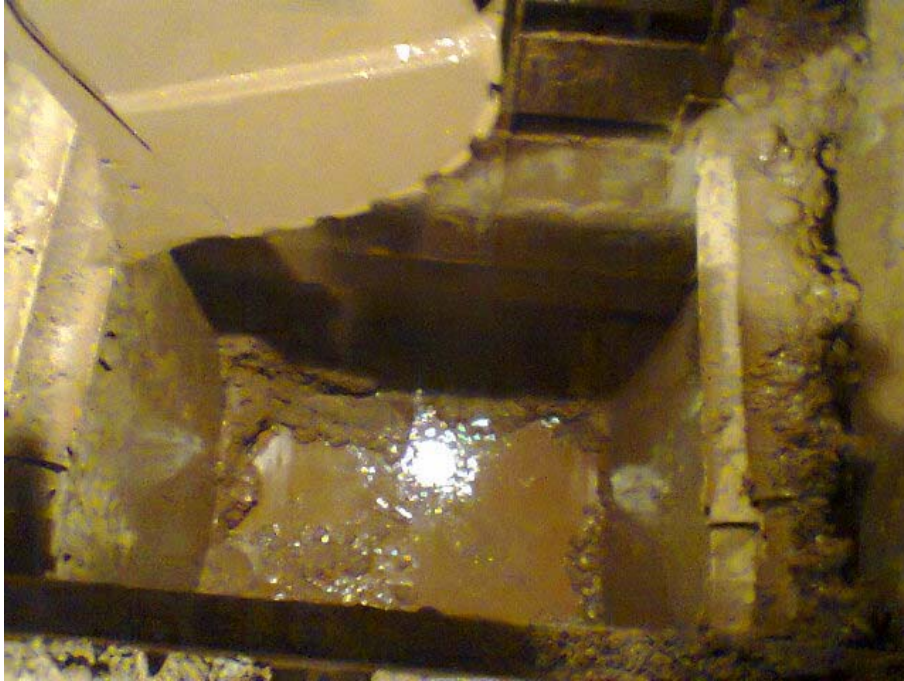
1. Pier # 12 Exposed bedrock.

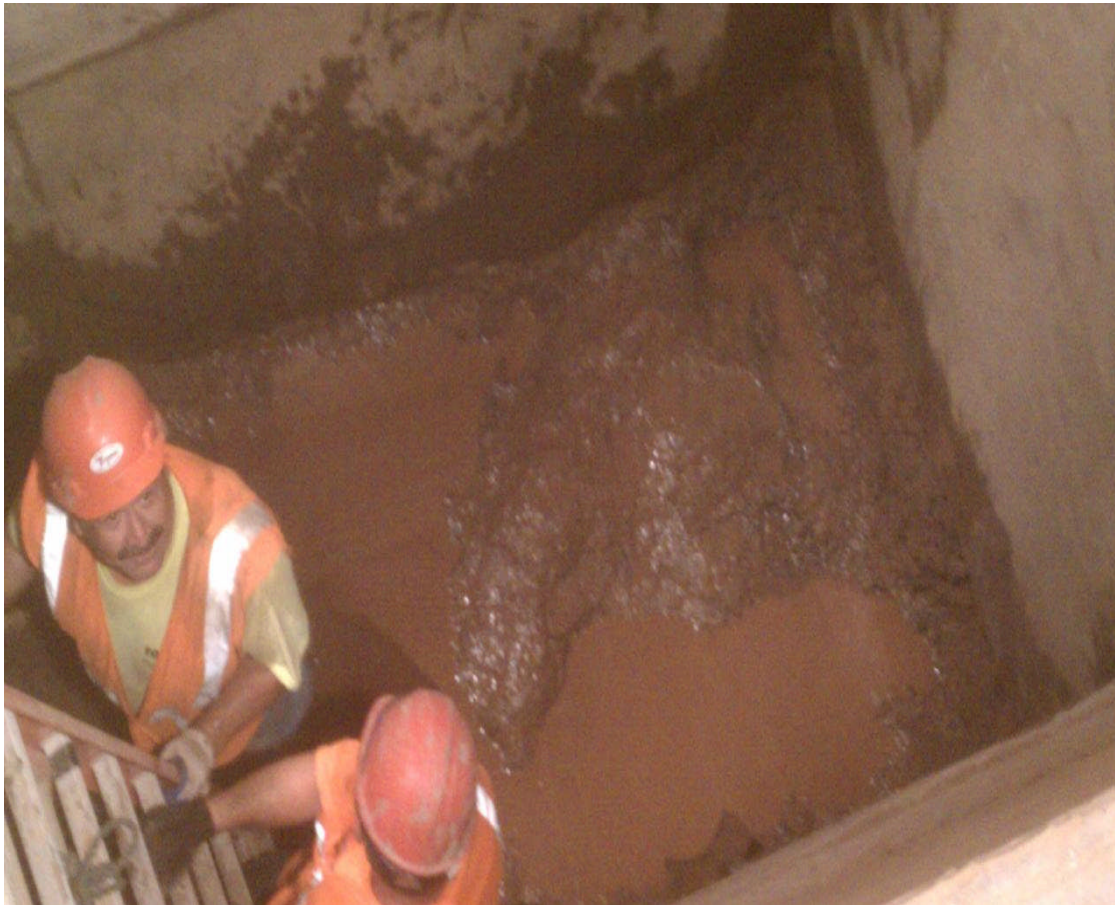
1. Pier # 15 excavated to bedrock depth.

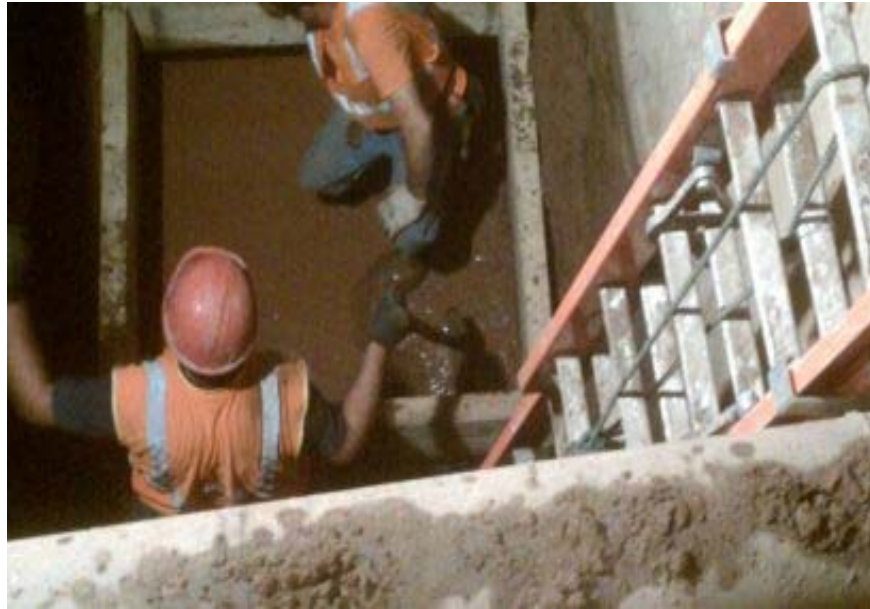
1. Pier #14 excavated to bedrock

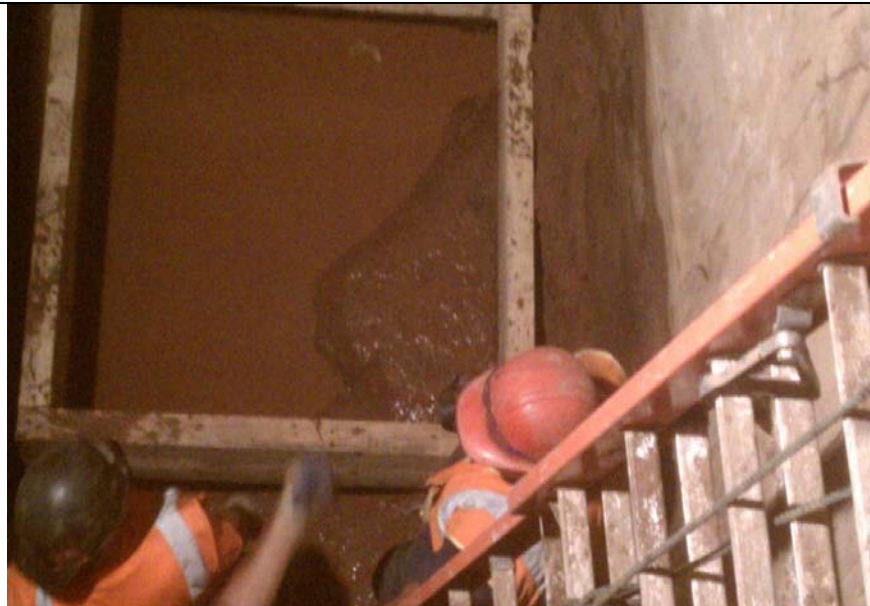
2. Pier #14 excavated to bedrock

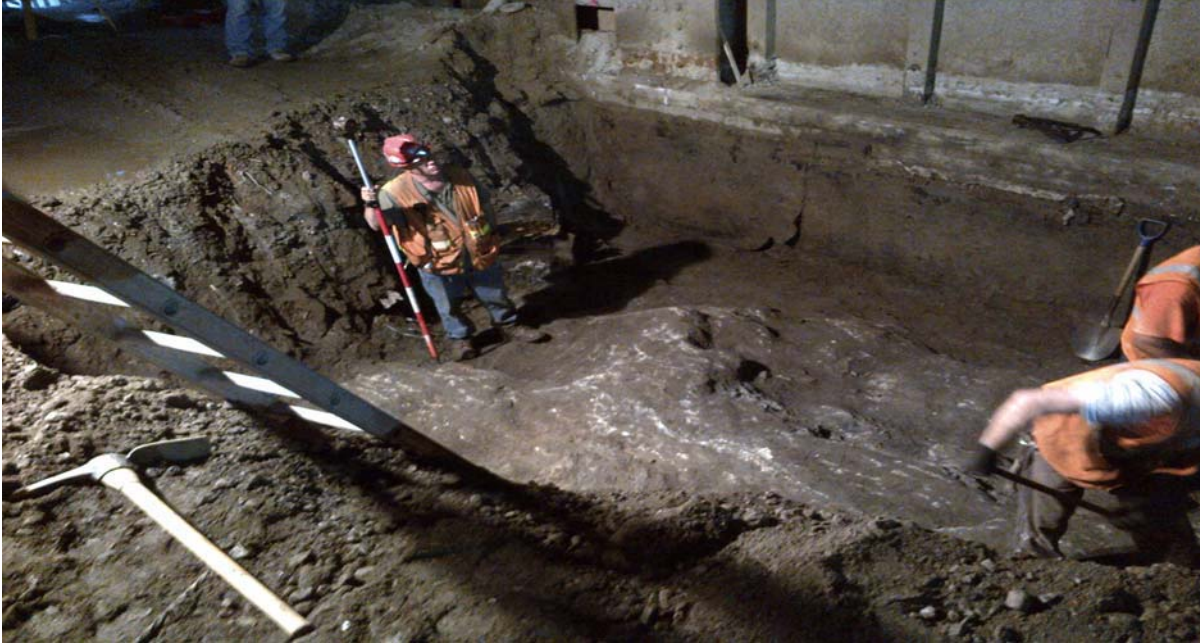
1. Phase 4 Excavation at Bedrock.

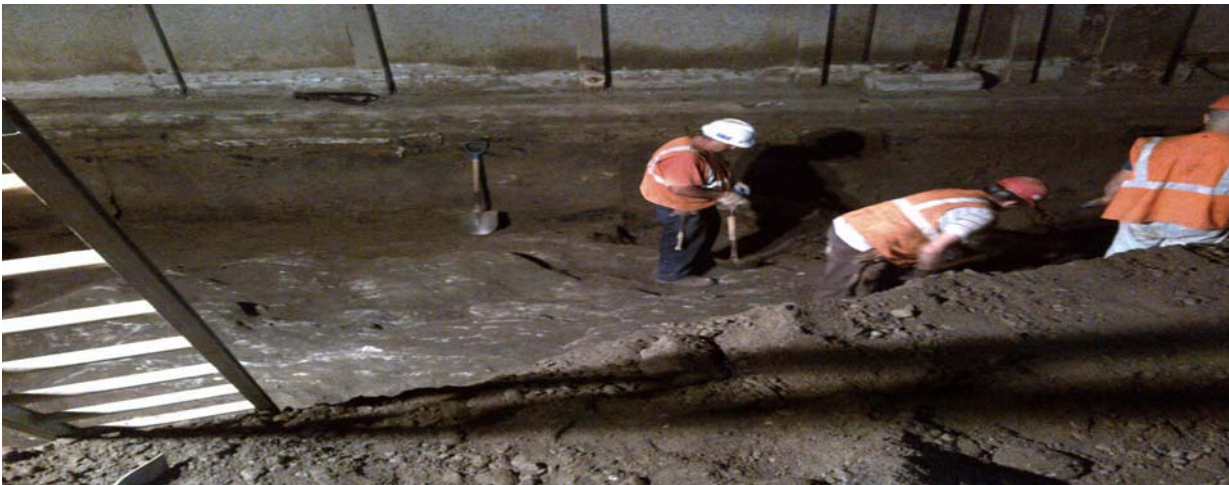
2. Phase 4 Excavation at Bedrock.

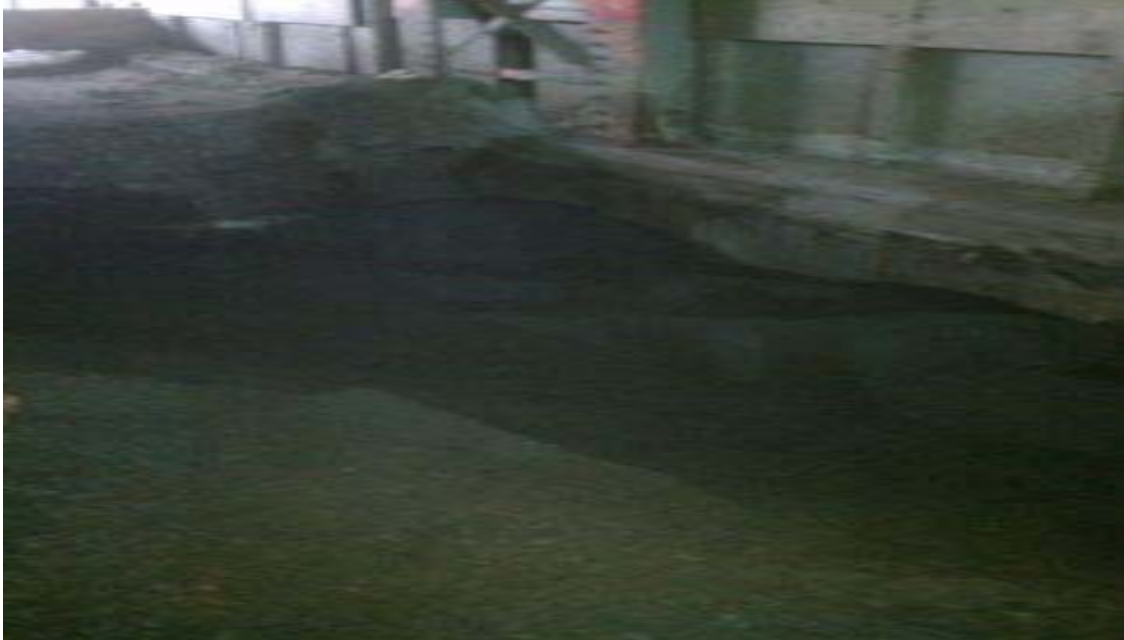
1. Phase 4 backfilled with approved fill material.

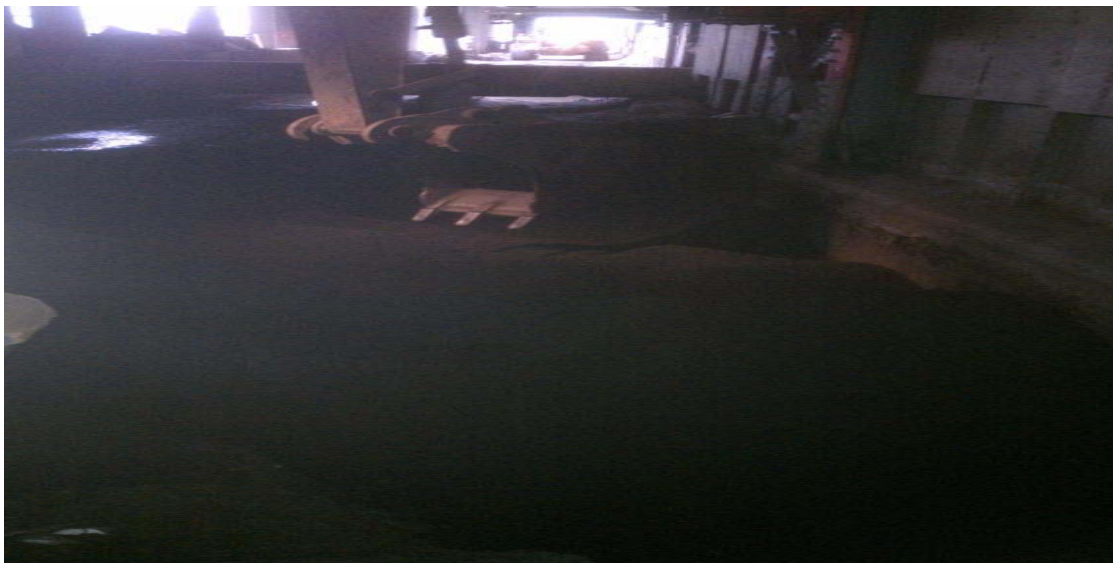
2. Phase 4 backfilled with approved fill material.

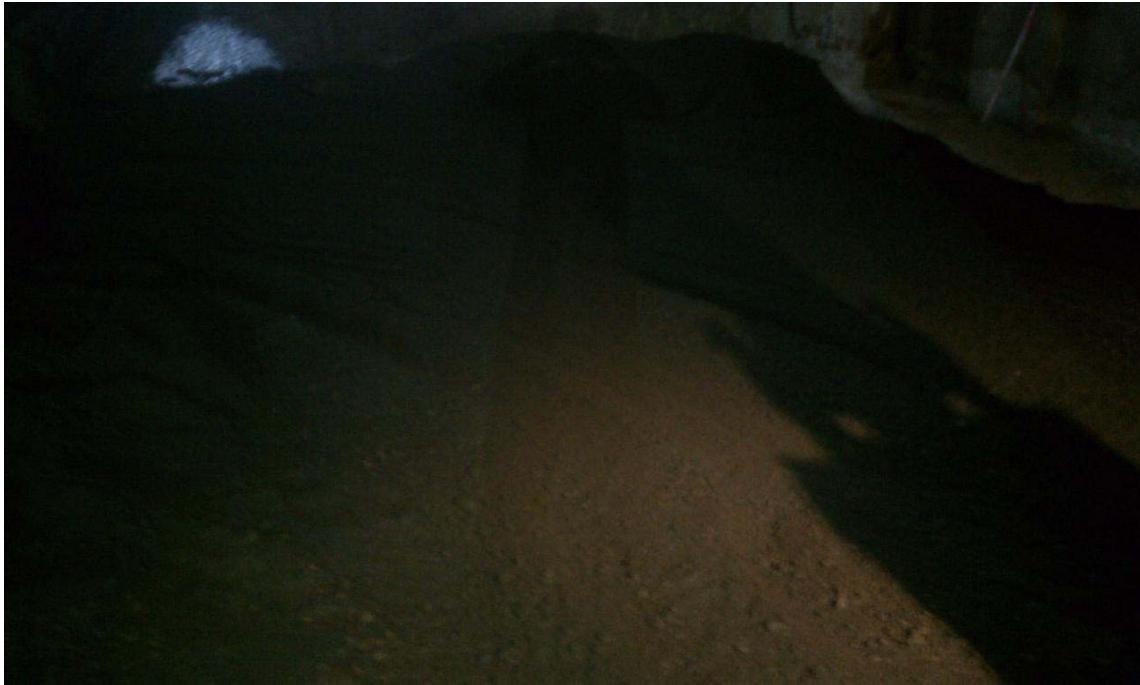
1. Phase 4 final load of backfill.

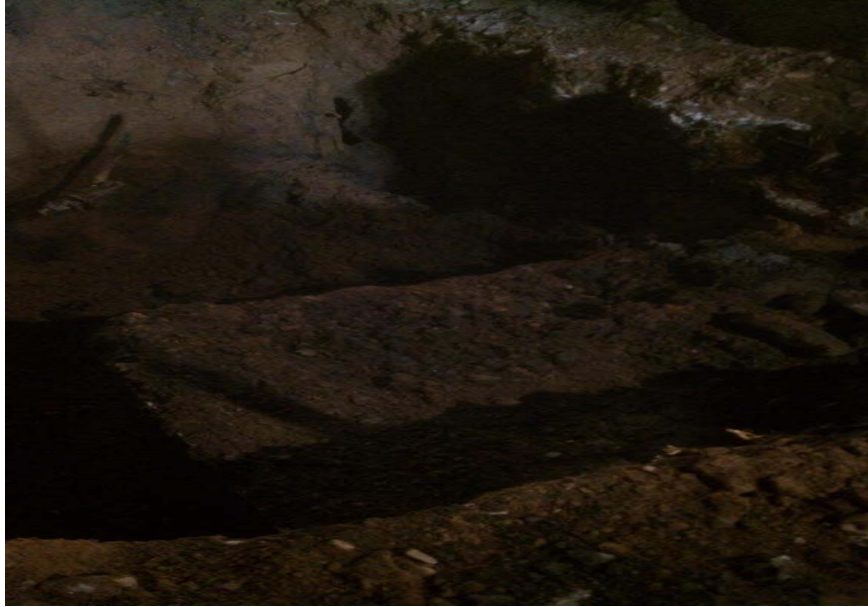
1. Existing pier located adjacent to Pier #13 exposed.

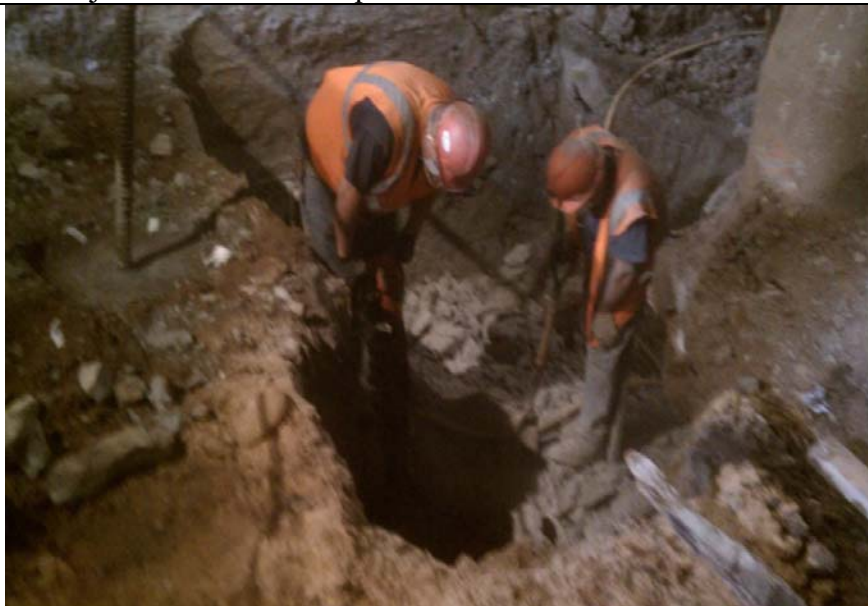
2. Hand excavation being conducted in area adjacent to Pier #13 in preparation of tie-backing.

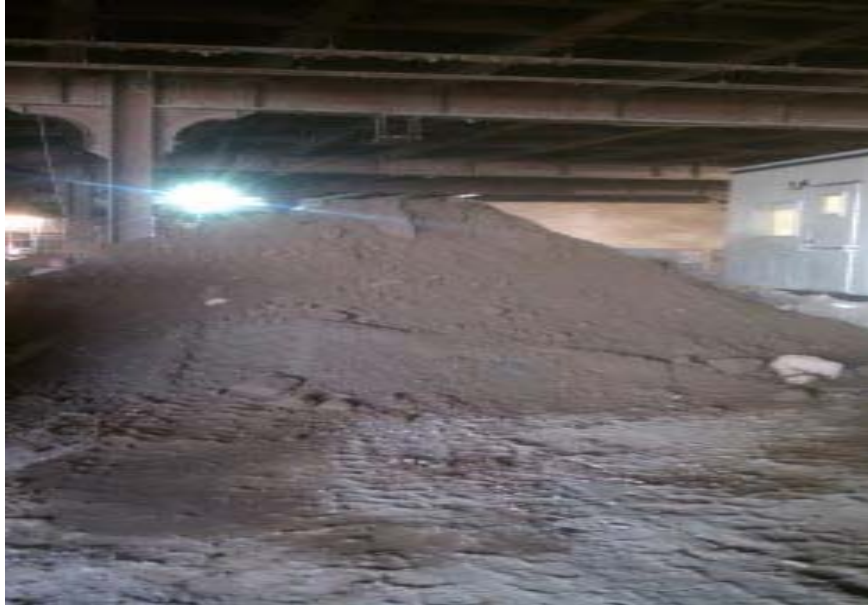
1. Stockpile was slightly odorous material which was rejected at Lincoln Park Landfill and returned to the Site.

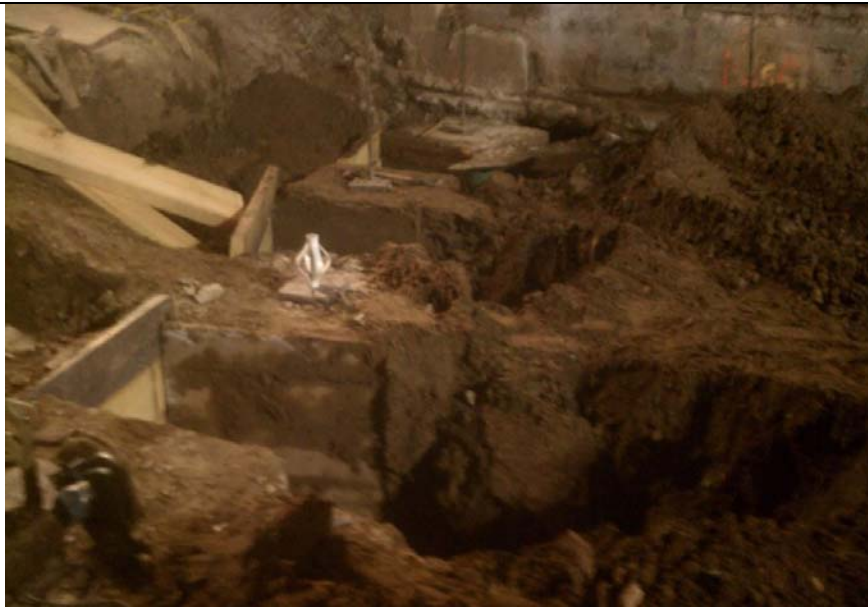
2. Excavation taking place along north side of Phase I.

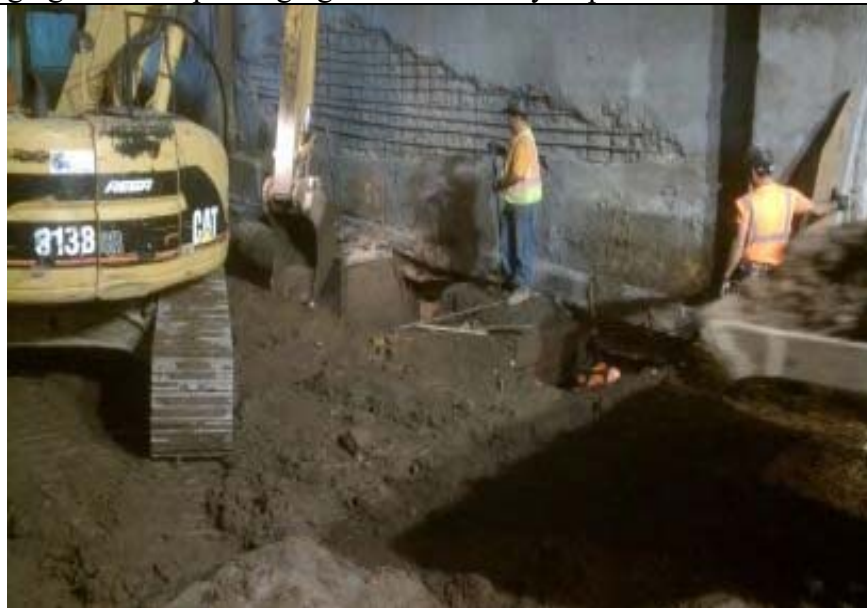
2. Phase I excavation and sheeting activities taking place along east wall and northeast corner.

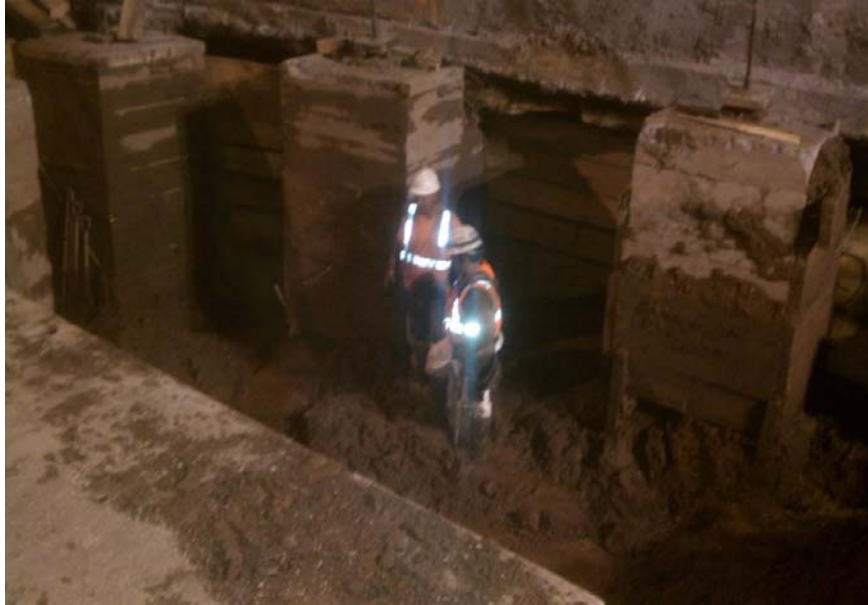
1. Excavation conducted at Phase I.

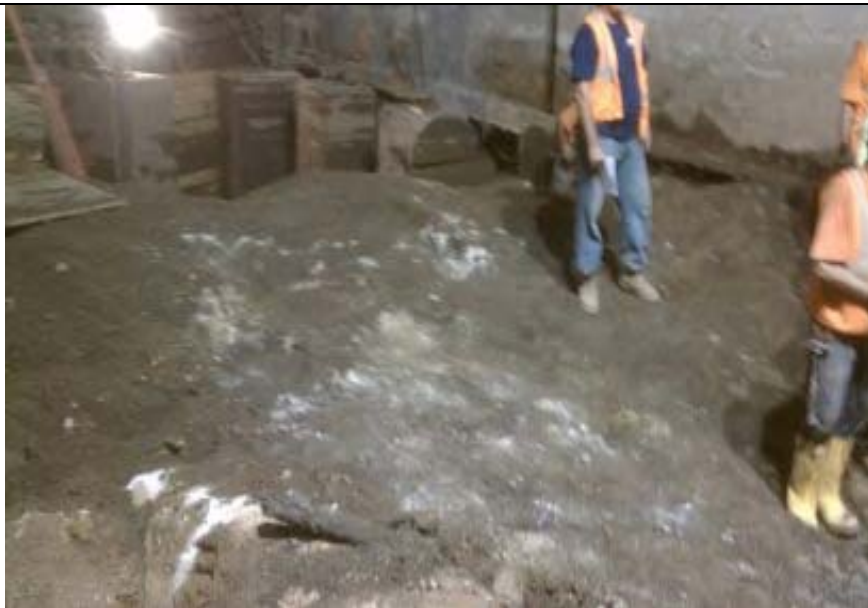
2. South section of Phase I, pictured excavated to bedrock.

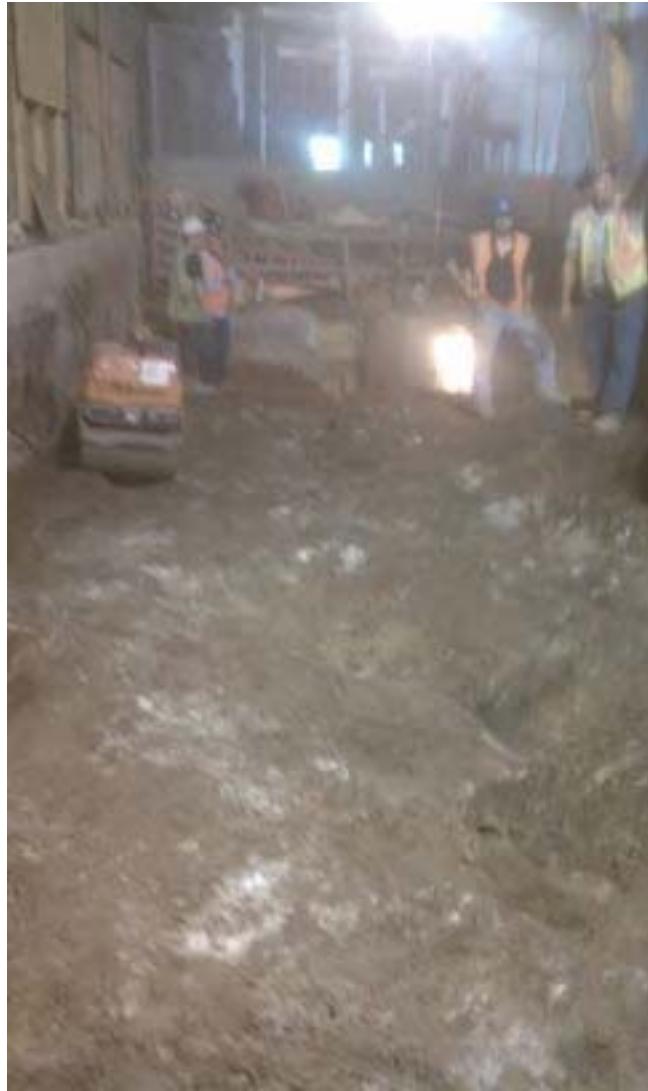
1. West side of Phase I, excavated to bedrock.

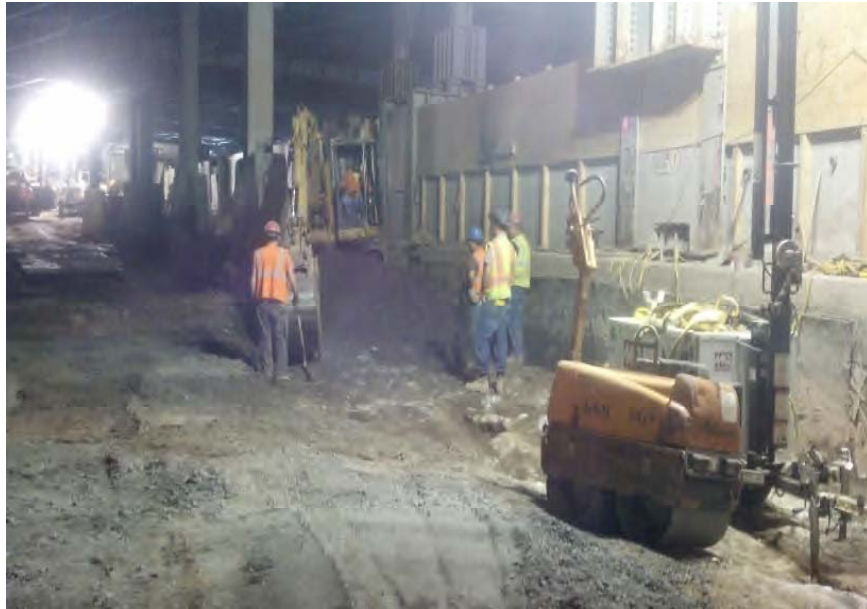
1. Excavation activities taking place in the last uncertified portion of Phase I.

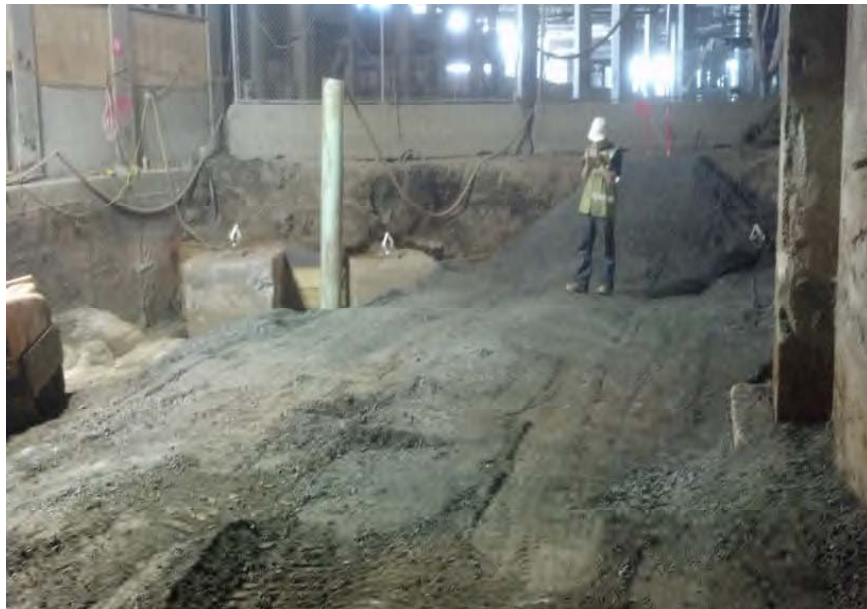
2. Backfilled and certified clean section of Phase I.

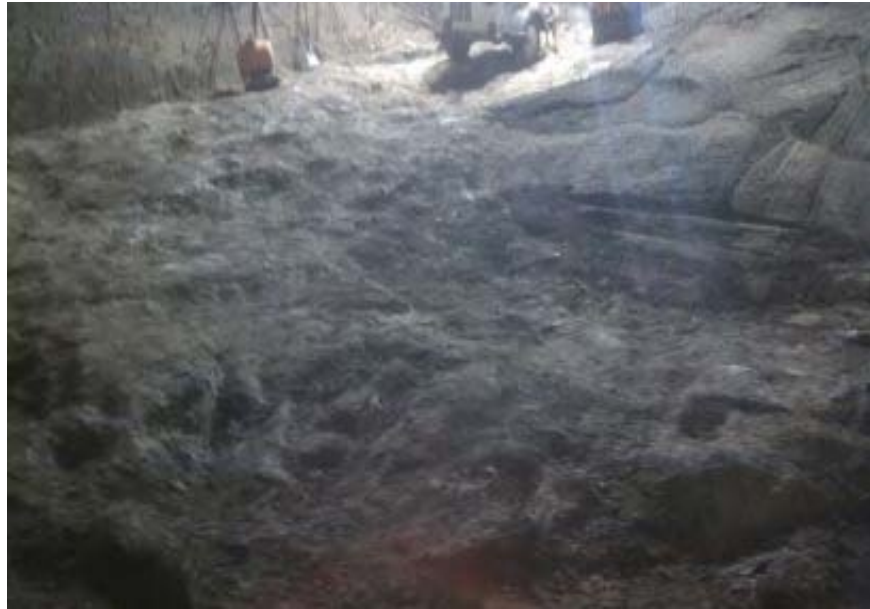
1. Inspected and certified portion of Phase I – excavated to bedrock.

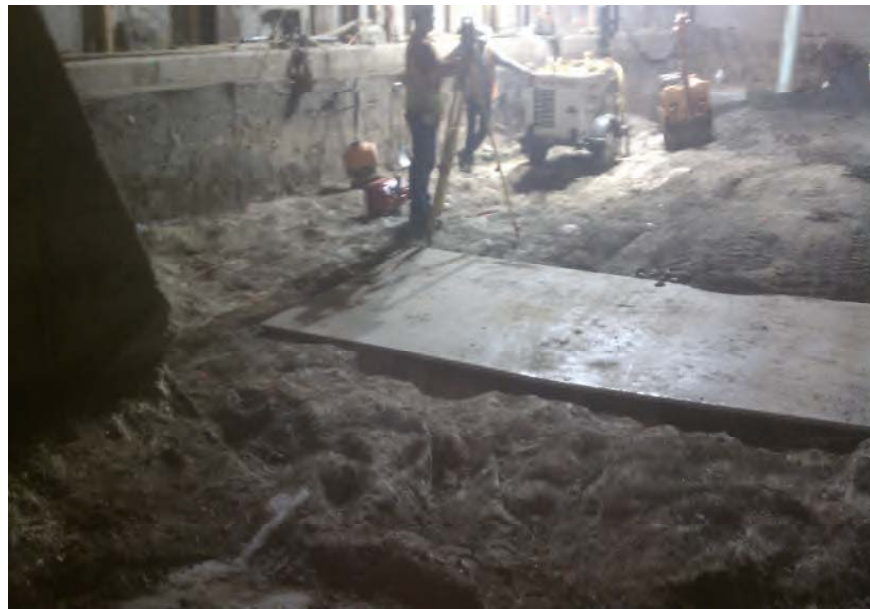
2. Inspected and certified portion of Phase I – excavated to bedrock.
