Appendix H

Photograph Log

**West 34th Street
New York, New York
BCP Site #C231049**

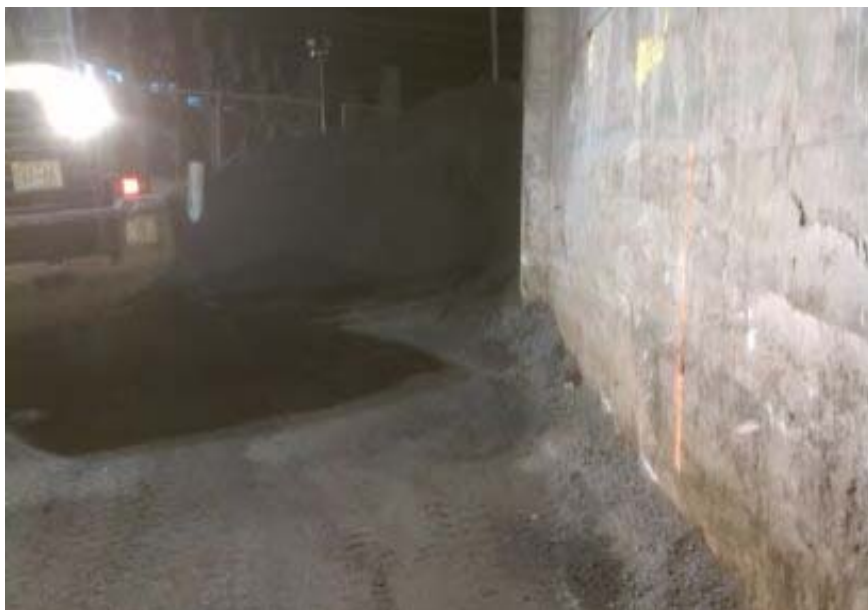
1. Backfilling and compacting activities being conducted at Phase I.

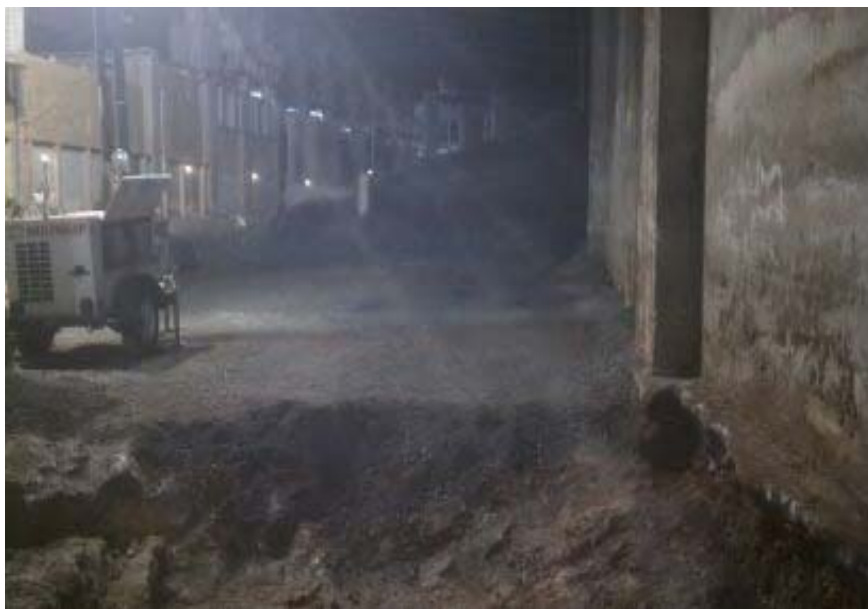
2. Phase I backfilled, viewed to the north.

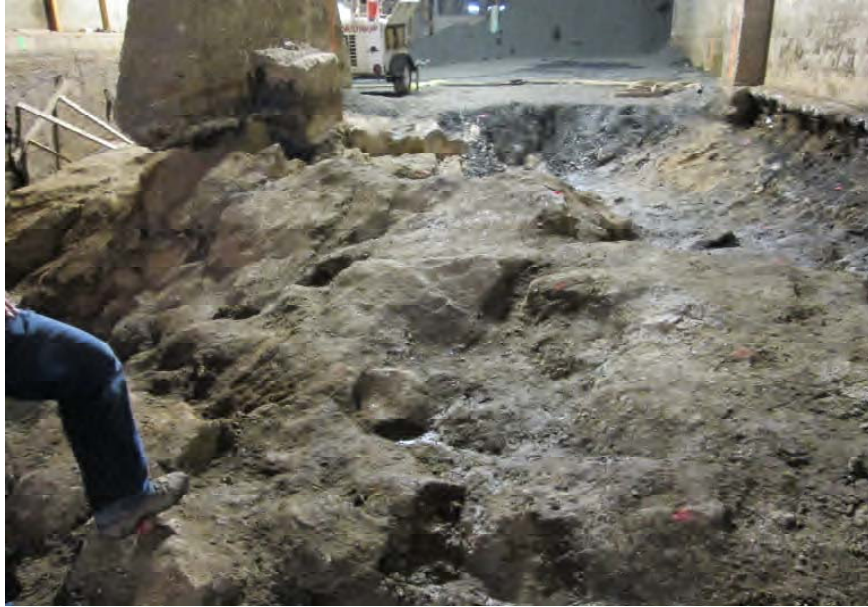
1. North side of Phase II, excavated to bedrock. Inspected and certified by FLS.

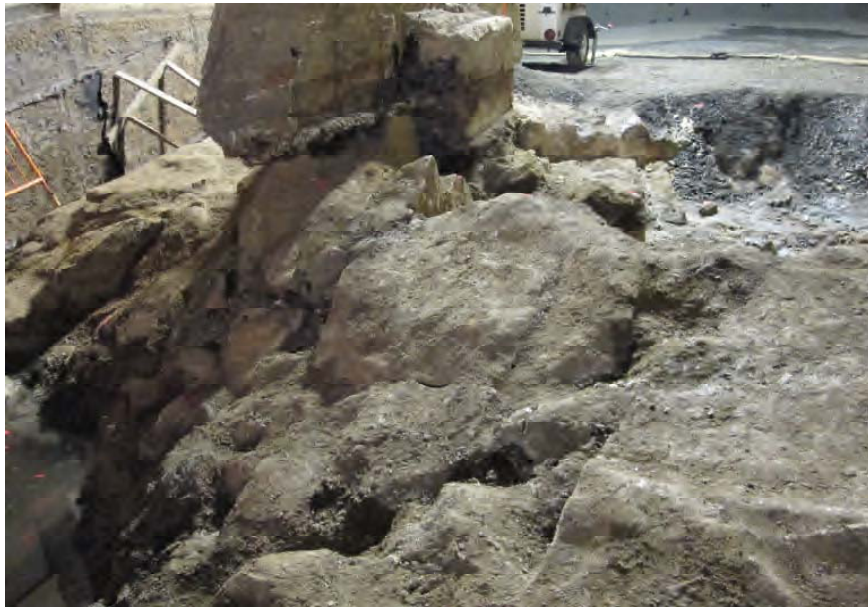
2. North side of Phase II, excavated to bedrock. Inspected and certified by FLS.

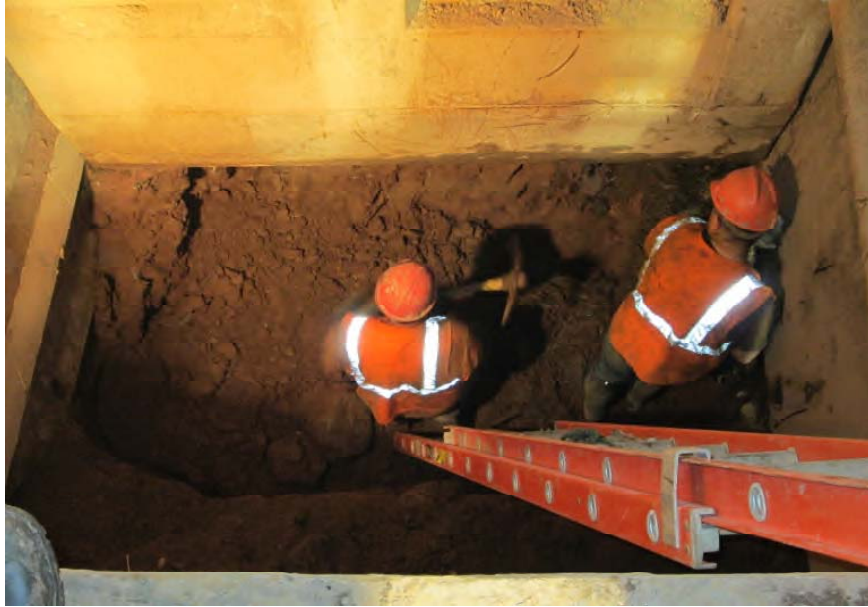
1. Hand clearing activities at Area “F” of Phase III excavation.

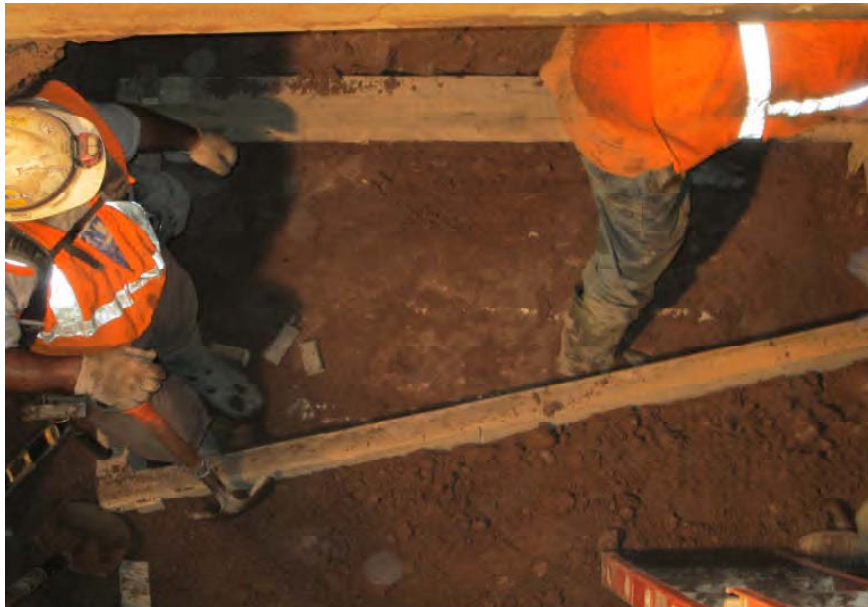
2. Area “F” of Phase III excavated down to bedrock.

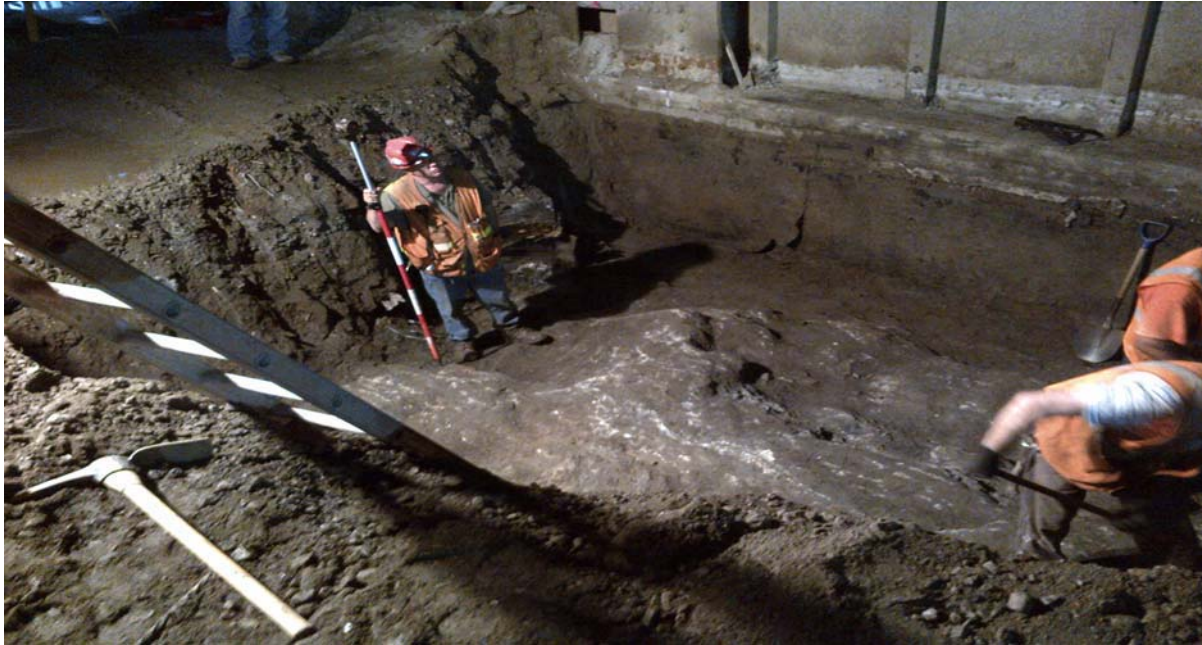
1. Phase 4 Excavation at Bedrock.

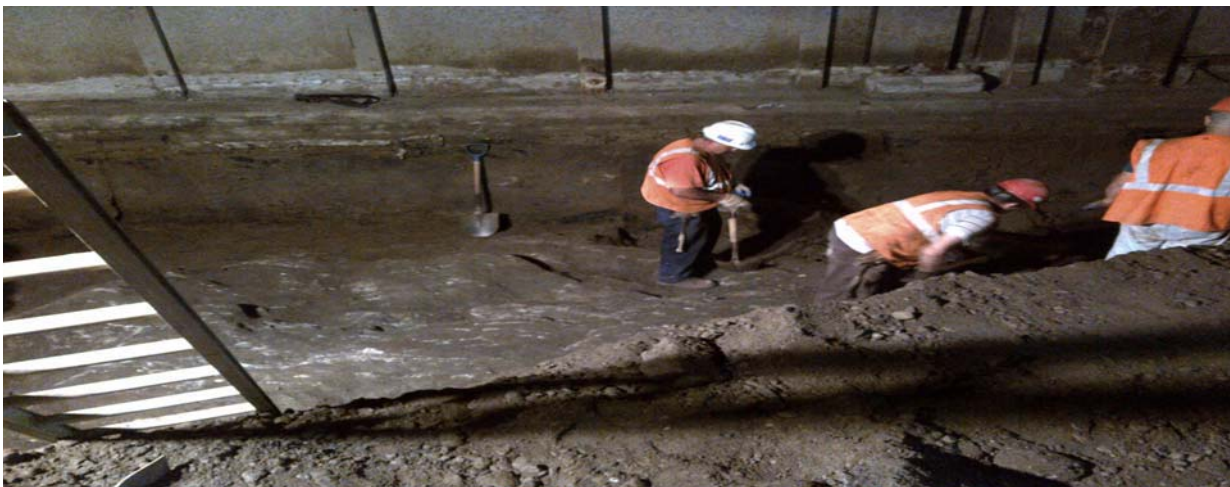
2. Phase 4 Excavation at Bedrock.

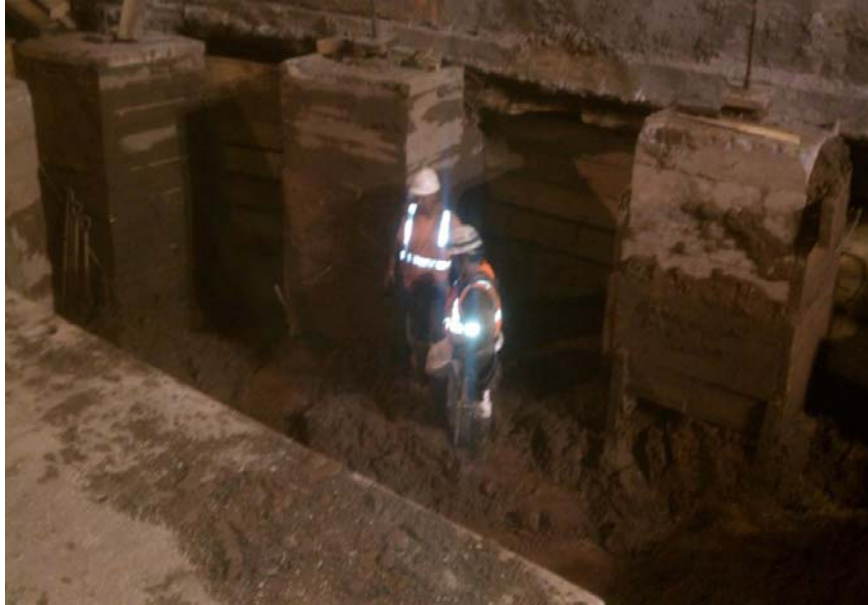
1. Excavation conducted at Phase I.

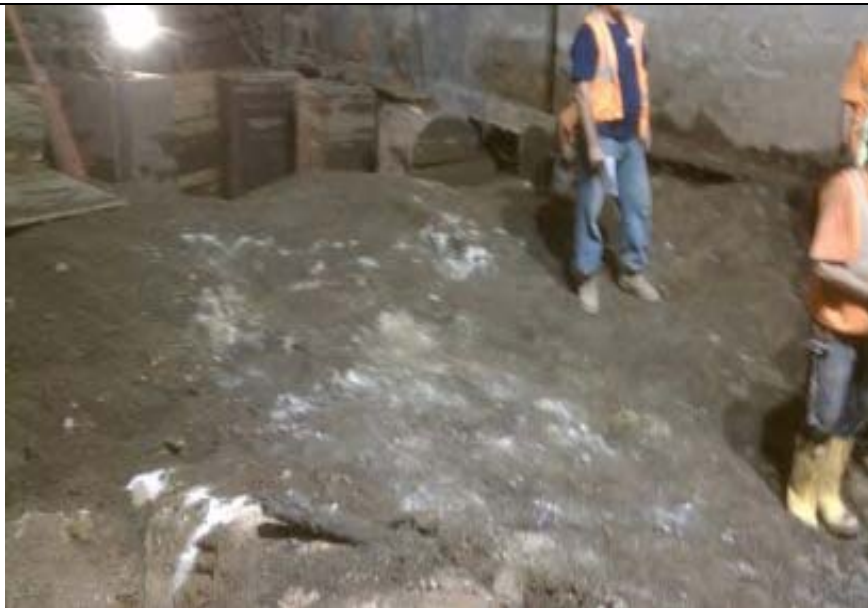
2. South section of Phase I, pictured excavated to bedrock.

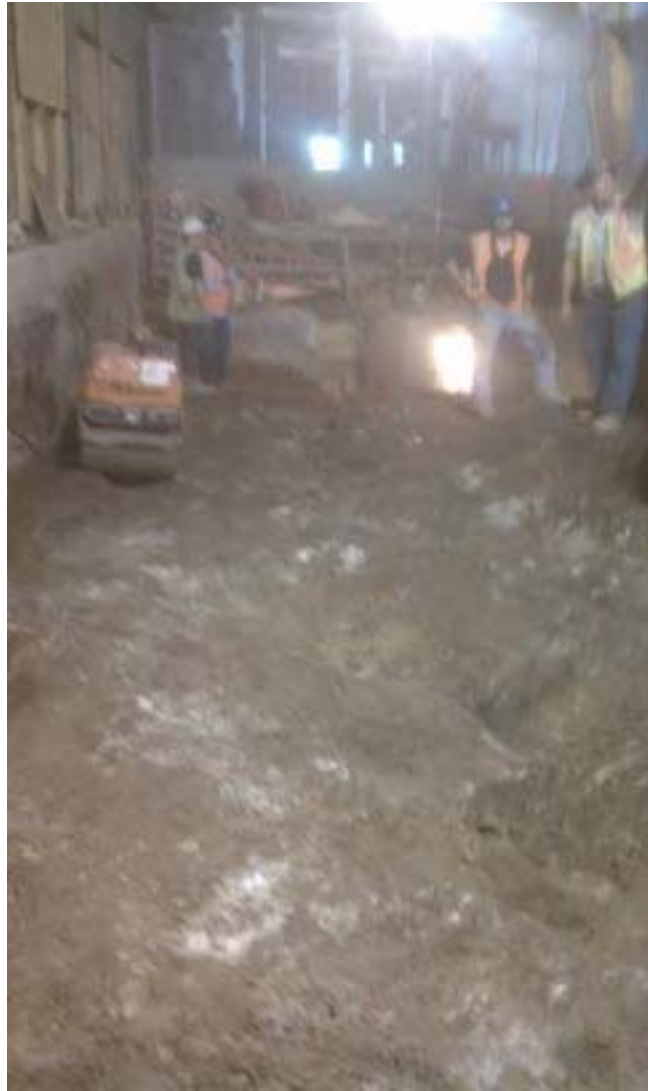
1. West side of Phase I, excavated to bedrock.

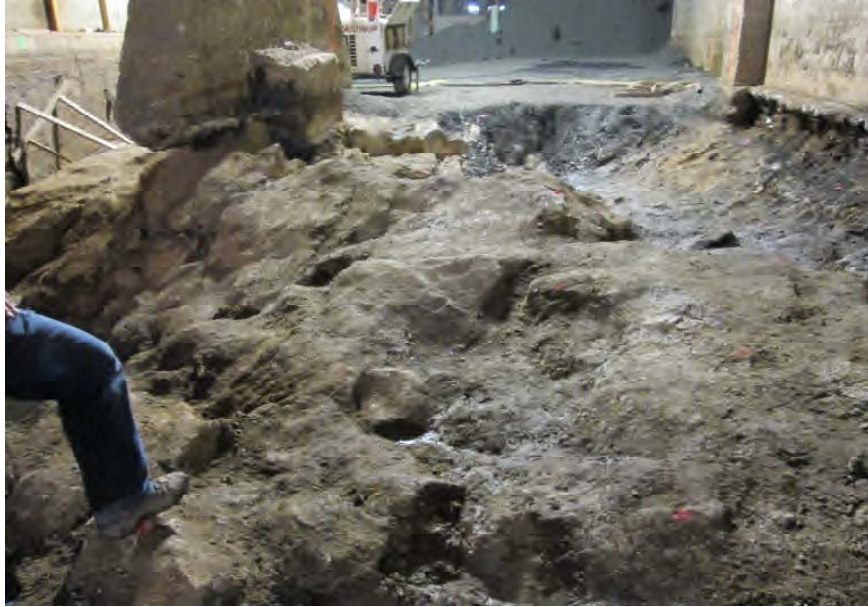
1. North side of Phase II, excavated to bedrock. Inspected and certified by FLS.

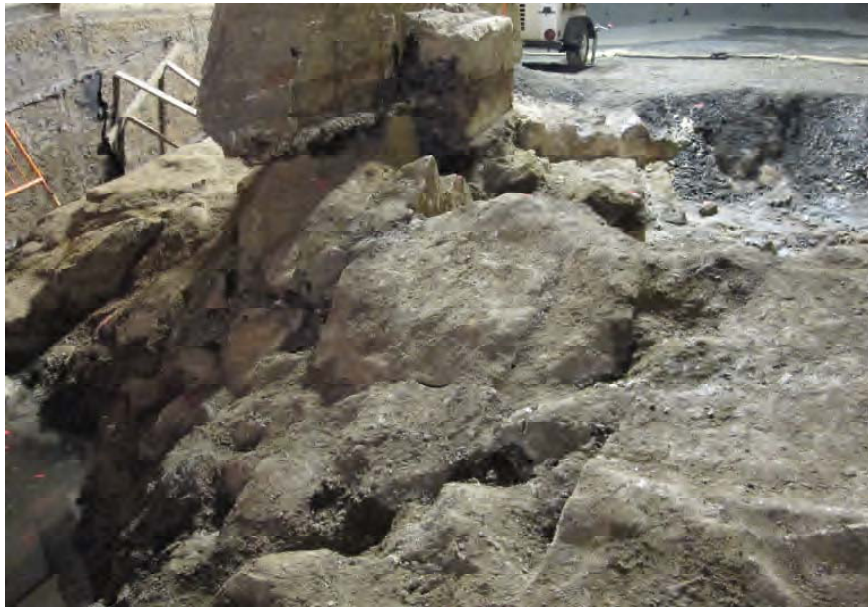
2. North side of Phase II, excavated to bedrock. Inspected and certified by FLS.

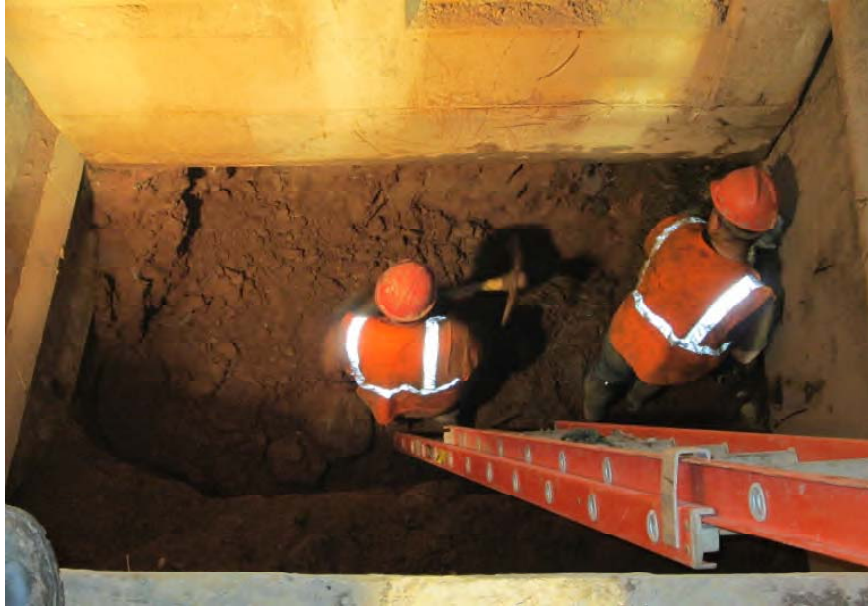
1. Hand clearing activities at Area "F" of Phase III excavation.

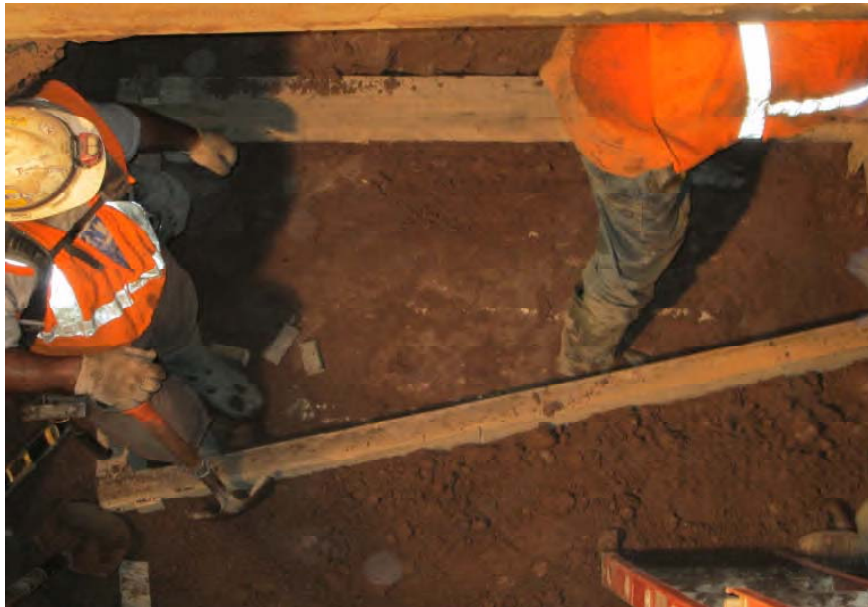
2. Area "F" of Phase III excavated down to bedrock.

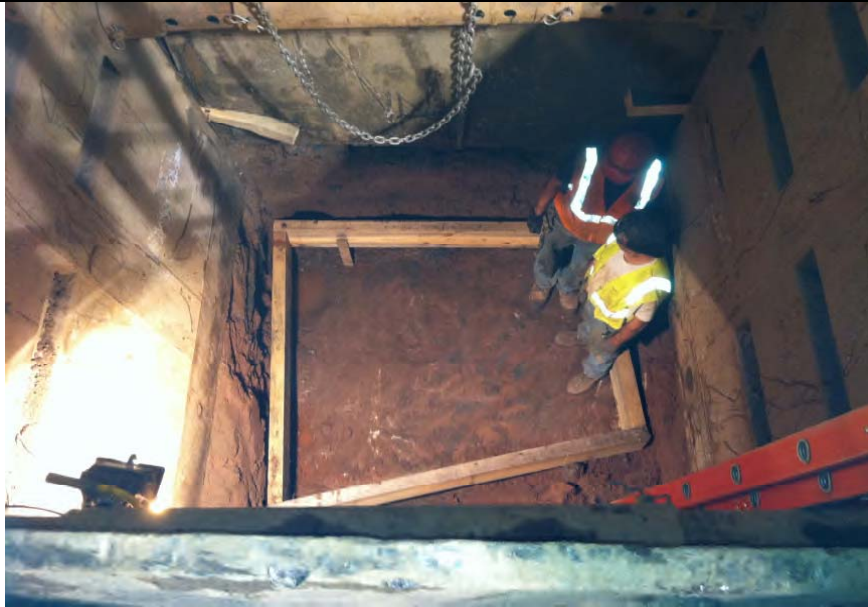
1. Phase III, Area "D" excavated down to bedrock.

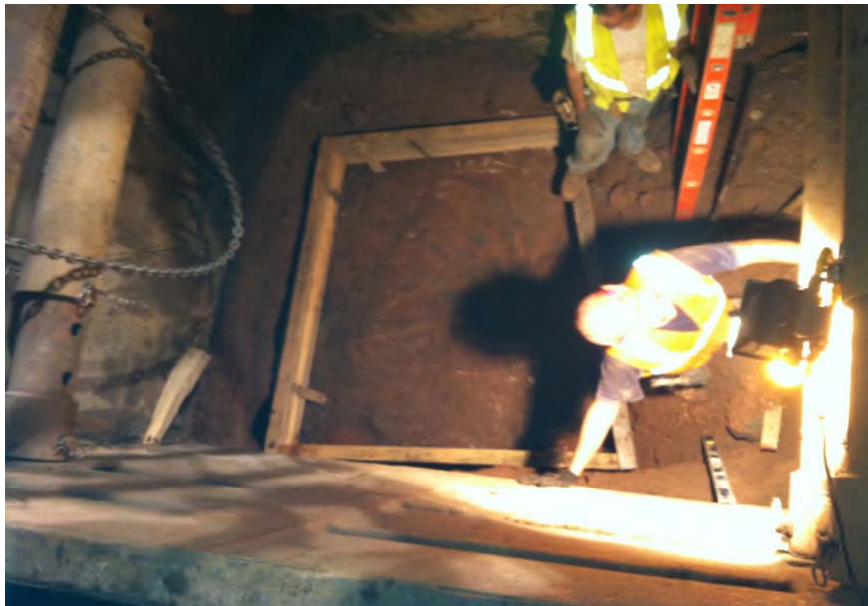
2. Phase III, Area "D" excavated down to bedrock.

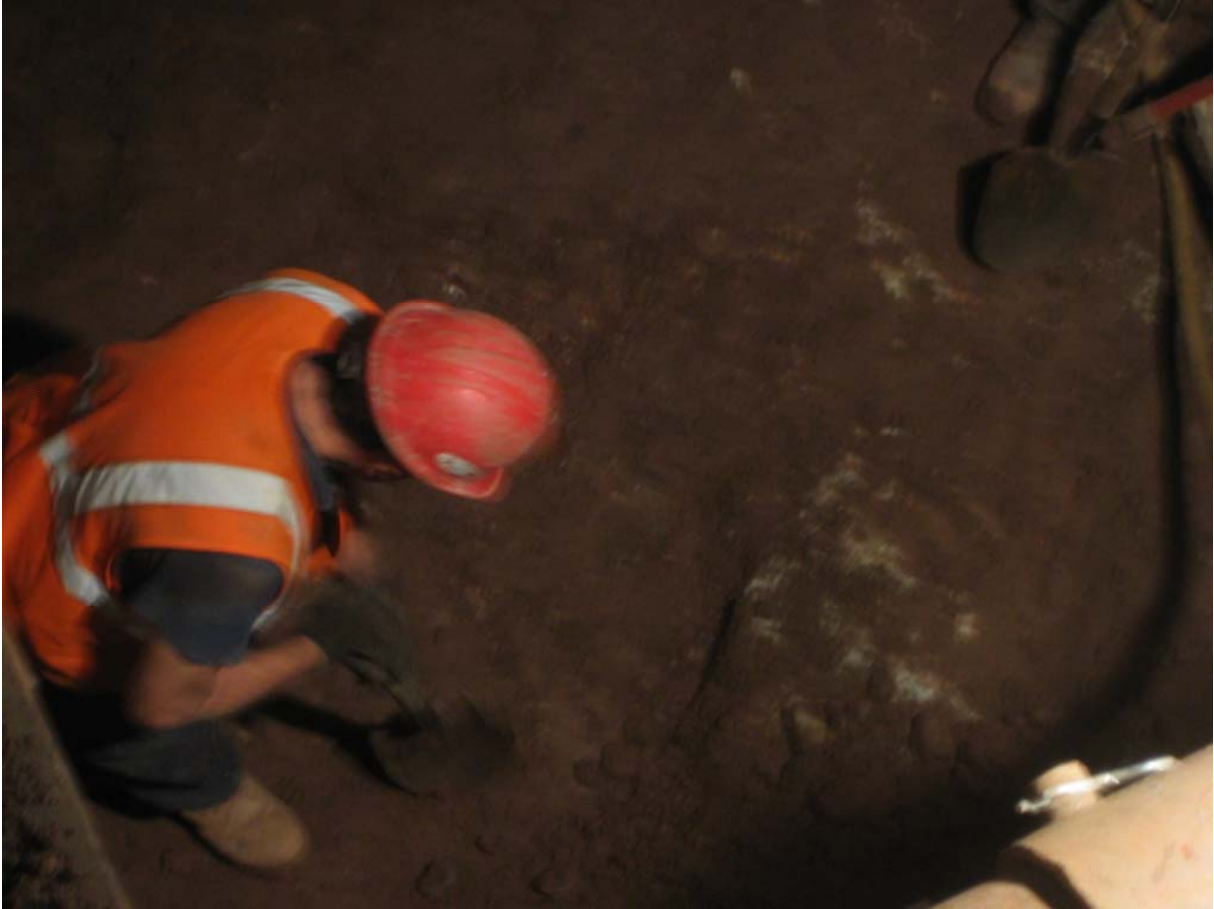
1. Area "B" excavated down to bedrock

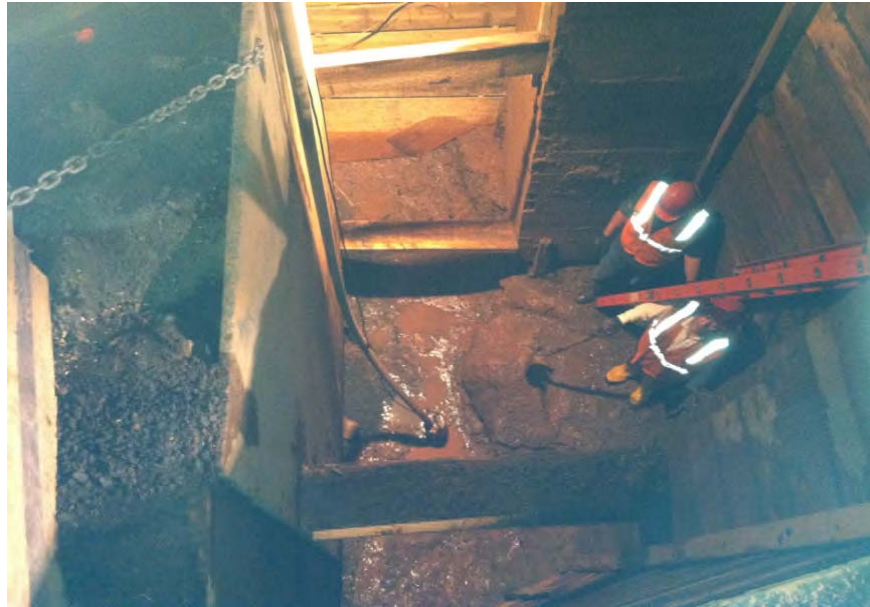
1. Phase II area excavated and cleaned to bedrock.

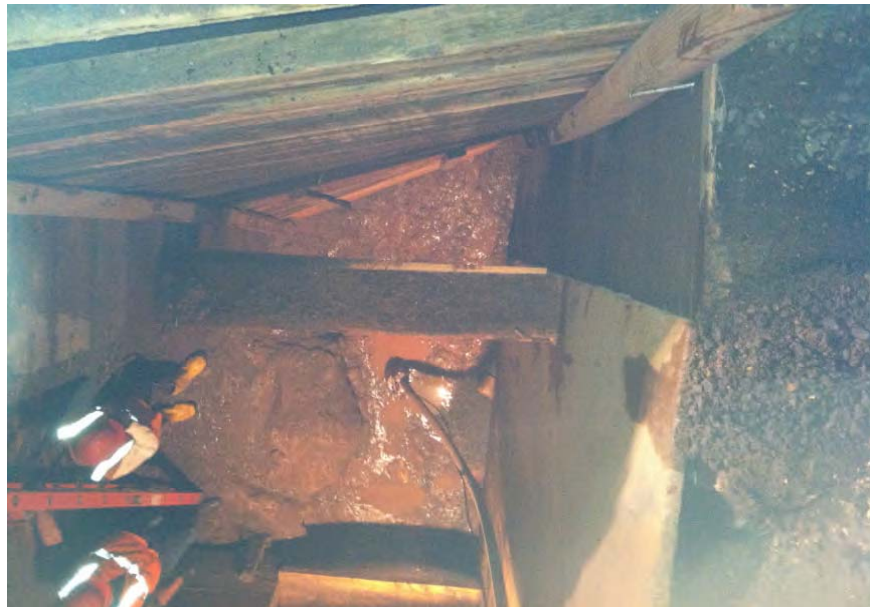
2. Phase II area excavated and cleaned to bedrock.

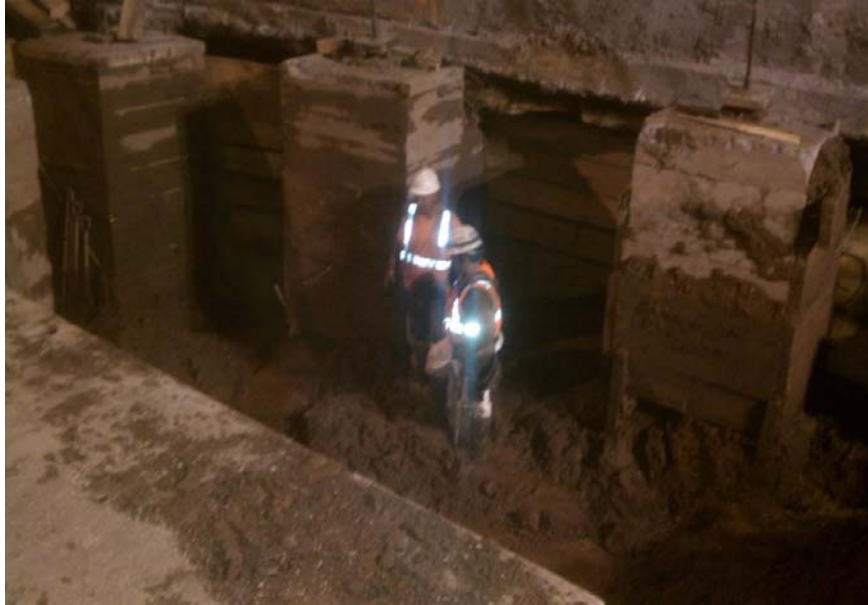
1. Excavation conducted at Phase I.

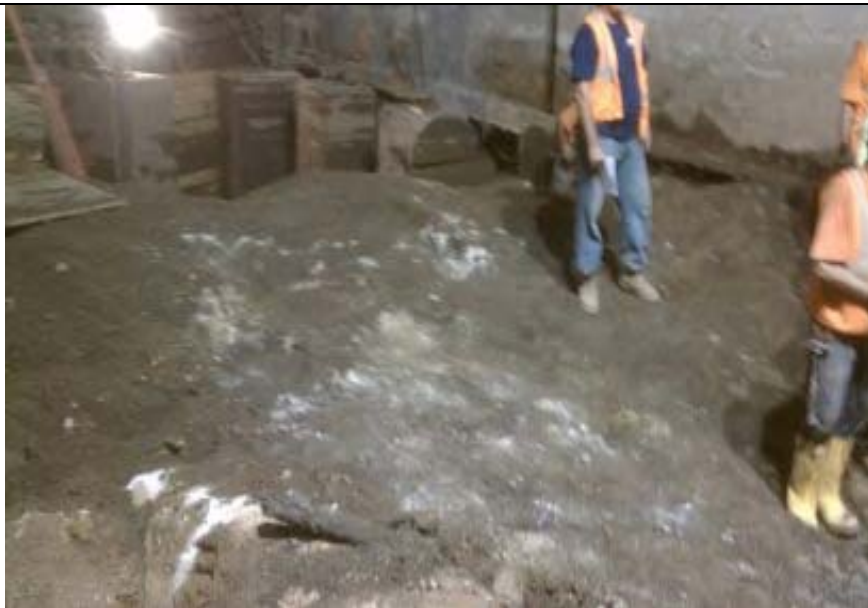
2. South section of Phase I, pictured excavated to bedrock.

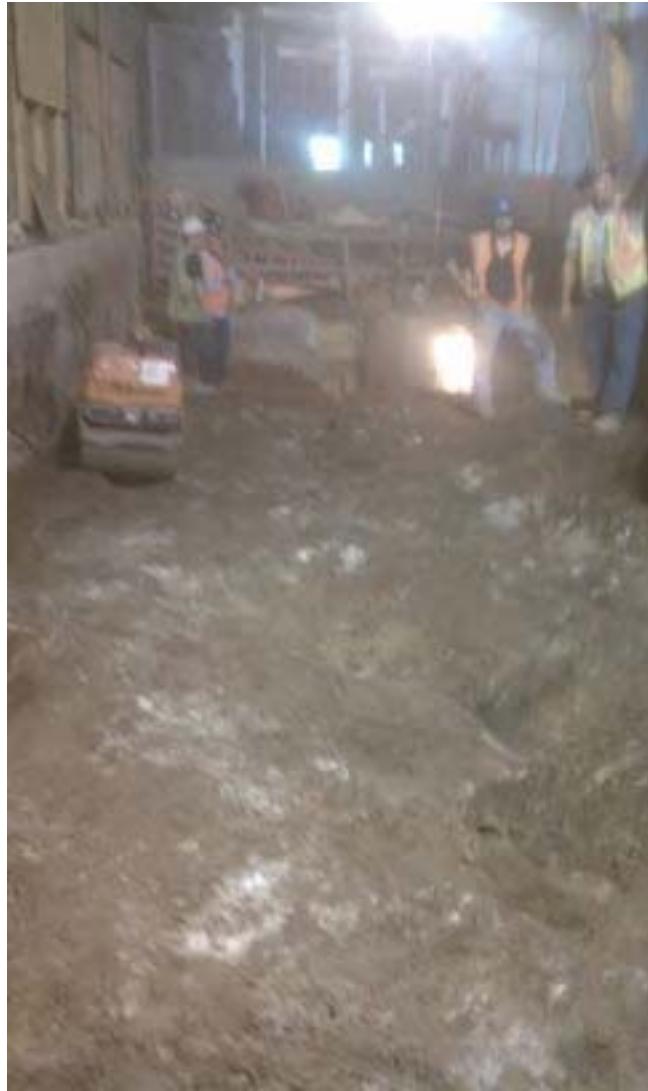
1. West side of Phase I, excavated to bedrock.

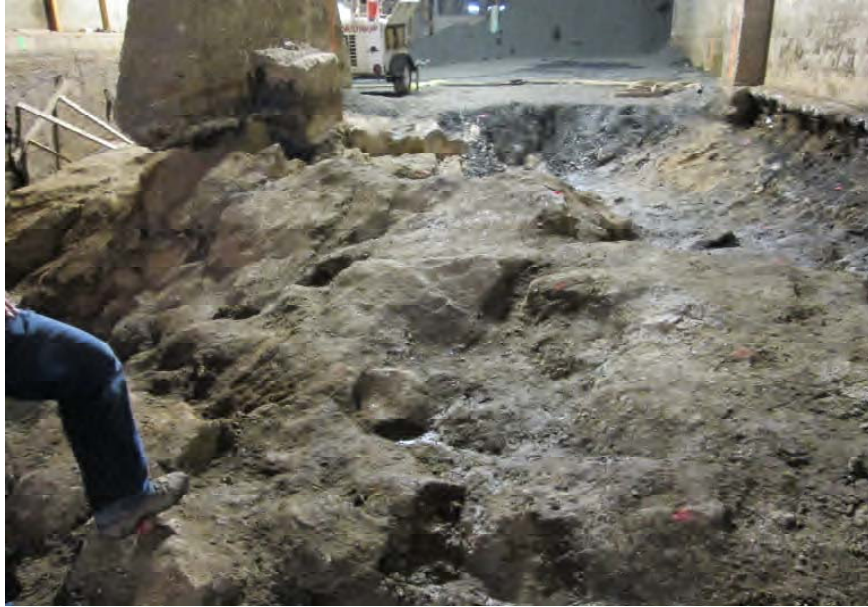
1. North side of Phase II, excavated to bedrock. Inspected and certified by FLS.

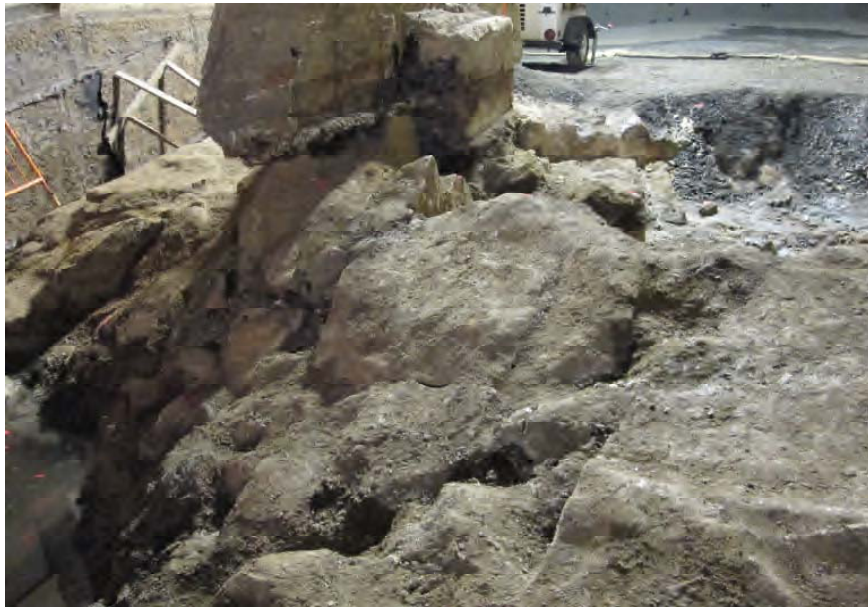
2. North side of Phase II, excavated to bedrock. Inspected and certified by FLS.

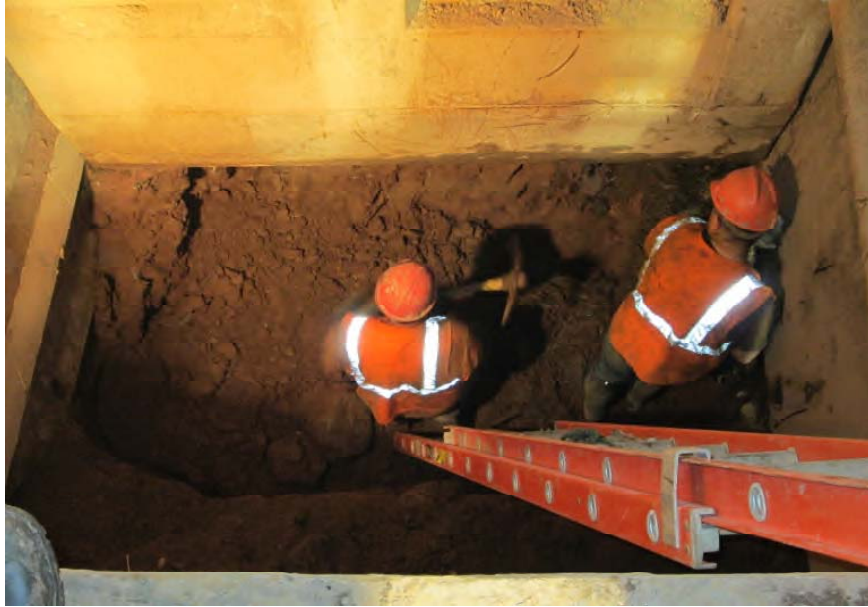
1. Hand clearing activities at Area “F” of Phase III excavation.

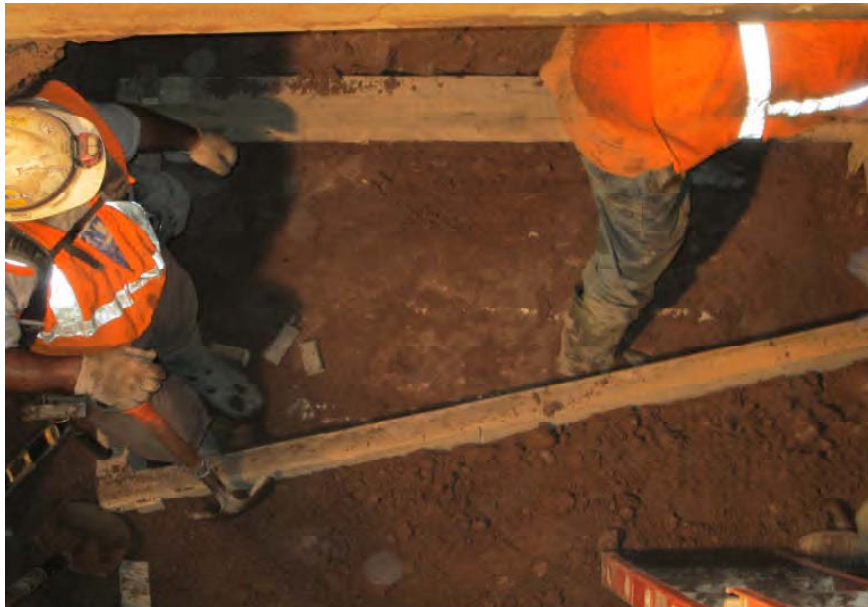
2. Area “F” of Phase III excavated down to bedrock.

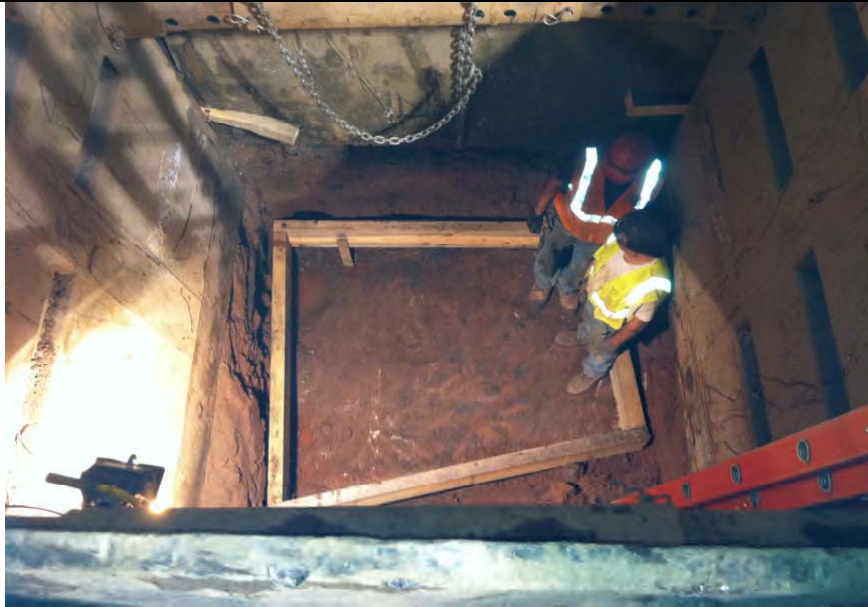
1. Phase III, Area "D" excavated down to bedrock.

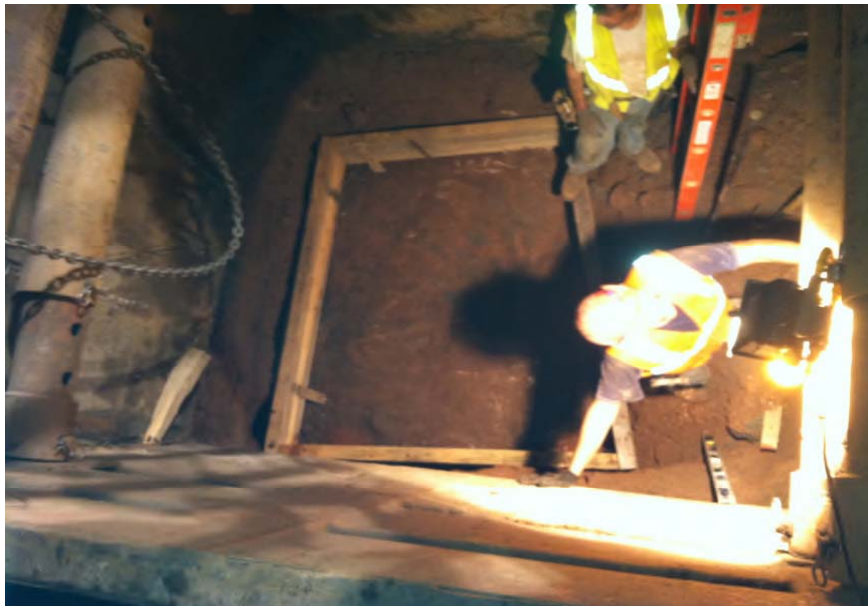
2. Phase III, Area "D" excavated down to bedrock.

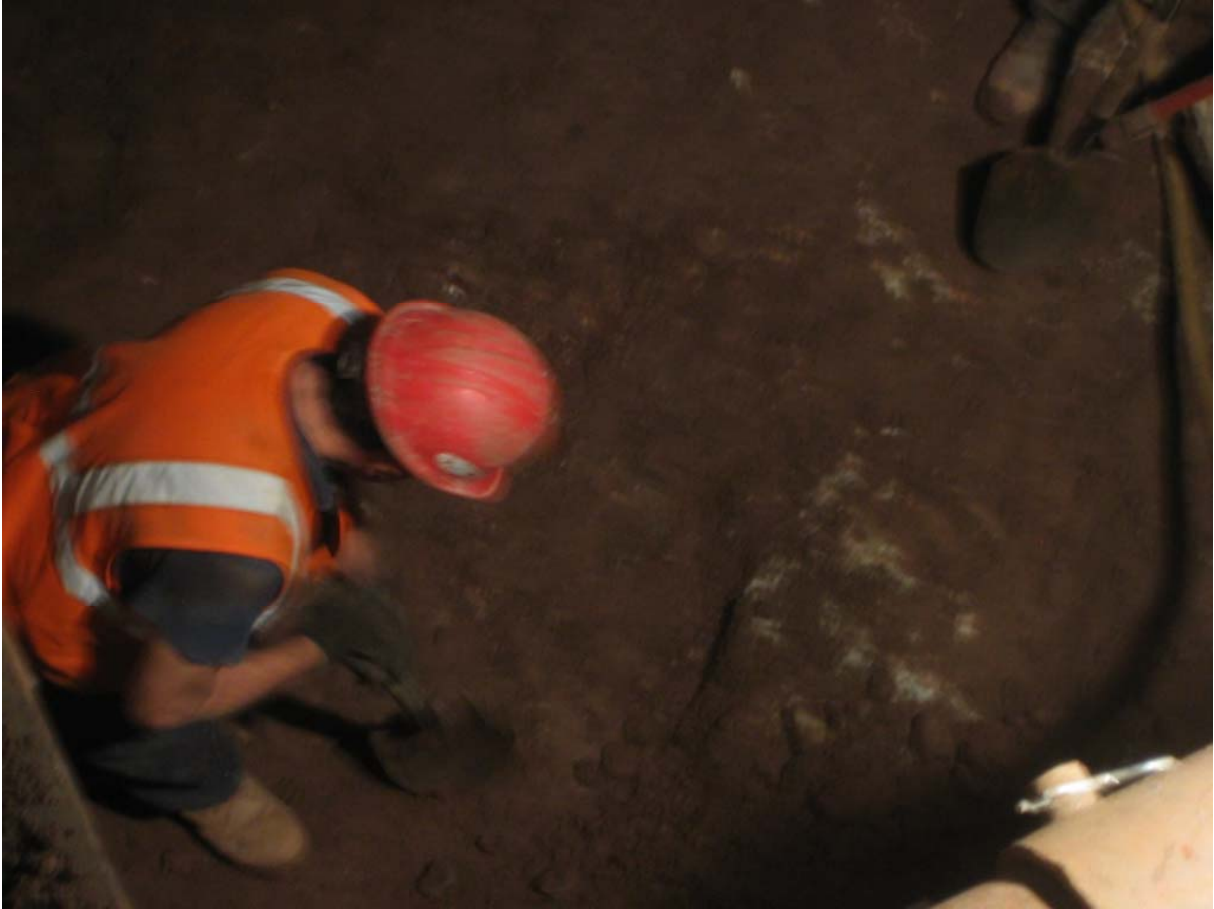
1. Area "B" excavated down to bedrock

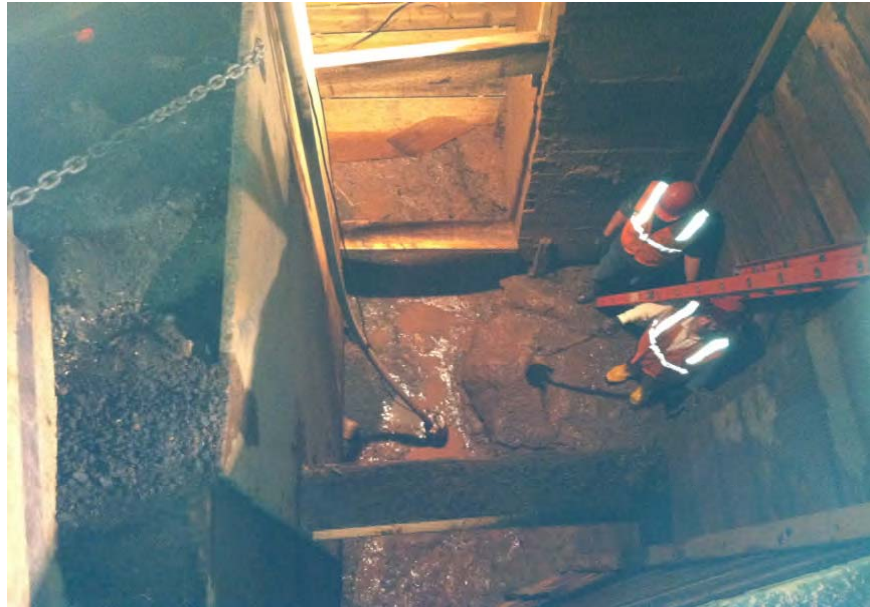
1. Phase II area excavated and cleaned to bedrock.

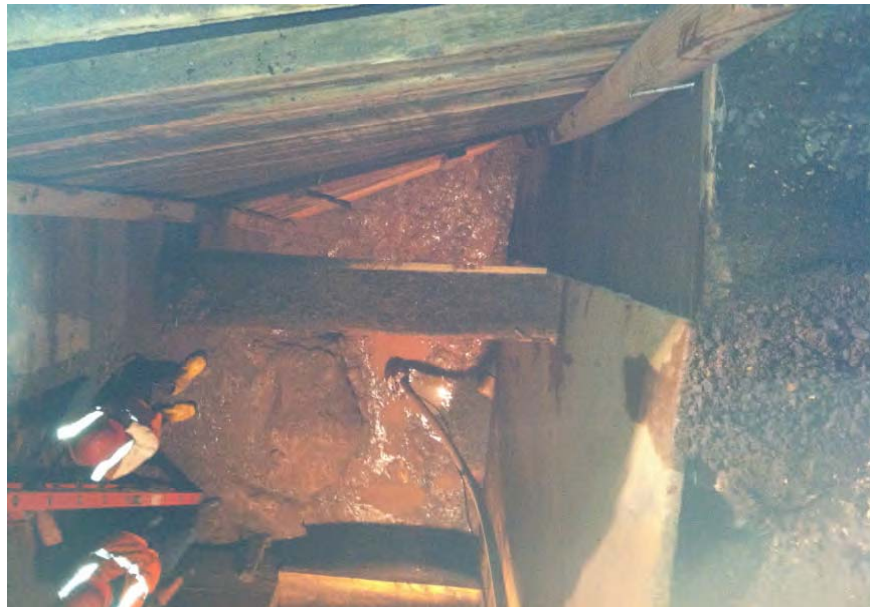
2. Phase II area excavated and cleaned to bedrock.

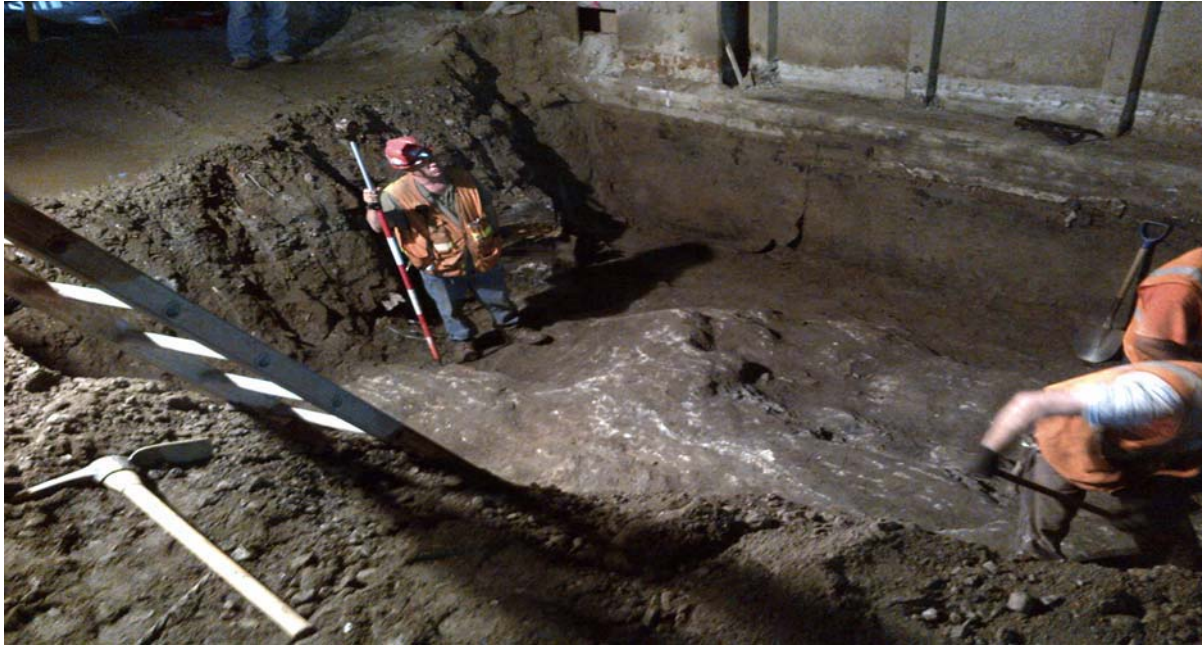
1. Phase 4 Excavation at Bedrock.

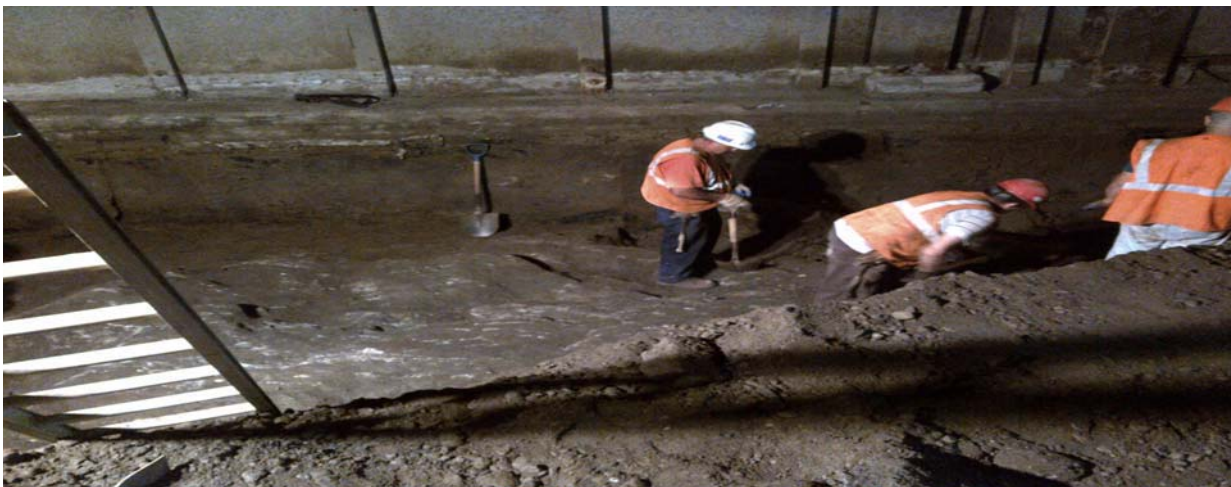
2. Phase 4 Excavation at Bedrock.
