West 61st Street Tennis Court Area Site

2024 Site Monitoring Report

AKRF Project Number: 10321

JULY 2024

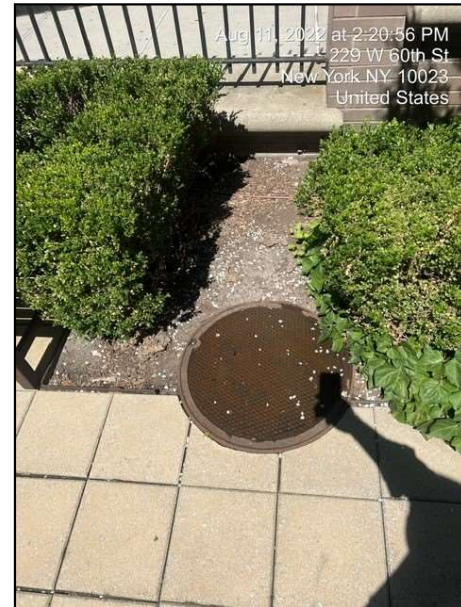
Photograph 4: No soil erosion noted around utilities protruding through the site cover.

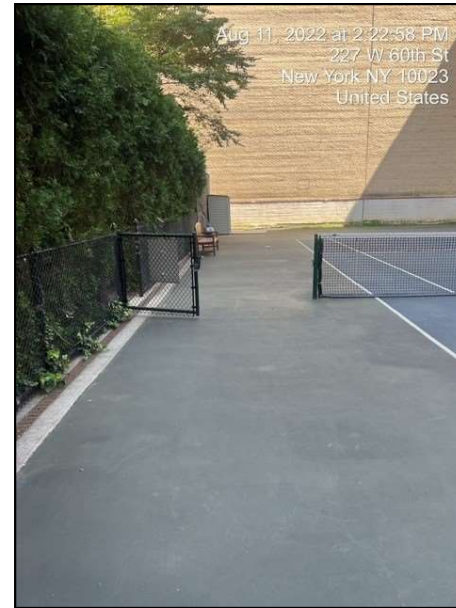
Photograph 6: Northern side of the tennis court; no cracking or erosion noted around the drainage system.

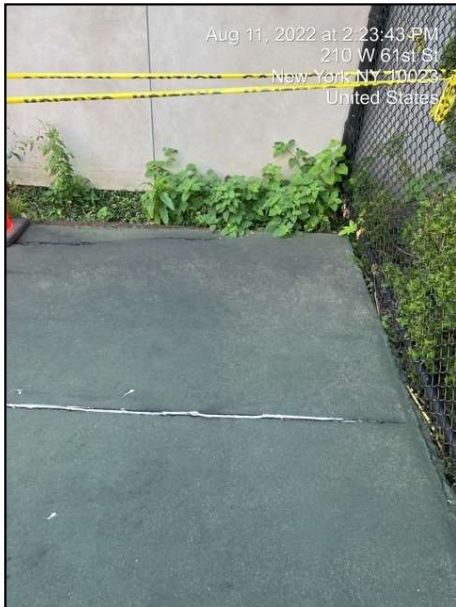
Several cracks were noted along the southern edge of the tennis court on 08/12/2022. The cracks had been repaired with grout and/or asphalt. None of the cracks had penetrated the demarcation layer.

Photograph 7: Repaired, approximately 6-foot long crack in the tennis court cover (paved element of composite cover system)

Photograph 7: An approximately 6-foot long crack in the southwestern corner of the tennis court, repaired with grout.

Any new cracks must be patched according to SMP (re-paving not necessary); tennis court surface should be professionally repaired.

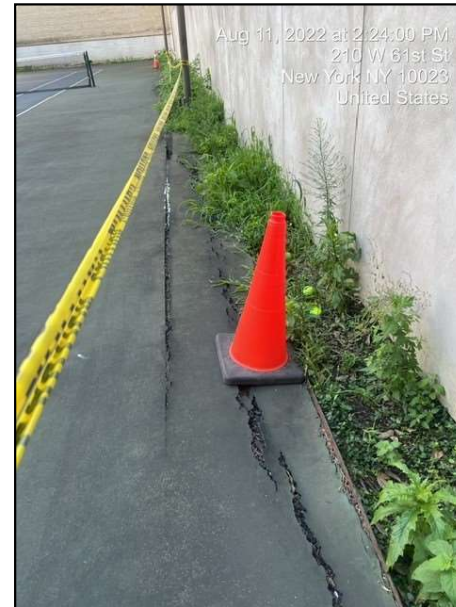
Photograph 8: Repaired, approximately 23- and 34-foot long cracks in the tennis court cover (paved element of composite cover system)

Photograph 8: Cracks, repaired with grout and asphalt, at the southern edge of the tennis court.

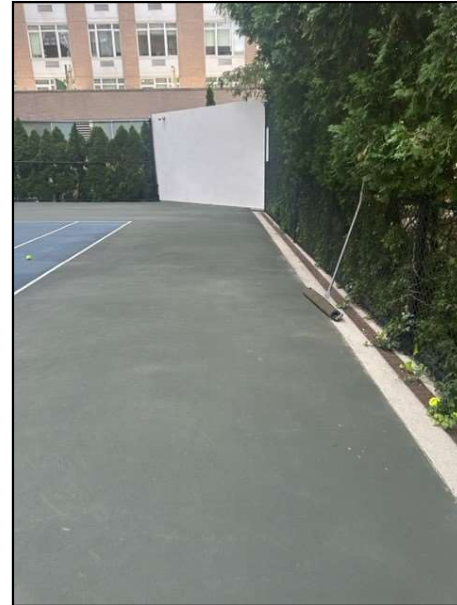
Photograph 4: Northwestern corner of the tennis court; no cracking or erosion noted around the drainage system.

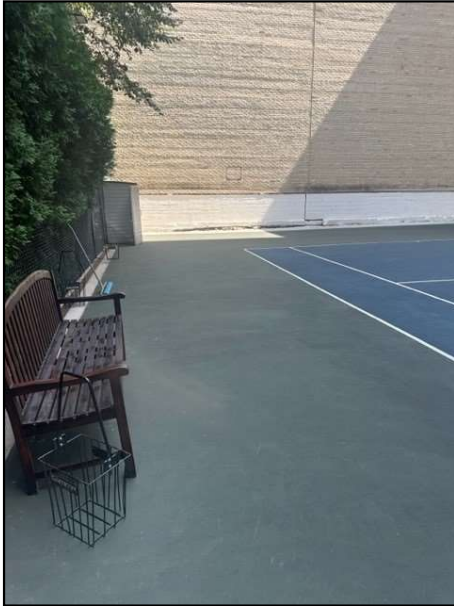
Photograph 5: Northern side of the tennis court; no cracking or erosion noted around the drainage system.

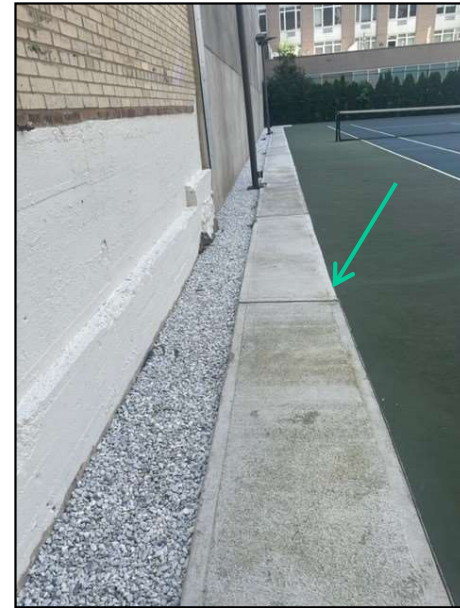
Photograph 6: The southern edge of the tennis court, with new concrete pavement installed as part of crack repair.

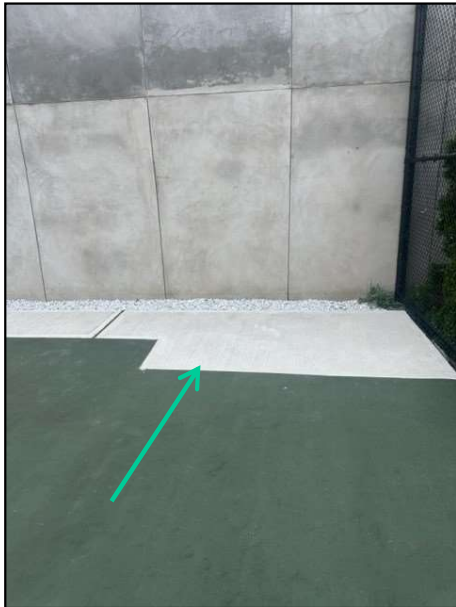
Photograph 7: The southwestern corner of the tennis court, with new concrete pavement installed as part of crack repair.

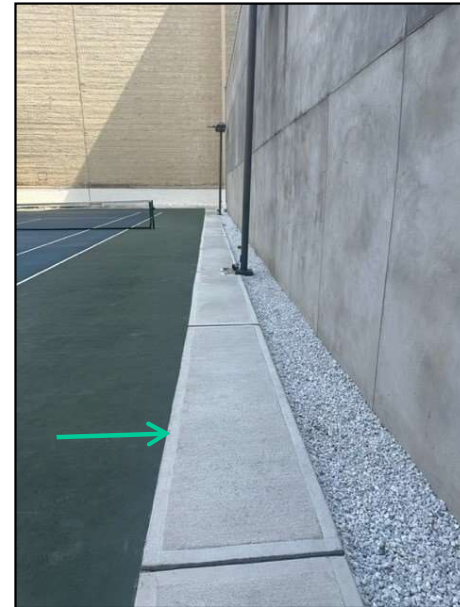
Photograph 8: The southern edge of the tennis court, with new concrete pavement installed as part of crack repair.

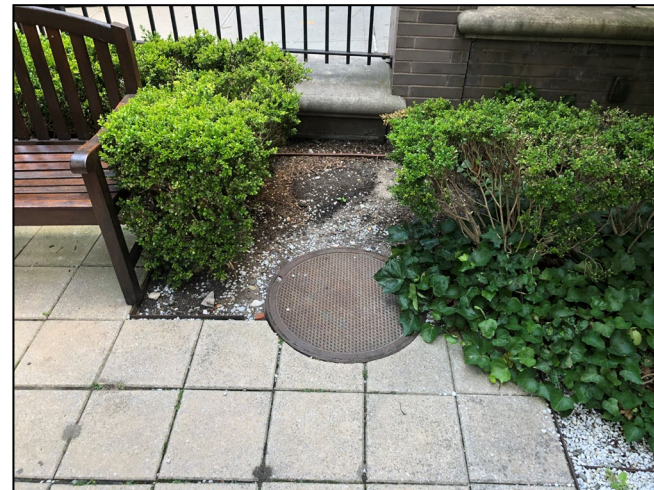
Photograph 4: No soil erosion noted around utilities protruding through the site cover.

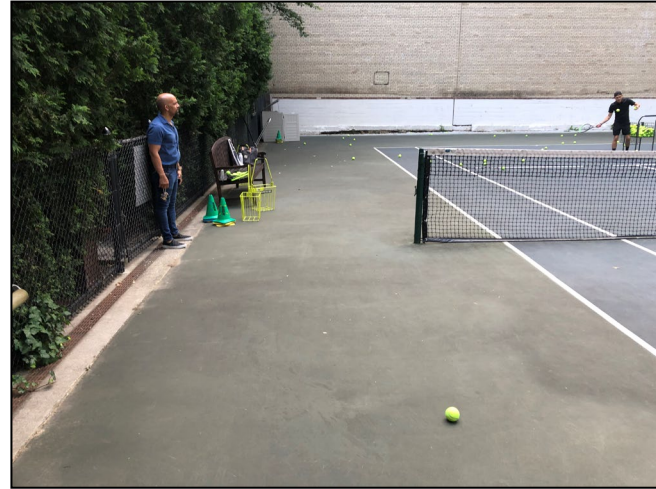
Photograph 6: Northern side of the tennis court; no cracking or erosion noted around the drainage system.

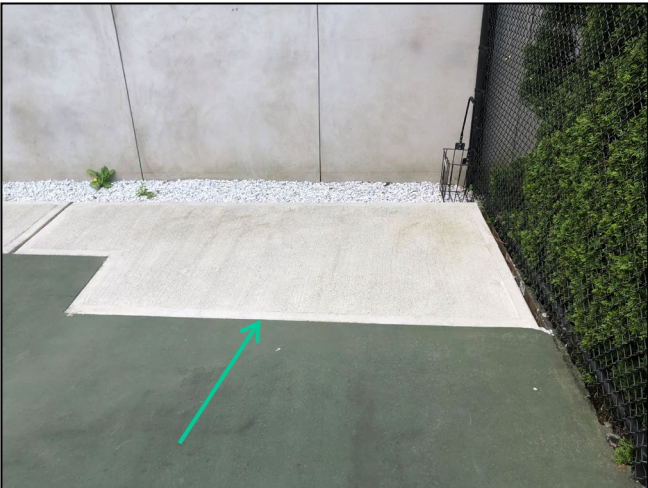
Photograph 7: The southwestern corner of the tennis court, with new concrete pavement installed as part of crack repair.

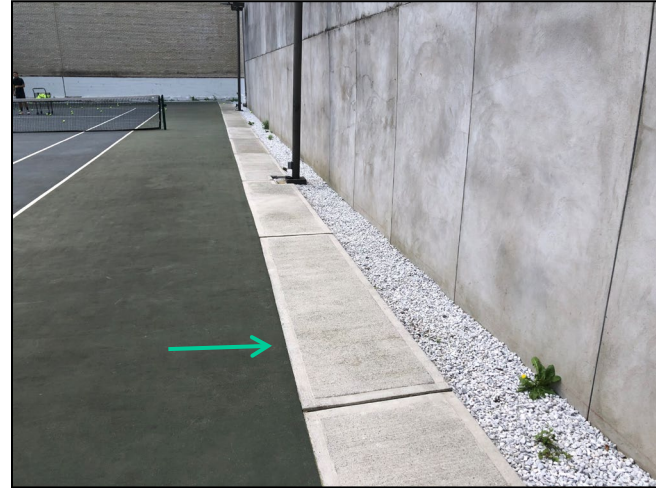
Photograph 8: The southern edge of the tennis court, with new concrete pavement installed as part of crack repair.

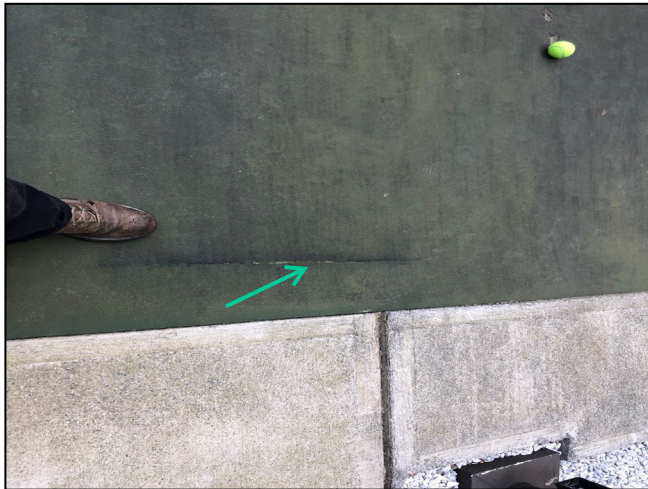
One crack was noted along the southern edge of the tennis court on 06/05/2024. This crack is to be repaired. The cracks did not penetrate the demarcation layer.

Photograph 9: Approximately 30-inch long crack in the tennis court cover (paved element of composite cover system), to be repaired.

Photograph 9: A new crack along the southern edge of the court (to be repaired).

The crack must be patched according to SMP (re-paving not necessary).
