APPENDIX K

Battered Secant Photo Log and
Engineering Sign-off

Lot 22 Secant Pile Log

Job #2139021

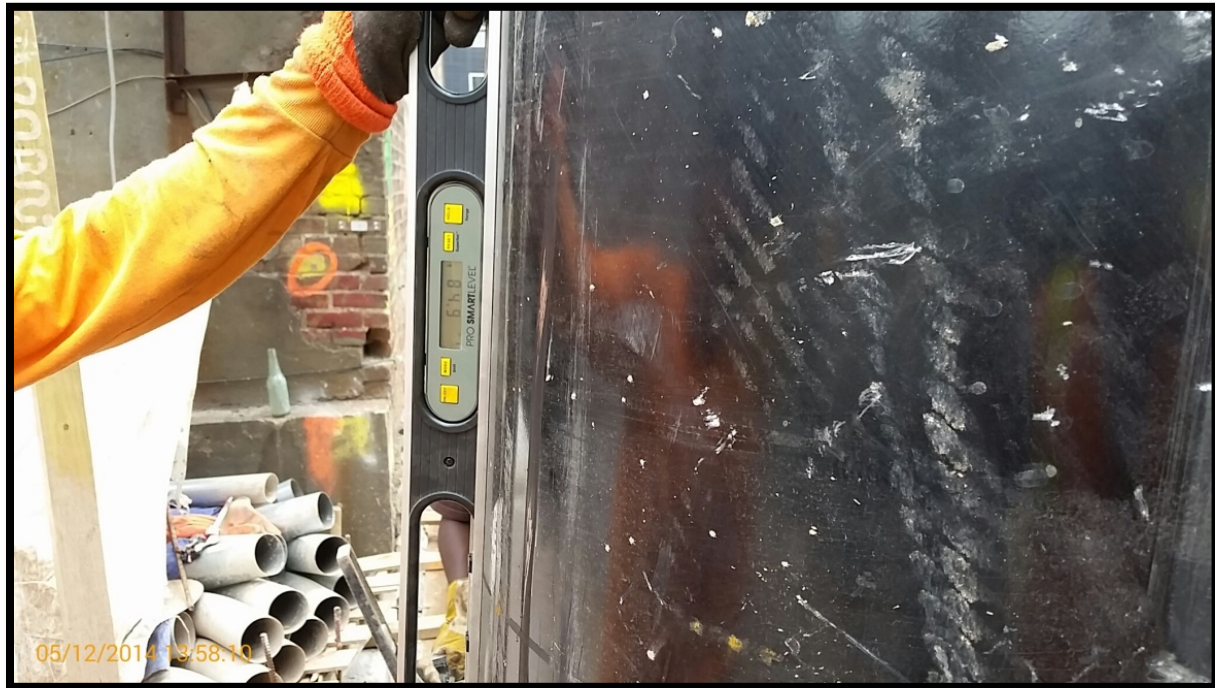
Photo 1: Battered secant pile #89P; confirming 6 degree casing tilt at EL +5 using a jig and bubble level.

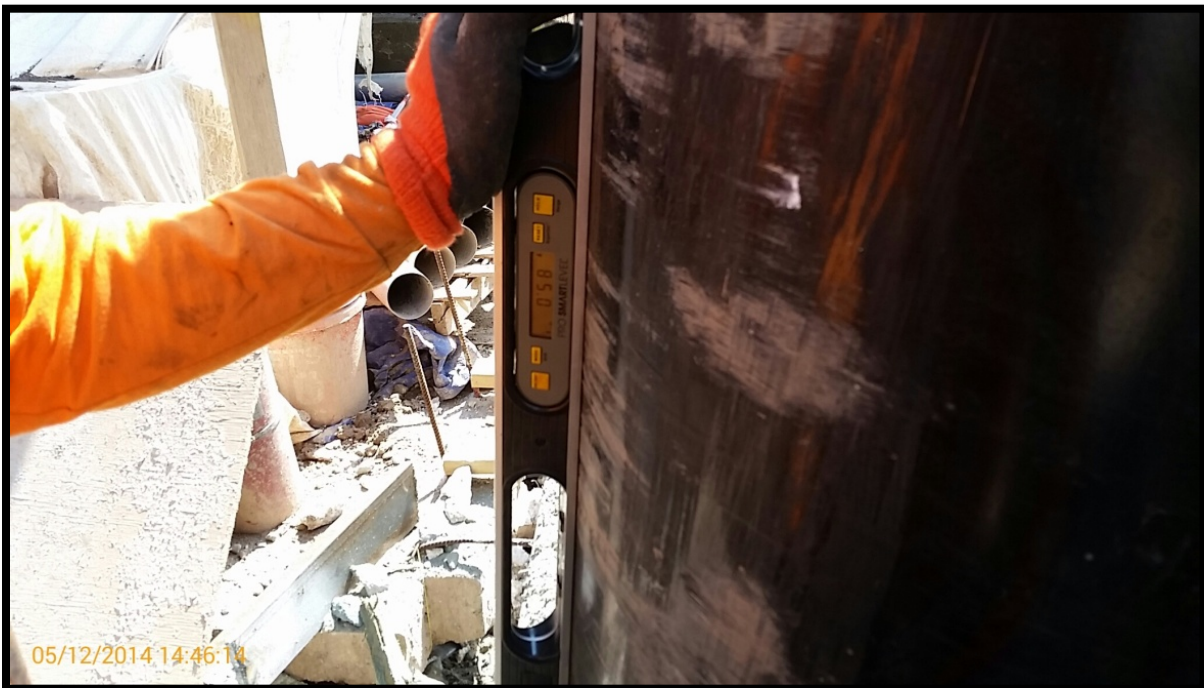
Photo 2: Battered secant pile #89P; confirming 6 degree tilt at EL +0 using a jig and bubble level.

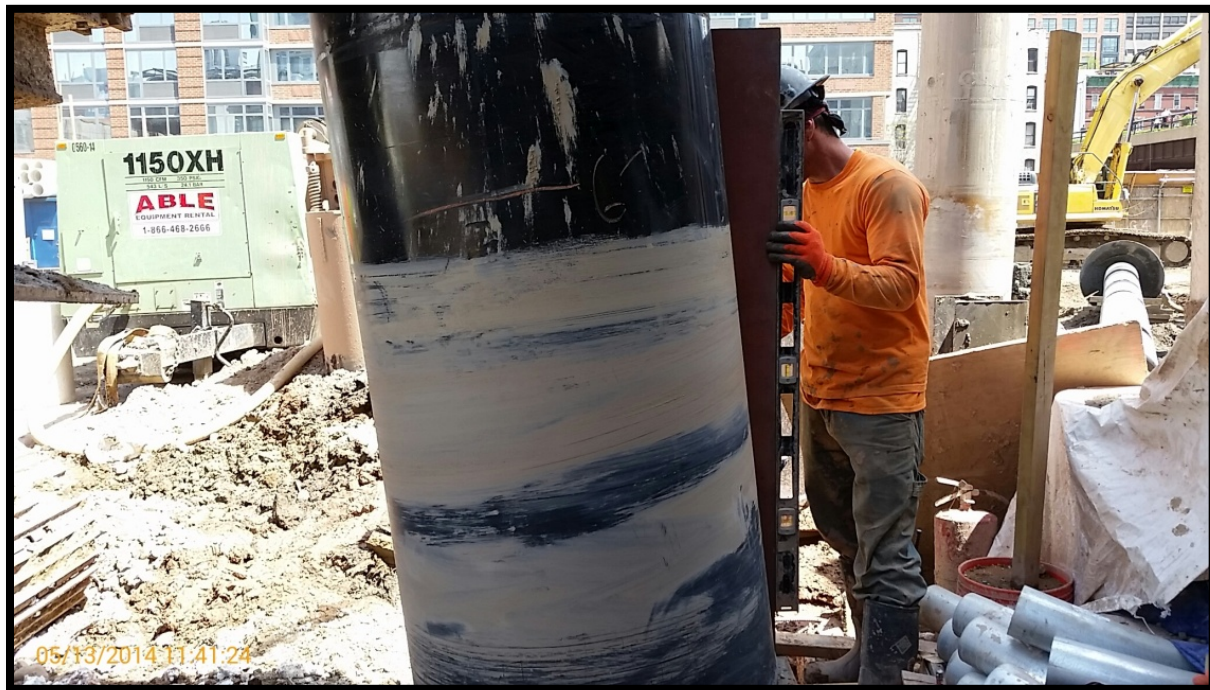
Photo 3: Battered secant pile #93P; confirming 6 degree tilt at EL +5 using a jig and bubble level.

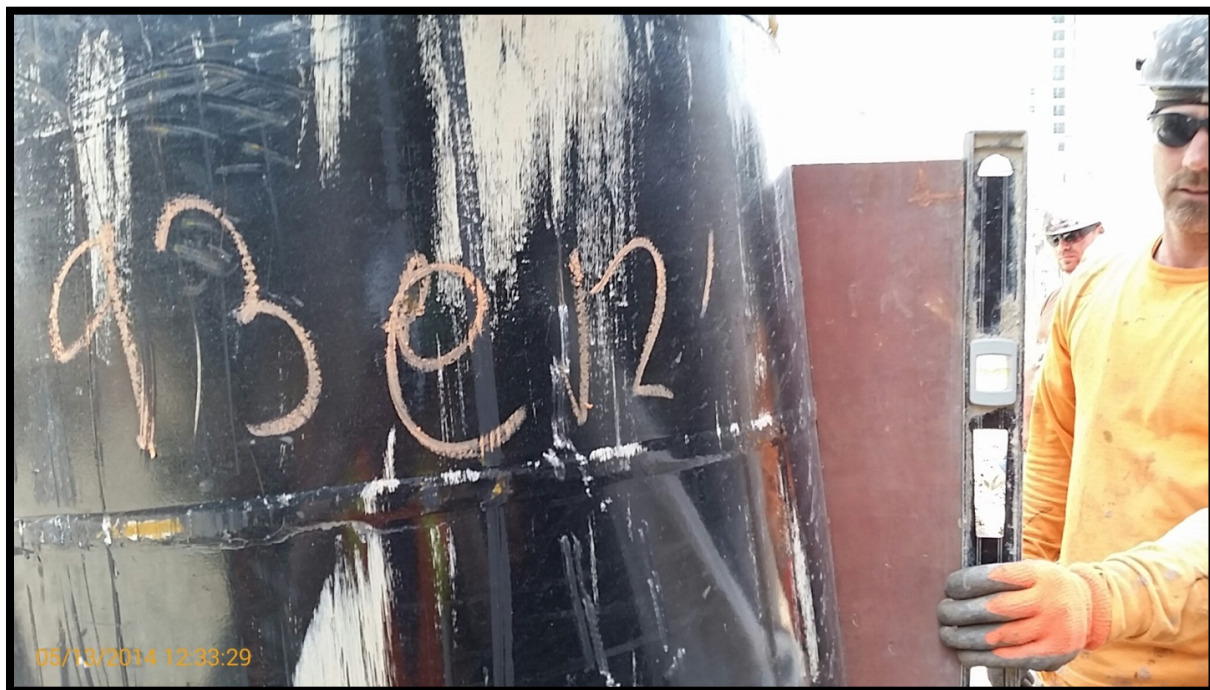
Photo 4: Battered secant pile #93P; confirming 6 degree tilt at EL +0 using a jig and bubble level.

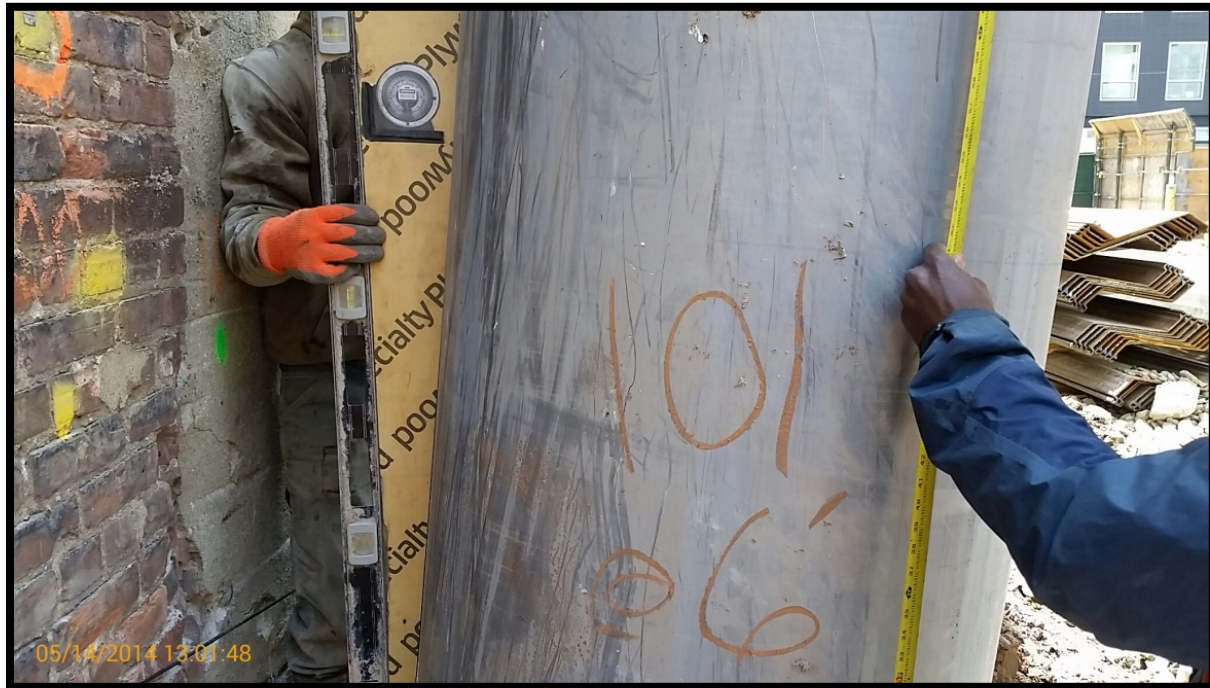
Photo 5: Battered secant pile #101P; confirming 6 degree tilt at EL +5 using a jig and bubble level.

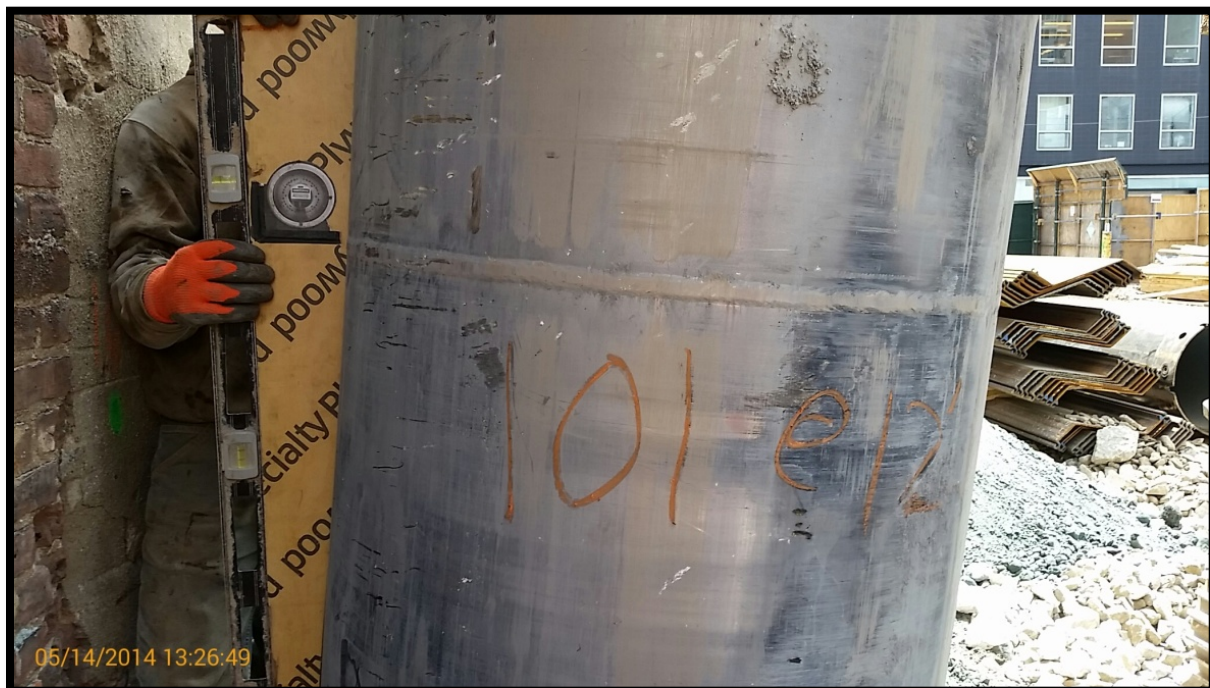
Photo 6: Battered secant pile #101P; confirming 6 degree tilt at EL +0 using a jig and bubble level.

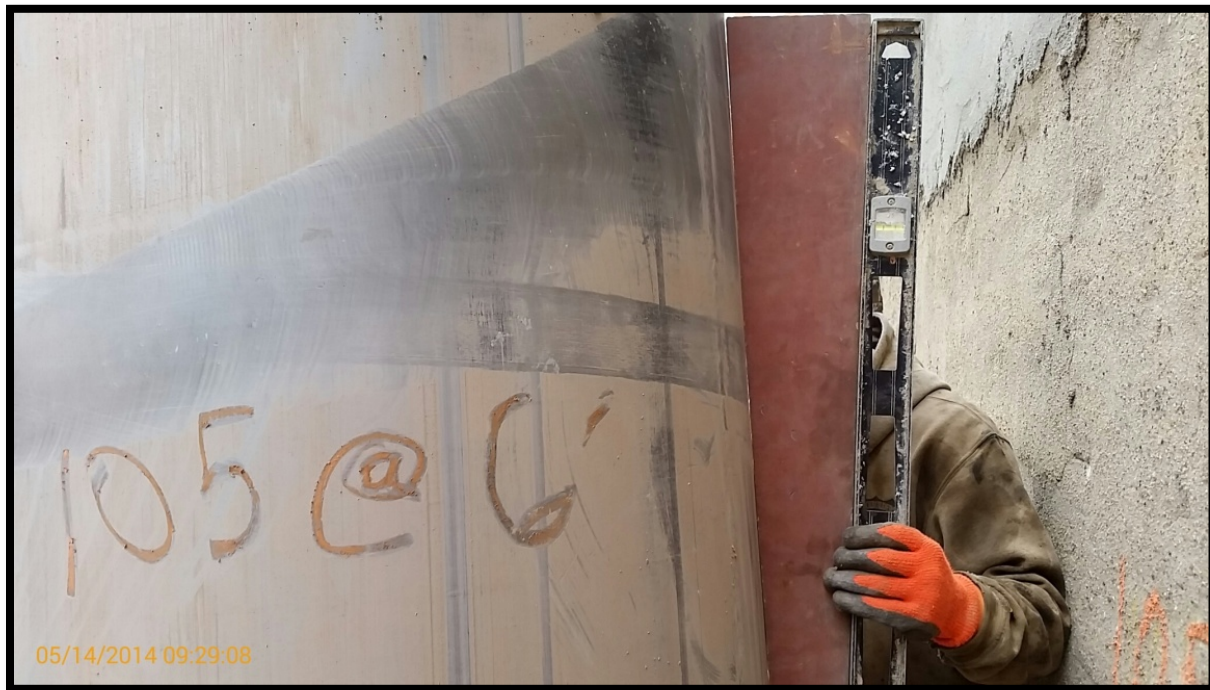
Photo 7: Battered secant pile #105P; confirming 6 degree tilt at EL +5 using a jig and bubble level.

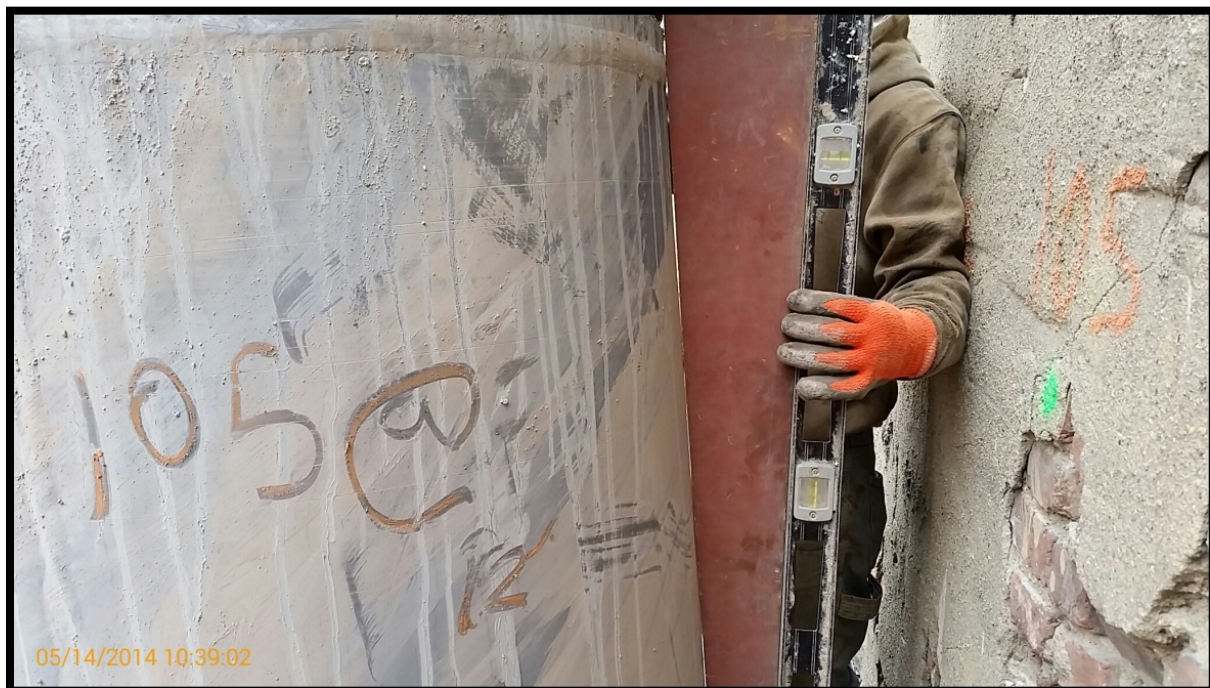
Photo 8: Battered secant pile #105P; confirming 6 degree tilt at EL +0 using a jig and bubble level.

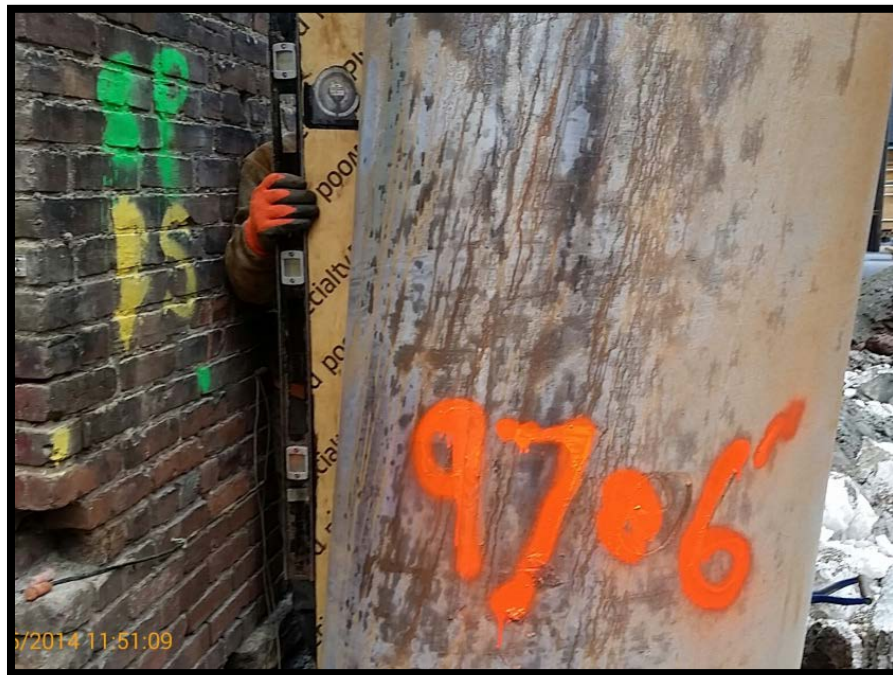
Photo 9: Battered secant pile #97P: confirming 6 degree tilt at EL +5 using a jig and bubble level.

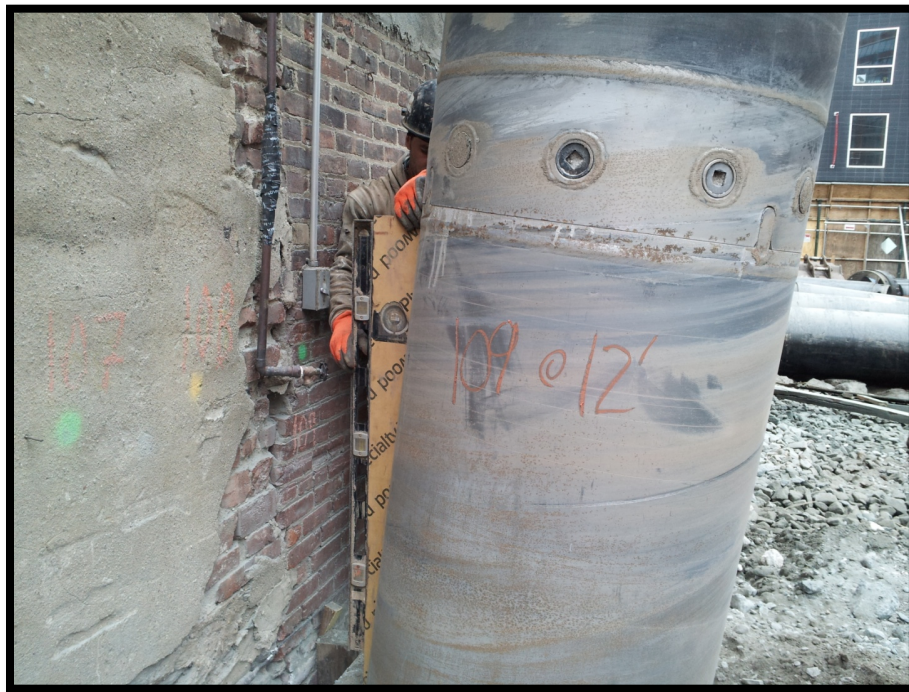
Photo 12: Battered secant pile #109P; confirming 6 degree tilt at EL +0 using a jig and bubble.

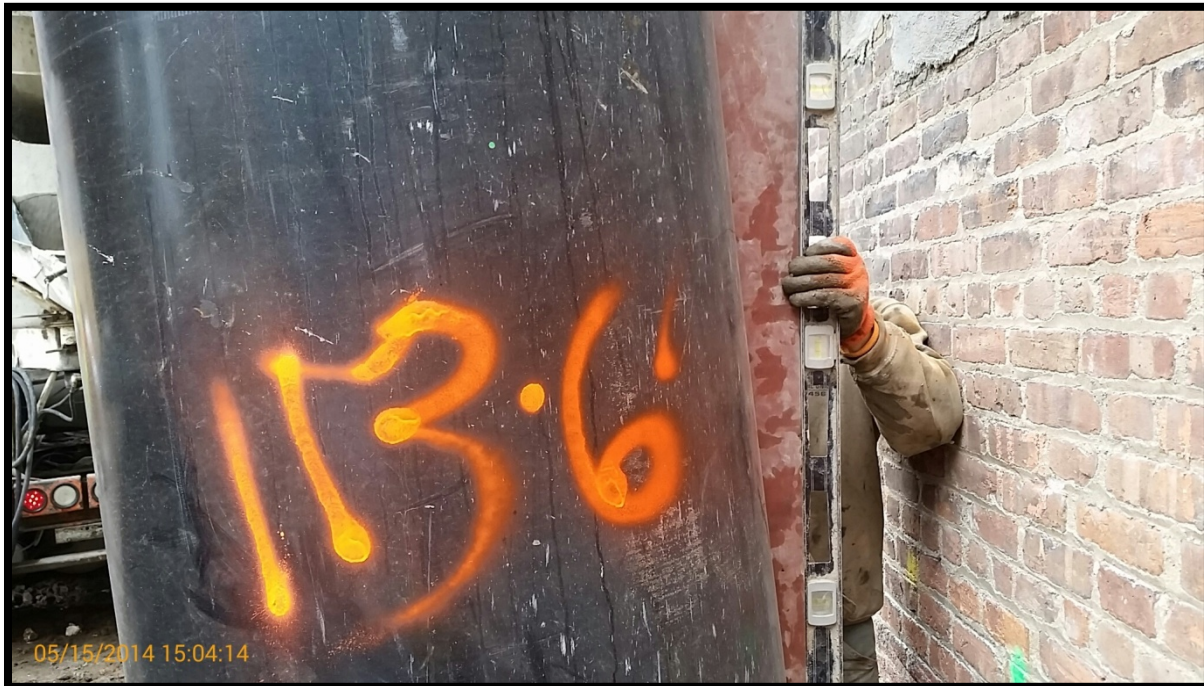
Photo 13: Battered secant pile #113P; confirming 6 degree tilt at EL +5 using a jig and bubble level.

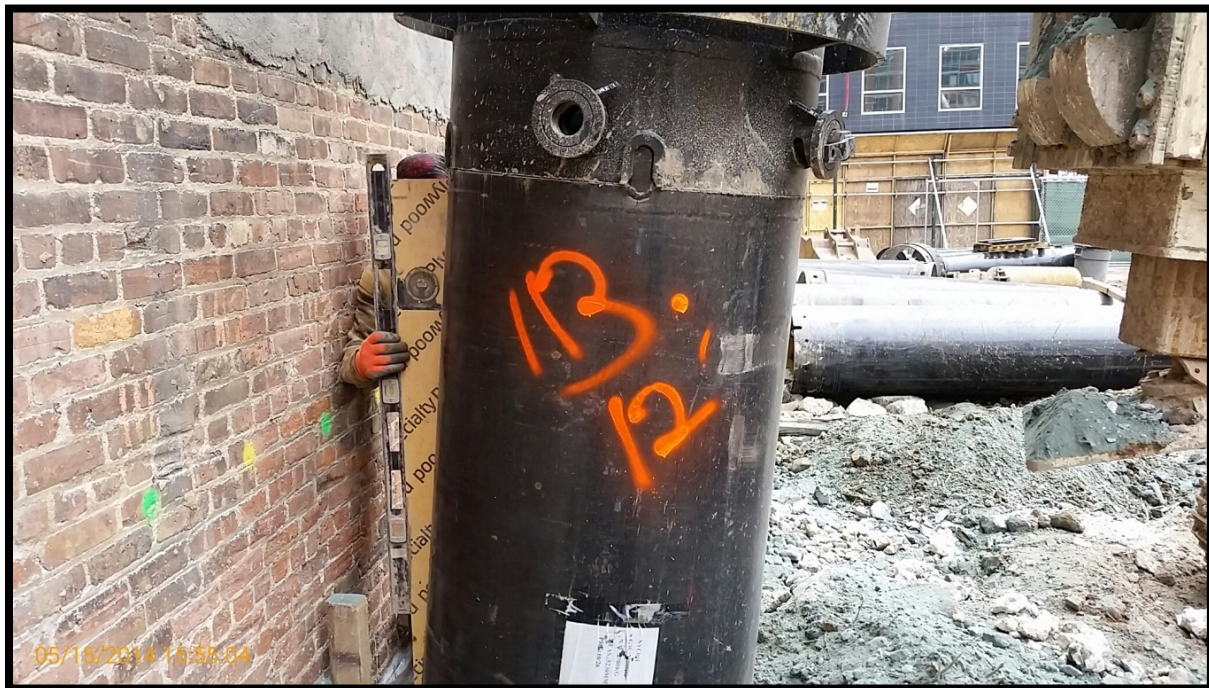
Photo 14: Battered secant pile #113P; confirming 6 degree tilt at EL +0 using a jig and bubble level.

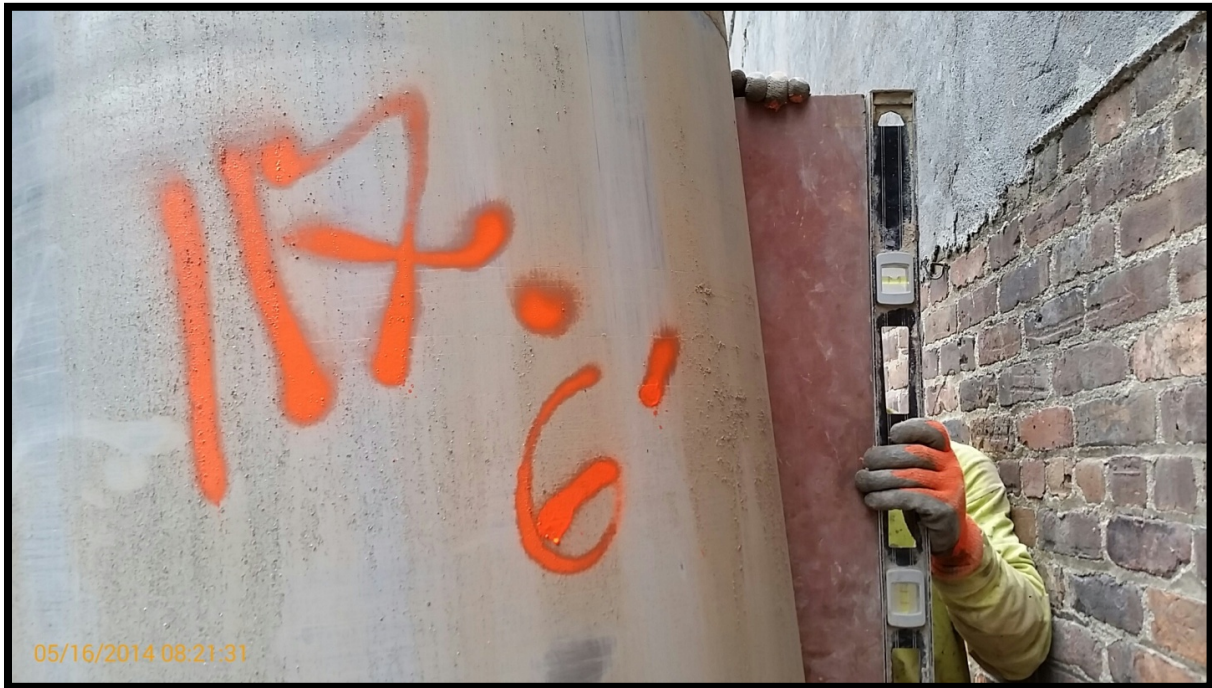
Photo 15: Battered secant pile #117P; confirming 6 degree tilt at EL +5 using a jig and bubble level.

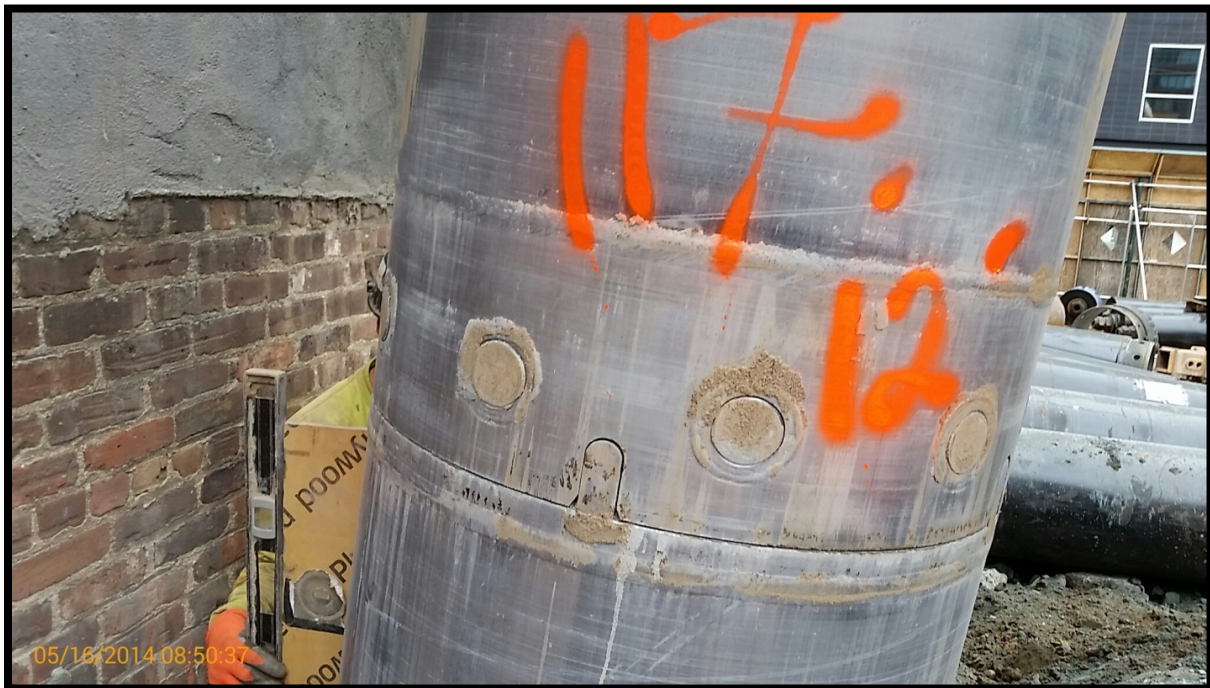
Photo 16: Battered secant pile #117P; confirming 6 degree tilt at EL +0 using a jig and bubble level.

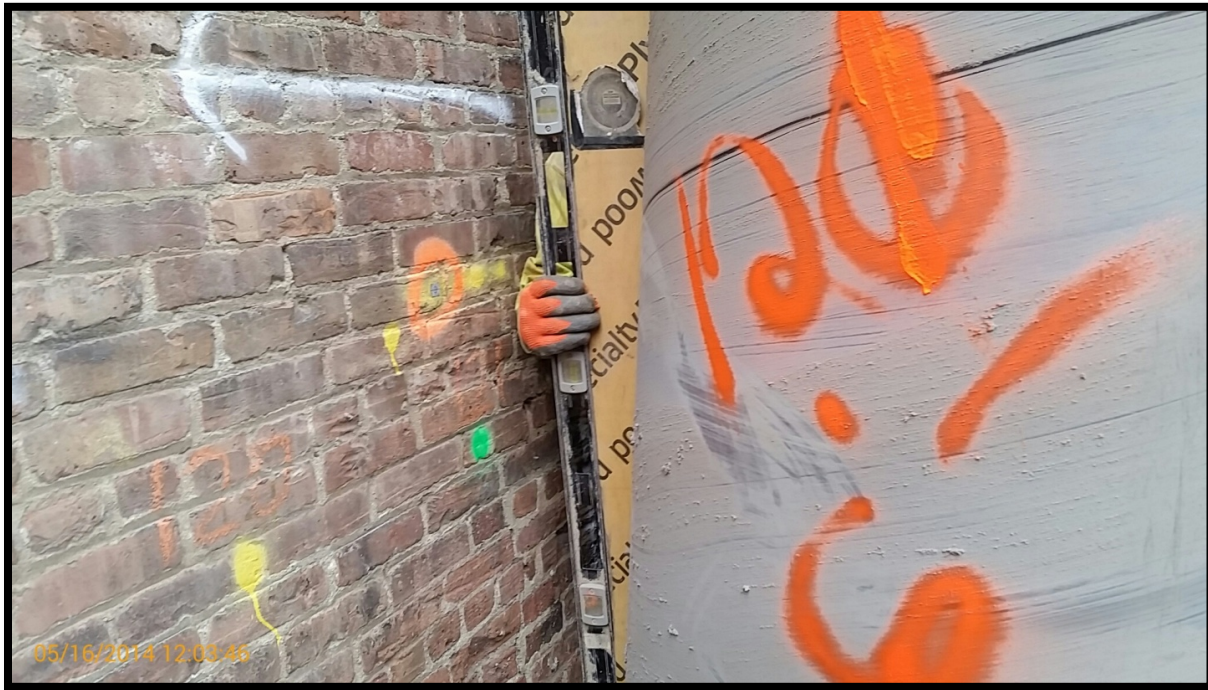
Photo 17: Battered secant pile #121P; confirming 6 degree tilt at EL +5 using a jig and bubble level.

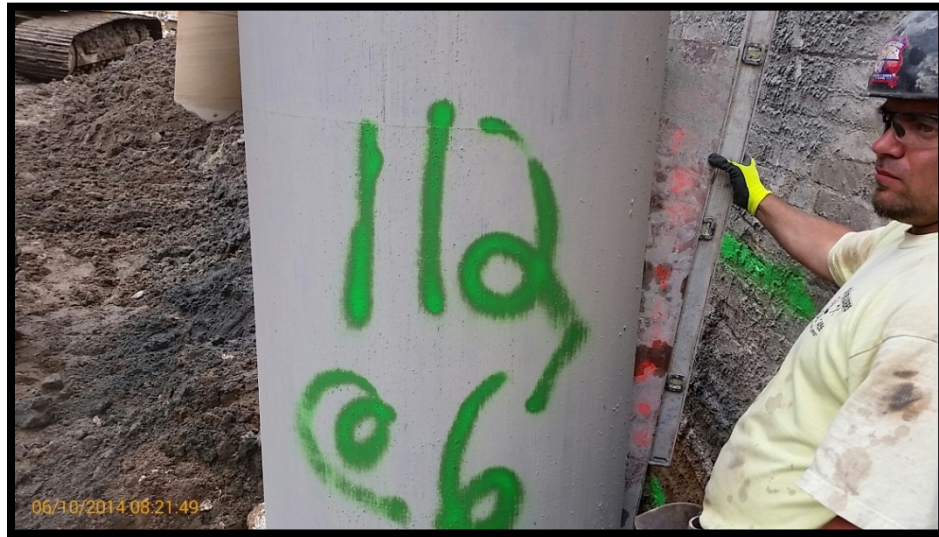
Photo 81: Battered secant pile #122S; confirming 6 degree tilt at EL +5 using a jig and bubble level.

***NOTE:** Secant pile #122S was incorrectly labeled in the photo as #112.*
