SITE OBSERVATION REPORT

PROJECT No.: 170381202

250 Water Street

Langan was present to document remediation activities in accordance with the NYSDEC-approved November 2021 Remedial Action Work Plan (RAWP) at the 250 Water Street site (NYSDEC Brownfield Cleanup Program [BCP] Site No C231127).

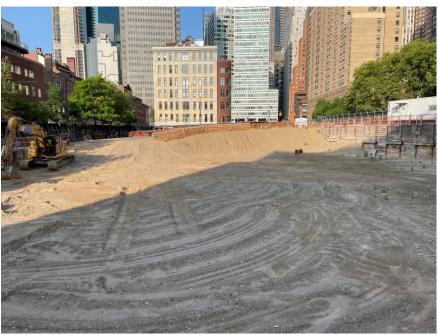
Photo 1: General view of the site (facing west)
