SITE OBSERVATION REPORT

PROJECT No.: 170432001 PROJECT: 266-270 West 96 th Street LOCATION: 266-270 West 96 th Street New York, NY		CLIENT: 266 West 96 th Street Associates LLC	DATE: Fri. December 4, 2020 WEATHER: Cloudy/rainy, 40-50s, Wind: N 0-5 mph TIME: 7:45am to 2:45pm
CONTRACTOR: None		LANGAN REP. : Adam Kaiser	
EQUIPMENT: Peri-Pump 100' Heron Interface Probe Horiba U-52 MiniRAE 3000		PRESENT AT SITE: Adam Kaiser – Langan RI Day 10	
OBSERVATIONS, DISCUSSIONS, TEST RESULTS, ETC.: <p>Langan was present to implement the December 2019 Remedial Investigation Work Plan for BCP site C231133 at 266-270 West 96th Street (Block 1243, Lots 57, 59, and 60). Observed activities were as follows:</p> <p>Site Activities</p> <ul style="list-style-type: none"> Langan used a peristaltic pump to purge and sample monitoring well MW-11. Prior to sampling, photoionization detector (PID) readings were collected in the well headspace. PID reading above background were not detected and odors were not observed. Depth to groundwater was about 17.11 feet below top of casing (22.11 feet below sidewalk grade [bsg]). Groundwater sampling was conducted in accordance with NYSDEC low-flow sampling protocols.

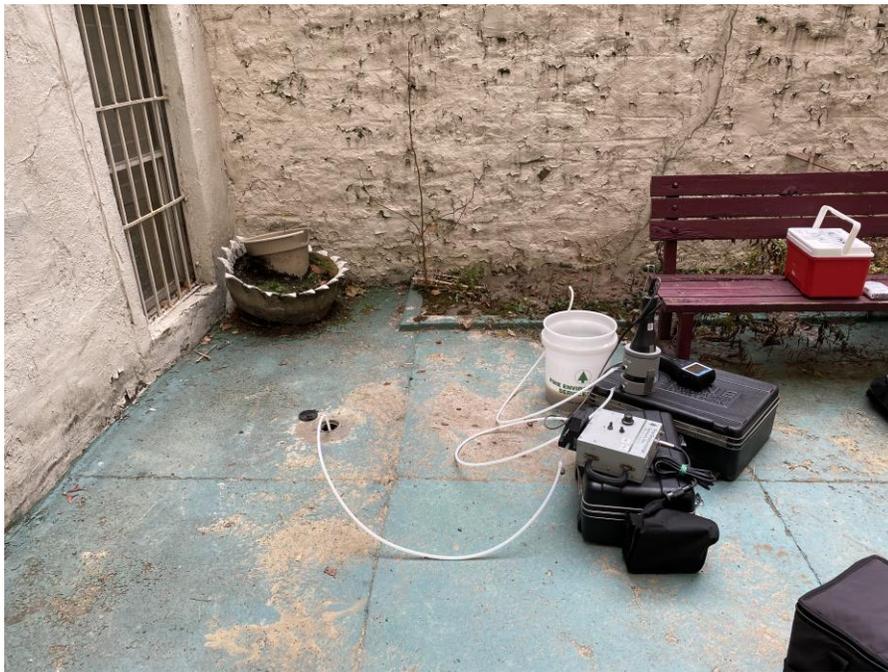
Photo 1: View of MW11 being purged using low-flow methodology in Lot 60 (facing east).

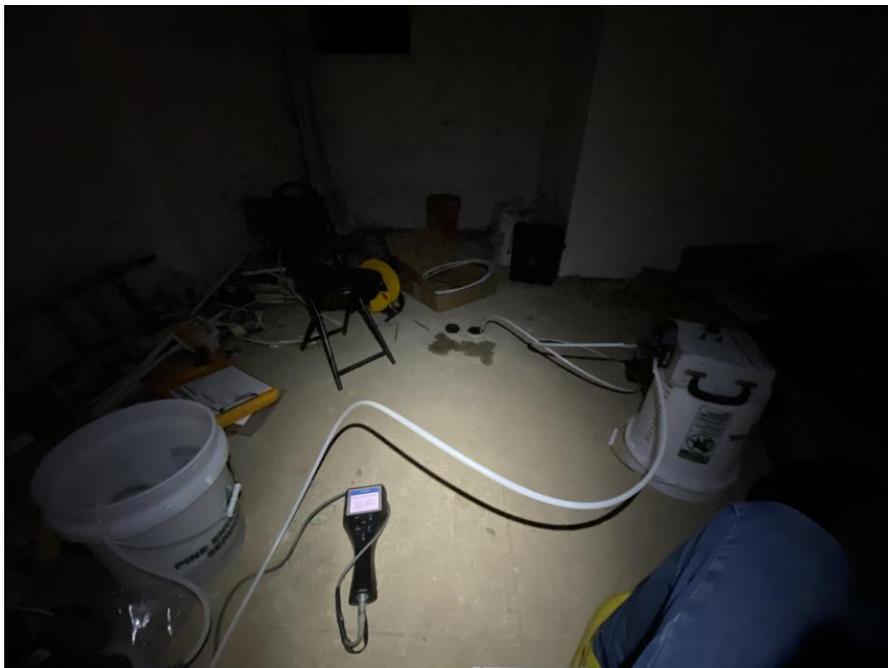
Photo 2: View of MW12 being purged using low-flow methodology in Lot 59 (facing south).
