Structural Engineer  
Signed and Stamped Letters in  
Response to Test Pit Investigation

RE: Paragon Paint and Varnish Co.  
Site Remedial Action  
45-40 Vernon Boulevard, Queens, NY.

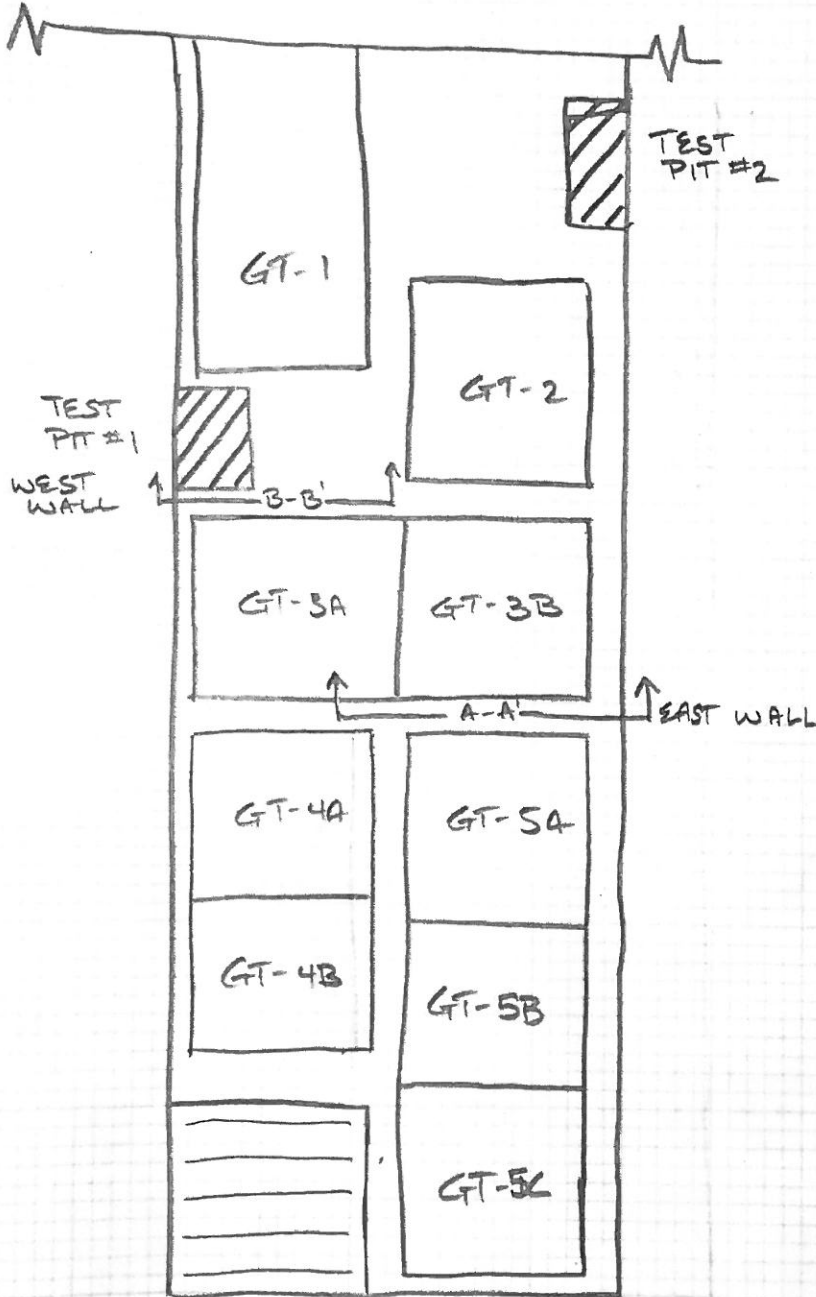
PAGE 1 OF 3

As you are aware, the above-referenced building contains several large underground tanks that had at one time stored various chemicals for manufacture of paint and varnish. The tanks were inspected and found to contain small amounts of those liquids.

Due to the very close proximity of these large tanks to the foundation walls, and to the fact that they extend deeper than these walls, and that the groundwater level lies well above the bottom of these tanks, sheeting and underpinning of these walls cannot be done in a safe manner. There is literally no space for workers to excavate along these walls. The structural stability of the existing building would be compromised. Excavation by mechanical means would also prove to be unsafe, as even small excavations and other construction equipment can collapse these tanks, causing spillage of the liquid chemicals into the ground.

DESCRIPTION VIEW OF GARAGE UST EXCAVATION W/ FOOTING TEST PITS

It is therefore strongly recommended that these tanks remain in place, be cleaned of all chemicals, and filled with clean sand, RCA or flowable fill. A gravel layer can then be placed over the tanks, and a new concrete slab can be placed over the gravel.

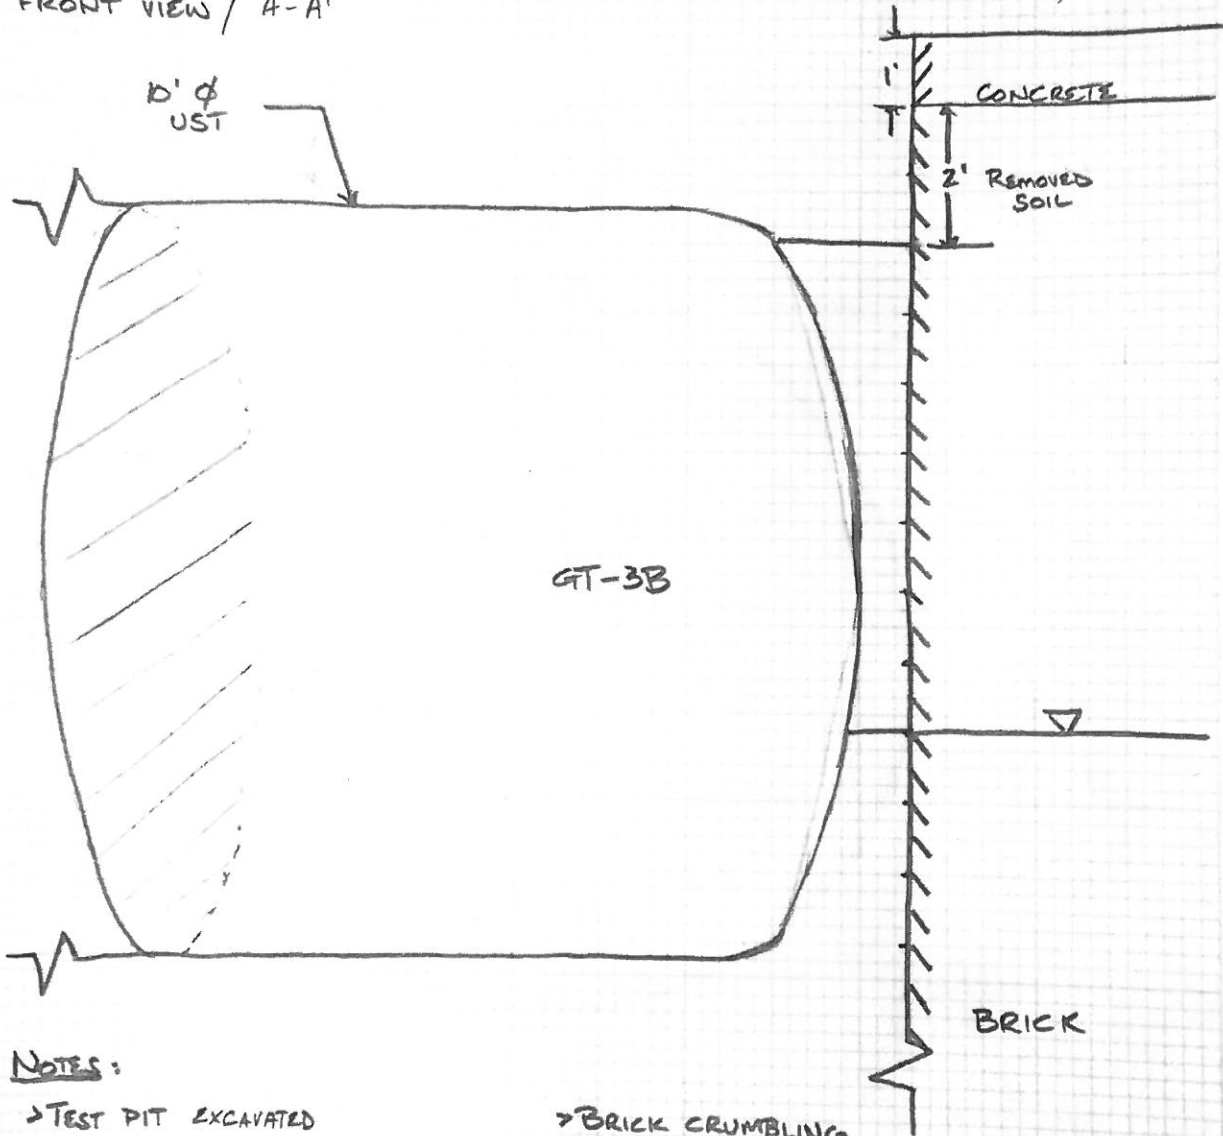
PAGE 2 OF 3

DESCRIPTION TEST PIT EXCAVATED ALONG THE EAST GARAGE WALL ON 10/19/15

- > TEST PIT EXCAVATED TO 10.5' BELOW CONCRETE SURFACE (10/19/15)
- > COULD NOT FIND FOOTING; WALL EXT. BELOW 10.5' BELOW CONCRETE
- > WATER LEVEL AT 9.0 FT BELOW CONCRETE
- > SOIL EXCAVATED TO APPROX 2 FT BELOW CONCRETE

- > BRICK CRUMBLING BELOW 9 FT BELOW CONCRETE
- > COMPARTMENT WALL BETWEEN GT-3B AND GT-3A SHOWN

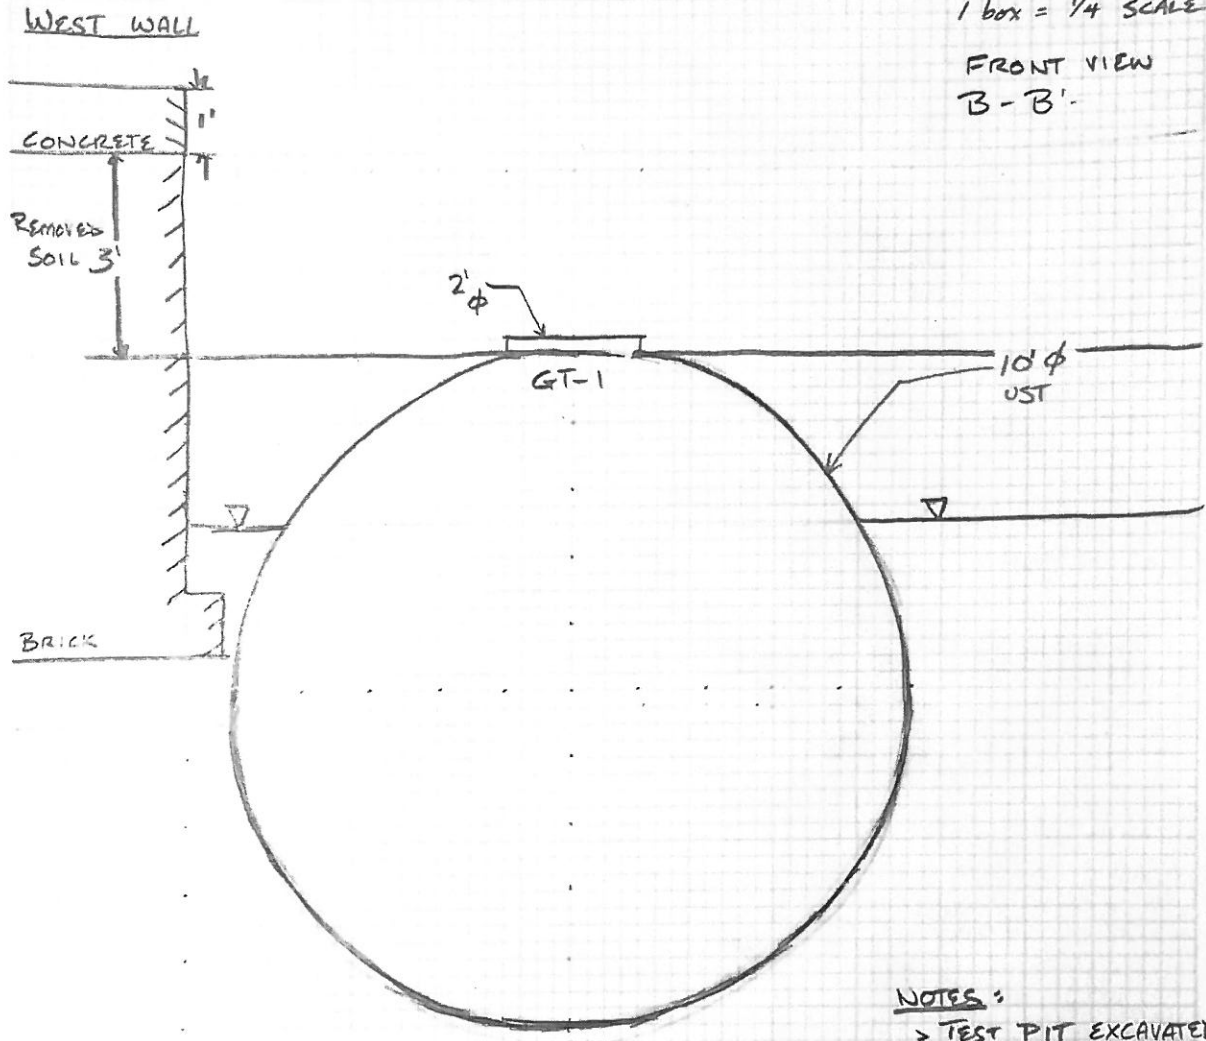
PAGE 3 OF 3

DESCRIPTION TEST PIT EXCAVATED ALONG THE WEST GARAGE WALL ON 10/14/15

- NOTES:
- > TEST PIT EXCAVATED TO FOOTING DEPTH; WAS NOT ADV. FURTHER (10/14/15)
  - > FOOTING ON THE WEST WALL AT APPROX. 7.5 FT BELOW CONCRETE SURFACE
  - > WATER LEVEL AT APPROX. 6.5 FT BELOW CONCRETE SURFACE
  - > SOIL BENEATH THE CONC SURFACE AT 3' BELOW
