**Interim Remedial Measures
Construction Completion Report**

**Former Johnny on the Spot Cleaners
152-153 10th Avenue
Whitestone, NY 11357
Brownfield Cleanup Program
Site #C241125**

August 12, 2022

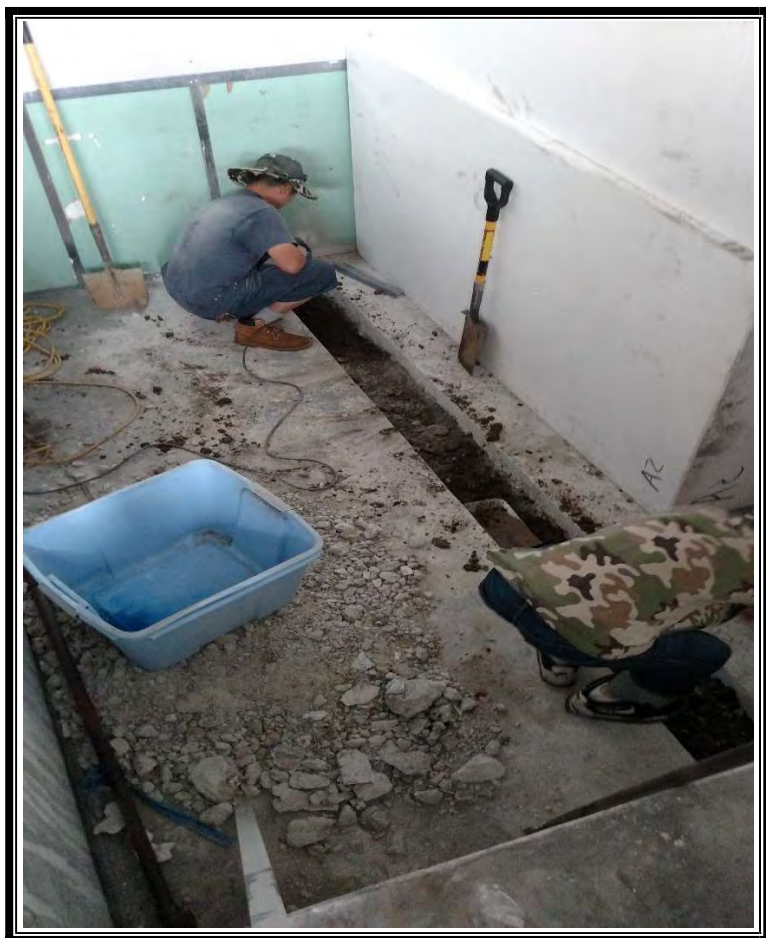
Photo 1 – Trench excavation for pipe segment A1 in lower floor area of former dry cleaner

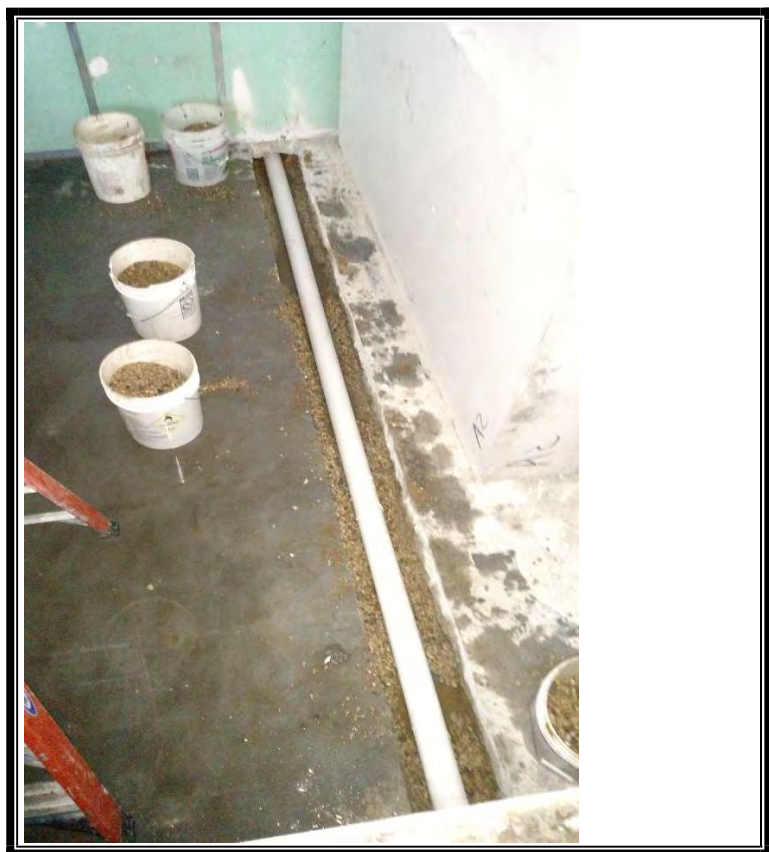
Photo 2 – Pipe segment A1 in lower floor, prior to backfill.

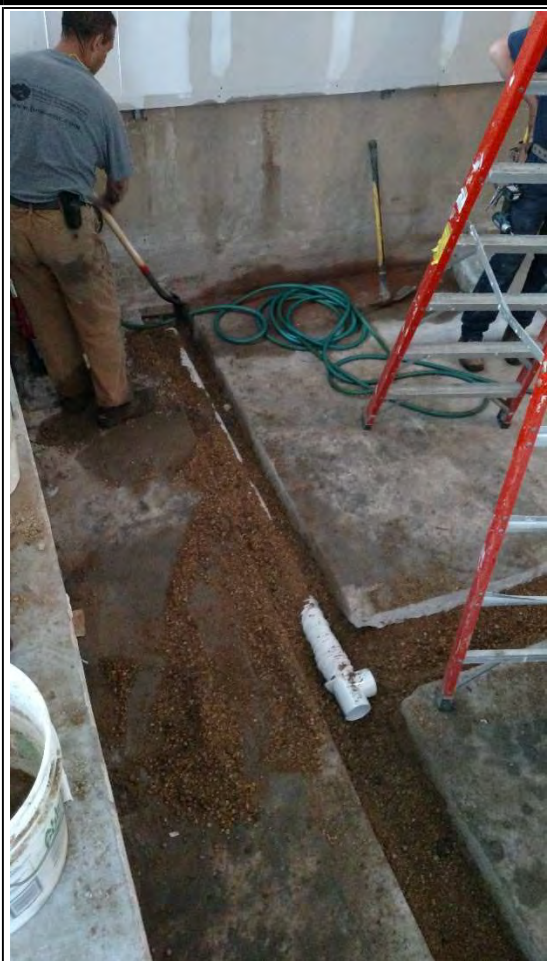
Photo 3 – Trench and piping segments B1 and C1 in lower floor area of former dry cleaner.

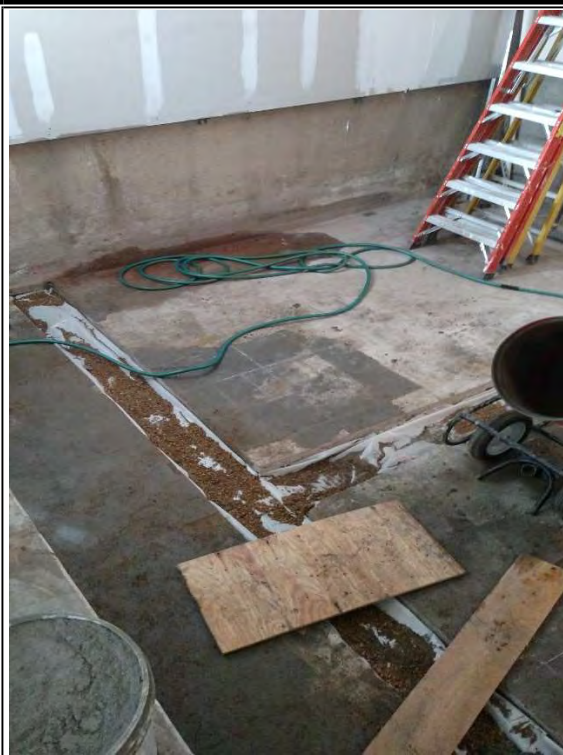
Photo 4 – Piping segments B1 and C1 with vapor barrier.

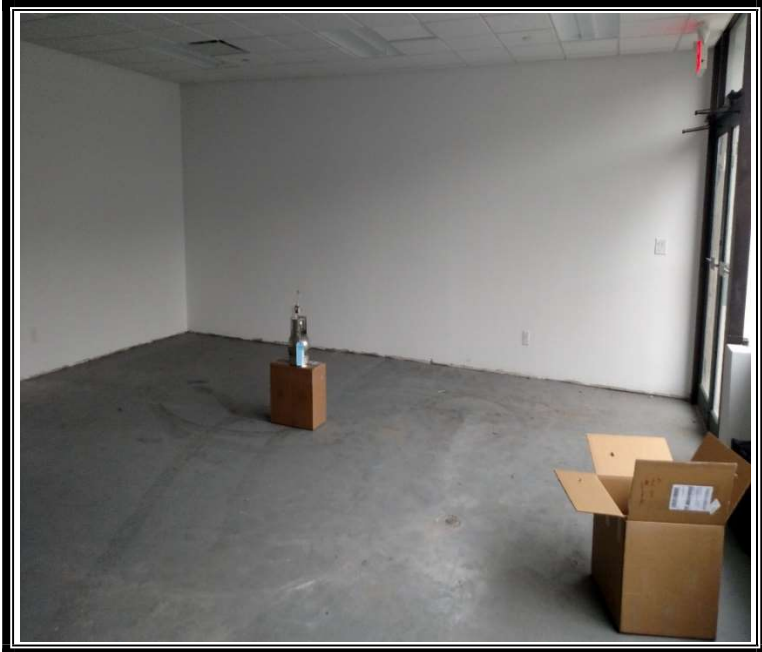
Photo 5 – Area of renovated former dry cleaner showing new floor over piping segment A1

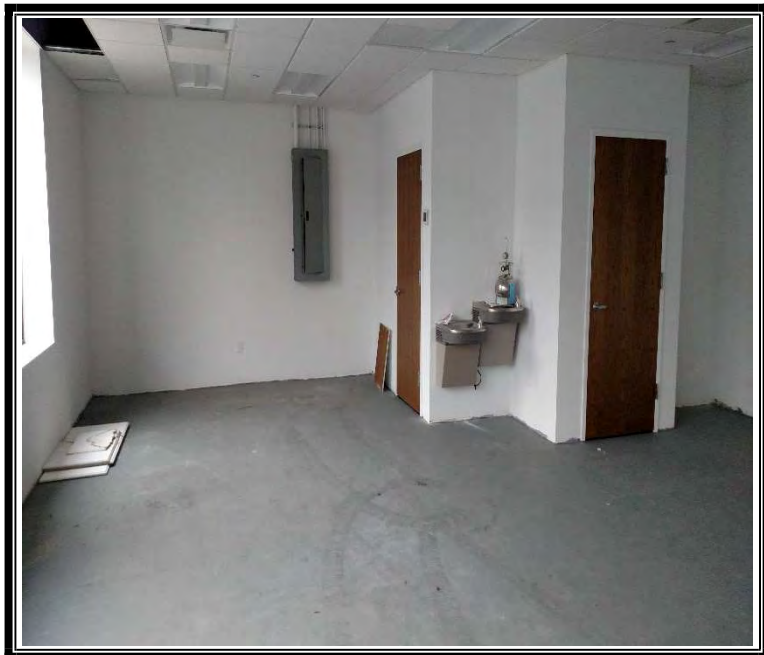
Photo 6 – Area of renovated former dry cleaner showing new floor over piping segment B1 and C1.

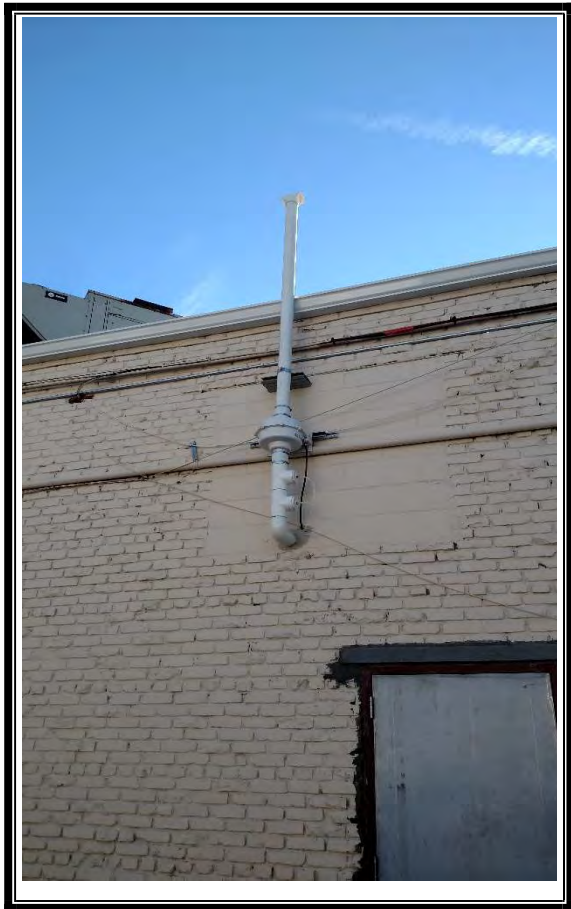
Photo 7 – Radon fan located on outside wall of former dry cleaner.

On January 23, 2020, Stantec oversaw the replacement of the malfunctioned Fan associated with the System B SSDS. The new Fan (a RadonAway GP-501) was the same model with the same ratings and velocity as the malfunctioned fan. The new fan was successfully installed and observed to be operating and creating a vacuum.

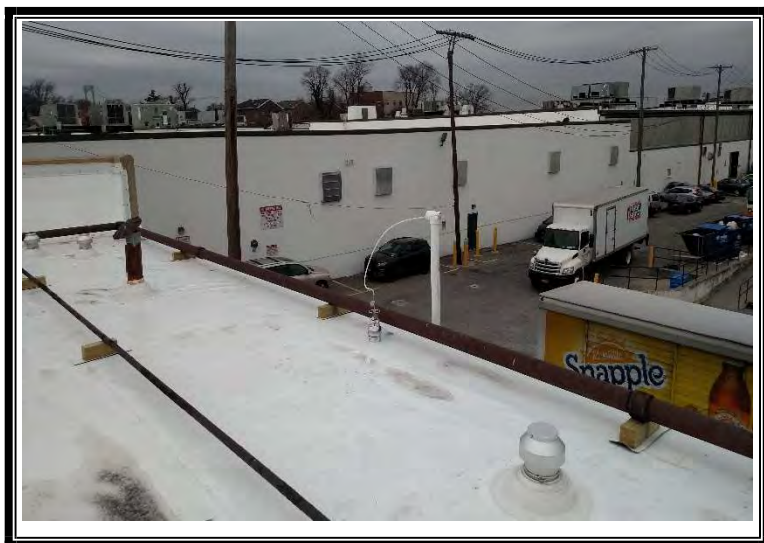
Photo 8 – Vent pipe above roof line at former dry cleaner.

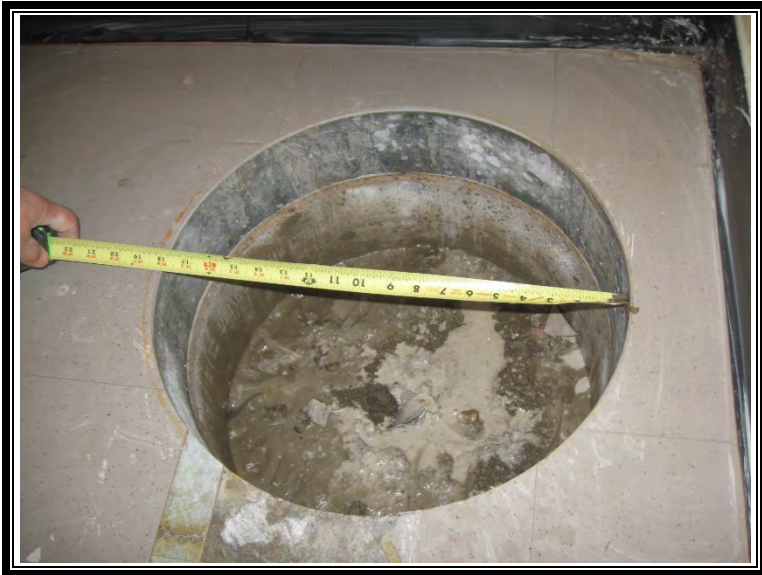
Photo 1 – Suction Pit at Bank, showing thickness of concrete

- The suction pit in the Bank for the vertical system was designed to be installed by drilling a 6-inch diameter hole through the concrete slab and then hand-digging a suction pit approximately 18-inches deep by 18-inches in diameter below the slab. However, the concrete at this location was found to be approximately 12-inches thick, which prevented hand-digging below it. Therefore, an 18-inch diameter concrete corer was used to remove the concrete slab. The underlying materials were then hand-dug and removed, and the suction pit and vertical slotted piping were installed and backfilled with pea stone. A vapor barrier (6-mil poly) was placed over the pea stone and new concrete floor installed.

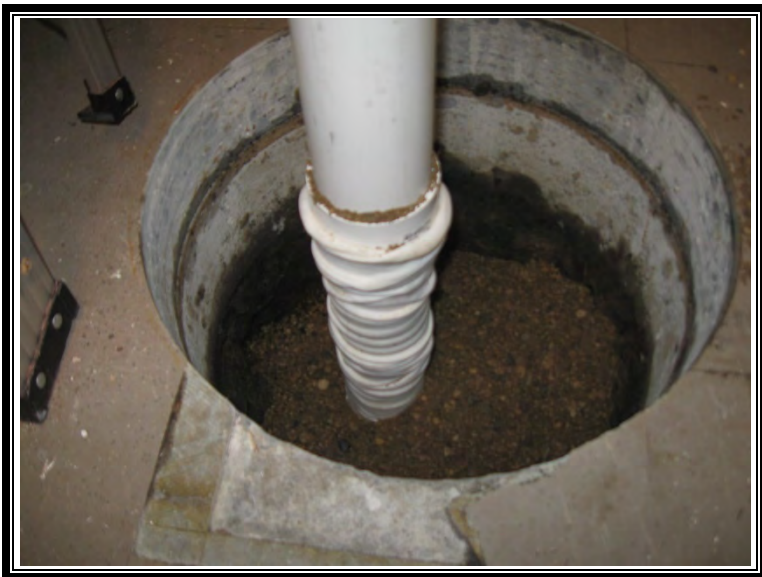
Photo 2 – Suction Pit with wrapped, slotted section of perforated pipe.

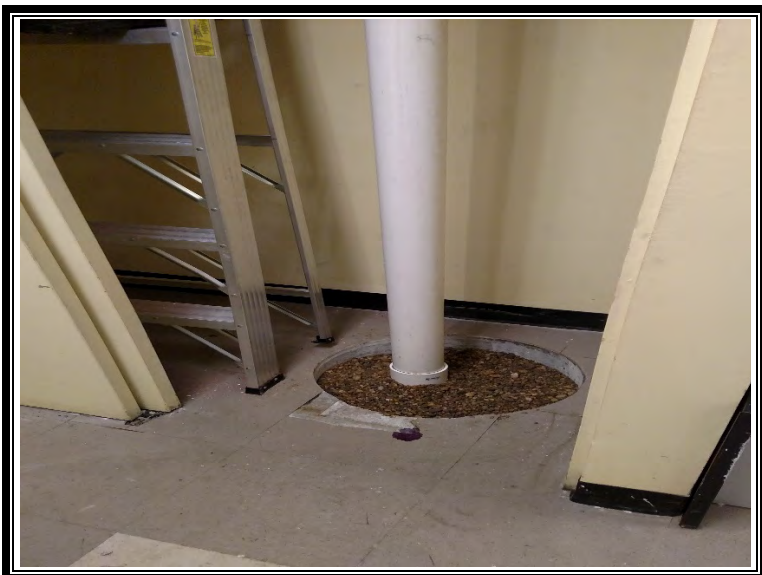
Photo 3 – Suction Pit with pea stone backfill.

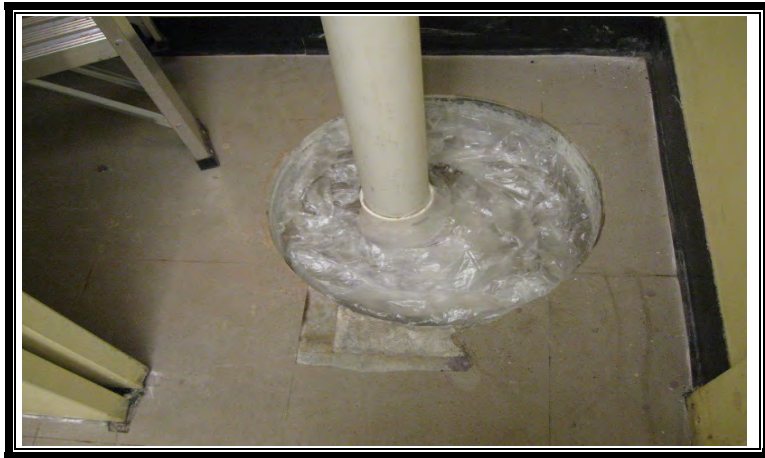
Photo 4 – Suction Pit with vapor barrier.

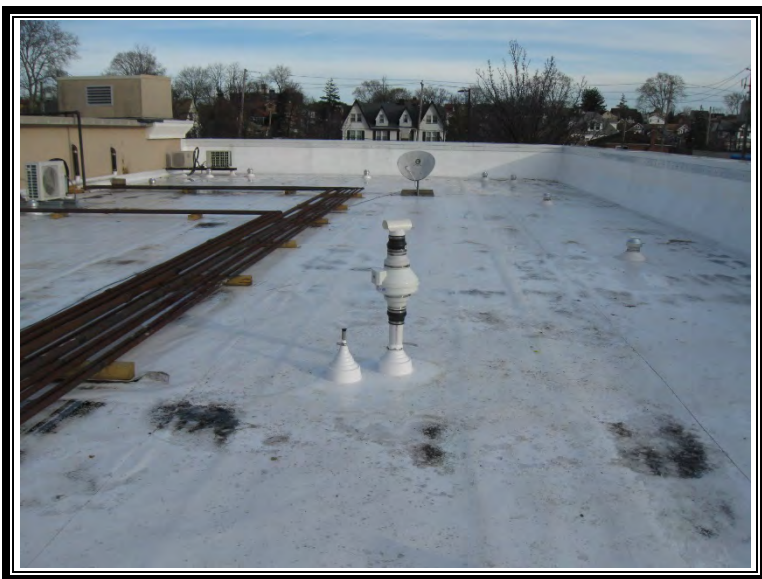
Photo 5 – Radon Fan for Bank SSDS on roof

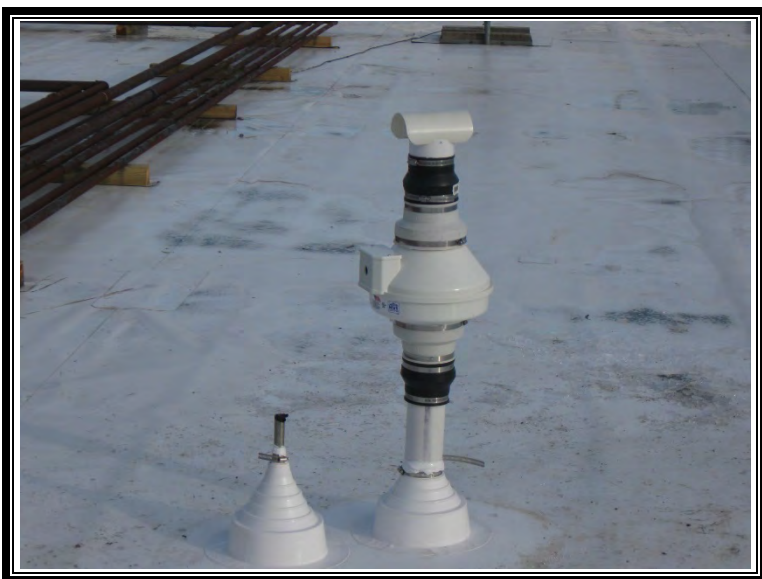
Photo 6 – Radon Fan for Bank on Roof.

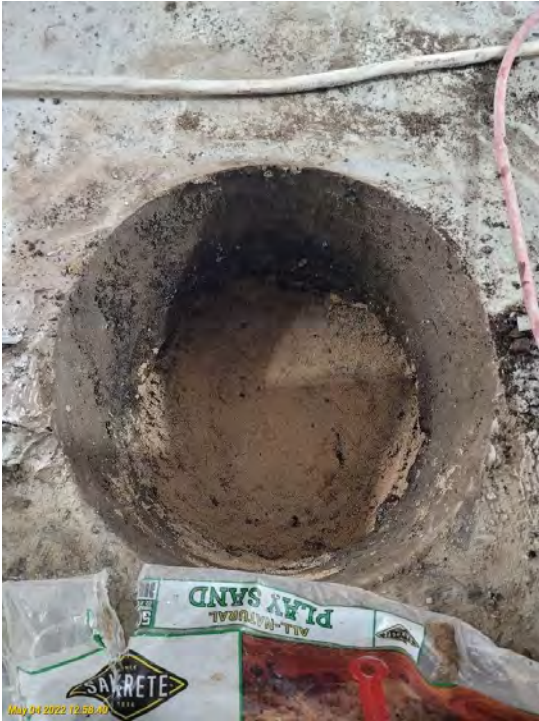
Photo Location:		
Direction:		
Survey Date: 5/4/2022		
Comments: Suction Pit: Relocated in Rehabilitation Center		
Photograph ID: 2

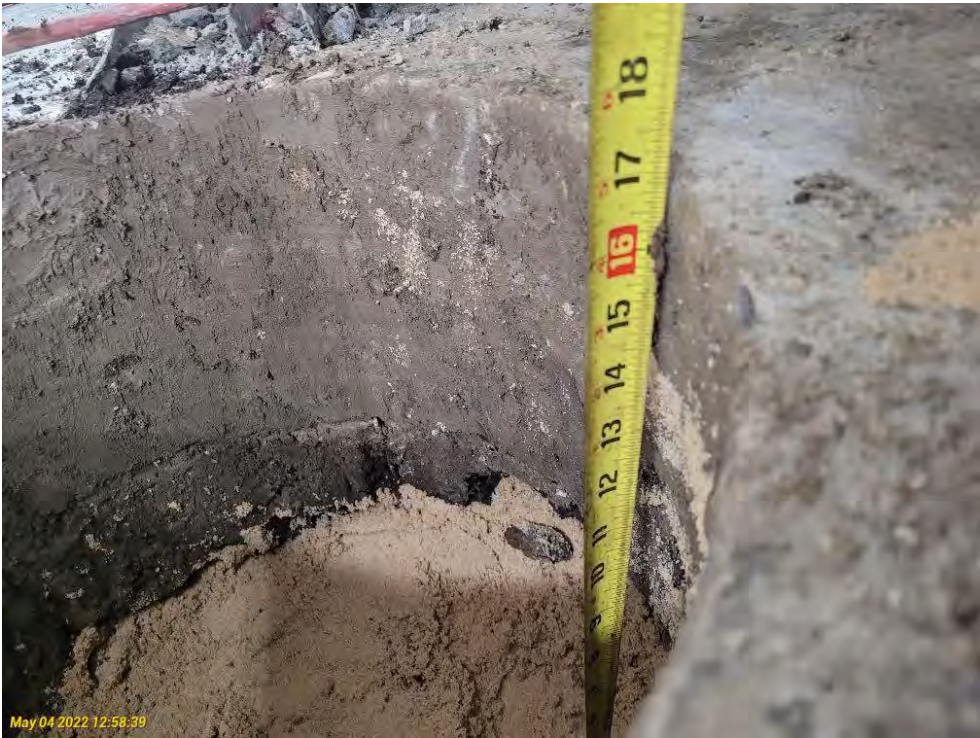
Photo Location:		
Direction:		
Survey Date: 5/4/2022		
Comments: Suction Pit: Relocated in Rehabilitation Center

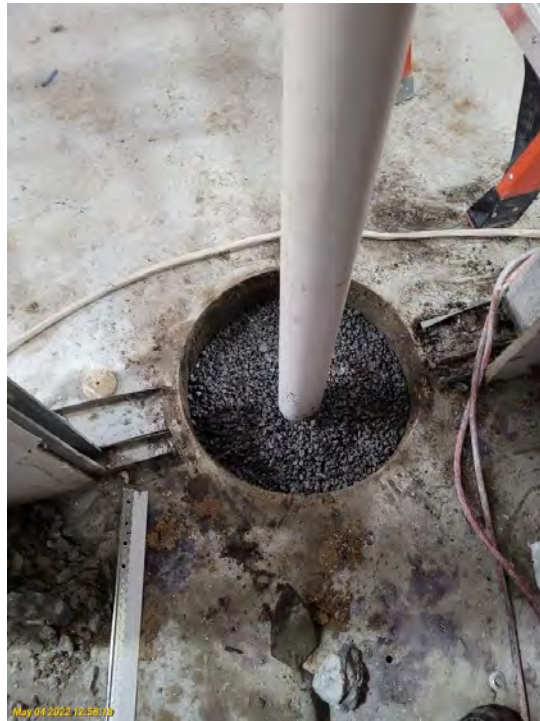
Comments:
Suction Pit with Pea Stone
Backfill

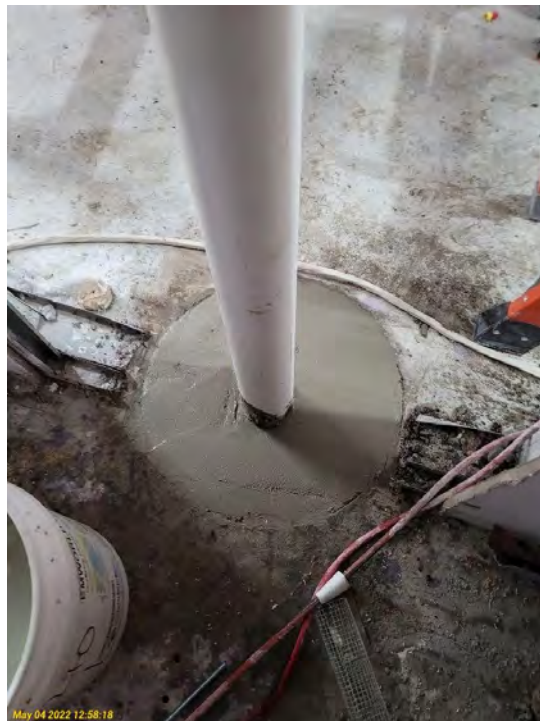
Comments:
Suction Pit with Final
Concrete

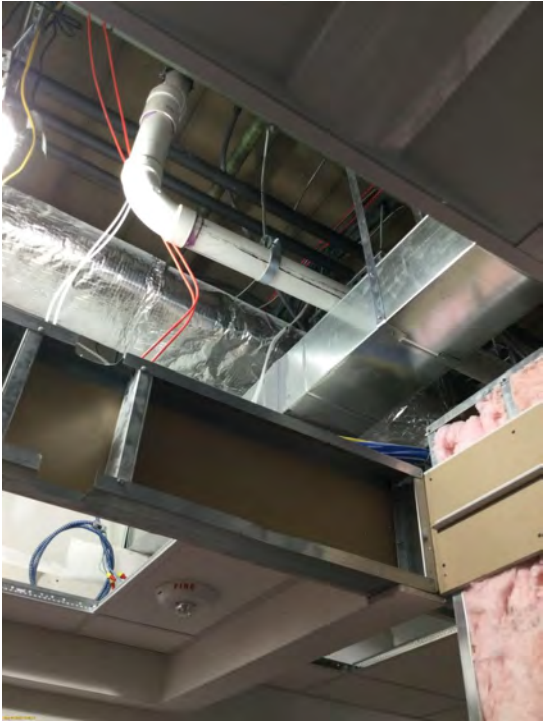
Photo Location:			
Direction:			
Survey Date: 5/4/2022			
Comments: New Piping Connected to Existing Piping Through Roof			
Photograph ID: 6

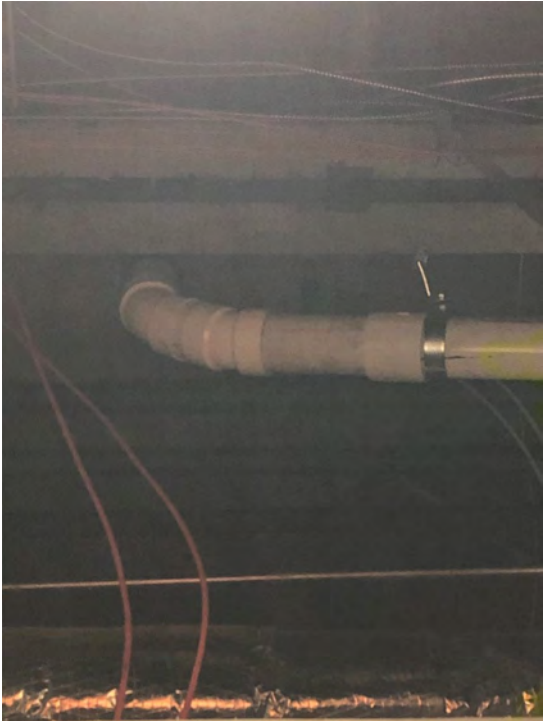
Photo Location:			
Direction:			
Survey Date: 8/5/2022			
Comments: Reconfigured piping through roof. Replaced 90 degree bends with street elbows to provide smoother air flow.
