**RE: Second Site Management Periodic Review Report
DeWalt Service Center, 56-15 Queens Boulevard, Woodside, New York
Brownfield Cleanup Program Site Number C241129**

Second Site Management Periodic Review Report

**DeWalt Service Center
56-15 Queens Boulevard
Woodside, New York**

**December 2018
(Revised March 2019)**

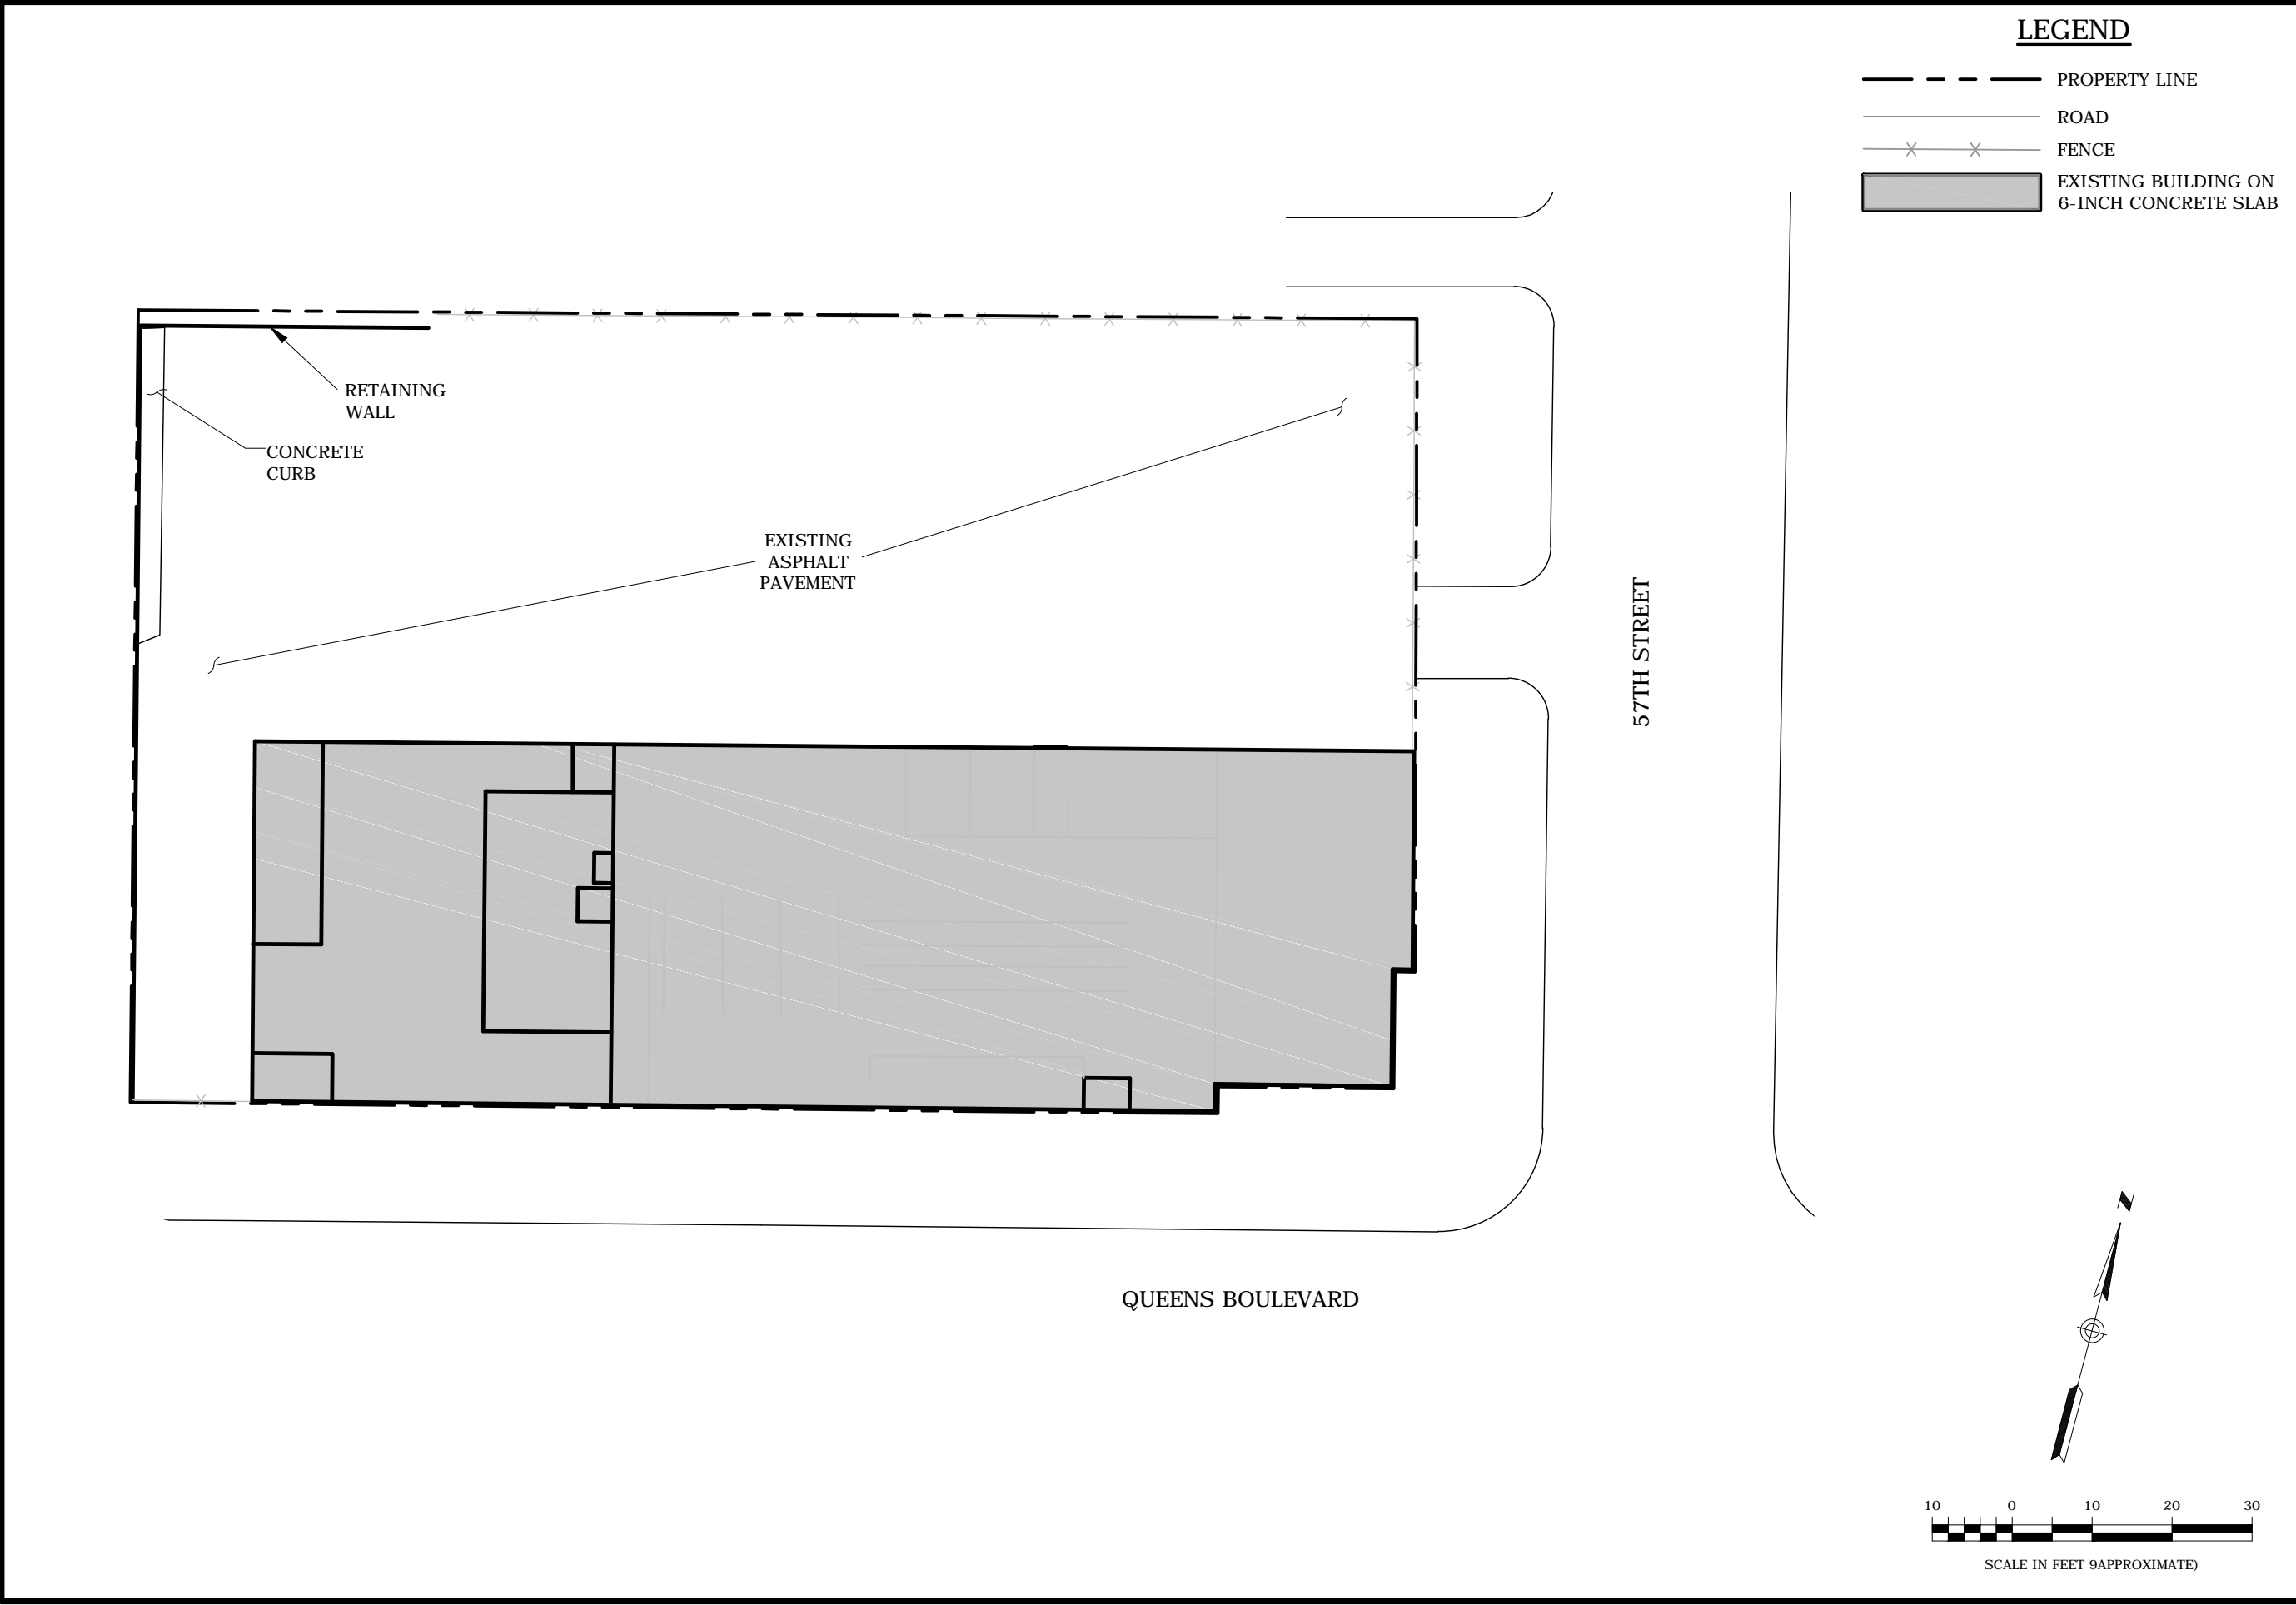
| COMPOSITE COVER SYSTEM | SCALE 1" = 20' | Loureiro Engineering • Construction • EHS • Energy Waste • Facility Services • Laboratory |

The composite cover system is inspected annually in accordance with Section 3.4 of the SMP. Inspections were performed during the reporting period on December 7, 2017 and November 30, 2018. The concrete slab for the Site building was noted to be in good condition. The asphalt pavement was observed to be intact with no visible exposure of the underlying soils. Completed inspection forms for the composite cover system are presented in Appendix B.

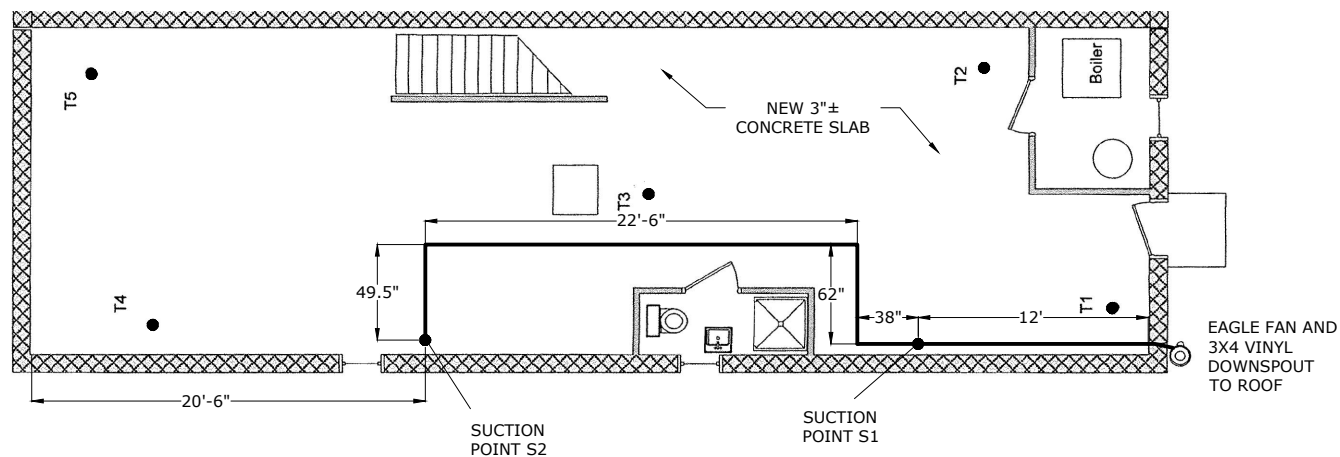
**PLAN VIEW
(REVISED SHOWING FEBRUARY 2019 REPAIRS)
43-31 57TH STREET, WOODSIDE, NEW YORK**

The SSD system at 43-31 57th Street was deactivated in early 2017 by the property owner during removal of the basement floor. A new poured concrete slab was installed in the fall 2018. On February 13, 2019, sub-slab vacuum points were re-installed beneath the slab by Loureiro and connected to the existing above grade SSD piping. The SSD fan was also replaced and power to the system was restored by a licensed electrician. As-built drawings presented in the *Sub-Slab Depressurization System Construction Completion Report* dated July 2014 have been revised to reflect the completed repairs and are presented in Appendix D.
