DeWalt Service Center
QUEENS COUNTY, NEW YORK

Fourth Site Management Periodic Review Report

**DeWalt Service Center
56-15 Queens Boulevard
Woodside, New York**

NYSDEC Site Number: C241129

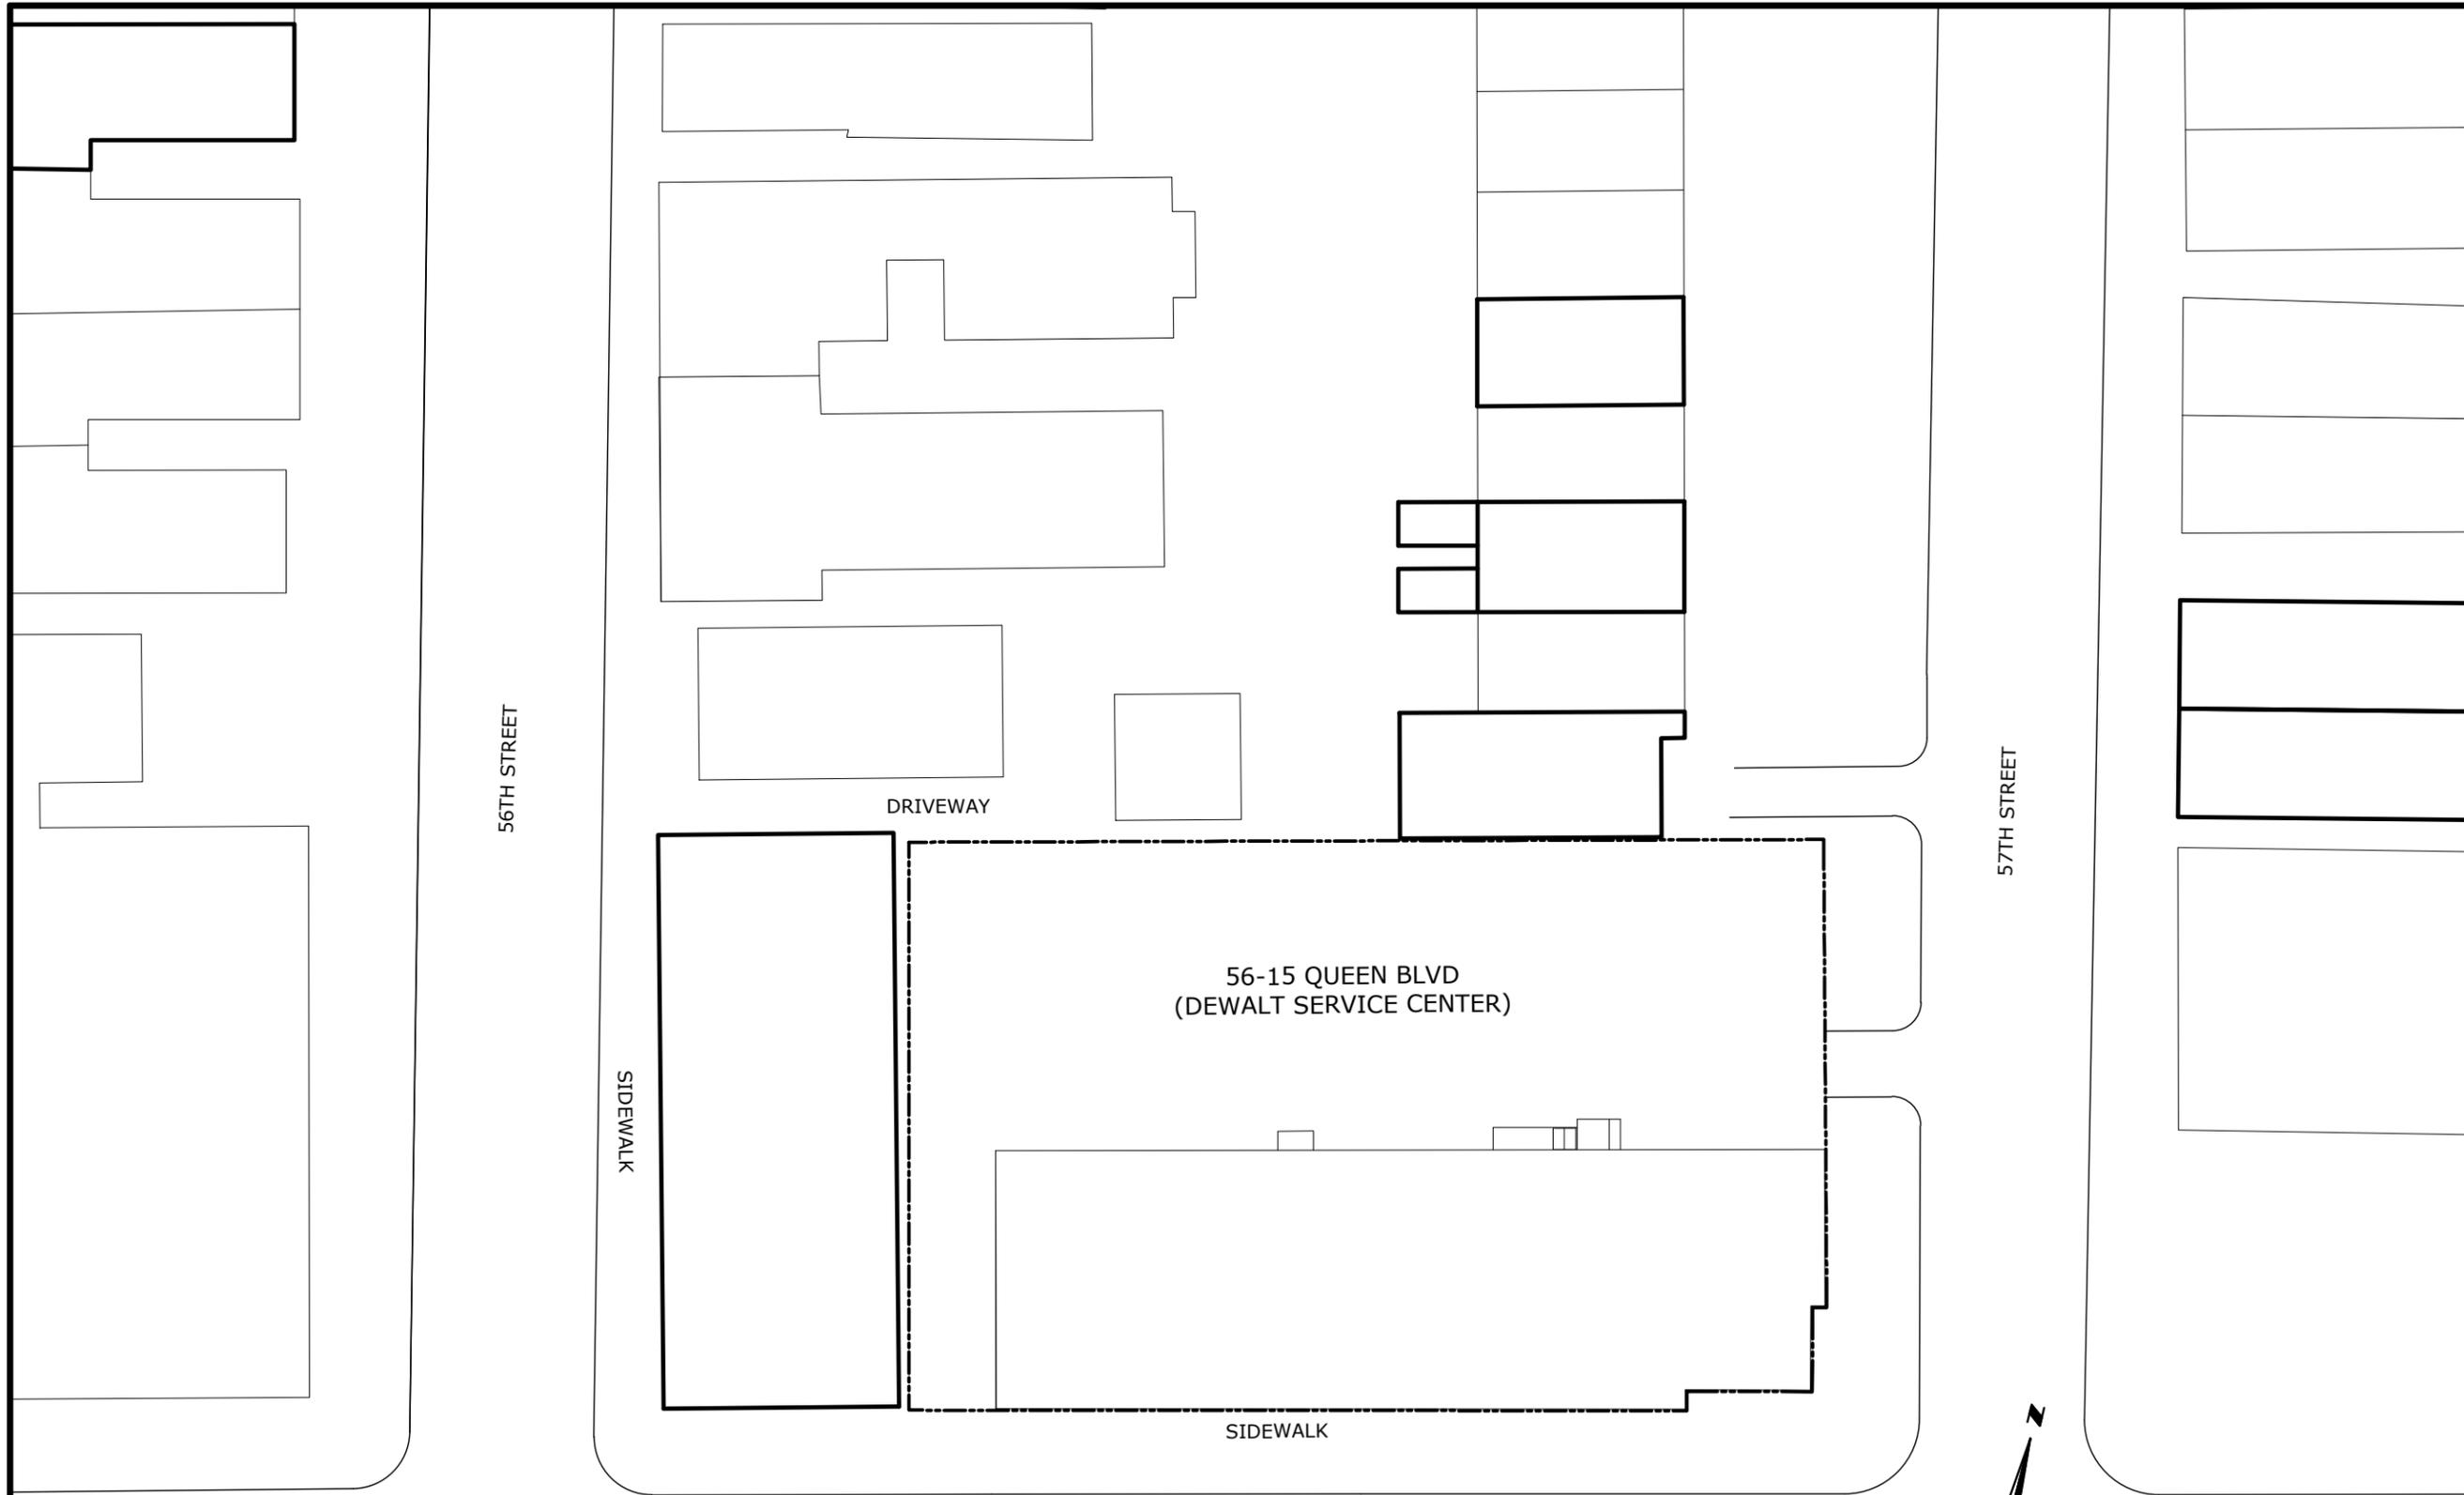
Annual inspections performed during the fall of 2020 confirmed that six of the seven systems were functioning properly. Replacement of a faulty SSD fan at 56-01 Queens Boulevard was completed on December 3, 2020 and the system was restored to full operation.
