<b>CLIENT:</b> Queens Development Group, LLC <b>PROJECT No.:</b> 170197632.300.101.0 <b>PROJECT:</b> Willets Point   OU-1 (Phase 1A) <b>LOCATION:</b> Queens, New York	<b>DATE:</b> Monday, November 28, 2022 <b>WEATHER:</b> Sunny, 34-43°F <b>TIME:</b> 6:30 AM – 2:30 PM <b>BCP SITE ID:</b> C241146
<b>EQUIPMENT:</b> Hand tools KX040-4 Kubota Excavator Kubota Excavator PC 490 Kubota Excavator PC 238 Hitachi PL5	<b>PRESENT AT SITE:</b> <b>PRESENT AT SITE:</b> <b>Langan:</b> Sophia Misiakiewicz <b>Triumph Construction:</b> (General Contractor) Scott Delise, one assistant super, and 8-person crew <b>AECOM:</b> Anthony Zaccoli and Chuck Bunyaviroch

<b>CLIENT:</b> Queens Development Group, LLC <b>PROJECT No.:</b> 170197632.300.101.0 <b>PROJECT:</b> Willets Point   OU-1 (Phase 1A) <b>LOCATION:</b> Queens, New York	<b>DATE:</b> Tuesday, November 29, 2022 <b>WEATHER:</b> Sunny, 34-43°F <b>TIME:</b> 6:30 AM – 2:30 PM <b>BCP SITE ID:</b> C241146
<b>EQUIPMENT:</b> Hand tools KX040-4 Kubota Excavator Kubota Excavator PC 490 Kubota Excavator PC 238 Hitachi PL5	<b>PRESENT AT SITE:</b> <b>PRESENT AT SITE:</b> <b>Langan:</b> Sophia Misiakiewicz <b>Triumph Construction:</b> (General Contractor) Scott D

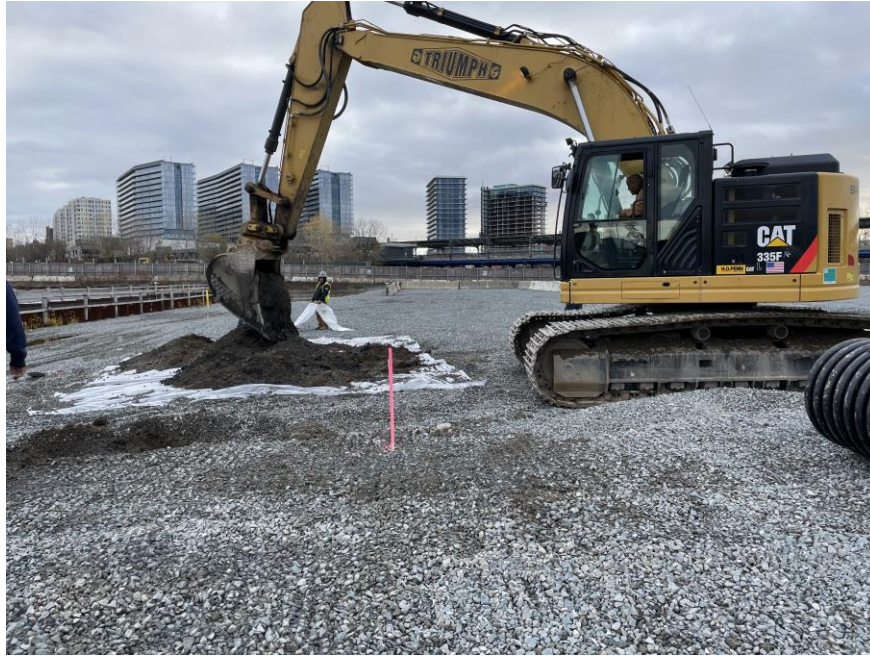
Photo 1: Triumph excavating and segregating clean fill and contaminated fill adjacent to excavation in the southern part of site (facing east)

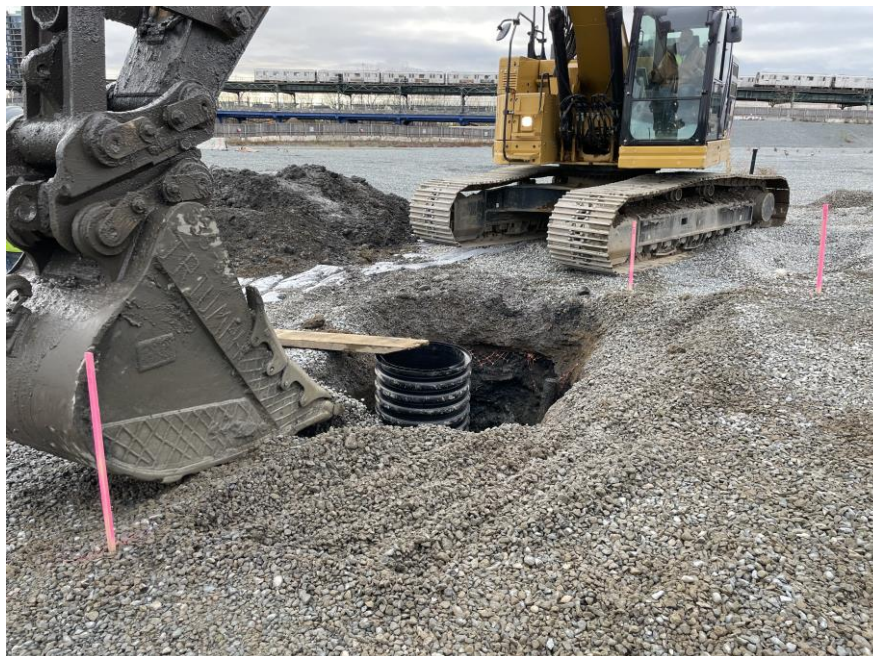
Photo 2: Triumph backfilling excavated area with 3/4-inch stone and imported clean fill (facing southeast)

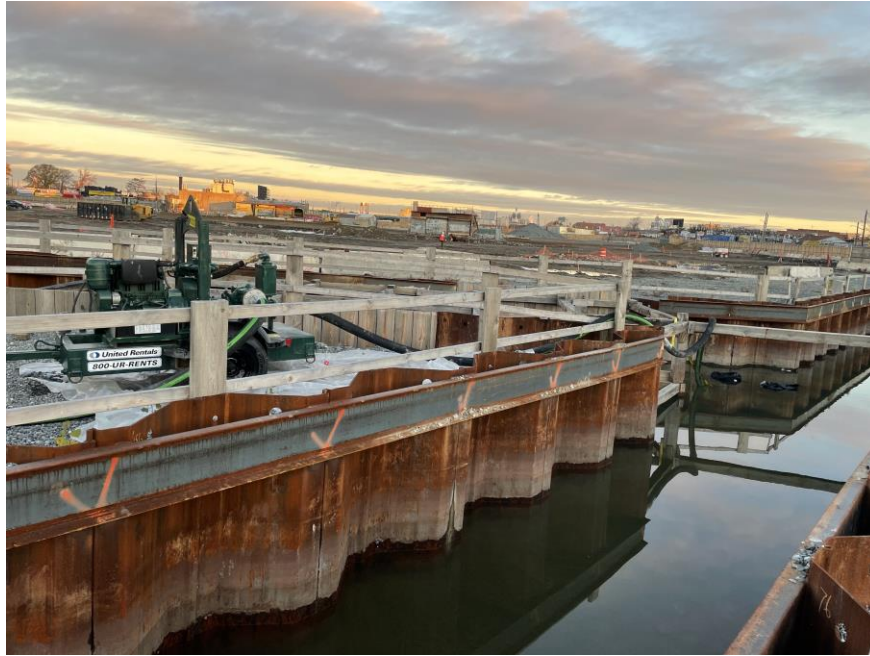
Photo 1: Triumph dewatering the water main trench (facing north)

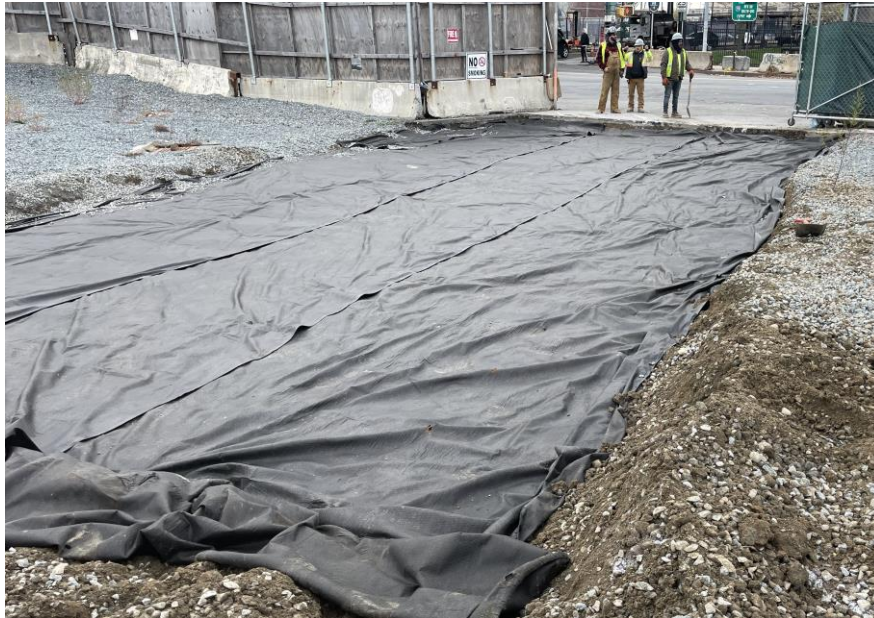
Photo 2: View of placing geotextile fabric for construction entrance in the southwest part of the site (facing southwest)

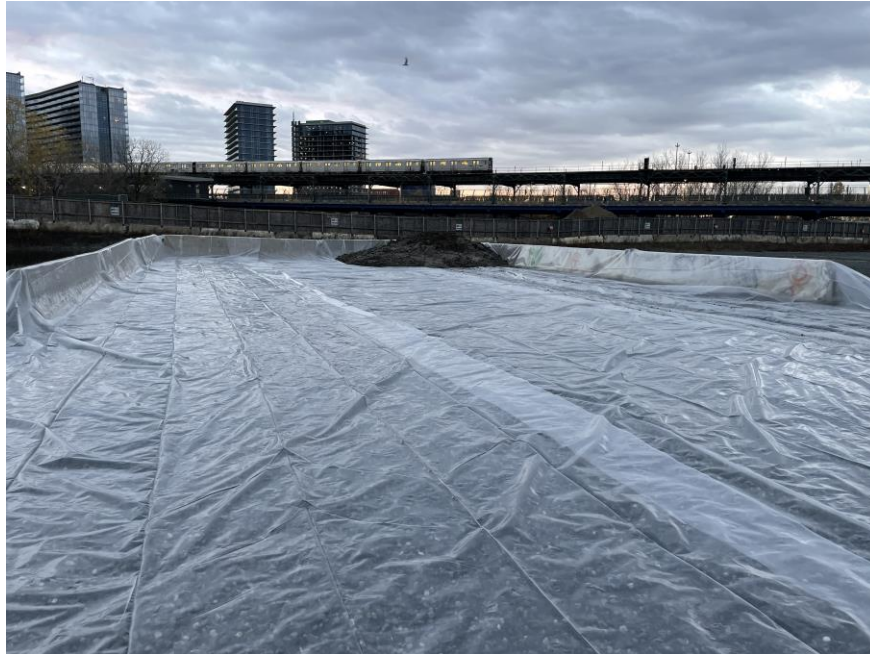
Photo 1: View of polyethene sheeting placed in the eastern part of site (facing east)

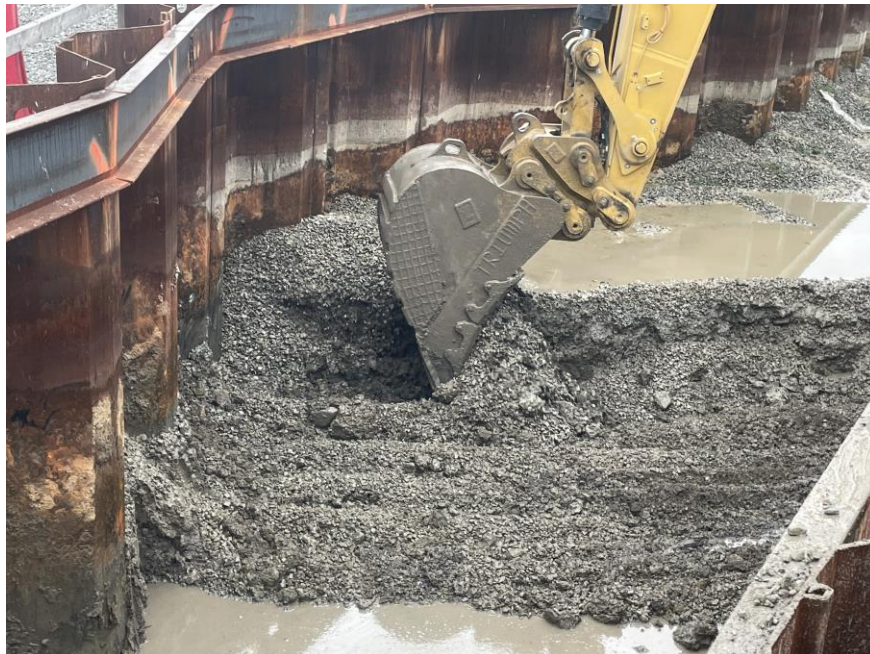
Photo 2: Triumph excavating 3/4-inch stone in the northern part of the 72" truck water main (facing northwest)
