18-46 Decatur Street Periodic Review Report

18-46 Decatur Street, Ridgewood, Queens, New York
Block 3579, Lot 45
NYSDEC BCP Site Number: C241194

May 2025

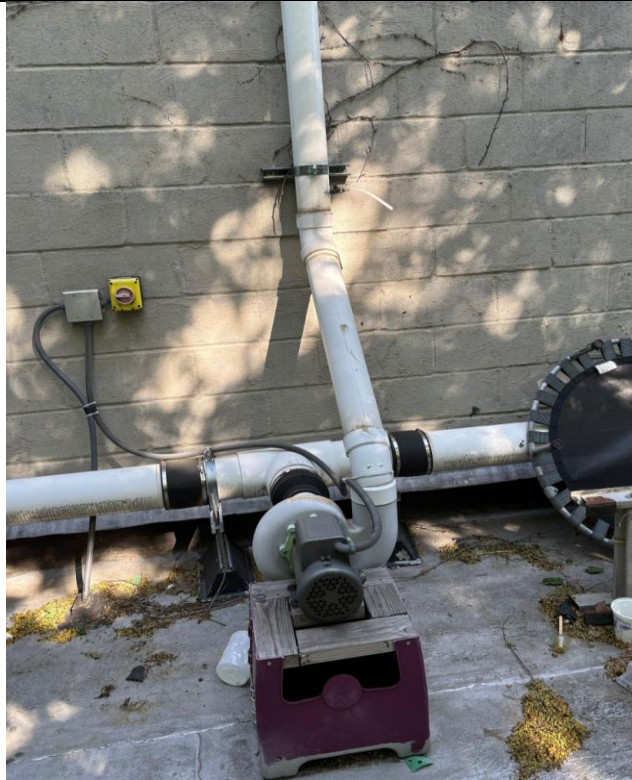
Photo 1 –
View of the
fan.

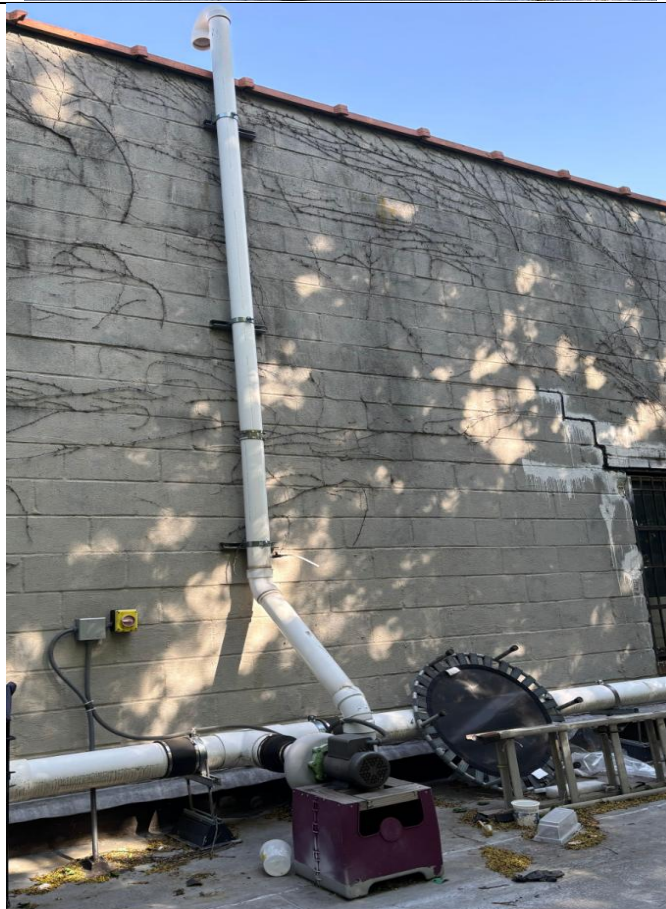
Photo 2 –
View of the
fan and
exhaust stack.

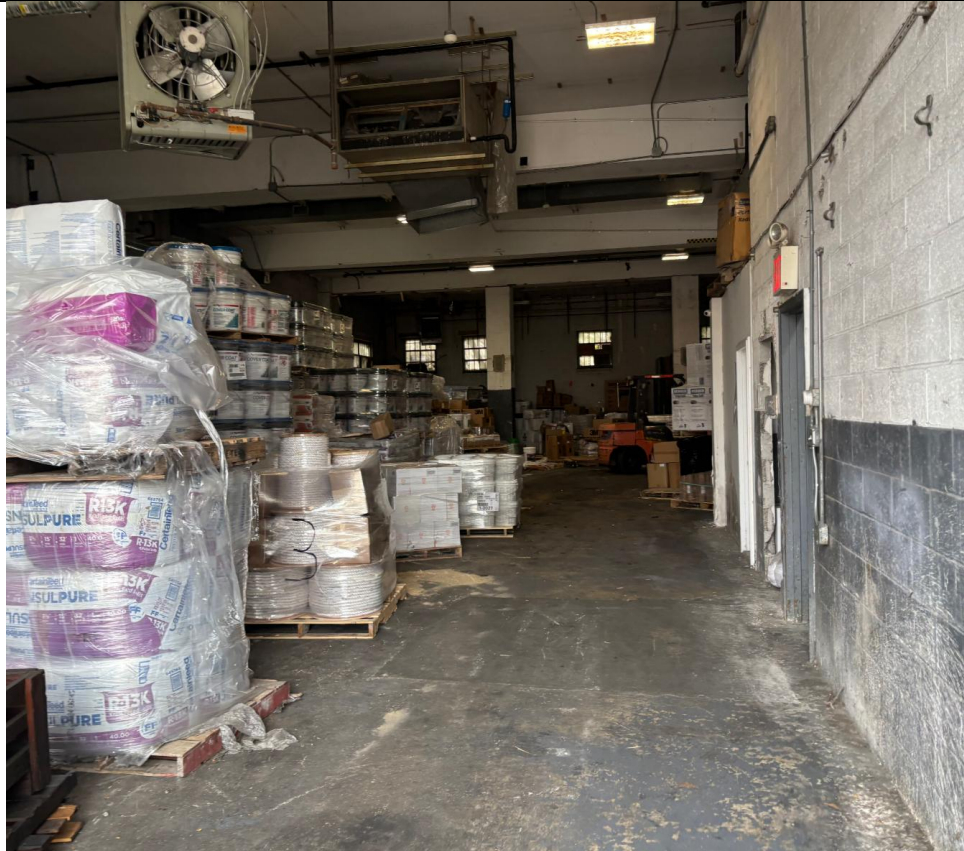
Photo 3 –
View of the
warehouse.

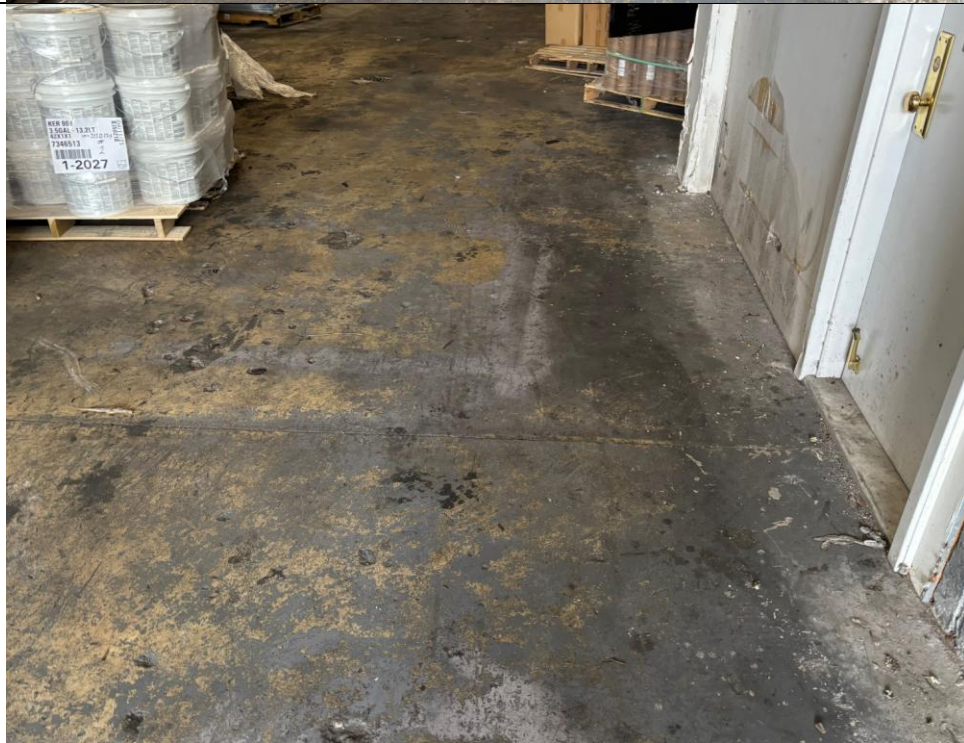
Current status: The soil cover system remains in place with no observed breach. The composite cover system is a permanent control and the quality and integrity of this system has been inspected annually as per the SMP. The inspection checklist is included in Appendix 1.

Photo 4 –
View of the
concrete slab.

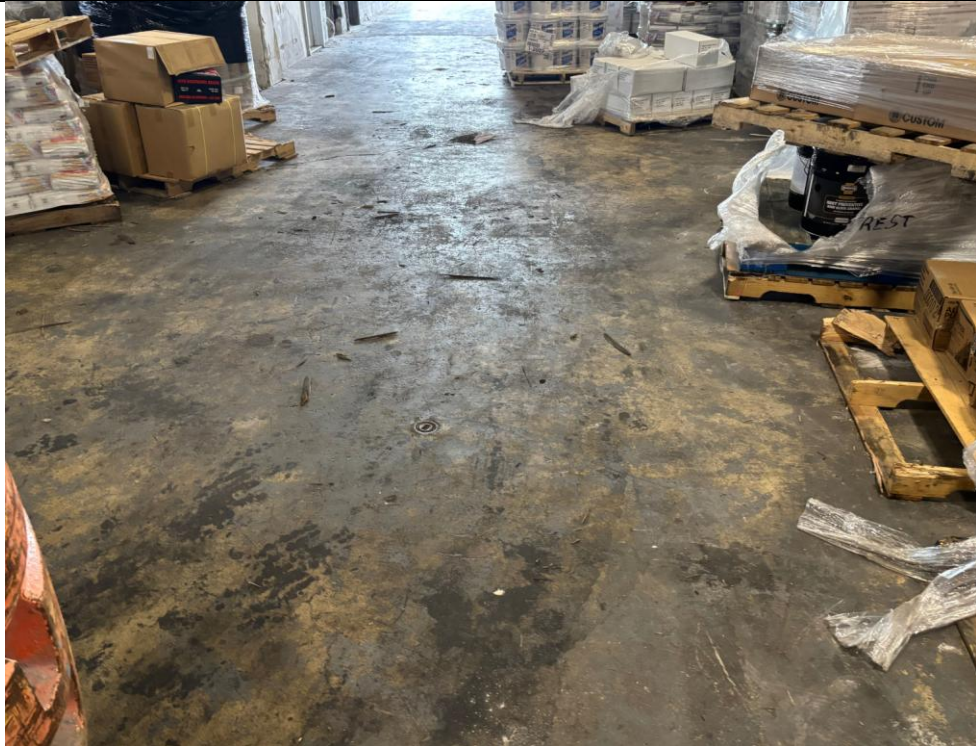
Photo 5 –
View of the
concrete slab.

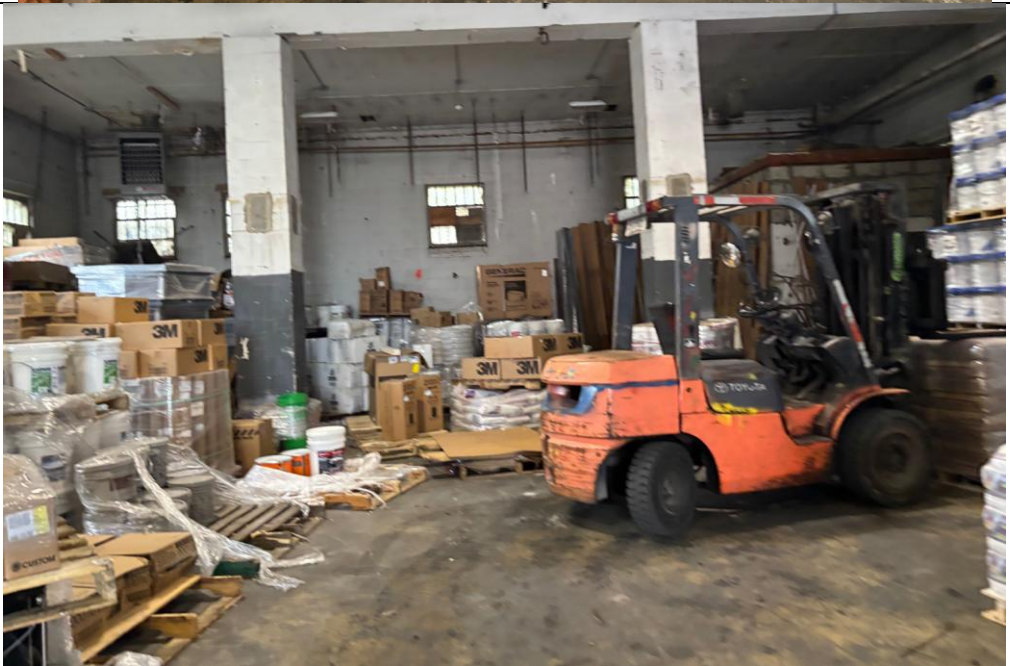
Photo 6 –
View of
warehouse.

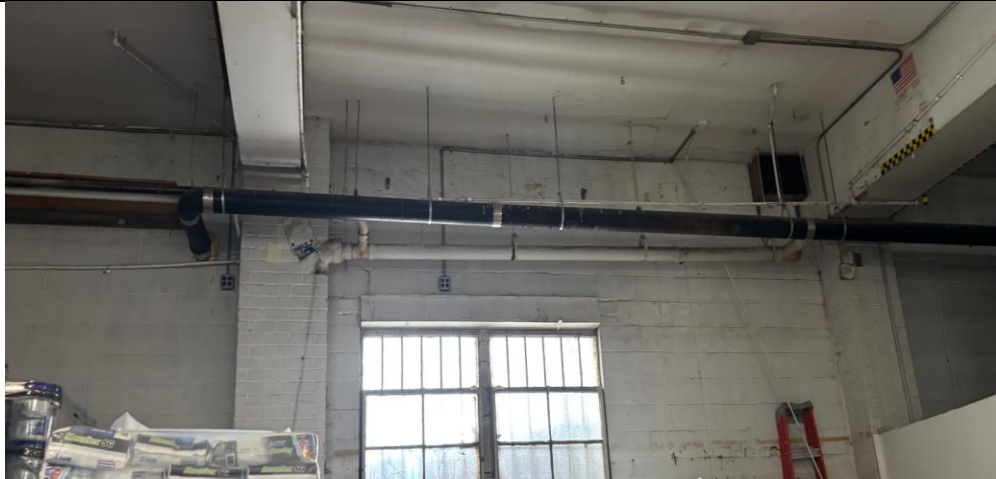
Photo 7 –
View of riser
pipe.

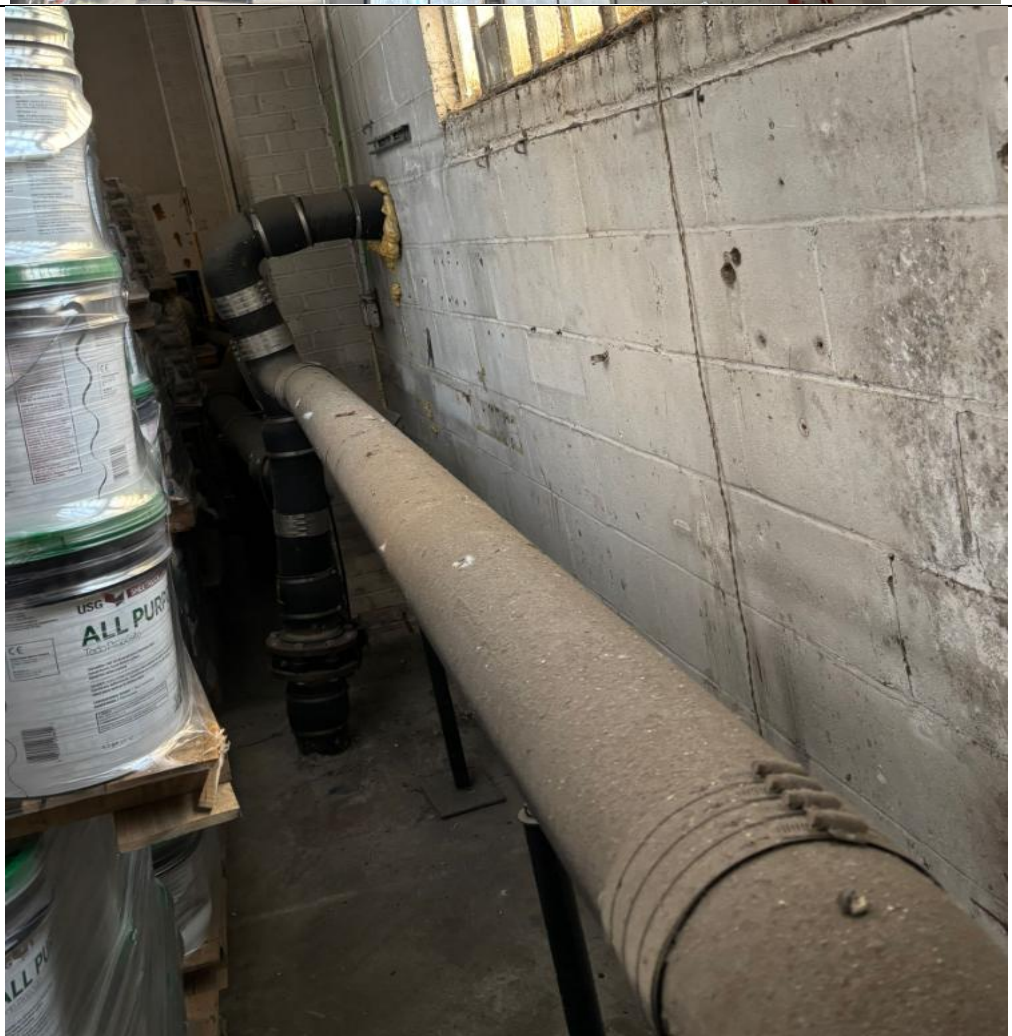
Photo 8 –
View of SVE
wells and
riser pipe.

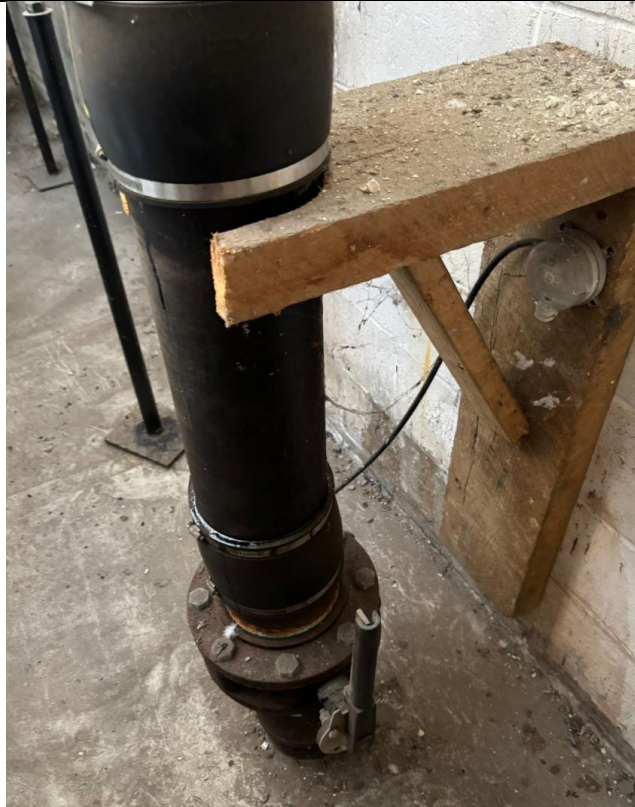
Photo 8 –
View of SVE
well.

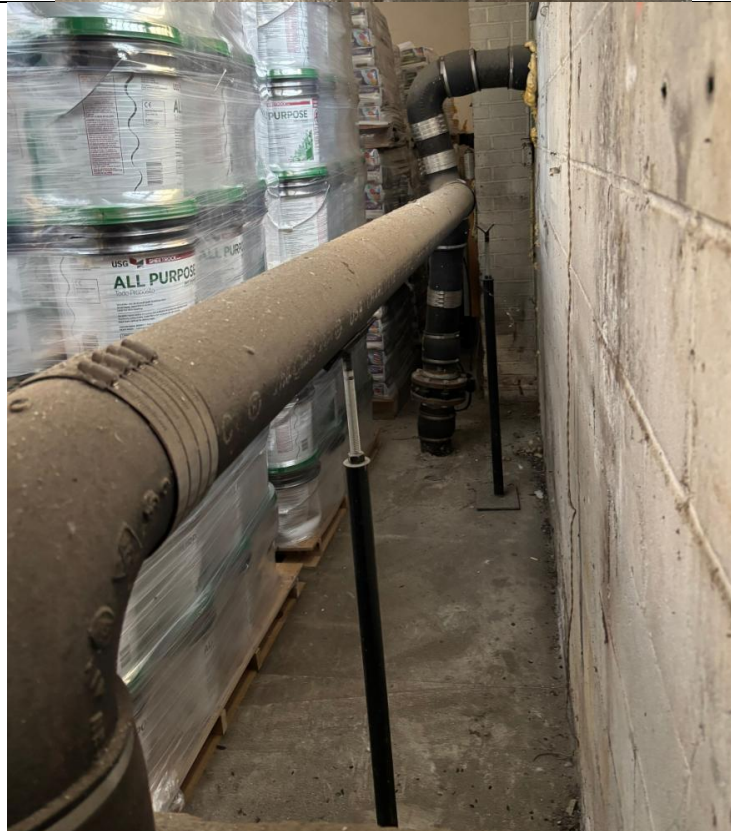
Photo 9 –
View of SVE
wells and
riser piping.

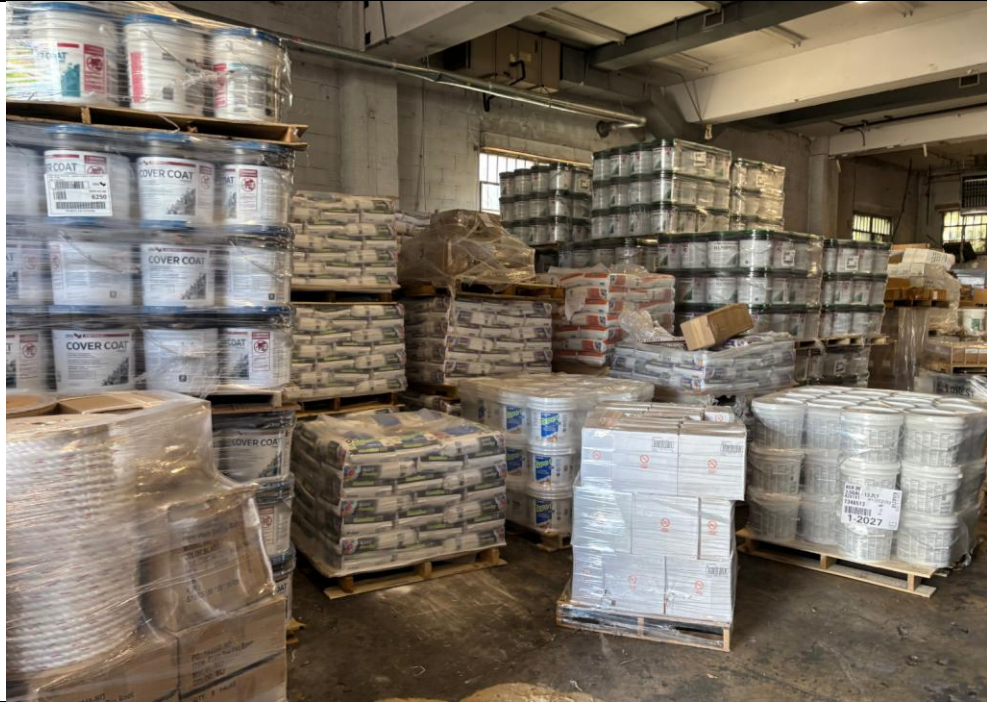
Photo 10 –
View of
warehouse.
