**DAILY STATUS REPORT**

NYSDEC BCP Project No.:	C241199	NYCOER Project No.:	17CVCP044Q	Date:	8/1/2023
Project Name:	148-28 Hillside Avenue

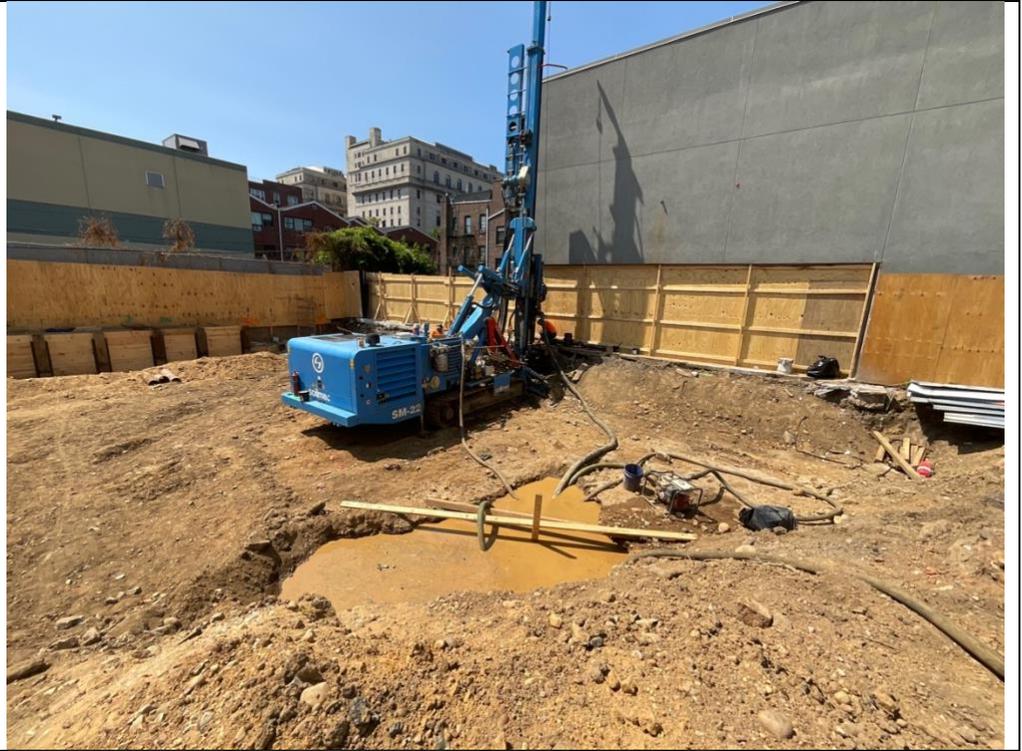
Photo 1 – Installation of the shoring pile on the southwestern portion of the property.

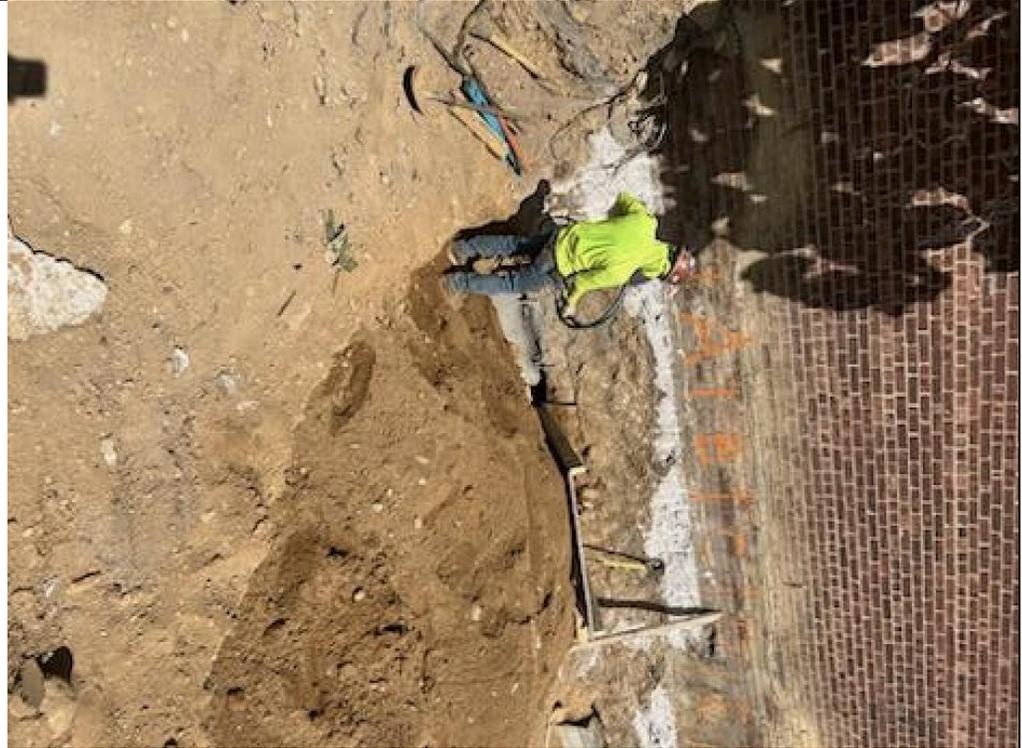
Photo 2 – Installation of lagging support on the southeastern portion of the property.

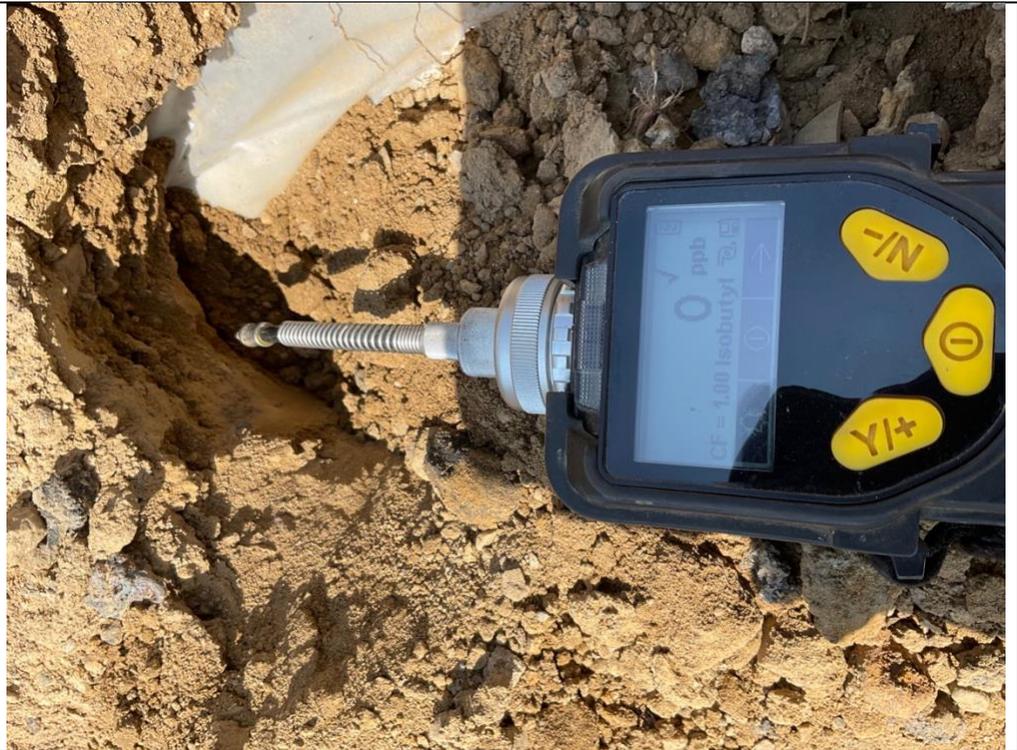
No PID readings were observed from the hazardous stockpile.

Photo 3 – PID readings in the hazardous stockpile.

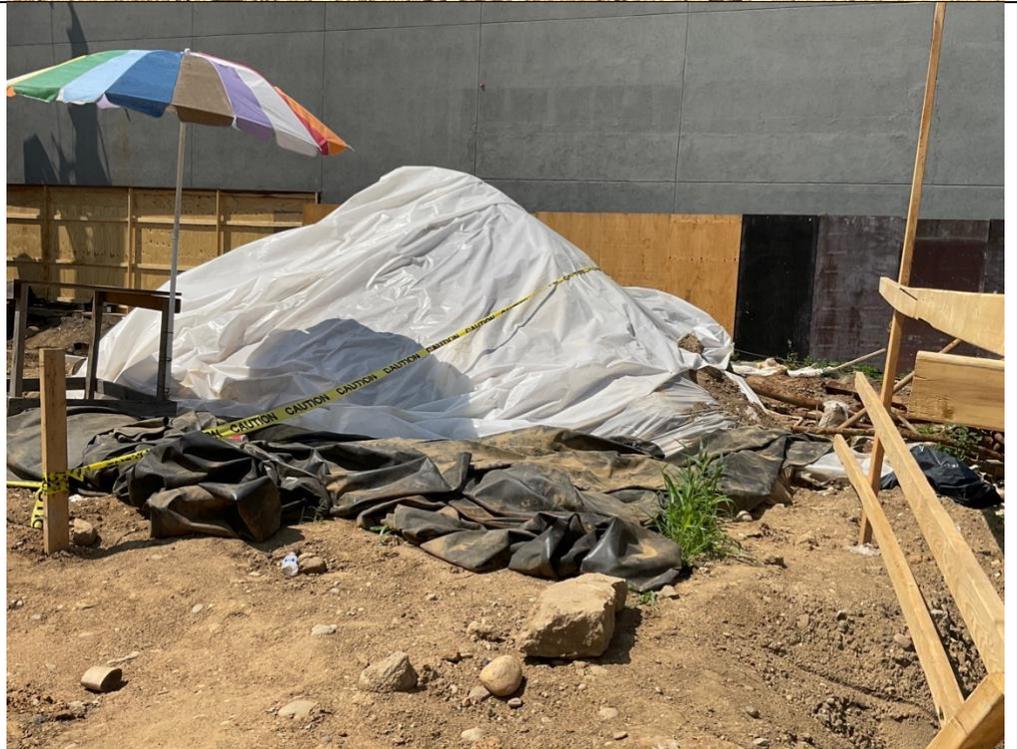
Photo 4 – The hazardous stockpile was covered with a plastic tarp after waste characterization sampling.

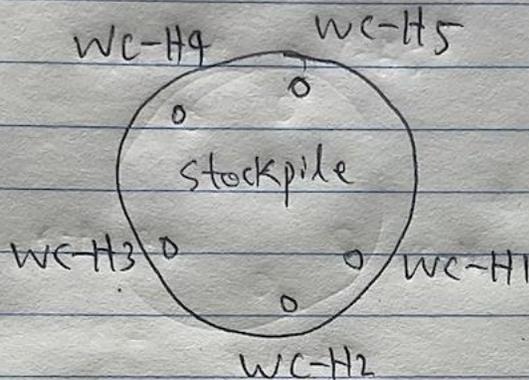
Soil Sampling at Hazardous Stockpile  
Hillside Avenue

- One composite soil sample collected from WC-H1, WC-H2, WC-H3, WC-H4, WC-H5.
- One Voc sample collected at WC-H1.
