Daily Report for November 1, 2019

**Far Rockaway Project
20-02 Mott Avenue
Far Rockaway, NY
BCP #C241224**

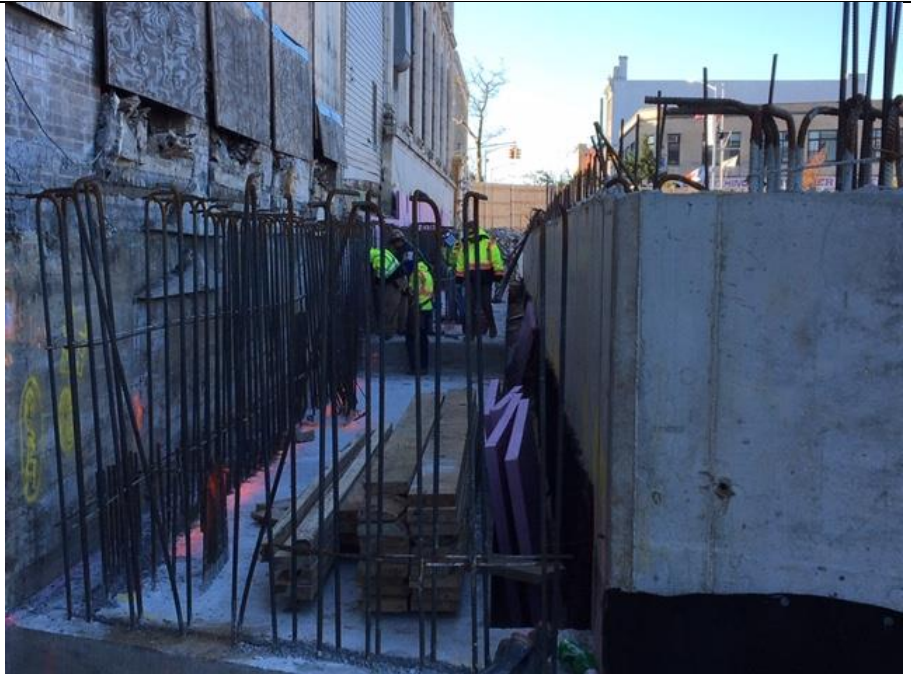
Photo 1- View of formwork in F2 and F3.

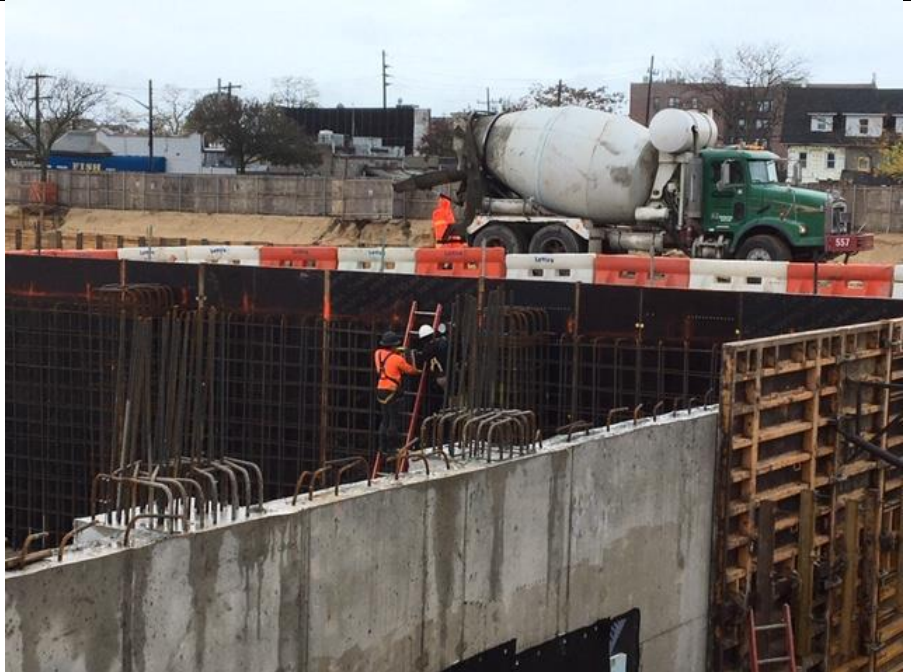
Photo 2- View of rebar installation in D3.

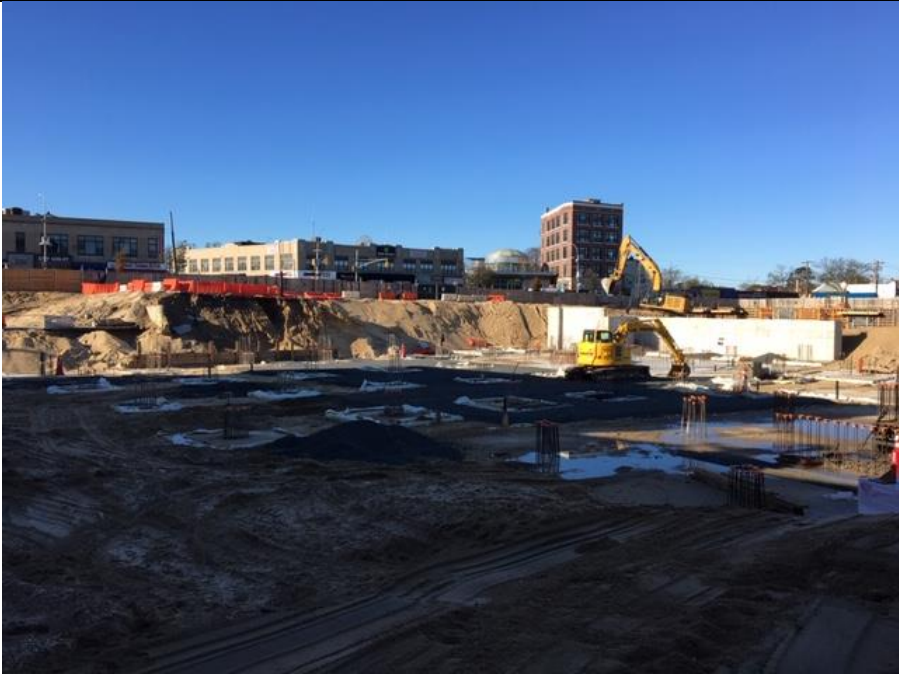
Photo 3- View of Building B footprint.

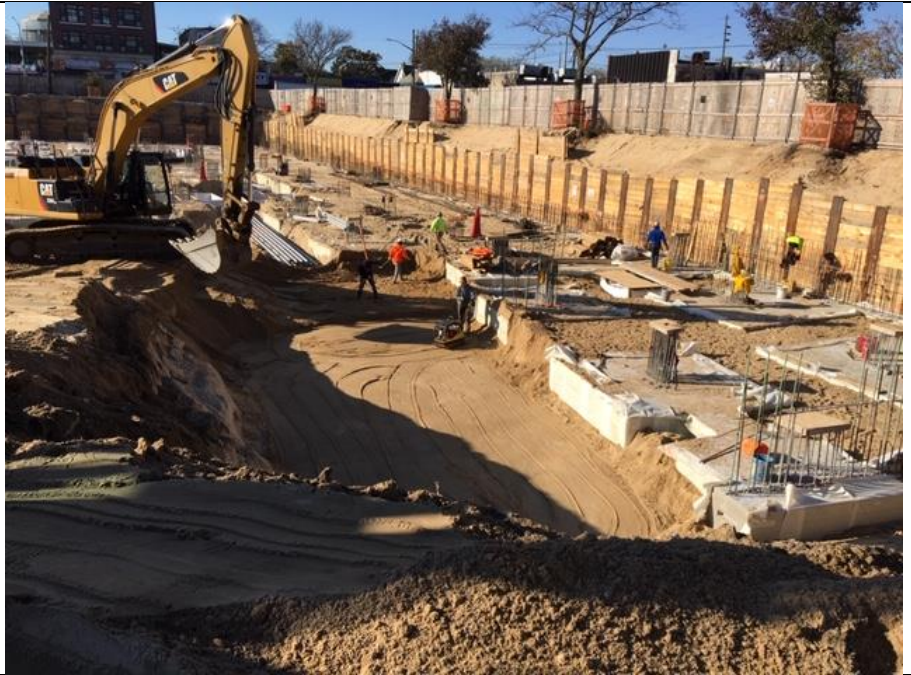
Photo 1- View of soil grading in A3 and A4.

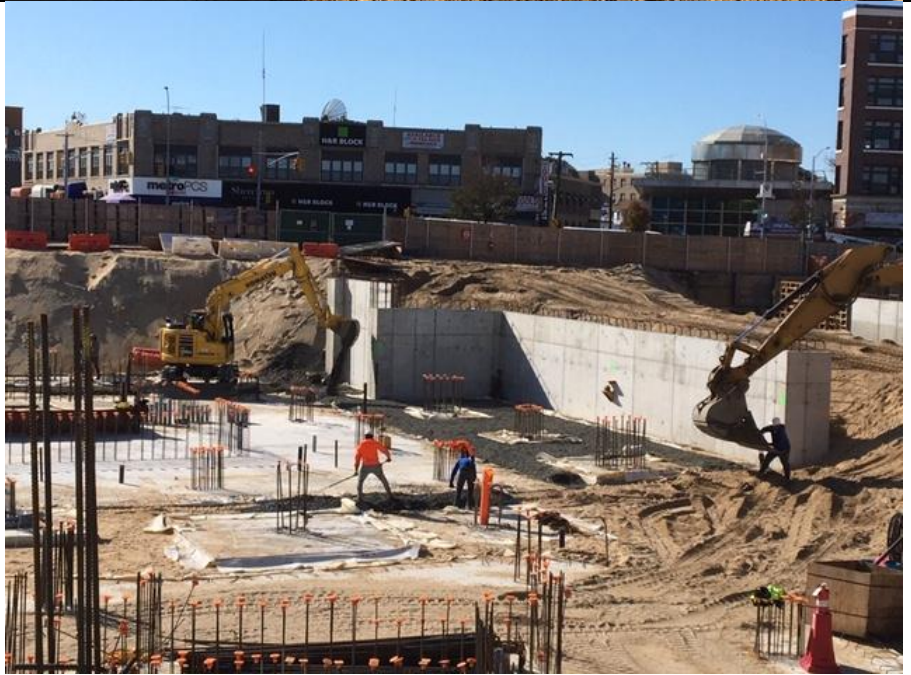
Photo 2- View of spreading stone in C1.

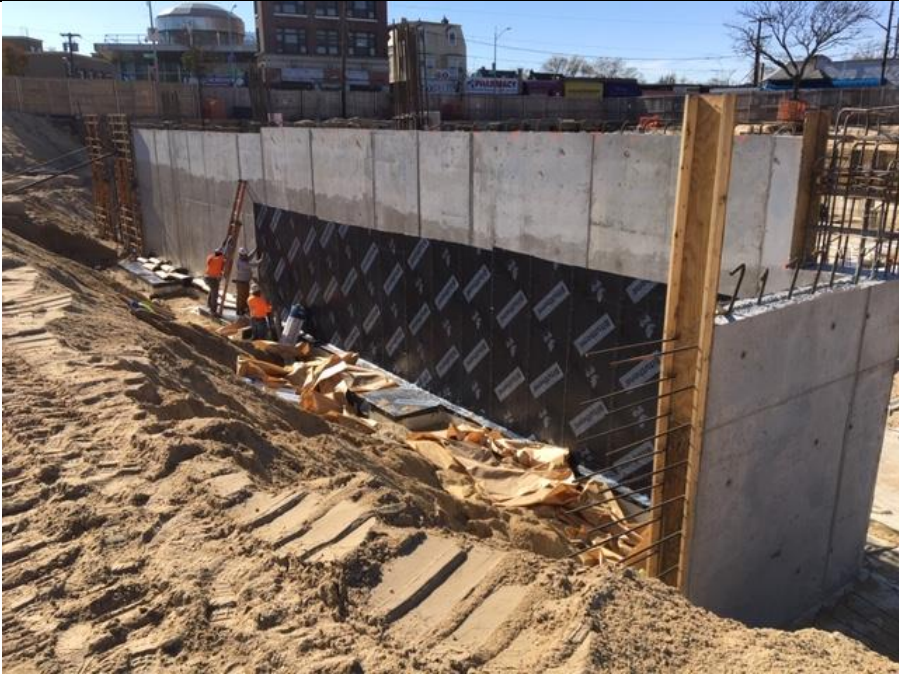
Photo 3- View of waterproofing in B1 and B2.

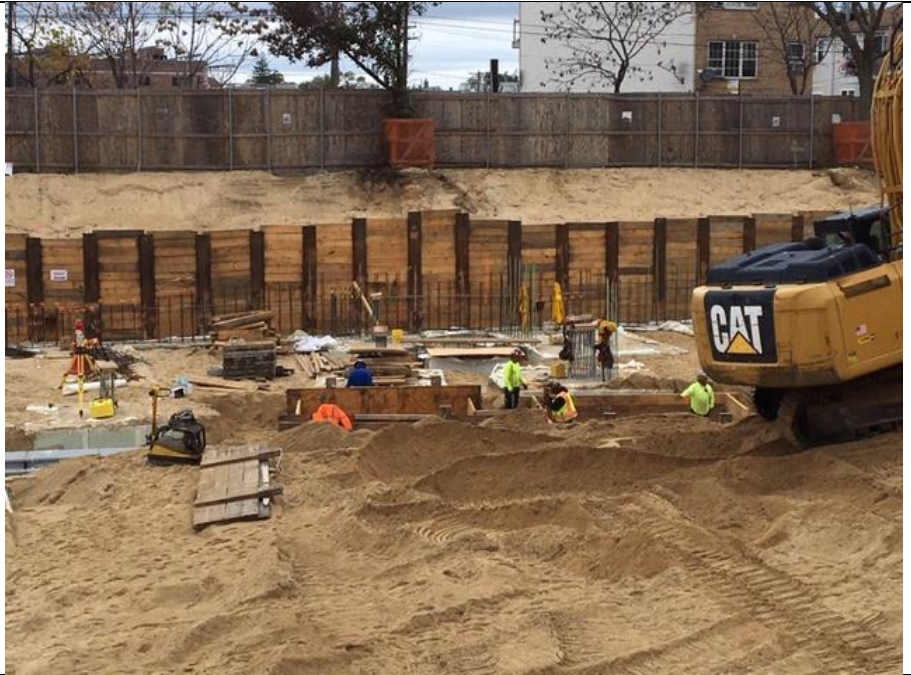
Photo 1- View of formwork in A3 and A4.

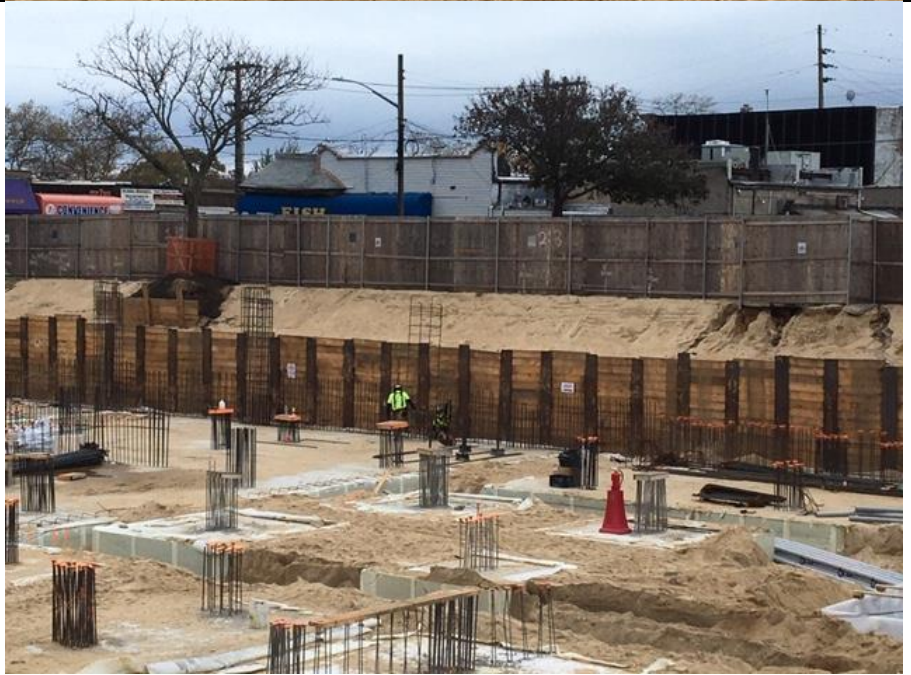
Photo 2- View of rebar installation in A2.

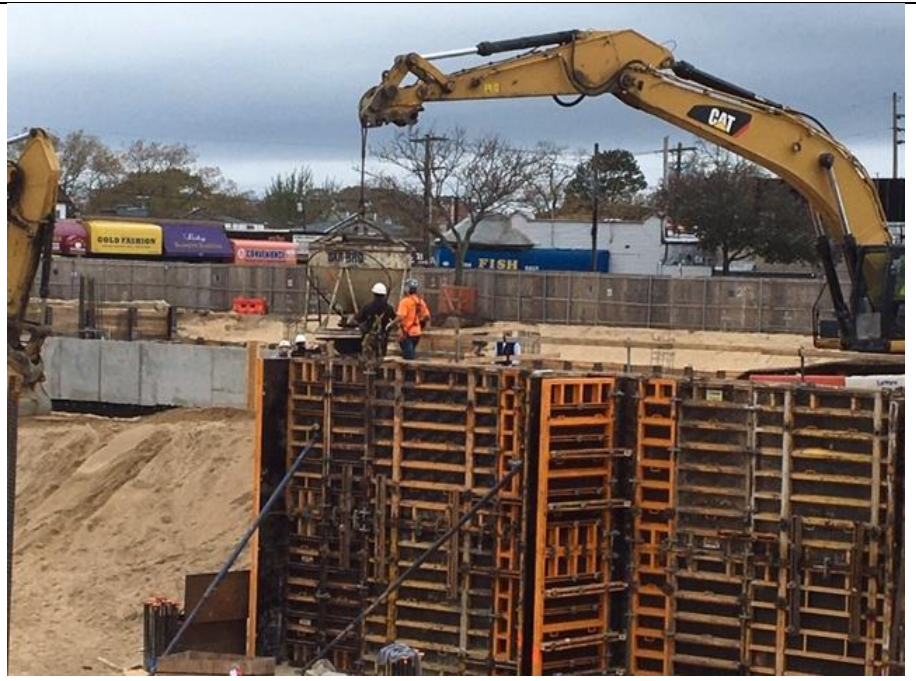
Photo 3- View of pouring concrete in D3.

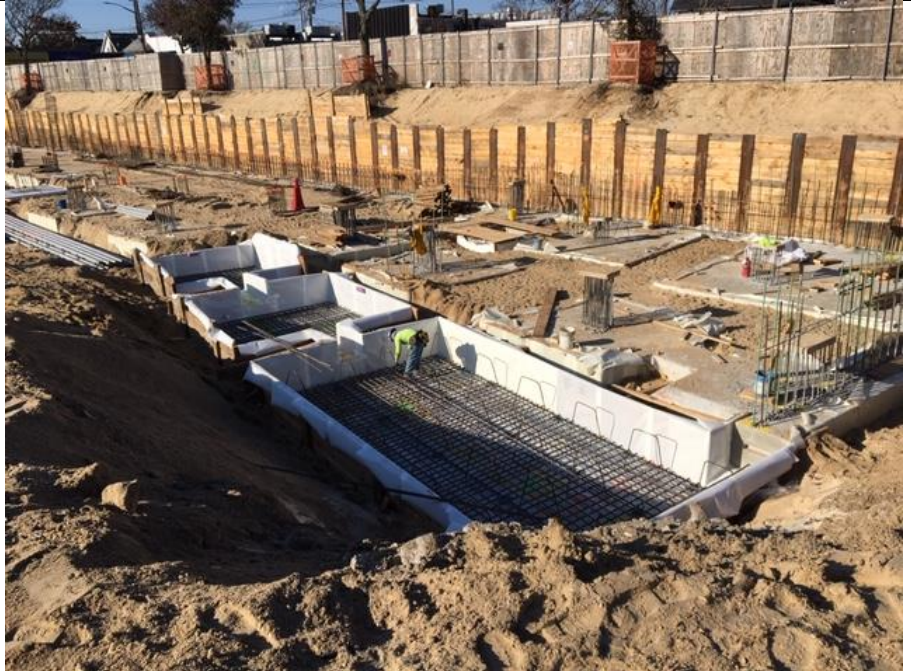
Photo 1- View of rebar installation in A3 and A4.

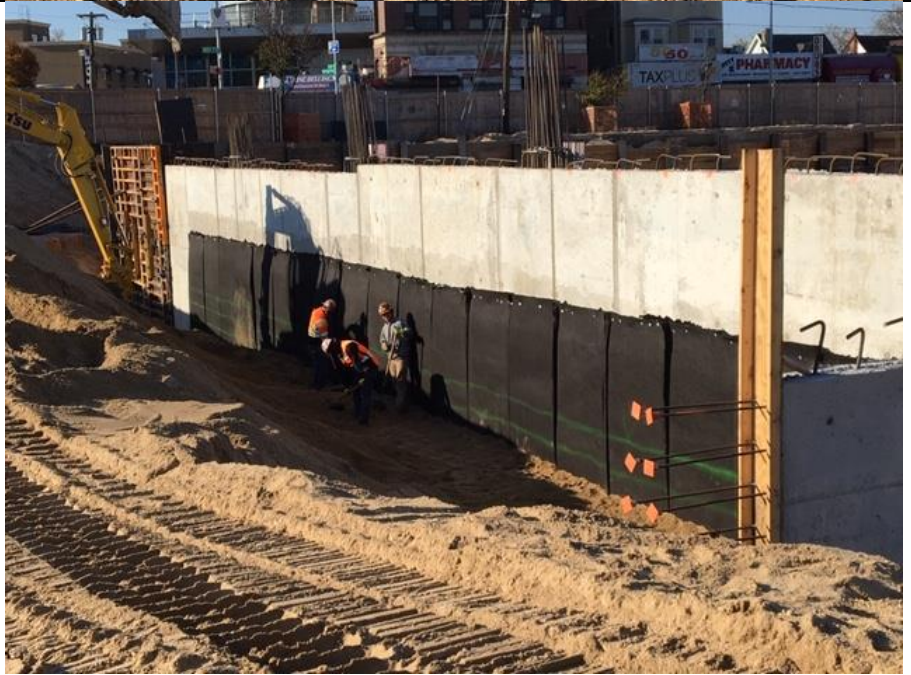
Photo 2- View of backfilling in B1 and B2.

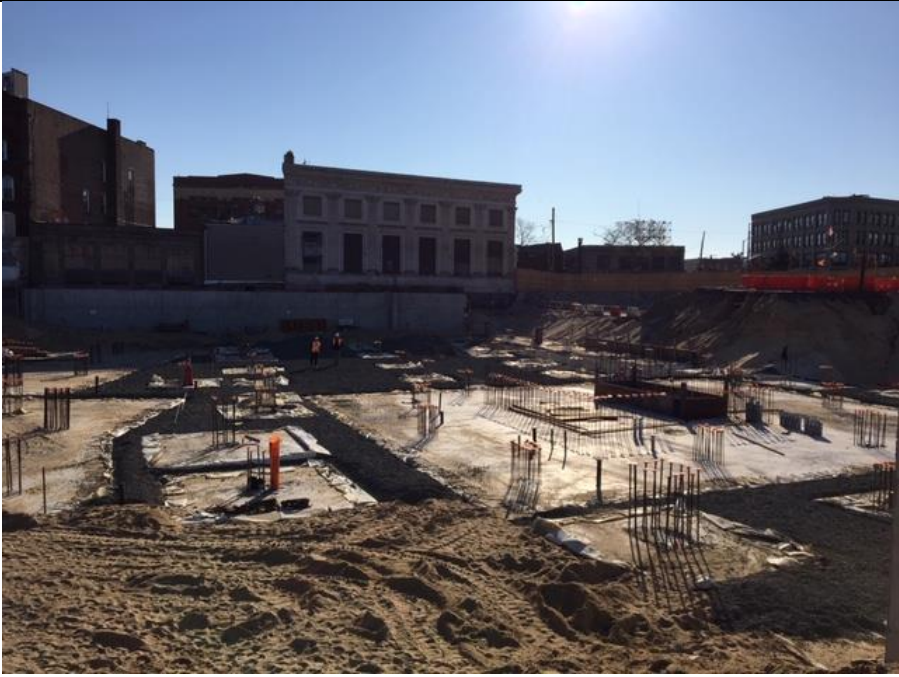
Photo 3- View of Building B footprint.

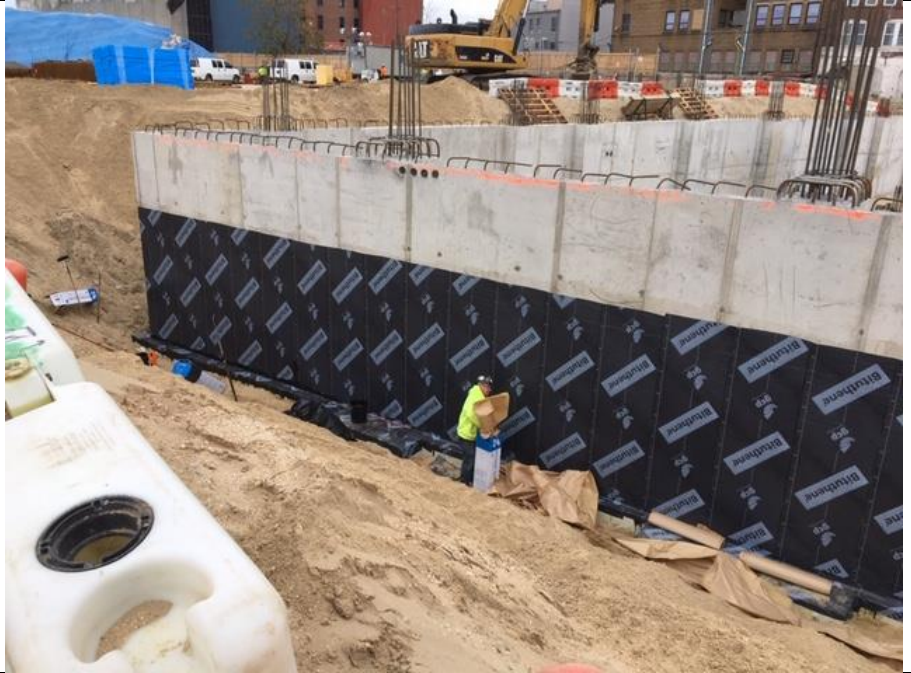
Photo 1- View of Bituthene installation in D2 and D3.

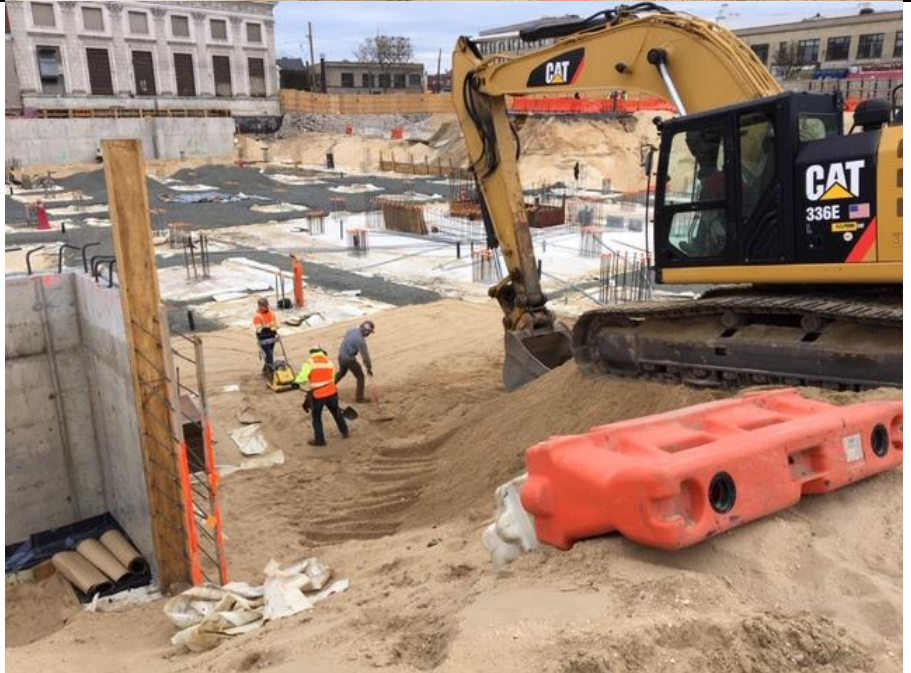
Photo 2- View of grading soil in C2 and D2.

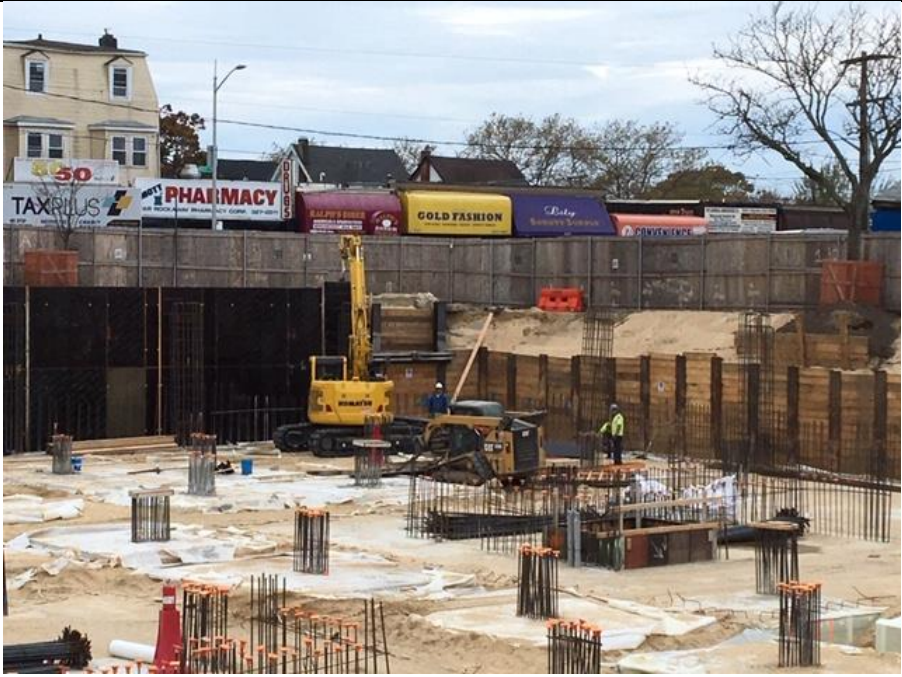
Photo 3- View of formwork in A1.

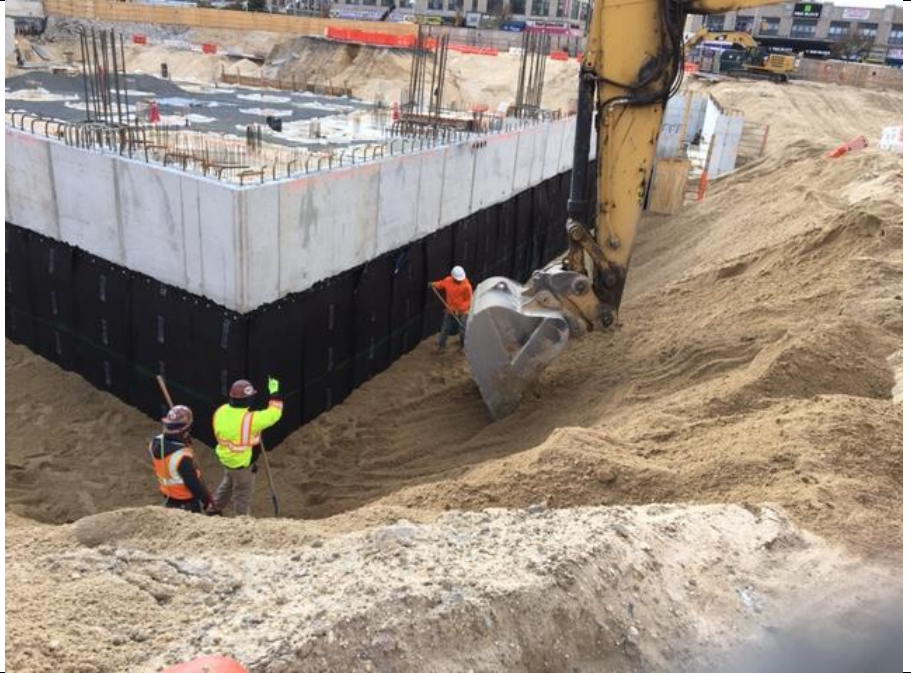
Photo 1- View of backfilling soil in D2 and D3.

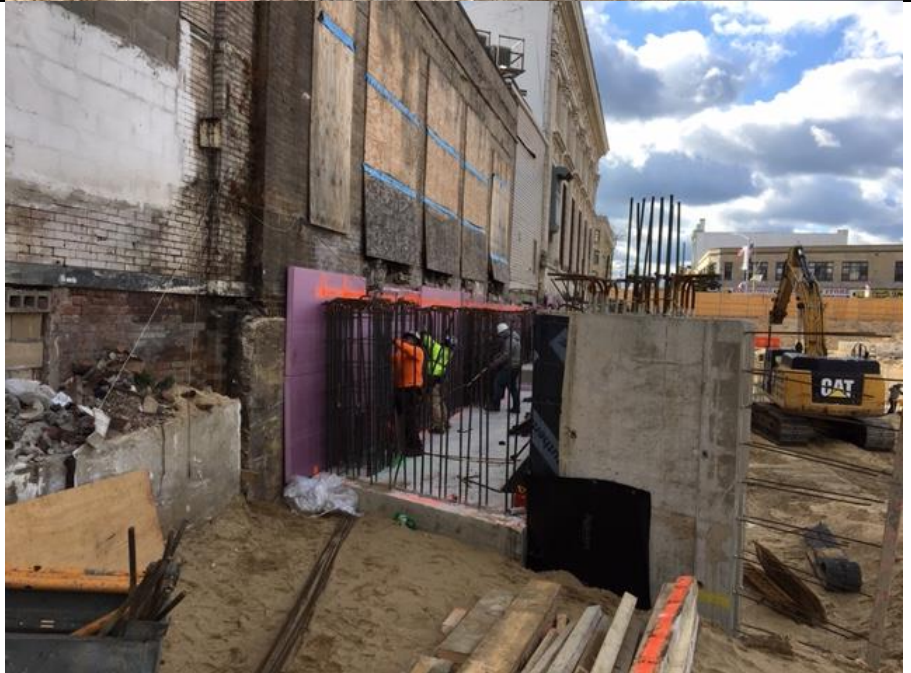
Photo 2- View of rebar installation and formwork in F2 and F3.

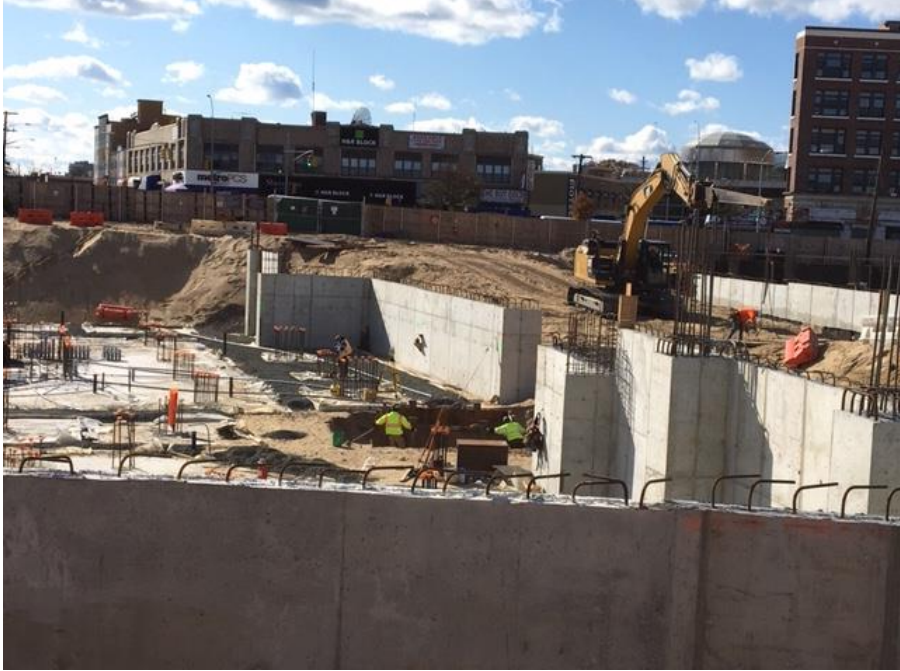
Photo 3- View of formwork in D2.

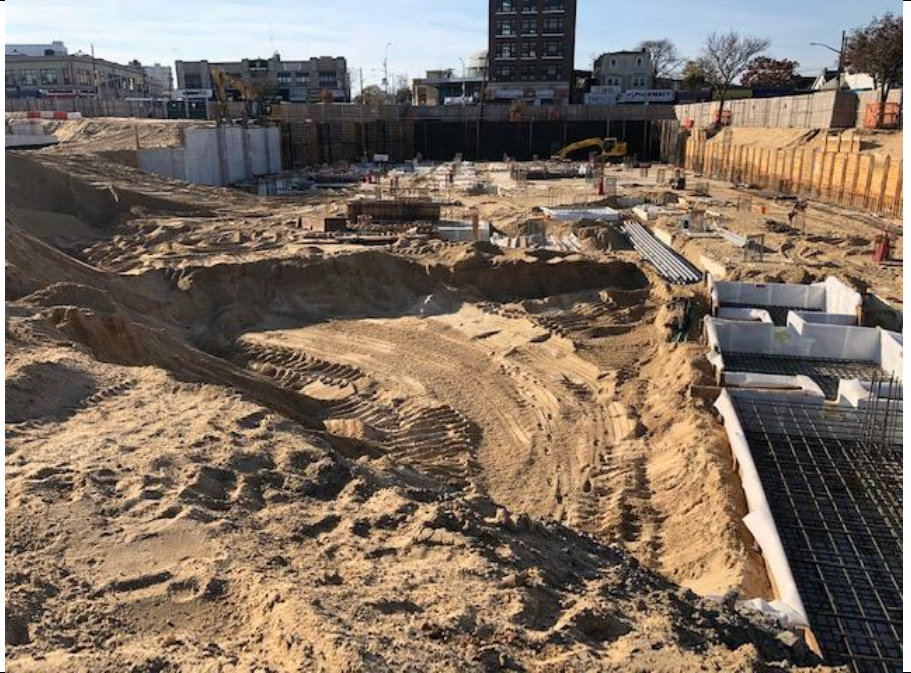
Photo 1- View of graded soil in A3, A4, B3, and B4.

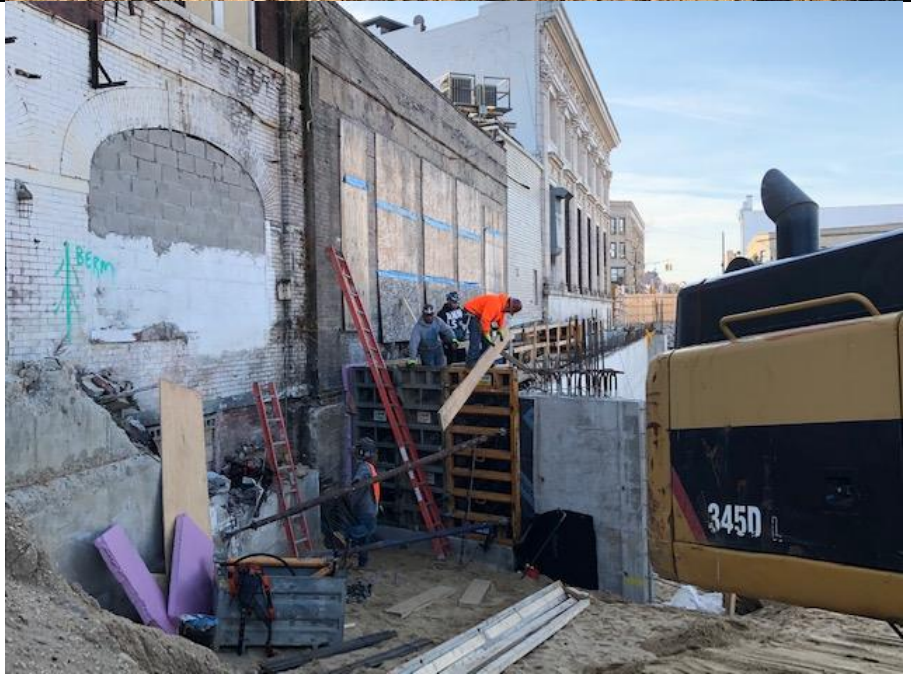
Photo 2- View of rebar installation and formwork in F2 and F3.

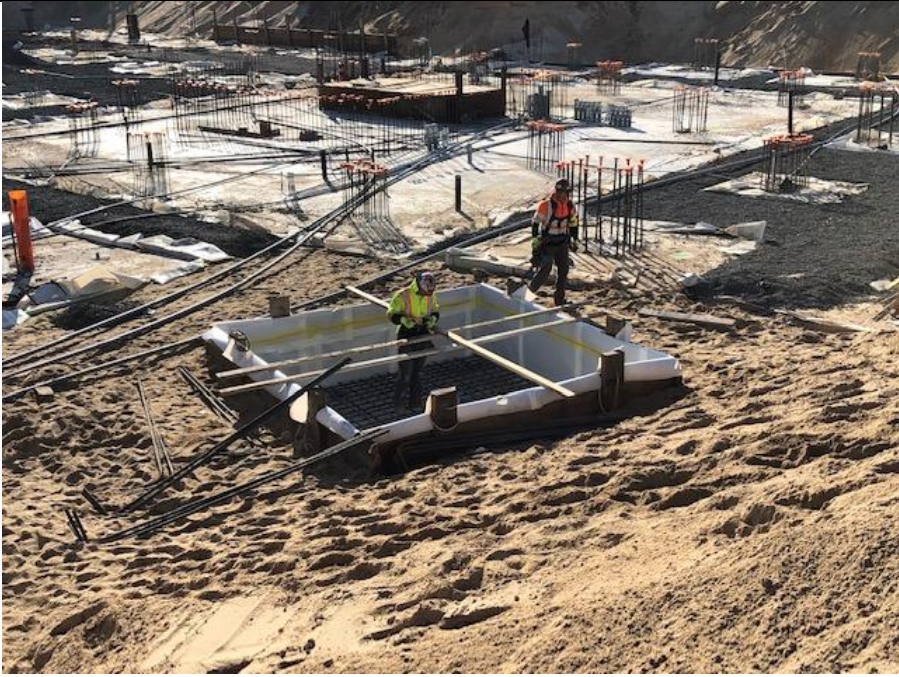
Photo 3- View of rebar installation in D2.

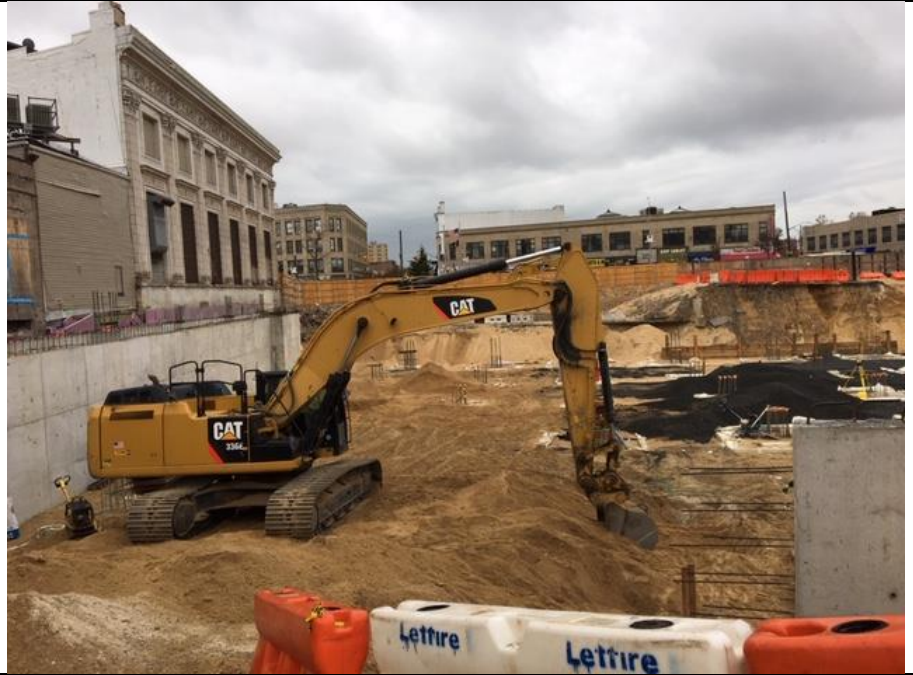
Photo 1- View of graded soil in E2 and E3.

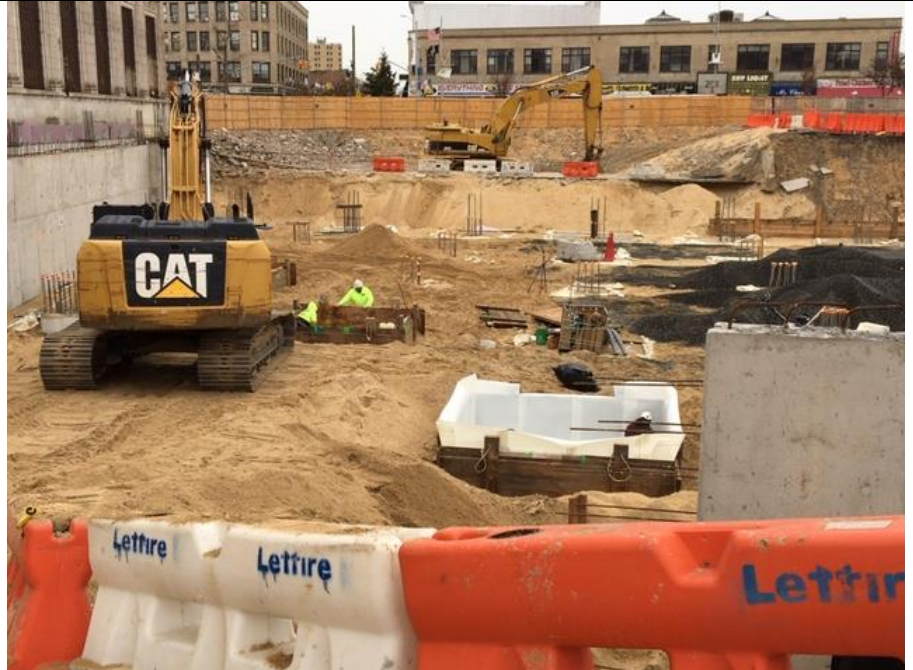
Photo 2- View of formwork in E2 and E3.

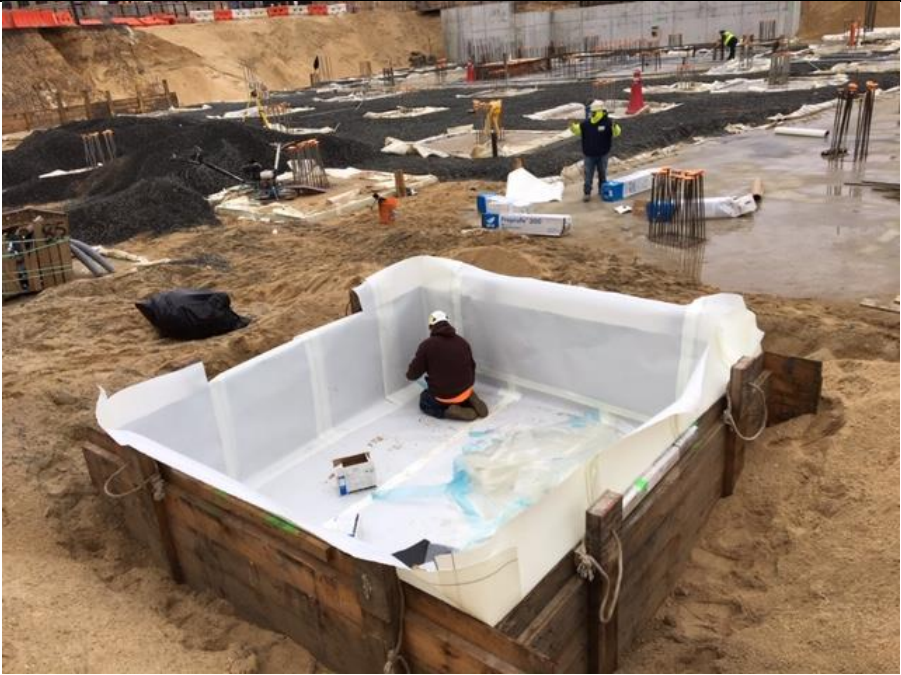
Photo 3- View of Preprufe 200 installation in E2.

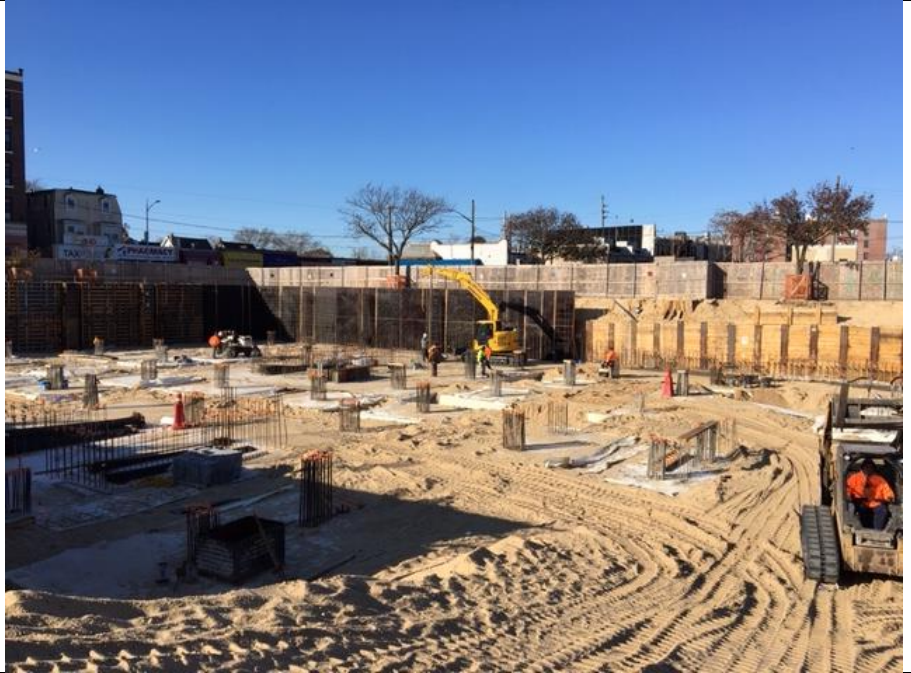
Photo 1- View of form work in A1 and A2.

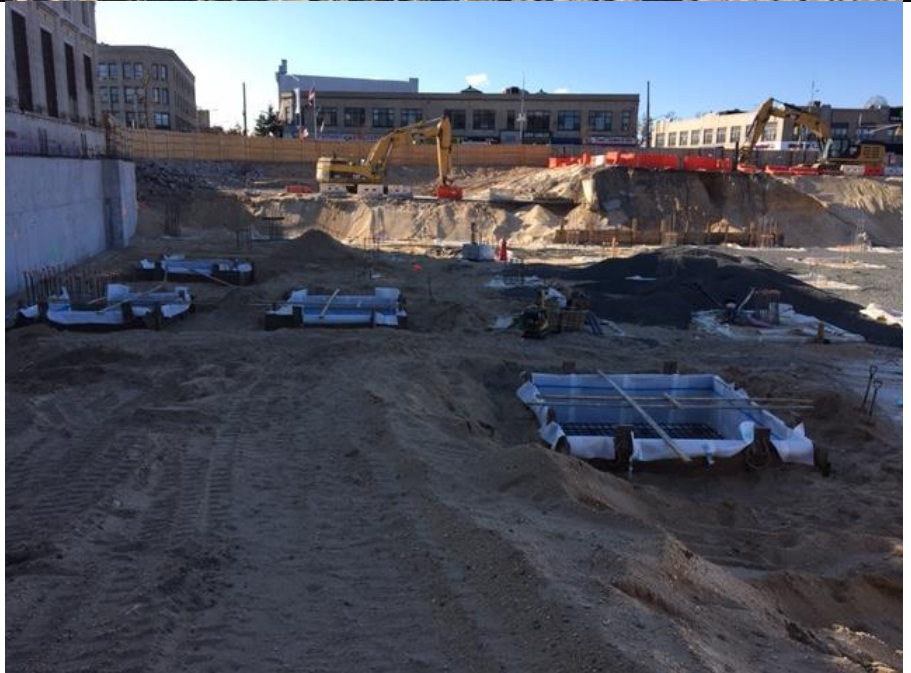
Photo 2- View of formwork, rebar, and Preprufe 200 installation in E2 and E3.

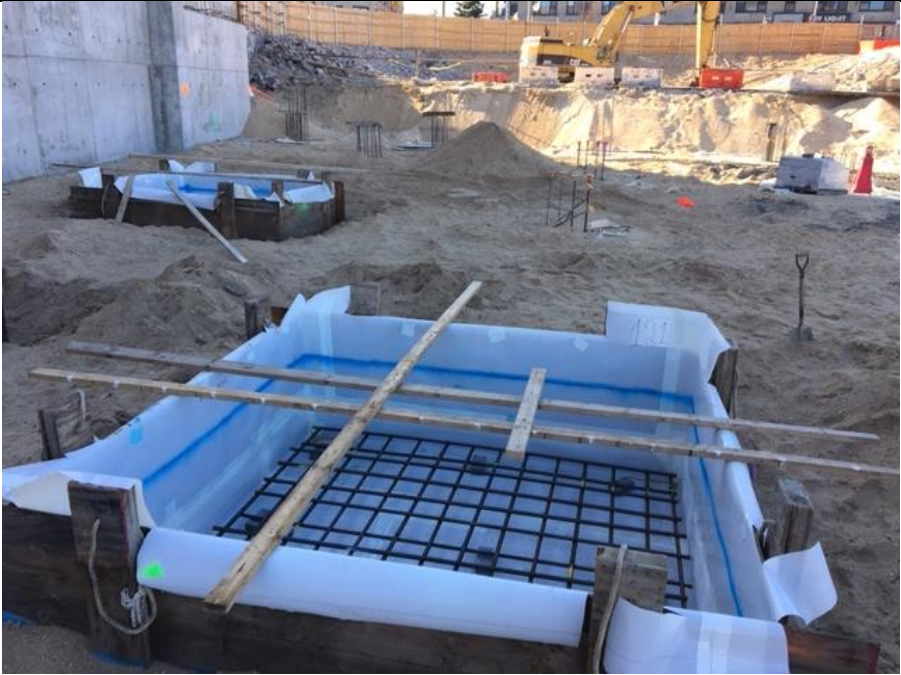
Photo 3- View of Preprufe 200 and rebar installation in E2.

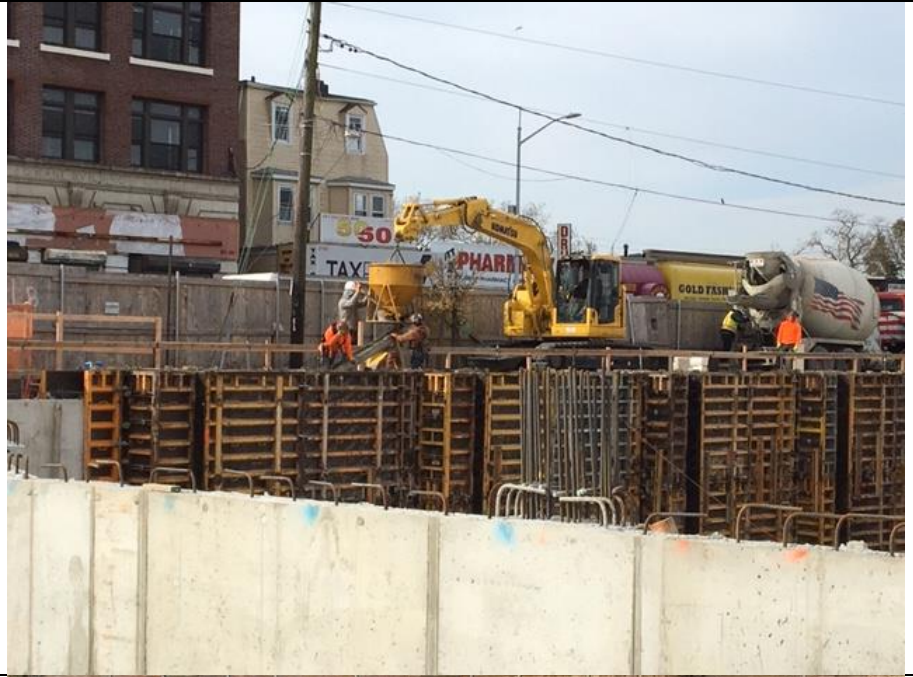
Photo 1- View of pouring concrete in A1 and B1.

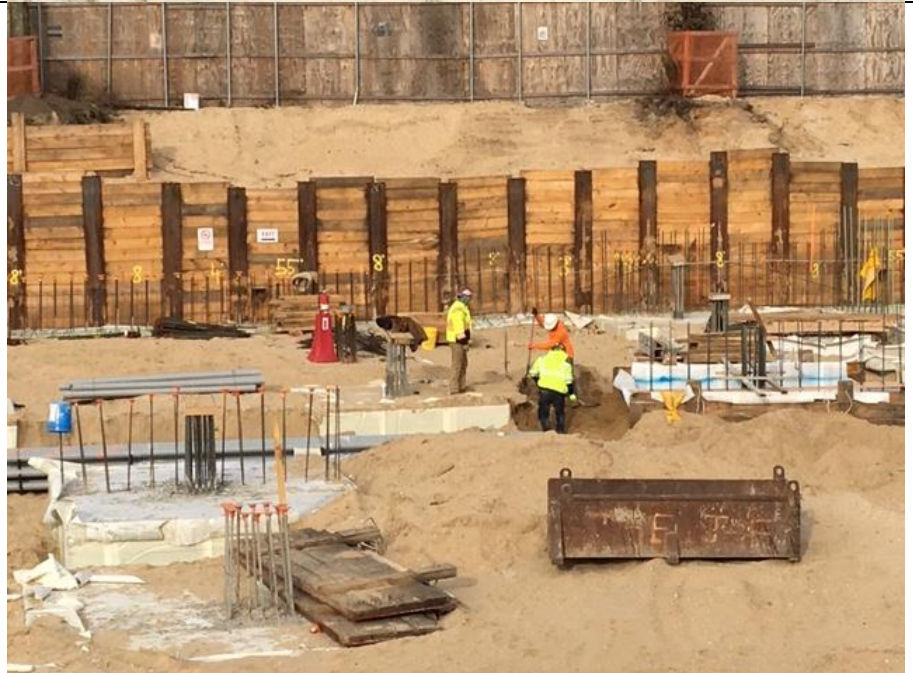
Photo 2- View of excavating soil in A3 for electrical conduit installation.

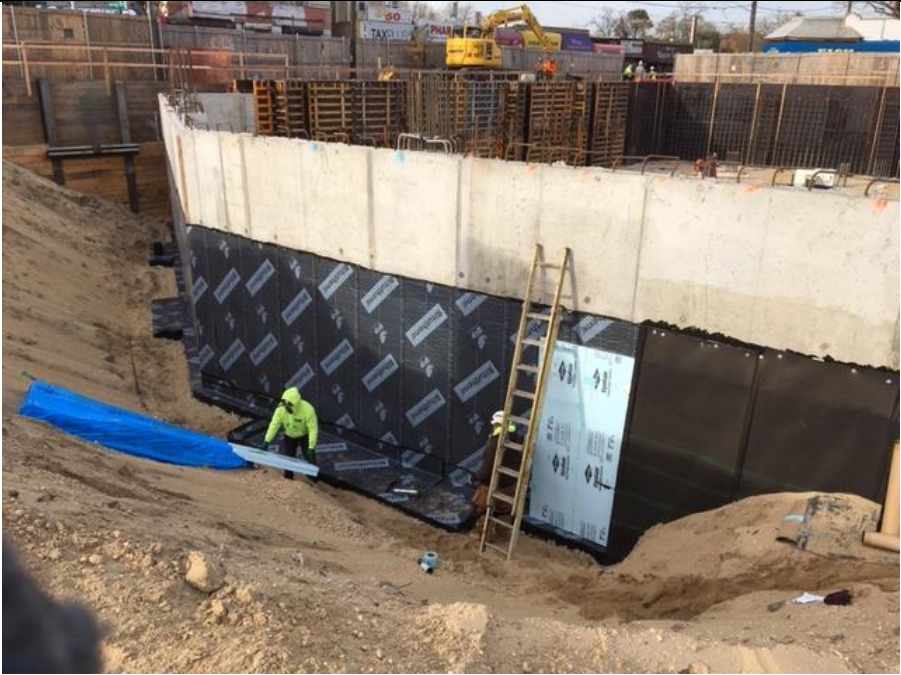
Photo 3- View of Bituthene and Hydroduct installation in B1 and B2.

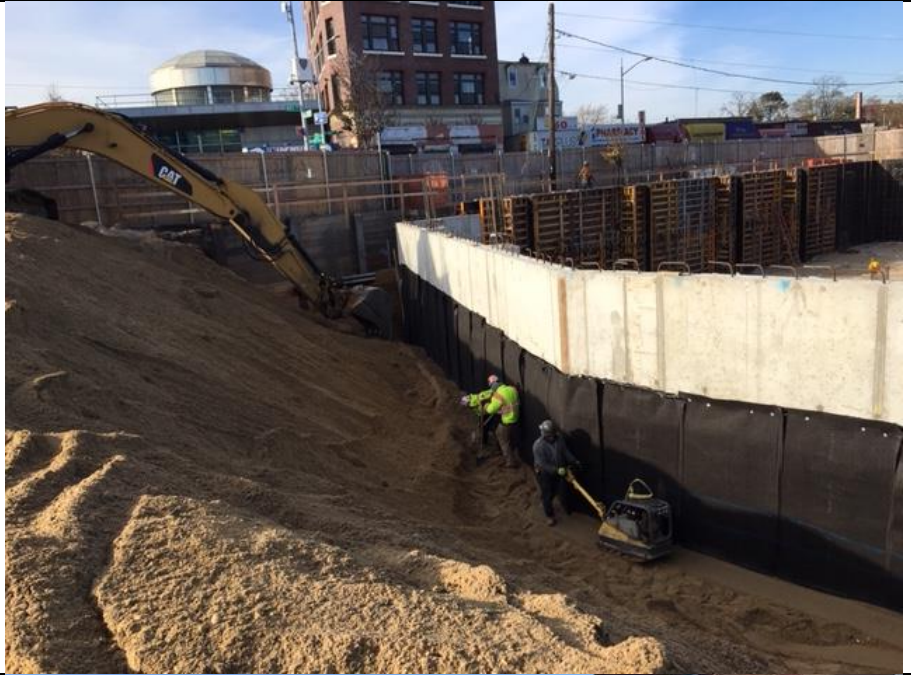
Photo 1- View of backfilling soil in B1 and B2.

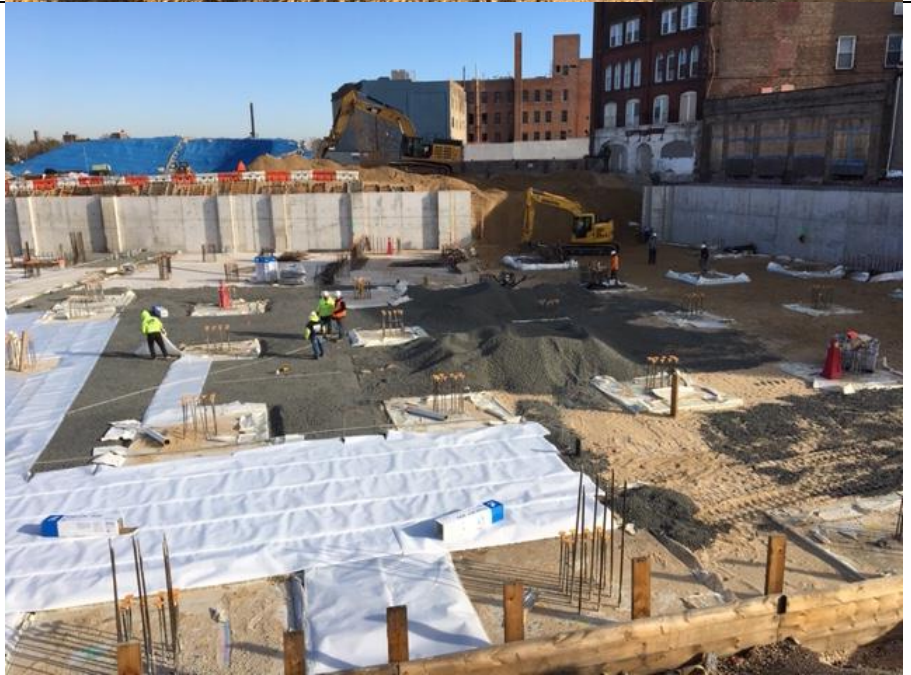
Photo 2- View of Preprufe 200 installation in E2 and E3.

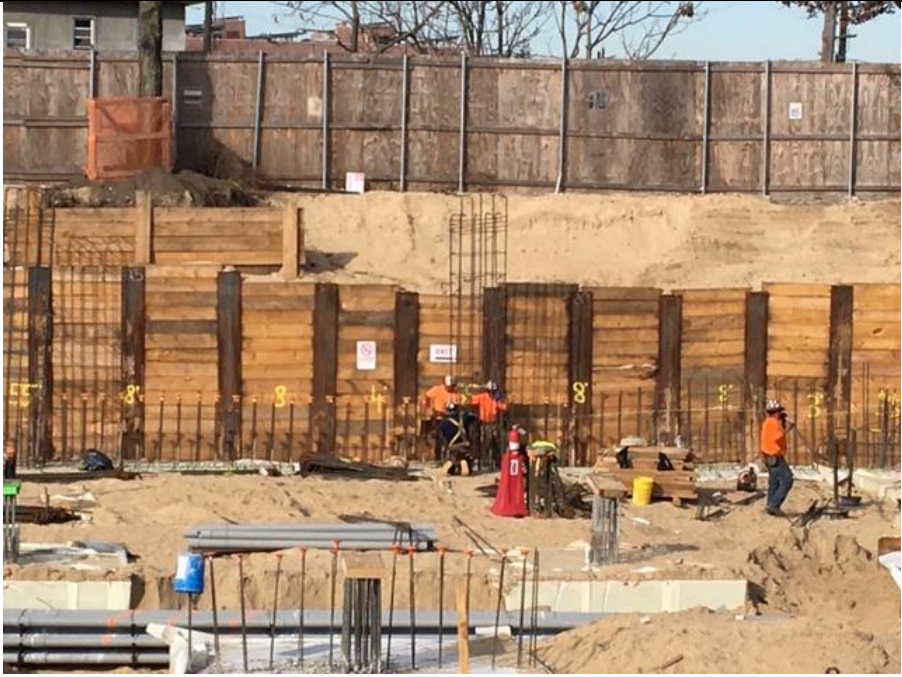
Photo 3- View of rebar installation in A3.

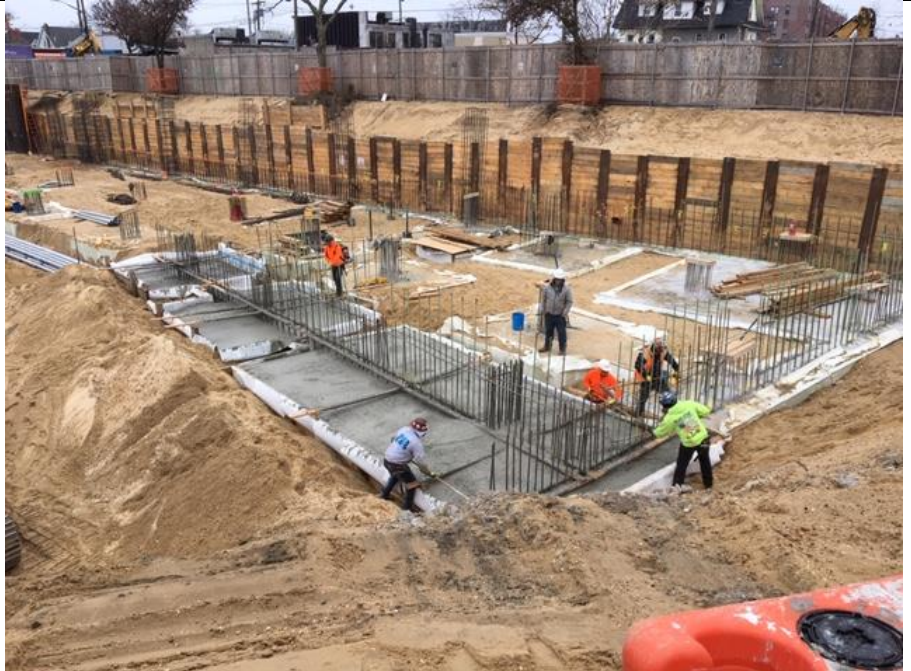
Photo 1- View of pouring concrete in A3 and A4.

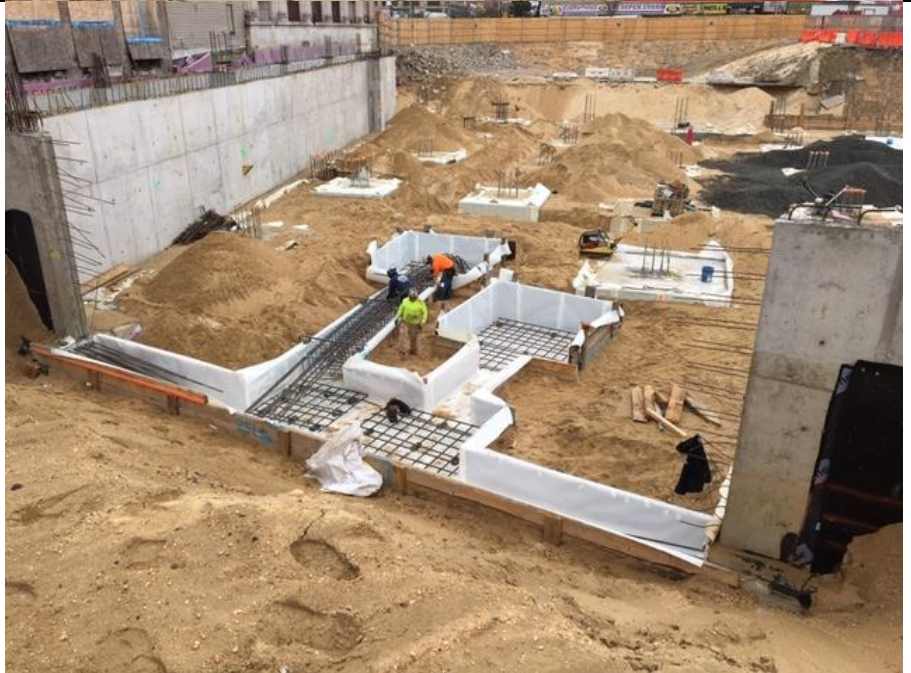
Photo 2- View of Preprufe 200 installation in E3, E4, and F3.

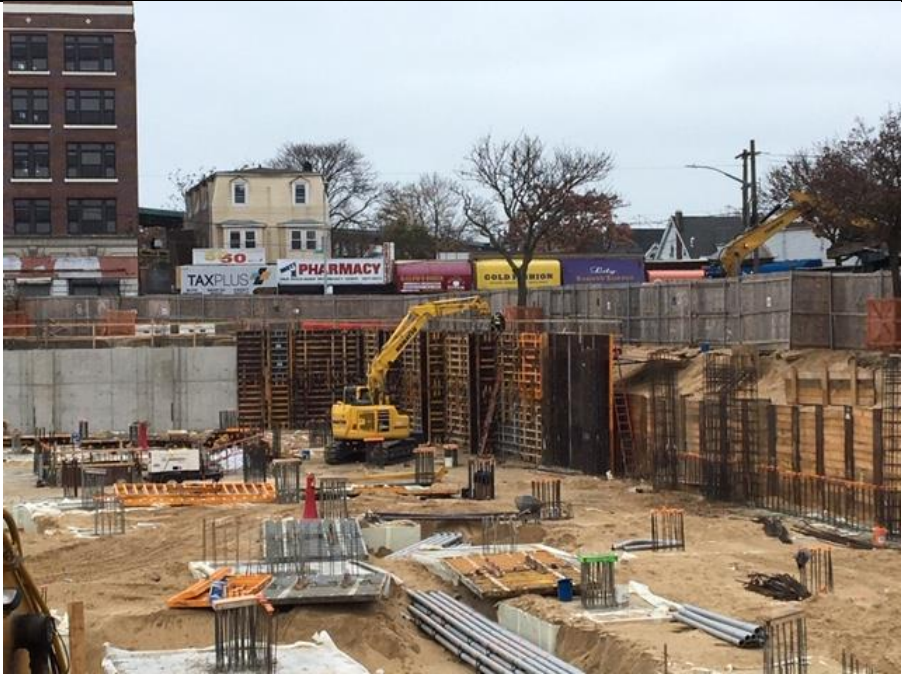
Photo 3- View of formwork in A1.

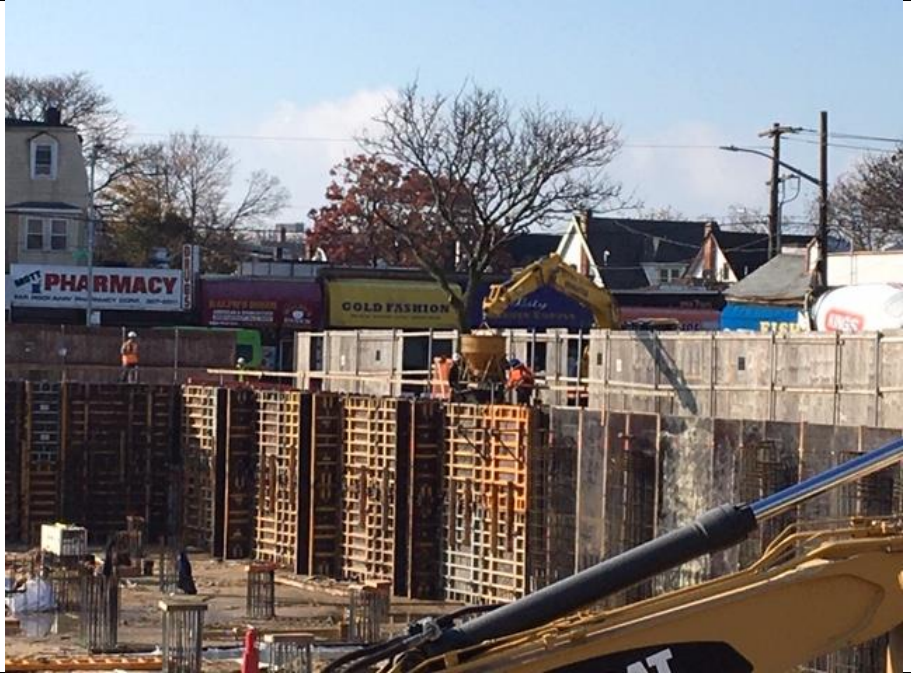
Photo 1- View of pouring concrete in A1 and A2.
