Daily Report for November 1, 2019

**Far Rockaway Project
20-02 Mott Avenue
Far Rockaway, NY
BCP #C241224**

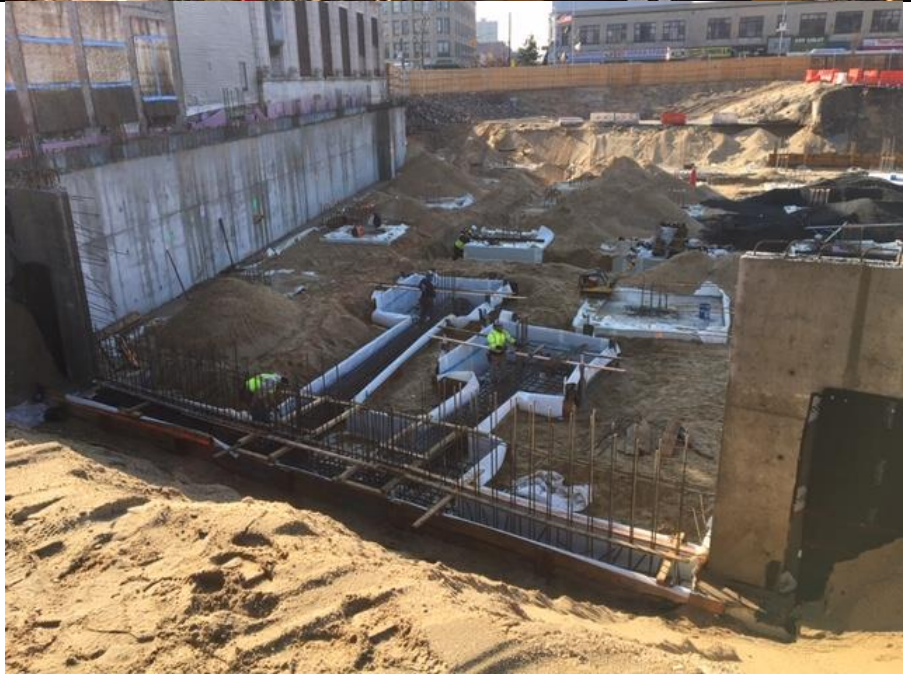
Photo 2- View of rebar installation in E3, E4, and F3.

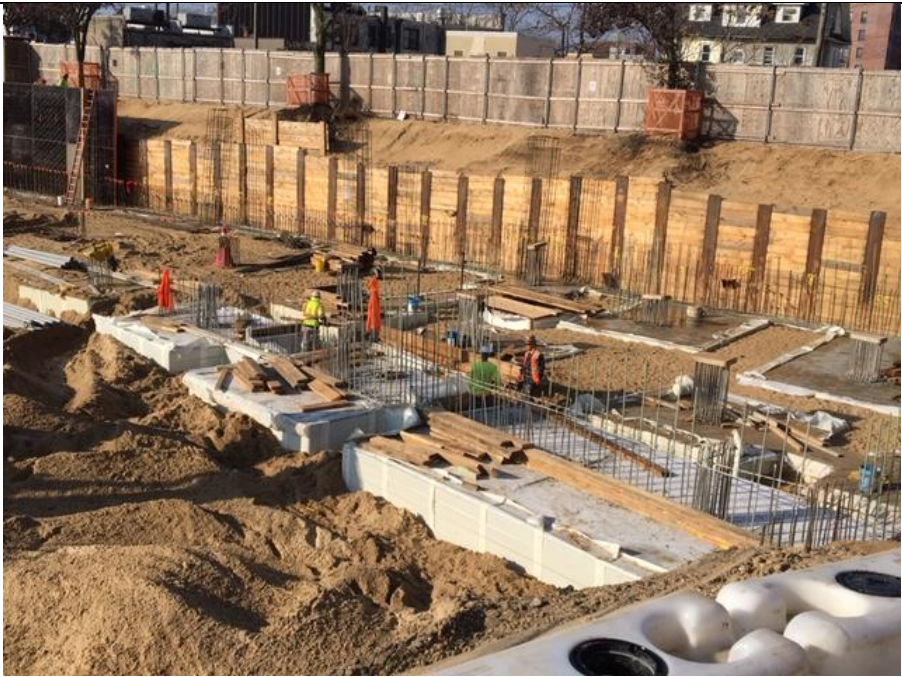
Photo 3- View of formwork in A3 and A4.

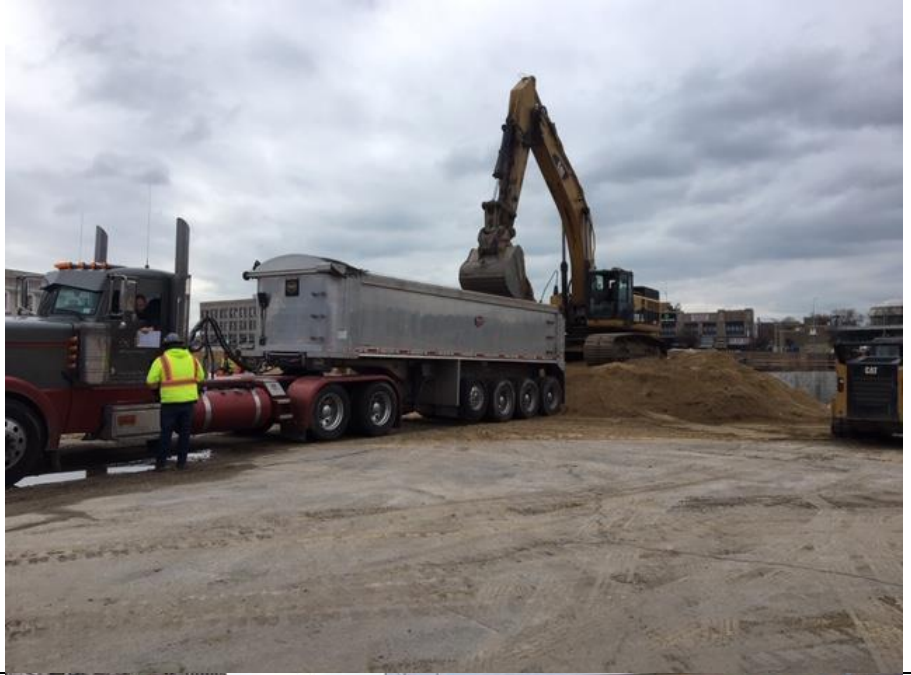
Photo 1- View of loading out soil.

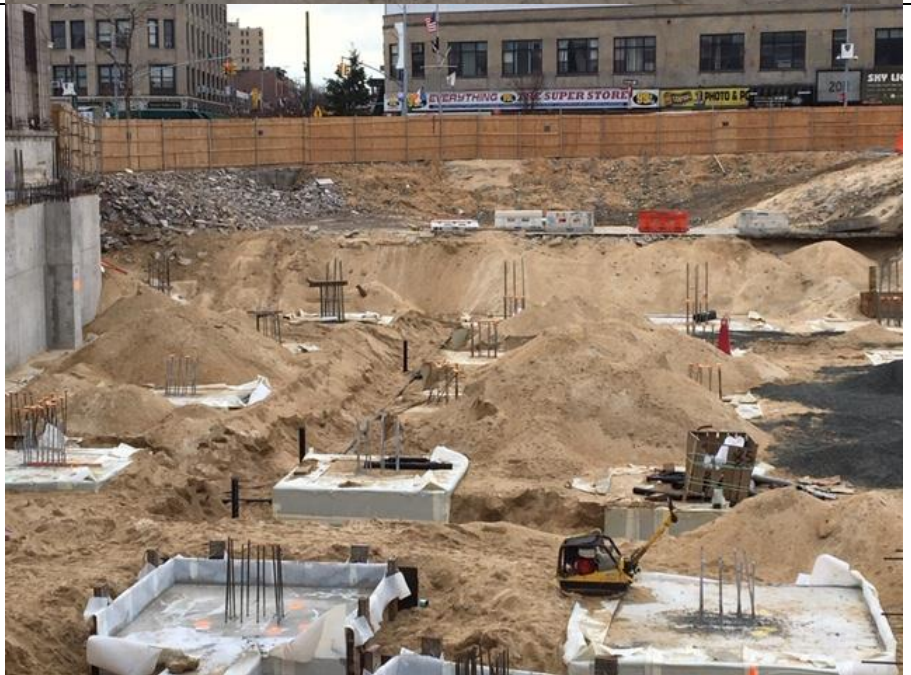
Photo 2- View of utility installation in E2 and E3

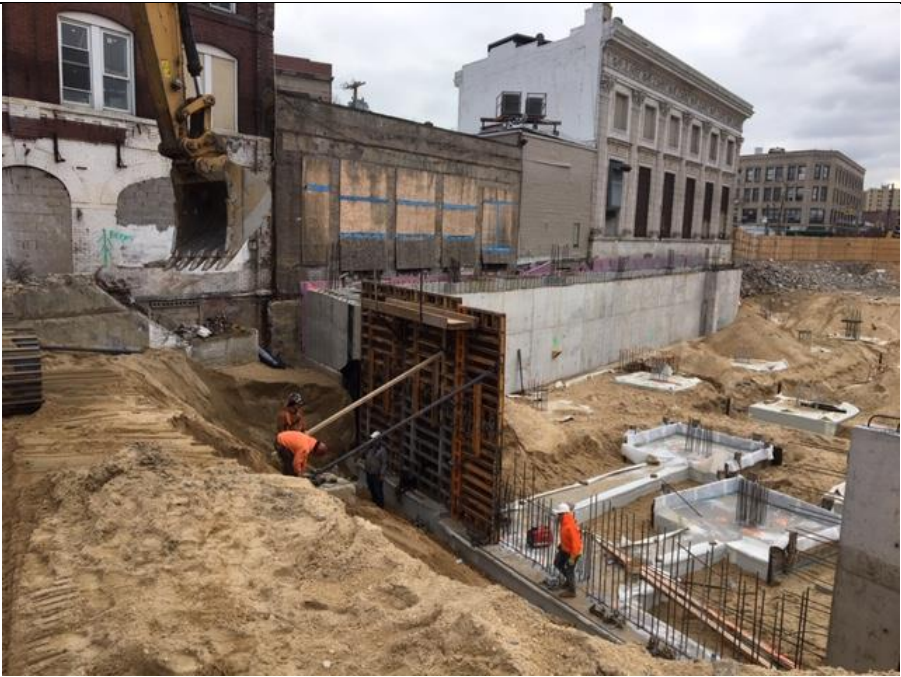
Photo 3- View of formwork in E3 and F3.

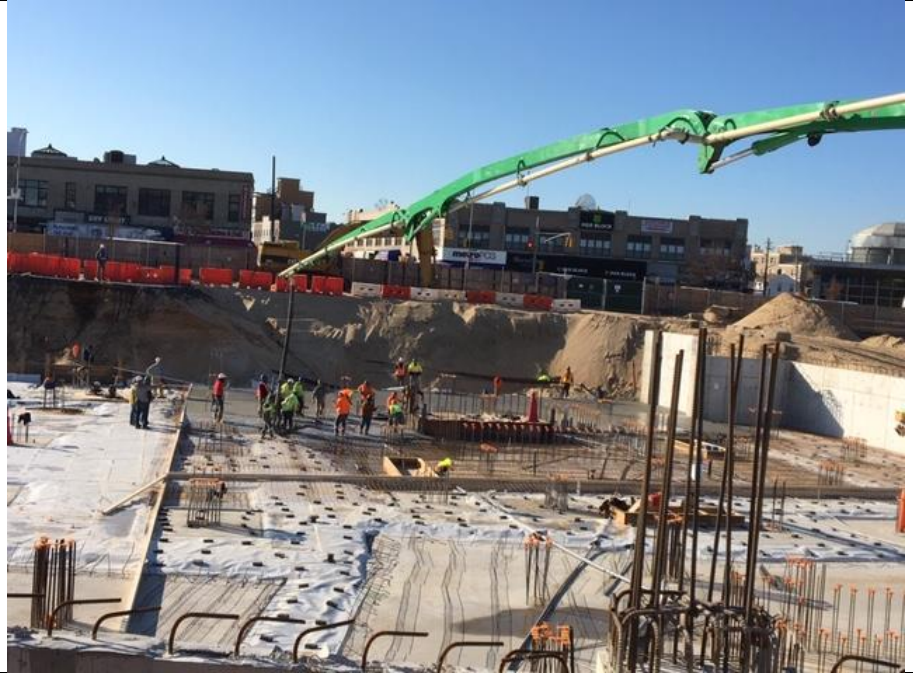
Photo 1- View of pouring concrete in C2, C3, D2, and D3.

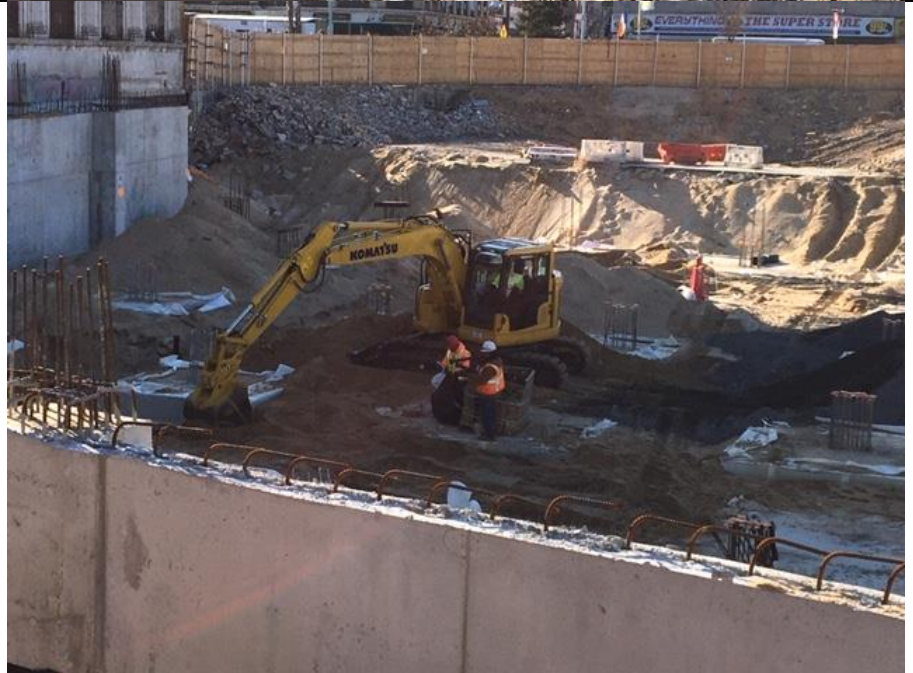
Photo 2- View of backfilling soil in E2 and E3

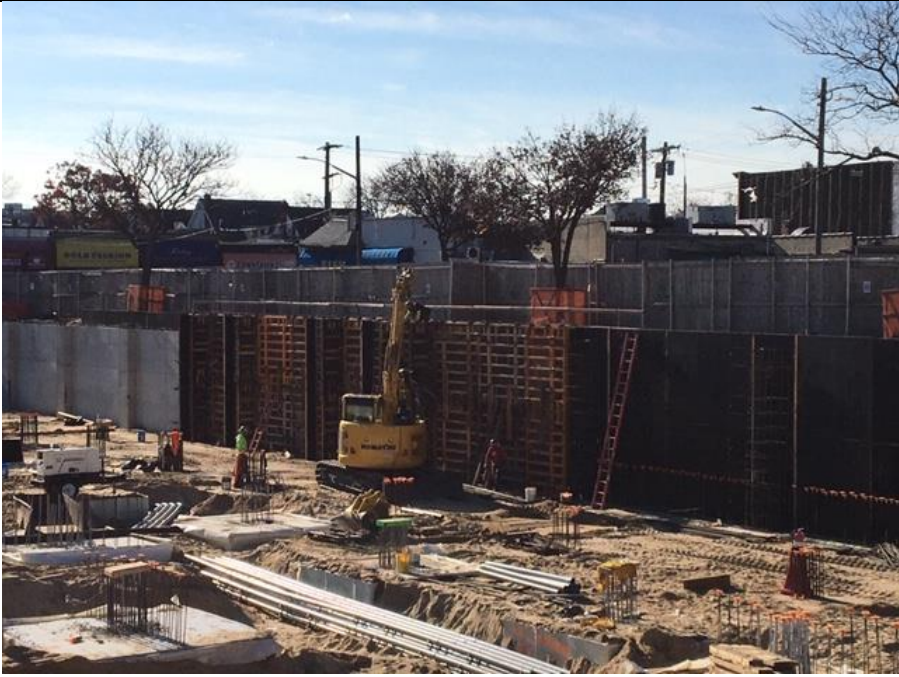
Photo 3- View of formwork in A2 and A3.

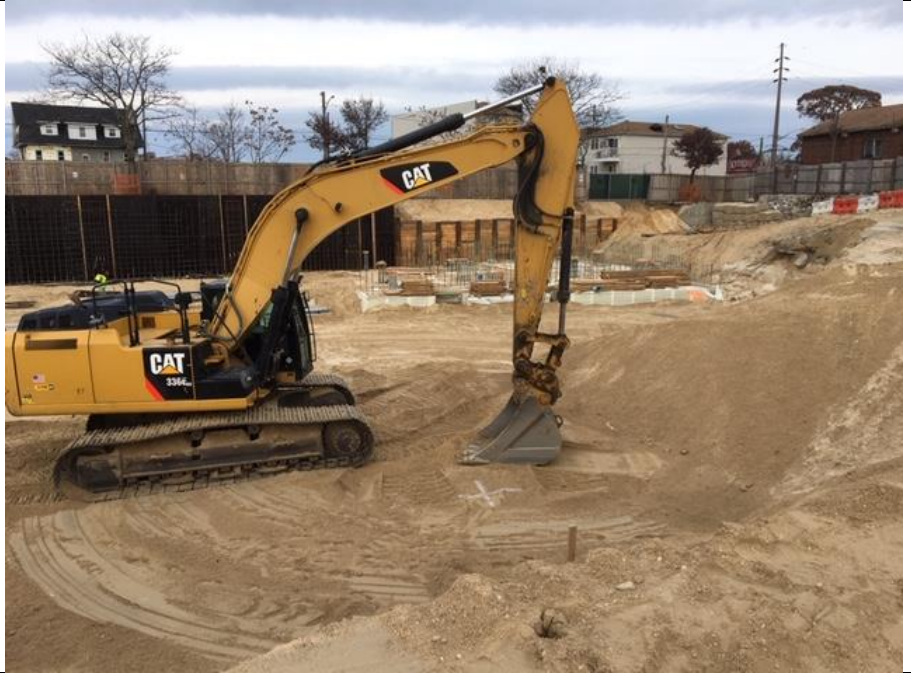
Photo 1- View of grading soil in B3 and B4.

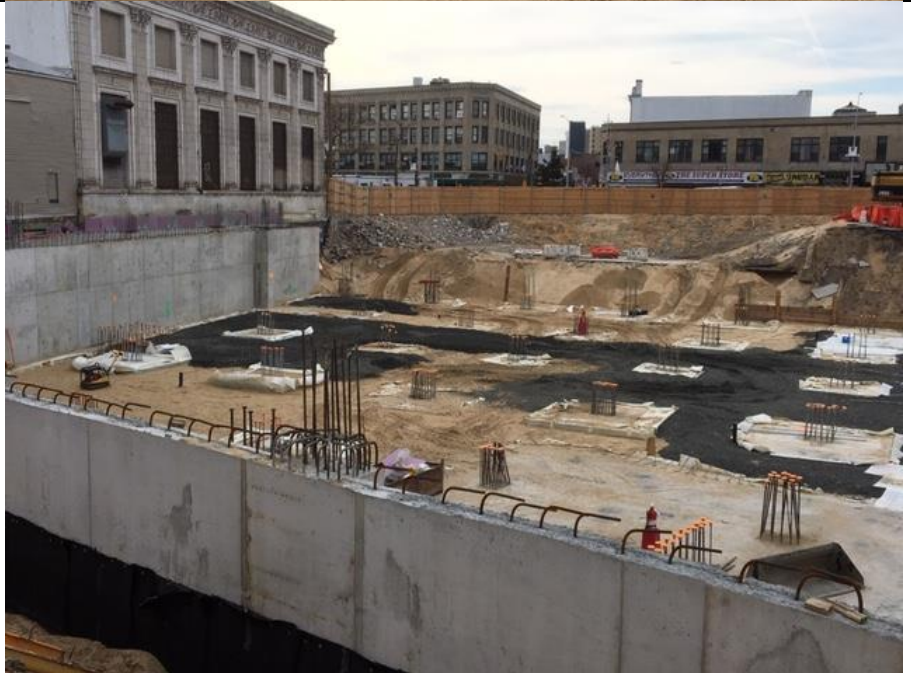
Photo 2- View of spread stone in E2, E3, F2, and F3.

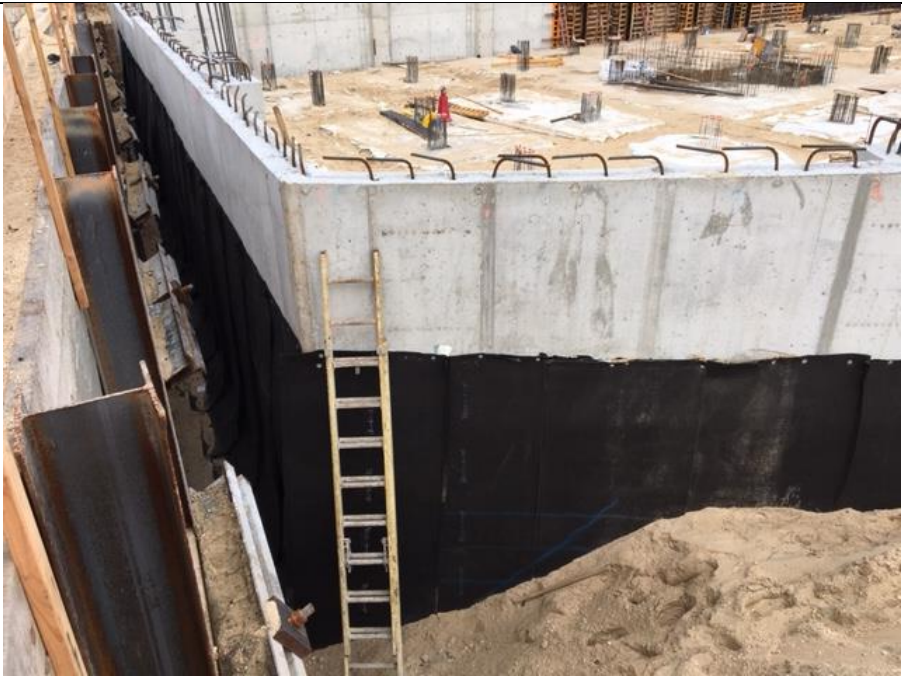
Photo 3- View of installed waterproofing membrane bituthene and hydroduct in A1 and B1.

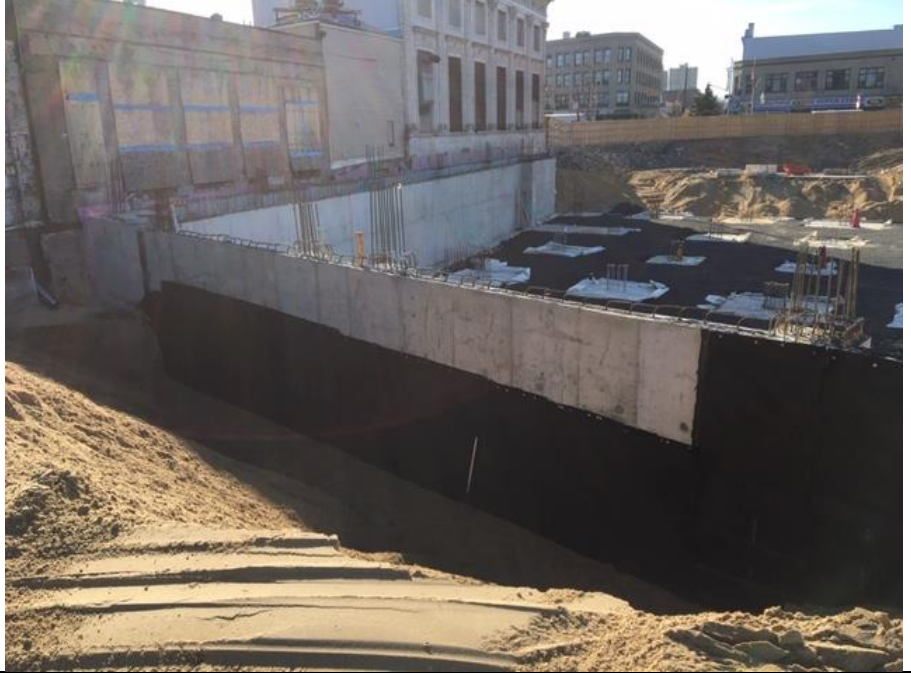
Photo 1- View of backfilled soil in E4 and F4.

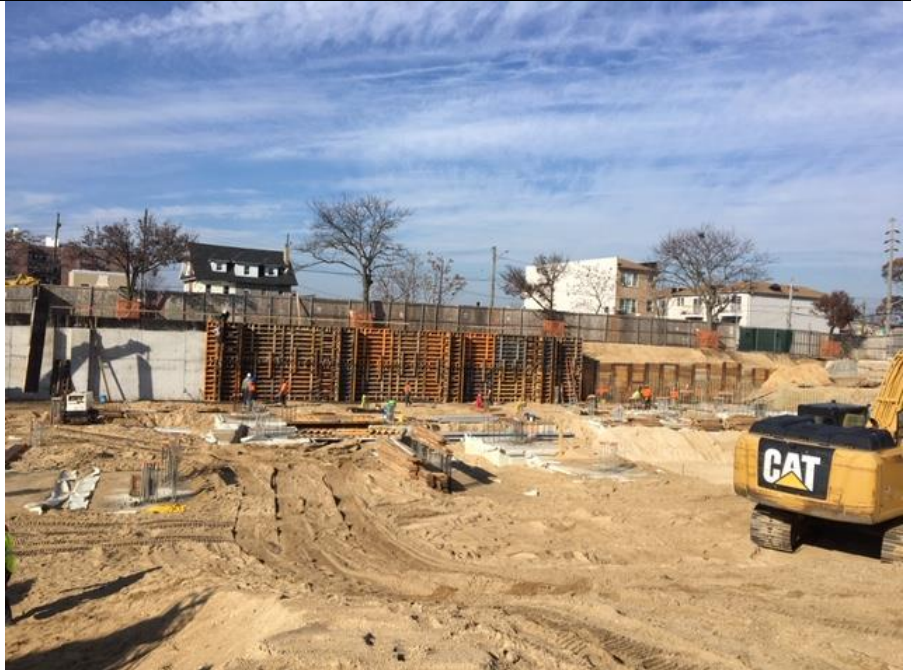
Photo 2- View of formwork in A3 and A4.

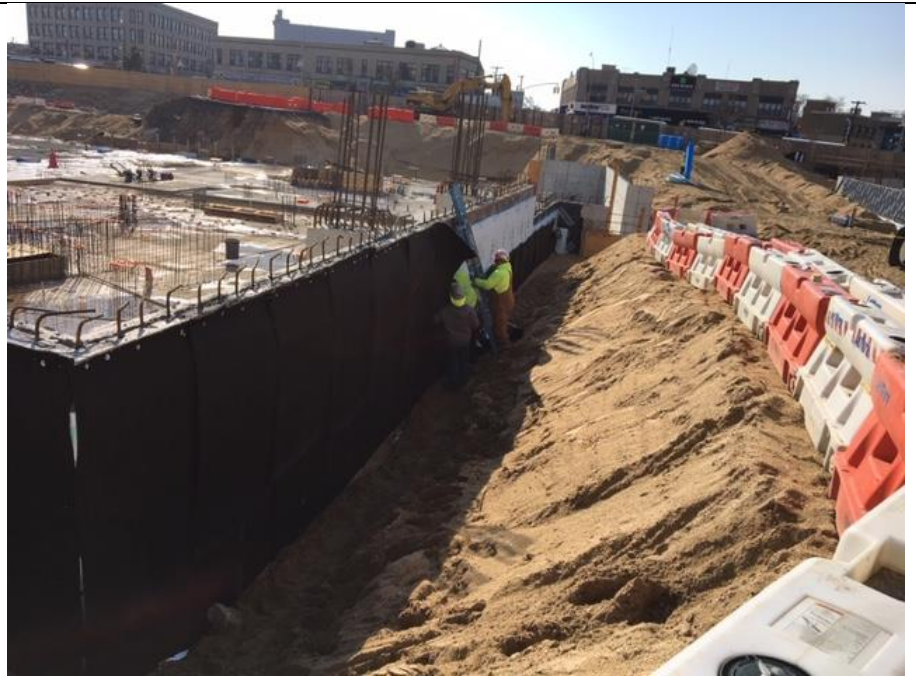
Photo 3- View of installed waterproofing membrane bituthene and hydroduct in D4 and E4.

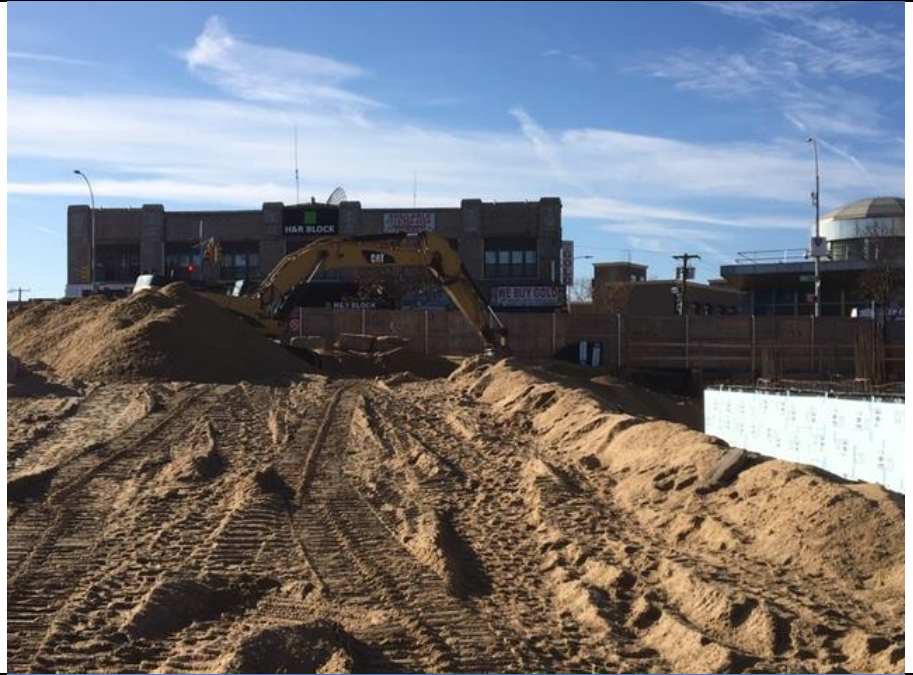
Photo 1- View of backfilled soil in B1 and B2.

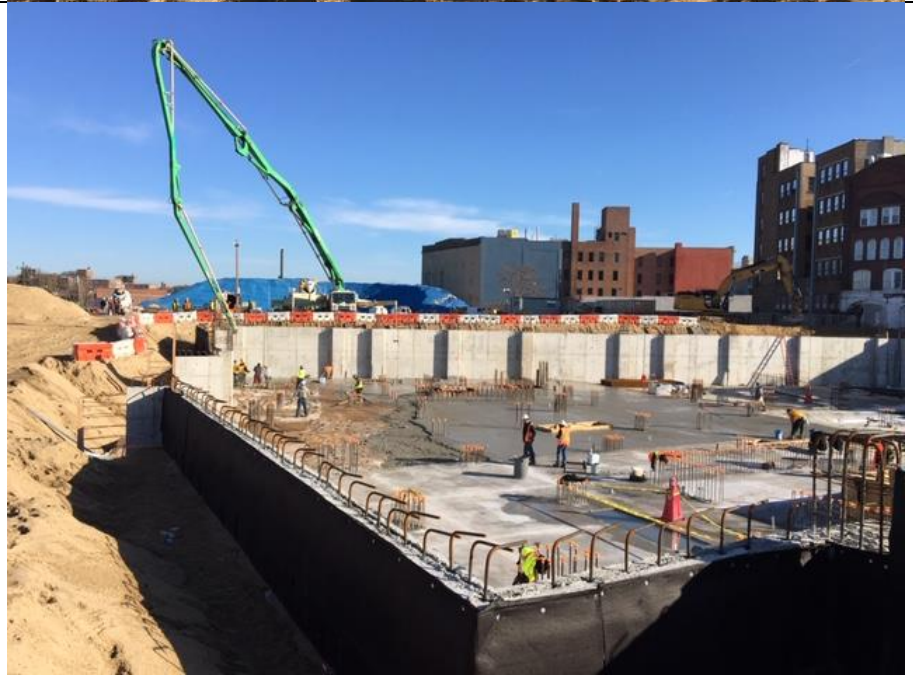
Photo 2- View of pouring concrete in D3, D4, E3, and E4.

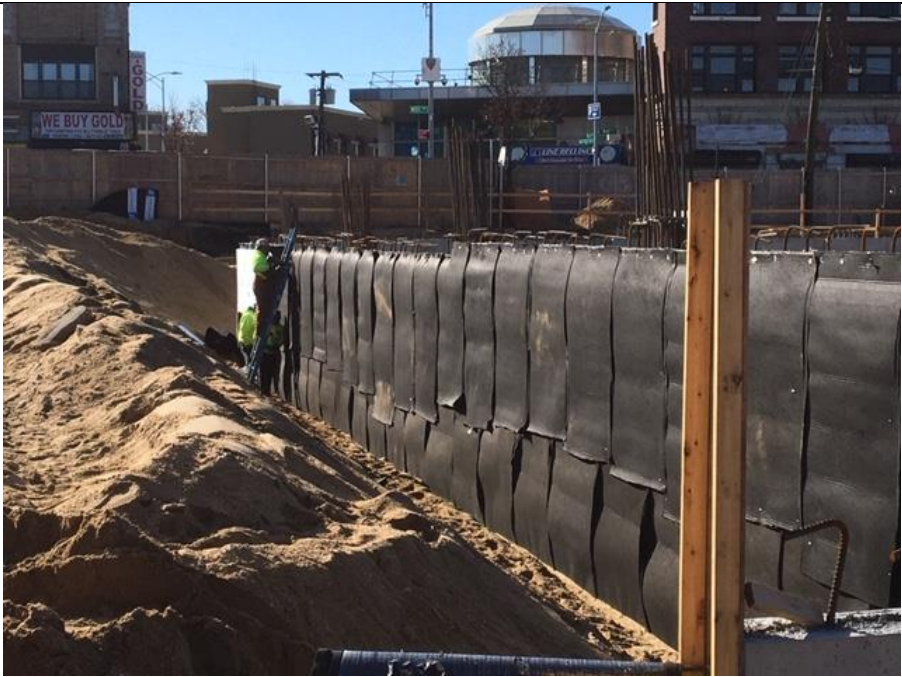
Photo 3- View of installed waterproofing membrane bituthene and hydroduct in B1 and B2.

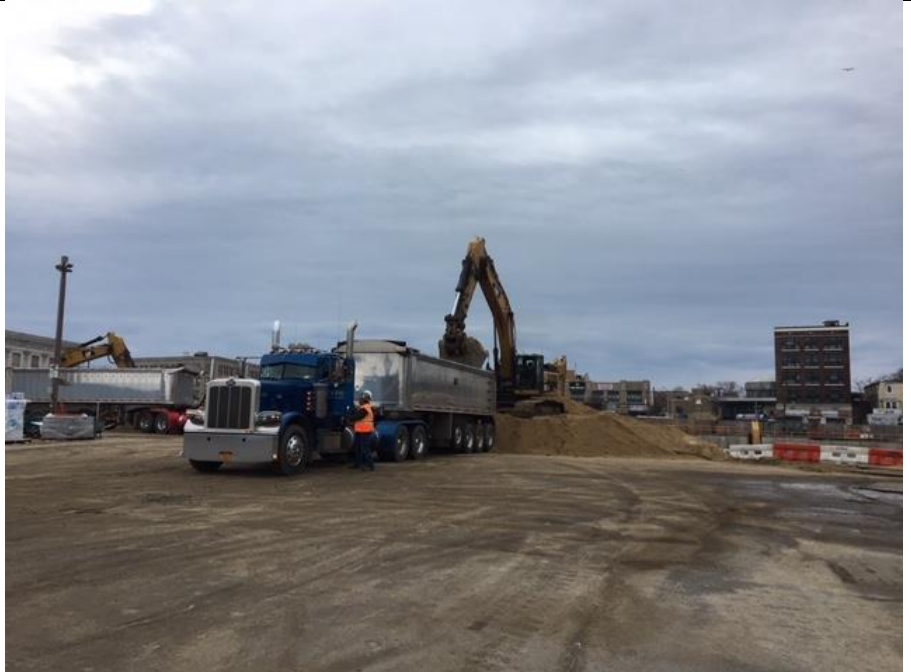
Photo 1- View of soil being exported offsite.

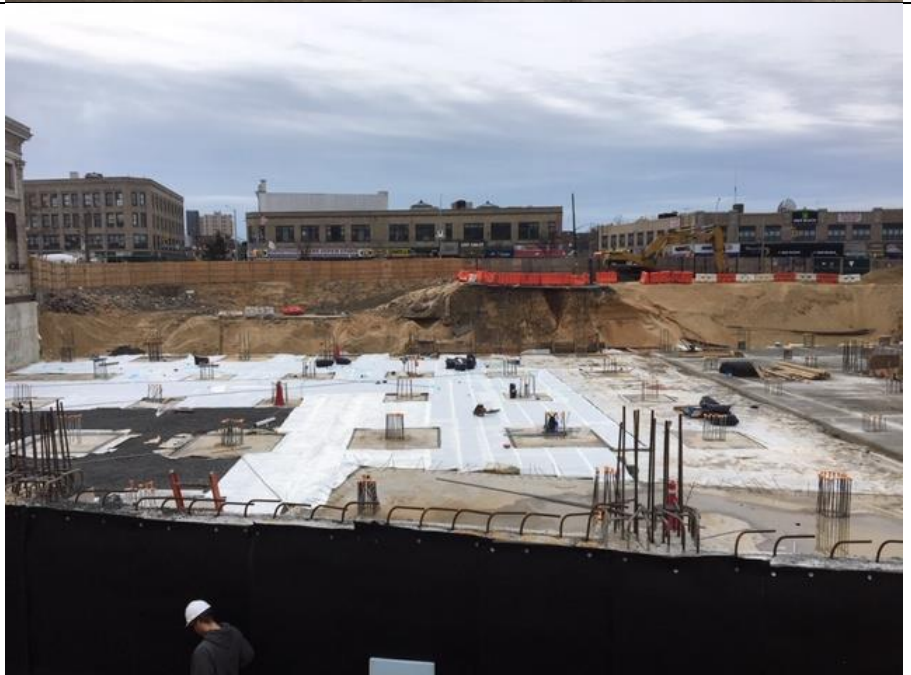
Photo 2- View of Preprufe 200 installation in D2, D3, E2, E3, F2, and F3.

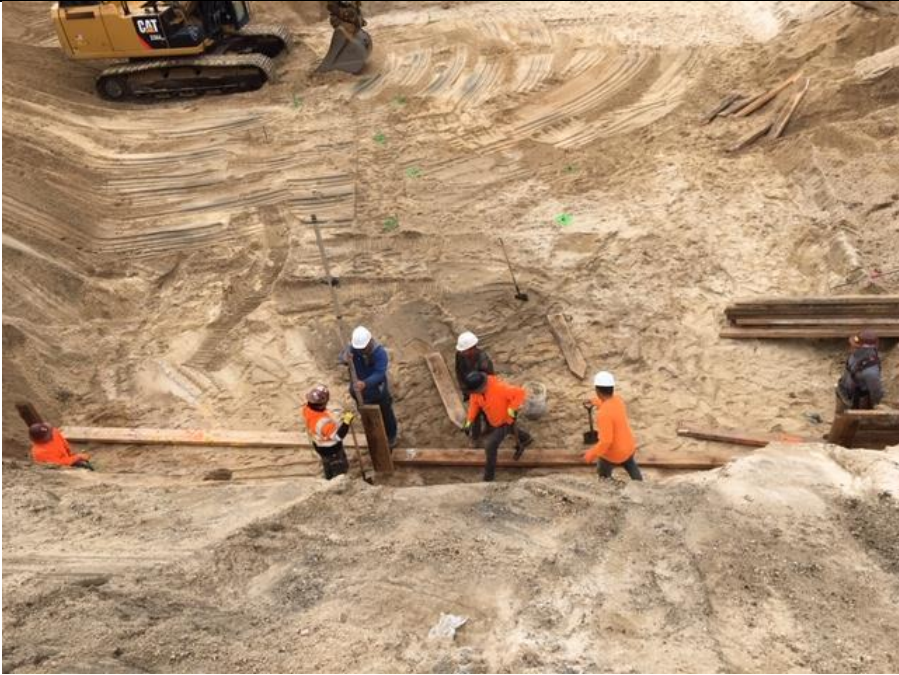
Photo 3- View of formwork in A4 and B4.
