Daily Report for January 2, 2020

**Far Rockaway Project
20-02 Mott Avenue
Far Rockaway, NY
BCP #C241224**

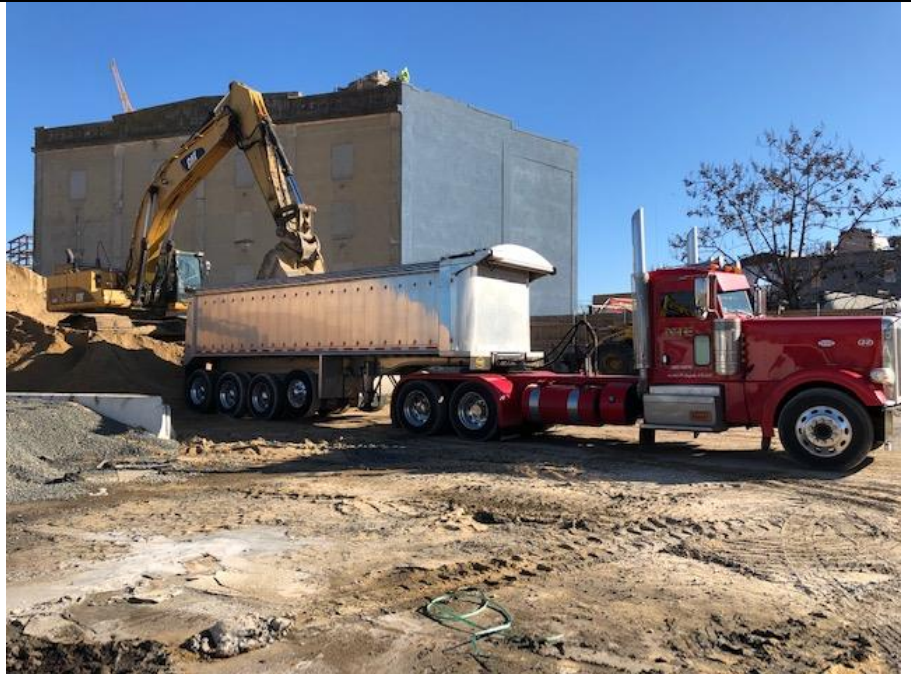
Photo 1- View
of exporting
soil offsite.

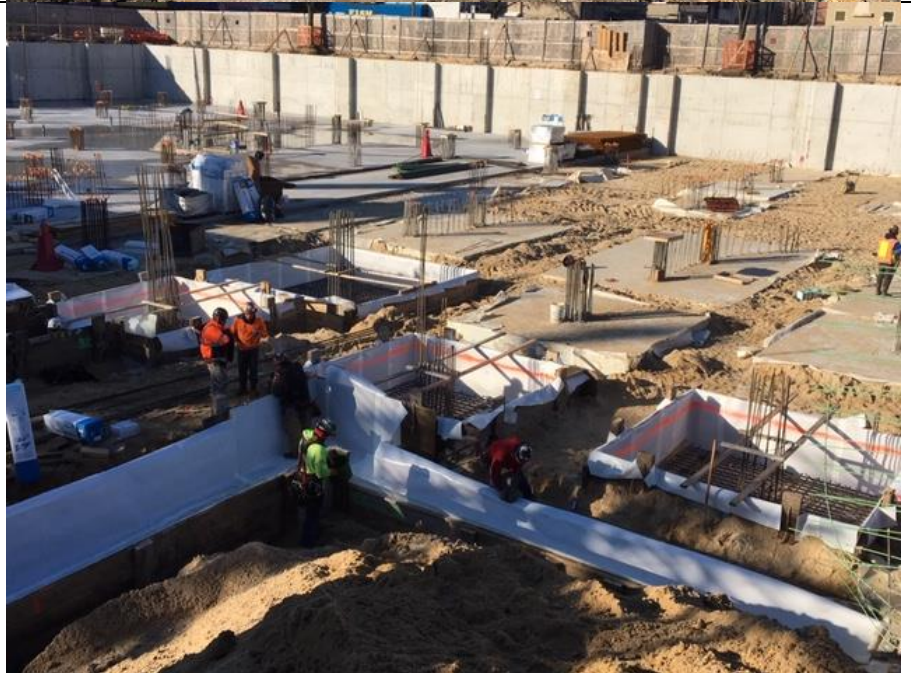
Photo 2- View
of formwork,
rebar and
waterproofing
installation in
B3 and C3.

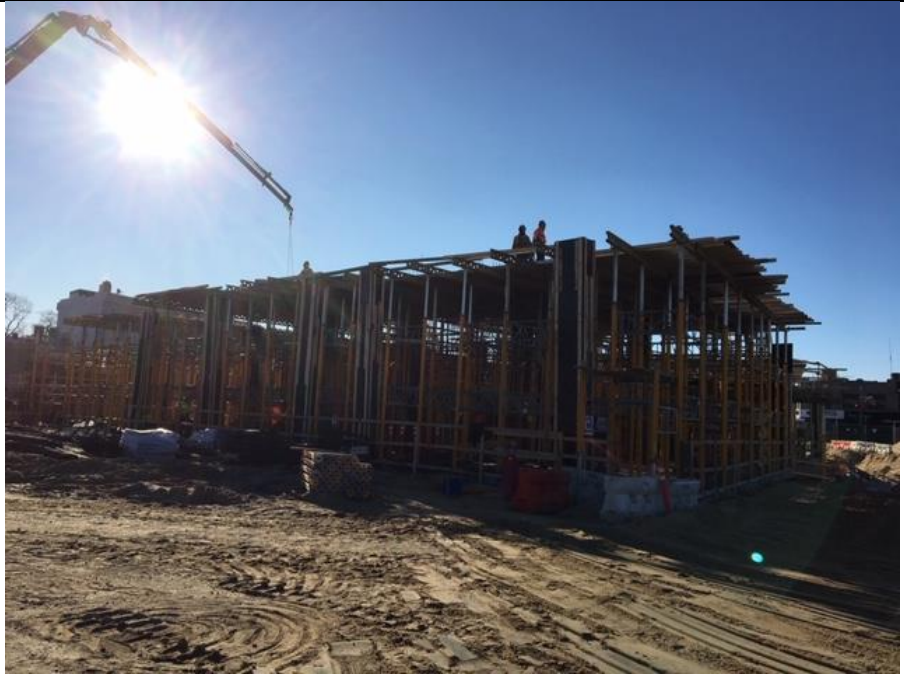
Photo 3- View of formwork and rebar installation in D2, D3, D4, E2, E3, and E4.

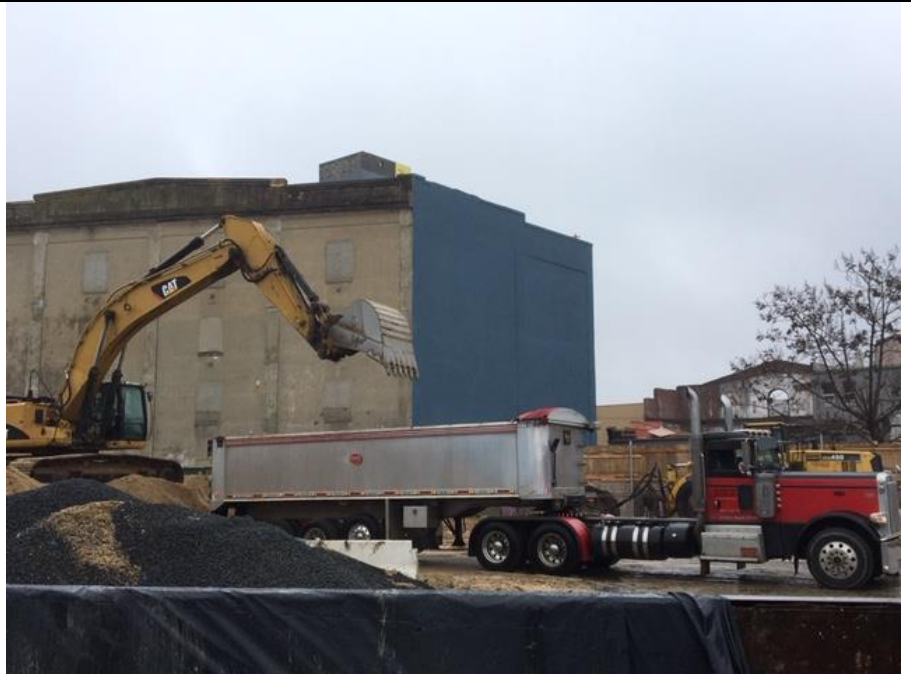
Photo 1- View
of exporting
soil offsite.

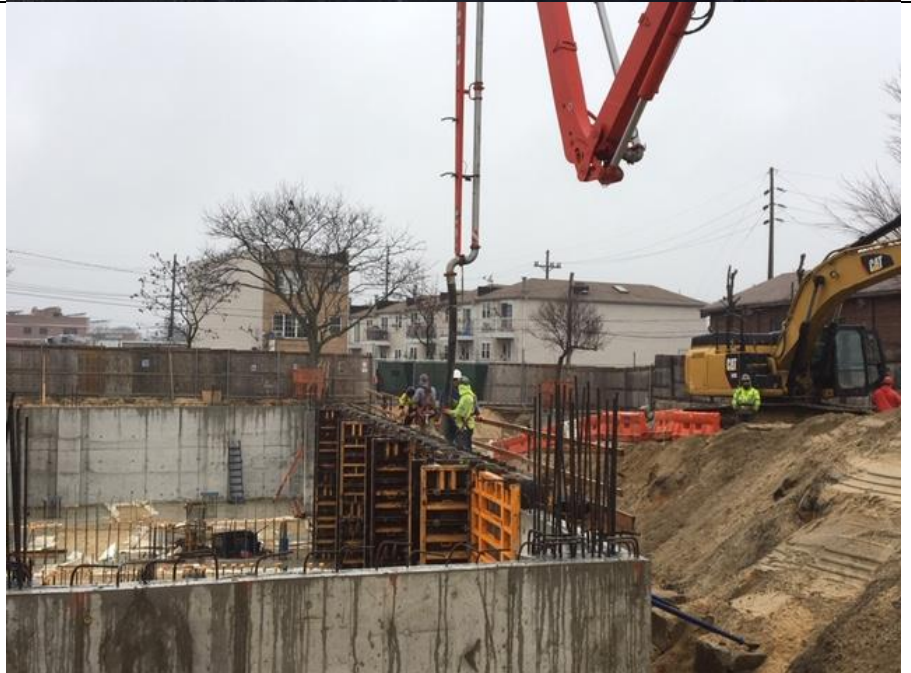
Photo 2- View
of pouring
concrete in
A4 and B4.

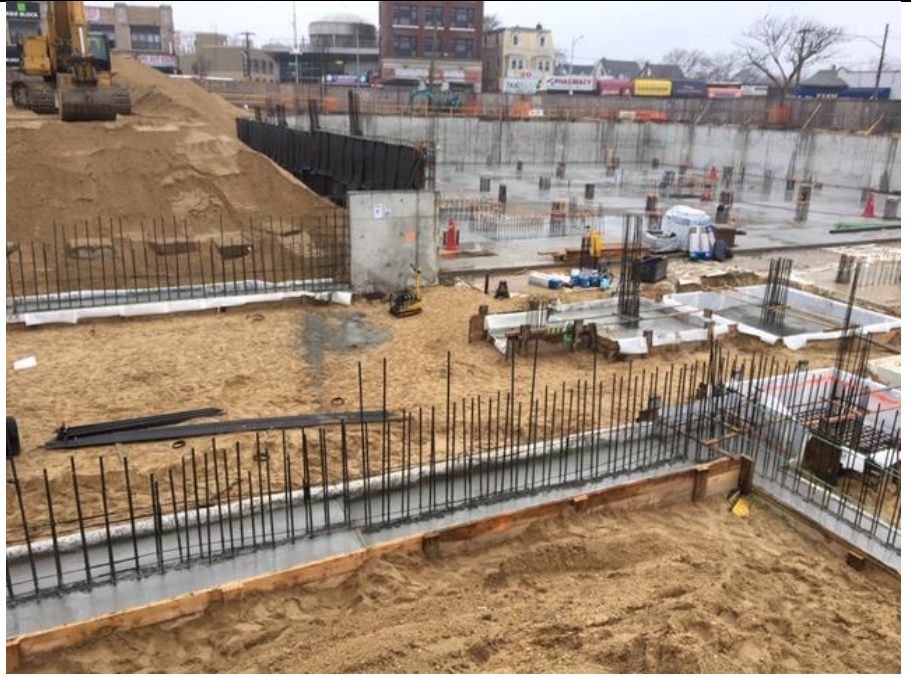
Photo 3- View
of poured
concrete in
B3 and C3.

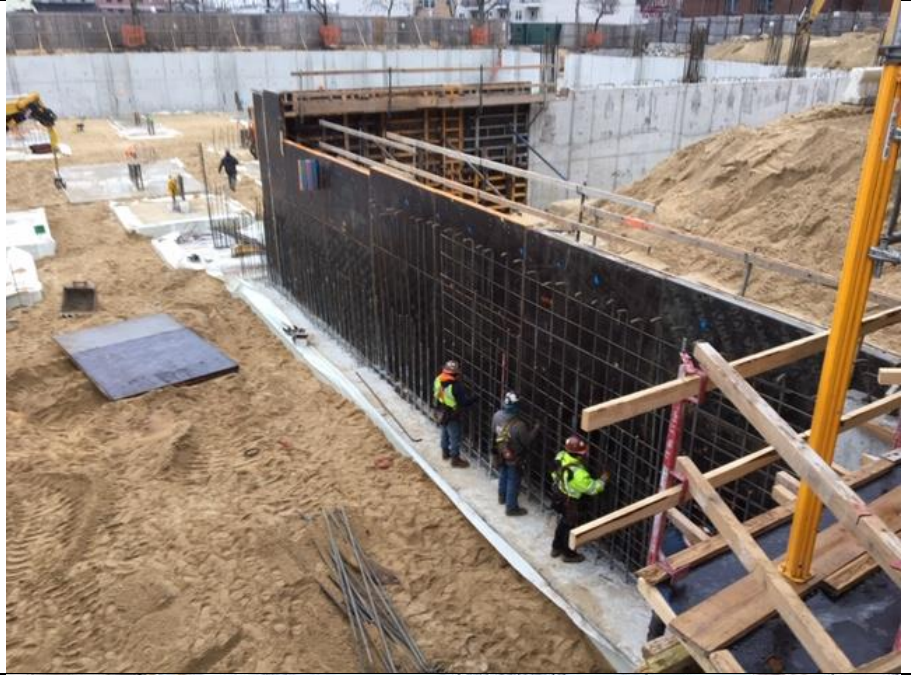
Photo 1- View of rebar installation and formwork in C3.

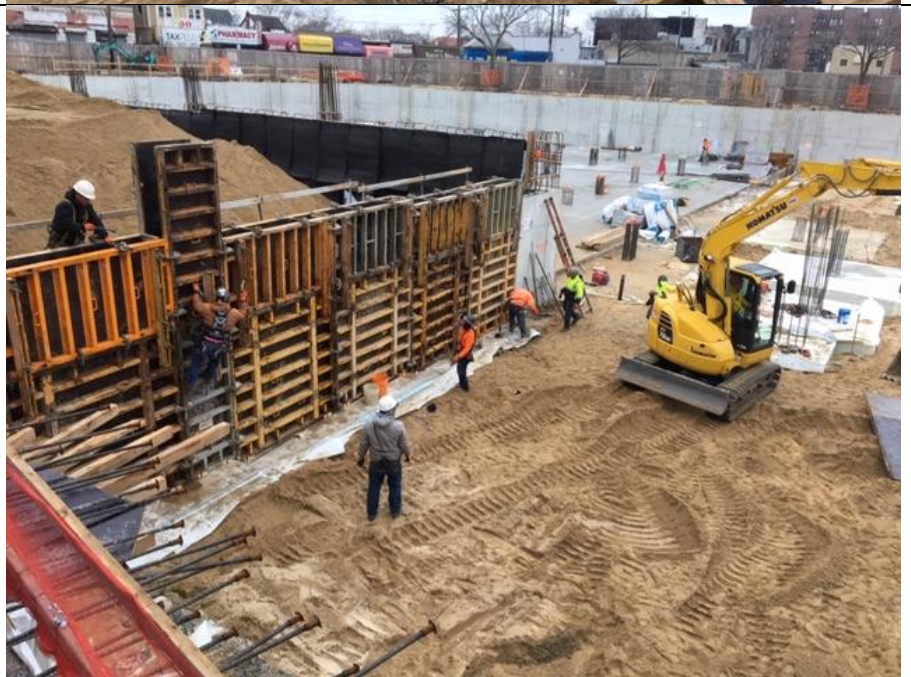
Photo 2- View of formwork in C3.

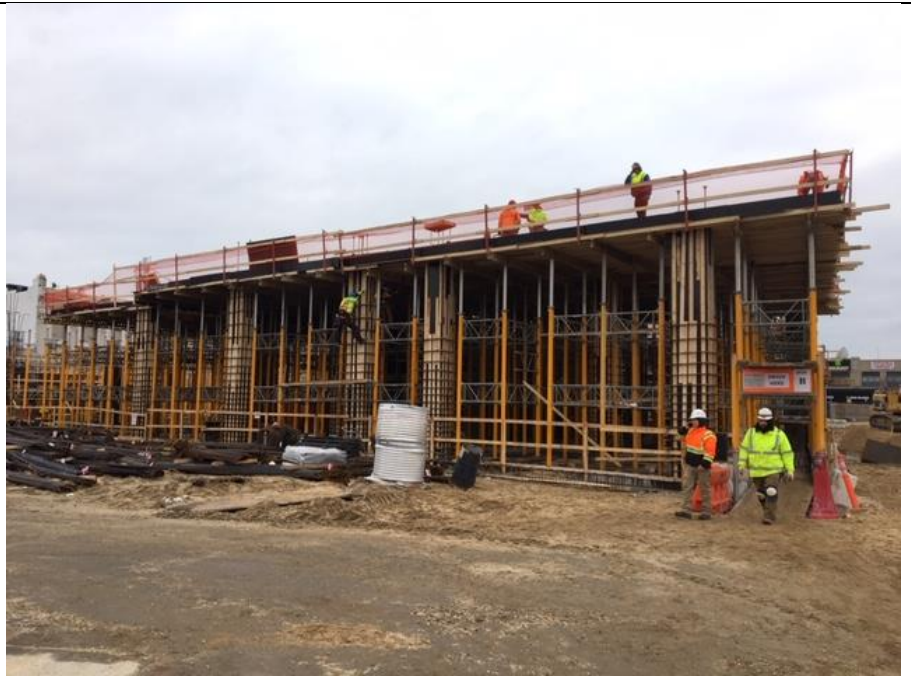
Photo 3- View
of formwork in
D2, D3, E2
and E3.

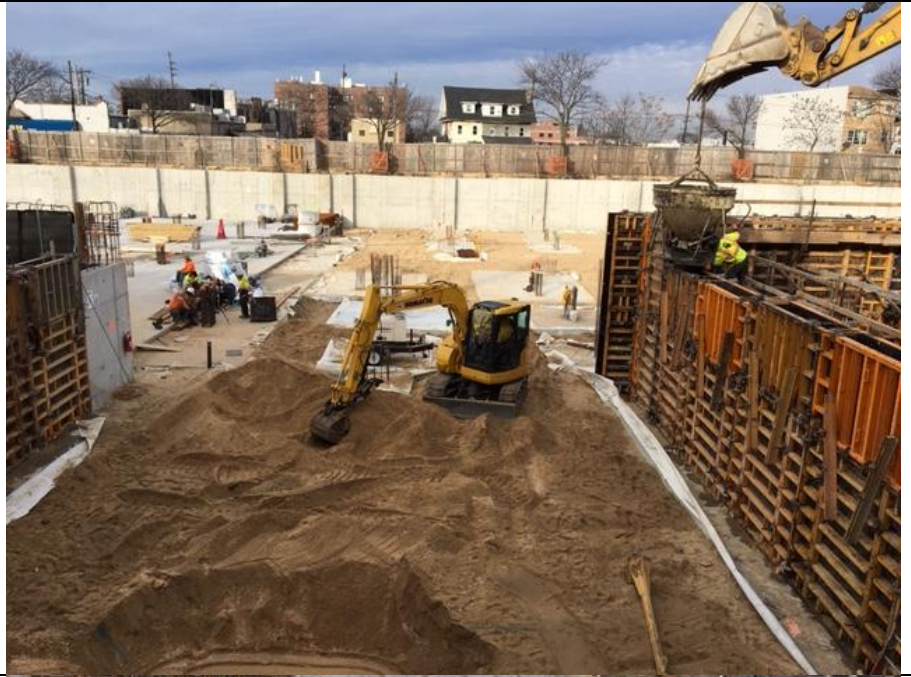
Photo 1- View
of footing
excavation in
C3.

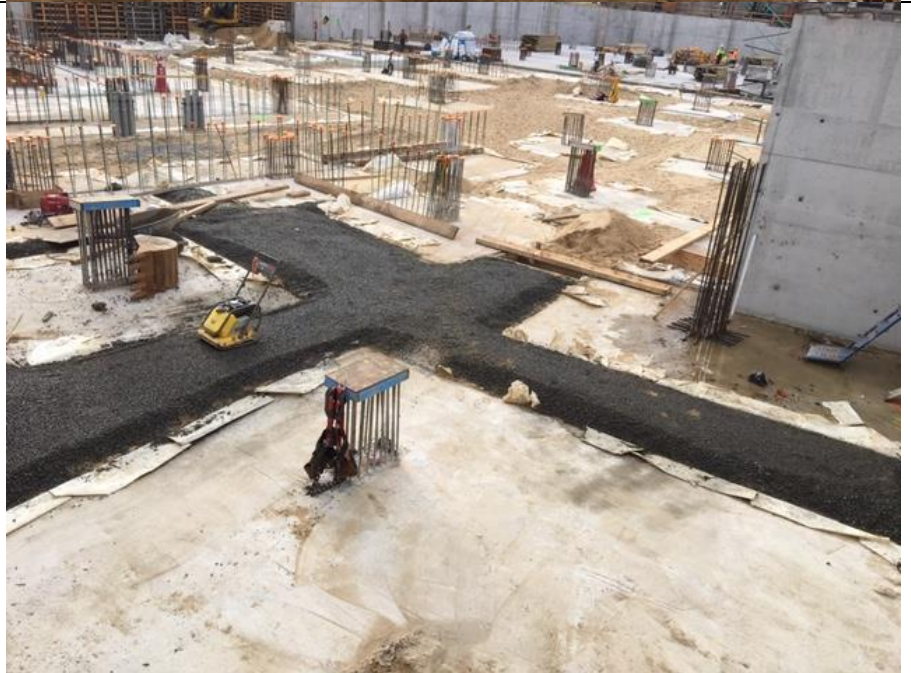
Photo 2- View
of laid stone
in A4.

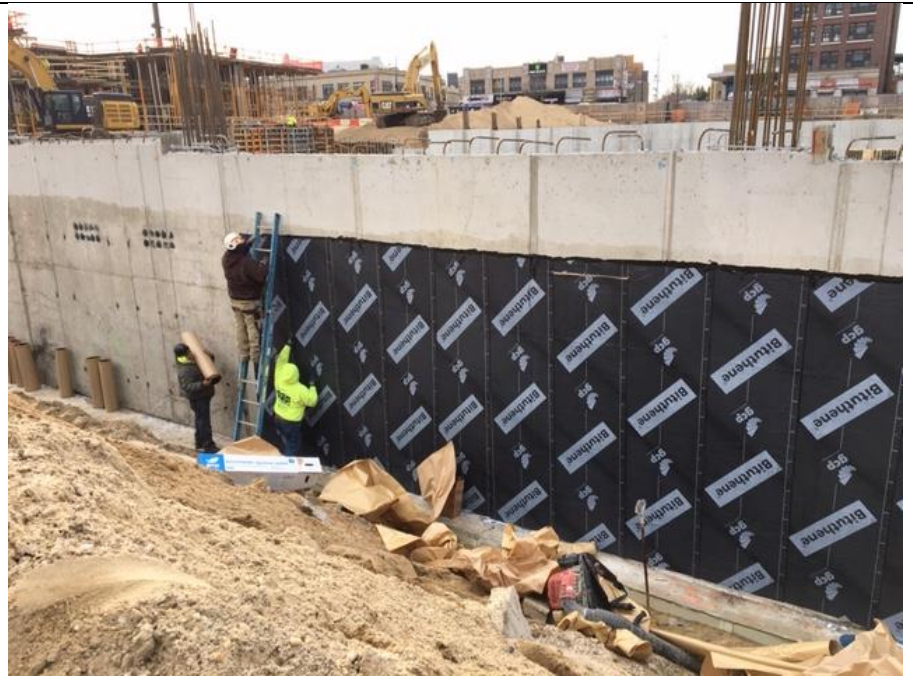
Photo 3- View
of Bituthene
installation in
A4 and B4.

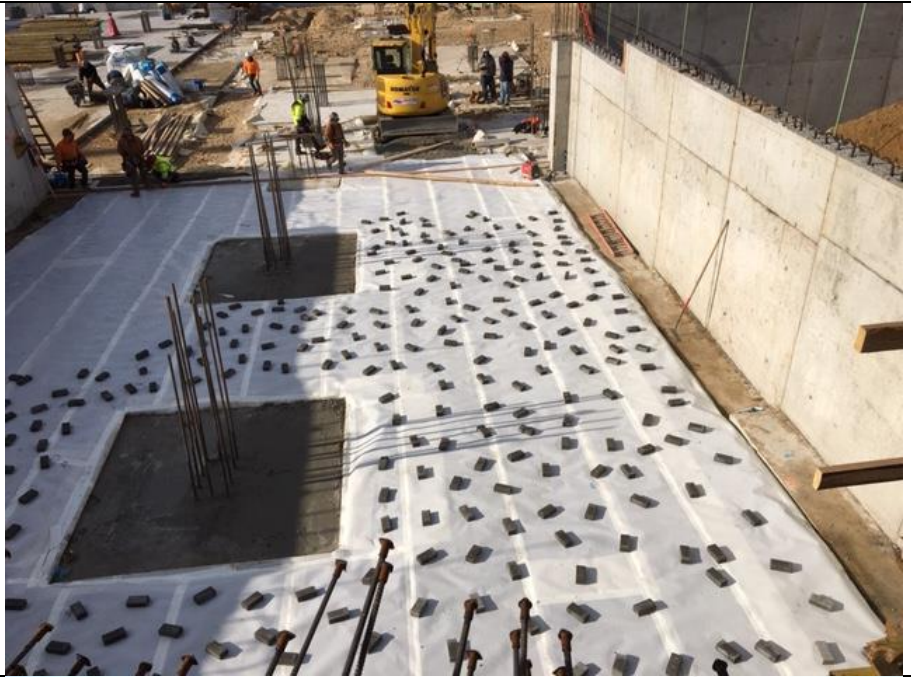
Photo 1- View of Preprufe 200 and rebar installation in B3 and C3.

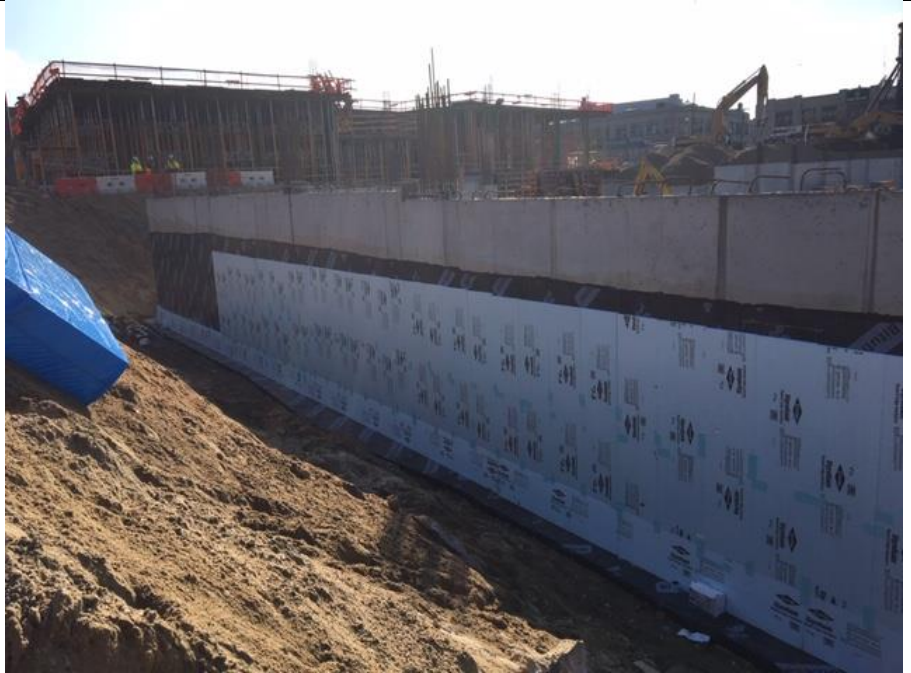
Photo 2- View of Bituthene and Hydroduct installation in A4 and B4.

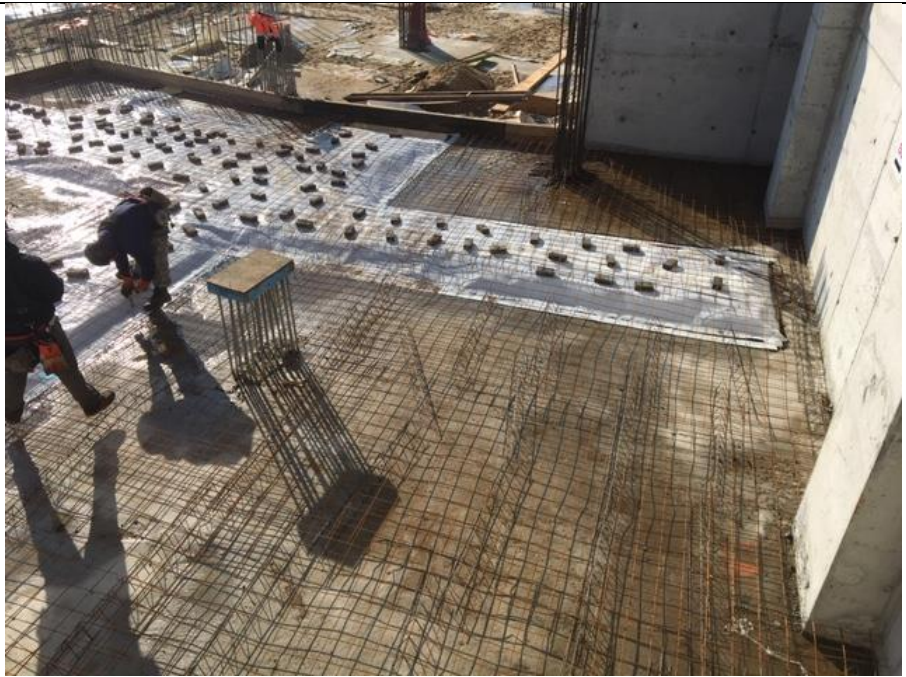
Photo 3- View
of Preprufe
200 and rebar
installation in
A4.

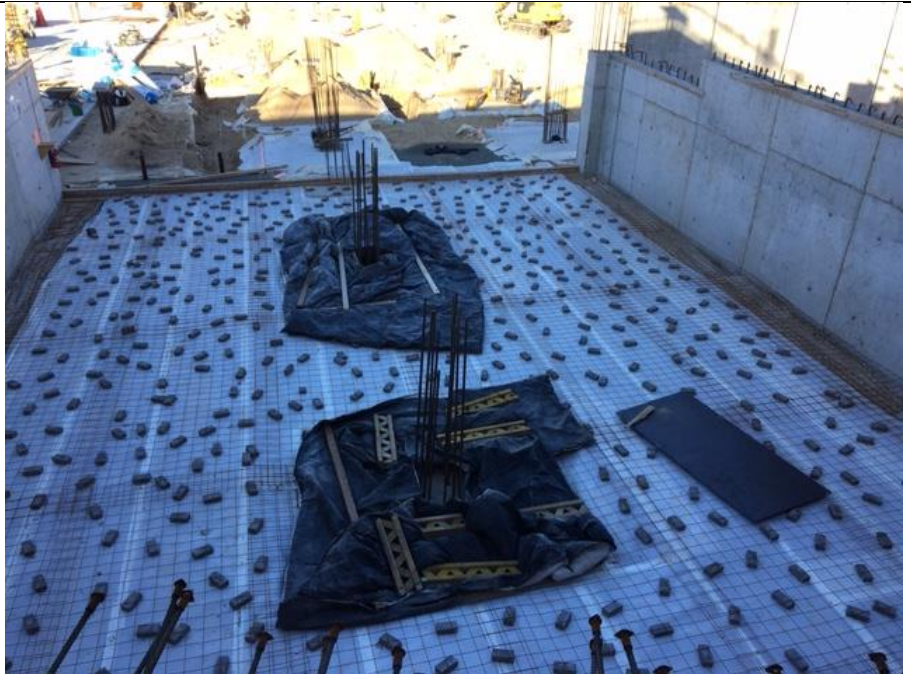
Photo 1- View of Preprufe 200 and rebar installation in B3 and C3.

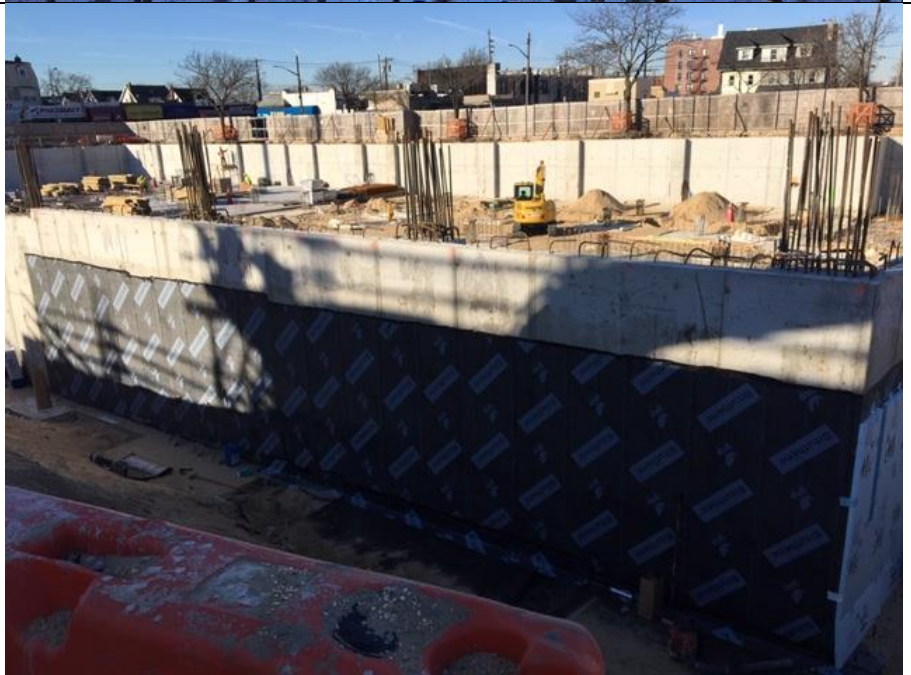
Photo 2- View of Bituthene installation in B3 and B4.

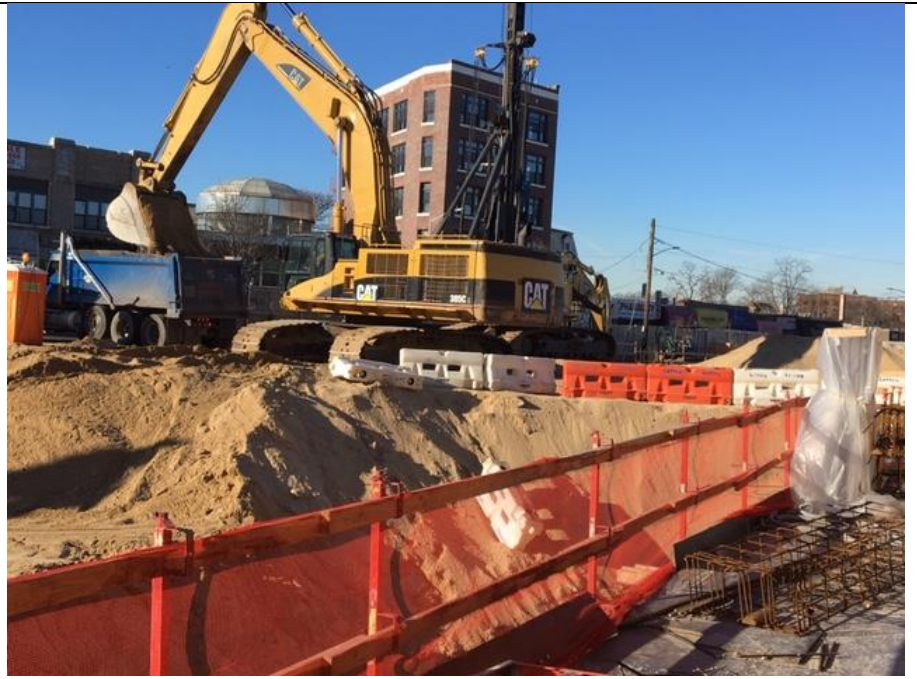
Photo 3- View of excavating soil for export to the Posillico facility in Farmingale, NY.

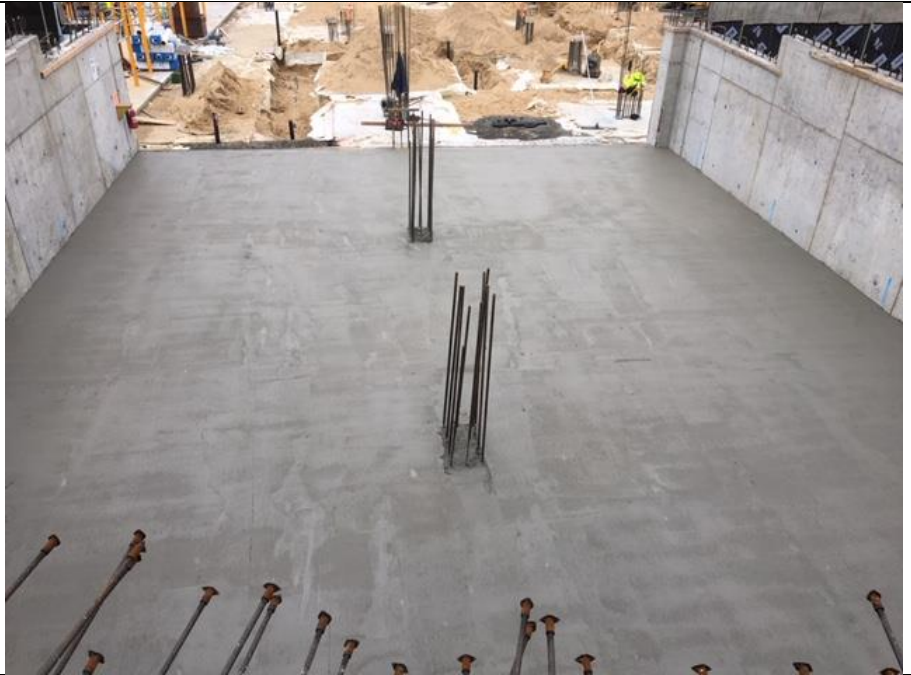
Photo 1- View
of poured
concrete in
B3 and C3.

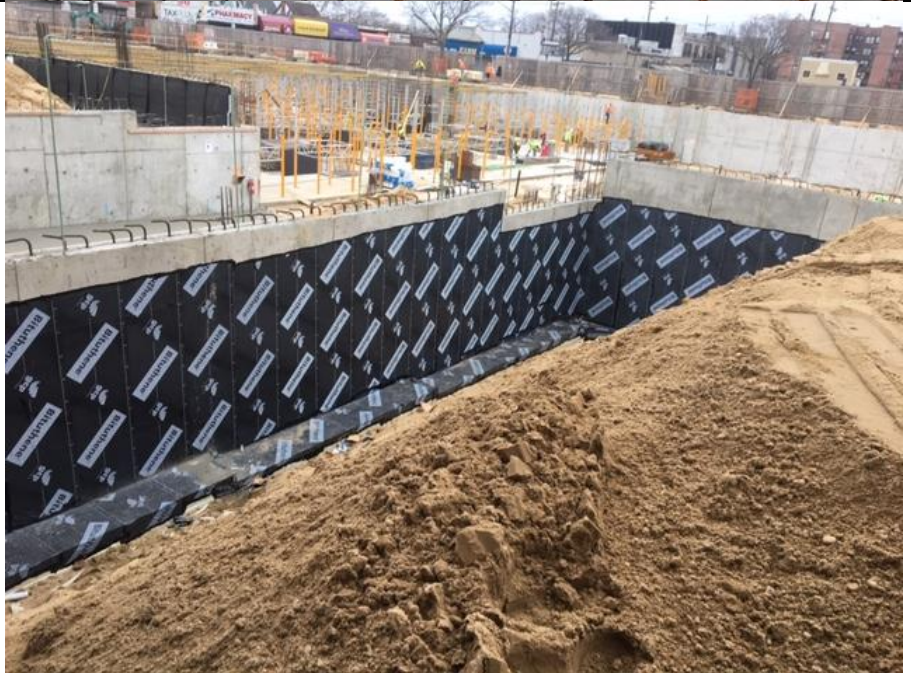
Photo 2- View
of Bituthene
installation in
B3 and C3.

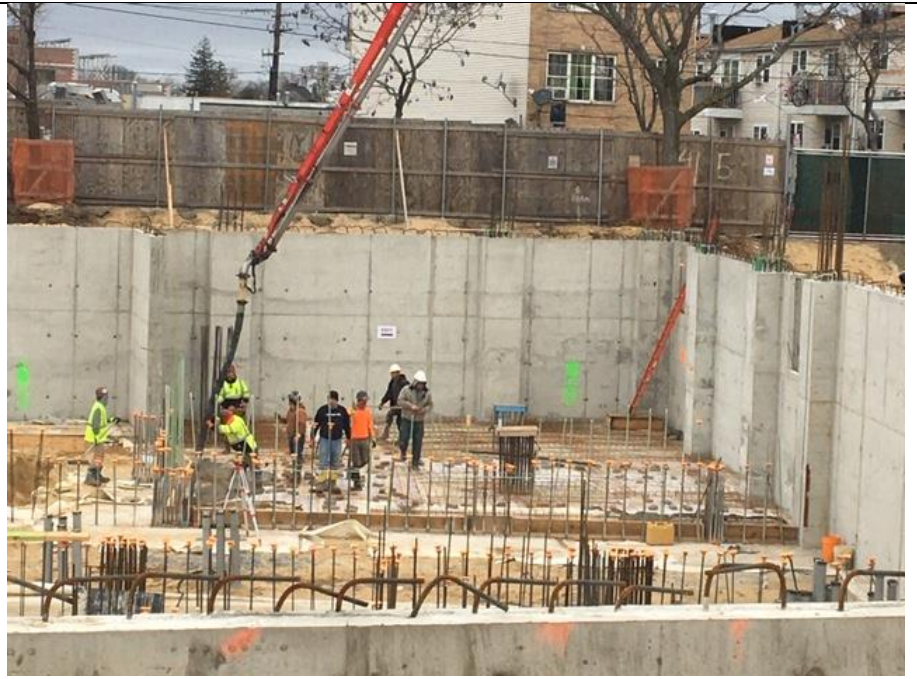
Photo 3- View
of pouring
concrete in
A4.

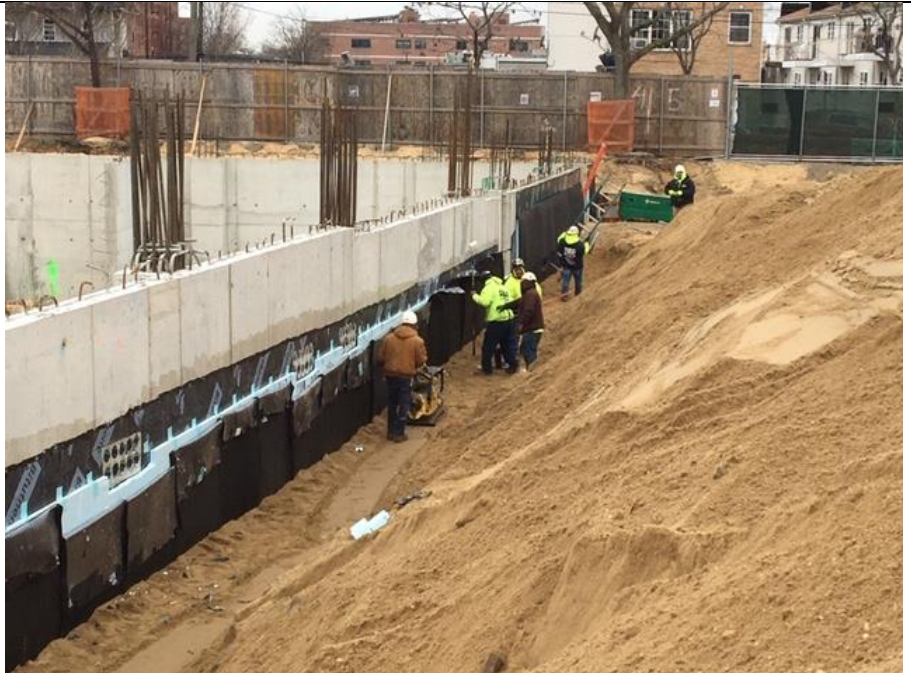
Photo 1- View of backfilling soil in A4 and B4.

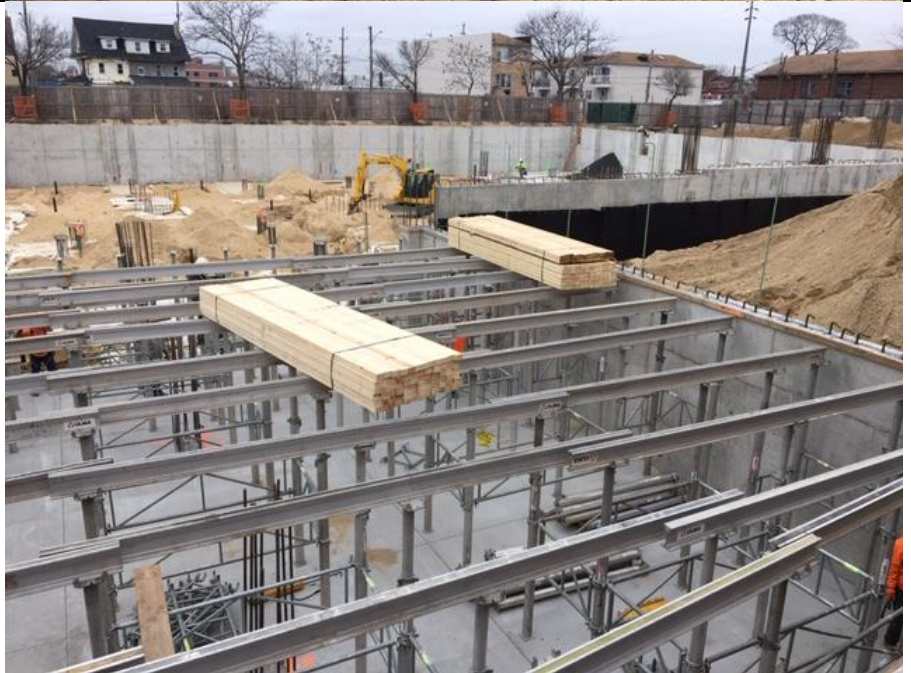
Photo 2- View of formwork in B3 and C3.

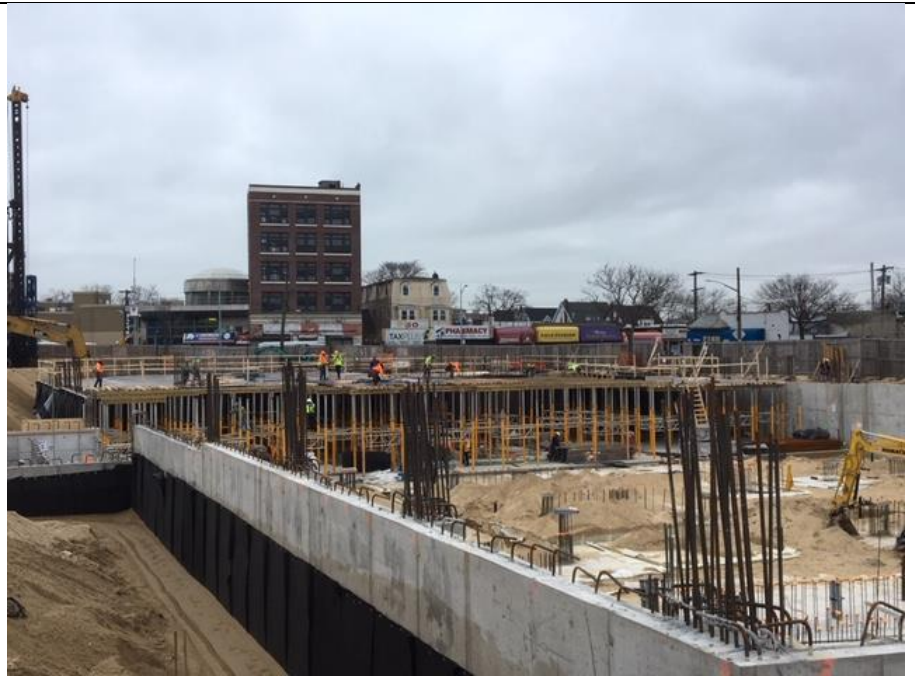
Photo 3- View of formwork and rebar installation in A1, A2, B1, and B2.

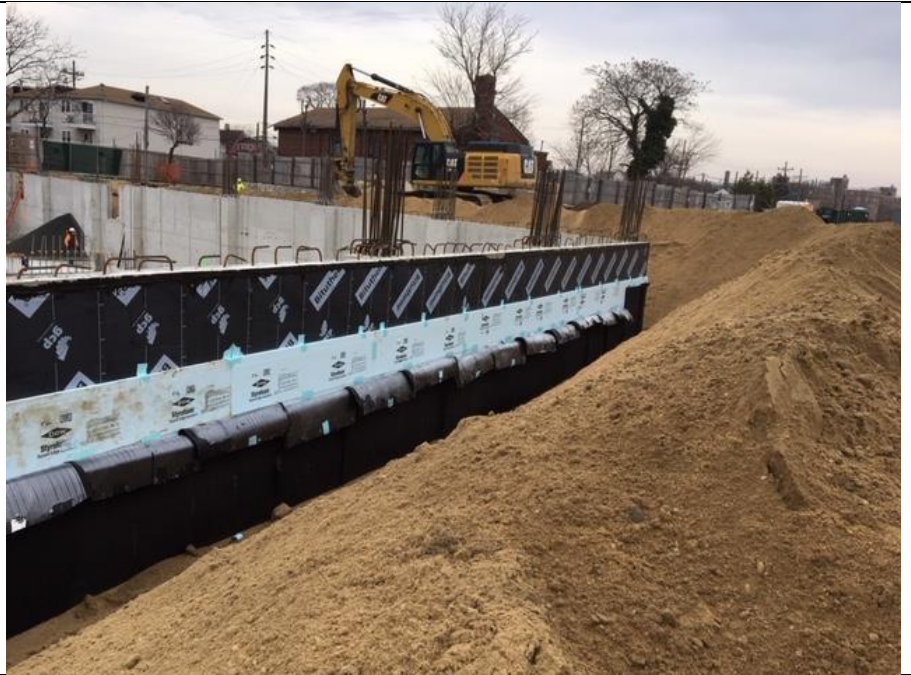
Photo 1- View of Bituthene and Hydroduct installation in B3 and B4.

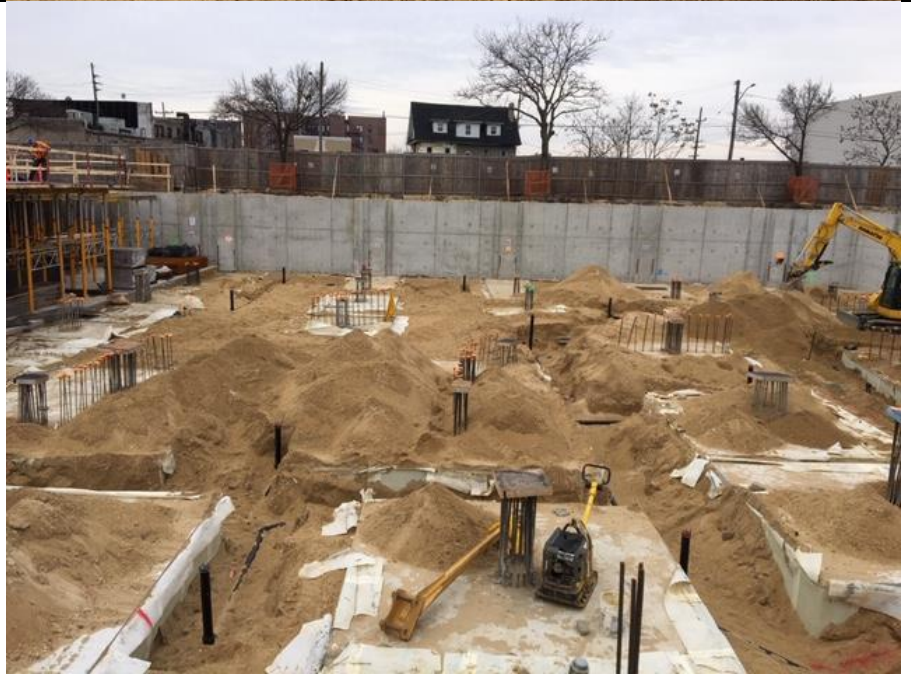
Photo 2- View of utility installation in A3 and B3.

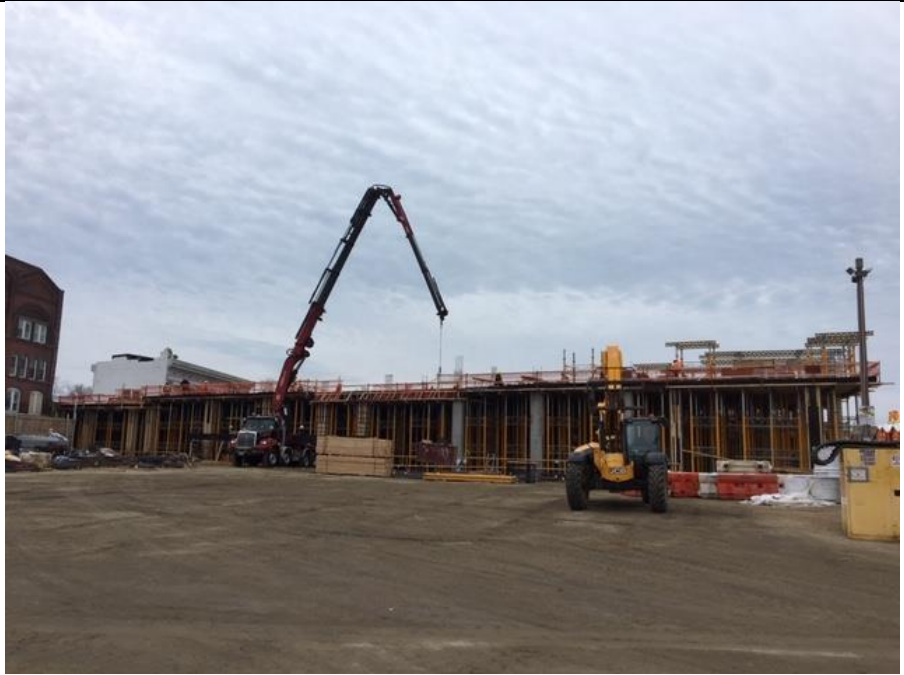
Photo 3- View of formwork and rebar installation in D3, D4, E3, E4, F3, and F4.

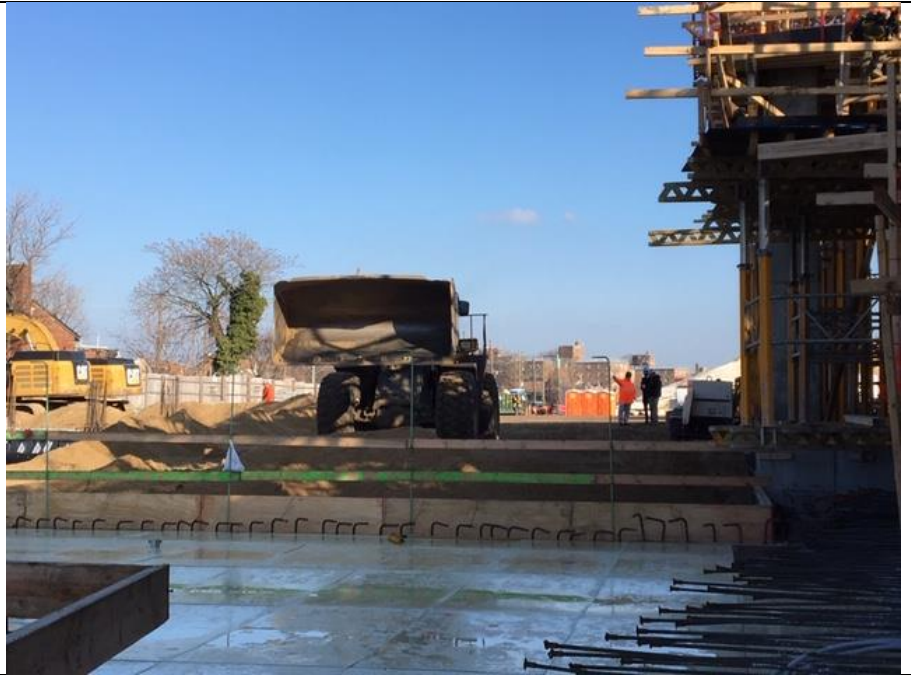
Photo 1- View of backfilling soil in B3 and C3.

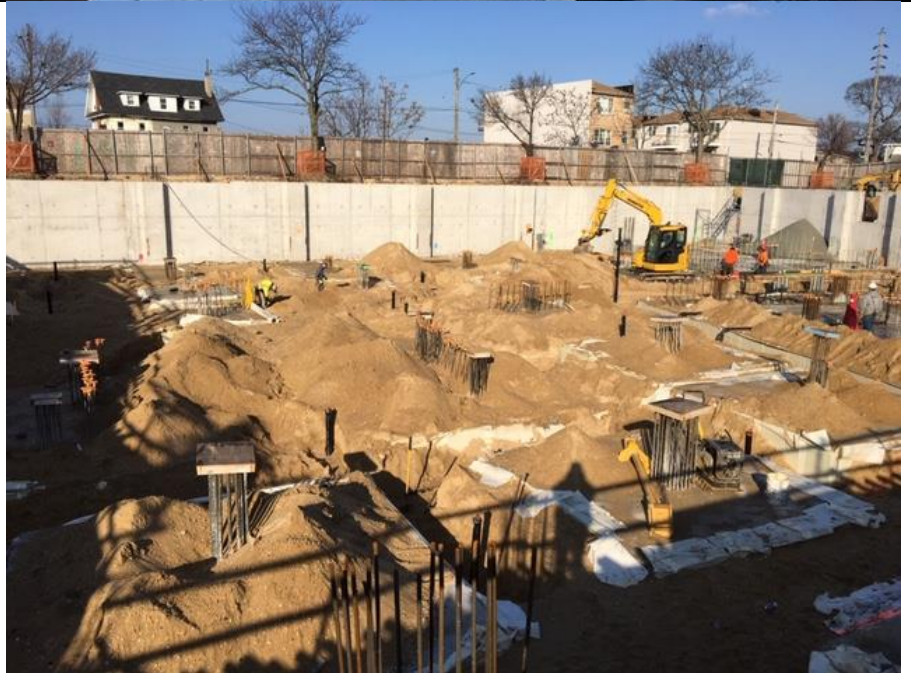
Photo 2- View of utility installation in A3, A4, B3 and B4.

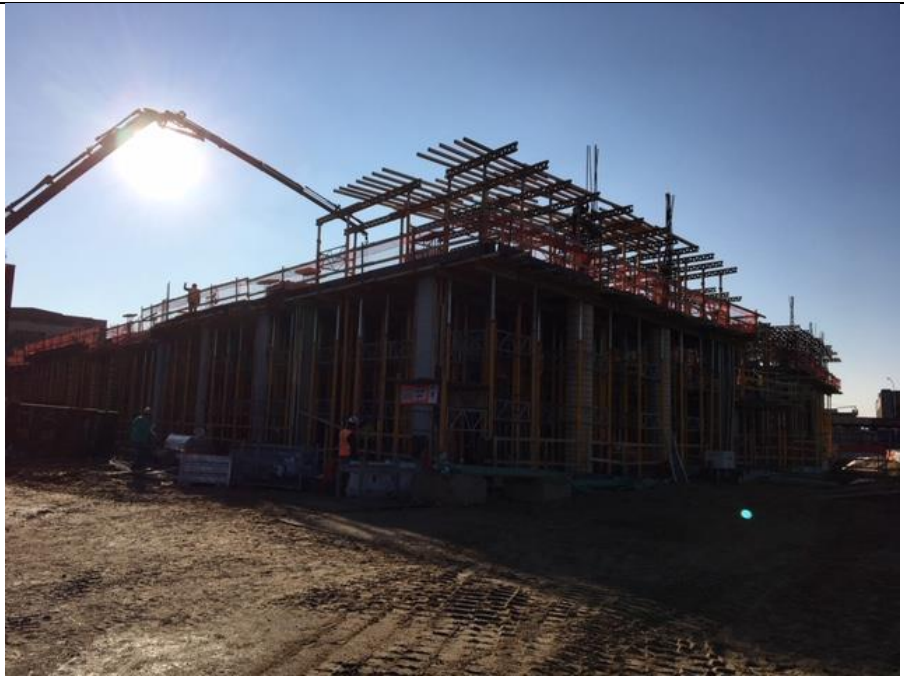
Photo 3- View of formwork and rebar installation in D3, D4, E3, E4, F3, and F4.

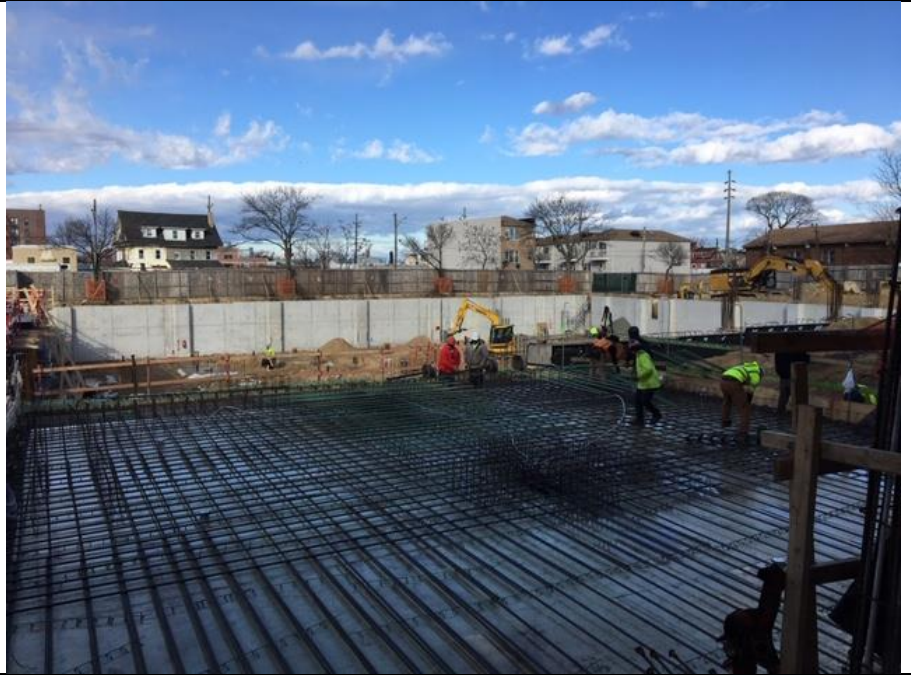
Photo 1- View of rebar installation in B3 and C3.

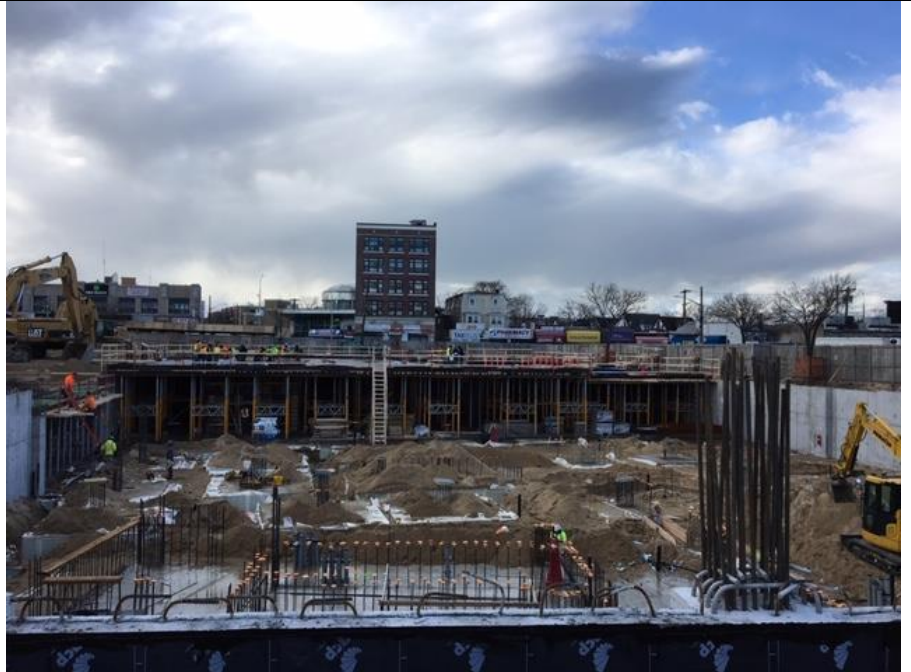
Photo 2- View of utility installation in A3, A4, B3 and B4.

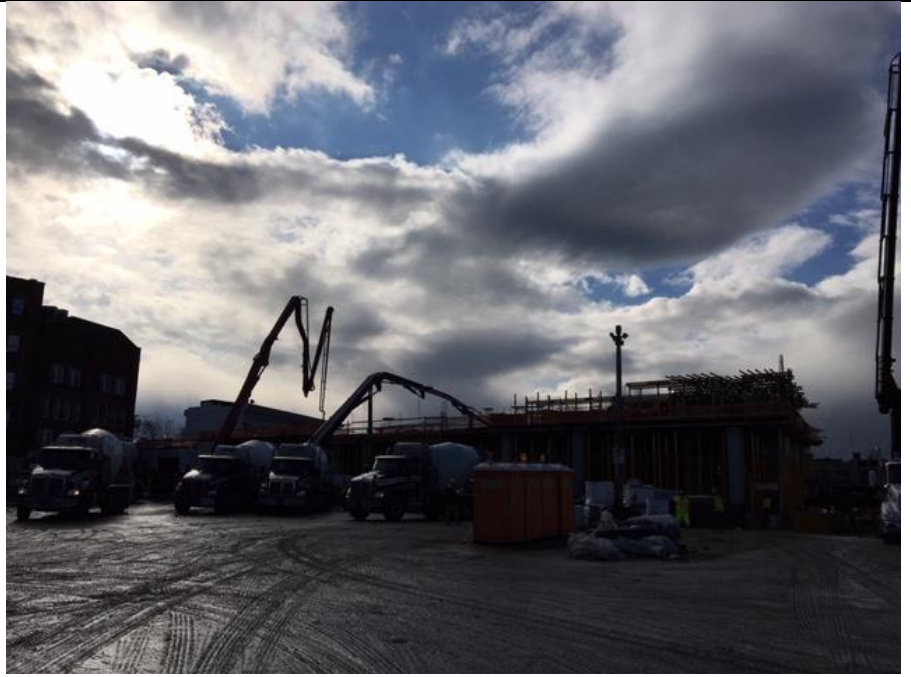
Photo 3- View
of pouring
concrete in
D3, D4, E3,
and E4

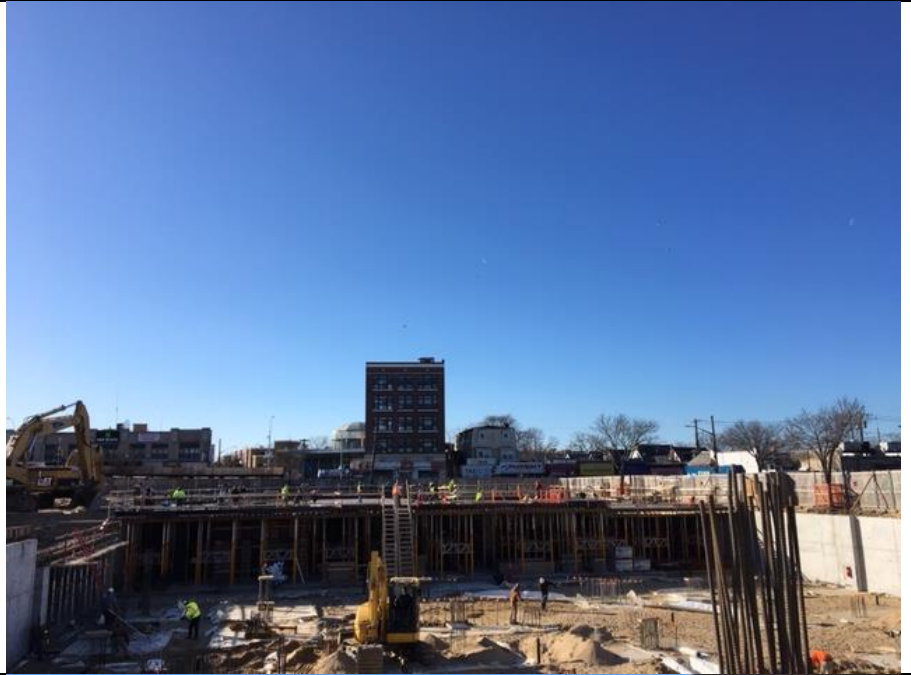
Photo 1- View of formwork and rebar installation in A1, A2, B1, and B2.

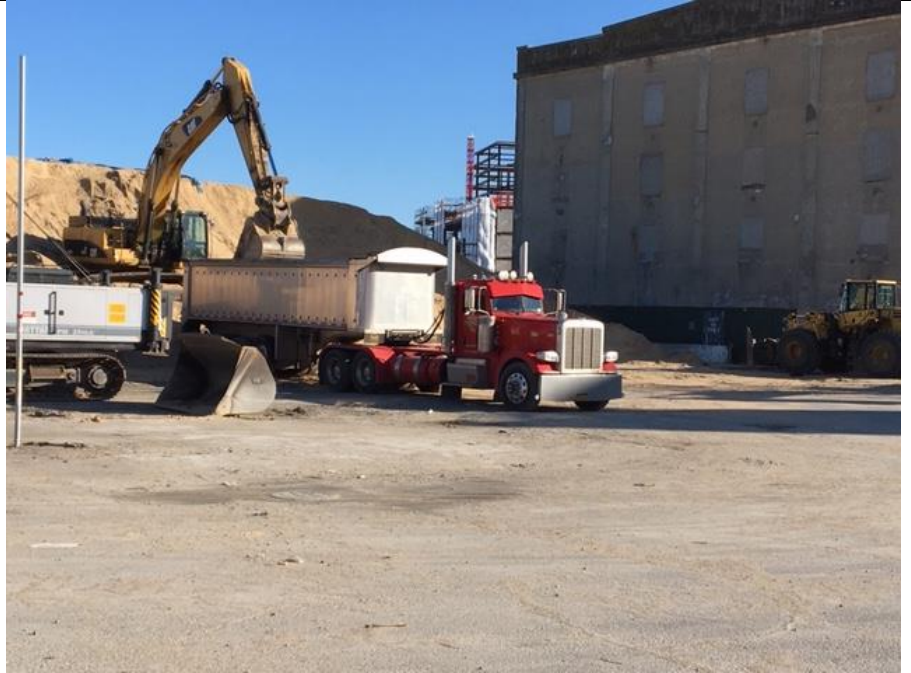
Photo 2- View of loading out truck with soil for export offsite.

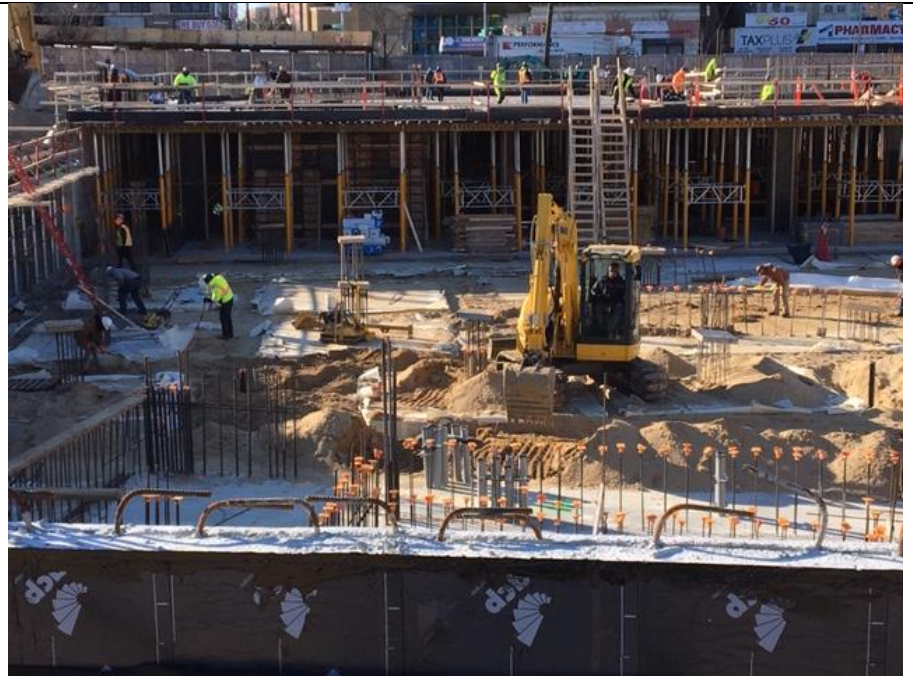
Photo 3- View
of utility
installation in
A3, A4, B3,
and B4.

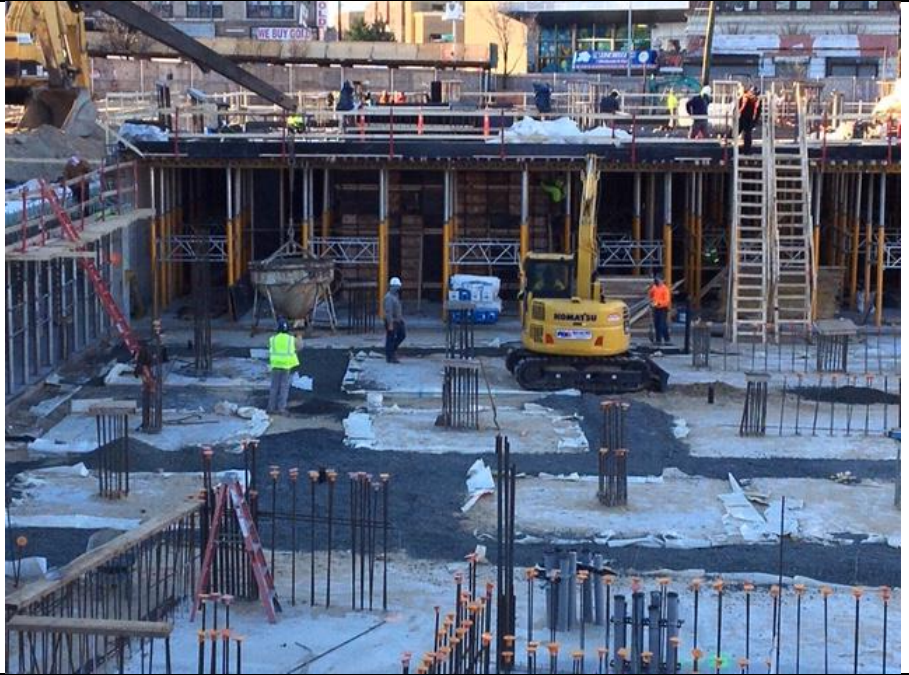
Photo 1- View of laying stone in B3.
