Daily Report for January 2, 2020

**Far Rockaway Project
20-02 Mott Avenue
Far Rockaway, NY
BCP #C241224**

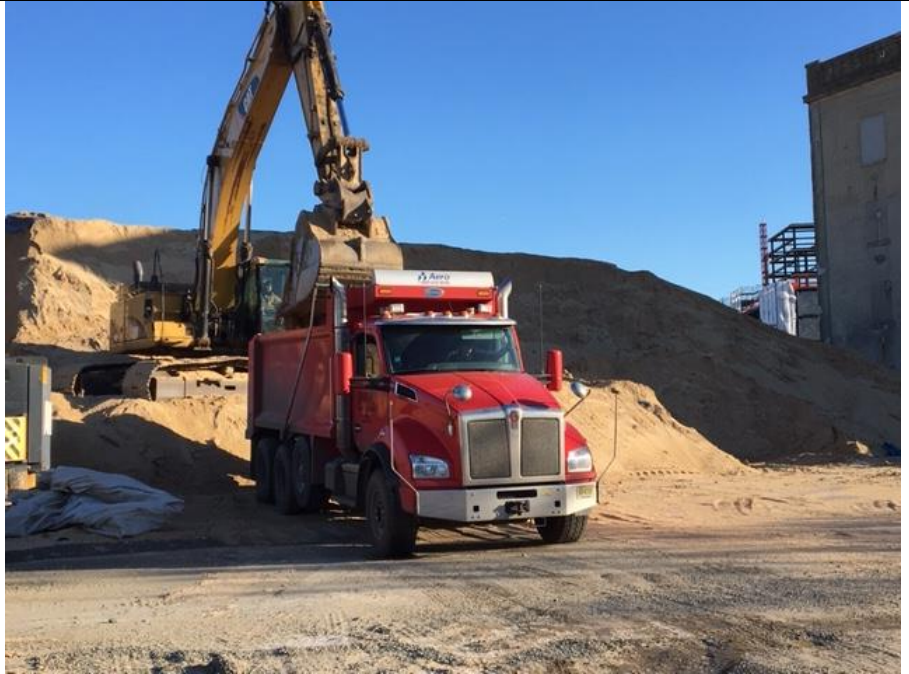
Photo 2- View of loading out truck with soil for export offsite to 97-01 Northern Boulevard under the Clean Soil Bank transfer #20CCSB151.

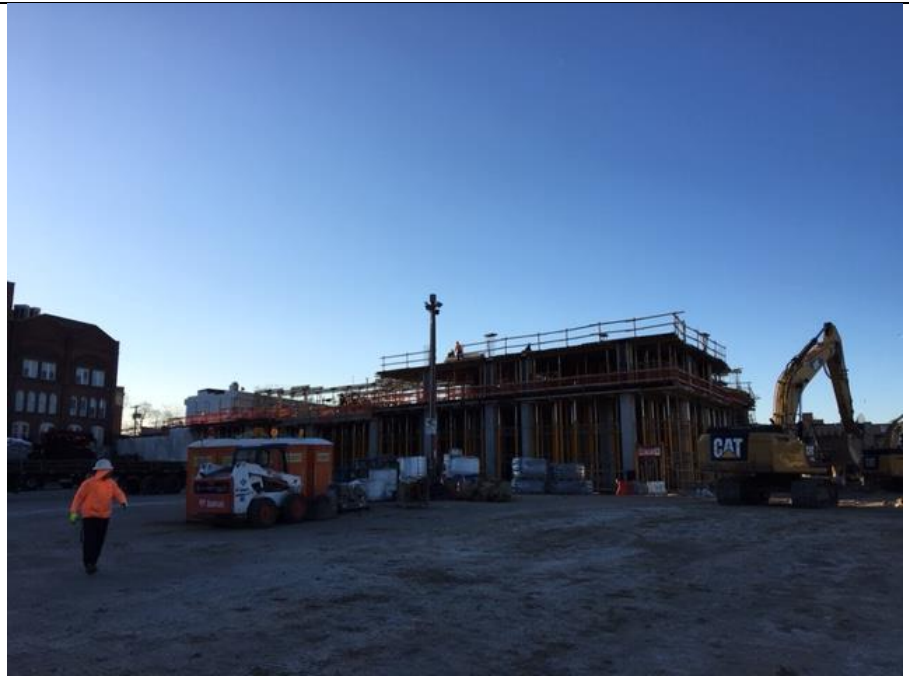
Photo 3- View of formwork and rebar installation in D3, D4, E3, and E4.

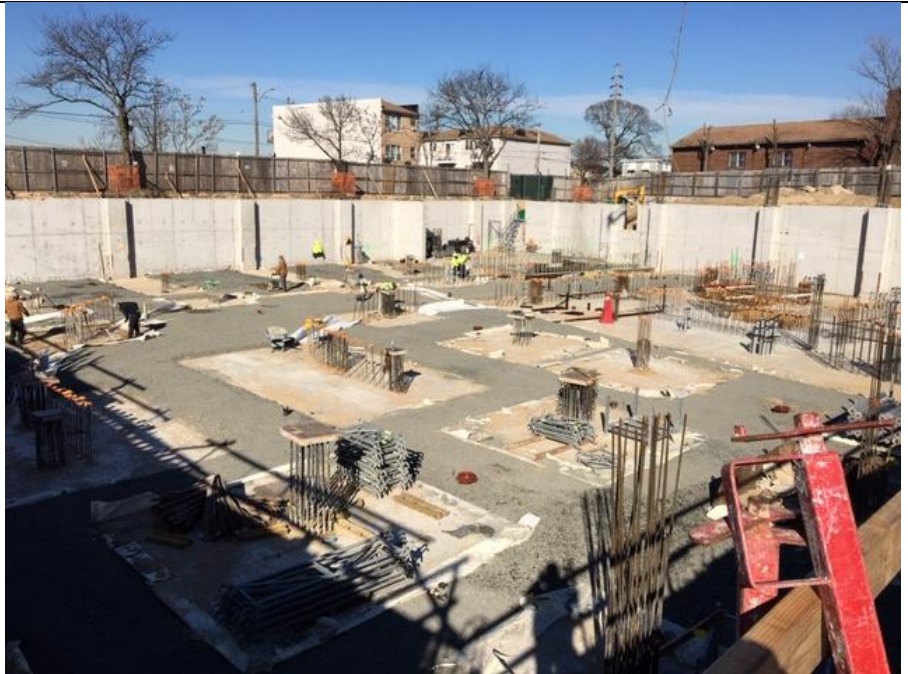
Photo 1- View of laying stone in A3, A4, B3, and B4.

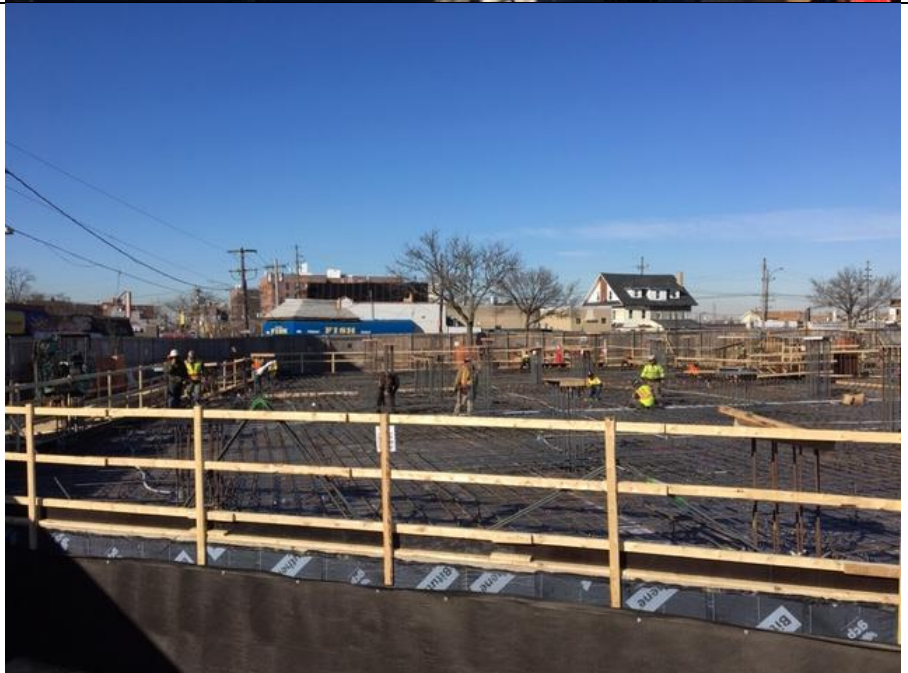
Photo 2- View of rebar and formwork in A1, A2, B1, and B2.

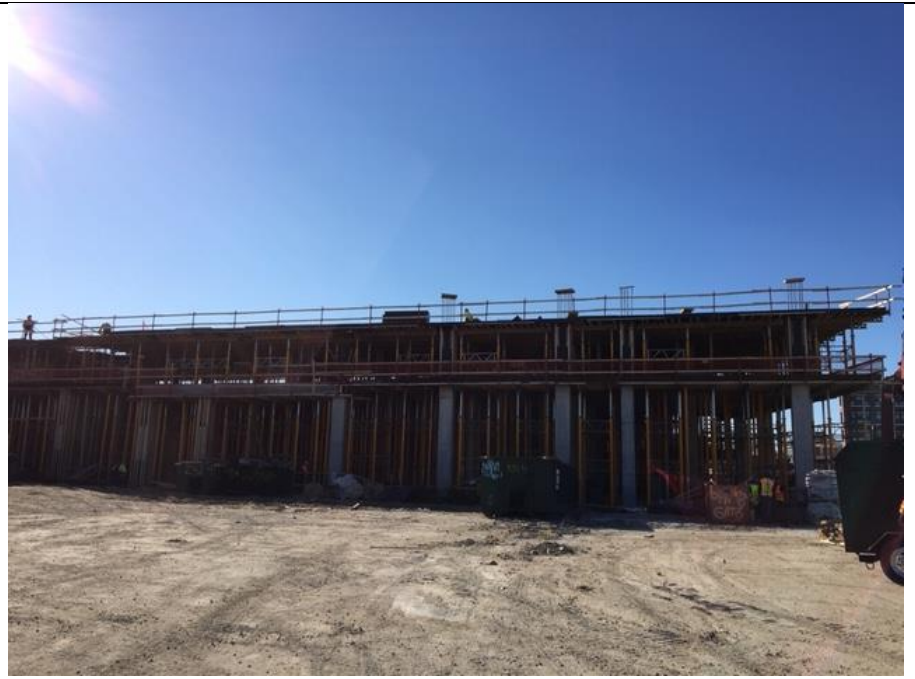
Photo 3- View of formwork and rebar installation in D3, D4, E3, and E4.

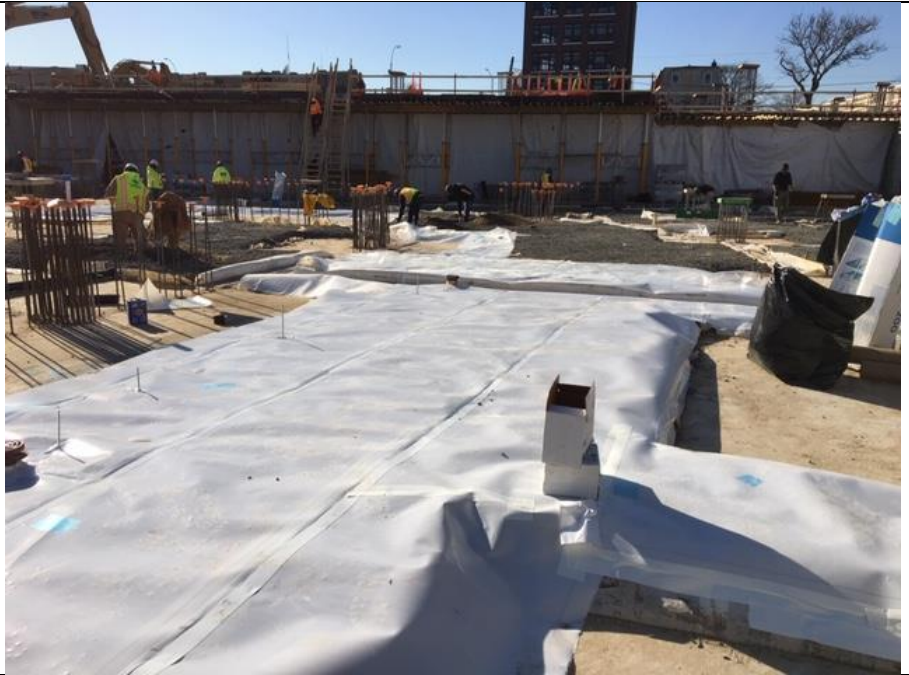
Photo 1- View of Preprufe 200 in A3, A4, B3, and B4.

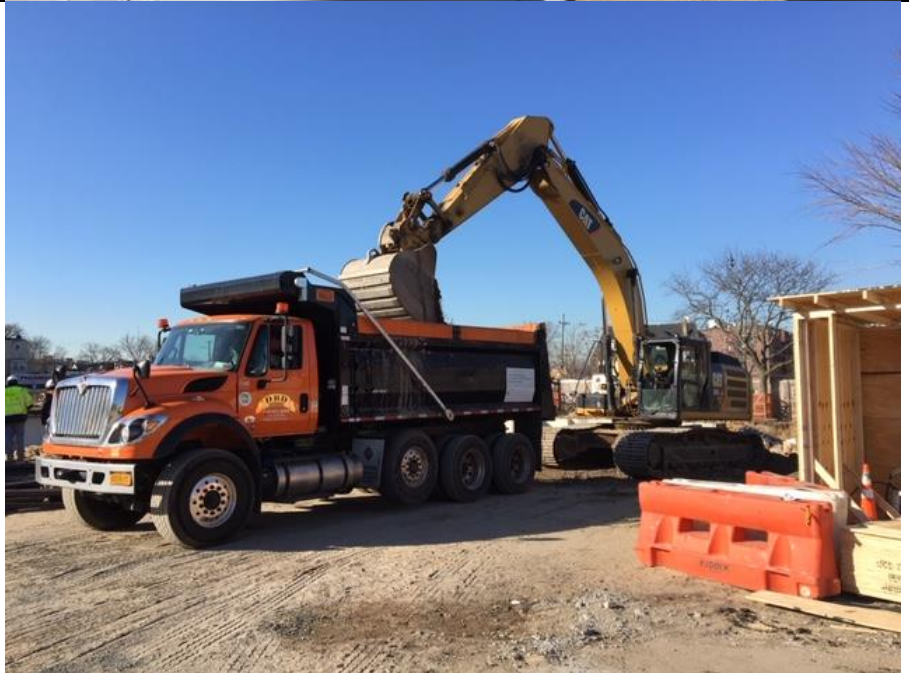
Photo 2- View of loading out concrete and debris for export offsite.

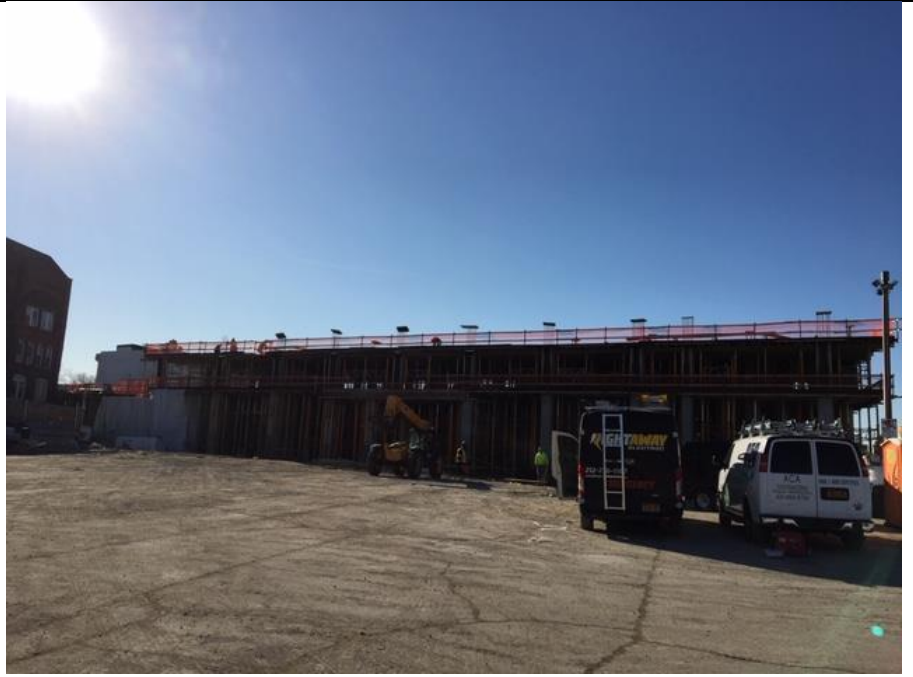
Photo 3- View of formwork and rebar installation in D3, D4, E3, and E4.

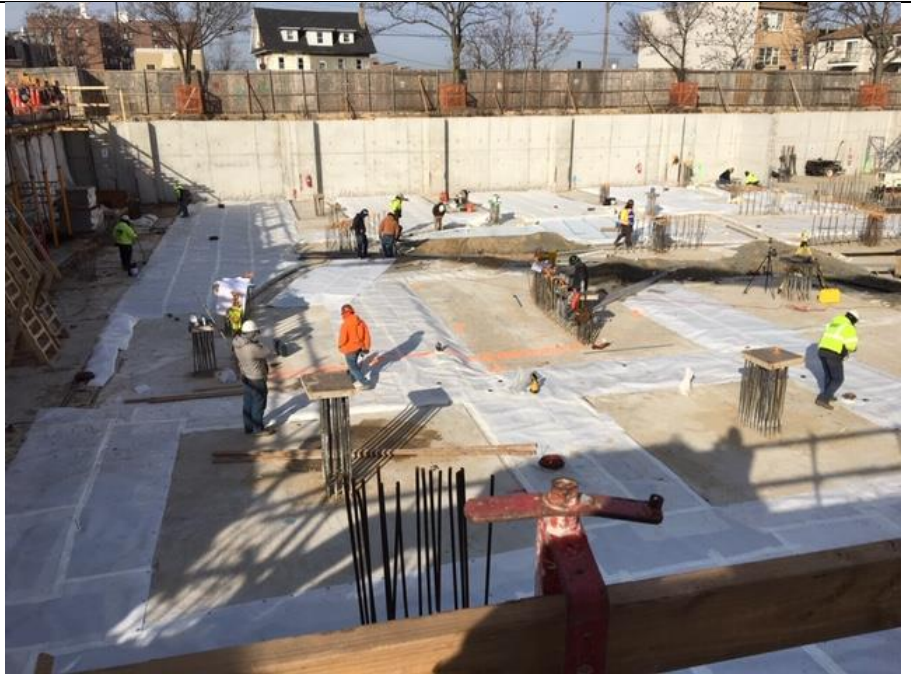
Photo 1- View of Preprufe 200 installation in A3, A4, B3, and B4.

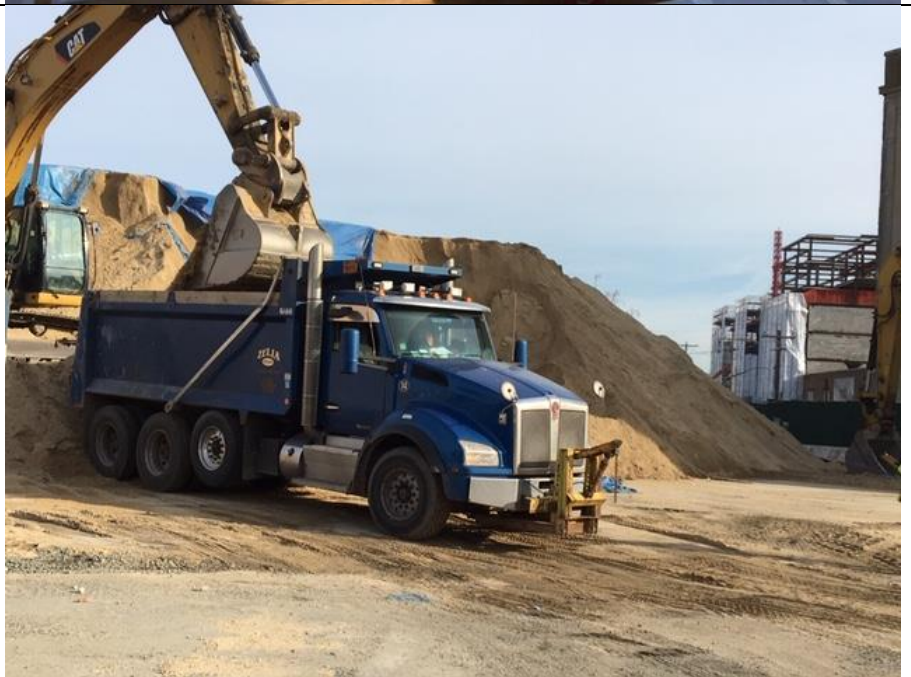
Photo 2- View of loading out soil for export offsite.

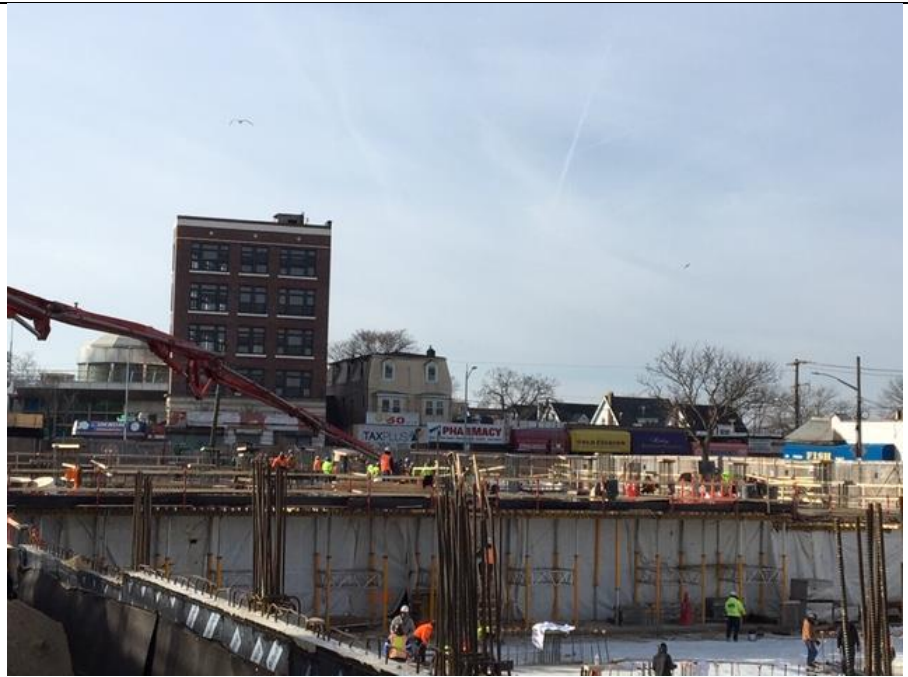
Photo 3- View
of pouring
concrete in A1,
A2, B1, and
B2.

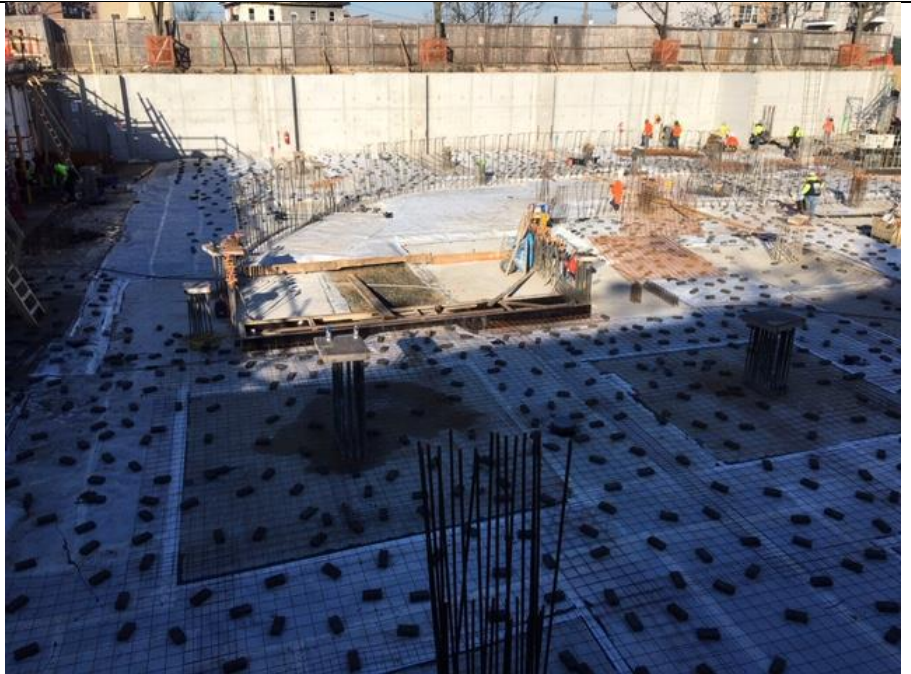
Photo 1- View of rebar installation in A3, A4, B3, and B4.

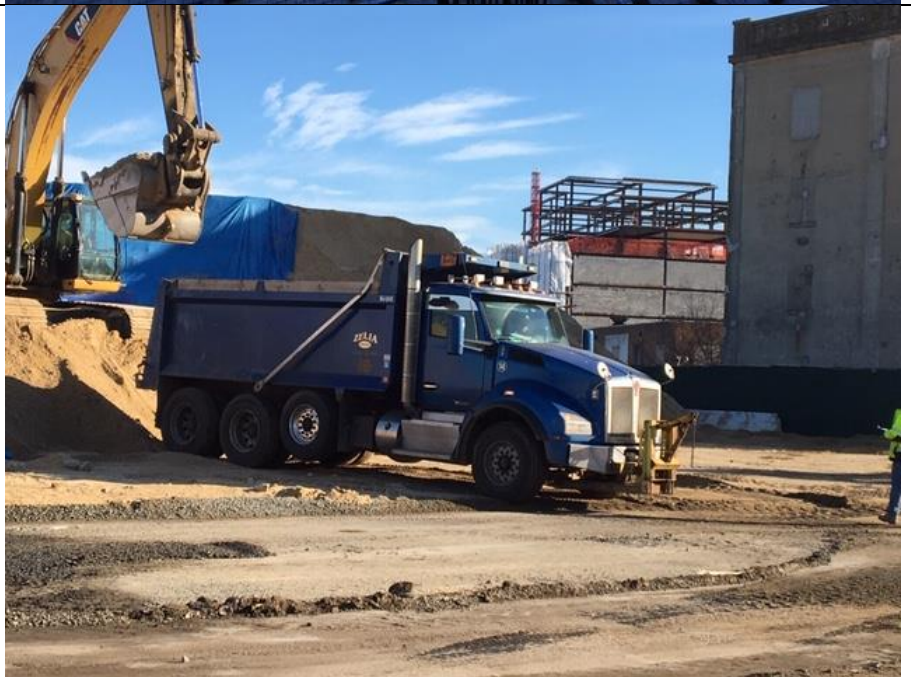
Photo 2- View of loading out soil for export offsite.

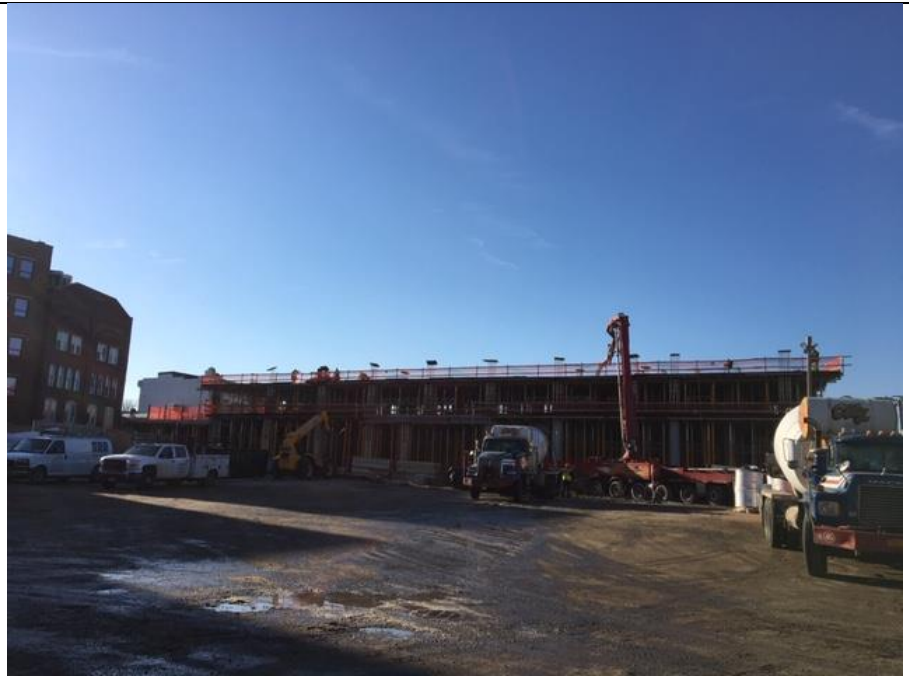
Photo 3- View
of pouring
concrete in D3,
D4, E3, and
E4.

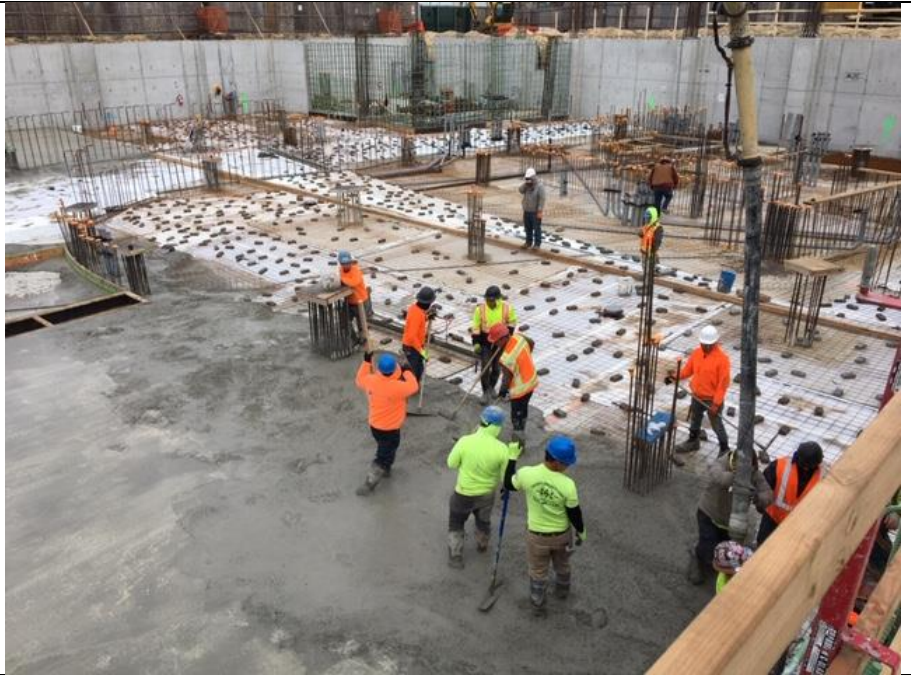
Photo 1- View of pouring concrete in A3 B3.

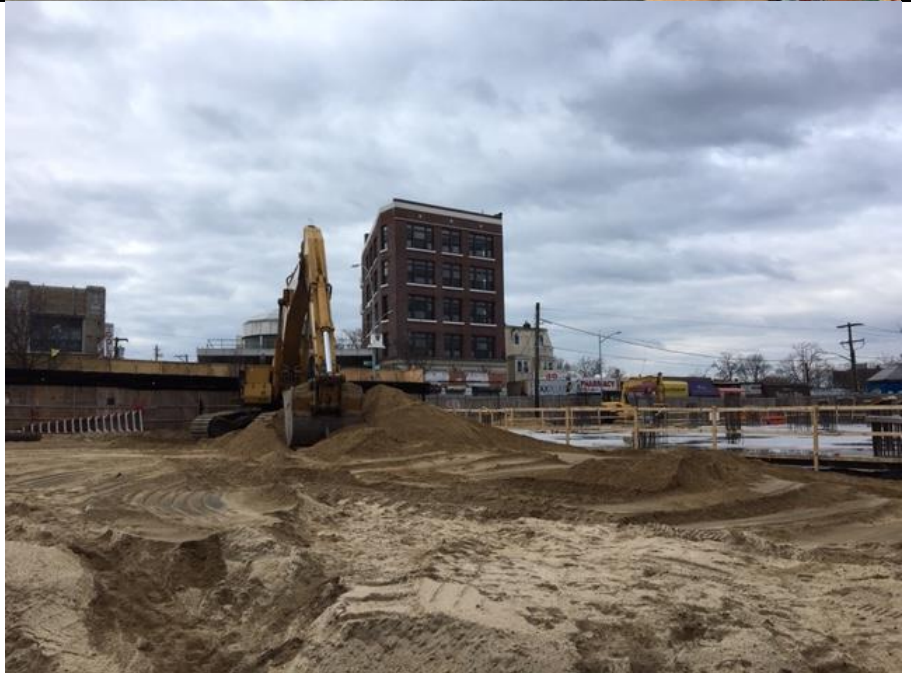
Photo 2- View of backfilling in A1 and B1.

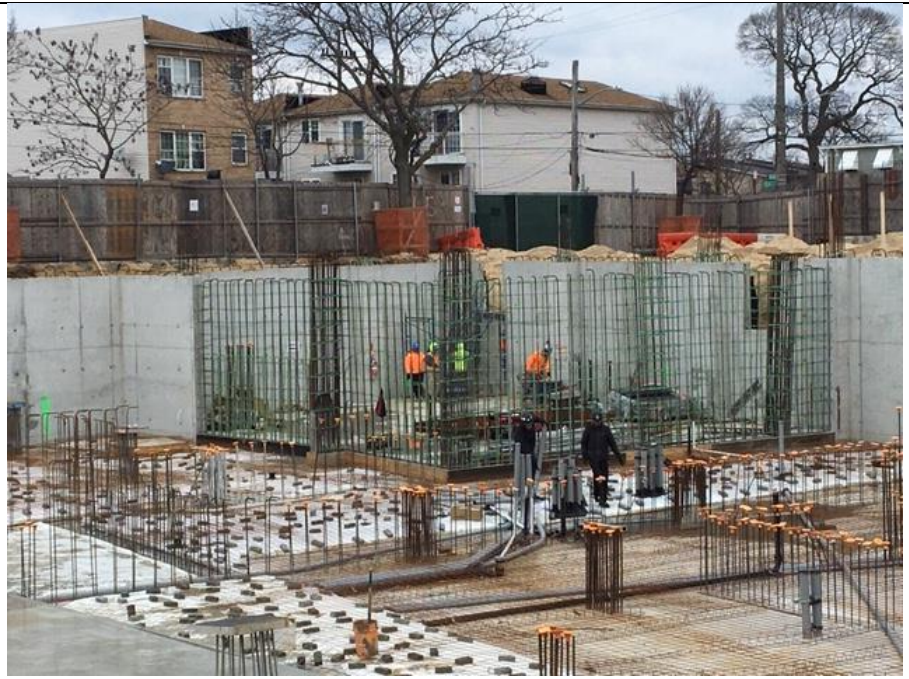
Photo 3- View
of rebar
installation in
A4.

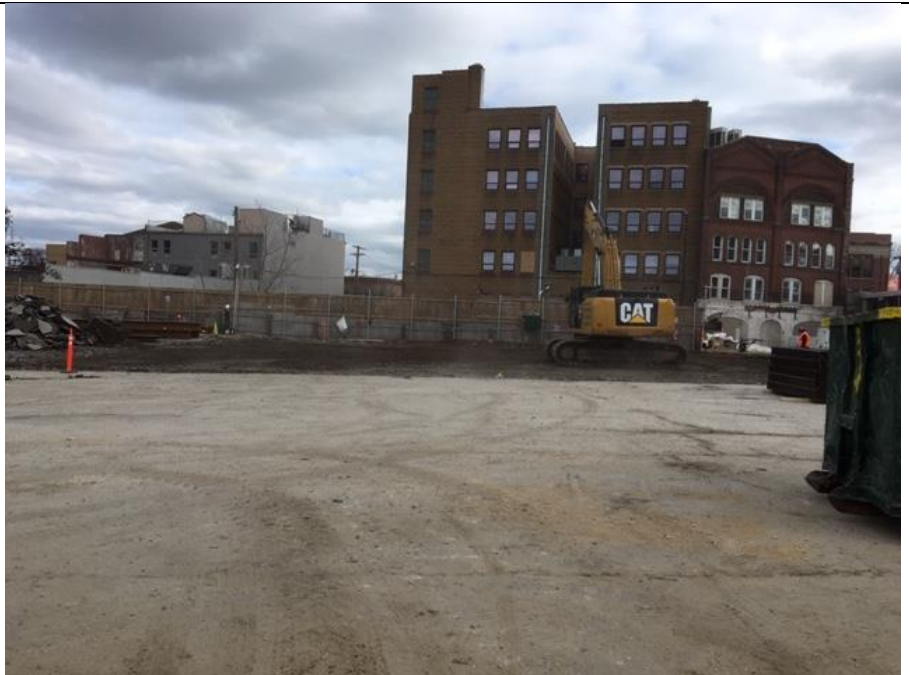
Photo 1- View of breaking up concrete and asphalt in D5 and D6.

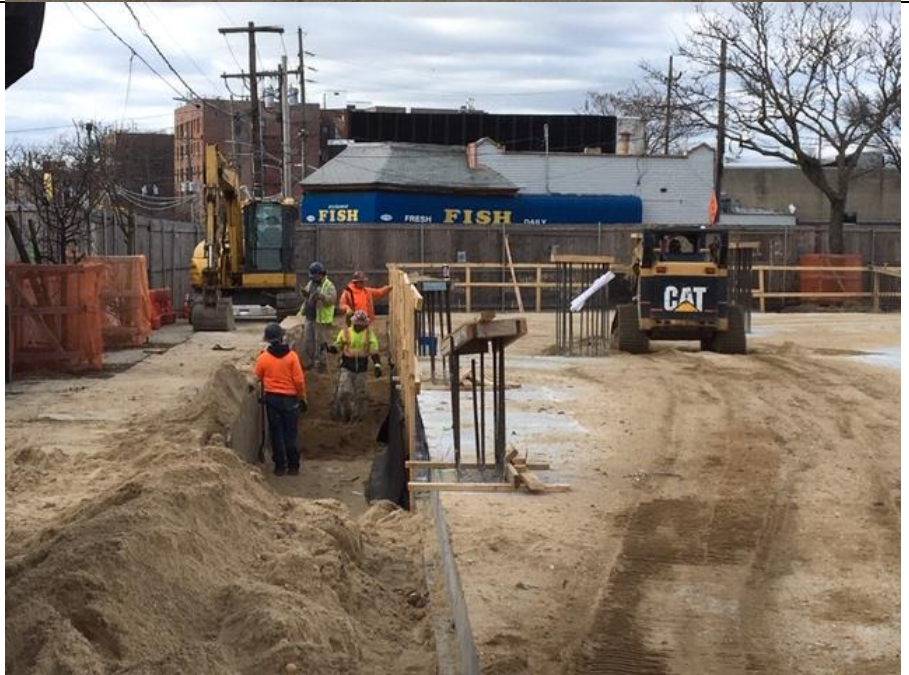
Photo 2- View of backfilling soil in A1 and B1.

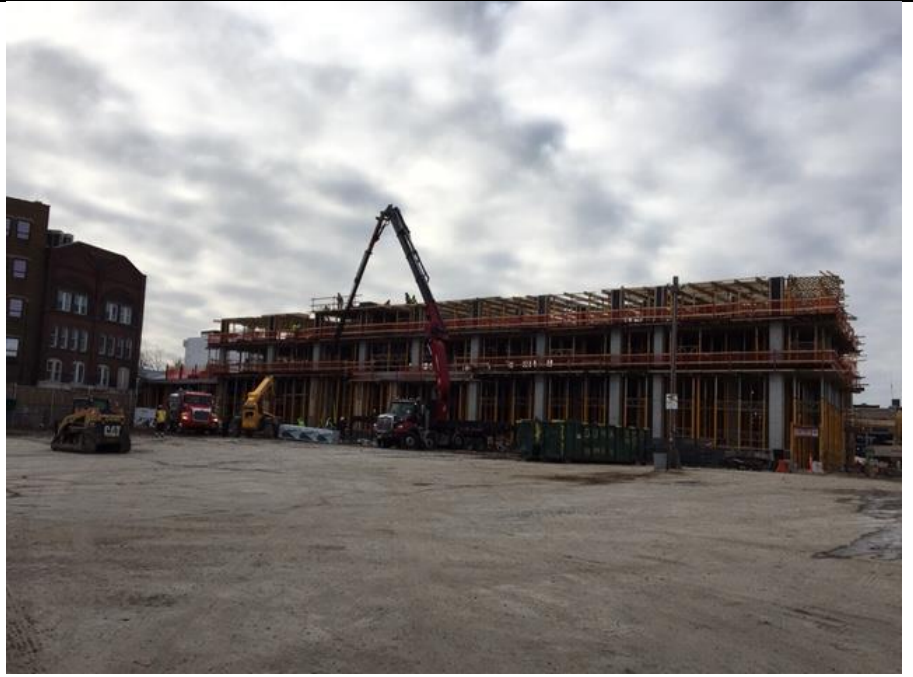
Photo 3- View of rebar installation and formwork in D3, D4, E3, E4, F3, and F4.

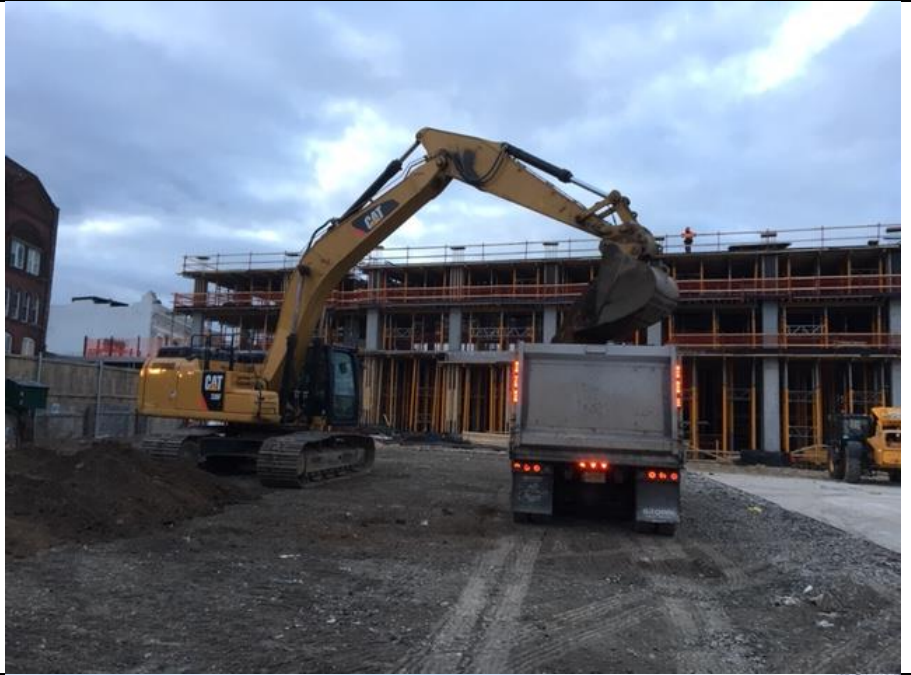
Photo 1- View of loading out soil in D6 for export offsite.

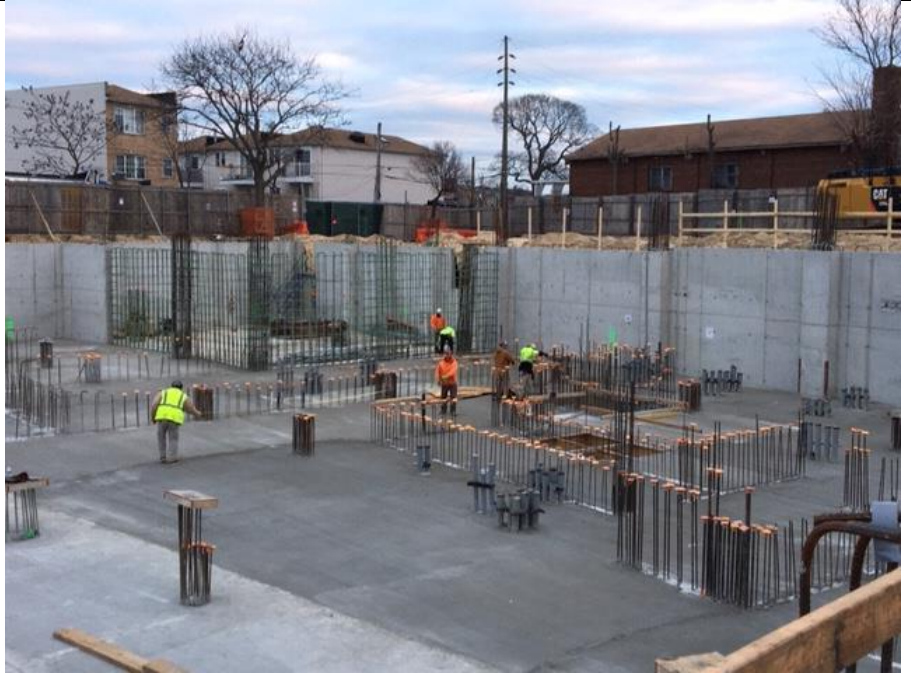
Photo 2- View of rebar installation in A4 and B4.

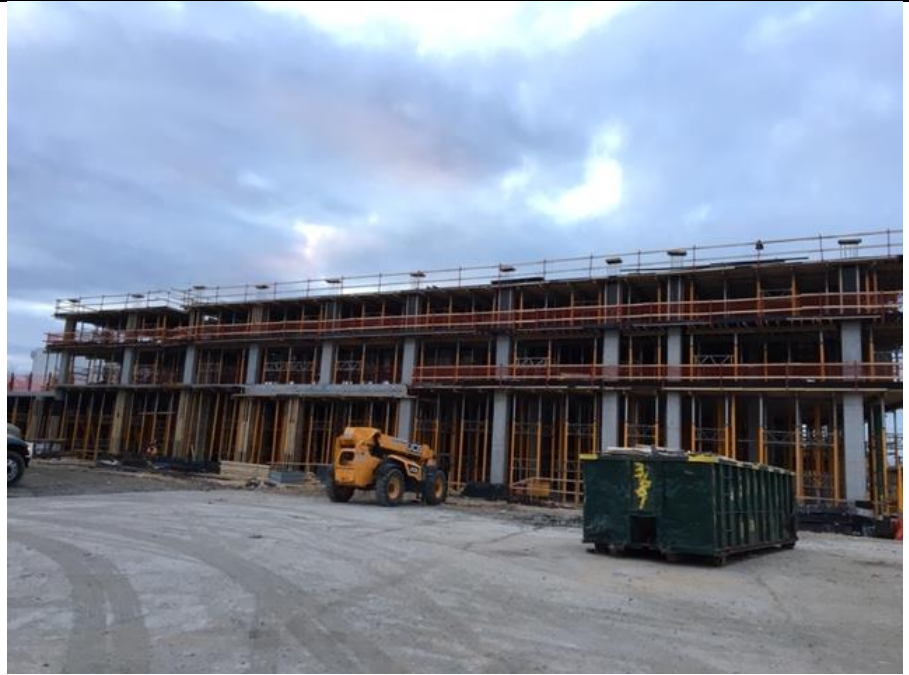
Photo 3- View of rebar installation and formwork in D3, D4, E3, E4, F3, and F4.

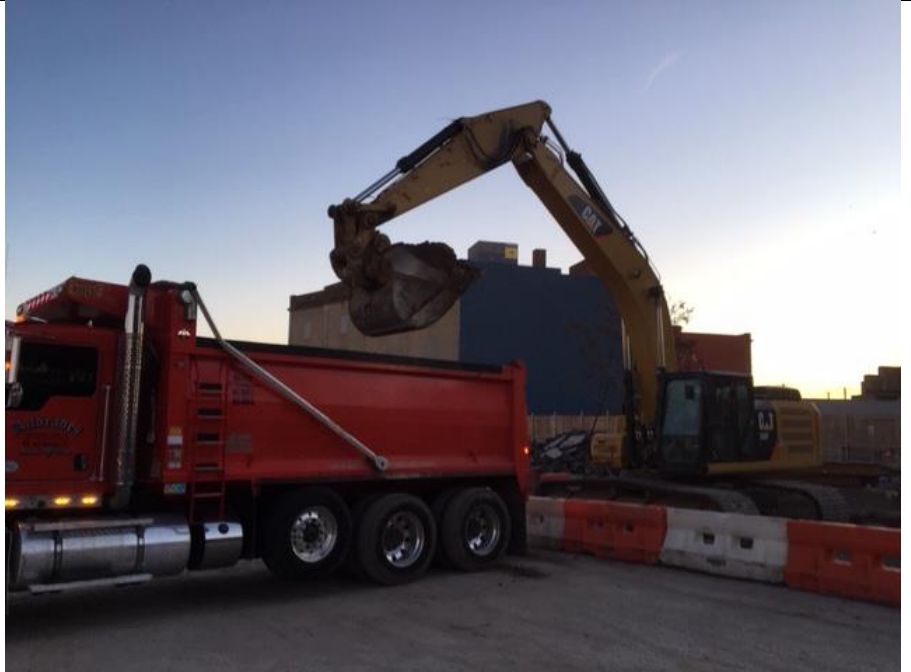
Photo 1- View of loading out soil in D6 for export offsite.

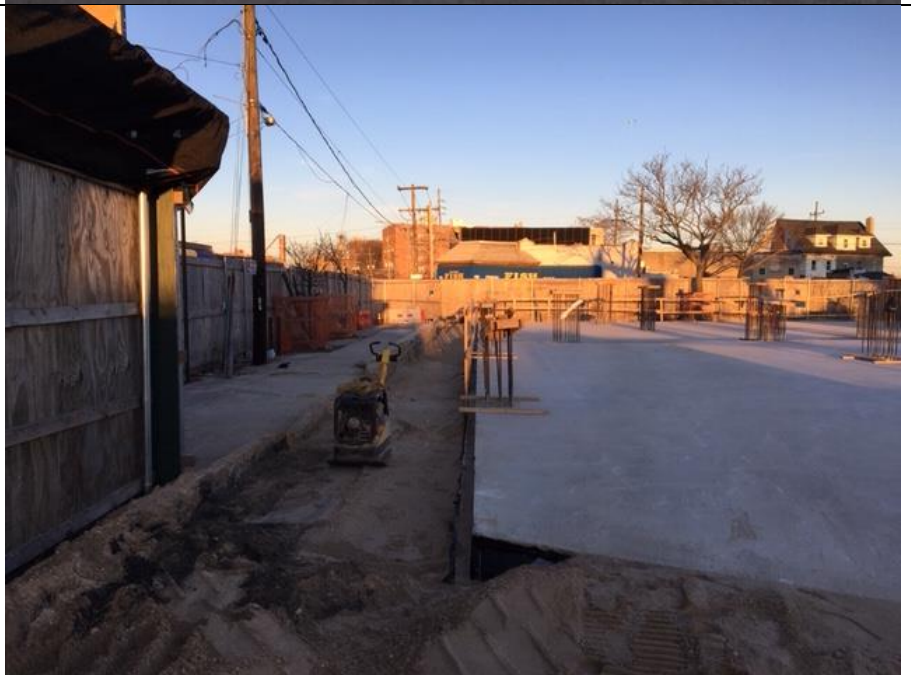
Photo 2- View of backfilled area in A1 and B1.

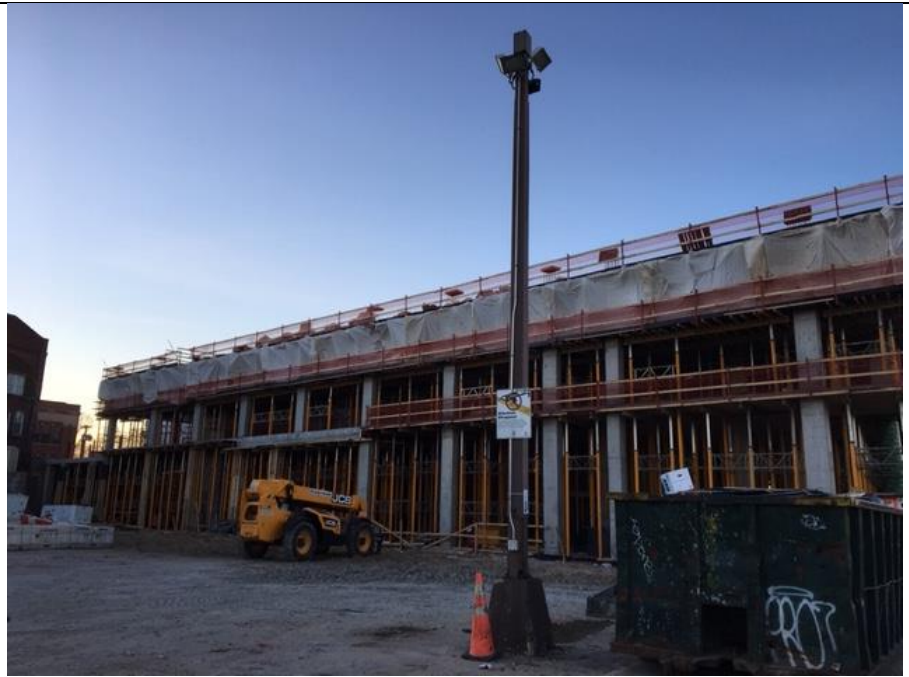
Photo 3- View of rebar installation and formwork in D3, D4, E3, E4, F3, and F4.

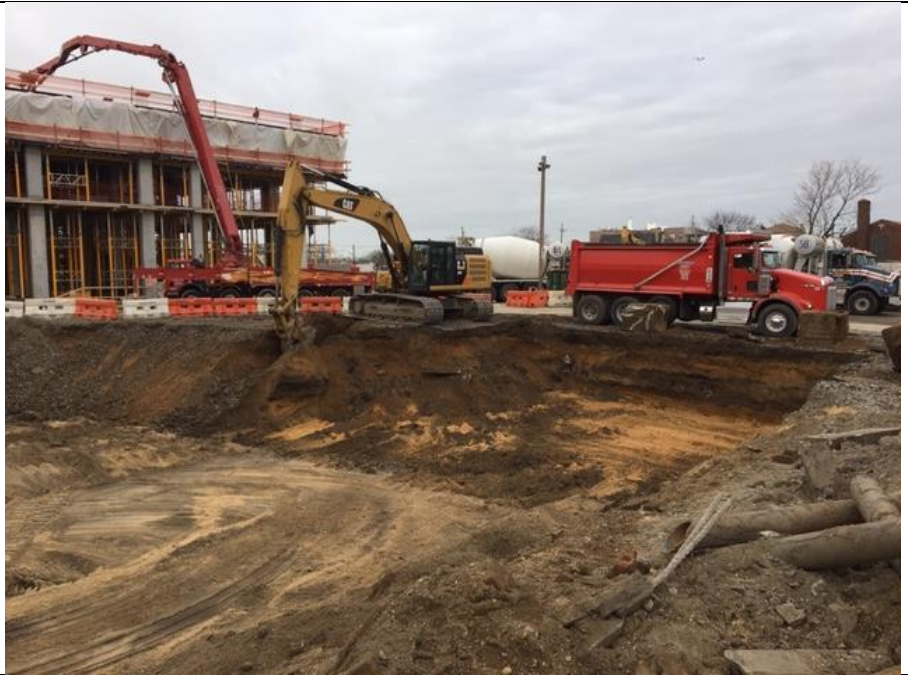
Photo 1- View of loading out soil in C5 for export offsite.

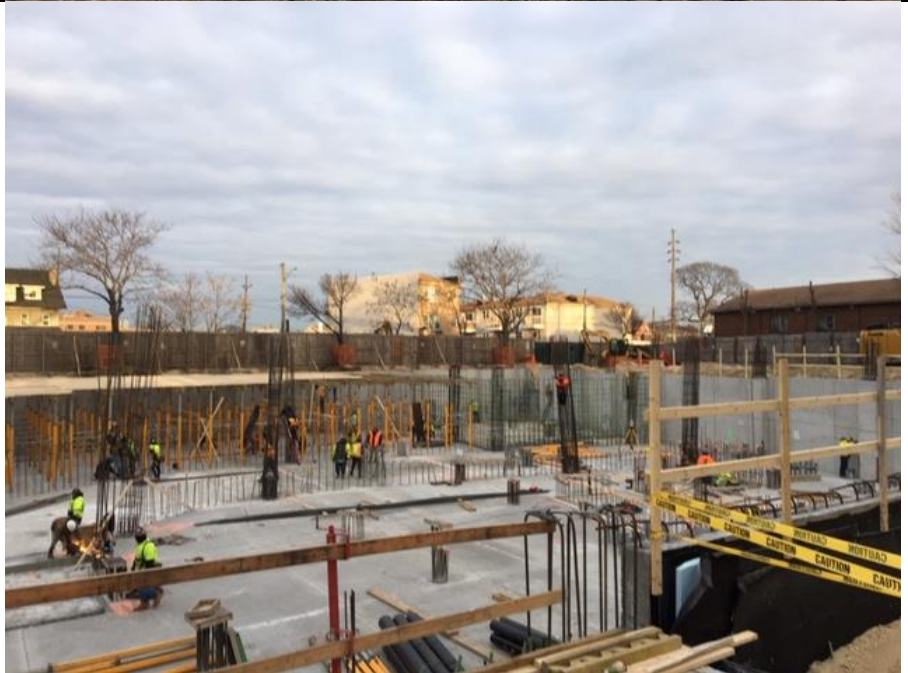
Photo 2- View of formwork and rebar installation in A3, A4, B3, and B4.

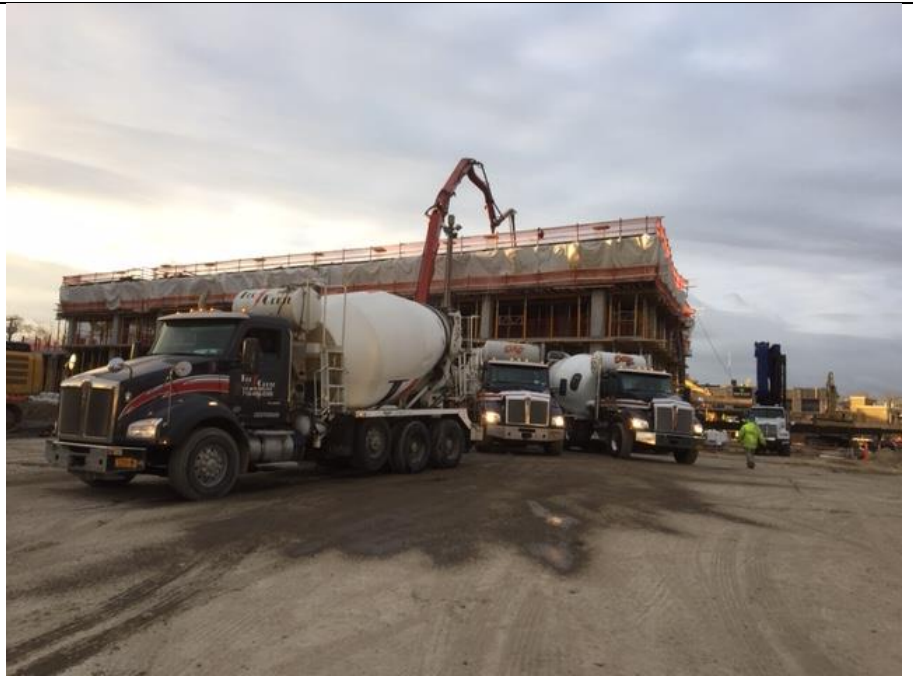
Photo 3- View of pouring concrete in D3, D4, E3, E4, F3, and F4.
