Daily Report for March 3, 2020

**Far Rockaway Project
20-02 Mott Avenue
Far Rockaway, NY
BCP #C241224**

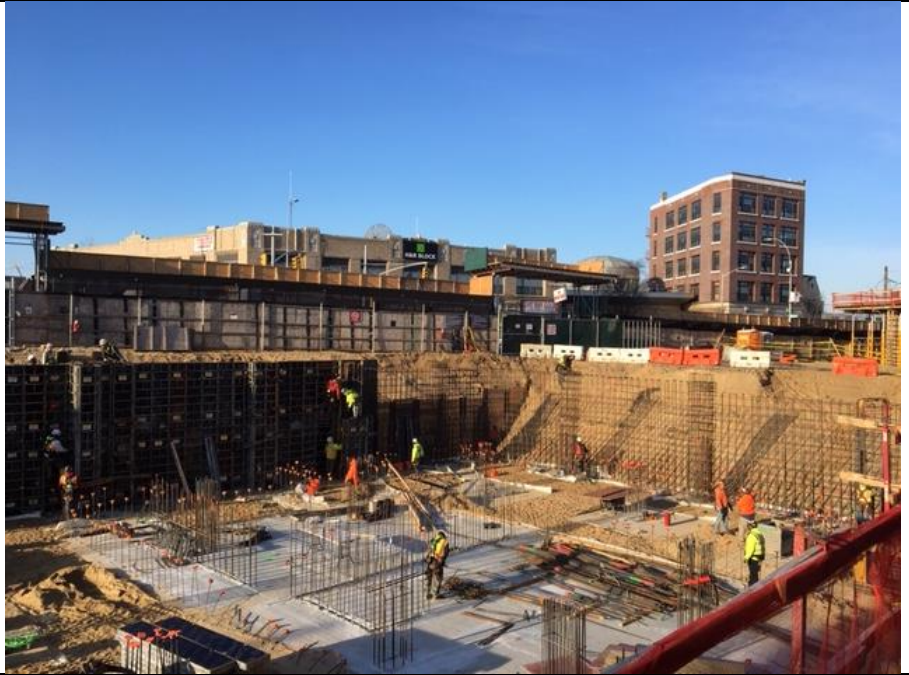
Photo 1- View of rebar installation and formwork in grid D1.

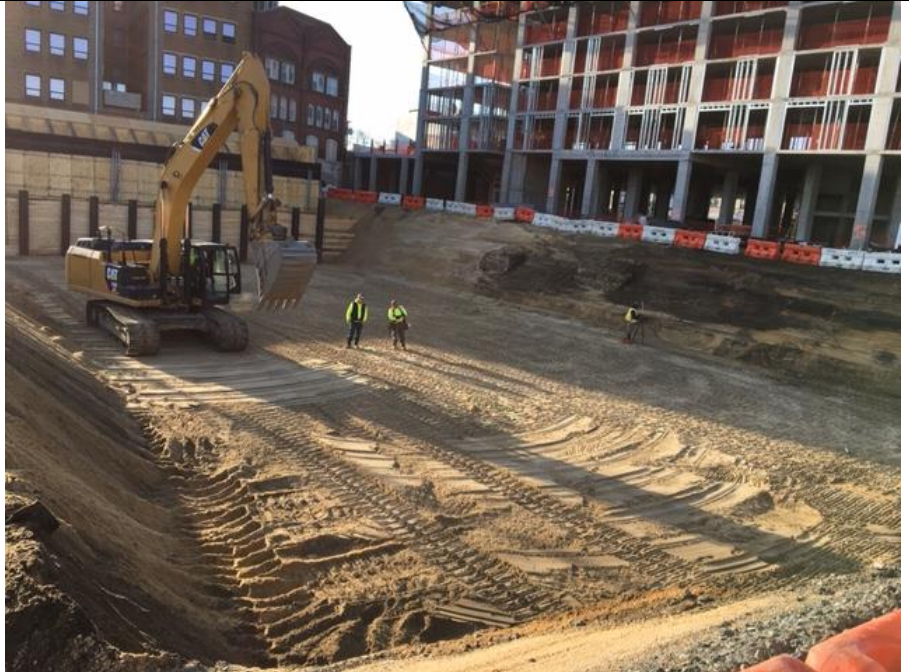
Photo 2- View of grading soil in D5 and E5.

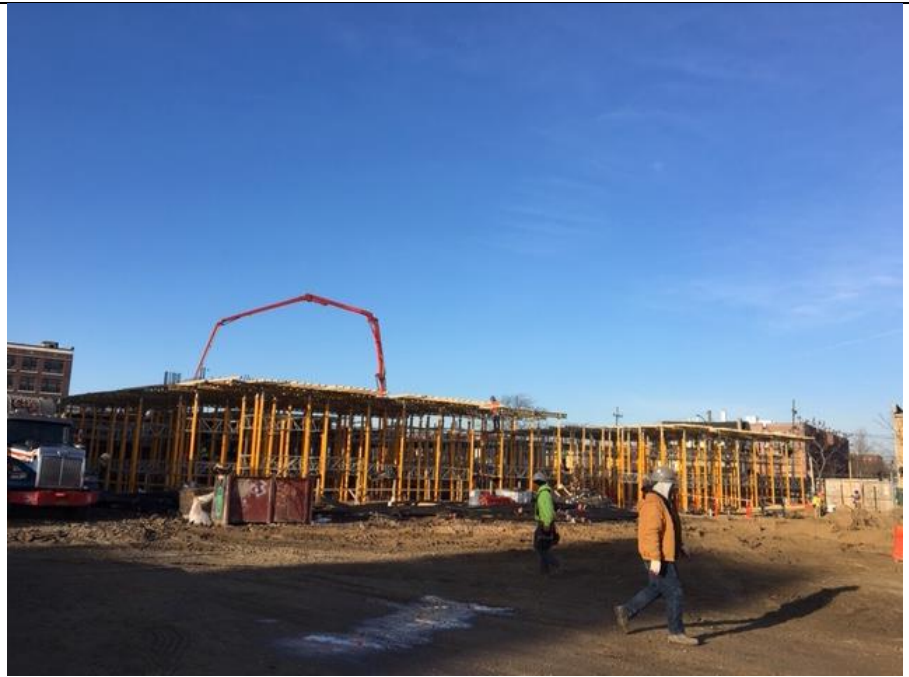
Photo 3- View of rebar, formwork installation, and pouring concrete in A3, A4, B3, and B4.

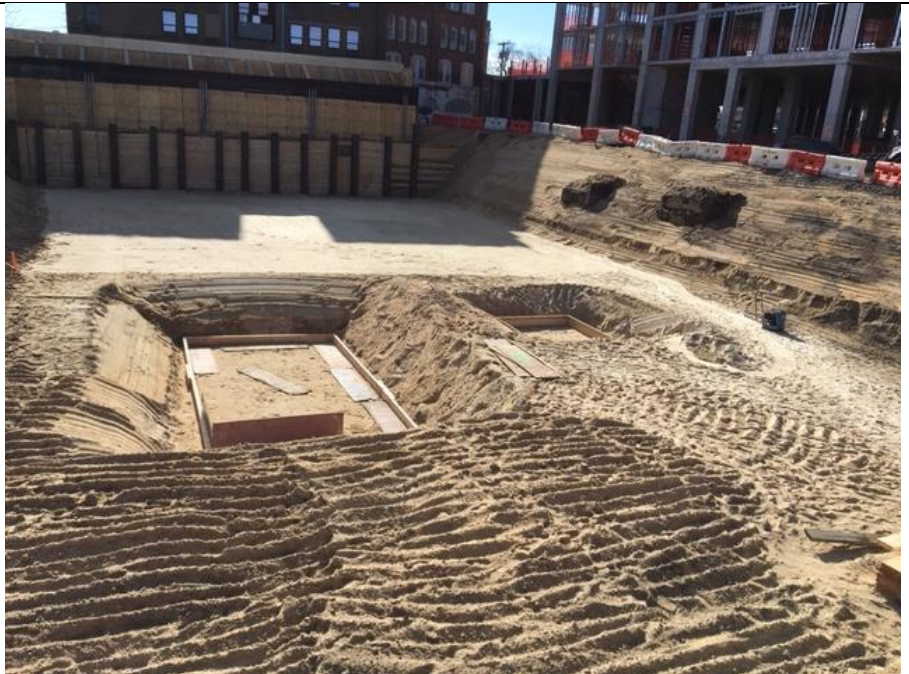
Photo 1- View of formwork in grid C5 and D5.

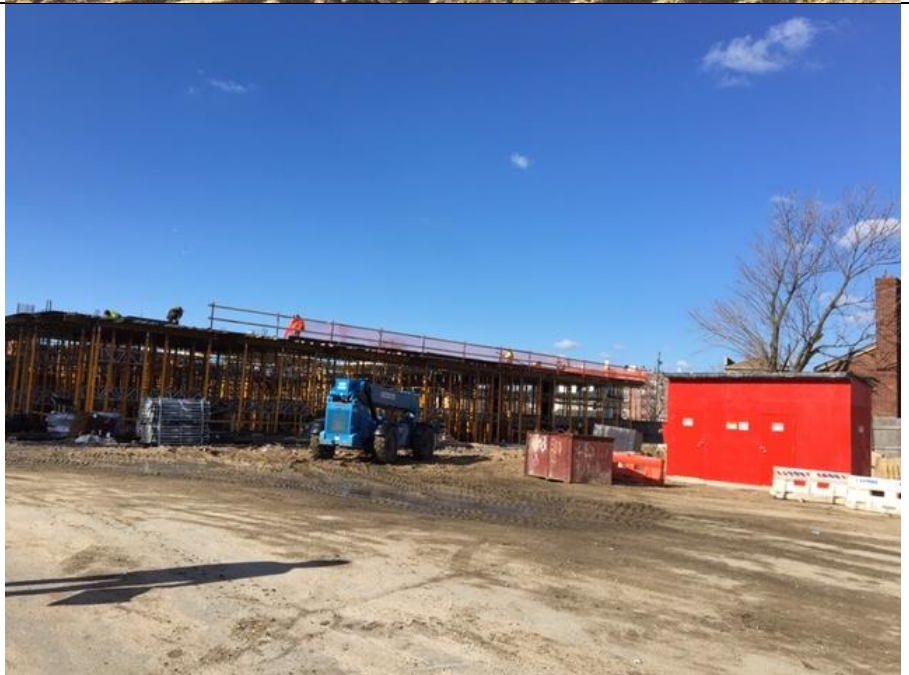
Photo 2- View of formwork and rebar installation in A3, A4, B3, and B4.

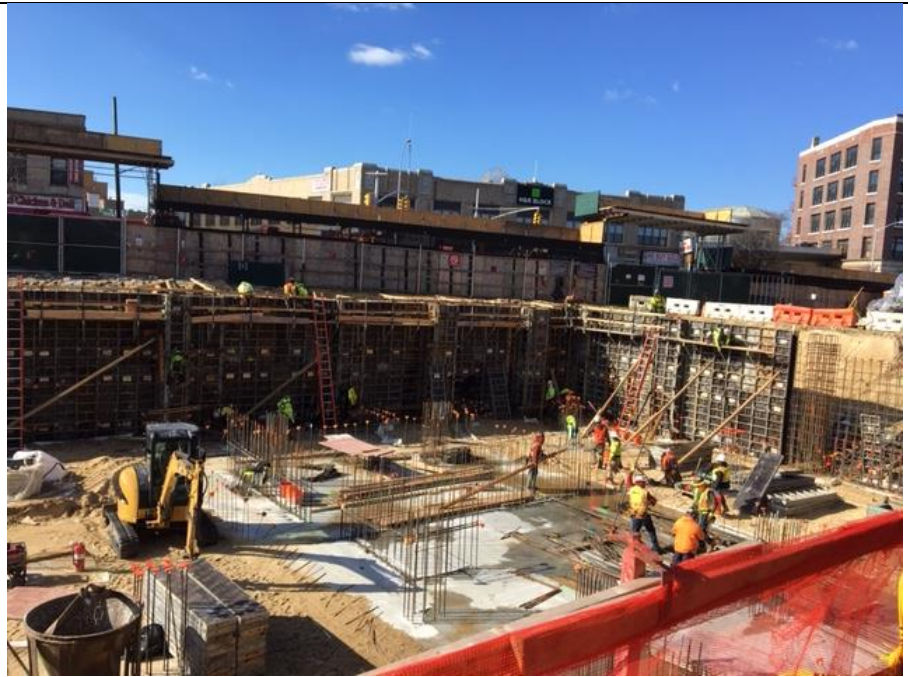
Photo 3- View
of rebar
installation and
formwork in
grid D1.

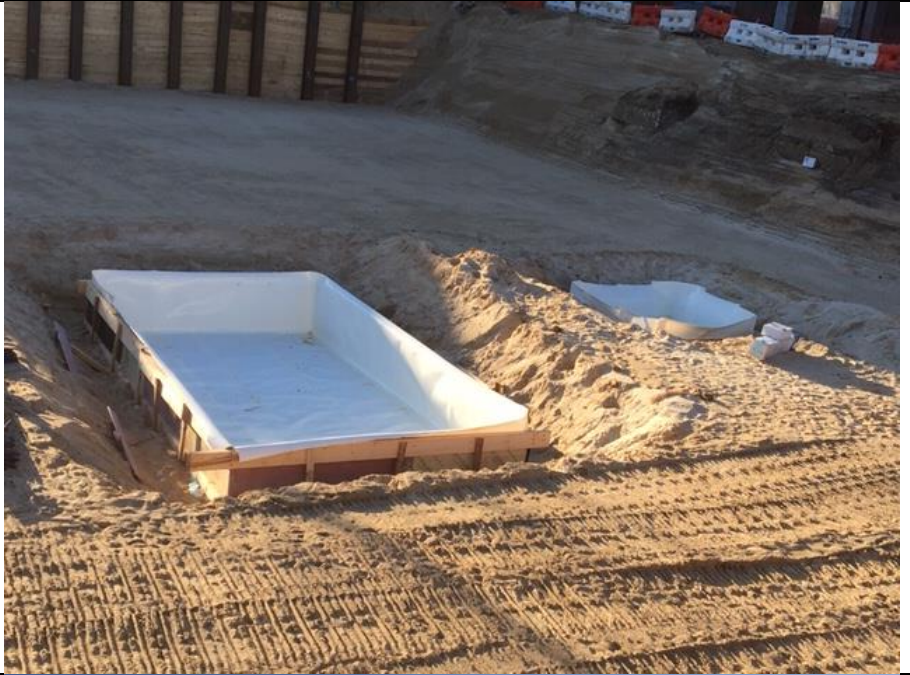
Photo 1- View of installation of Preprufe 200 in grids C5, C6, D5, and D6.

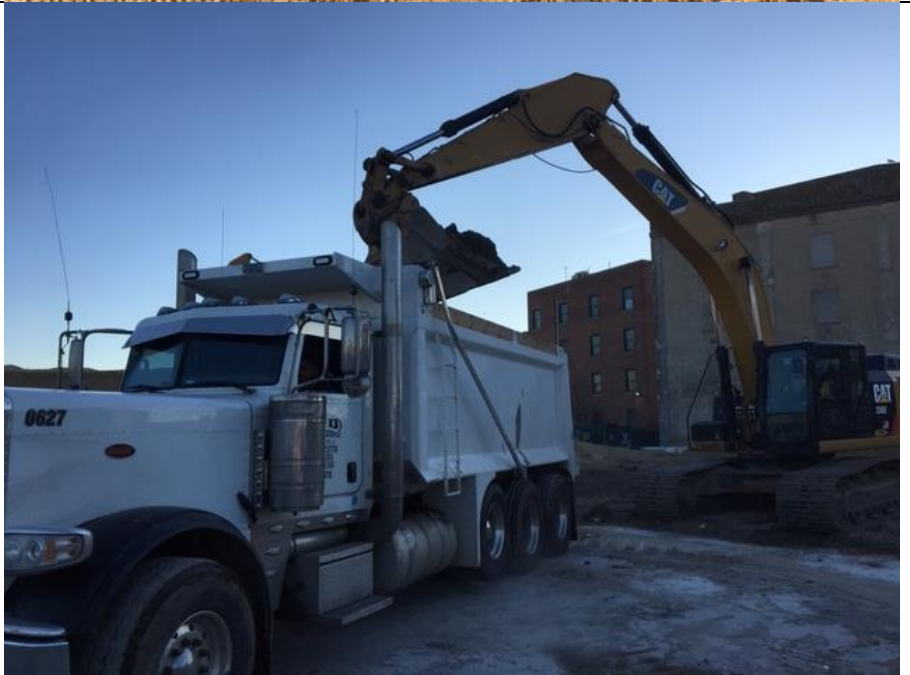
Photo 2- View of loading out of soil in grid C8.

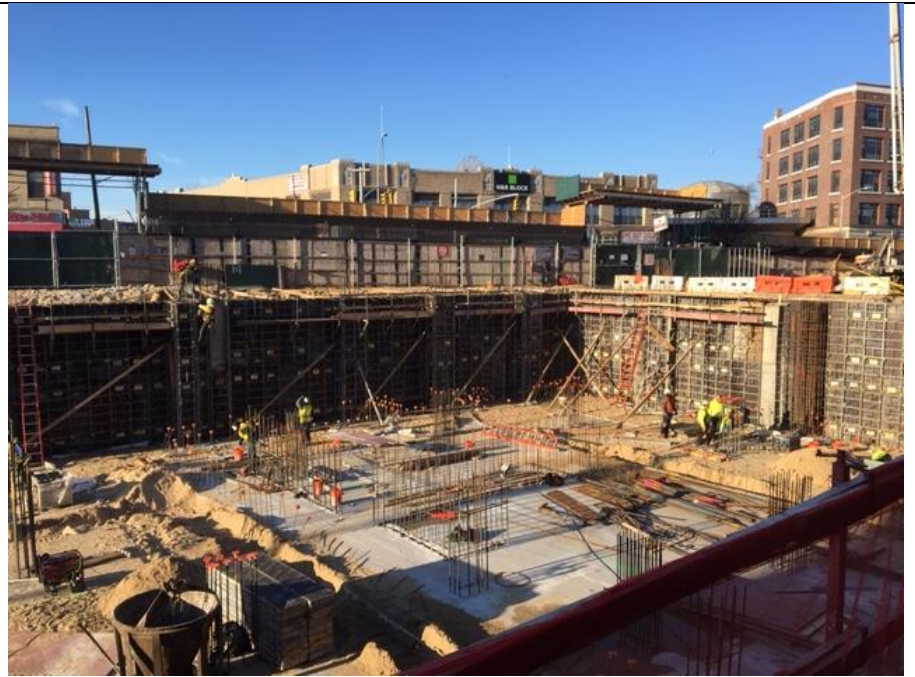
Photo 3- View
of rebar
installation and
formwork in
grid D1.

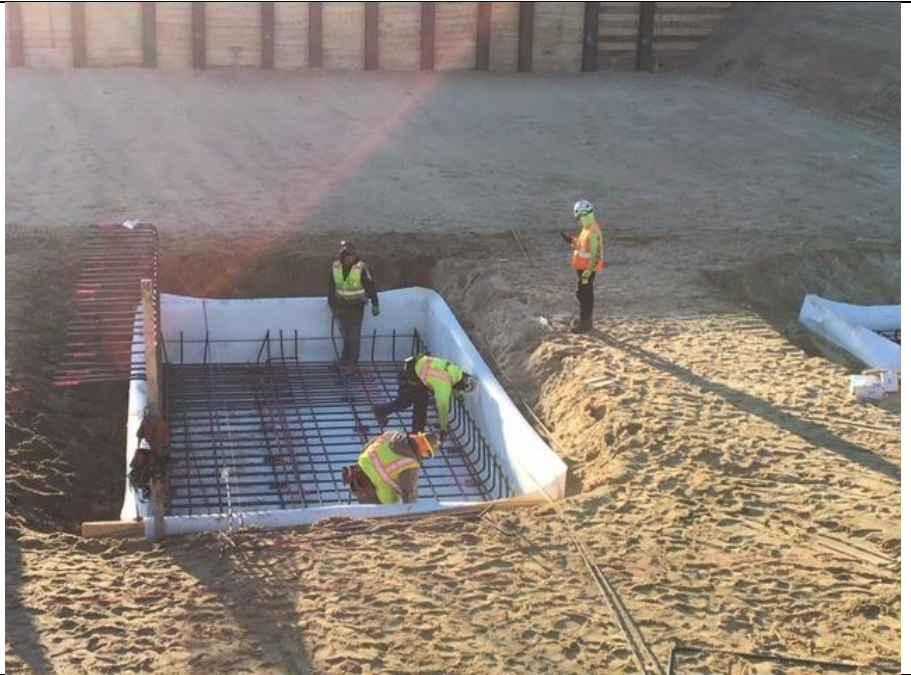
Photo 1- View of rebar installation in grids C5, C6, D5, and D6.

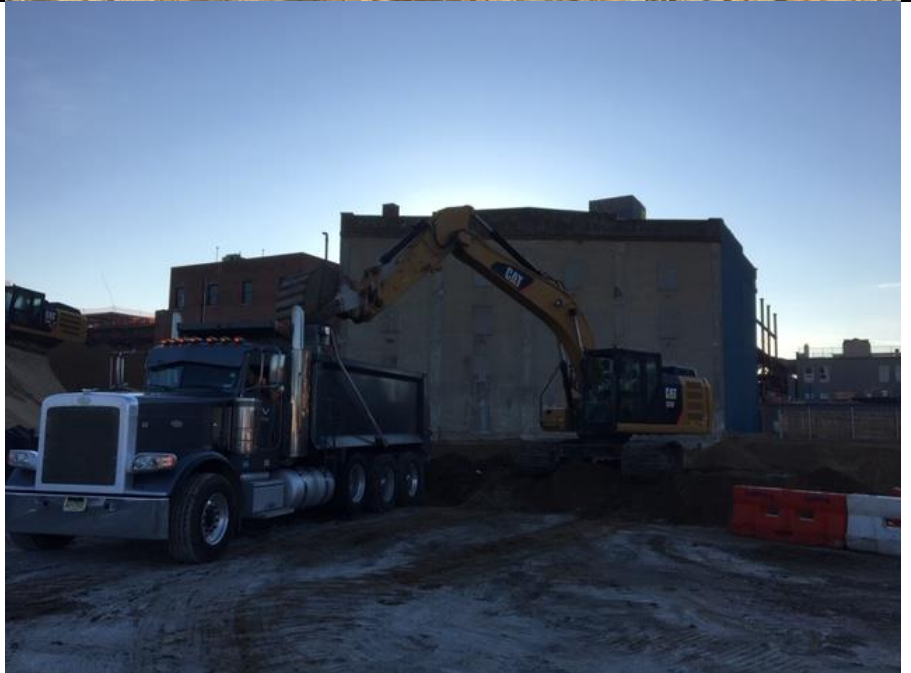
Photo 2- View of loading out of soil in grid C8.

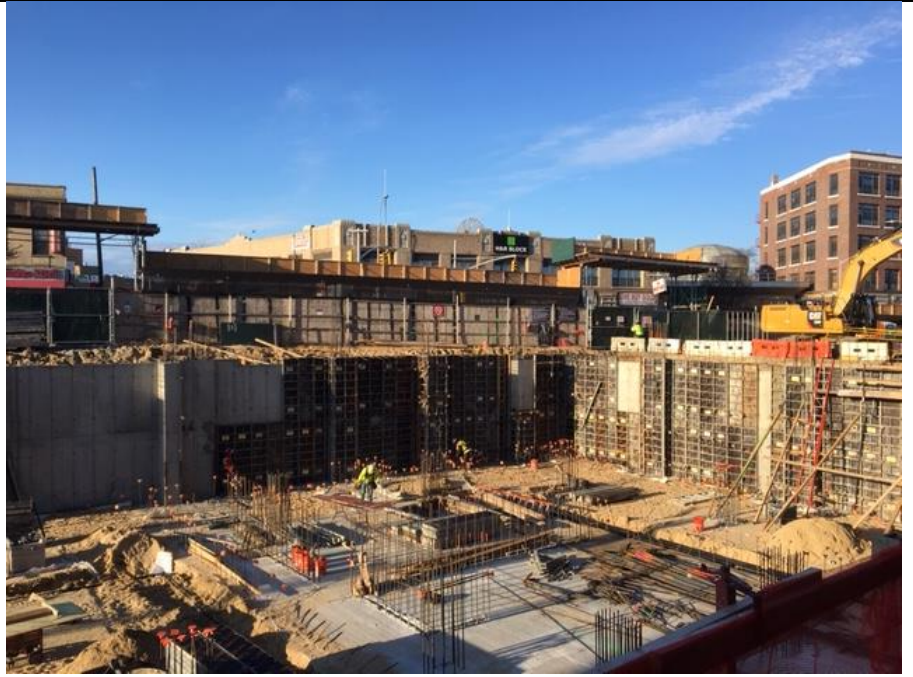
Photo 3- View
of rebar
installation and
formwork in
grid D1.

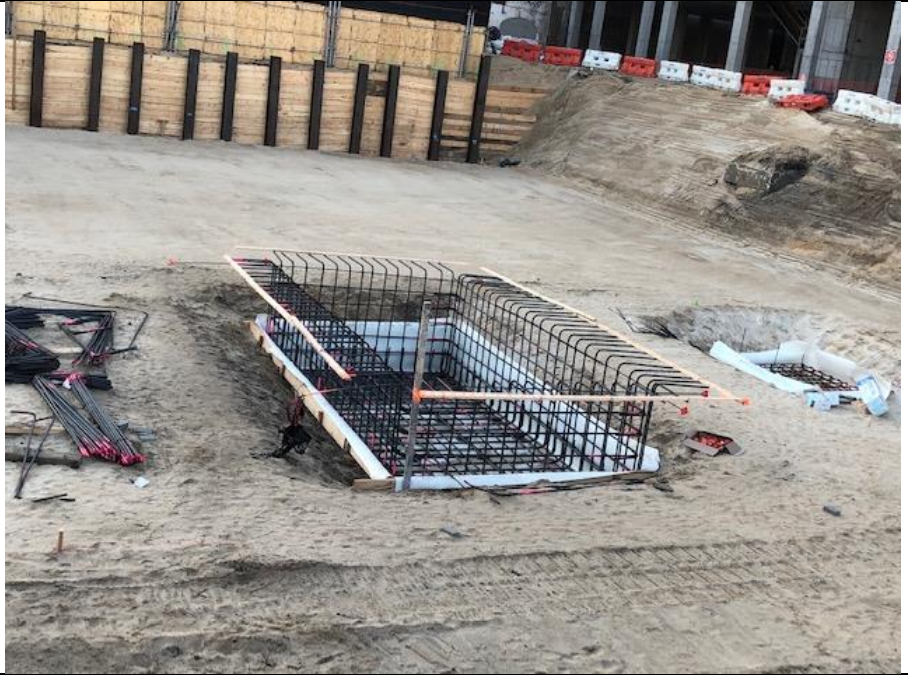
Photo 1- View of rebar installation in grids C5, C6, D5, and D6.

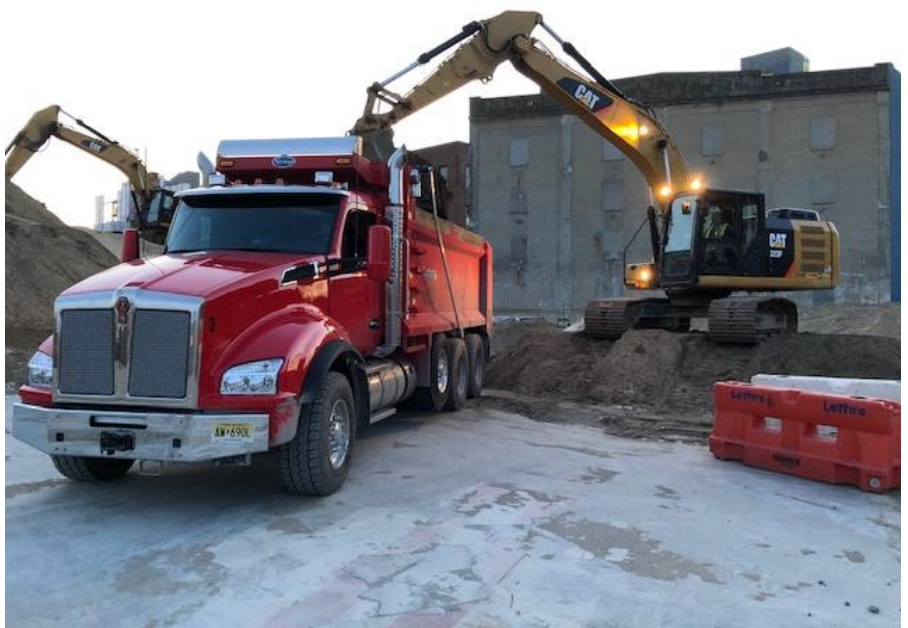
Photo 2- View of loading out of soil in grid C8.

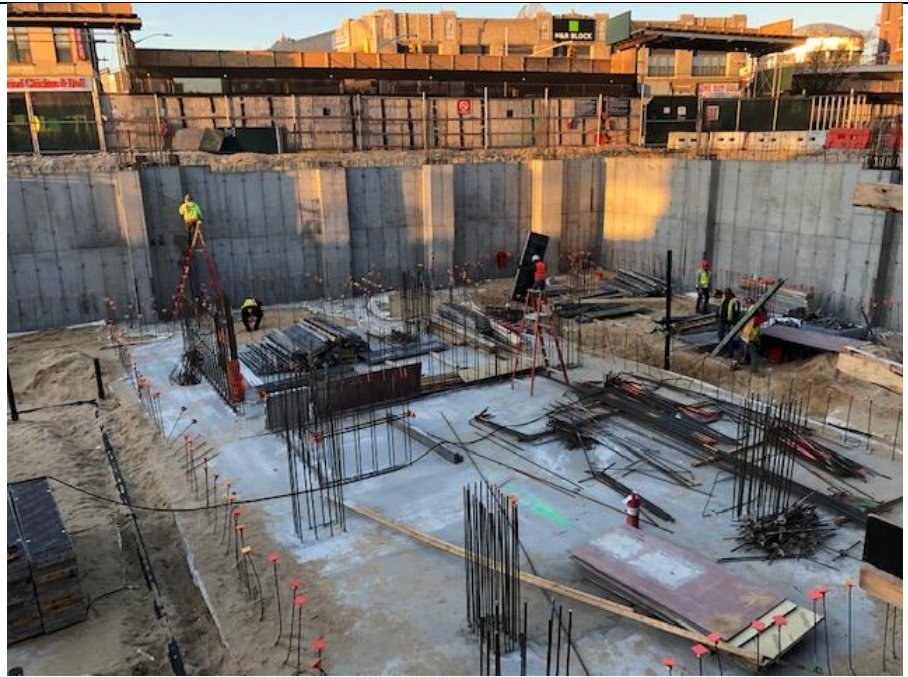
Photo 3- View
of rebar
installation and
formwork in
grid D1.

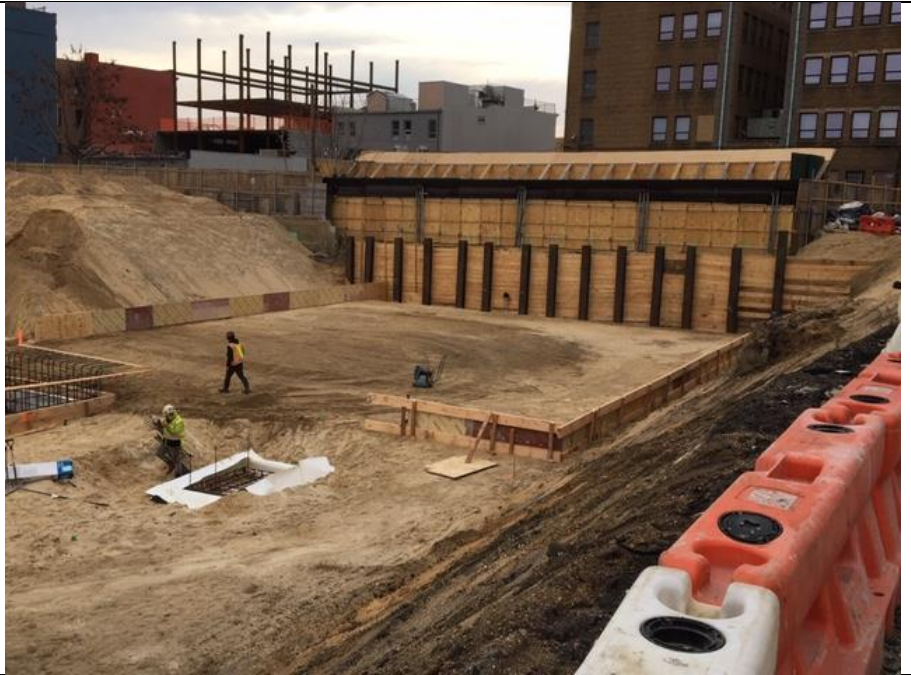
Photo 1- View of rebar installation in grids C5, C6, D5, and D6.

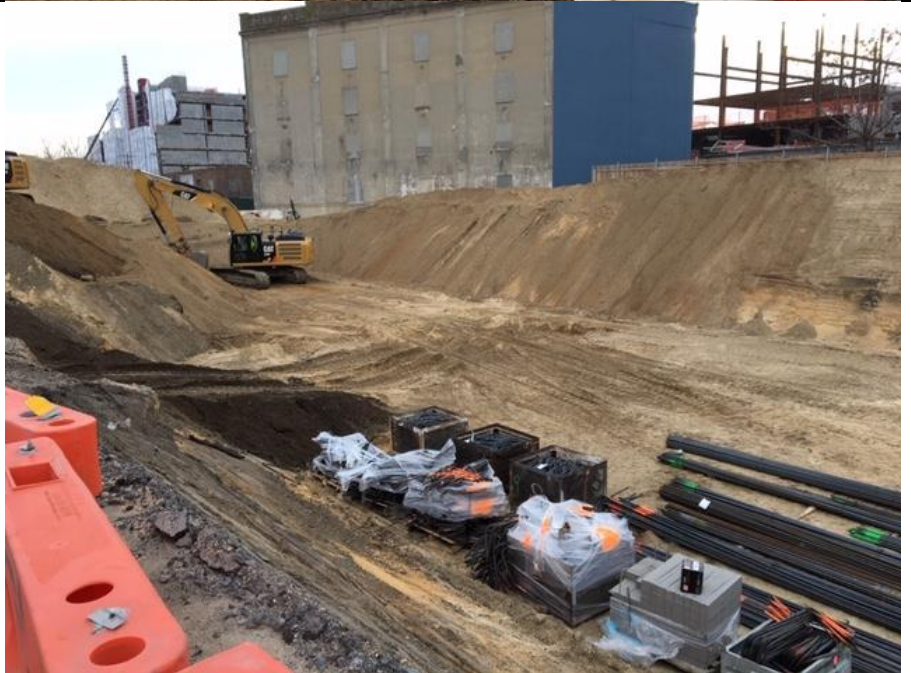
Photo 2- View of grading soil in D6 and D7.

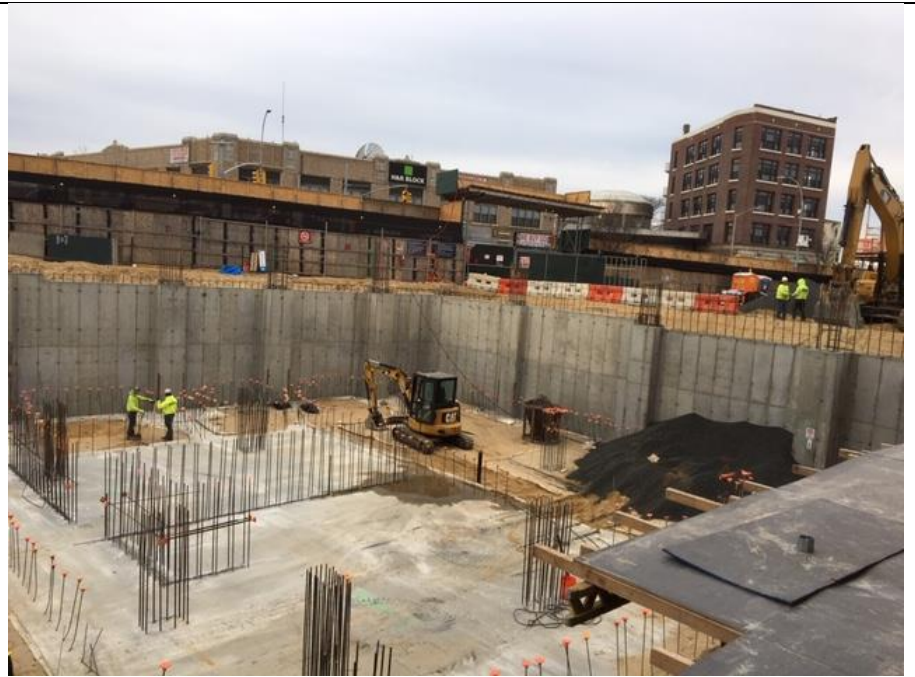
Photo 3- View
of spreading
stone in grid
D1.

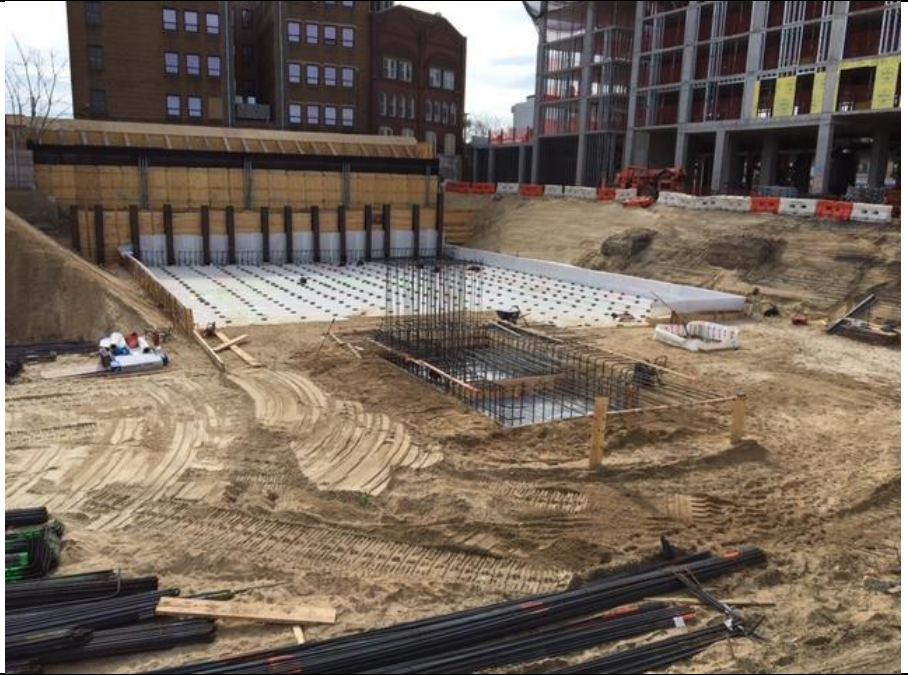
Photo 1- View of Preprufe 200 and rebar installation in grids C5, C6, D5, and D6.

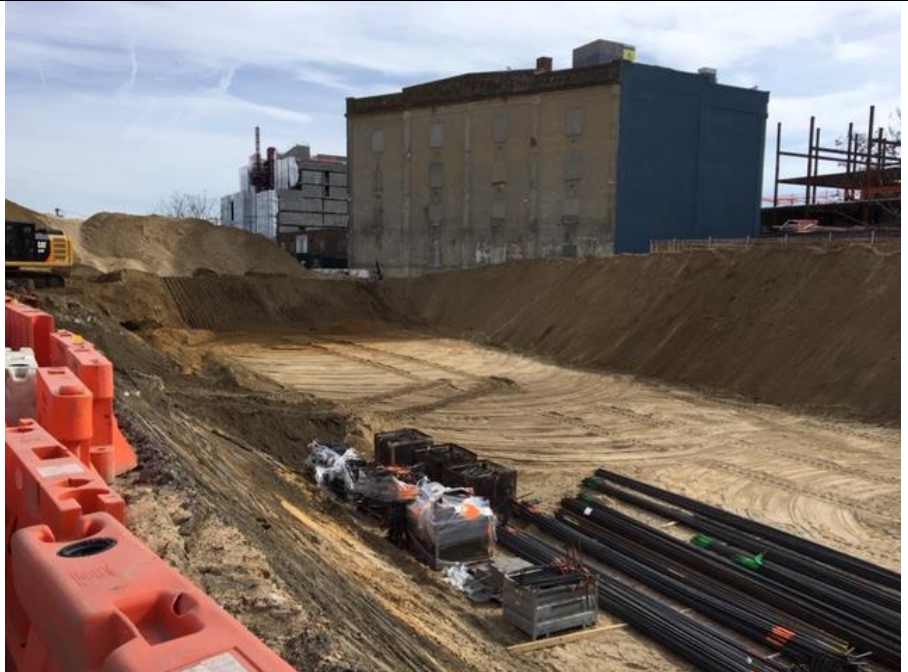
Photo 2- View of grading soil in C6 and C7.

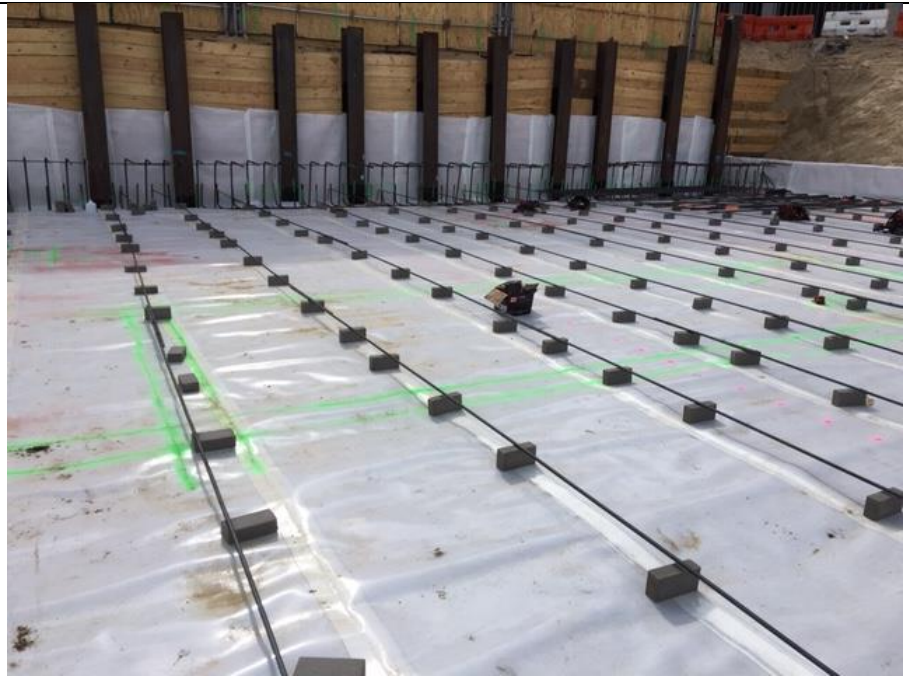
Photo 3- View
of installed
Preprufe 200
and rebar.

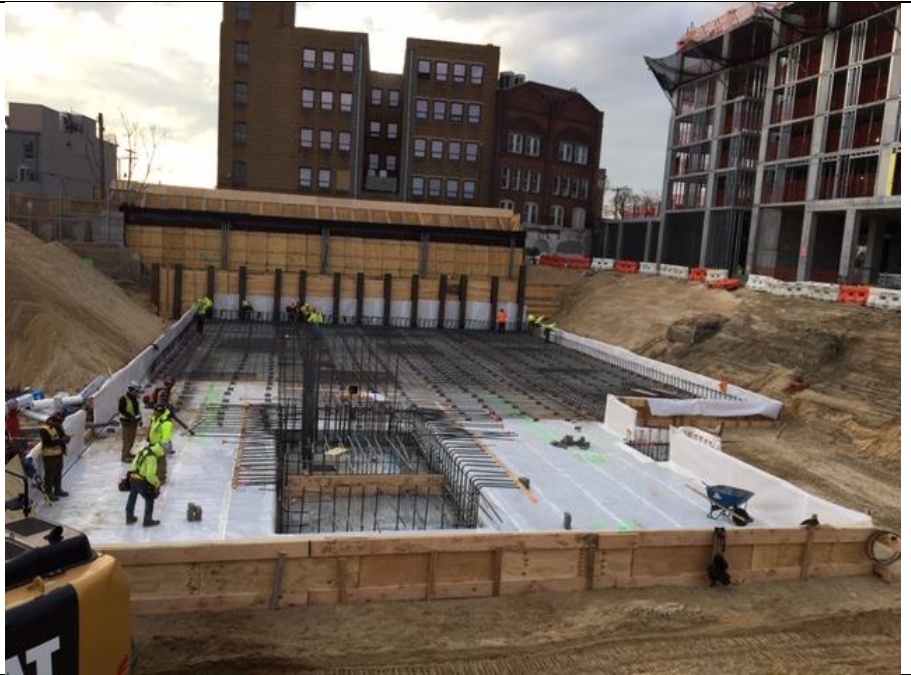
Photo 1- View of Preprufe 200 and rebar installation in grids C5, C6, D5, and D6.

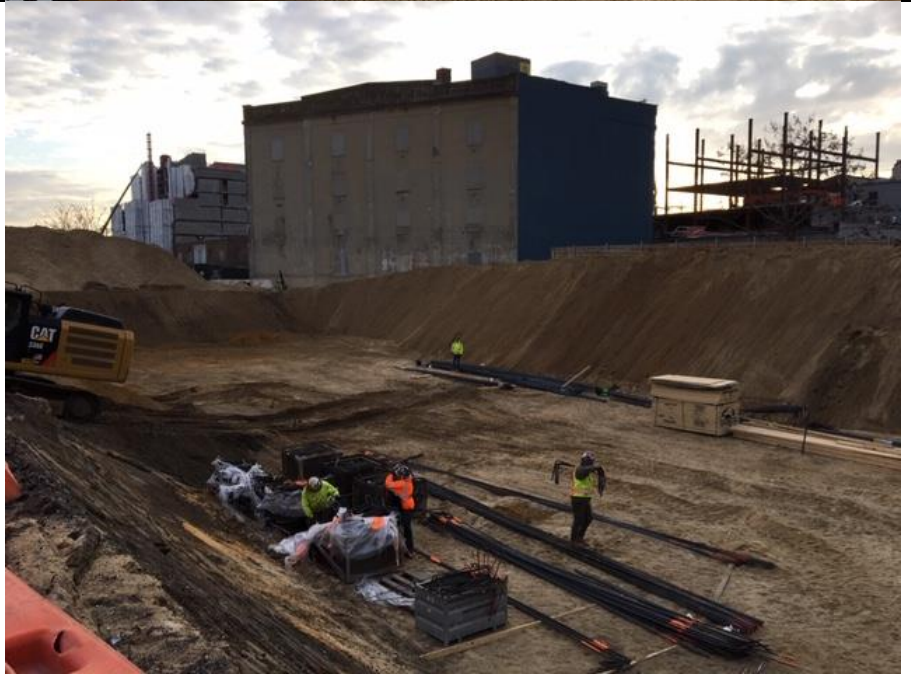
Photo 2- View of graded soil in C6 and C7.

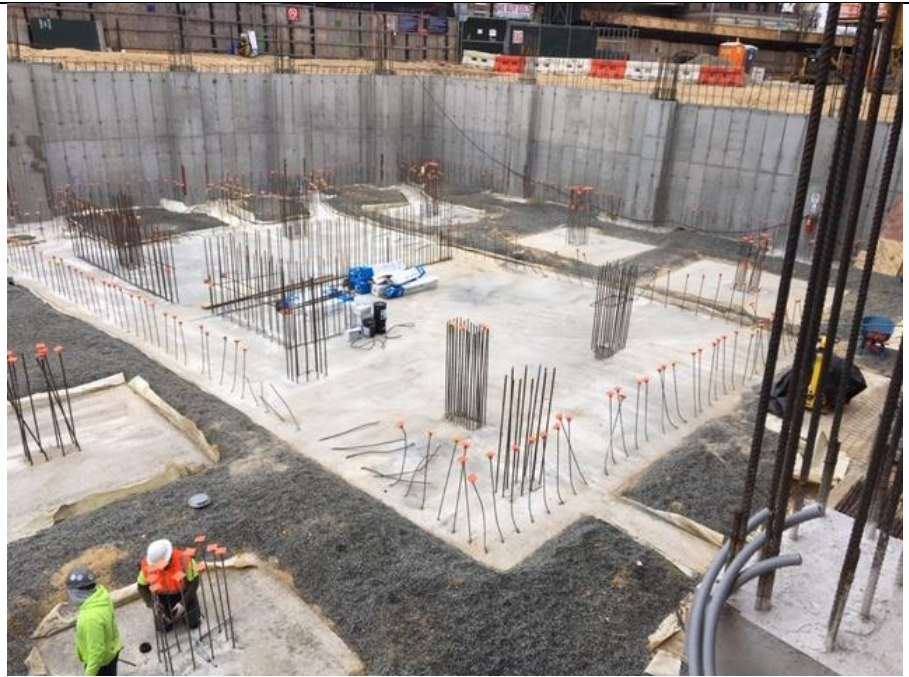
Photo 3- View
of laid stone in
grid D1.

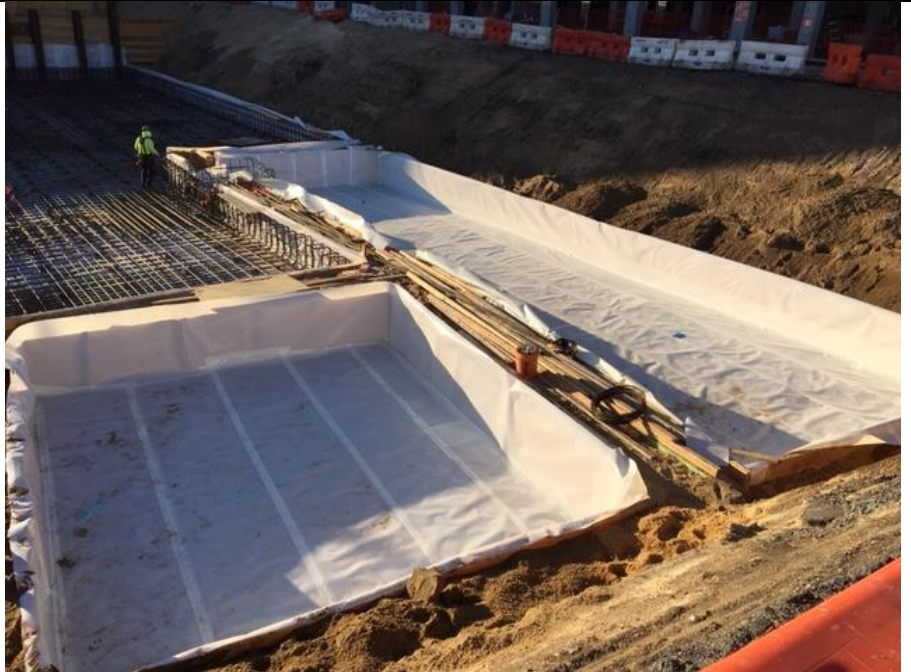
Photo 1- View of Preprufe 200, formwork, and rebar installation in grids C5, C6, D5, and D6.

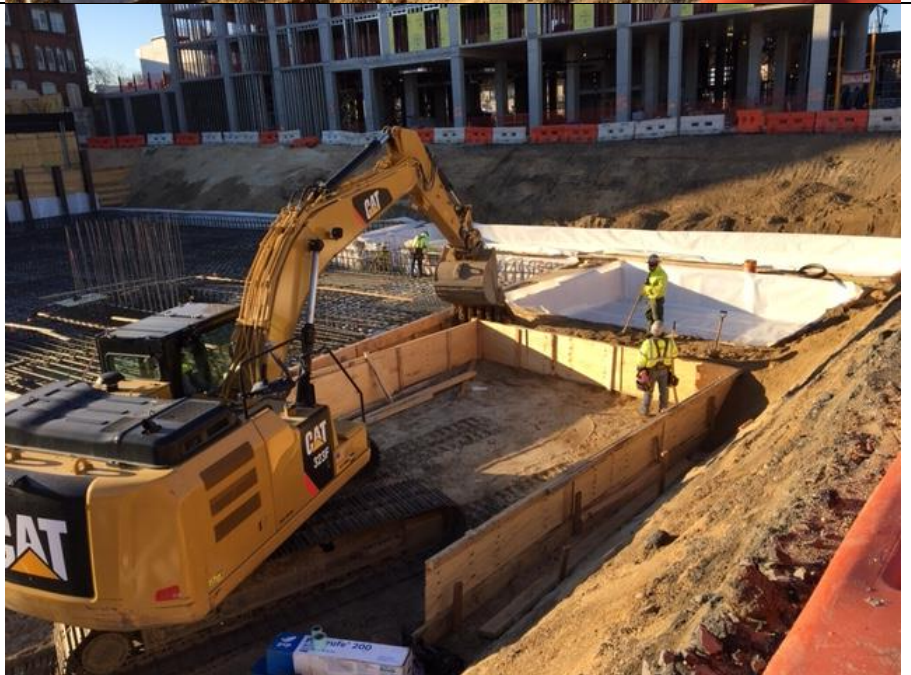
Photo 2- View of backfilling soil in C6.

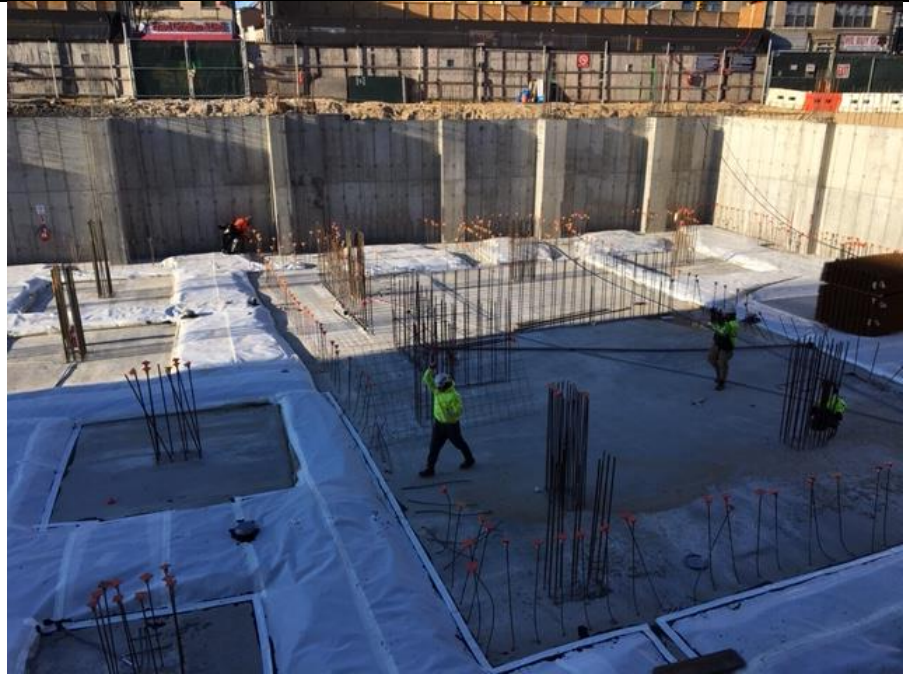
Photo 3- View
of installed
Preprufe 200 in
grid D1.

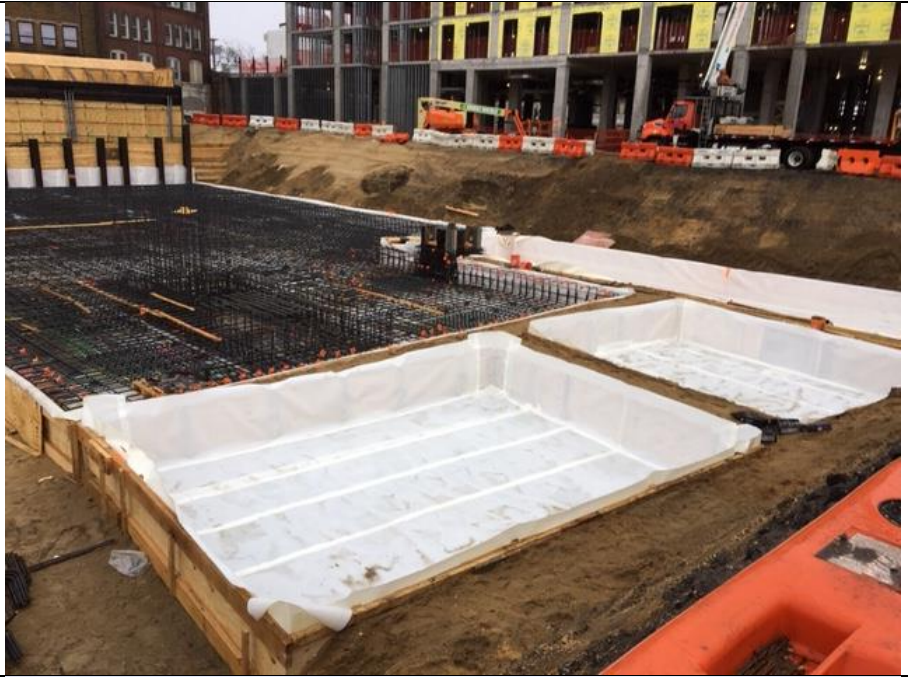
Photo 1- View of Preprufe 200, formwork, and rebar installation in grids C5, C6, D5, and D6.

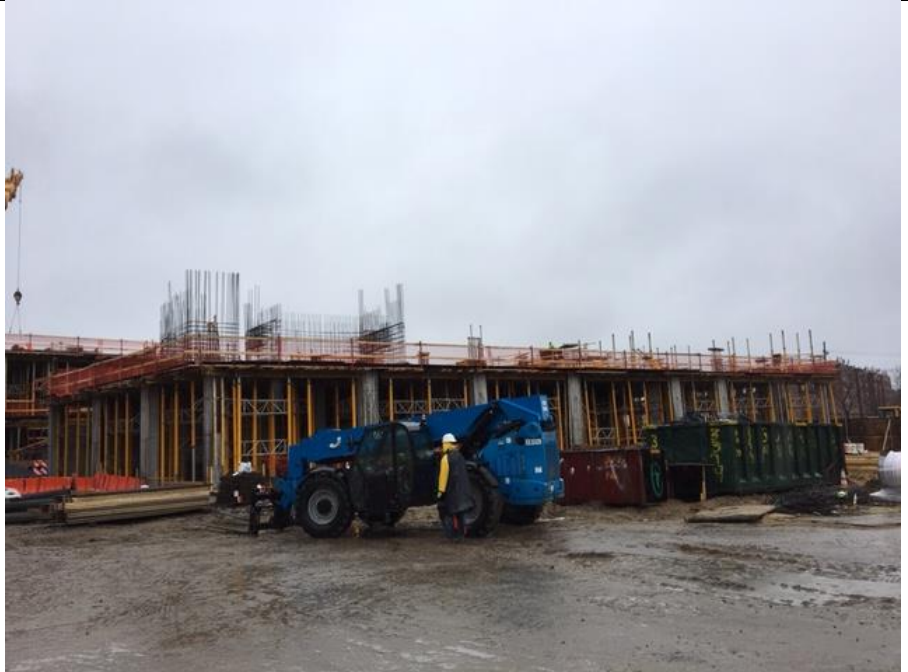
Photo 2- View of formwork in A3, A4, B3, and B4.

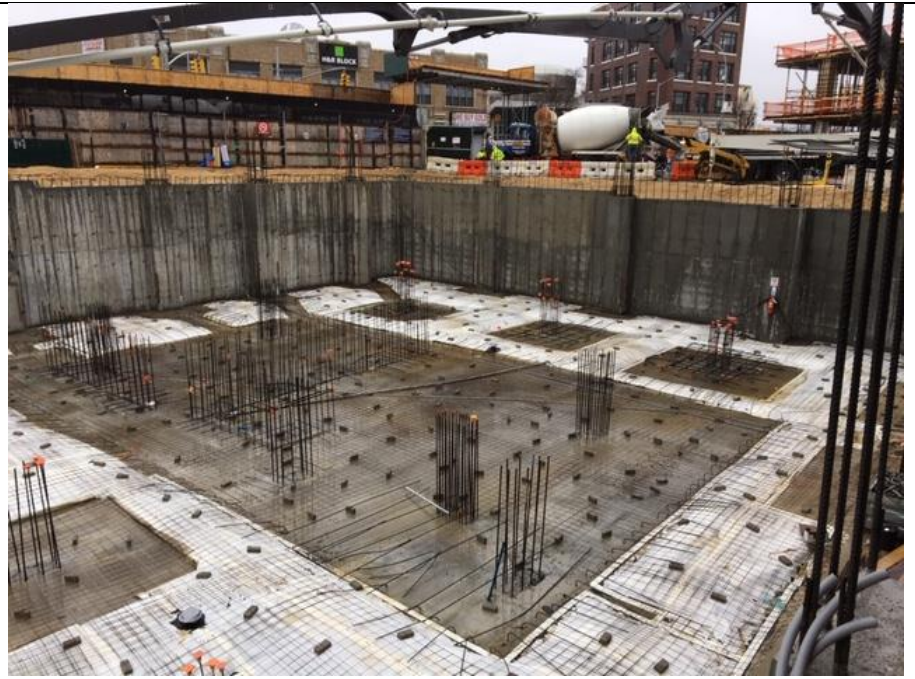
Photo 3- View
of installed
Preprufe 200
and rebar in
grid D1.

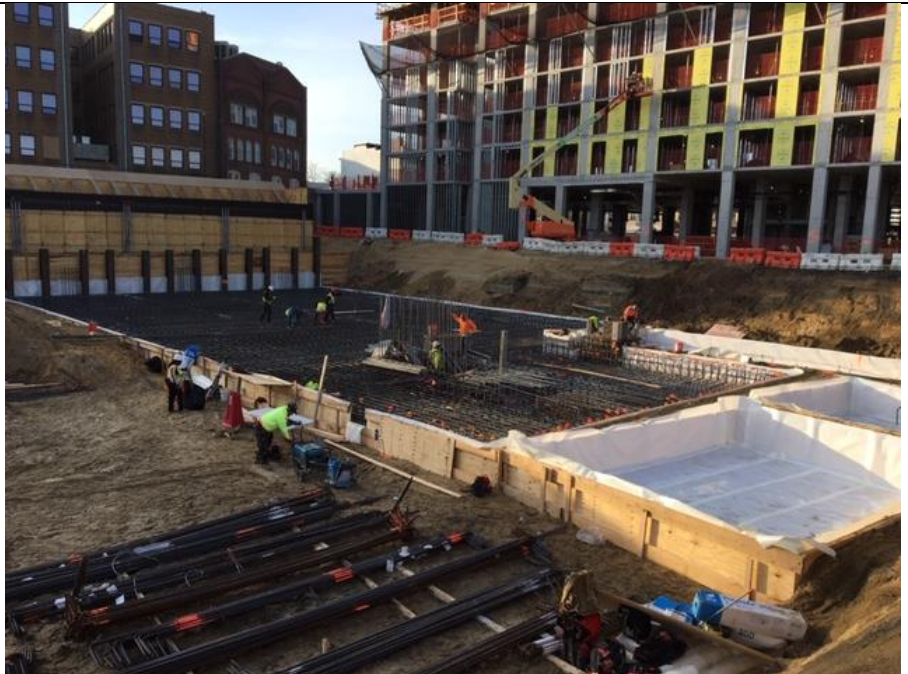
Photo 1- View of Preprufe 200, formwork, and rebar installation in grids C5, C6, D5, and D6.

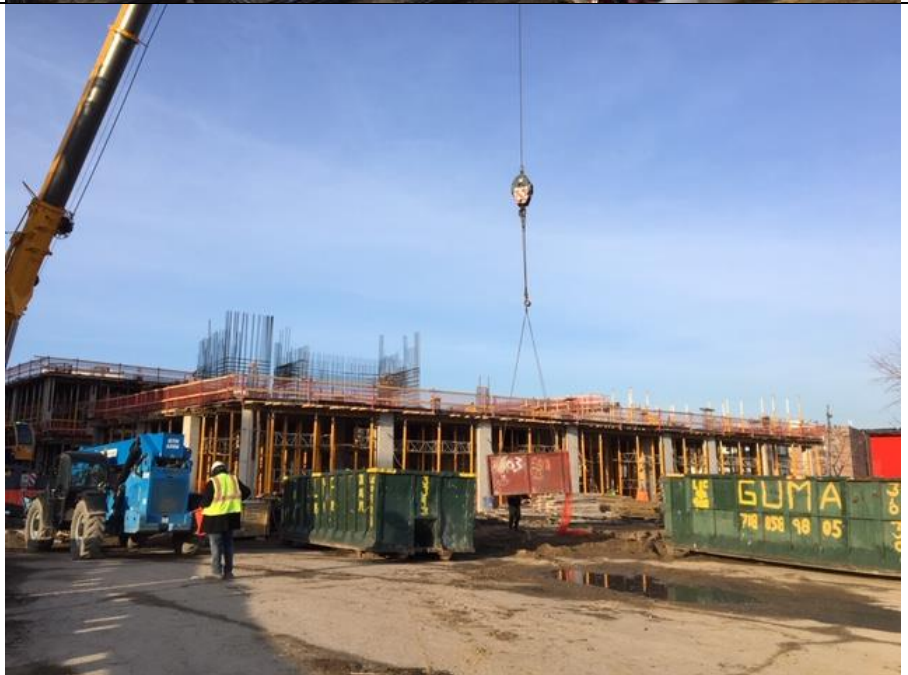
Photo 2- View of formwork in A3, A4, B3, and B4.

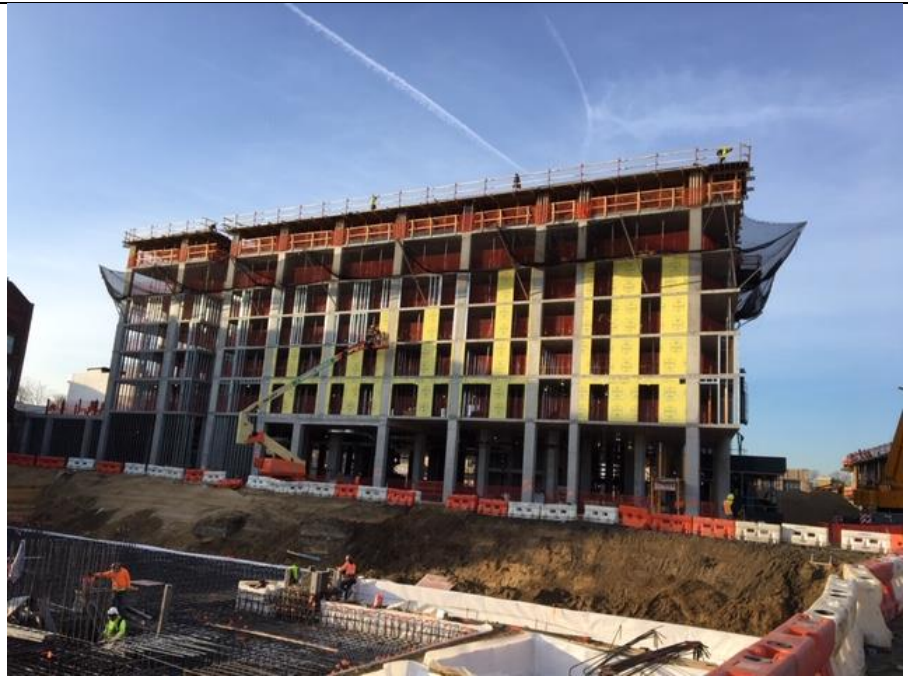
Photo 3- View of rebar and formwork installation in D4, D5, E4, and E5.

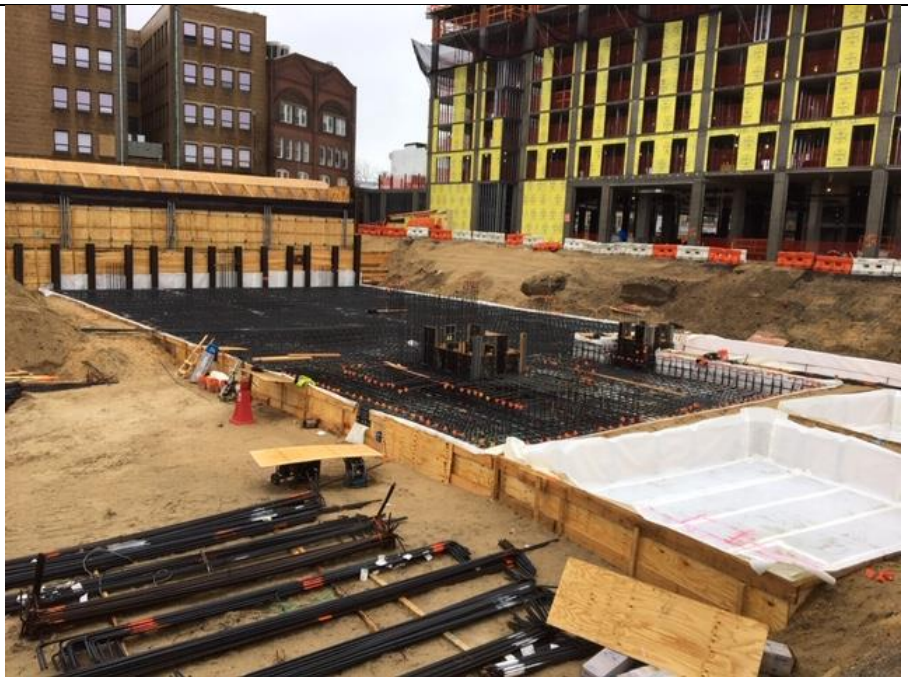
Photo 1- View of Preprufe 200, formwork, and rebar installation in grids C5, C6, D5, and D6.

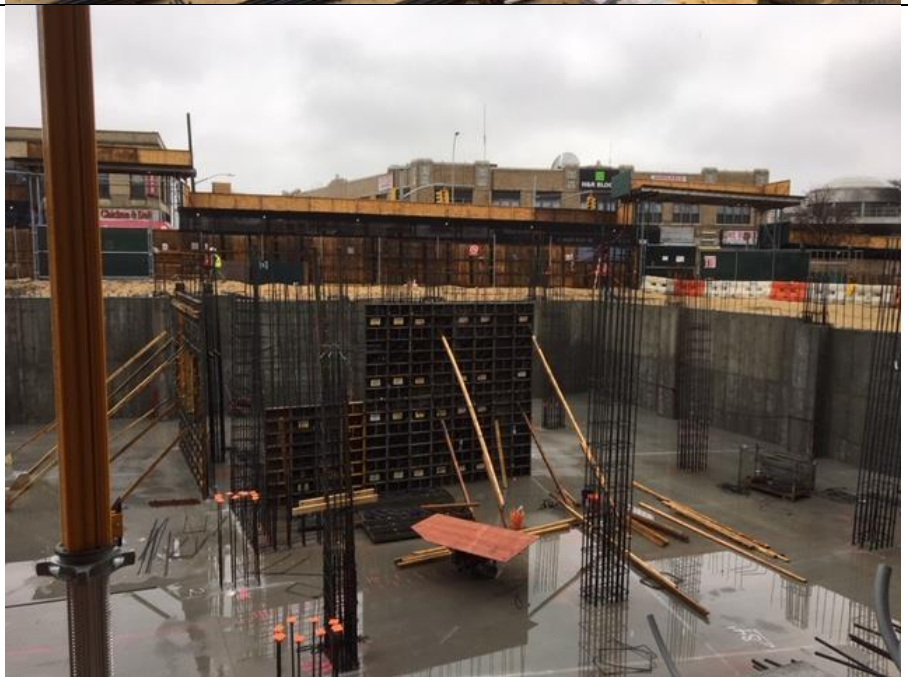
Photo 2- View of formwork and rebar installation in D1.

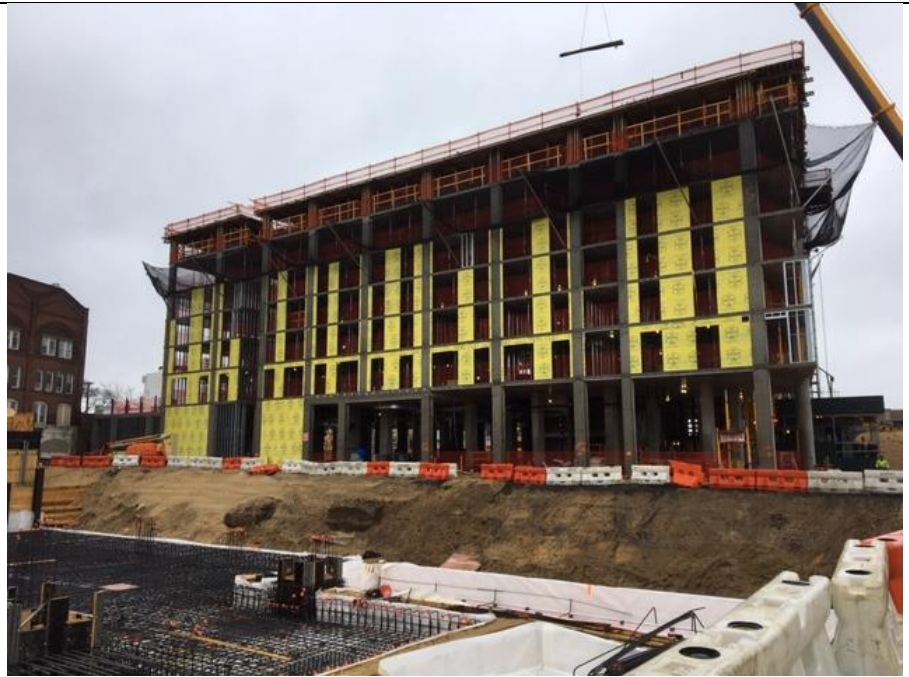
Photo 3- View of rebar and formwork installation in D4, D5, E4, and E5.

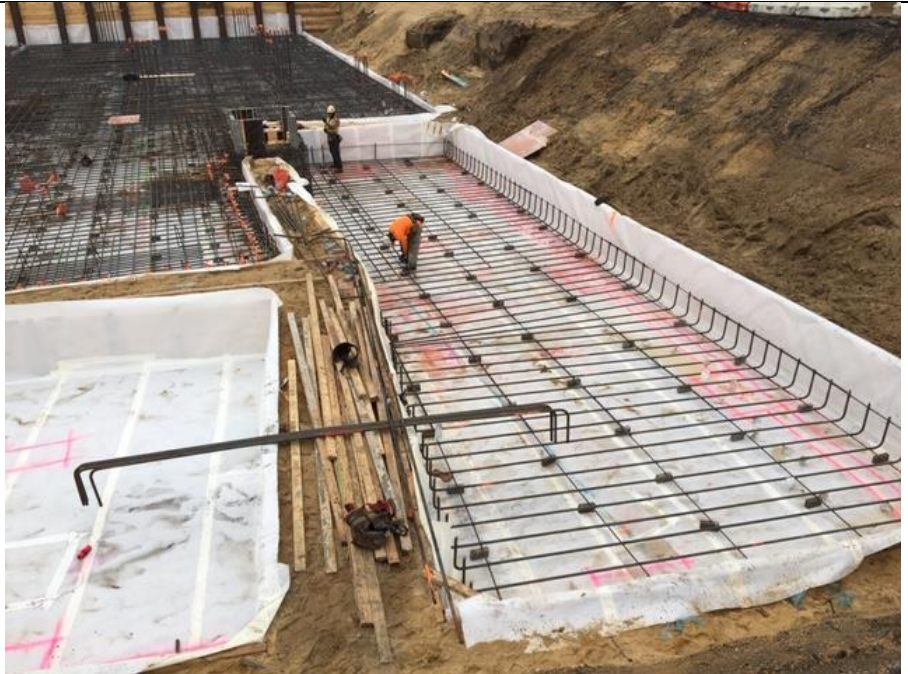
Photo 1- View of rebar installation in grids C5, C6, D5, and D6.
