Daily Report for March 3, 2020

**Far Rockaway Project
20-02 Mott Avenue
Far Rockaway, NY
BCP #C241224**

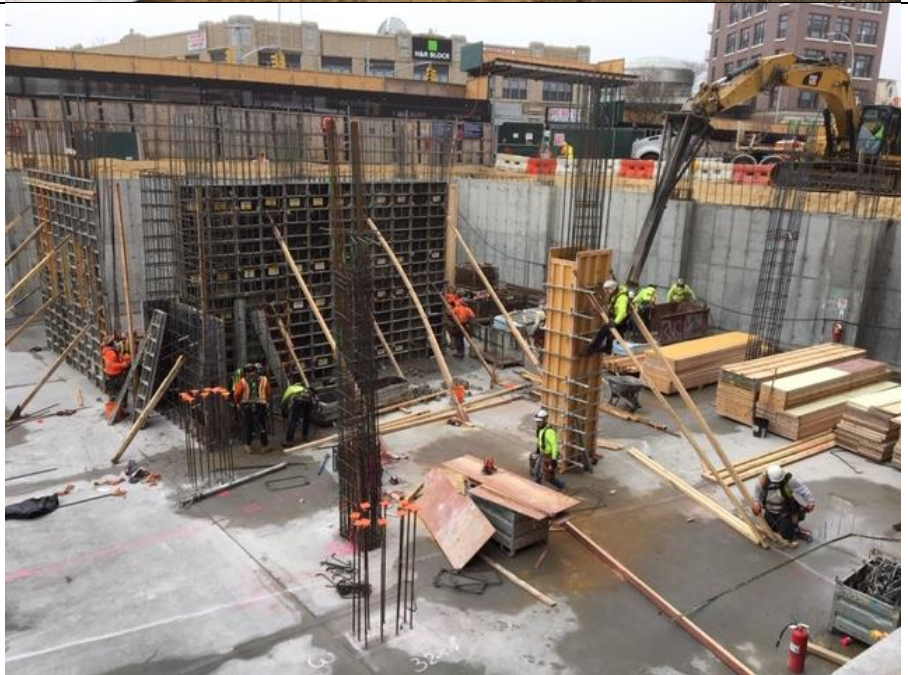
Photo 2- View of formwork and rebar installation in D1.

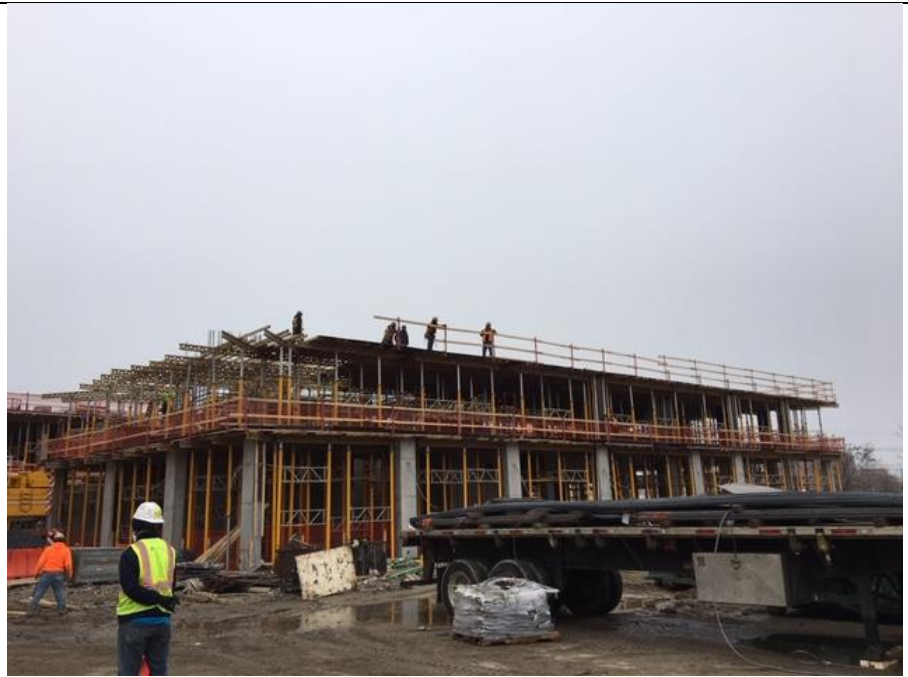
Photo 3- View of rebar and formwork installation in A3, A4, B3, and B4.

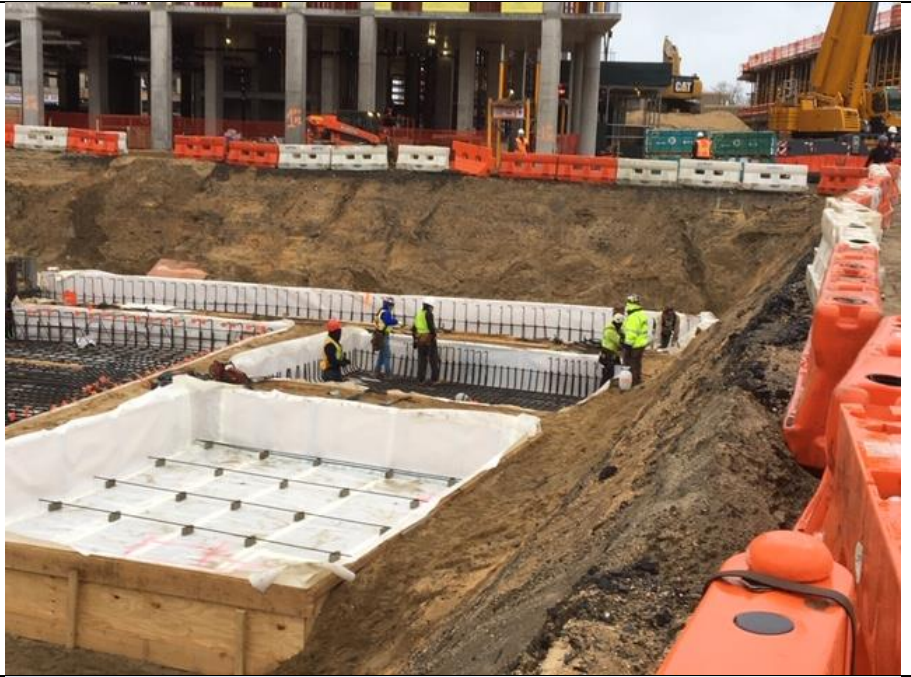
Photo 1- View of rebar installation in grids C5, C6, D5, and D6.

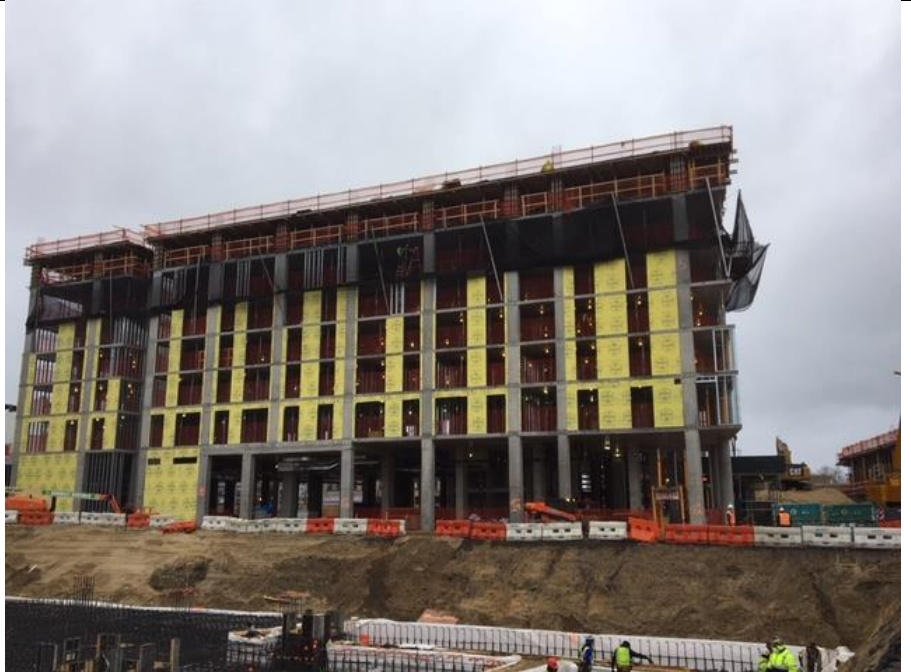
Photo 2- View of formwork and rebar installation in D3, D4, E3, and E4.

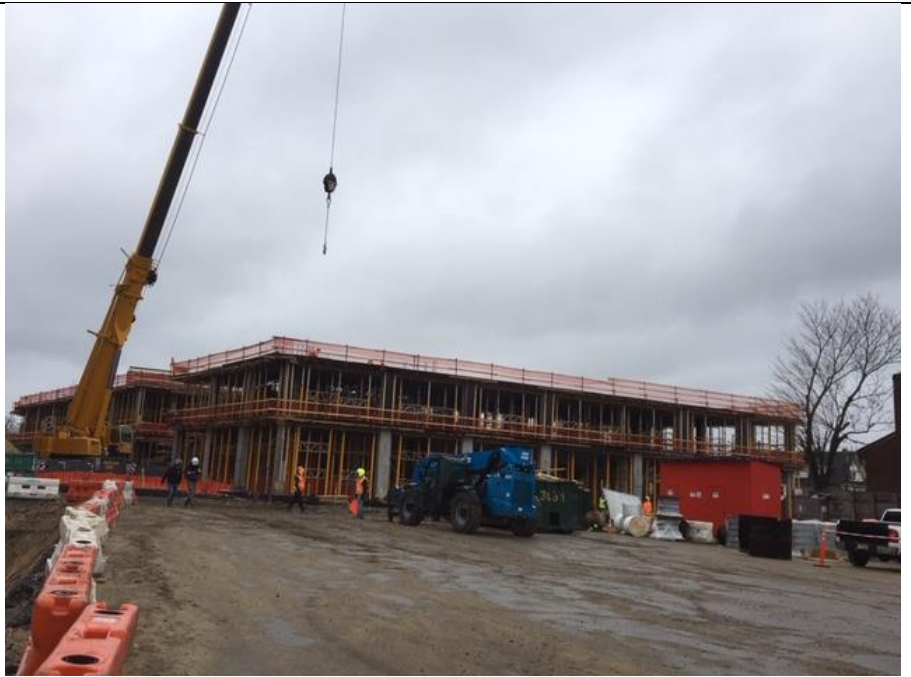
Photo 3- View of rebar and formwork installation in A3, A4, B3, and B4.

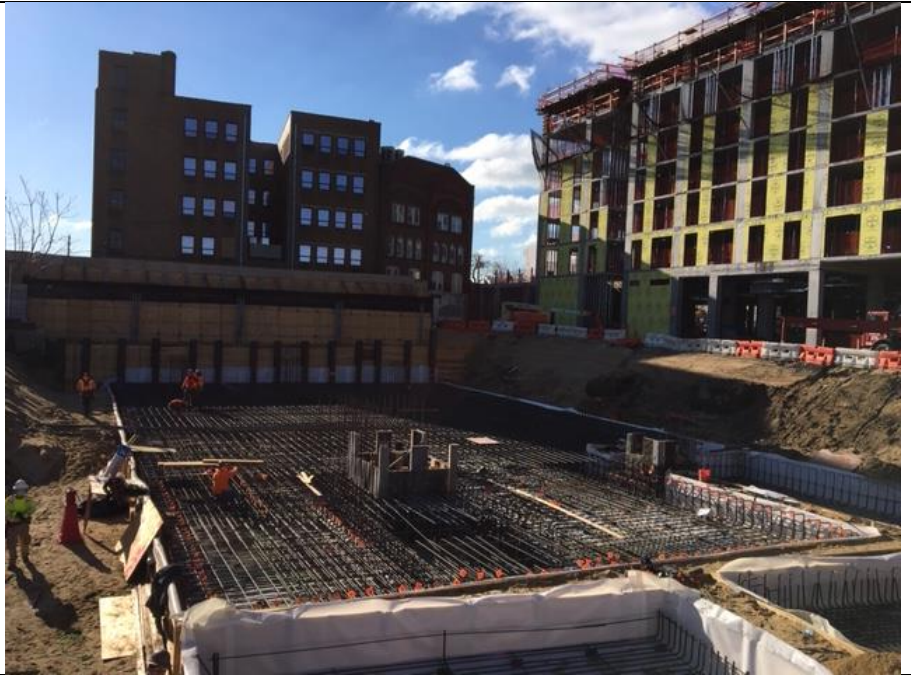
Photo 1- View of rebar installation in grids C5, C6, D5, and D6.

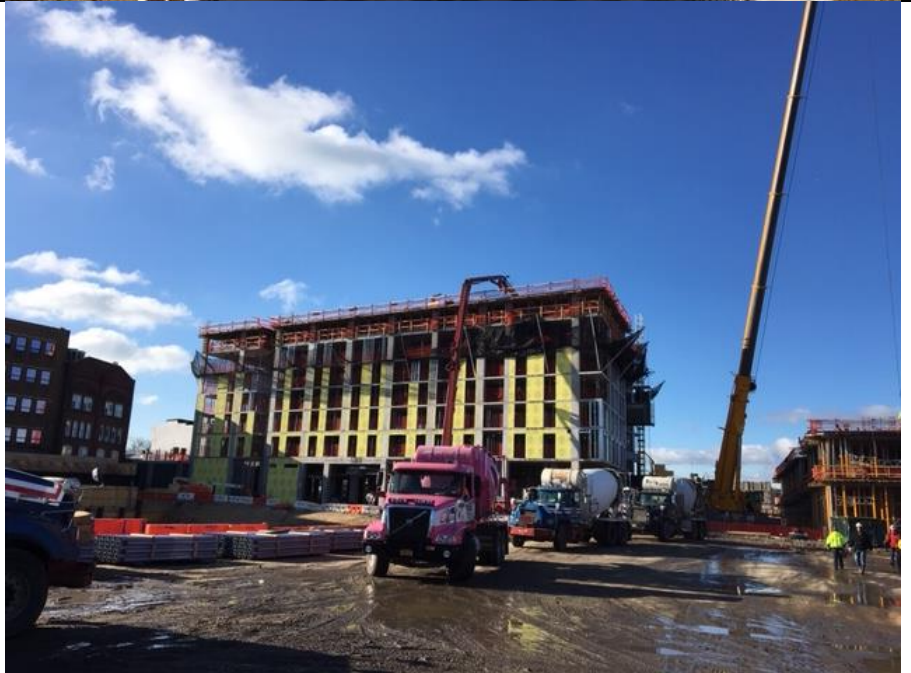
Photo 2- View of pouring concrete in D3, D4, E3, and E4.

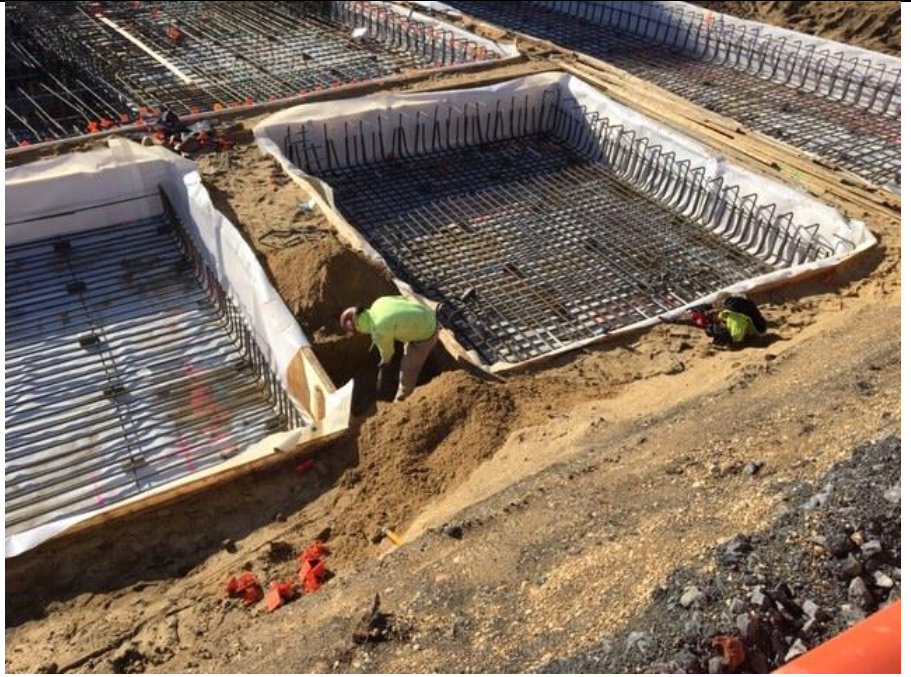
Photo 3- View
of excavating
soil for utilities
in grid C5.

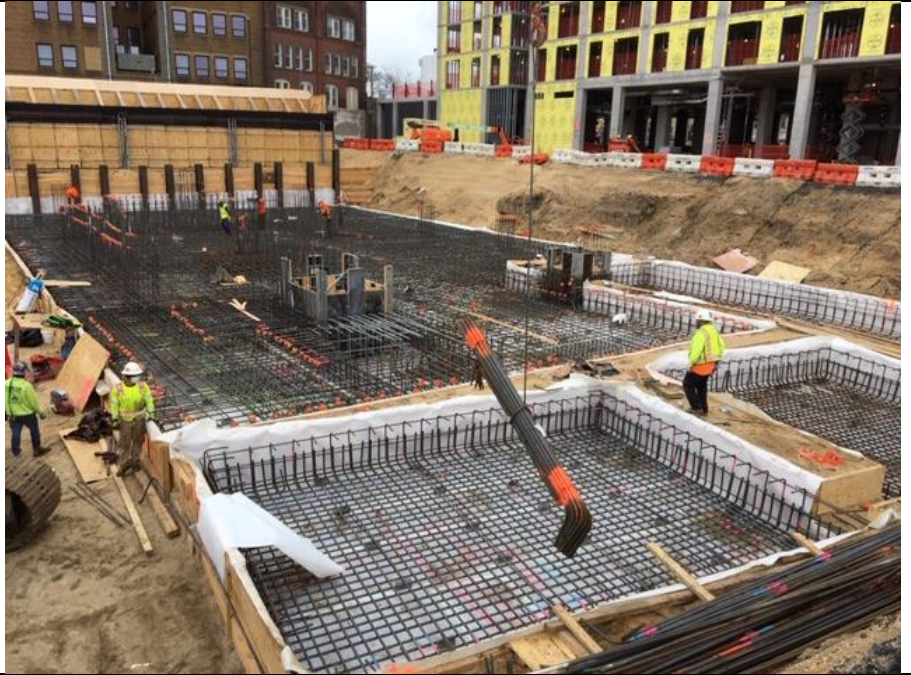
Photo 1- View of rebar installation in grids C5, C6, D5, and D6.

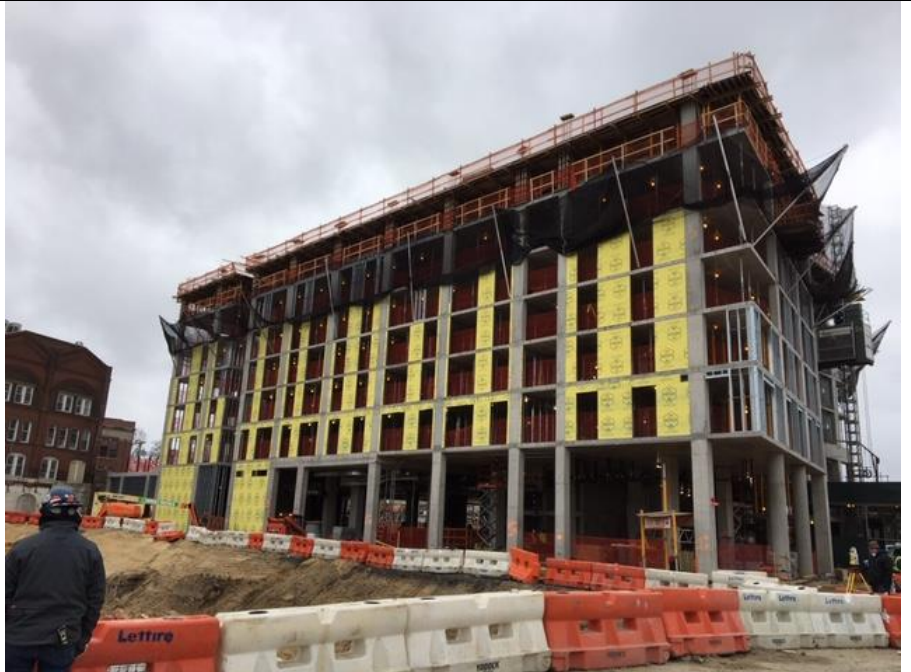
Photo 2- View of installing rebar and formwork in D3, D4, E3, and E4.

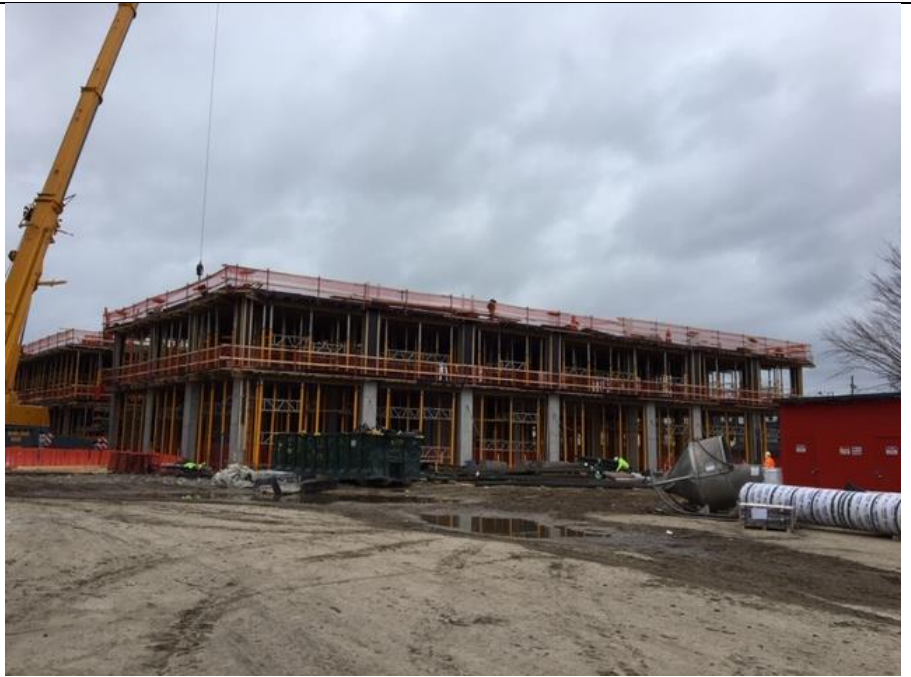
Photo 3- View of installing rebar and formwork in A3, A4, B3, and B4.

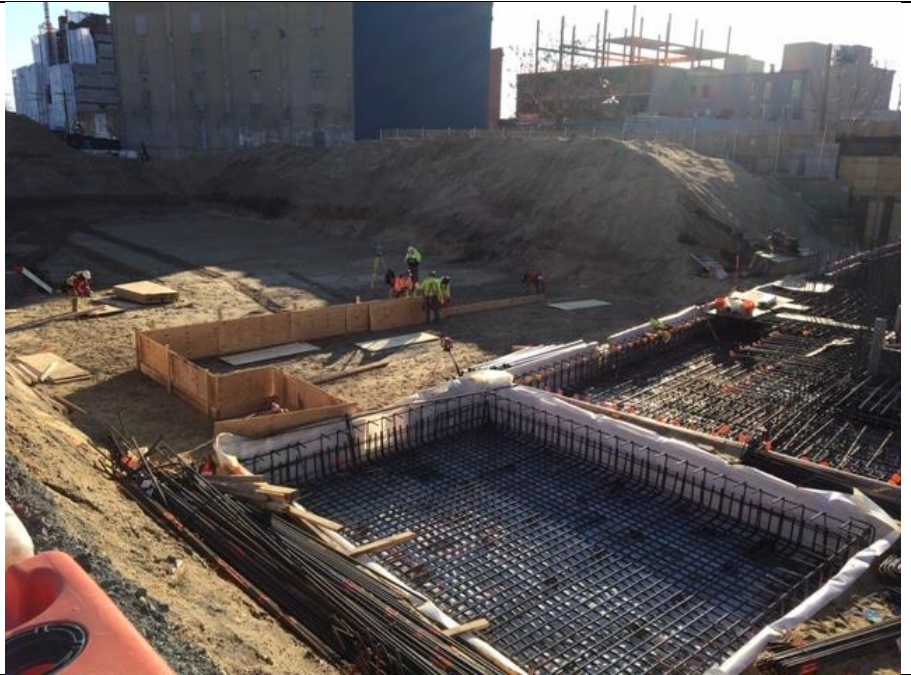
Photo 1- View of formwork and rebar installation in grids C5, C6, D5, and D6.

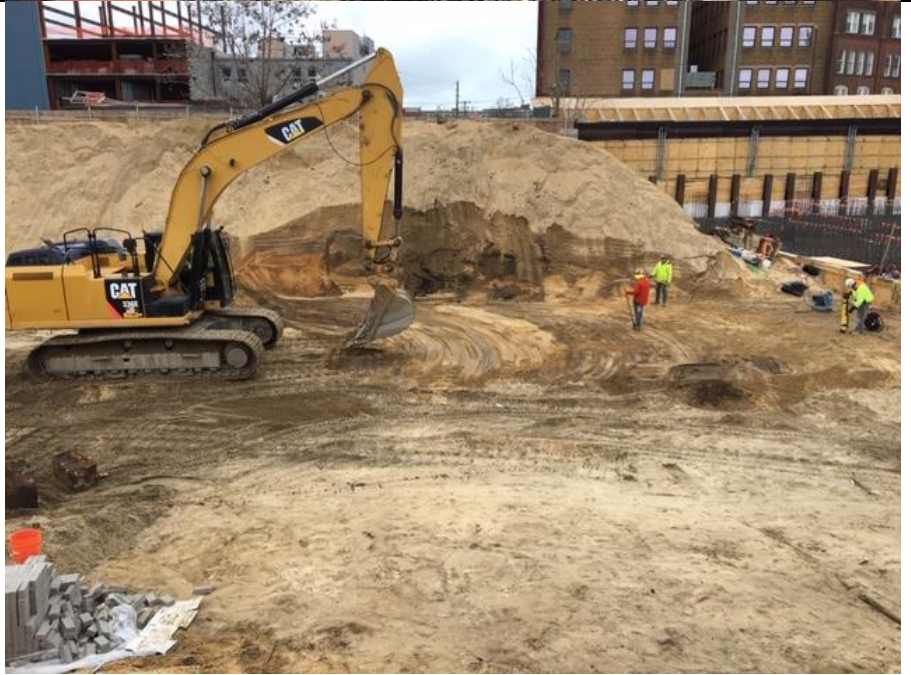
Photo 2- View of grading soil in C6.

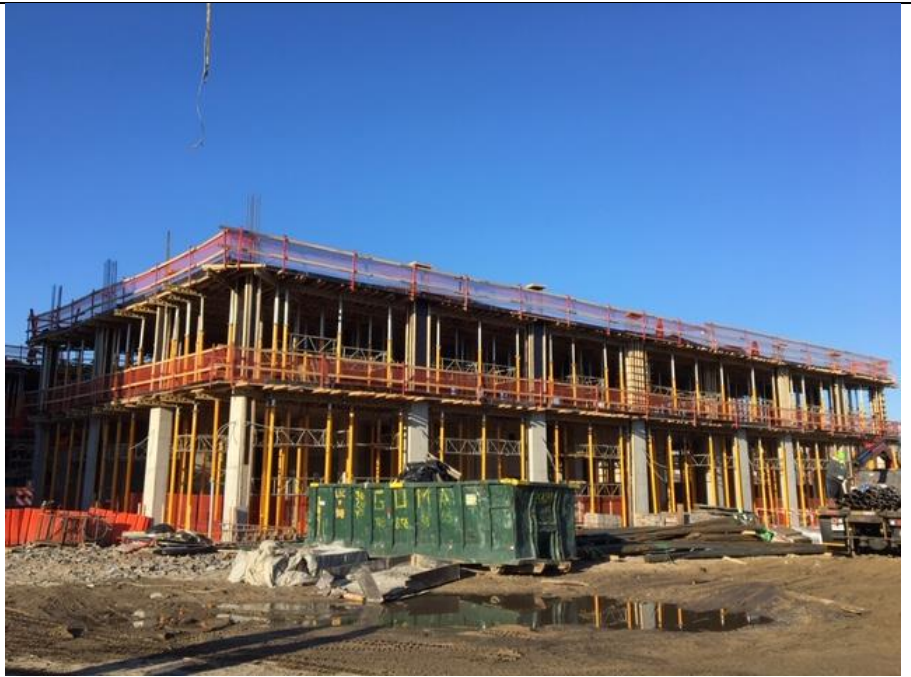
Photo 3- View of installing rebar and formwork in A3, A4, B3, and B4.

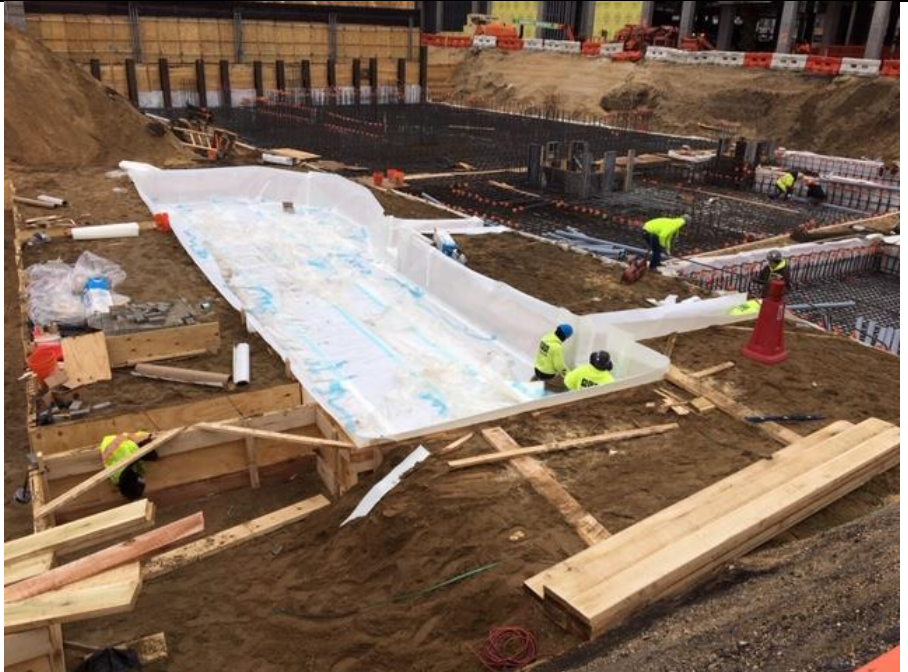
Photo 1- View of waterproofing installation in C6.

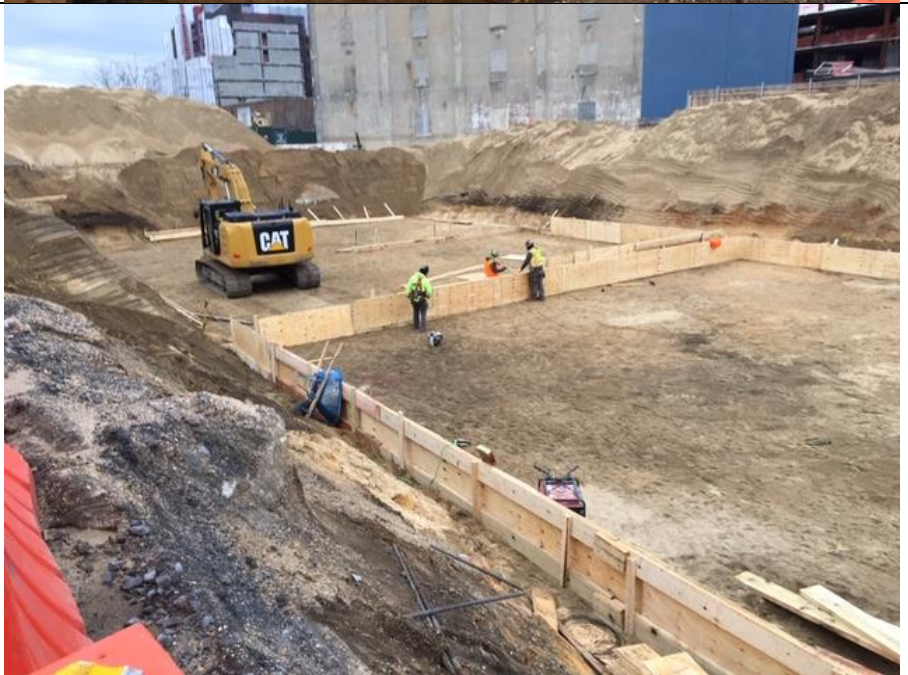
Photo 2- View of formwork and grading soil in C7 and C8.

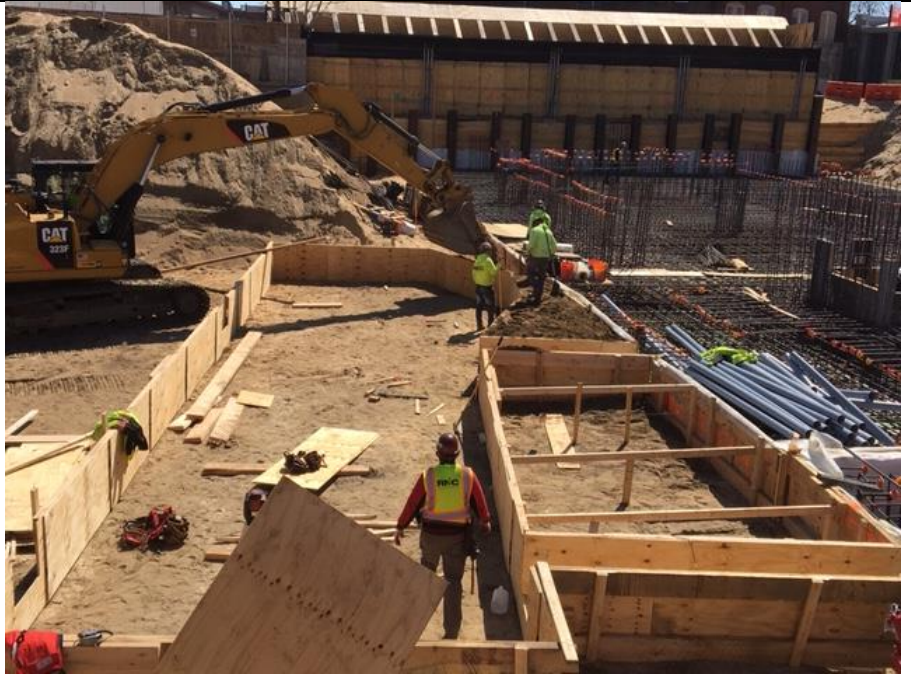
Photo 3- View
of backfilling in
C6.

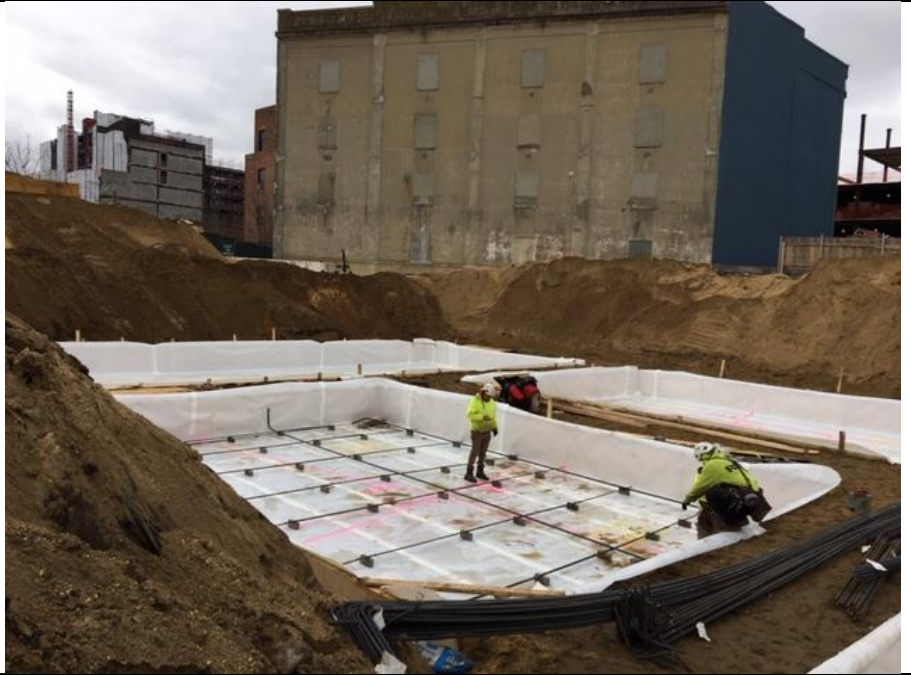
Photo 1- View of rebar and waterproofing installation in C6-C8, D7, and D8.

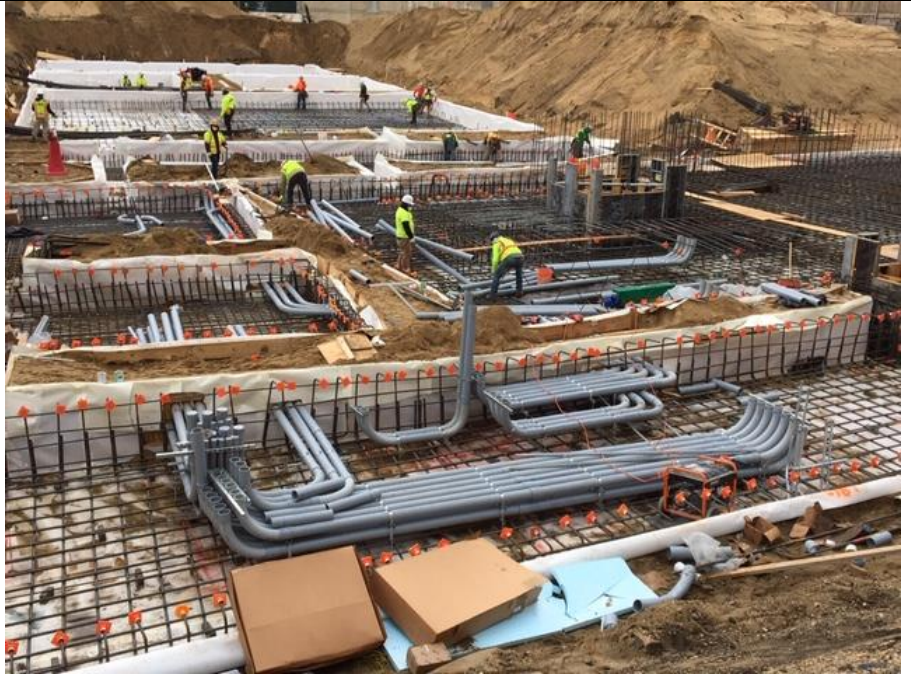
Photo 2- View of utility installation in C5 and C6.

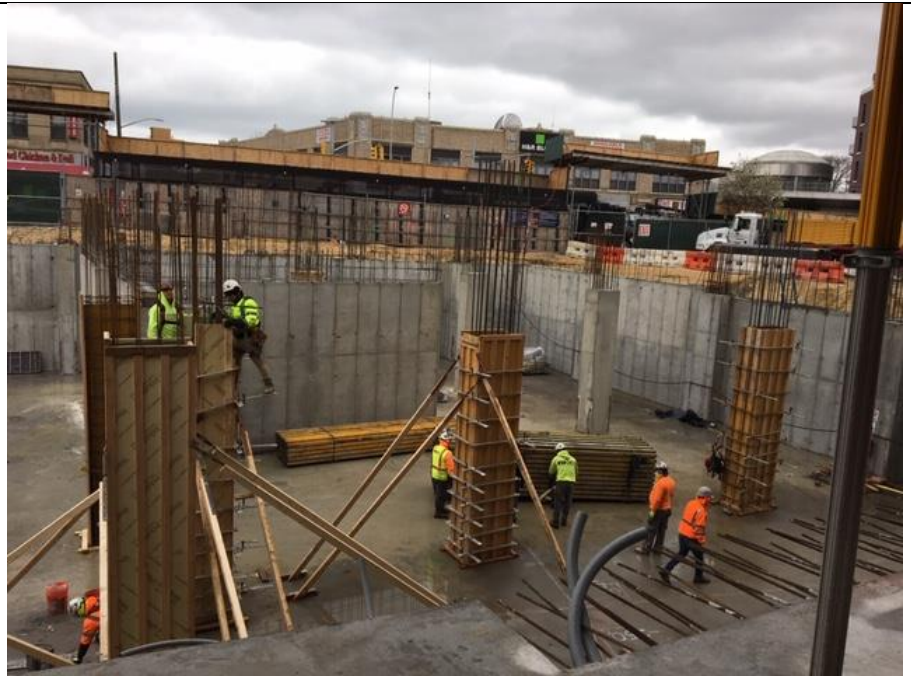
Photo 3- View
of formwork
and rebar
installation in
D1.
