## **Daily Report for April 1, 2020**

**Far Rockaway Project  
20-02 Mott Avenue  
Far Rockaway, NY  
BCP #C241224**

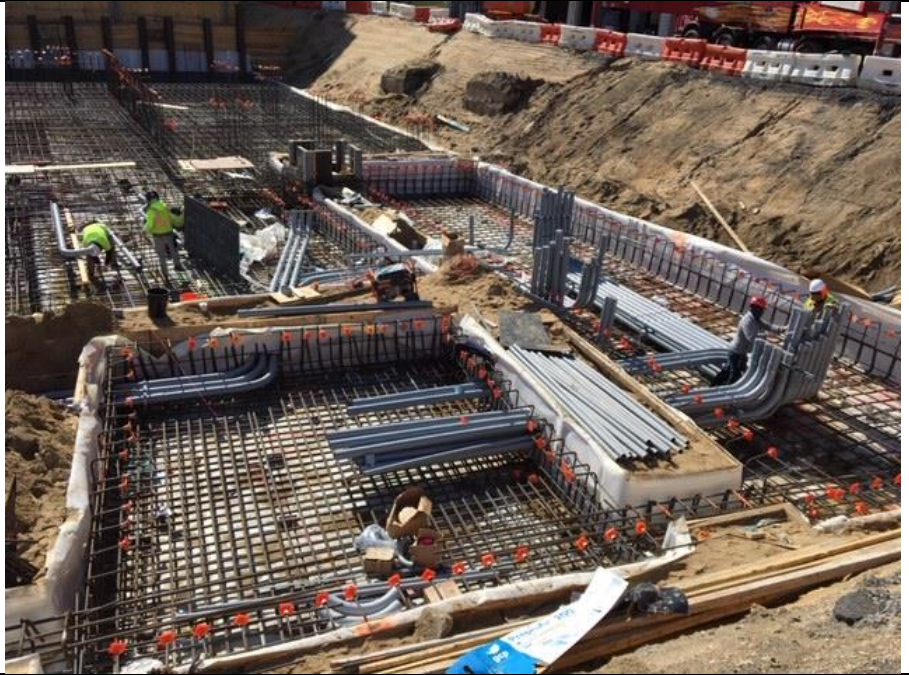
Photo 1- View of utility installation in C5 and C6.

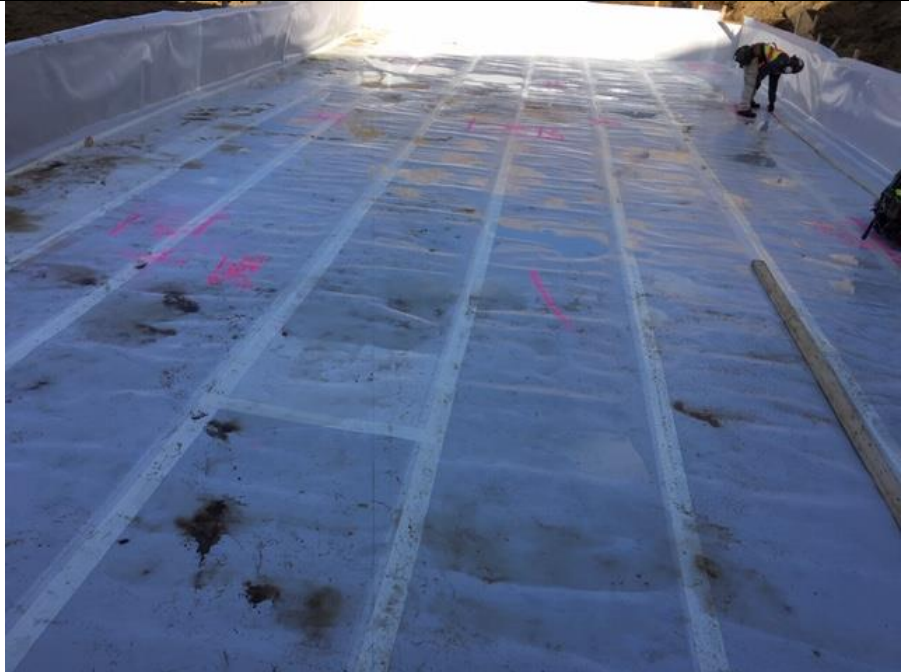
Photo 2- View of Preprufe 200 installation.

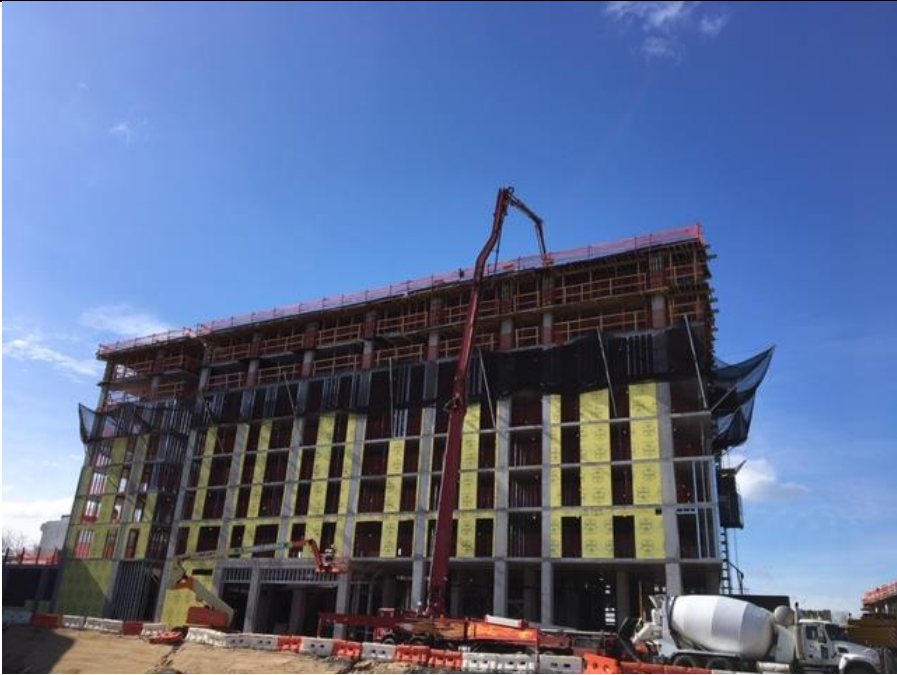
Photo 3- View of pouring concrete in Building B.

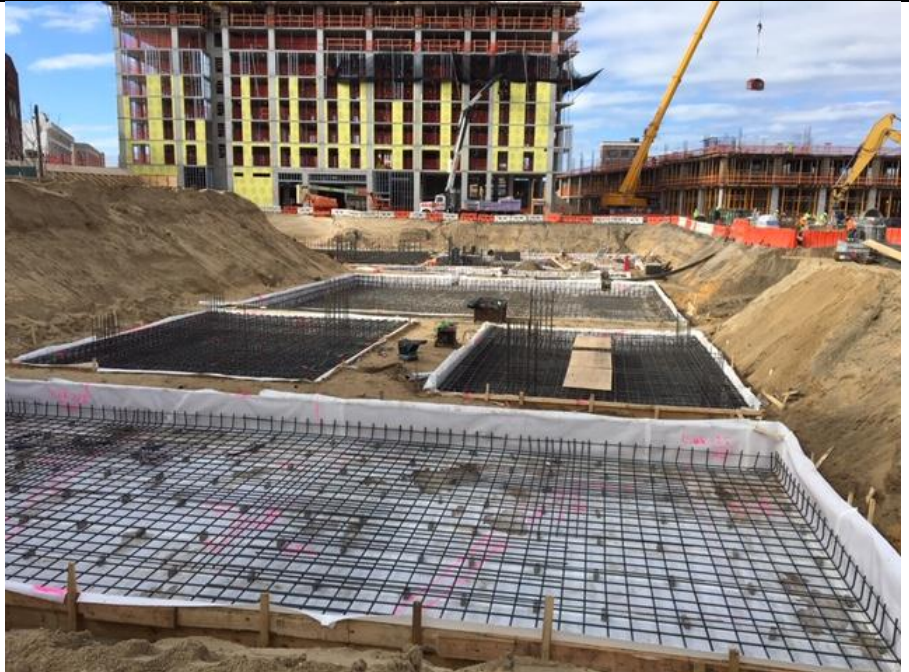
Photo 1- View of waterproofing and rebar installation in C6, C7, and C8.

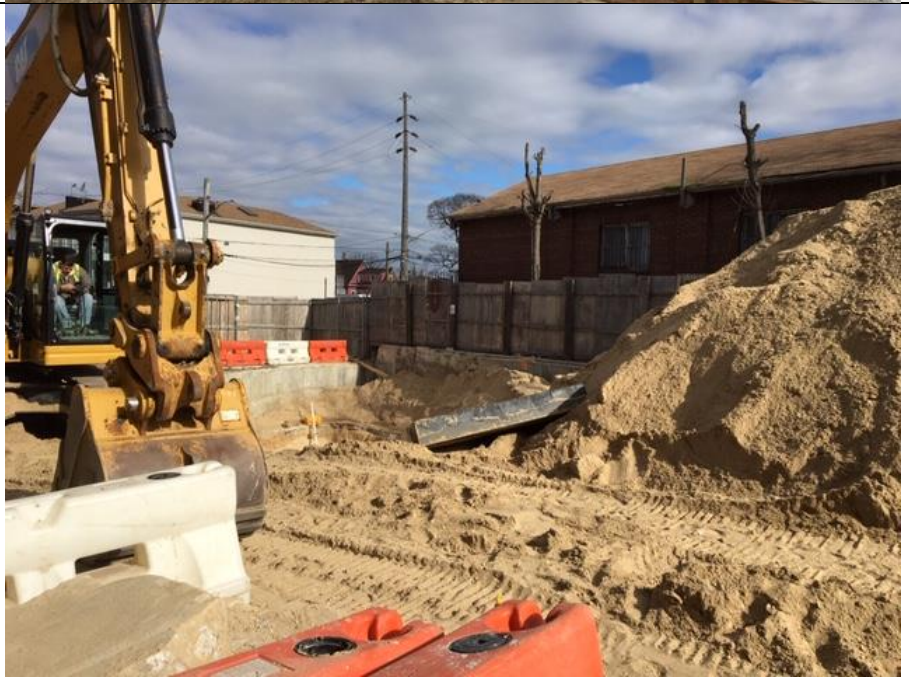
Photo 2- View of excavating backfill for utility installation.

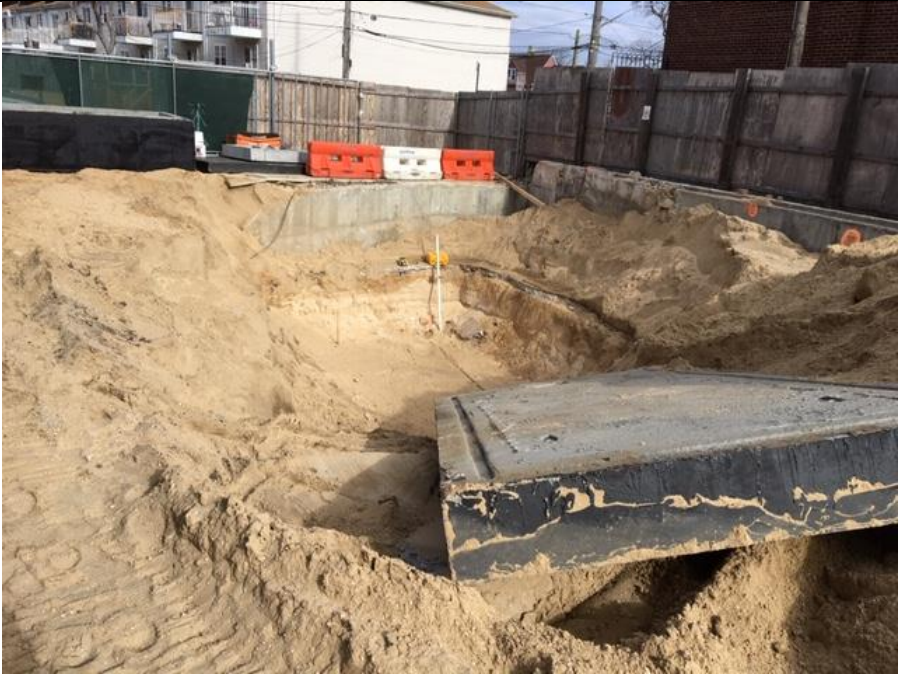
Photo 3- View of excavated backfill in A5.

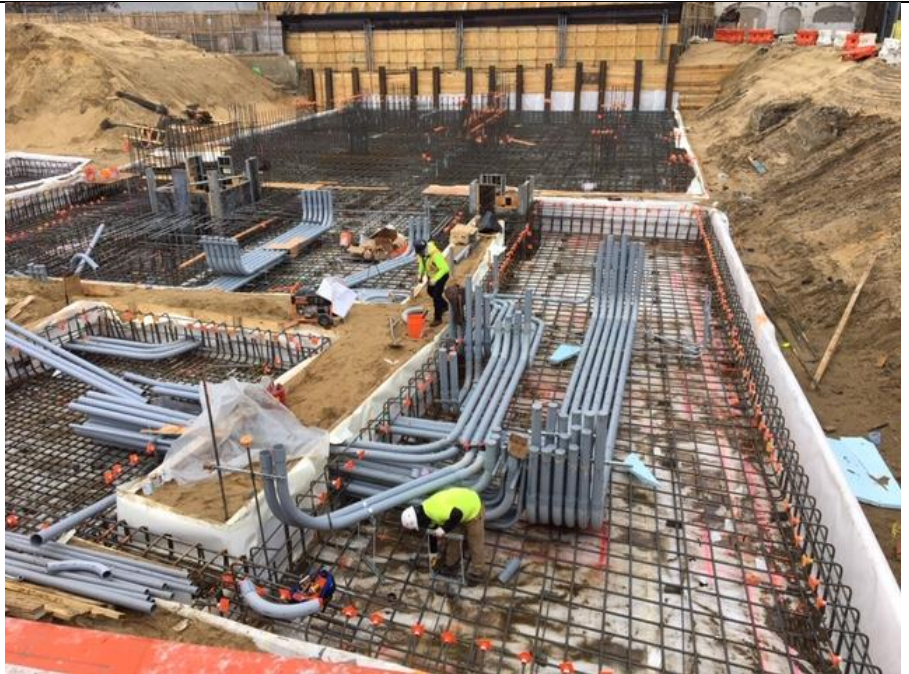
Photo 1- View of utility installation in C5 and C6.

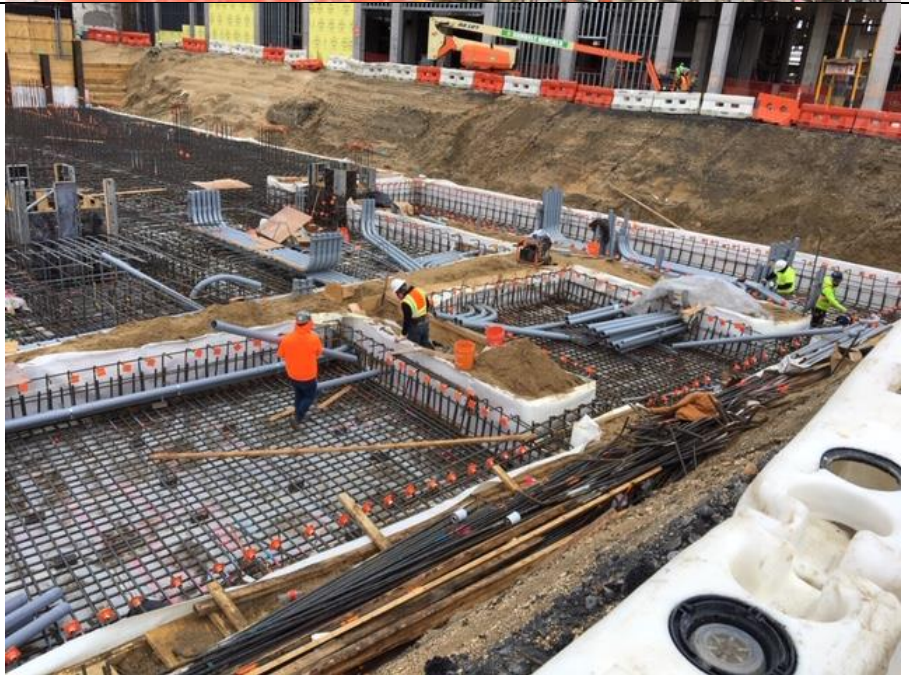
Photo 2- View of excavating backfill for utility installation.

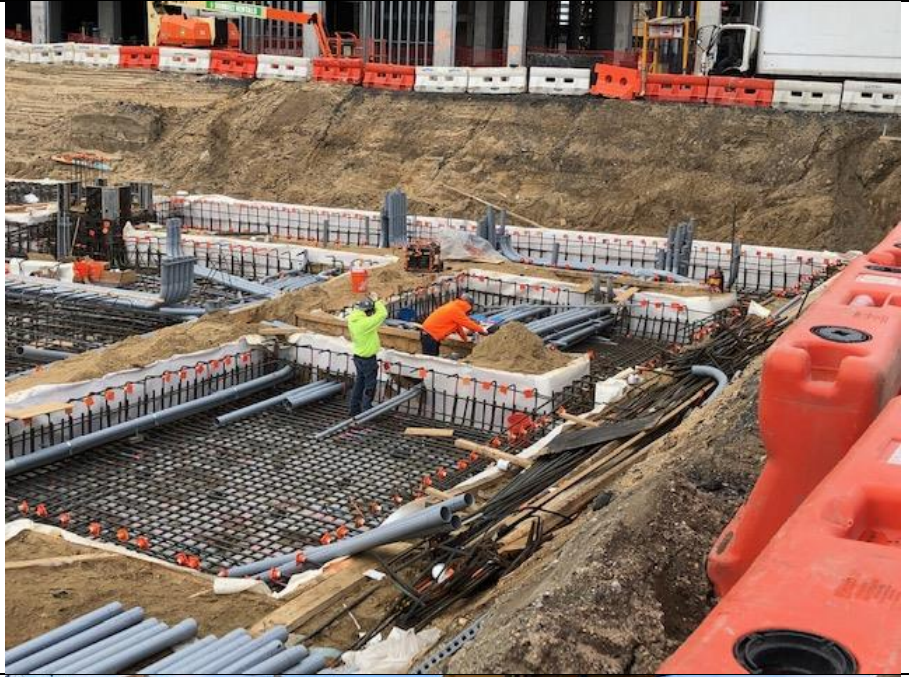
Photo 1- View of utility installation in C5 and C6.

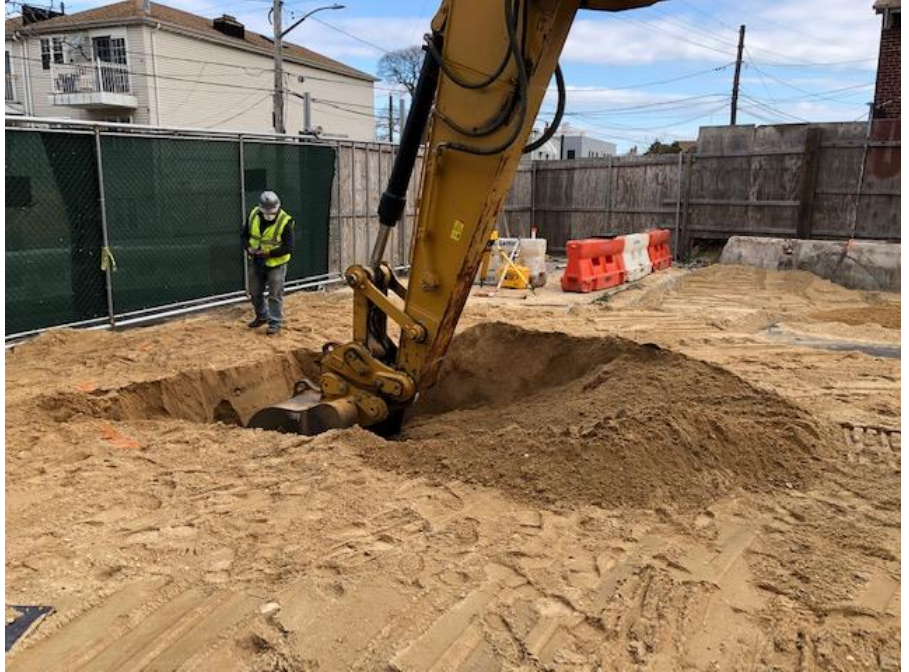
Photo 2- View of excavating backfill for utility installation in A5.

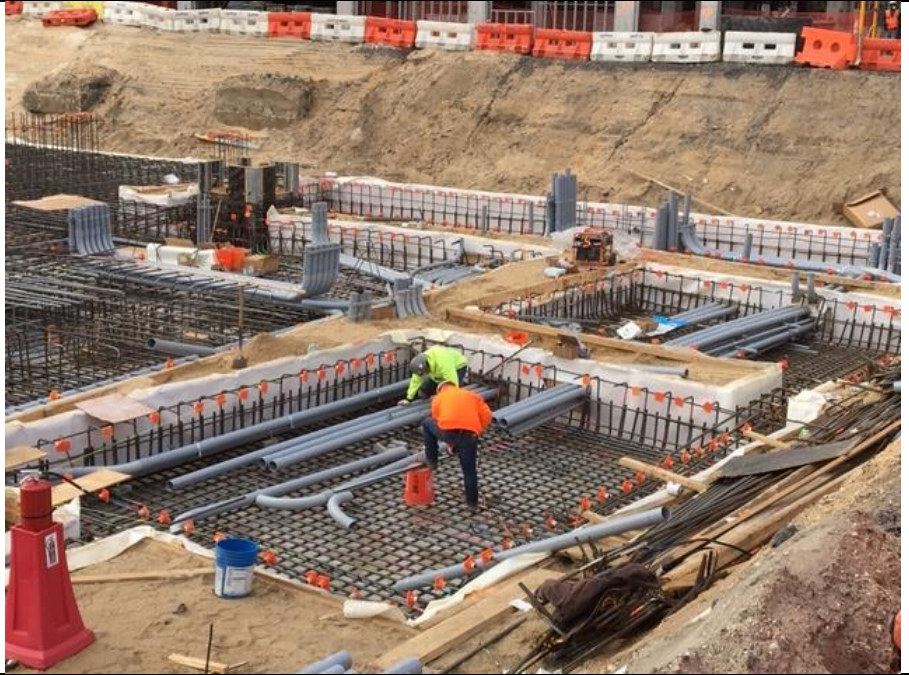
Photo 1- View of utility installation in C5 and C6.

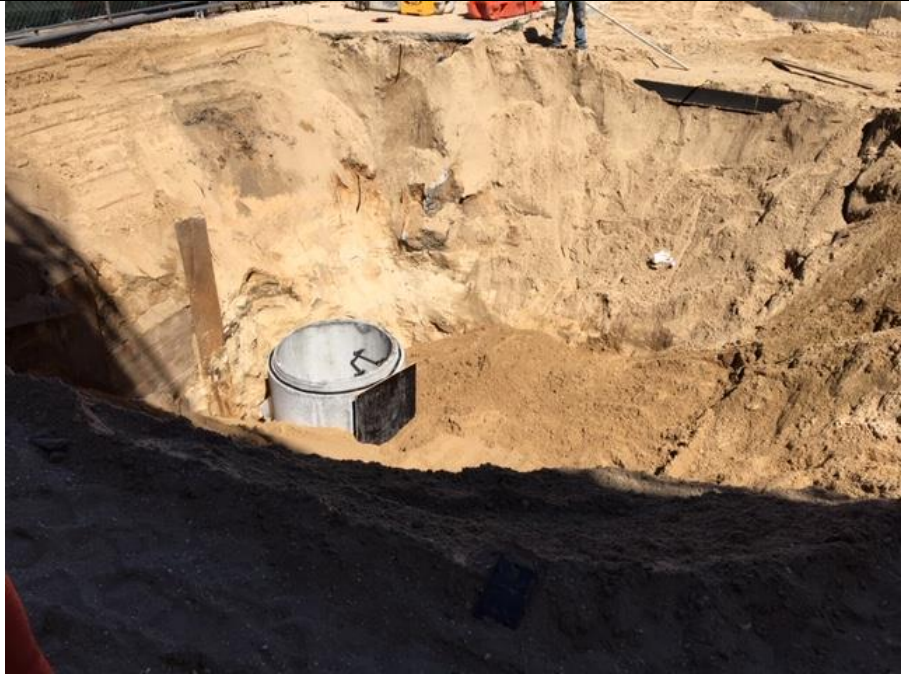
Photo 2- View of installing utilities in A5.

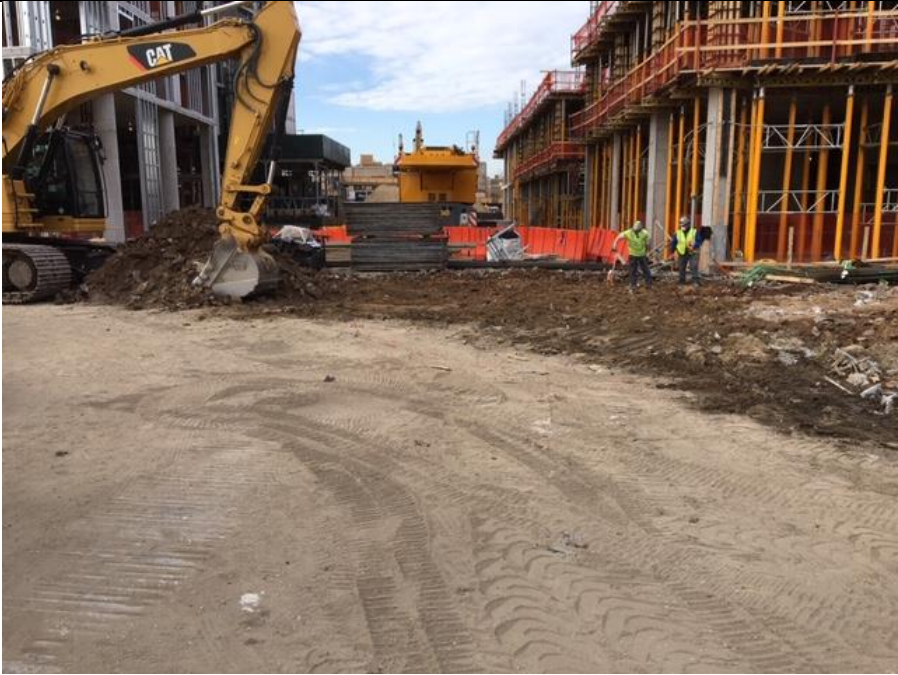
Photo 3- View of grading soil in C5.

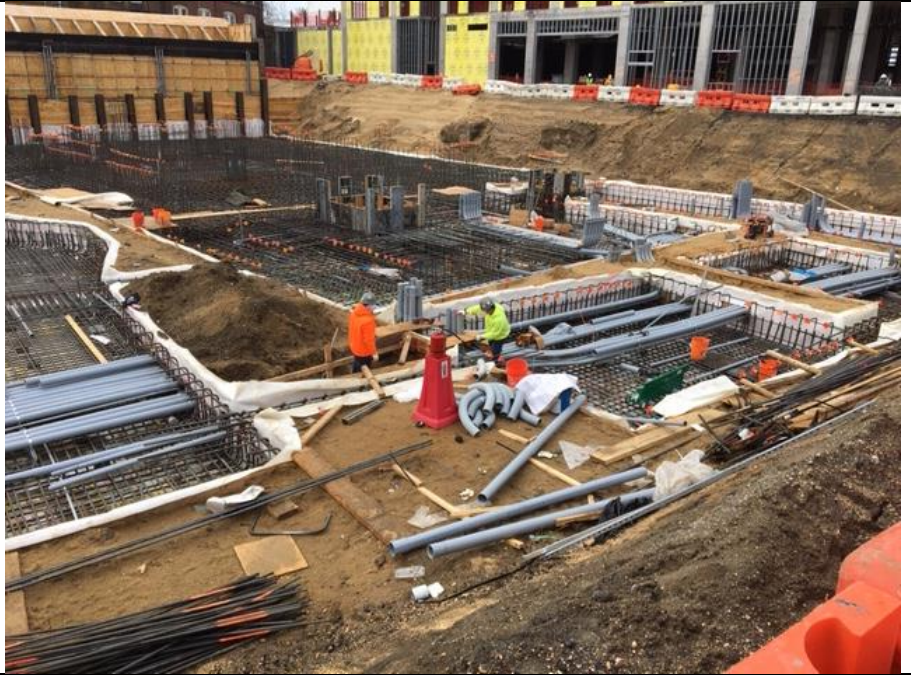
Photo 1- View of utility installation in C5 and C6.

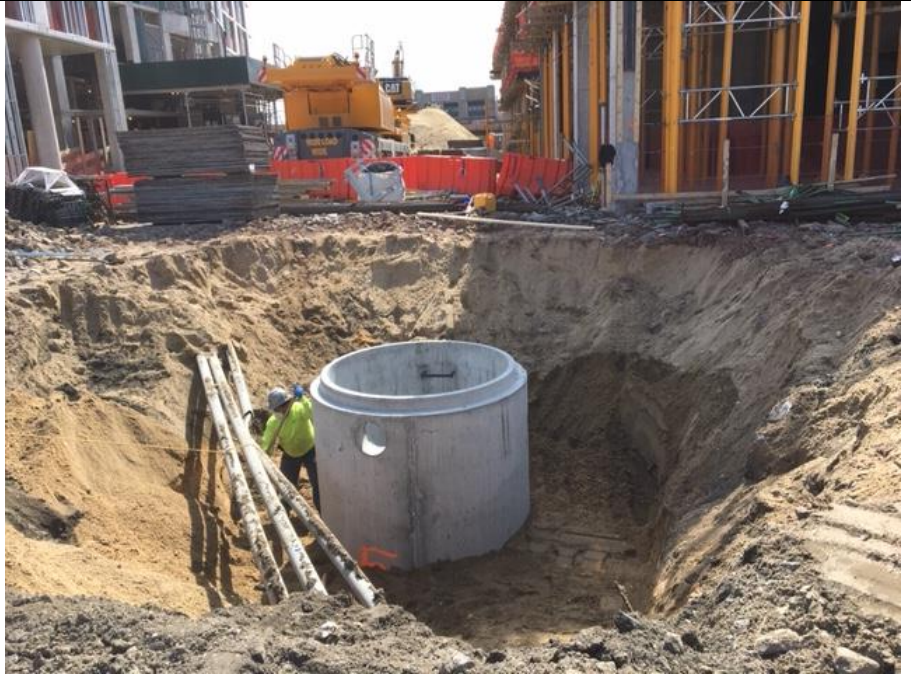
Photo 2- View of installing utilities in B5.

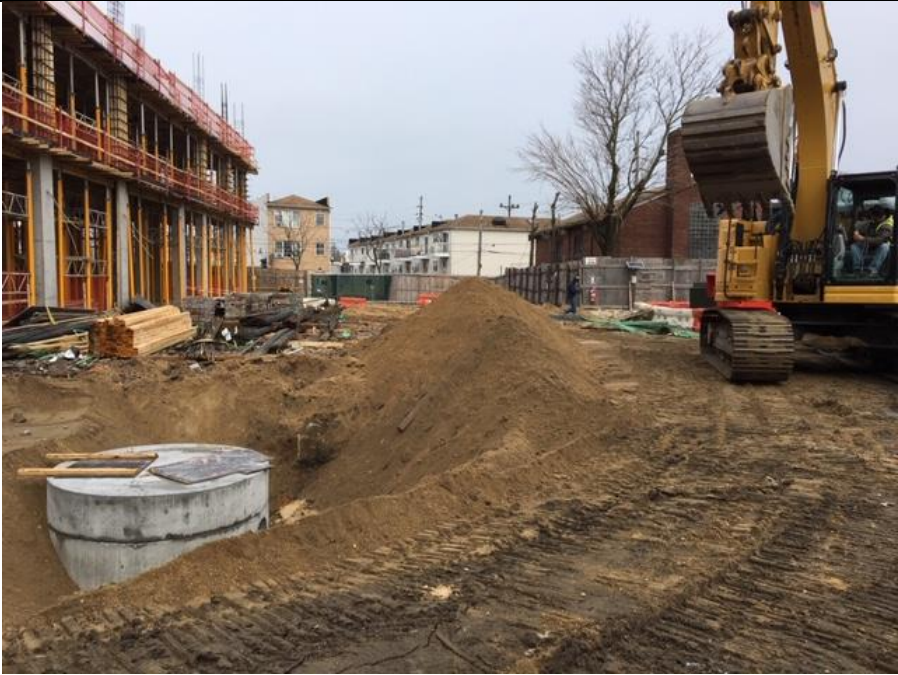
Photo 3- View of backfilling soil in B5.

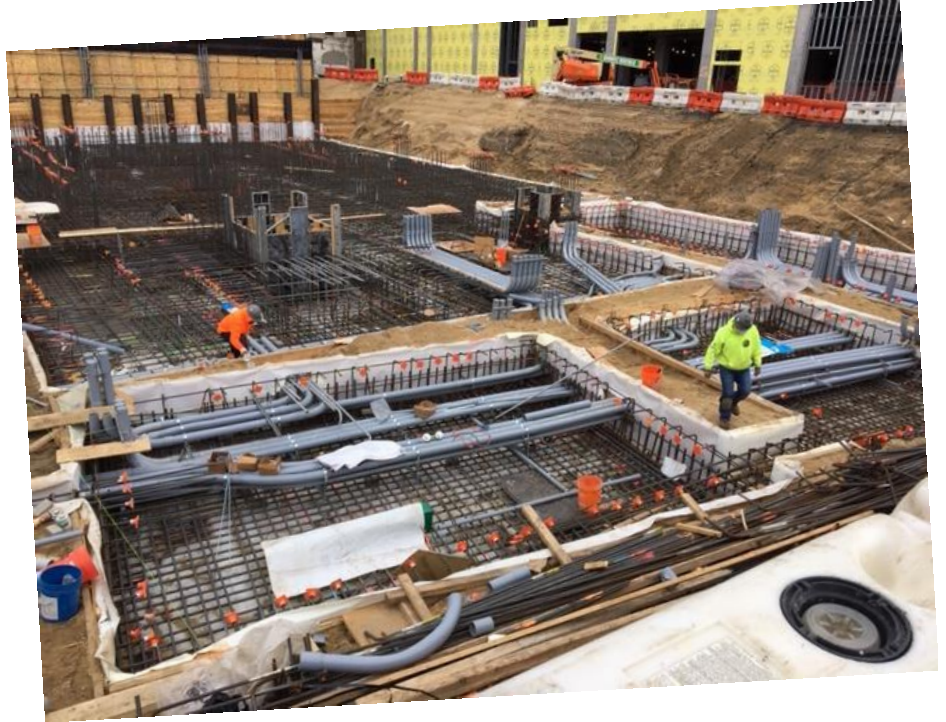
Photo 1- View of utility installation in C5 and C6.

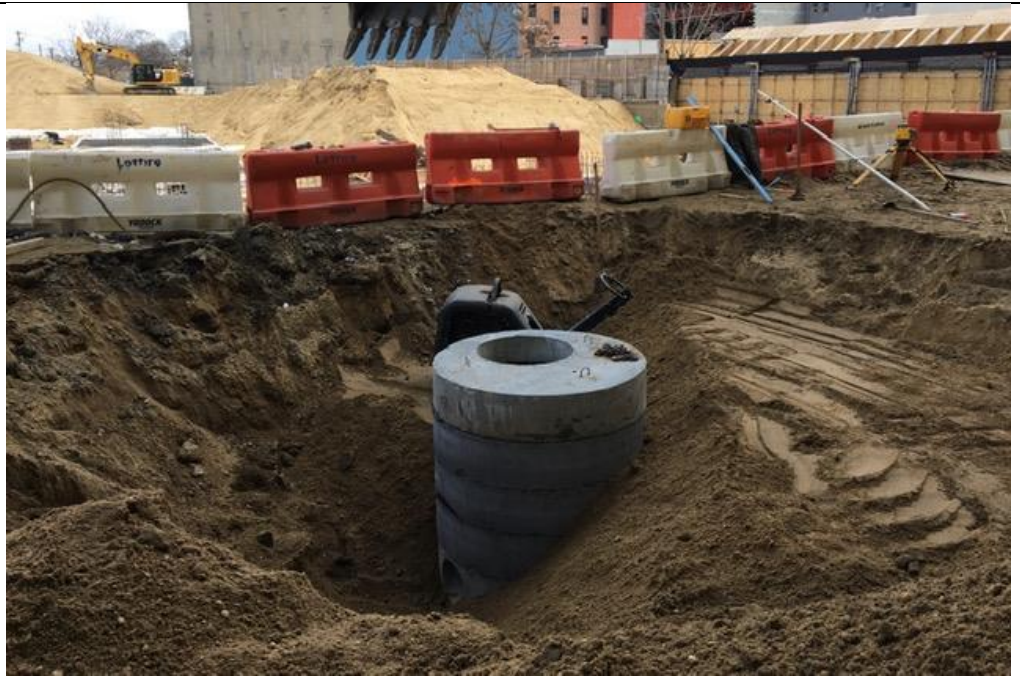
Photo 2- View of backfilling in C5.

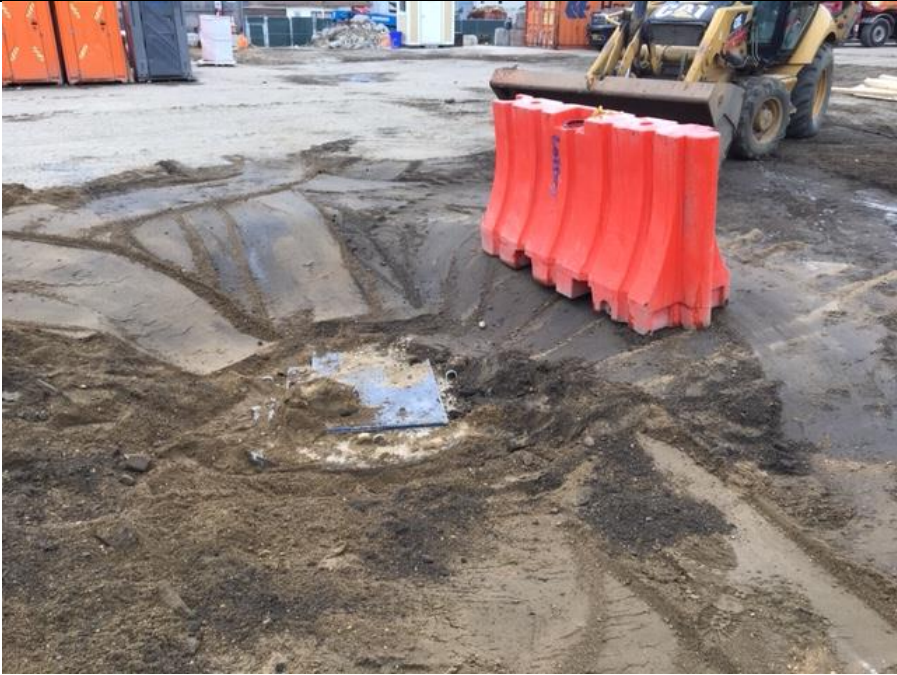
Photo 3- View  
of backfilling  
soil in B6.

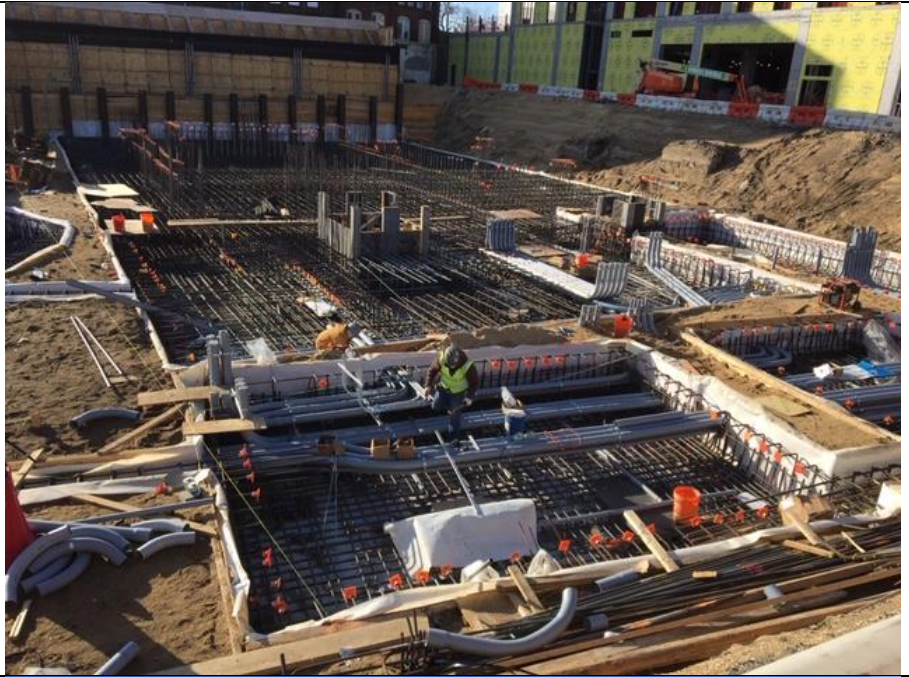
Photo 1- View of utility installation in C5 and C6.

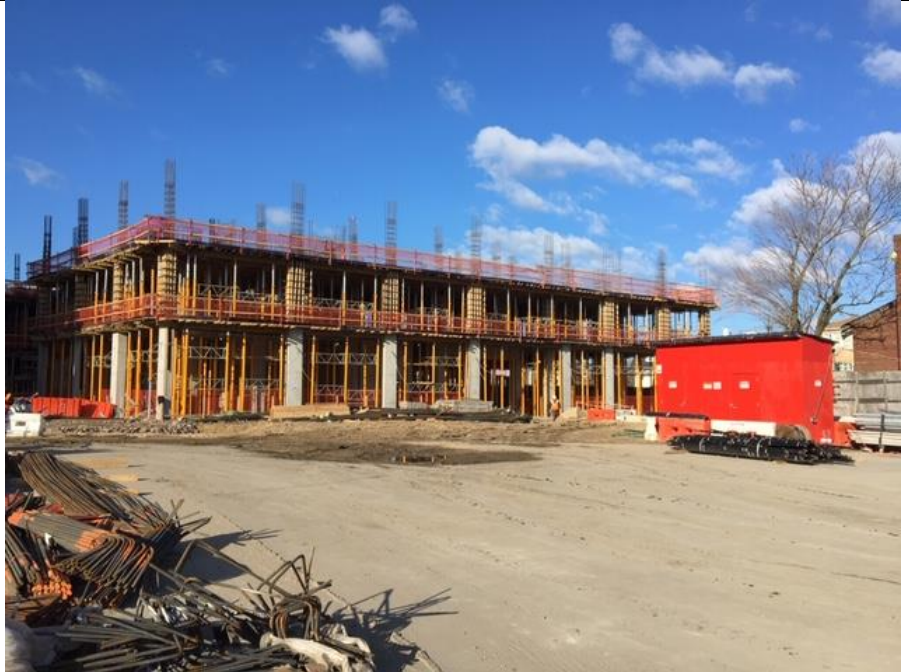
Photo 2- View of utility installation in A3, A4, B3, and B4.

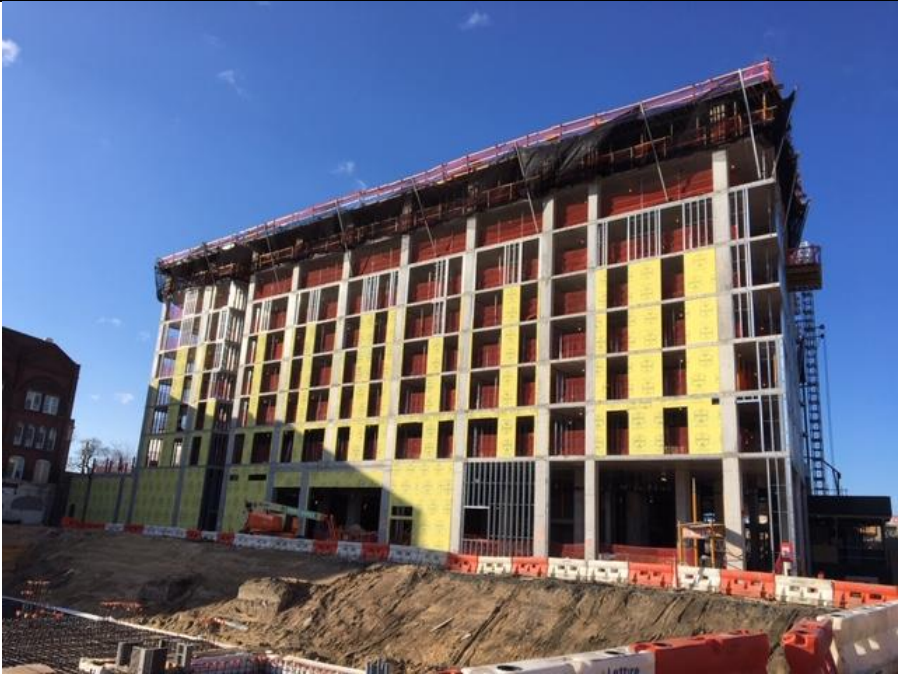
Photo 3- View of utility installation in D3, D4, E3, and E4.

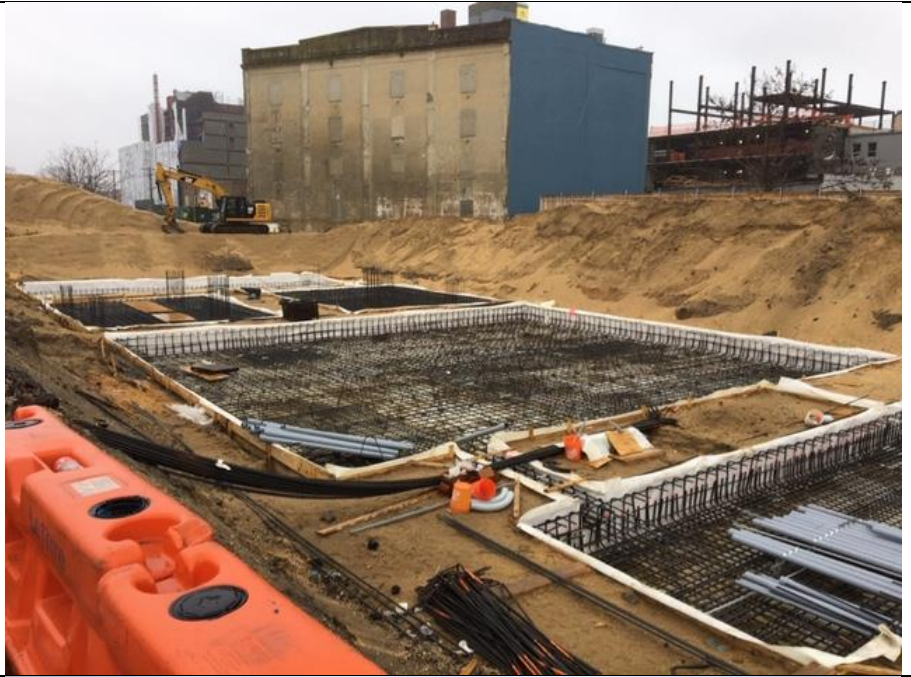
Photo 1- View of grids C6-C8, D7, and D8.

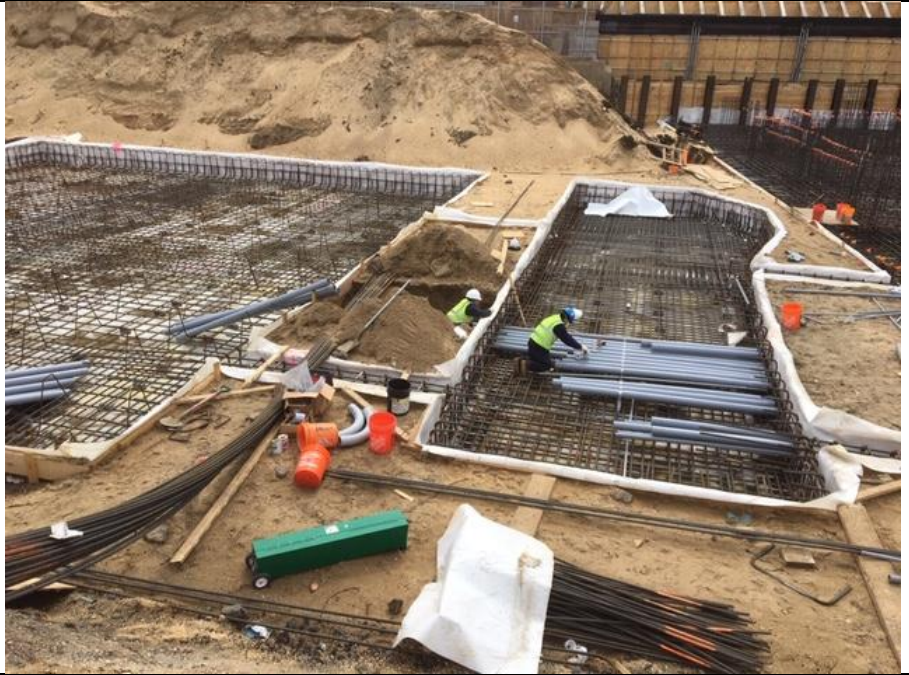
Photo 1- View of excavation and utility installation in C5 and C6.

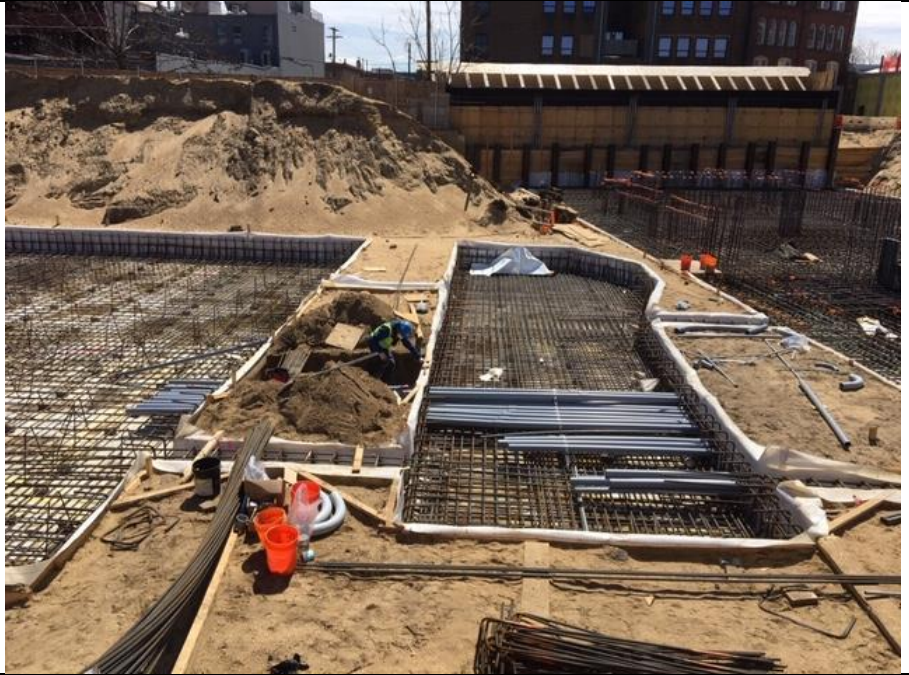
Photo 1- View of utility installation in C5 and C6.

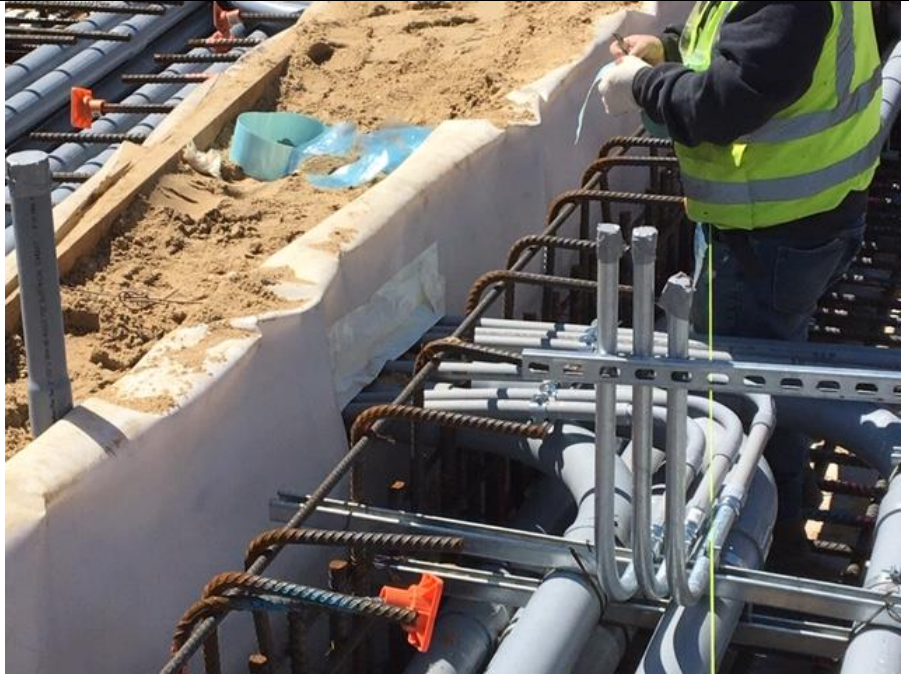
Photo 2- View of Preprufe 200 installation in C5 and C6.

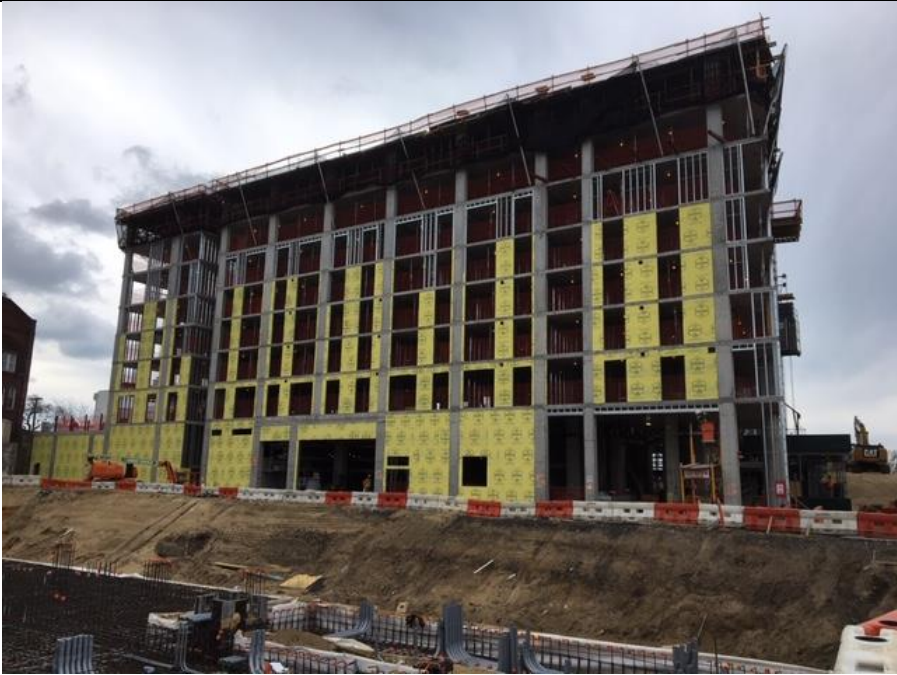
Photo 3- View of utility installation in D3, D4, E3, and E4.

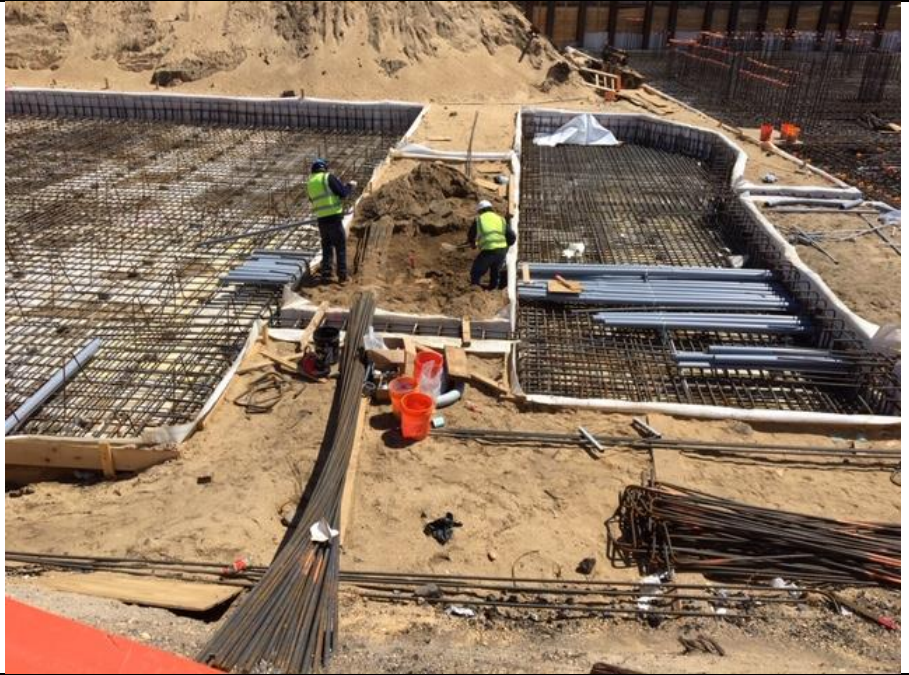
Photo 1- View of excavating clean fill for utility installation in C5 and C6.

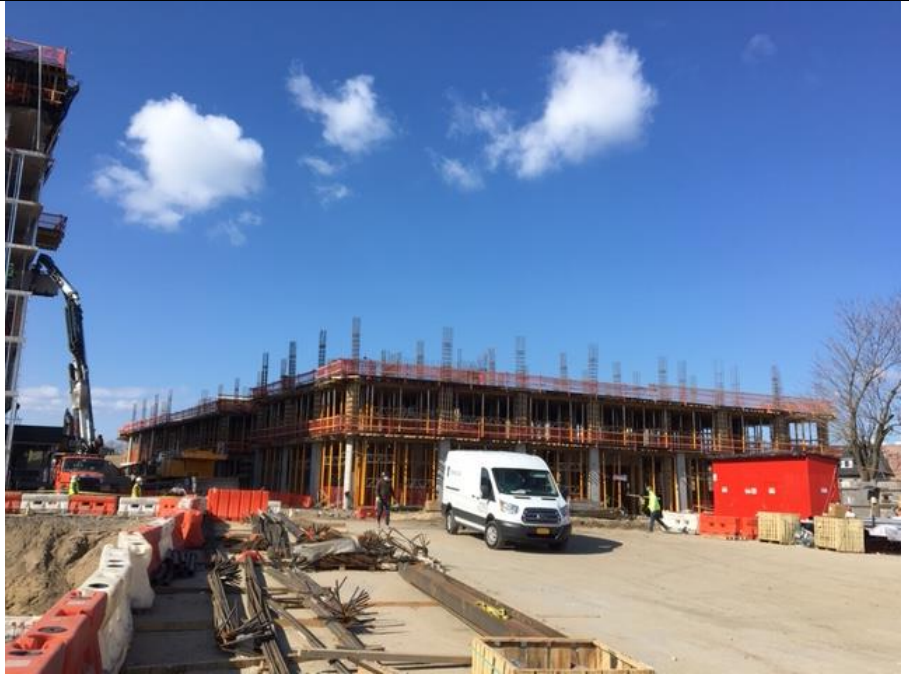
Photo 2- View of utility installation in A3, A4, B3, and B4.

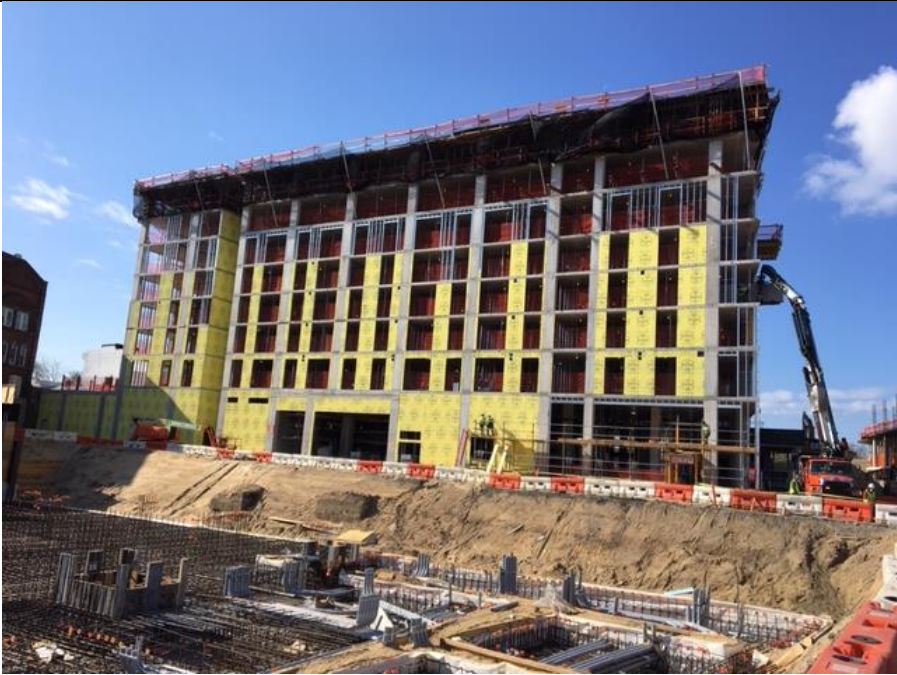
Photo 3- View of utility installation in D3, D4, E3, and E4.

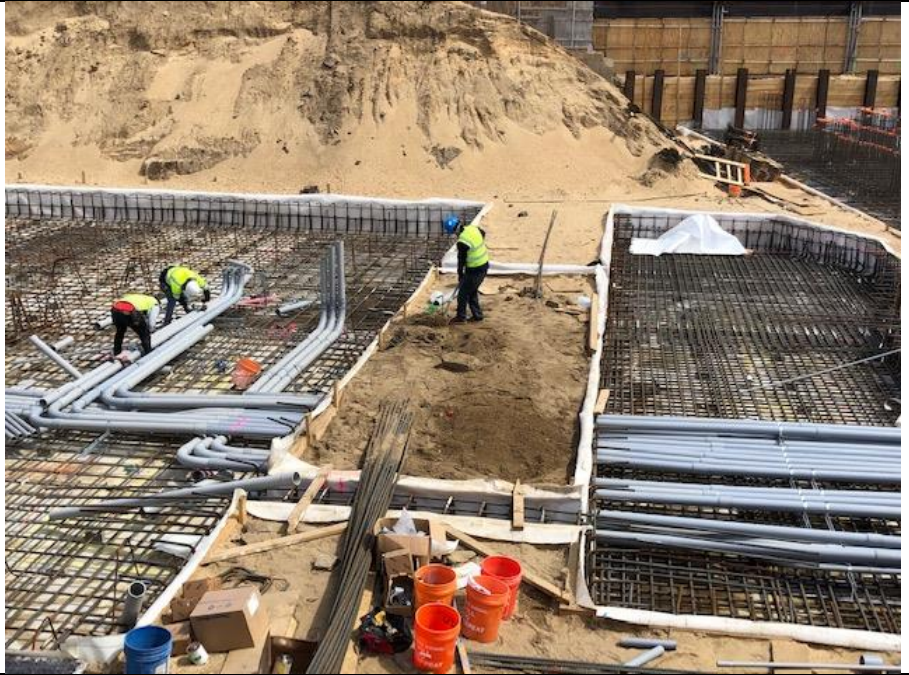
Photo 1- View of backfilling with clean fill for utility installation in C5 and C6.

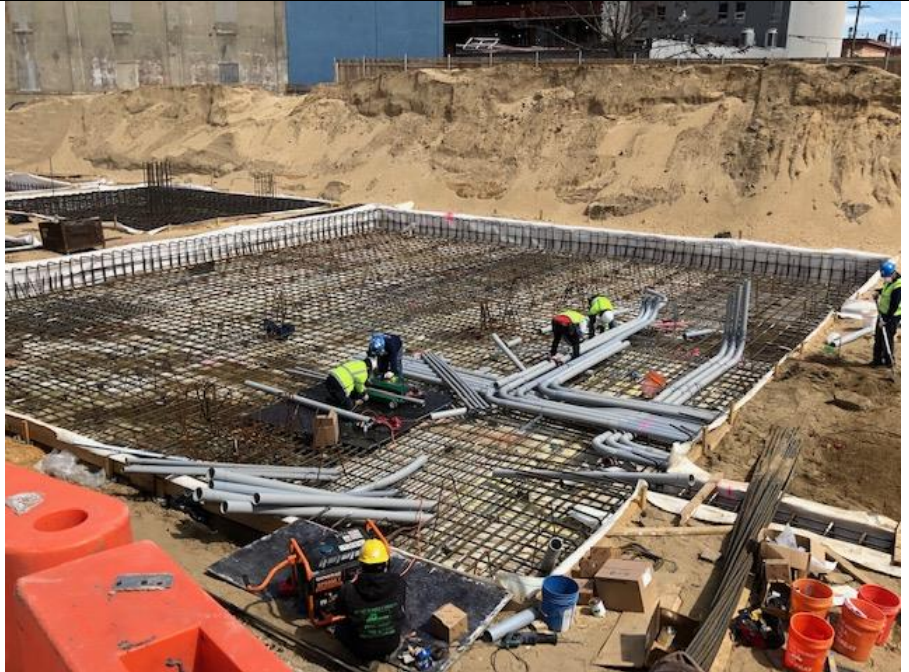
Photo 2- View of utility installation in C6 and C7.

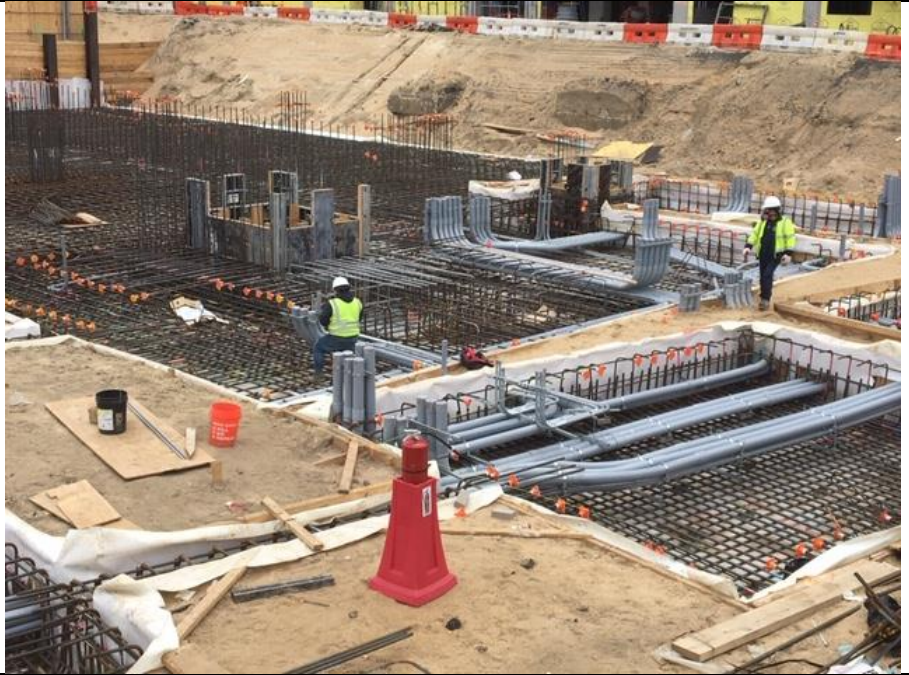
Photo 1- View of utility installation in C5 and C6.

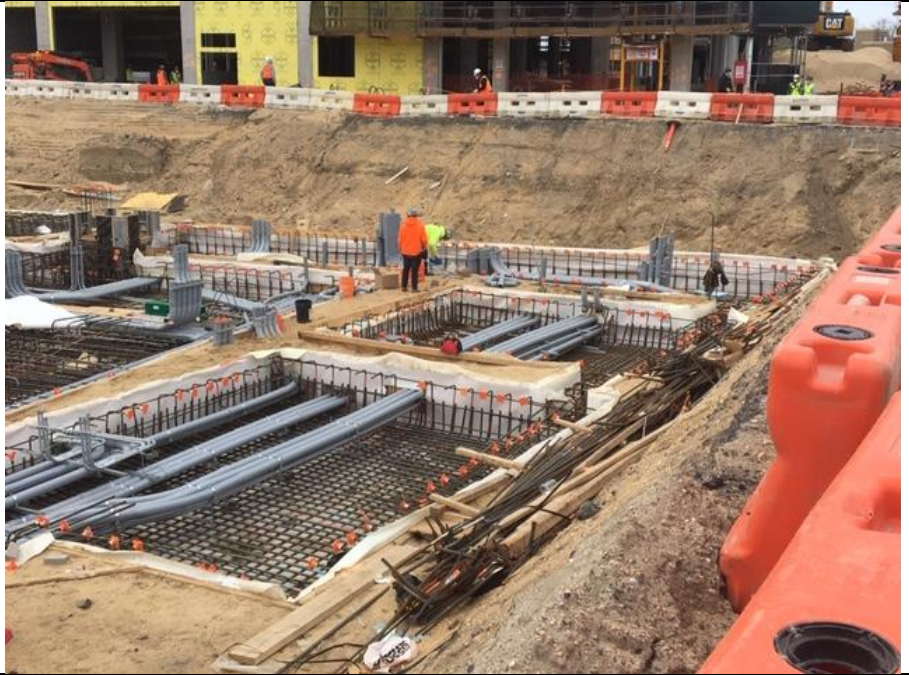
Photo 1- View of utility installation in C5 and C6.

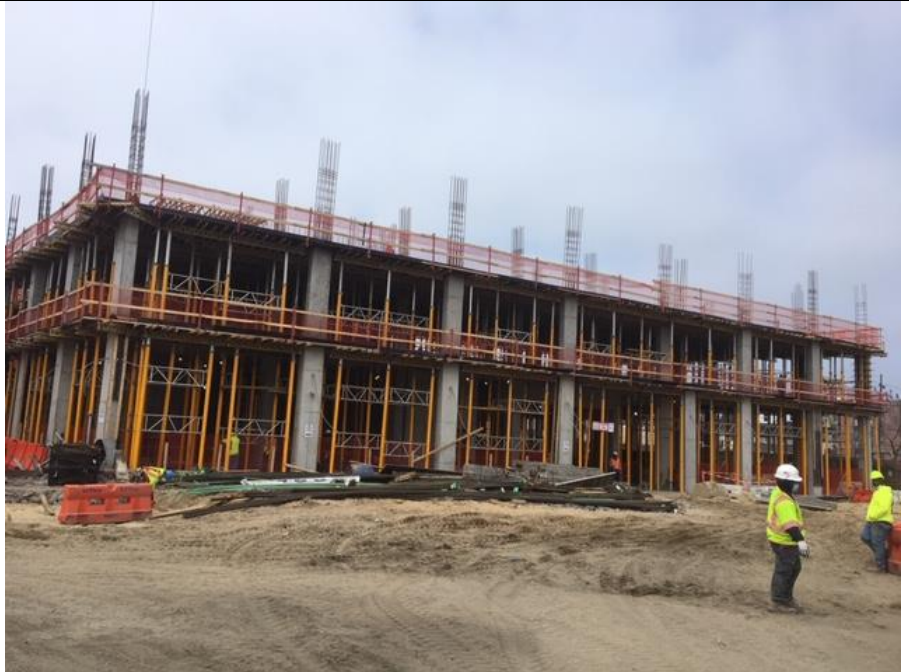
Photo 2- View of utility installation in A3, A4, B3, and B4.

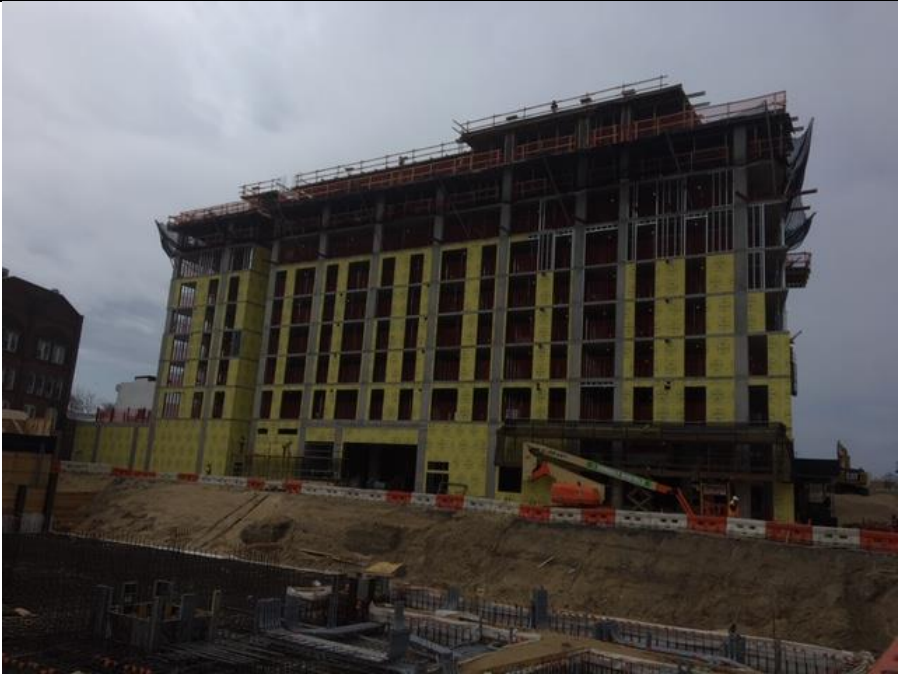
Photo 3- View of utility installation in D3, D4, E3, and E4.

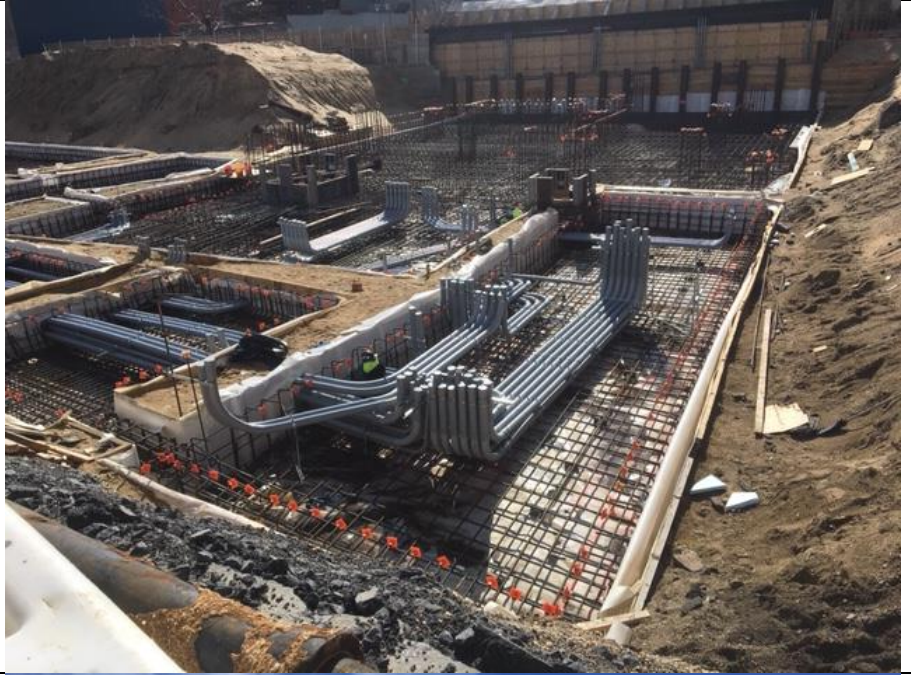
Photo 1- View of Preprufe 200 installation in C5 and C6.
