## **Daily Report for April 1, 2020**

**Far Rockaway Project  
20-02 Mott Avenue  
Far Rockaway, NY  
BCP #C241224**

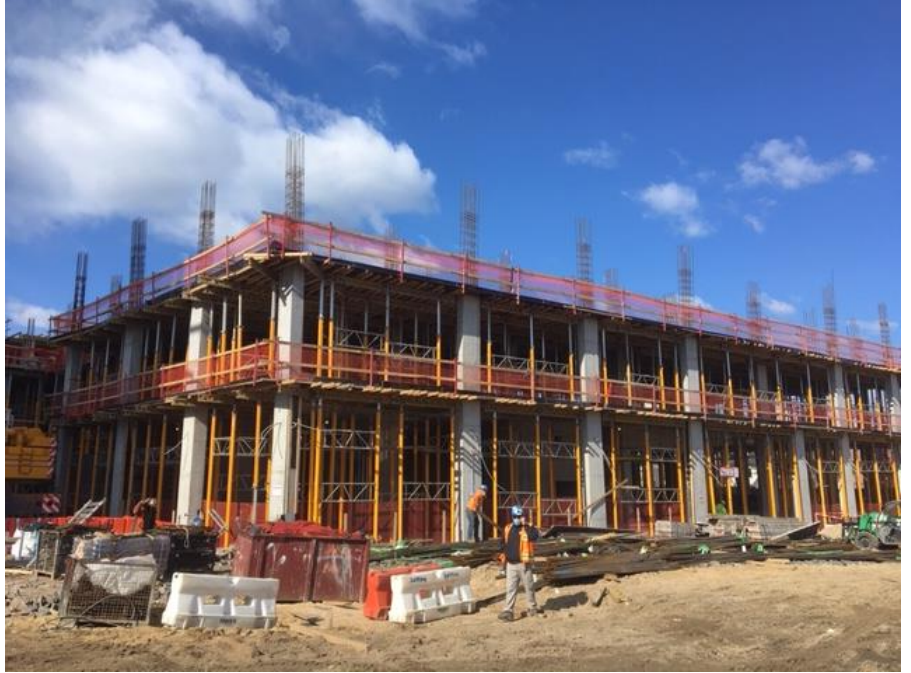
Photo 2- View of utility installation in A3, A4, B3, and B4.

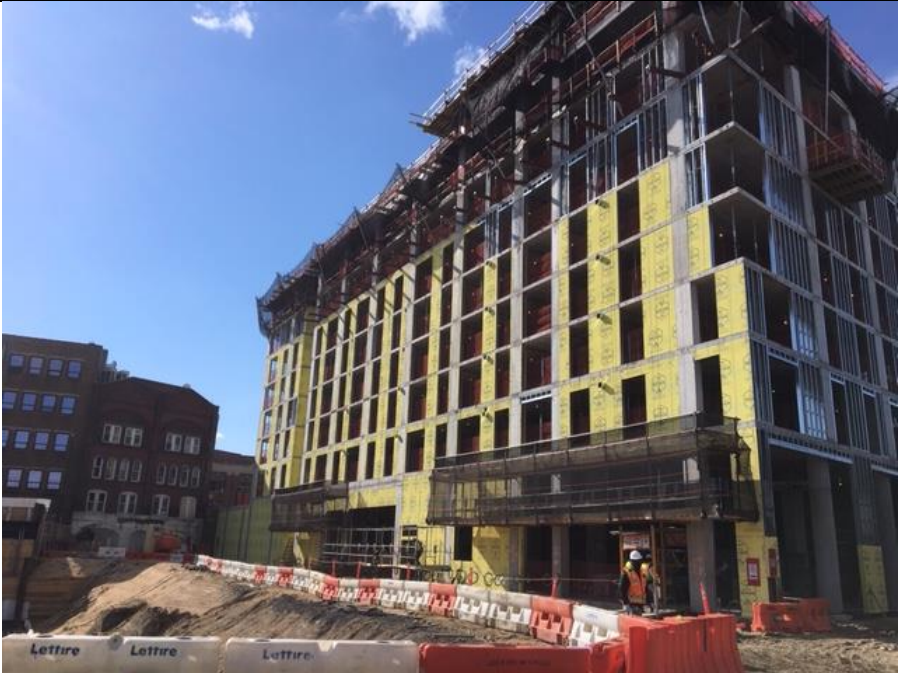
Photo 3- View of utility installation in D3, D4, E3, and E4.

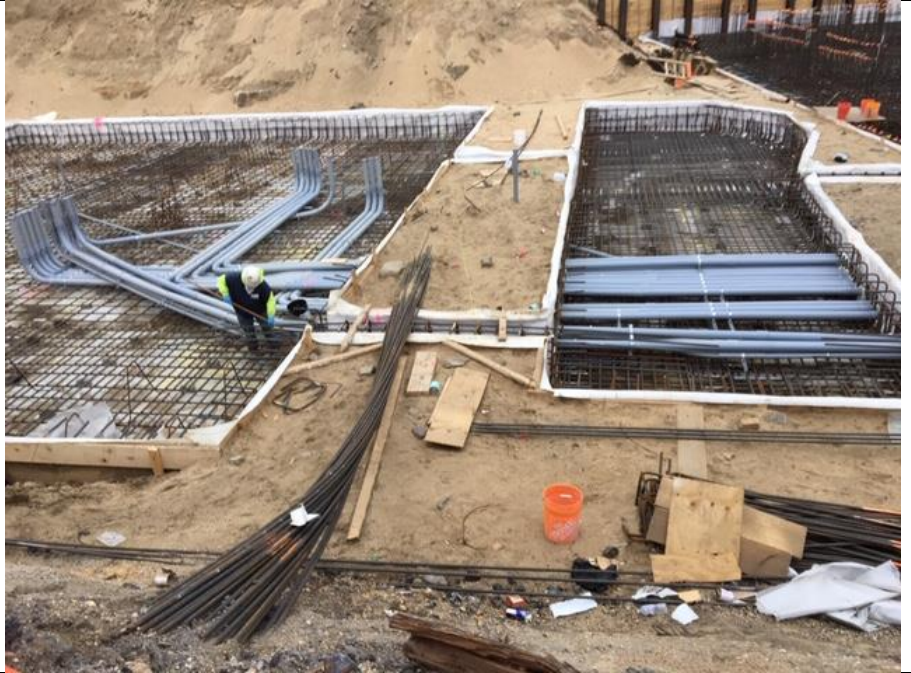
Photo 1- View of Preprufe 200 installation in C5 and C6.

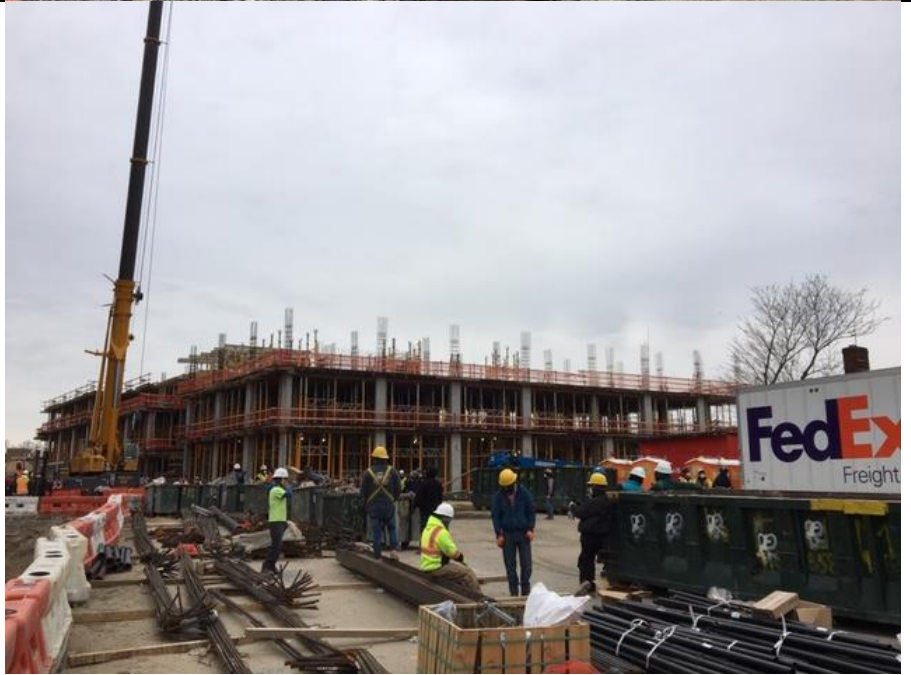
Photo 2- View of utility installation in A3, A4, B3, and B4.

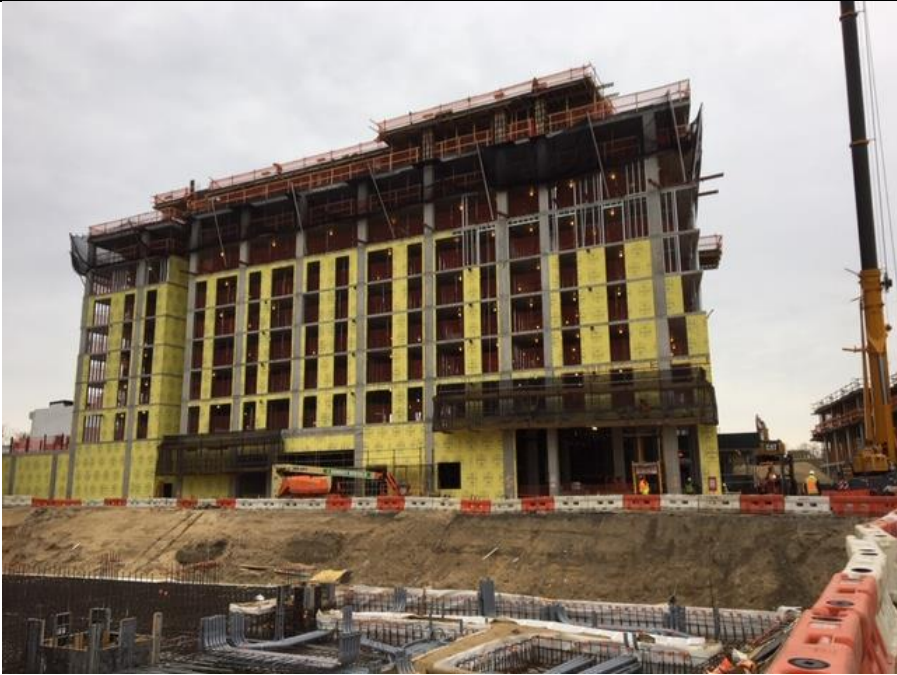
Photo 3- View of utility installation in D3, D4, E3, and E4.

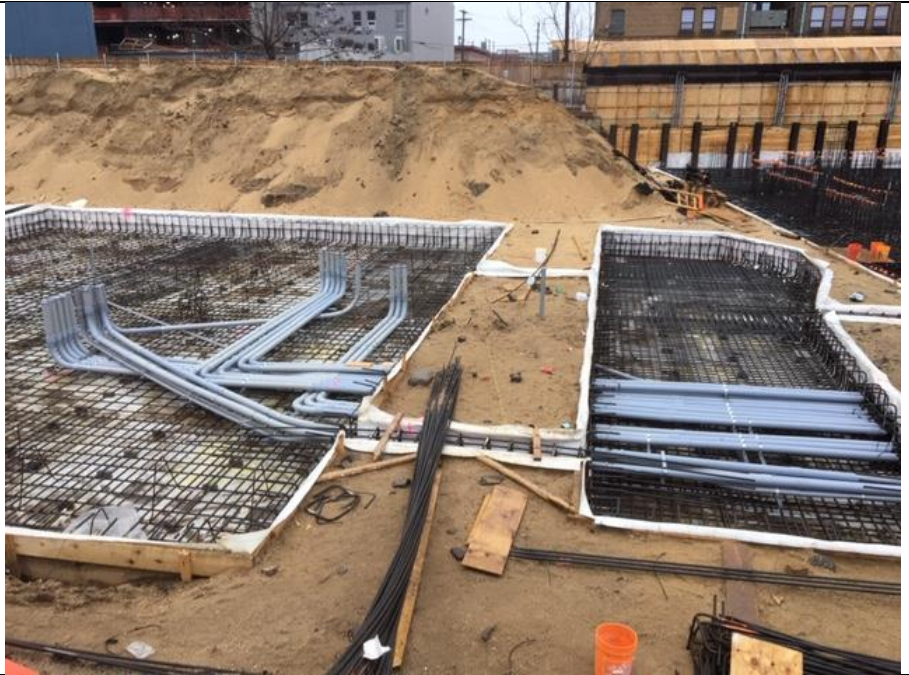
Photo 1- View of utility installation in C5 and C6.

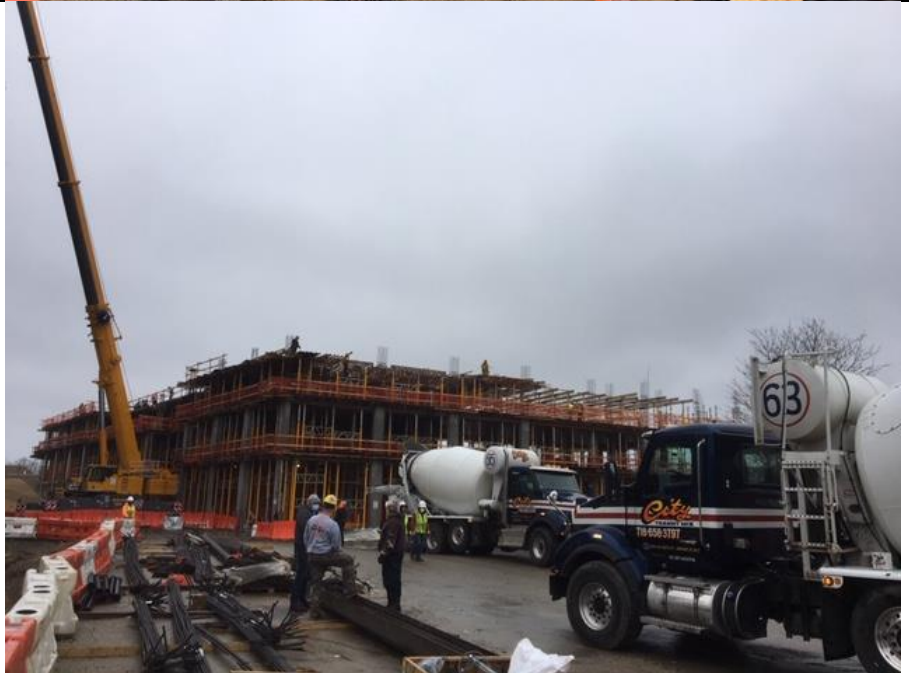
Photo 2- View of utility installation in A3, A4, B3, and B4.

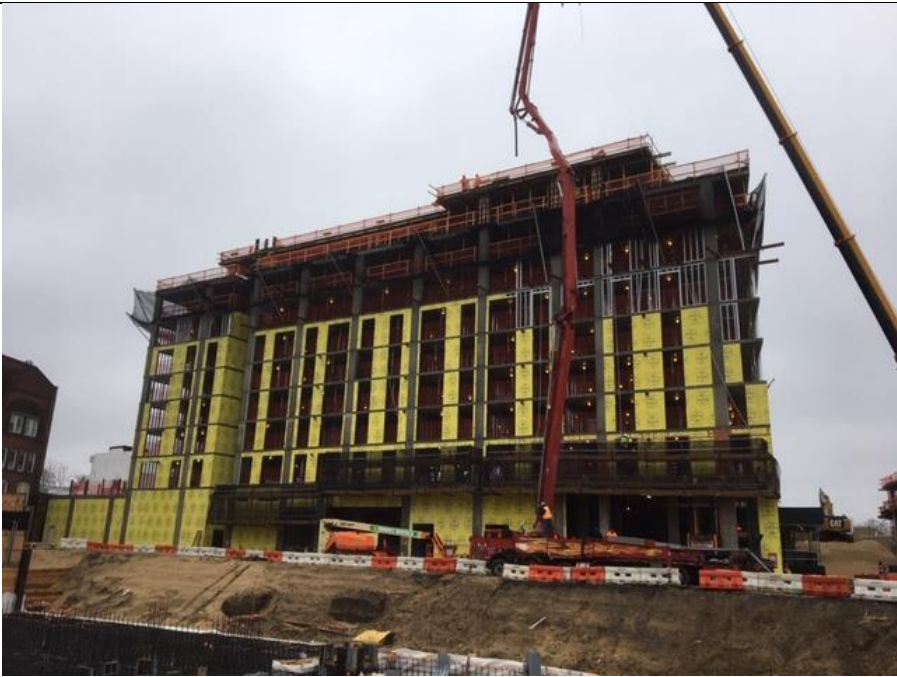
Photo 3- View of utility installation and pouring concrete in D3, D4, E3, and E4.

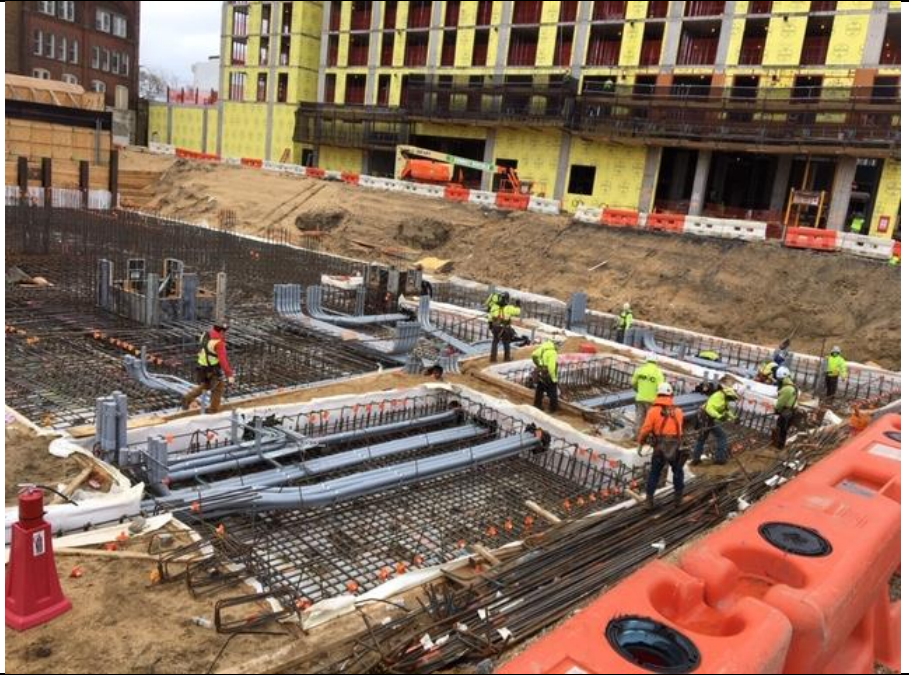
Photo 1- View of utility installation in C5 and C6.

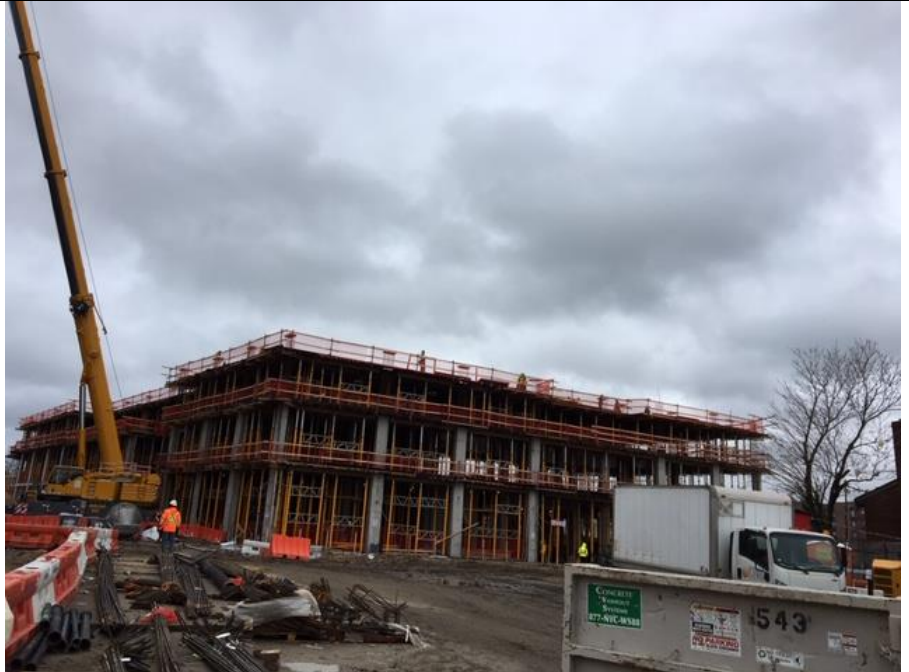
Photo 2- View of rebar, formwork, utility installation in A3, A4, B3, and B4.

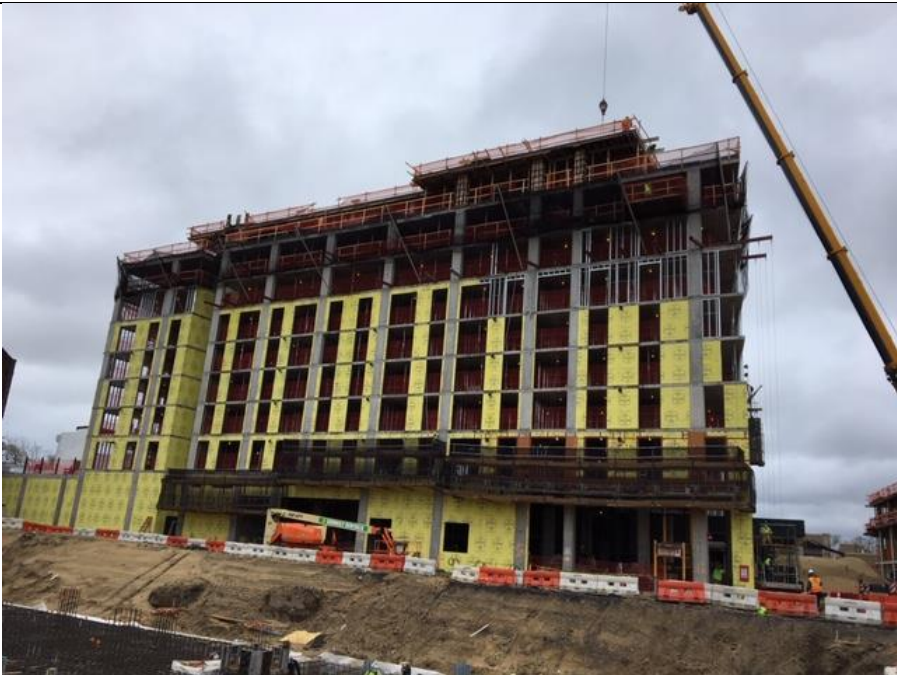
Photo 3- View of rebar, formwork, and utility installation in D3, D4, E3, and E4.

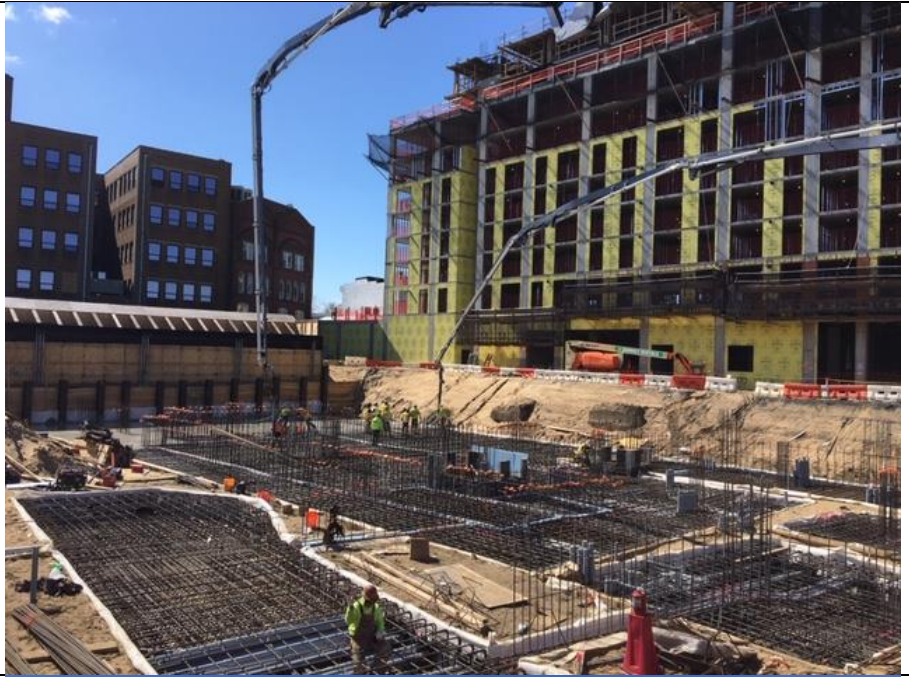
Photo 1- View of pouring concrete in C5, C6, D5, and D6.

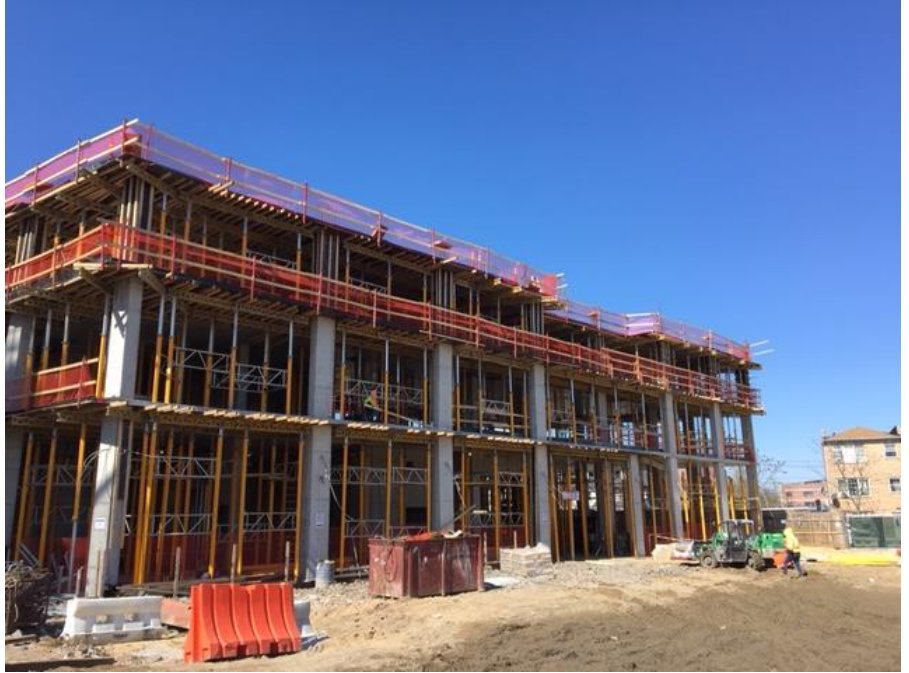
Photo 2- View of rebar, formwork, utility installation in A3, A4, B3, and B4.

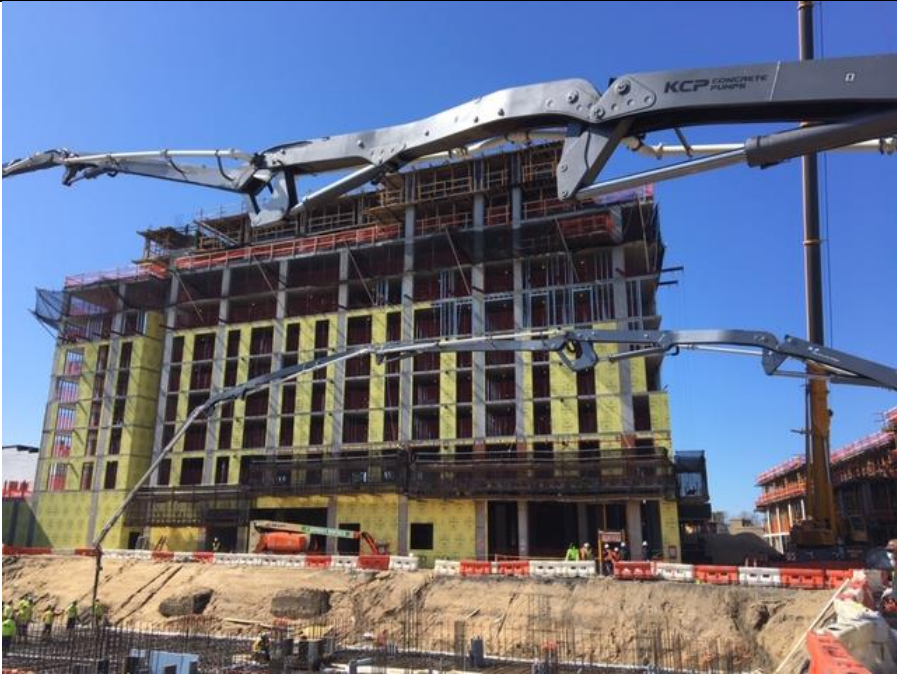
Photo 3- View of rebar, formwork, and utility installation in D3, D4, E3, and E4.

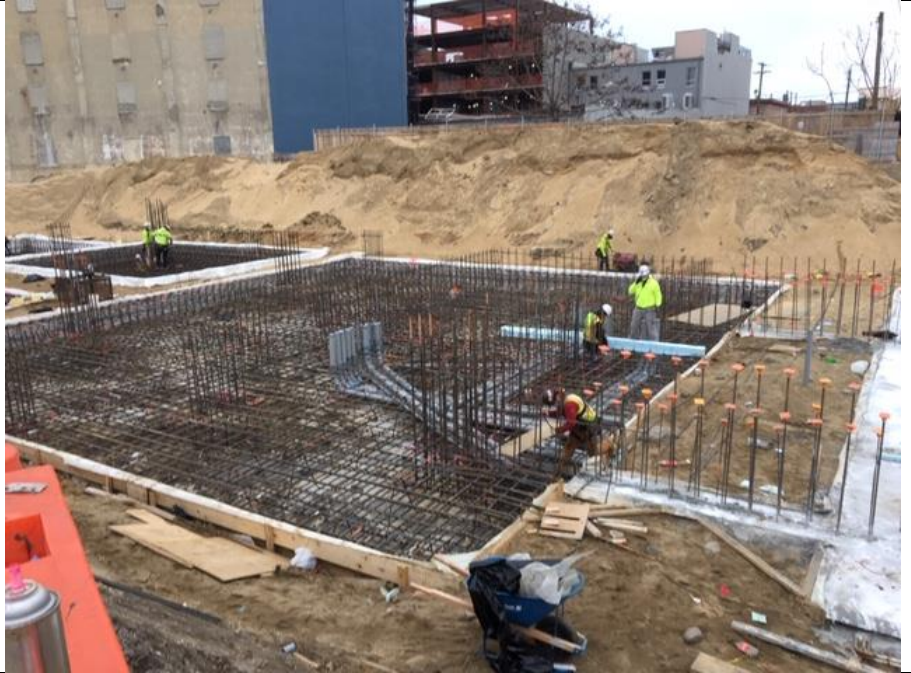
Photo 1- View of rebar and utility installation in C6 and C7.

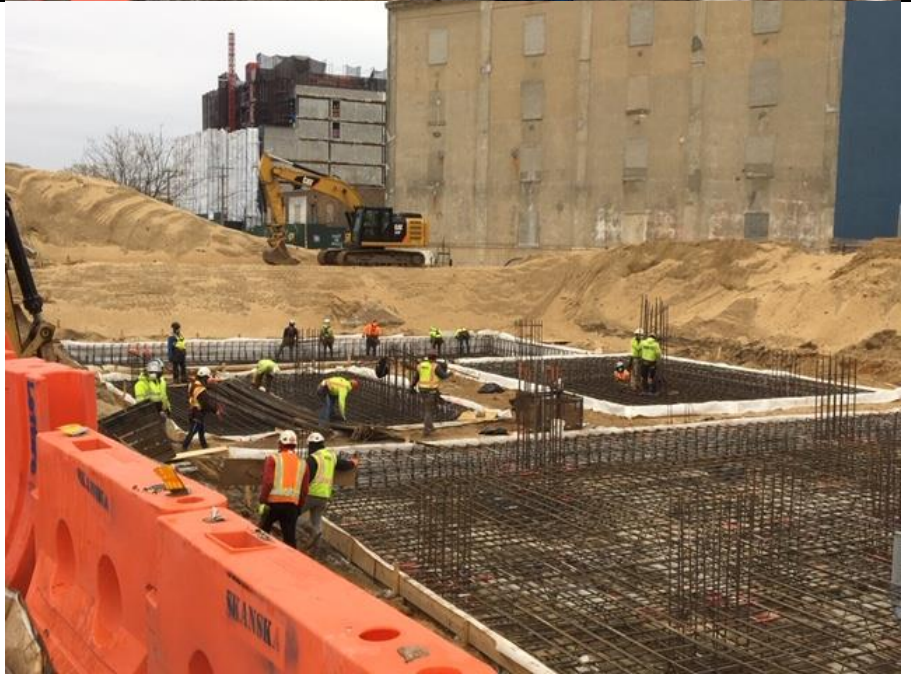
Photo 2- View of rebar installation in C6-C8.

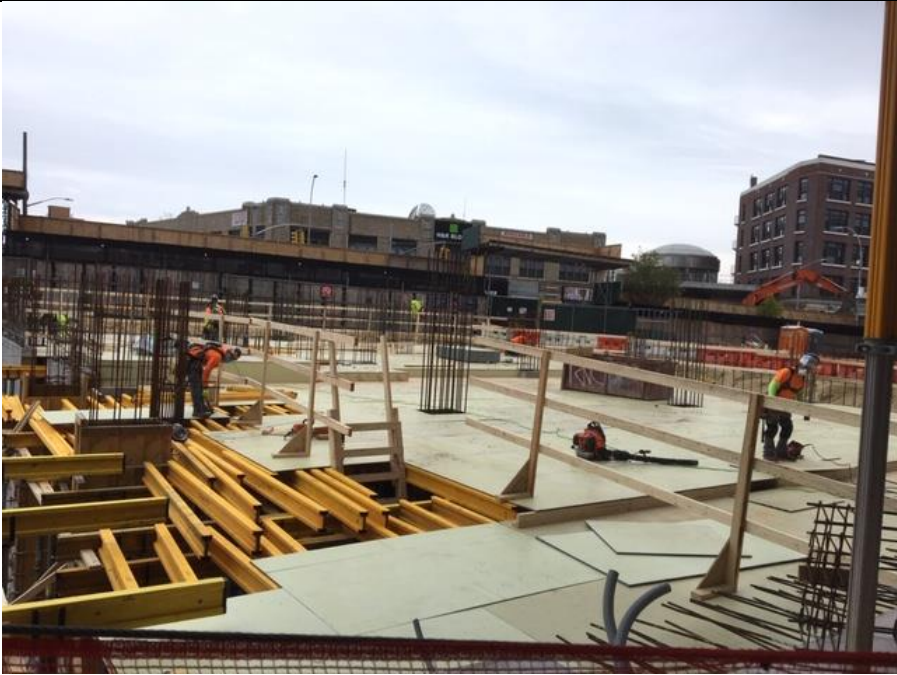
Photo 3- View of formwork and rebar installation in D1.

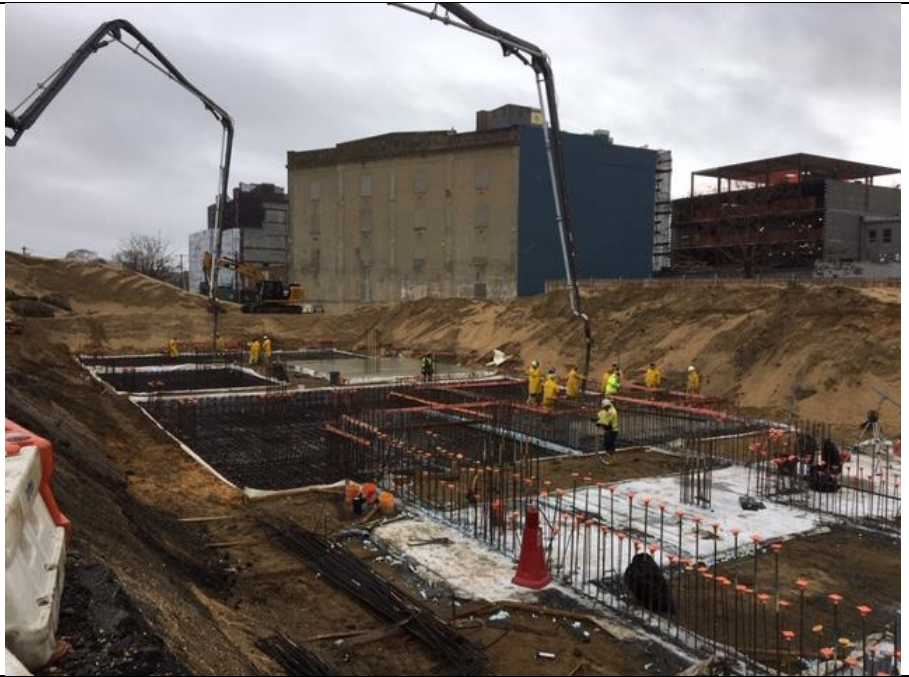
Photo 1- View of pouring concrete in C6-C8.

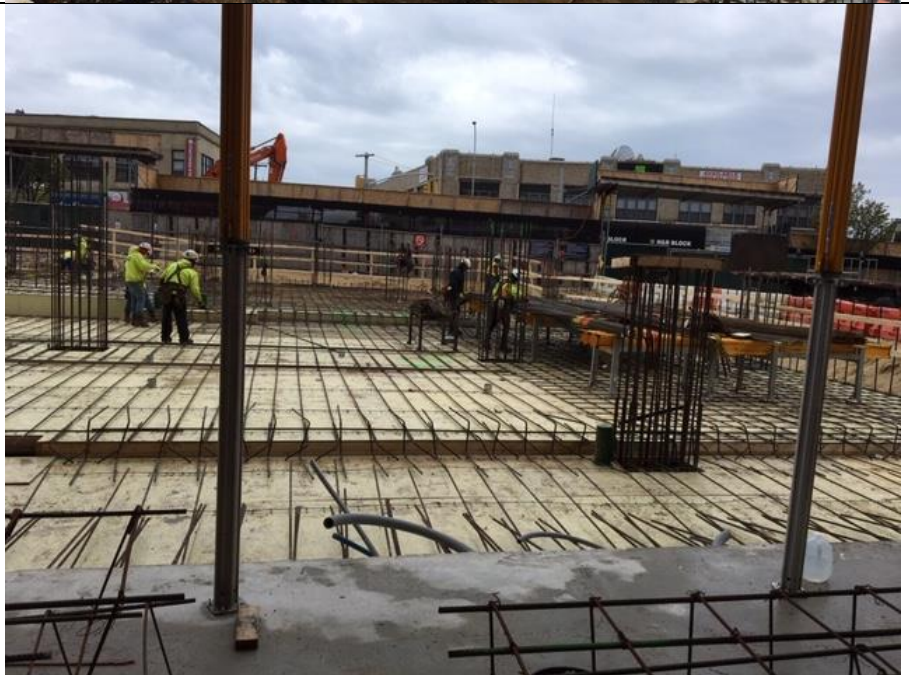
Photo 2- View of rebar and formwork installation in D1.
