Daily Report for July 1, 2020

Far Rockaway Project 20-02 Mott Avenue Far Rockaway, NY BCP #C241224

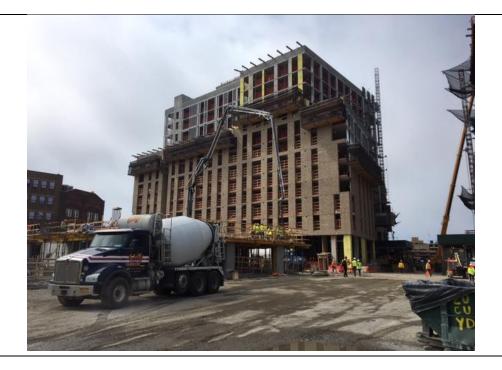
Photo 1- View of pouring concrete, rebar, utility, and formwork installation in C7 and C8.	
Photo 2- View of rebar, utility, and formwork installation in A3, A4, B3, and B4.

Photo 3- View of pouring concrete in C5 and C6, and rebar, utility, and formwork installation in D3, D4, E3, and E4.
