Daily Report for August 3, 2020

**Far Rockaway Project
20-02 Mott Avenue
Far Rockaway, NY
BCP #C241224**

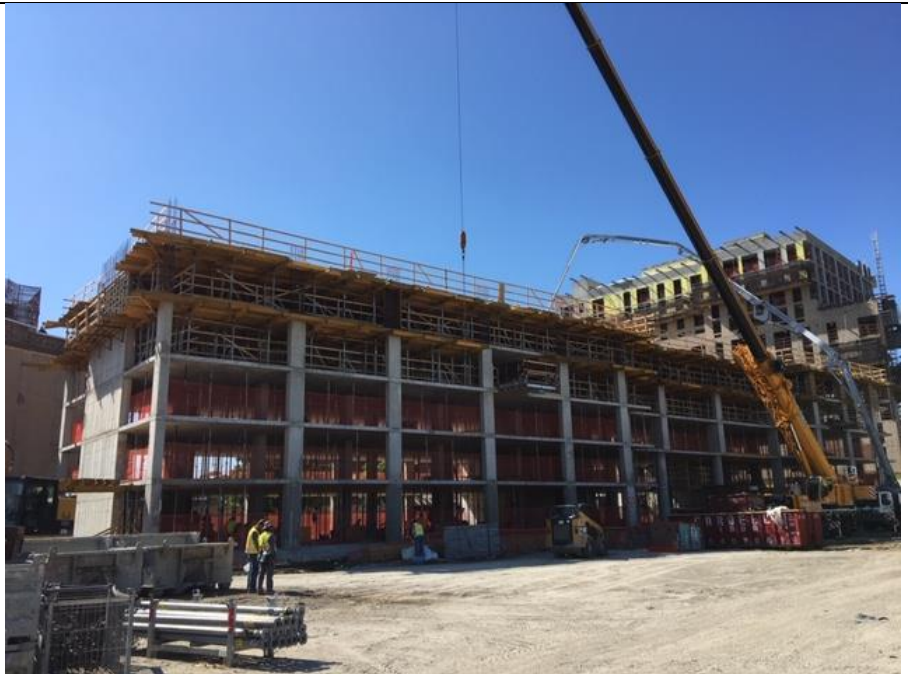
Photo 1- View of pouring concrete, rebar, utility, and formwork in C6-C8.

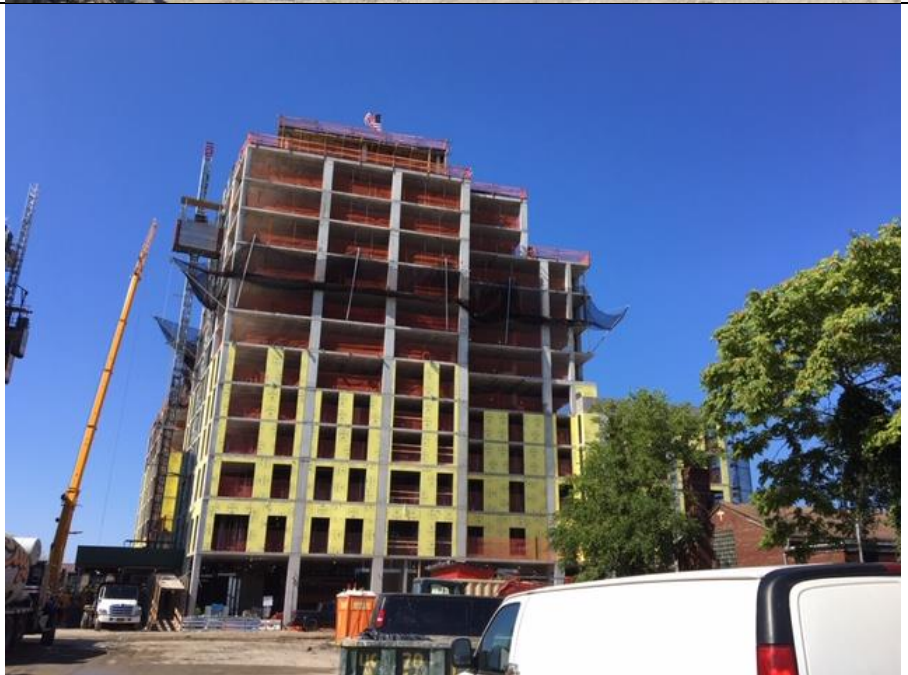
Photo 2- View of pouring concrete, rebar, utility, and formwork installation in A3, A4, B3, and B4.

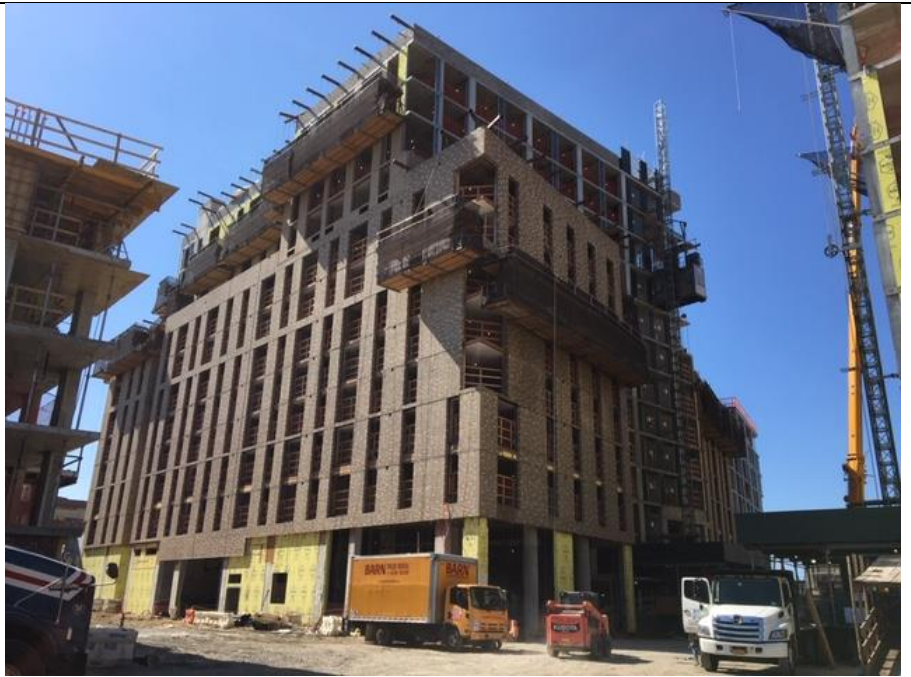
Photo 3- View of rebar, utility, and formwork in D3, D4, E3, and E4.

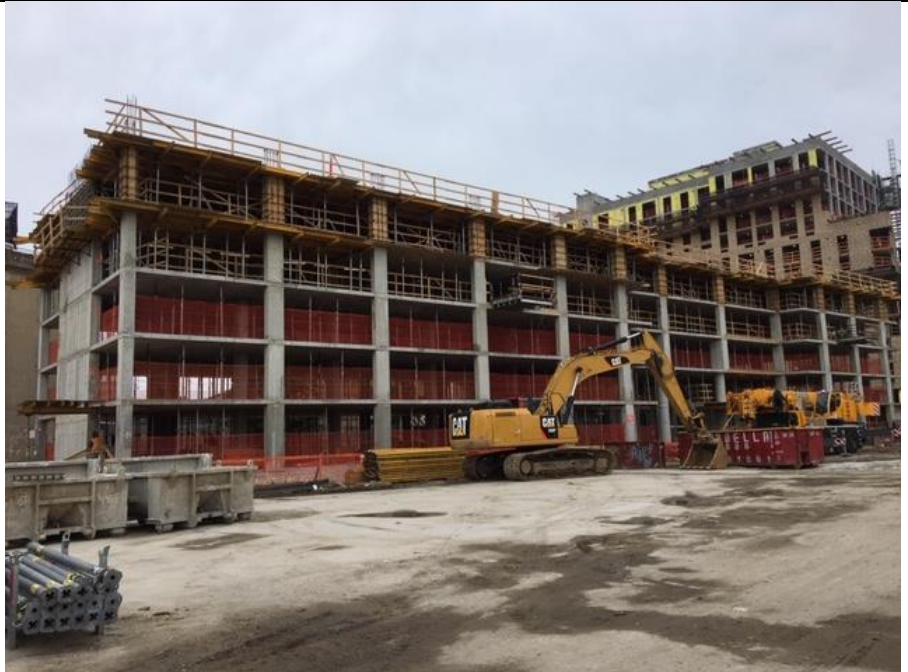
Photo 1- View of pouring concrete, rebar, utility, and formwork in C6-C8.

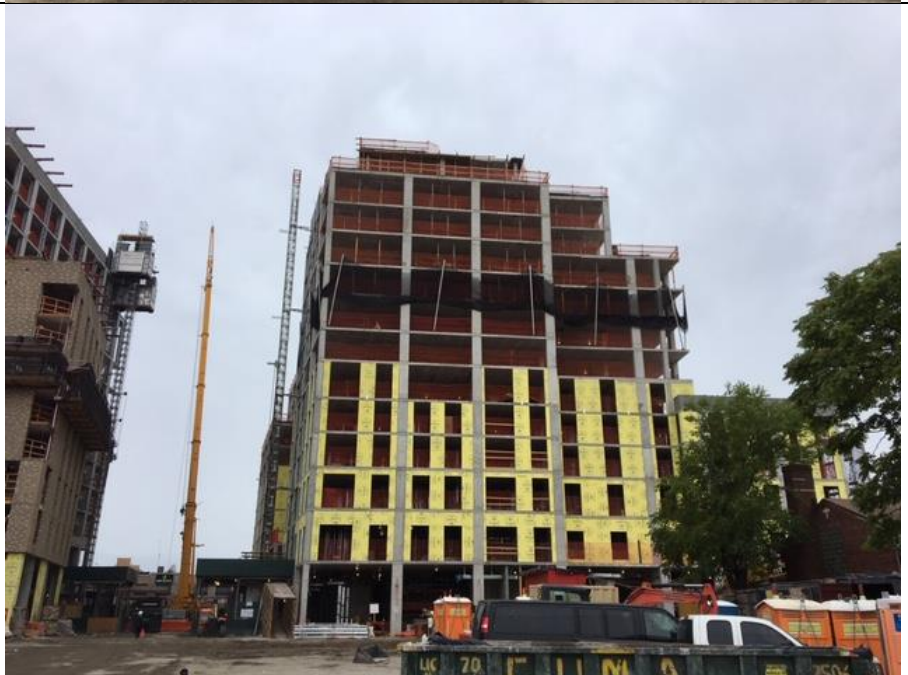
Photo 2- View of rebar, utility, and formwork installation in A3, A4, B3, and B4.

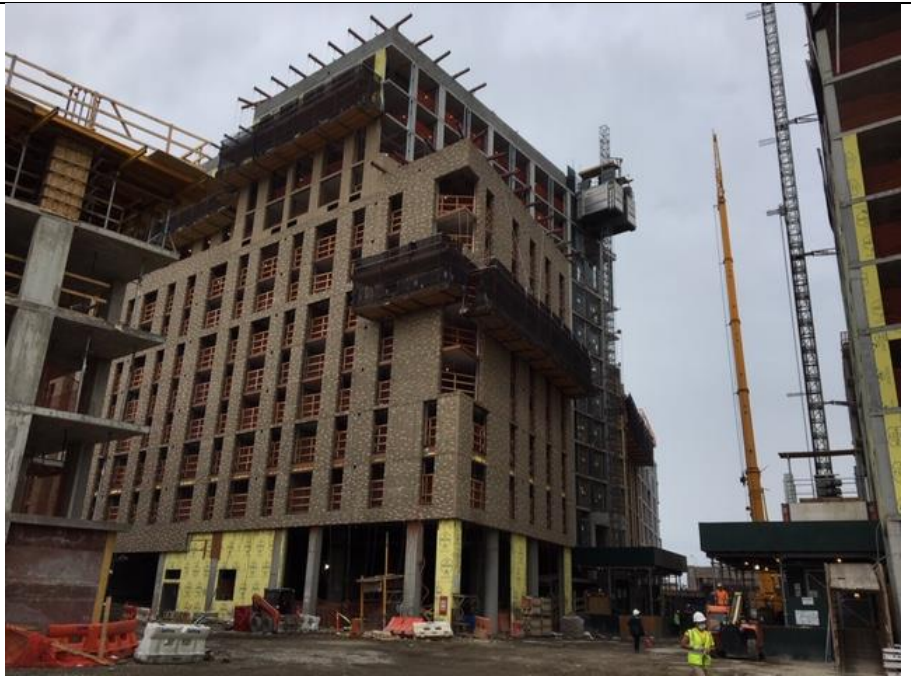
Photo 3- View of rebar, utility, and formwork in D3, D4, E3, and E4.

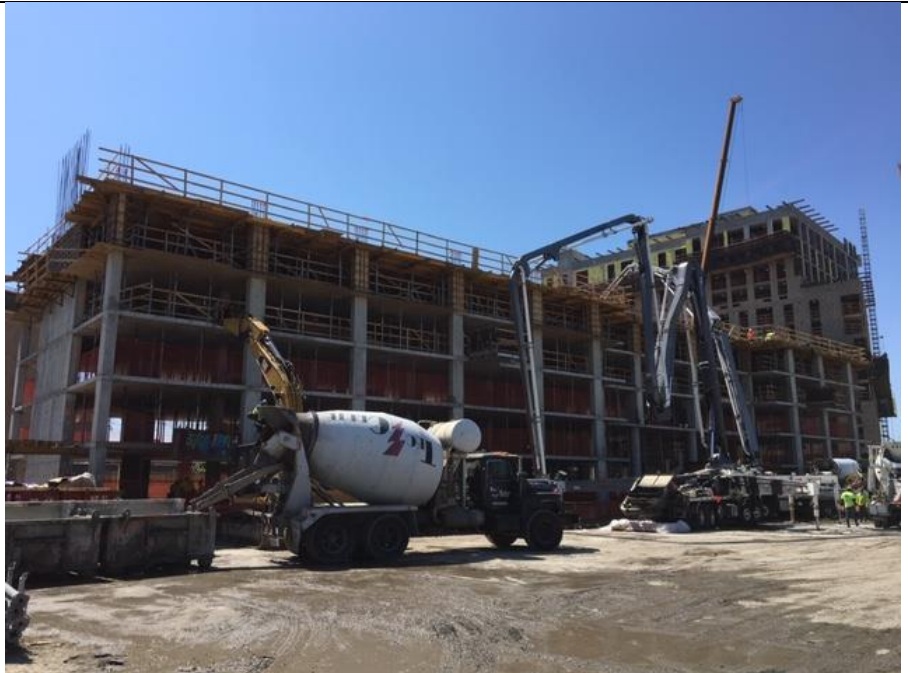
Photo 1- View of pouring concrete, rebar, utility, and formwork in C6-C8.

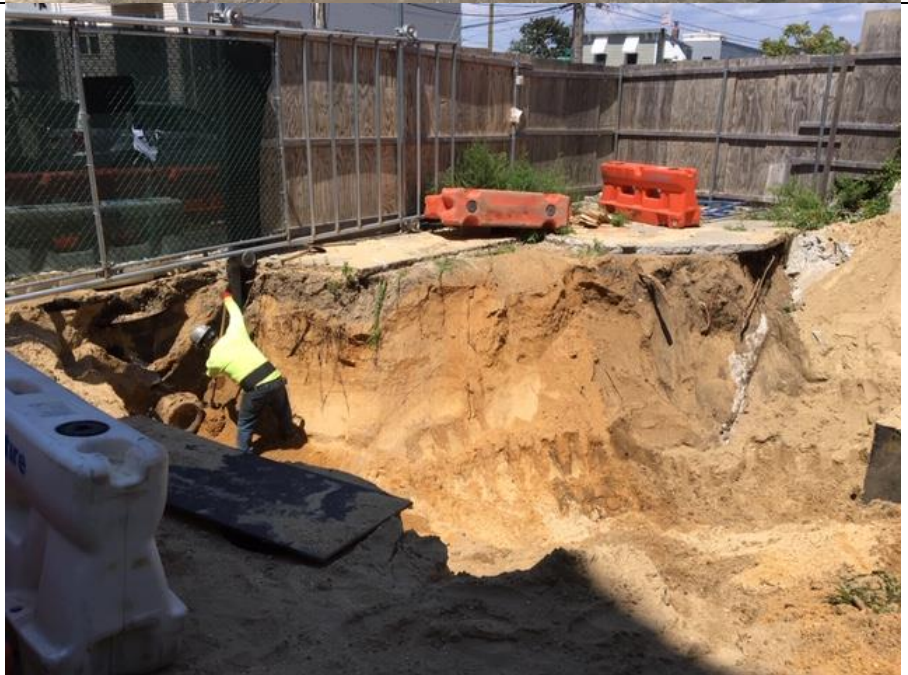
Photo 2- View of excavated area in A5 for utility installation.

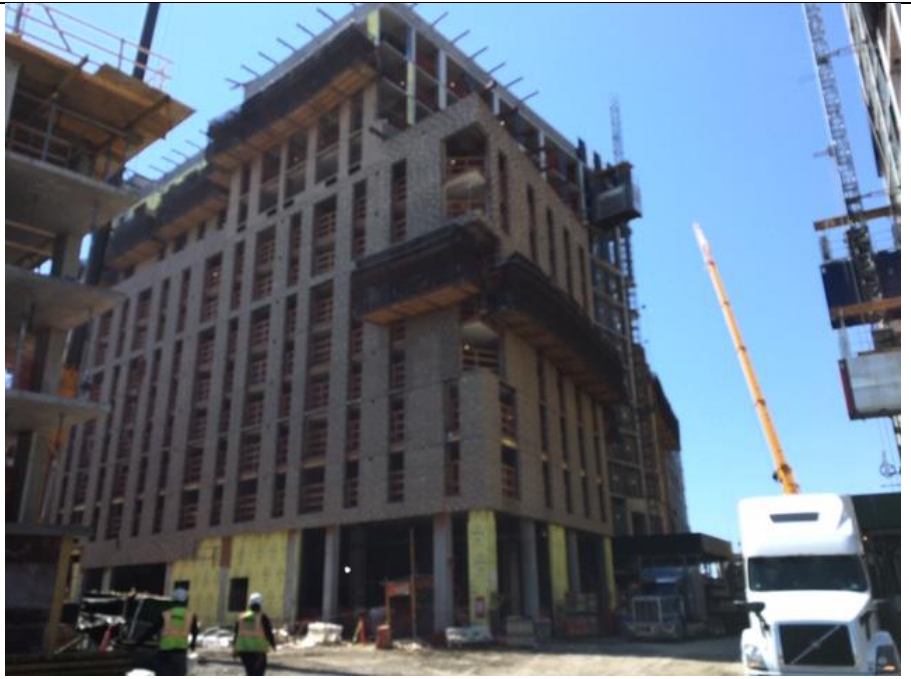
Photo 3- View of rebar, utility, and formwork in D3, D4, E3, and E4.

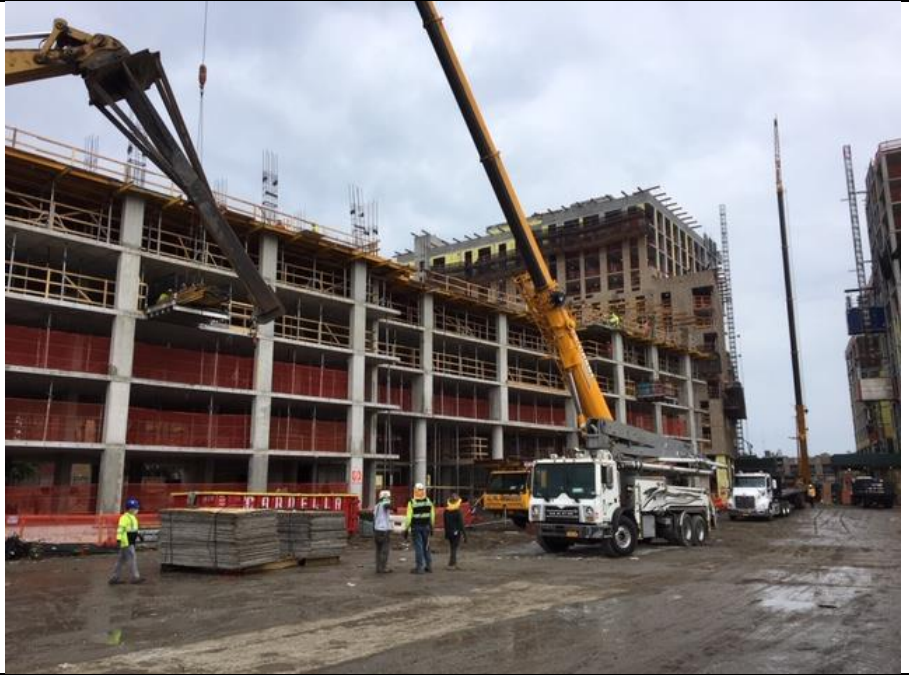
Photo 1- View of rebar, utility, and formwork in C6-C8.

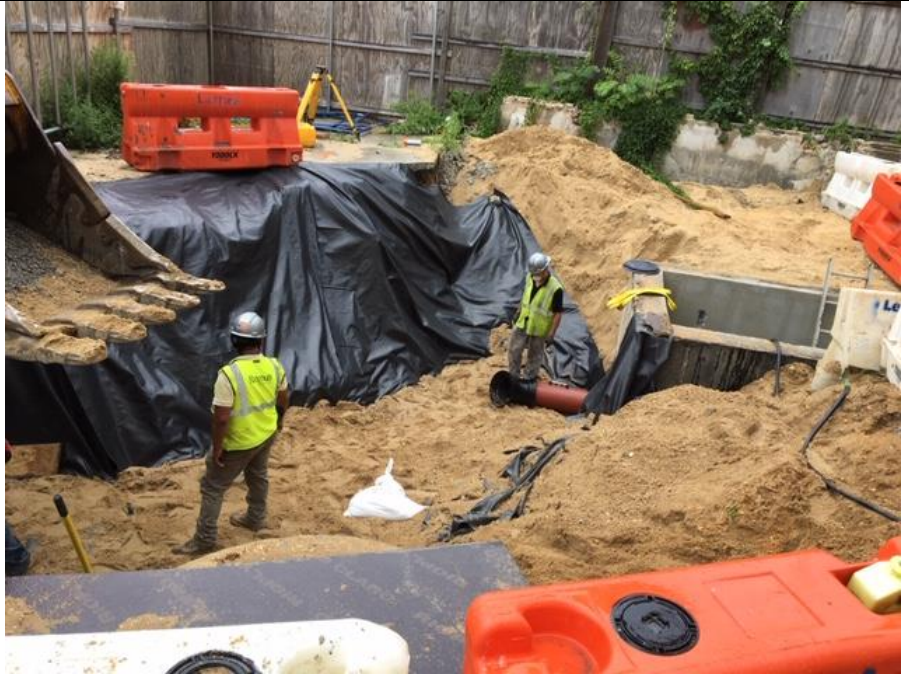
Photo 2- View of excavated area in A5 for utility installation.

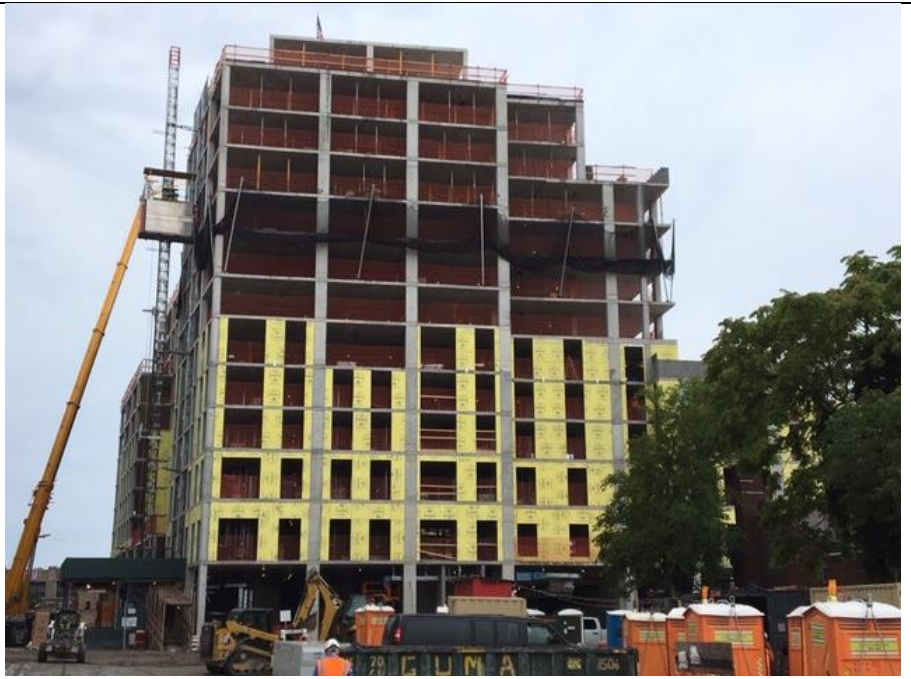
Photo 3- View of rebar, utility, and formwork in D3, D4, E3, and E4.

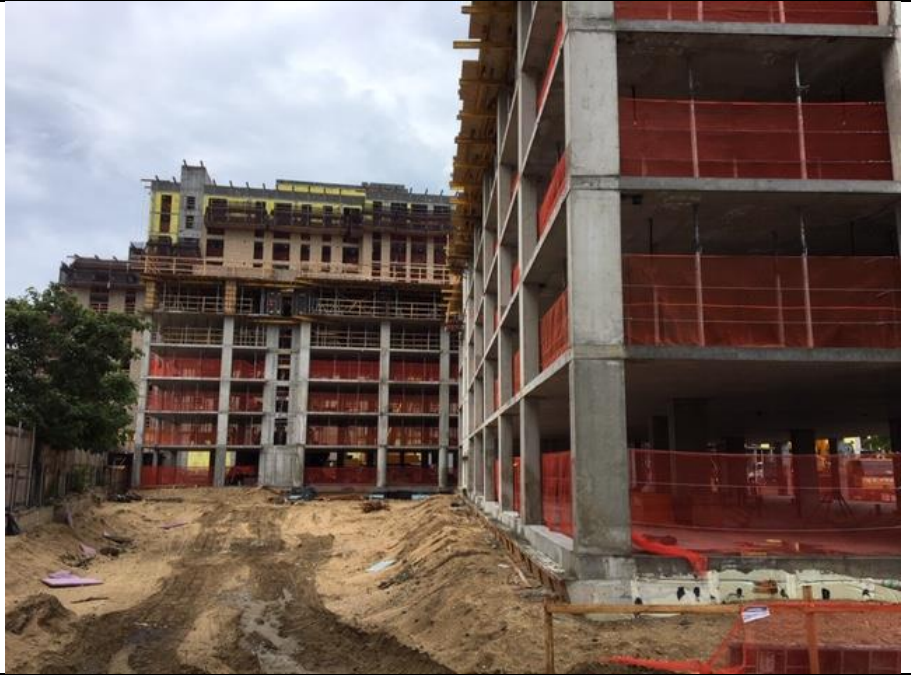
Photo 1- View of rebar, utility, and formwork in C5-C8, and D5.

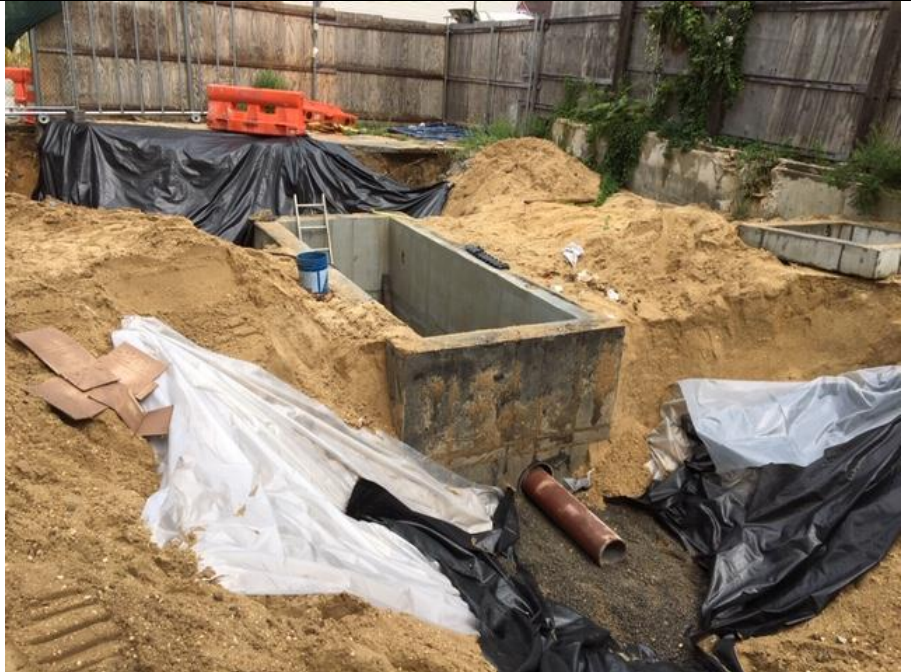
Photo 2- View of excavated area in A5 for utility installation.

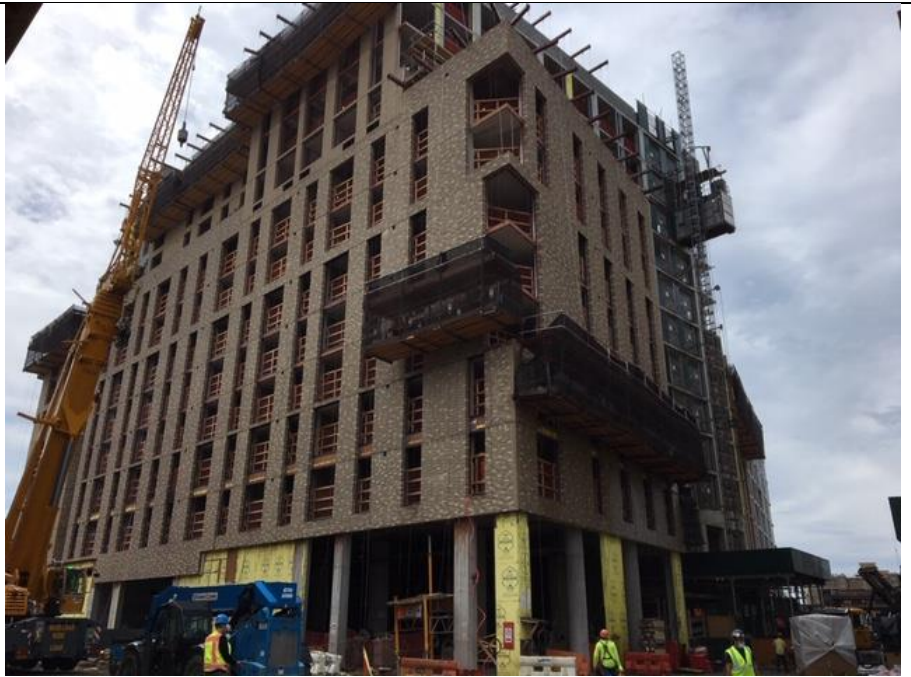
Photo 3- View of rebar, utility, and formwork in D3, D4, E3, and E4.

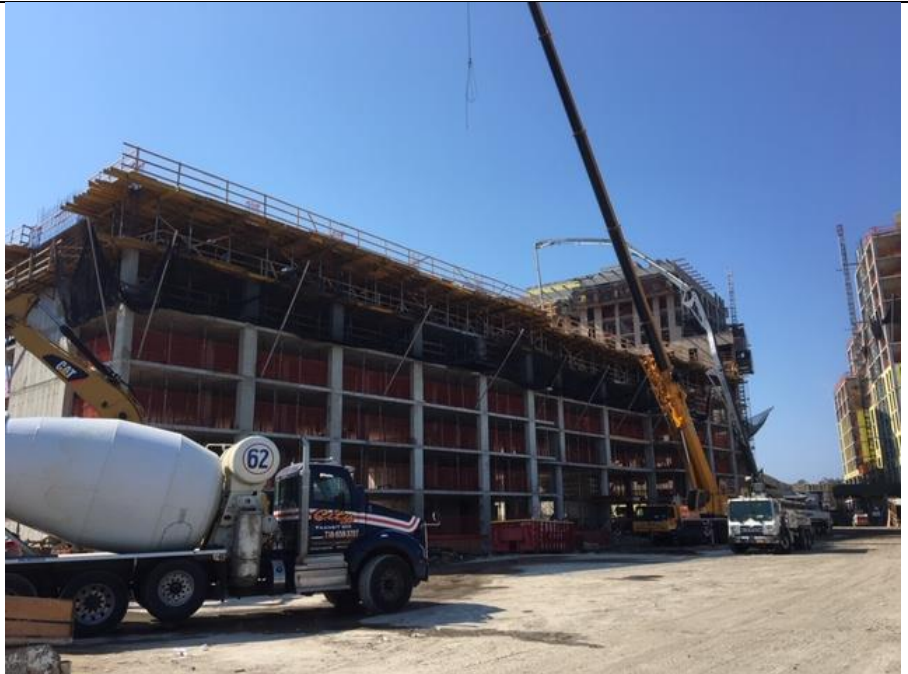
Photo 1- View of rebar, utility, and formwork in C5-C8, and D5.

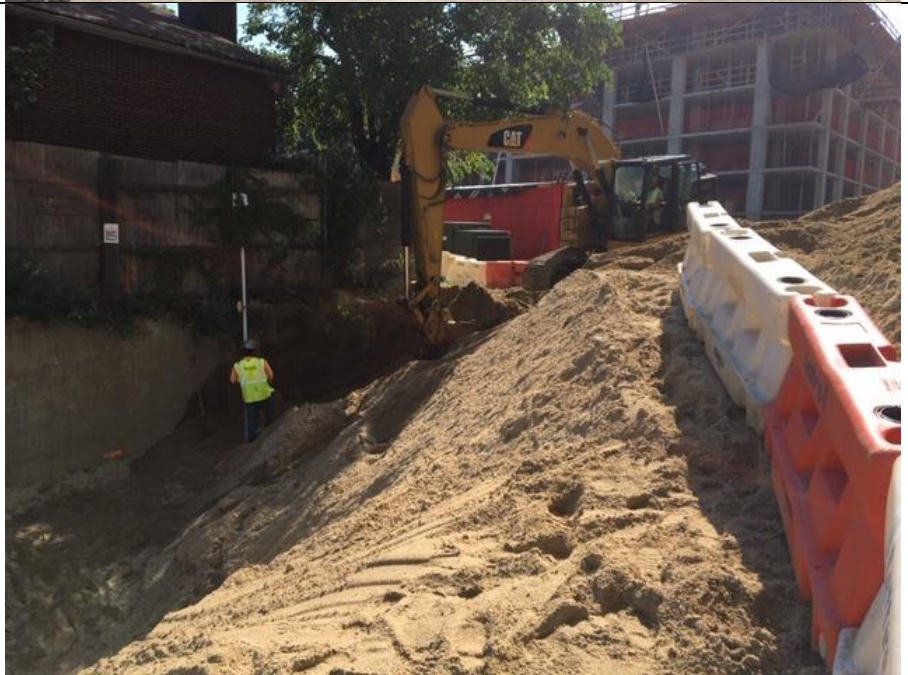
Photo 2- View of excavated area in A5 for utility installation.

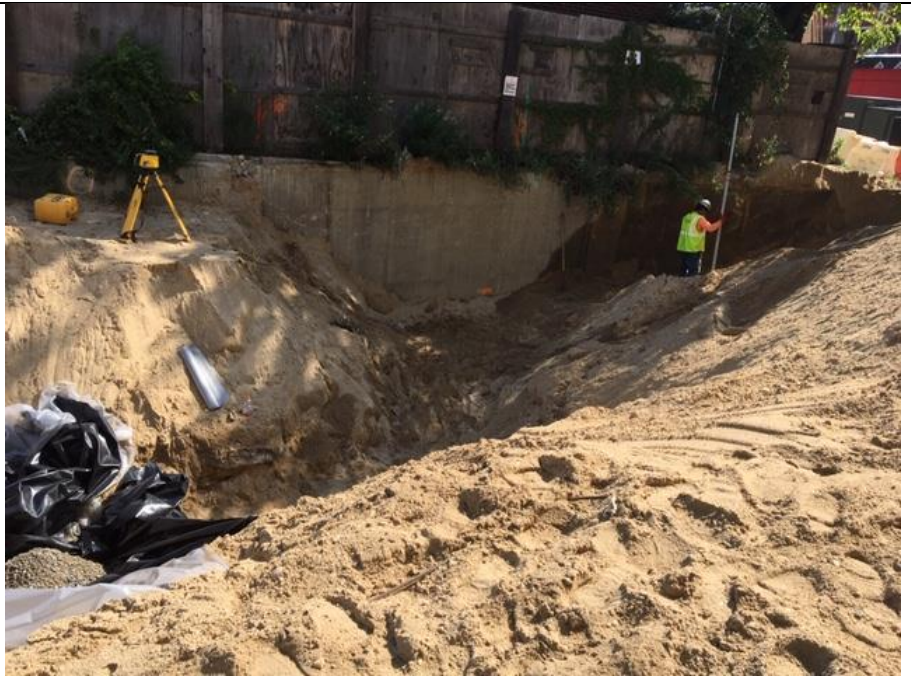
Photo 3- View of excavated area in A5 for utility installation.

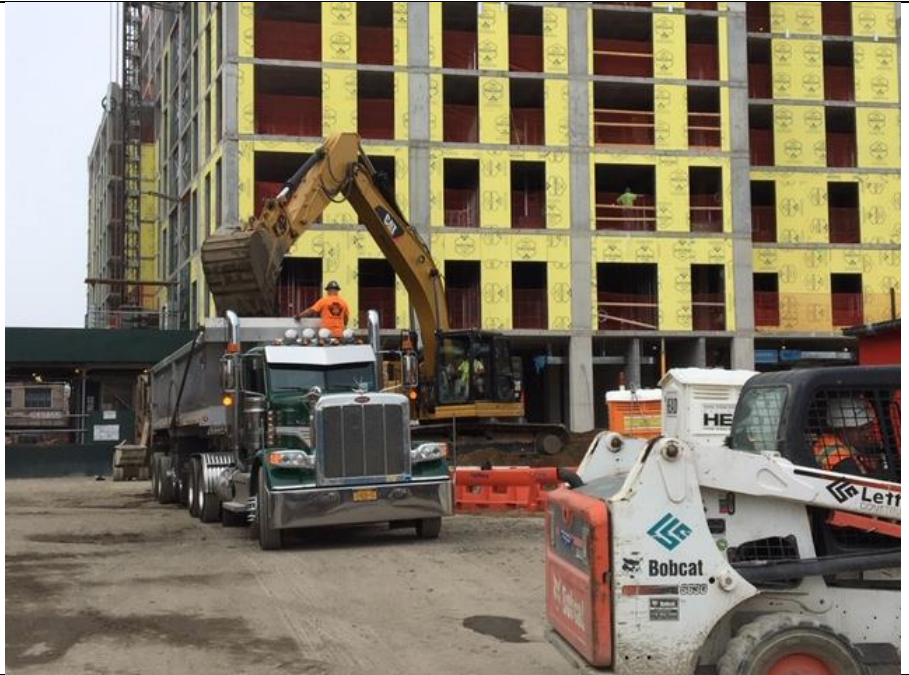
Photo 1- View of loading out of non-hazardous soil in B5.

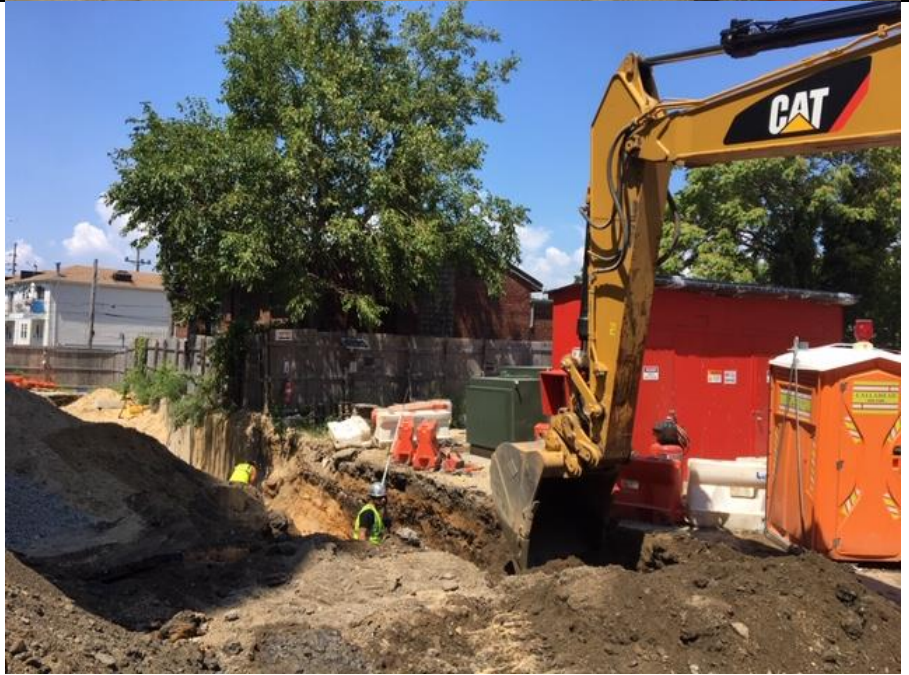
Photo 2- View of excavated area in A5 for utility installation.

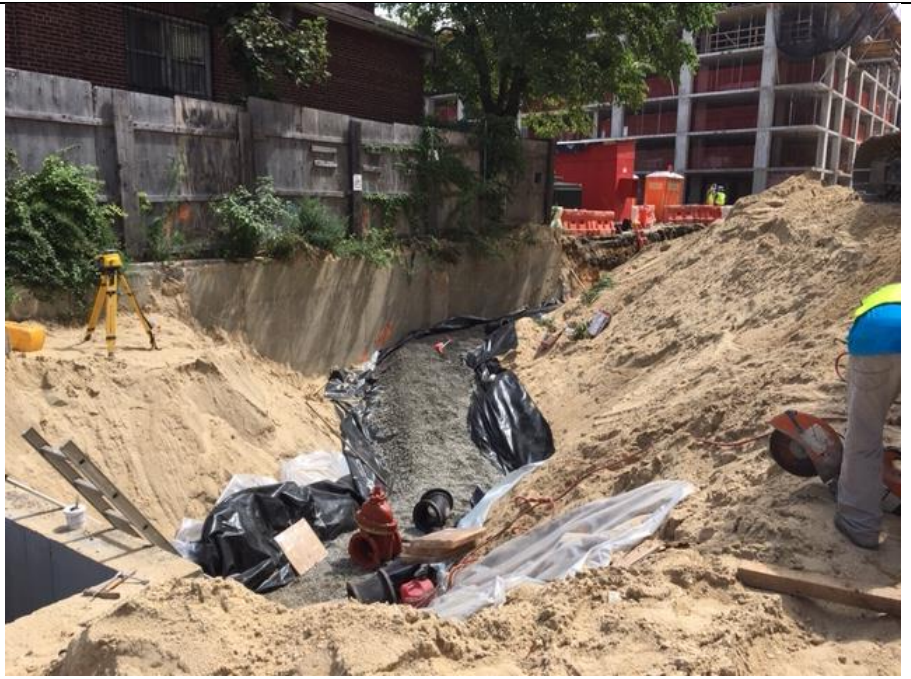
Photo 3- View of installed filter fabric and stone in A5 and B5 for utilities.

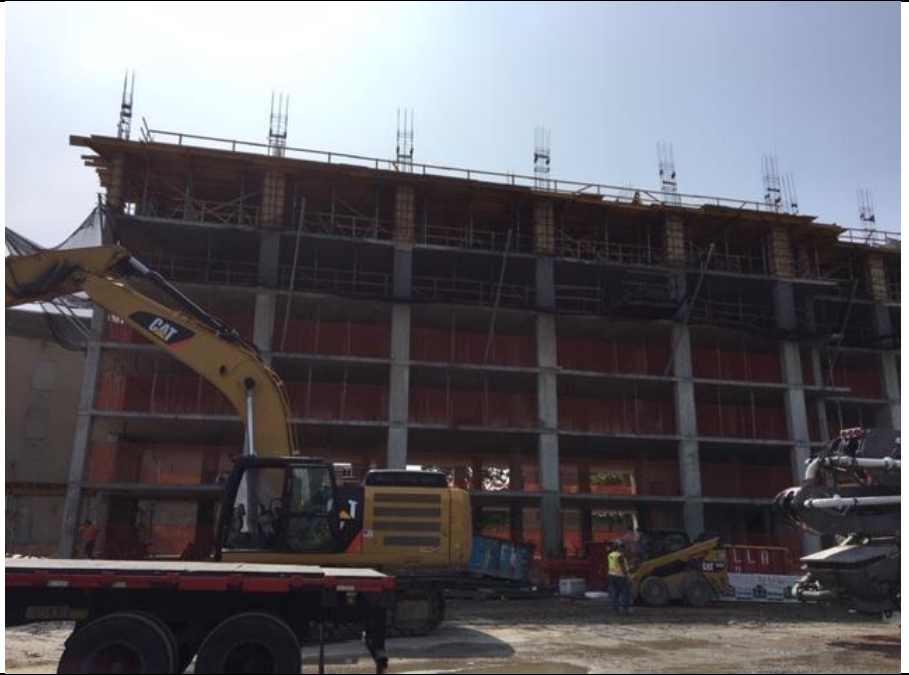
Photo 1- View of rebar, utility, and formwork in C6-C8.

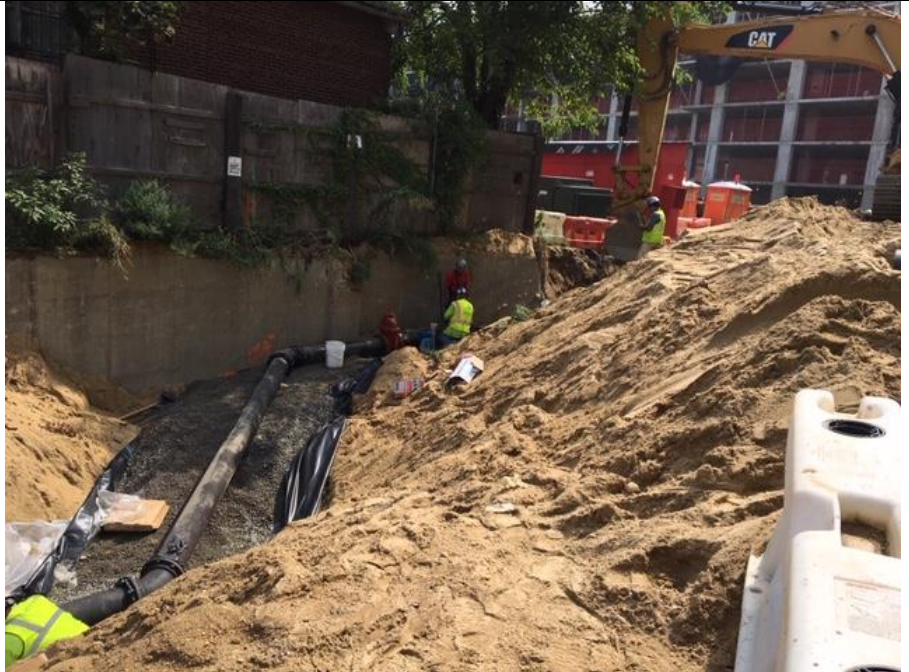
Photo 2- View of excavated area in A5 for utility installation.

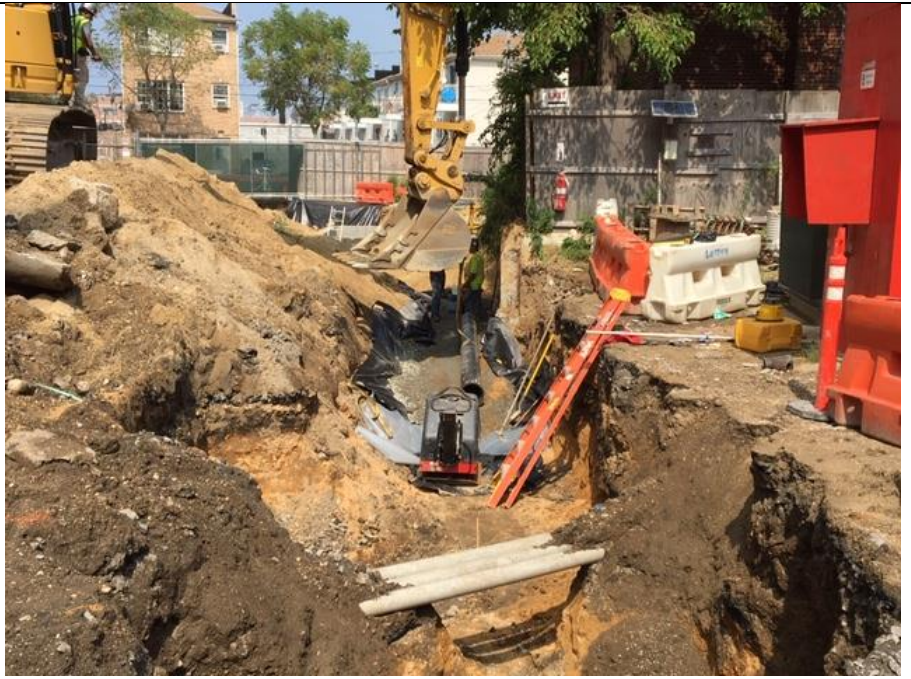
Photo 3- View of installed filter fabric and stone in A5 and B5 for utilities.

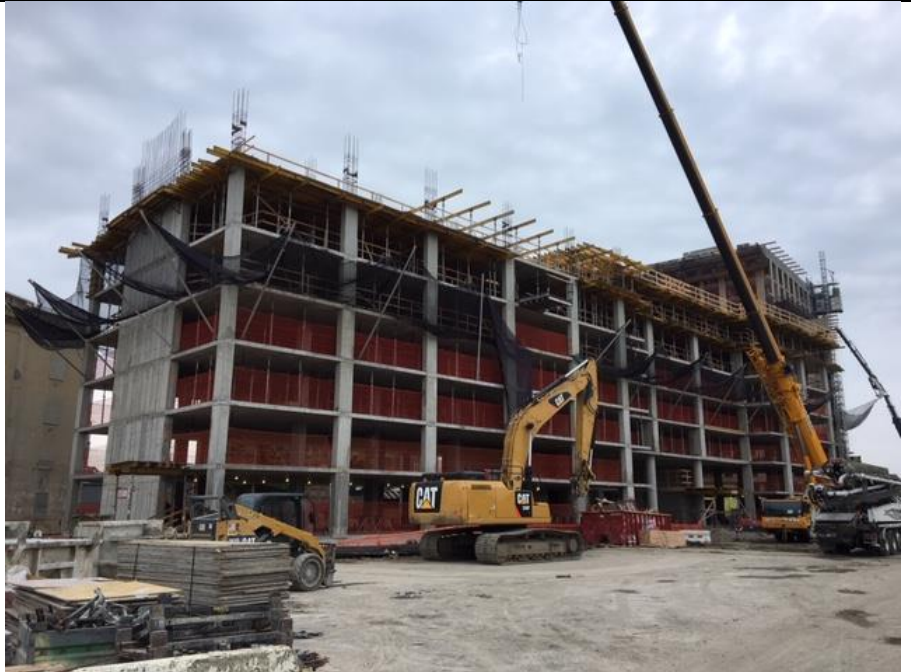
Photo 1- View of rebar, utility, and formwork in C6-C8.

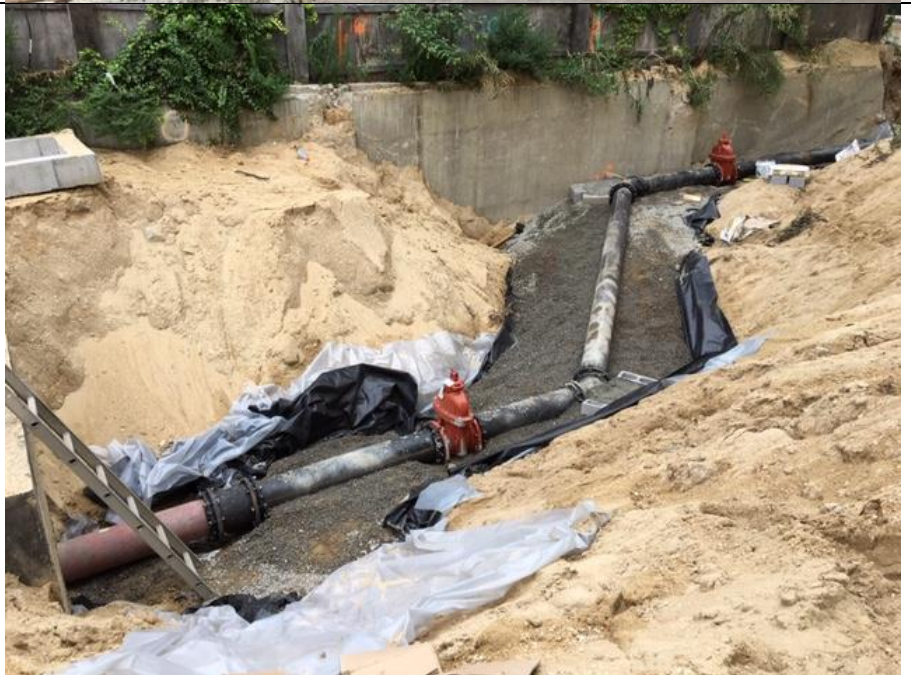
Photo 2- View of utility installation in A5.

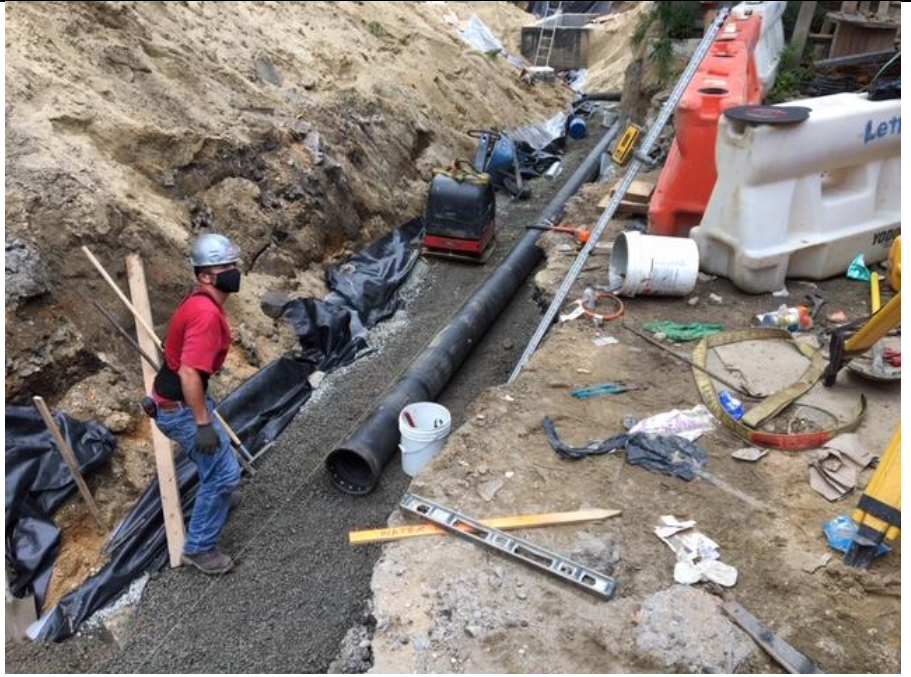
Photo 3- View
of utility
installation in
B5.

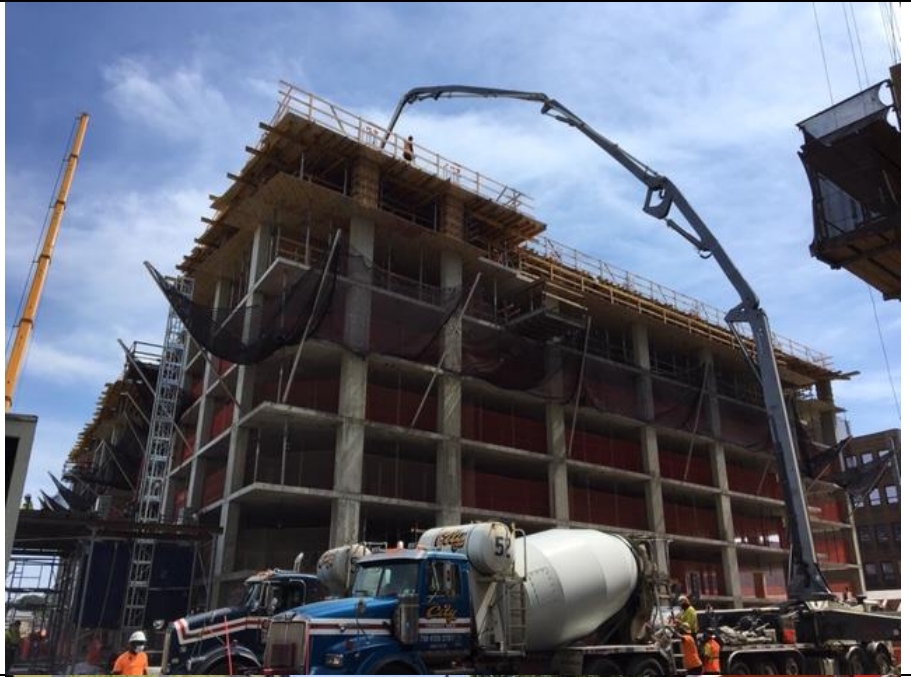
Photo 1- View of rebar, utility, and formwork in C6-C8.

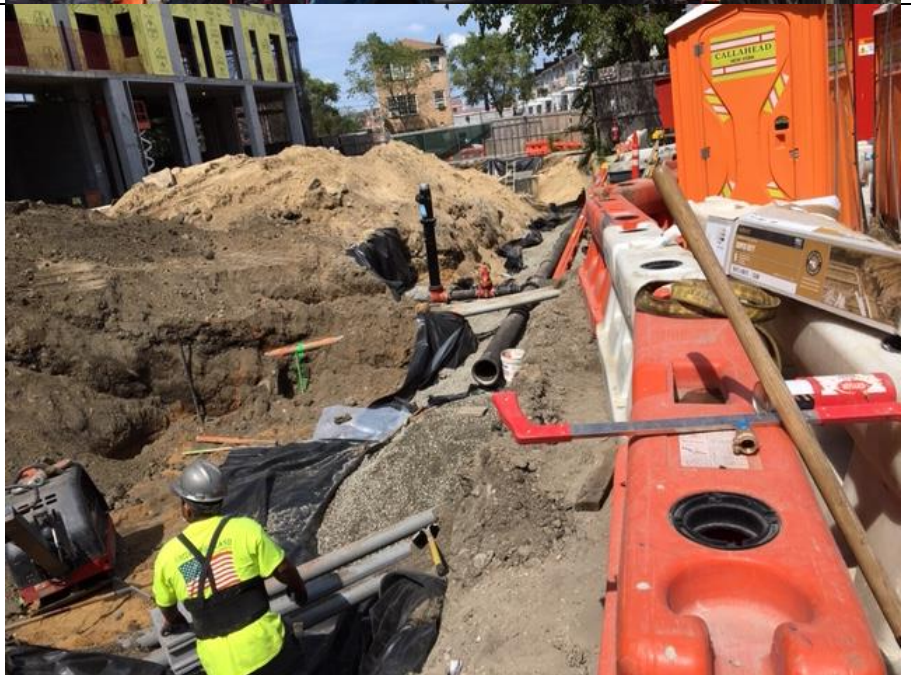
Photo 2- View of utility installation in A5 and B5.

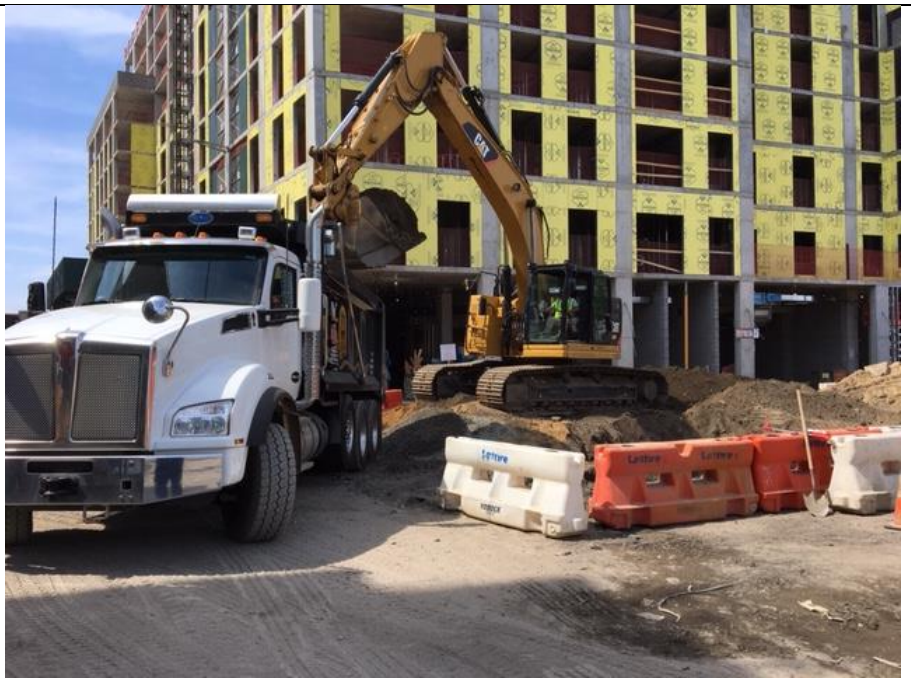
Photo 3- View of loading out truck with soil for export offsite.

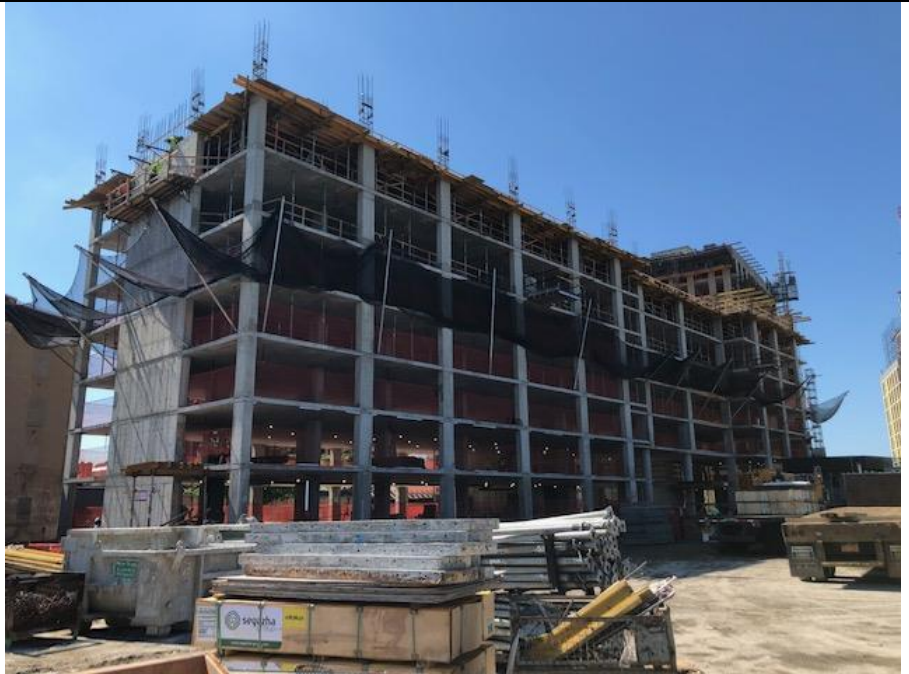
Photo 1- View of rebar, utility, and formwork in C6-C8.

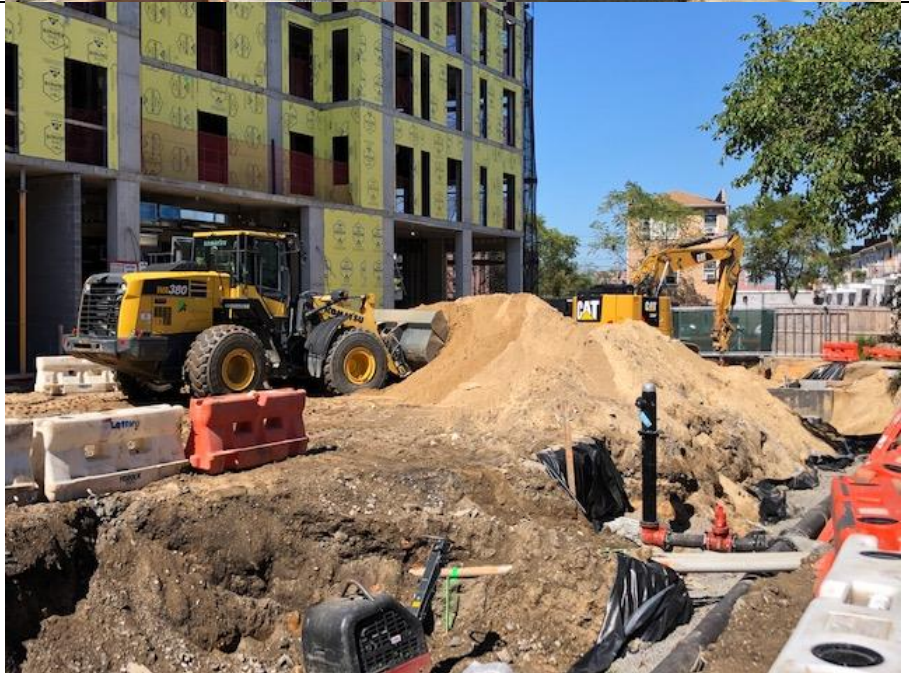
Photo 2- View of stockpiling clean fill.

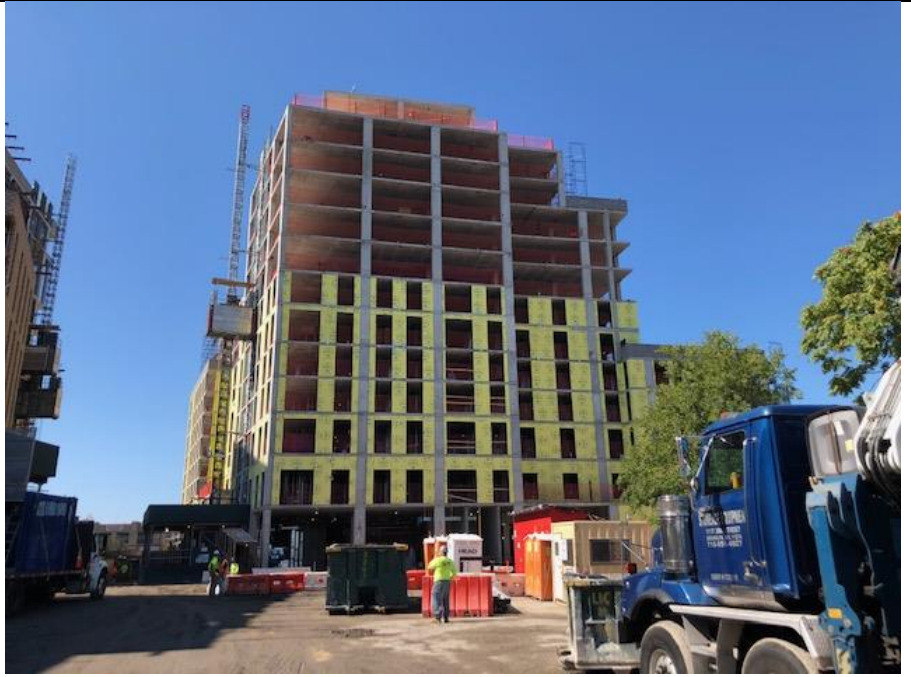
Photo 3- View of rebar, utility, and formwork in A1-A4, and B1-B4.

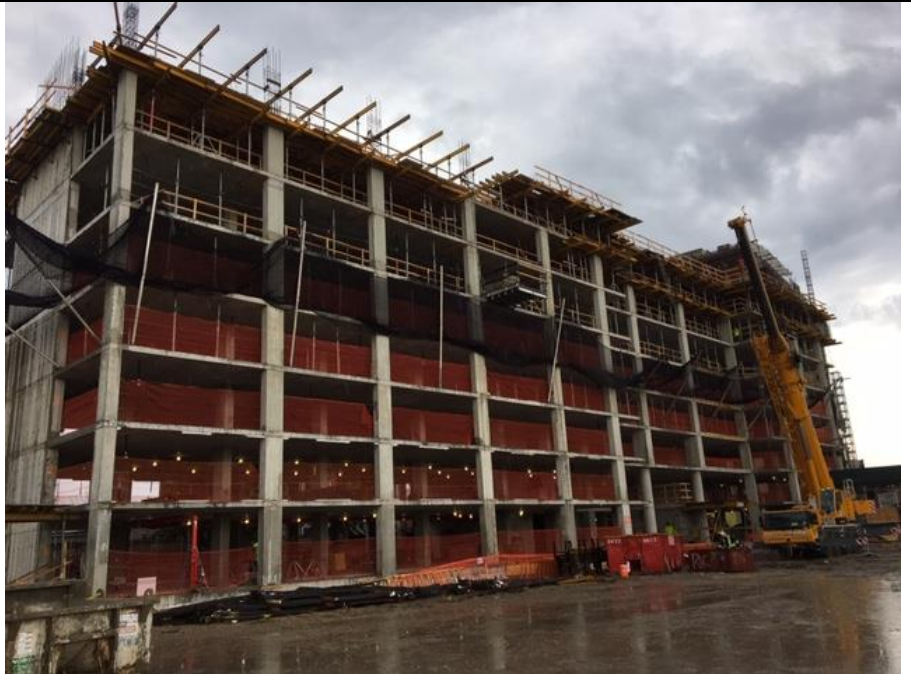
Photo 1- View of rebar, utility, and formwork in C6-C8.

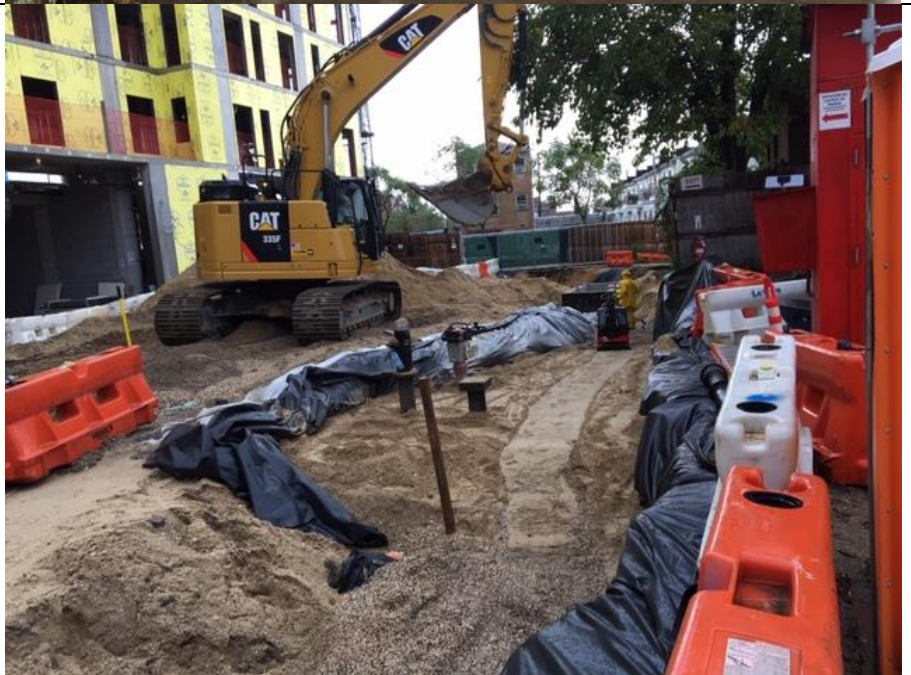
Photo 2- View of backfilling with clean fill in A5 and B5.

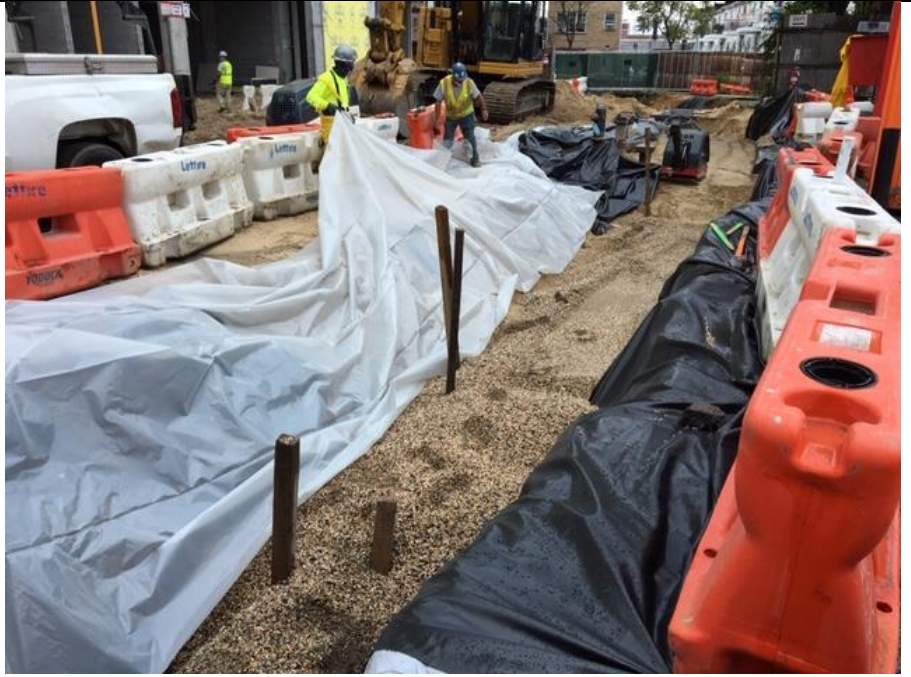
Photo 3- View of installing filter fabric and waterproofing membrane around utilities in A5 and B5.
