Daily Report for August 3, 2020

**Far Rockaway Project
20-02 Mott Avenue
Far Rockaway, NY
BCP #C241224**

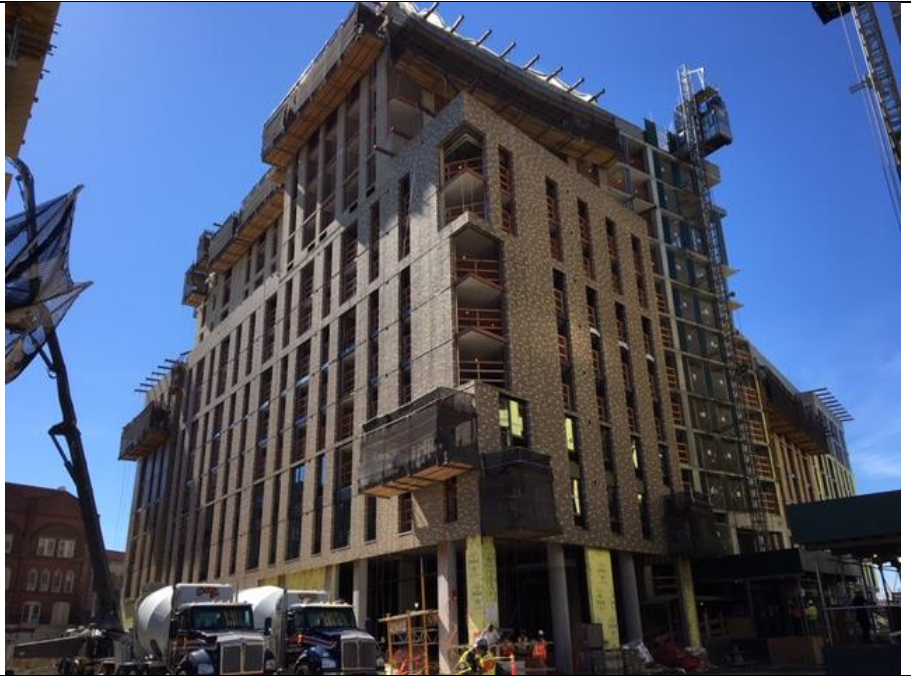
Photo 1- View of rebar, utility, and formwork in D3, D4, E3, and E4.

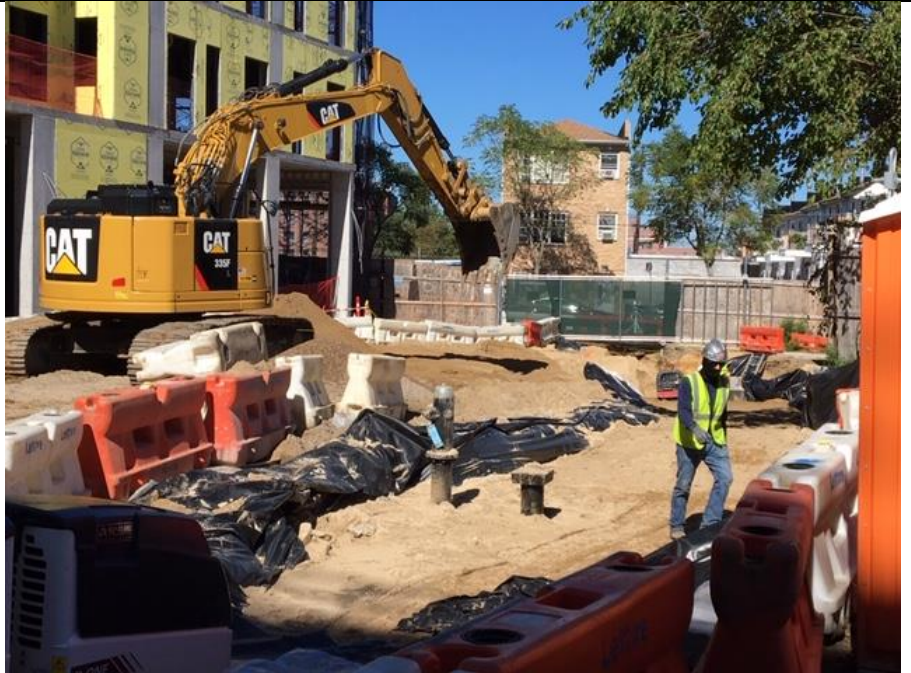
Photo 2- View of backfilling with clean fill in A5 and B5.

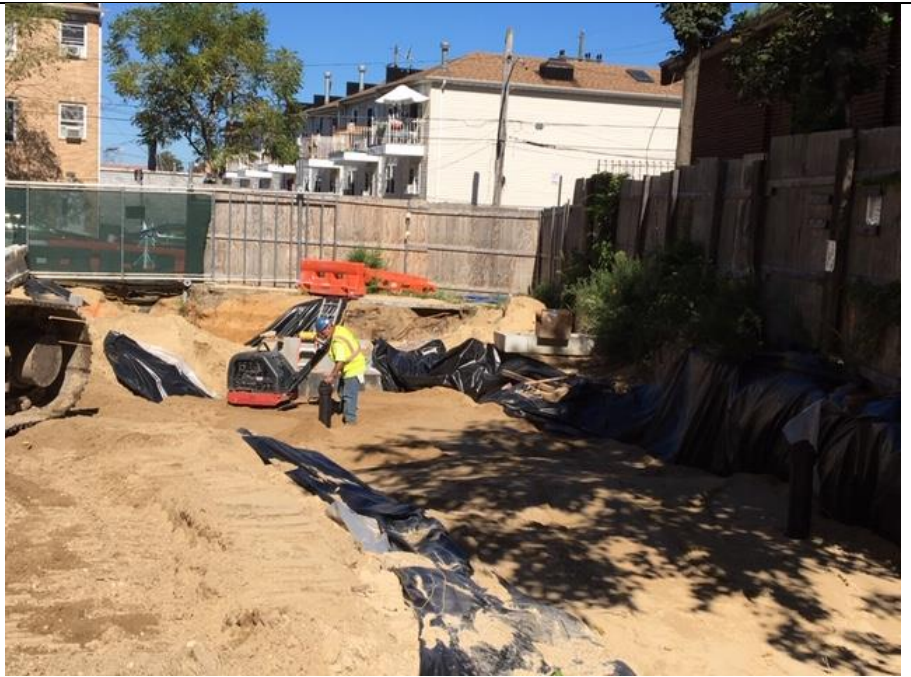
Photo 3- View
of tamping
down clean fill
in A5.

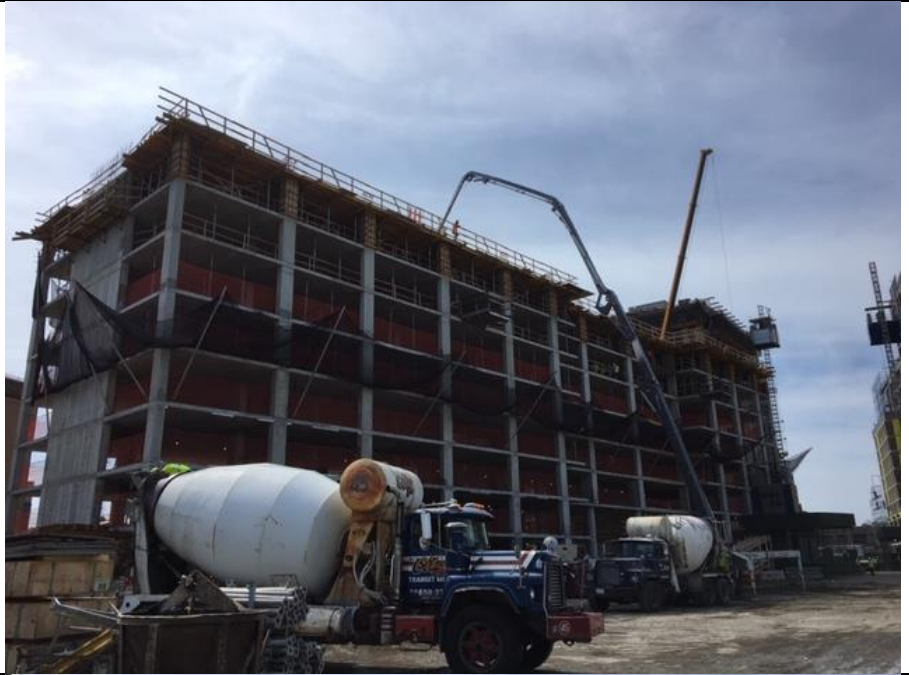
Photo 1- View of pouring concrete, rebar, utility, and formwork in C6-C8.

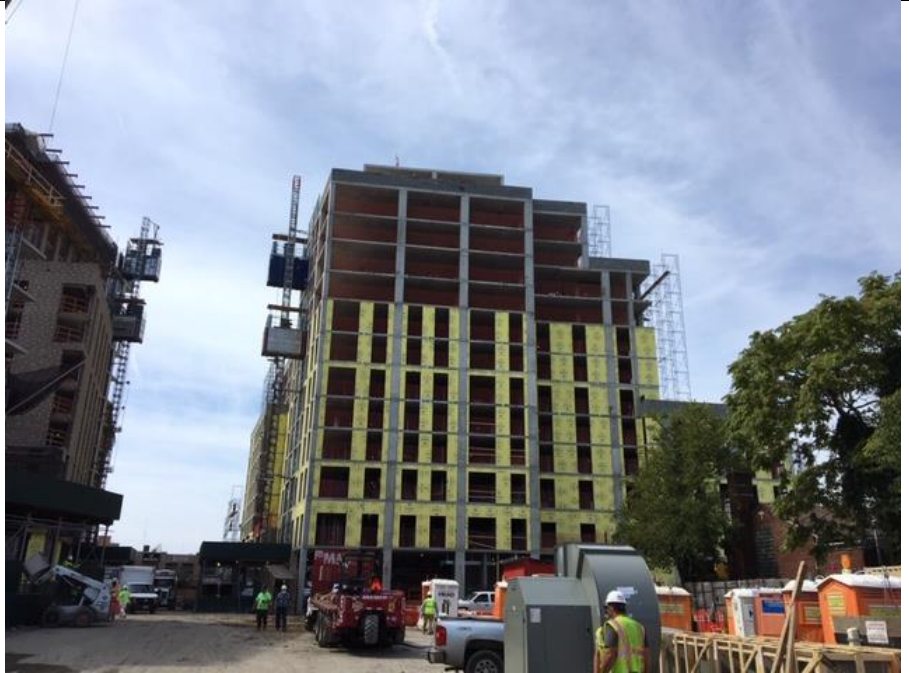
Photo 2- utility, and formwork in A3, A4, B3, and B4.

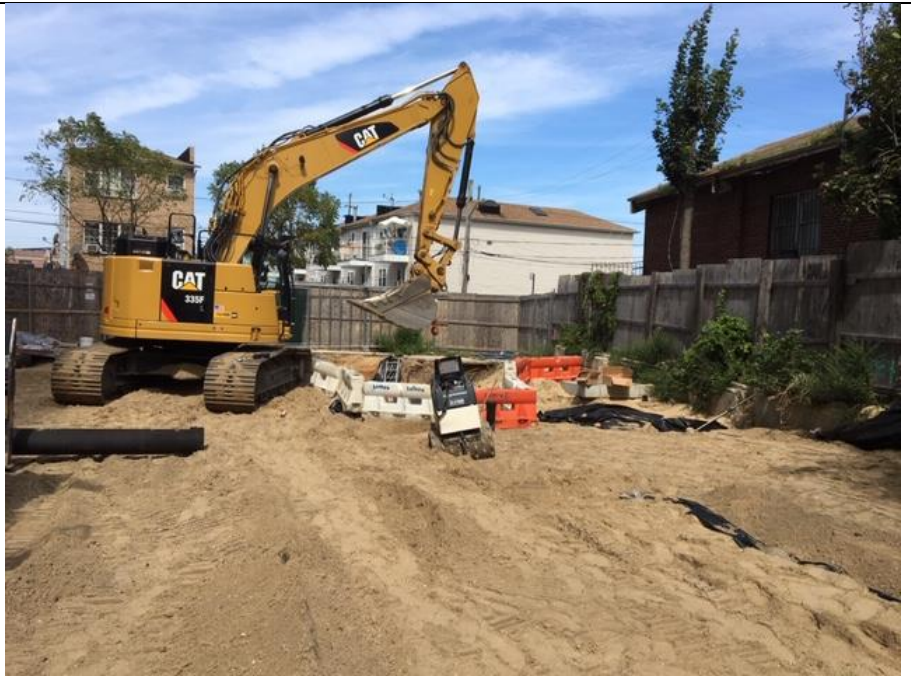
Photo 3- View
of backfilling
with clean fill in
A5.

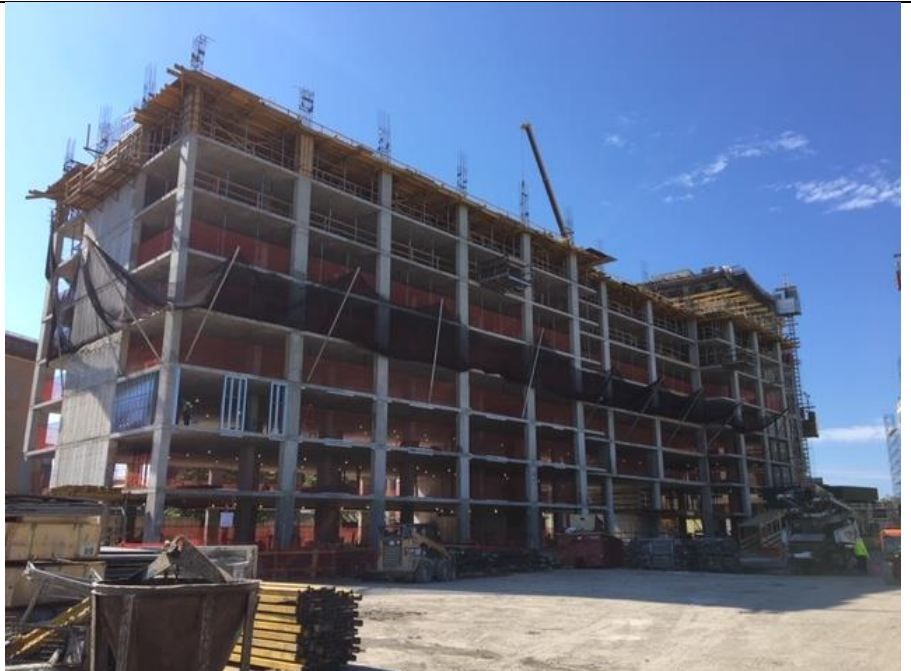
Photo 1- View of pouring concrete, rebar, utility, and formwork in C6-C8.

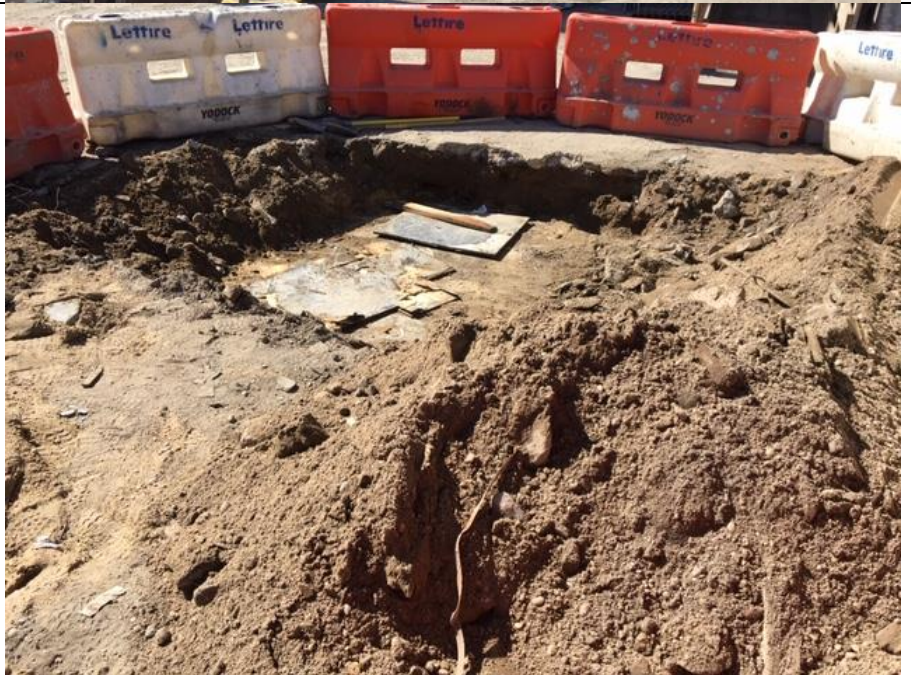
Photo 2- Excavating in C5.

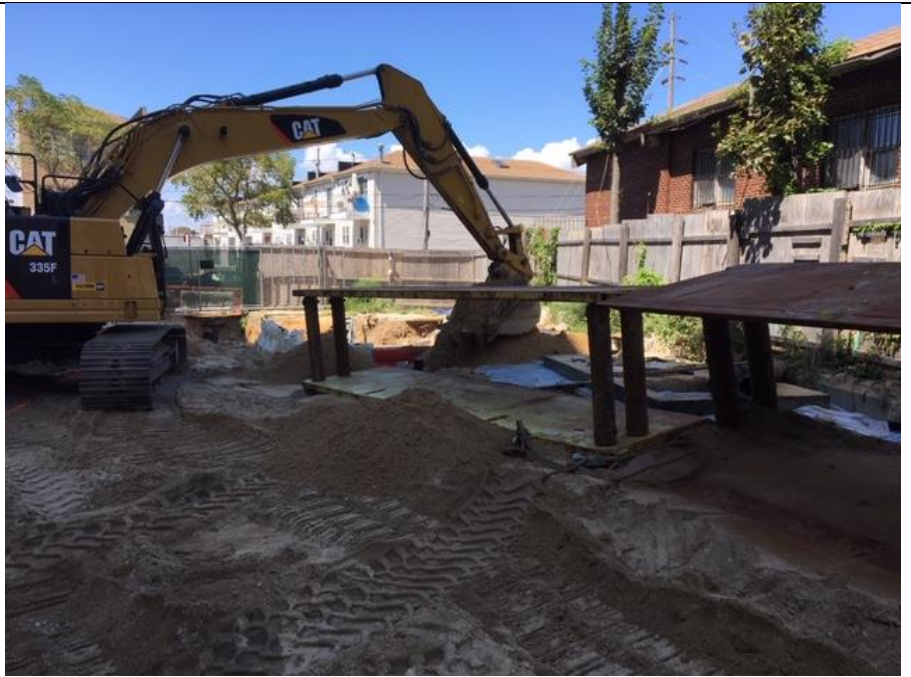
Photo 3- View
of backfilling
with clean fill in
A5.

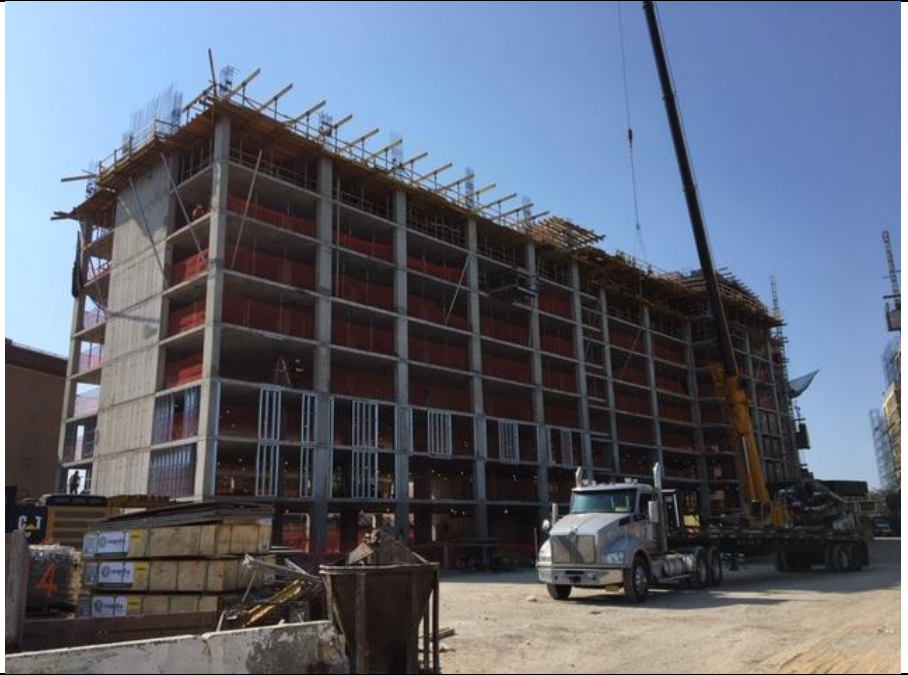
Photo 1- View of rebar, utility, and formwork in C6-C8.

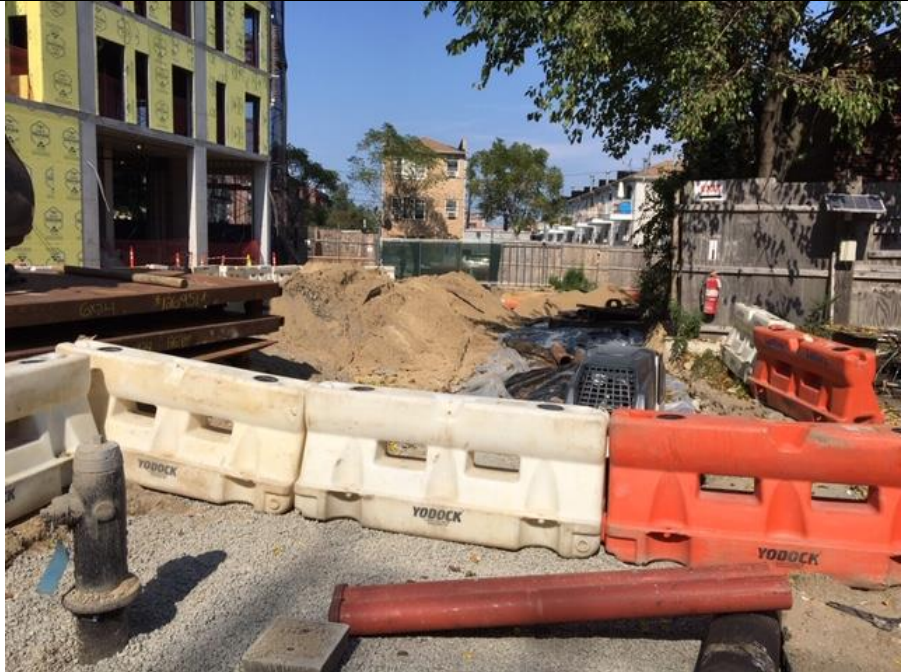
Photo 2- Installing utilities in A5 and B5.

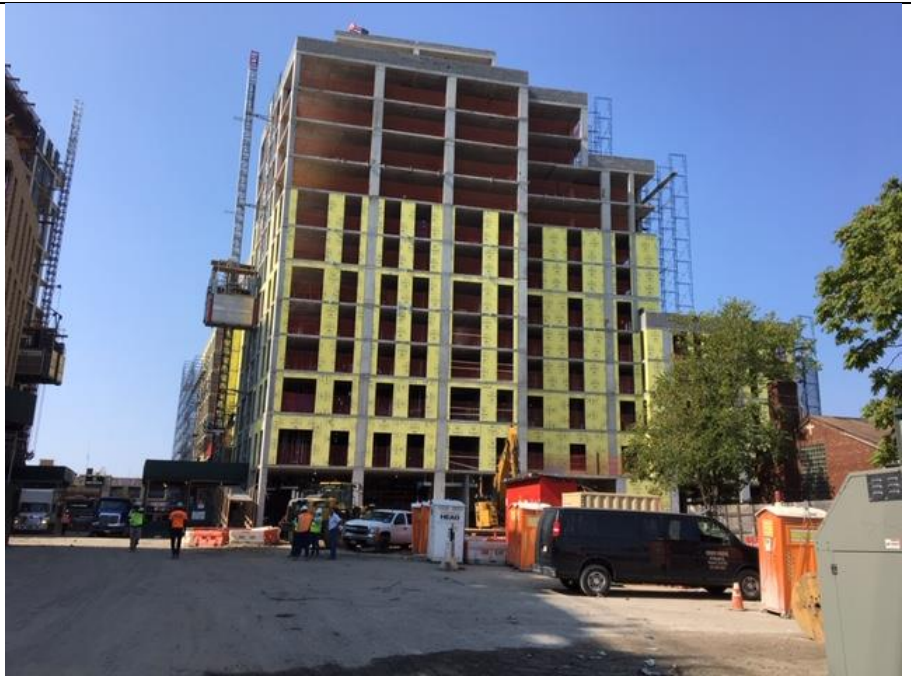
Photo 3- View of rebar, utility, and formwork in A3, A4, B3, and B4.

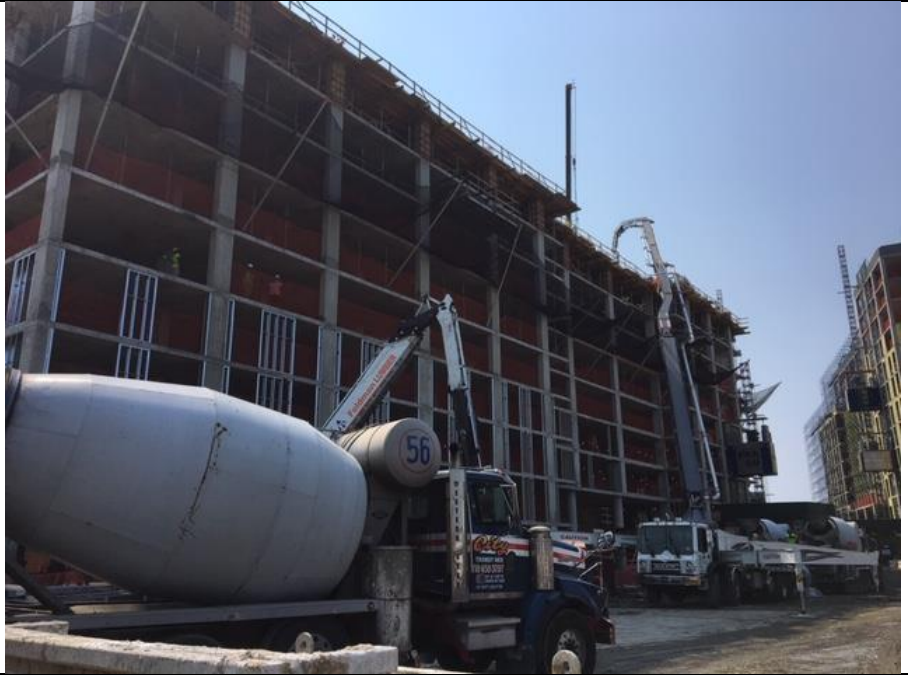
Photo 1- View of pouring concrete, rebar, utility, and formwork in C6-C8.

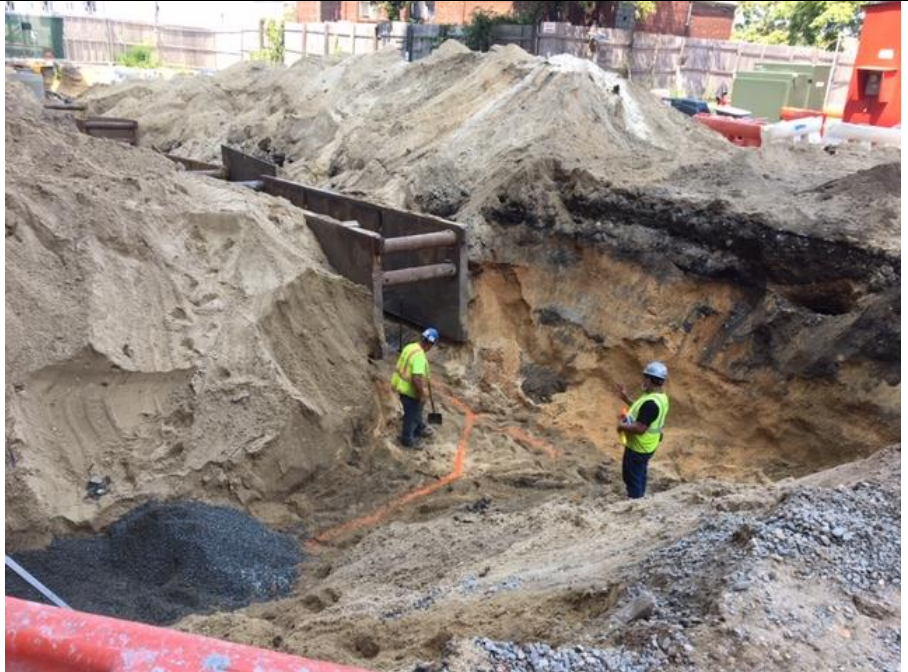
Photo 2- View of installing utilities in A5, B5, and C5.

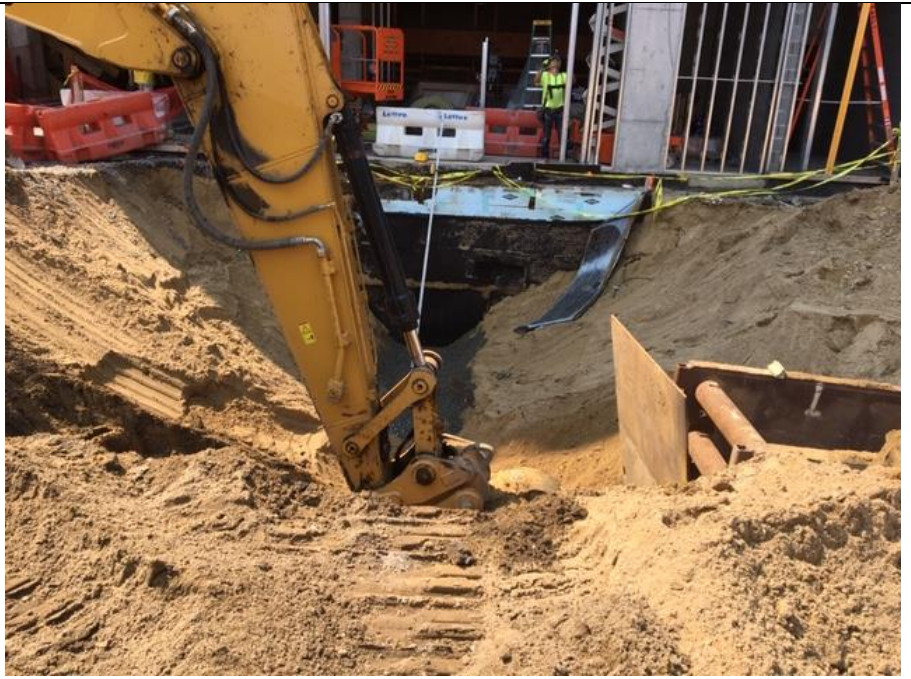
Photo 3- View
of excavating
clean fill in B5.

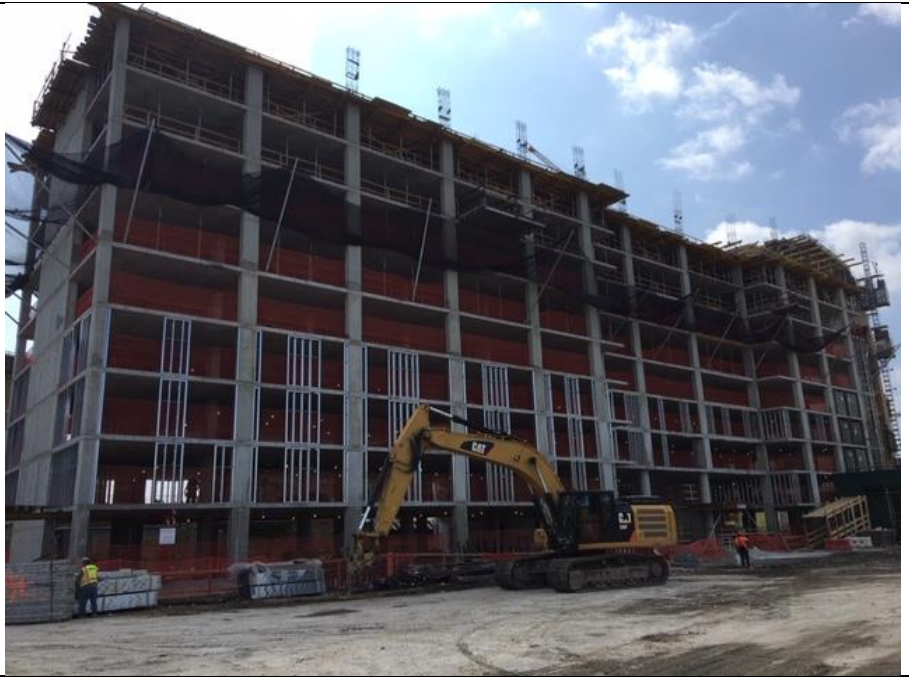
Photo 1- View of rebar, utility, and formwork installation in C6-C8.

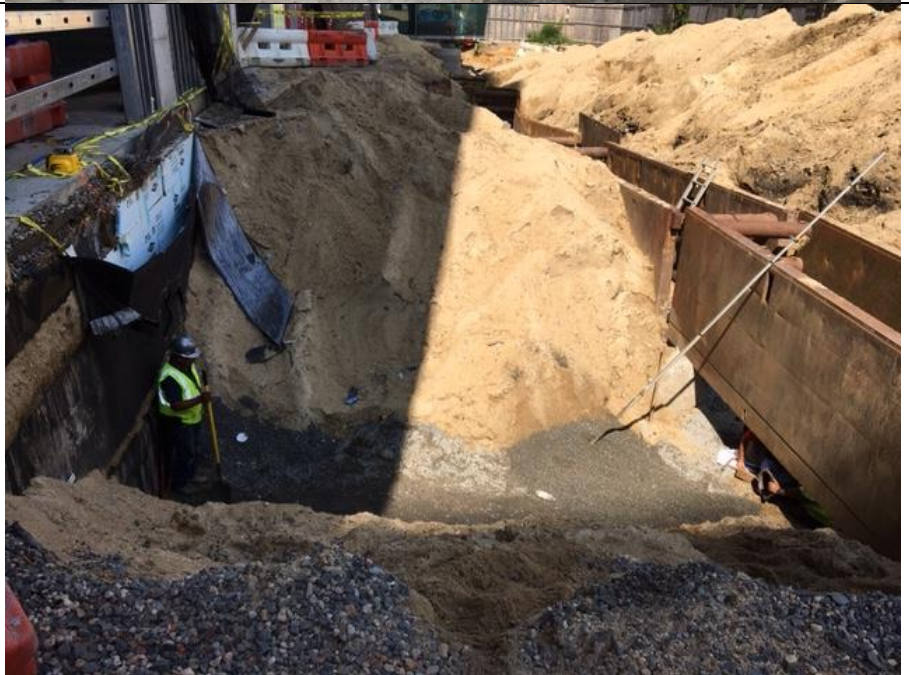
Photo 2- View of installing utilities in B5, and C5.

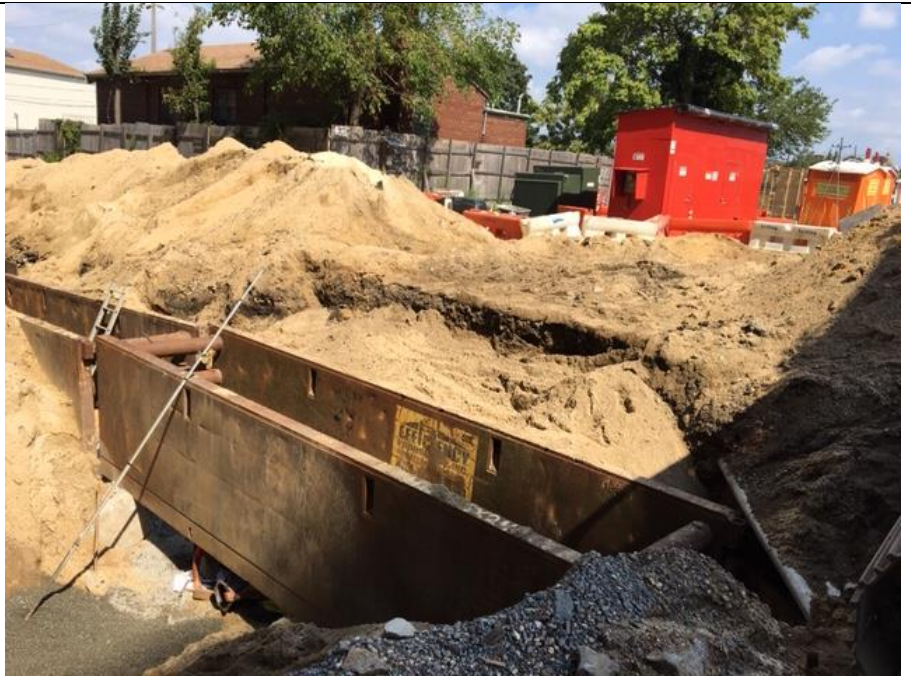
Photo 3- View
of installing
utilities in B5
and C5.

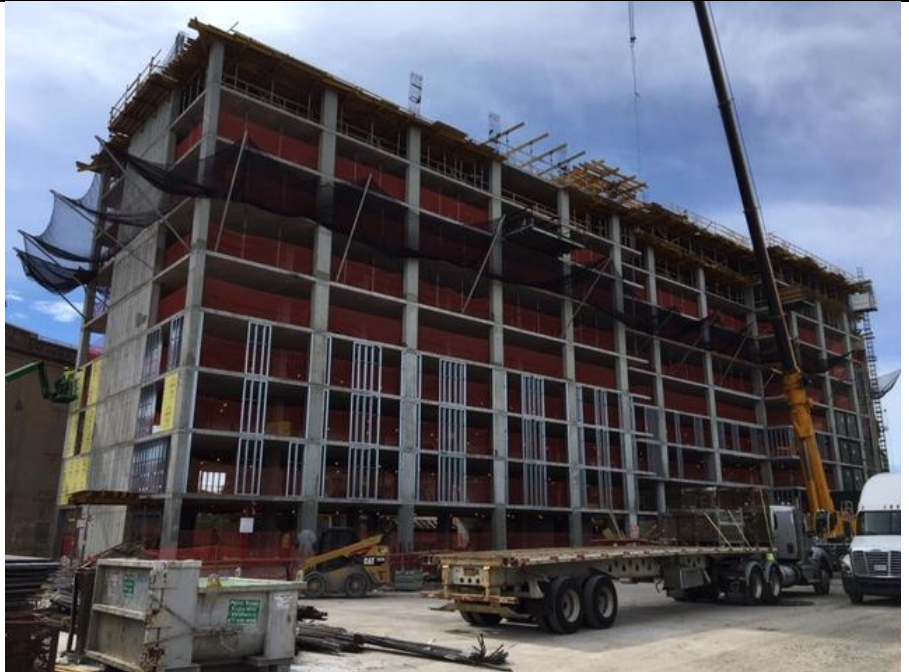
Photo 1- View of rebar, utility, and formwork installation in C6-C8.

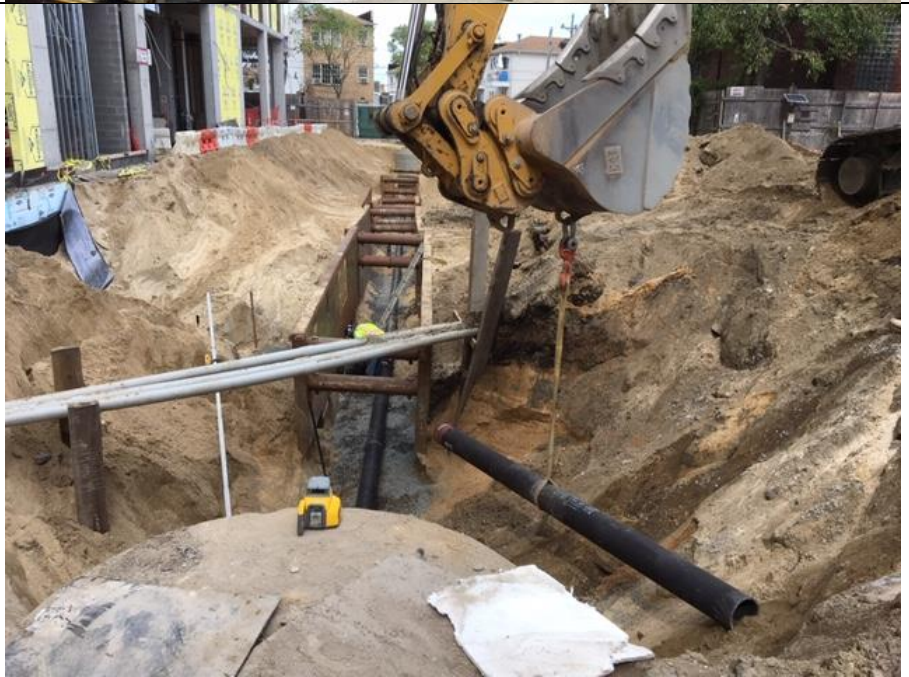
Photo 2- View of installing utilities in B5, and C5.

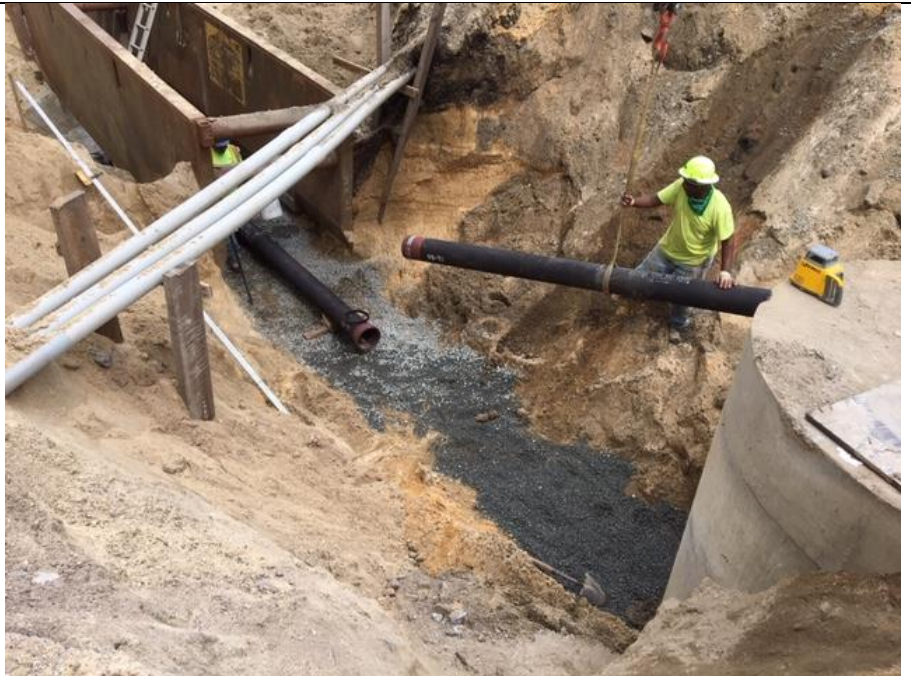
Photo 3- View
of installing
utilities in B5
and C5.
