#### Daily Report for September 2, 2020

Far Rockaway Project 20-02 Mott Avenue Far Rockaway, NY BCP #C241224

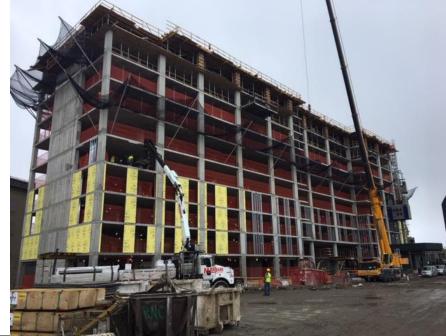
Photo 1- View of rebar, utility, and formwork installation in C6-C8.

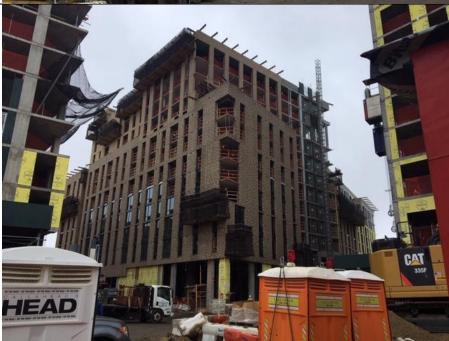
Photo 2- View of rebar, utility, and formwork installation in D3, D4, E3, and E4.

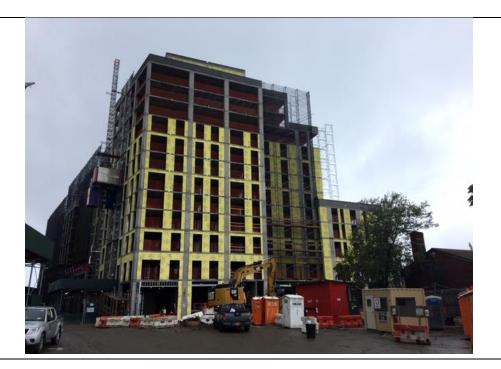
Photo 3- View of rebar, utility, and formwork installation in A3, A4, B3, and B4.

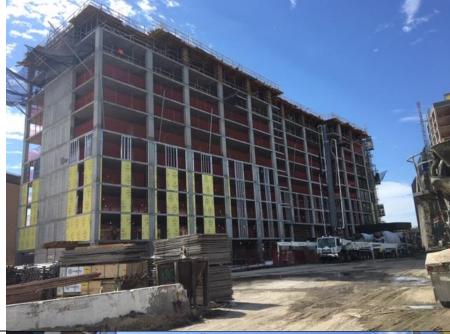
Photo 1- View of rebar, utility, and formwork installation in C6-C8.

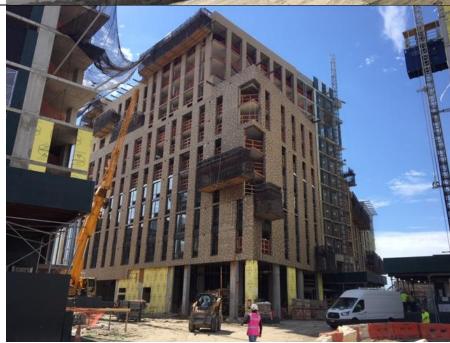
Photo 2- View of rebar, utility, and formwork installation in D3, D4, E3, and E4.

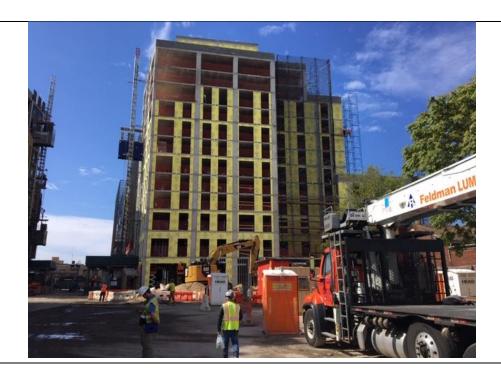
Photo 3- View of rebar, utility, and formwork installation in A3, A4, B3, and B4.

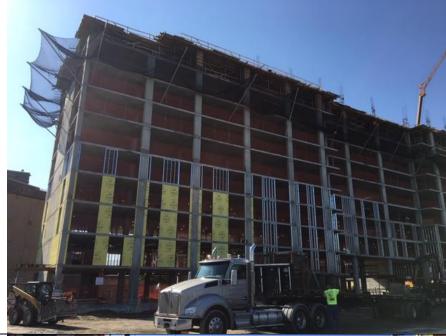
Photo 1- View of rebar, utility, and formwork installation in C6-C8.

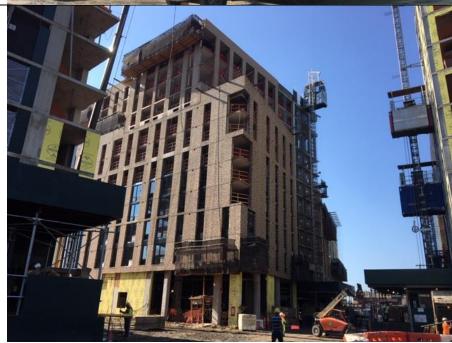
Photo 2- View of rebar, utility, and formwork installation in D3, D4, E3, and E4.

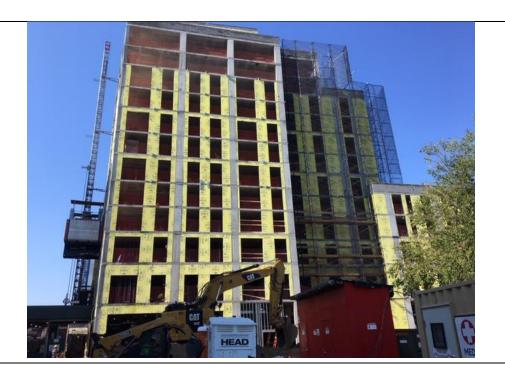
Photo 3- View of rebar, utility, and formwork installation in A3, A4, B3, and B4.

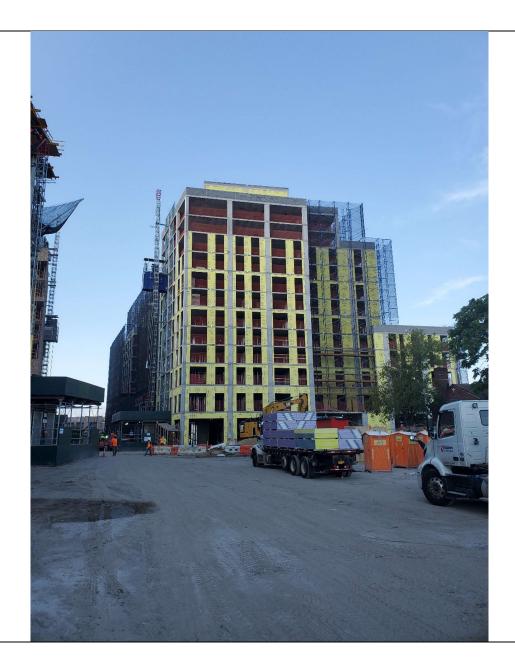
Photo 1- View of rebar, utility, and formwork installation in C6-C8.

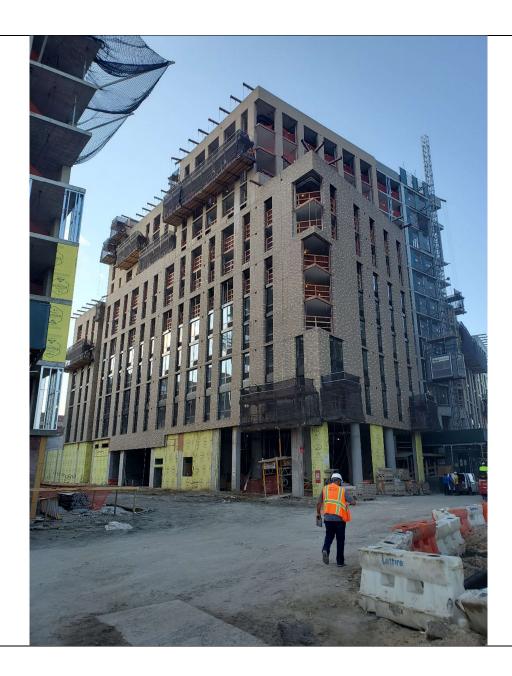
Photo 2- View of rebar, utility, and formwork installation in D3, D4, E3, and E4.

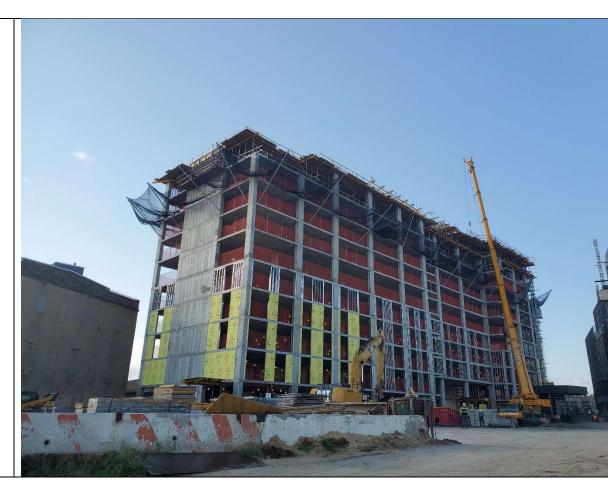
Photo 3- View of rebar, utility, and formwork installation in A3, A4, B3, and B4.

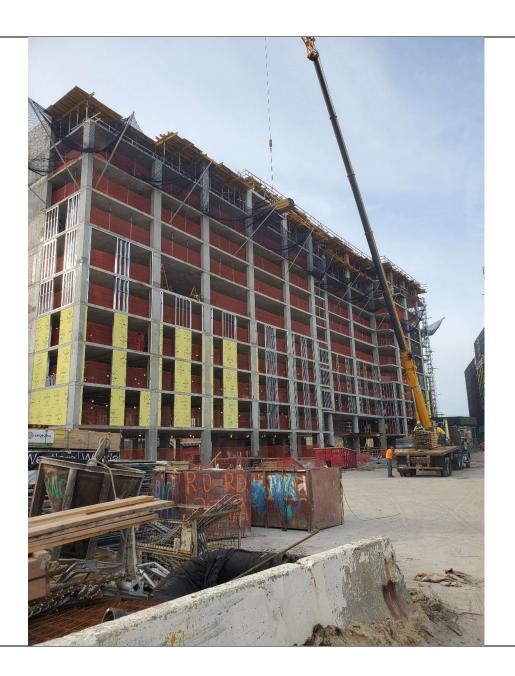
Photo 1- View of rebar, utility, and formwork installation in C6-C8.

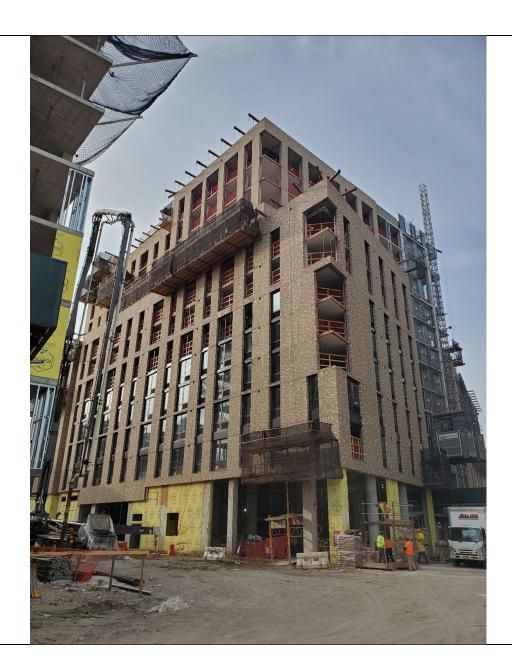
Photo 2- View of rebar, utility, and formwork installation in D3, D4, E3, and E4.

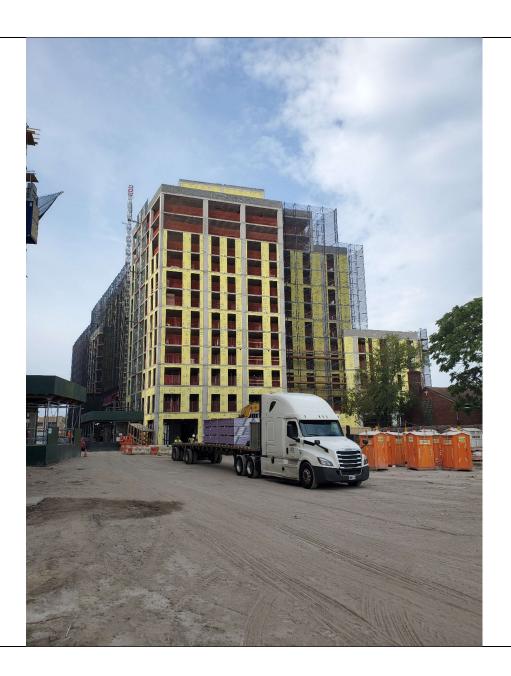
Photo 3- View of rebar, utility, and formwork installation in A3, A4, B3, and B4.

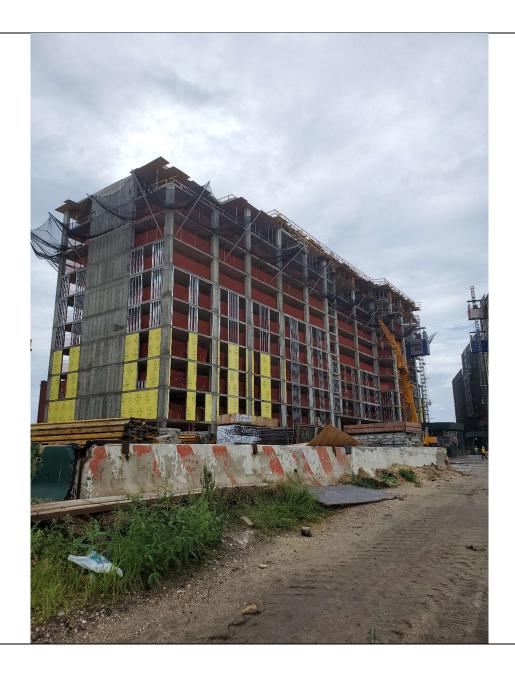
Photo 1- View of rebar, utility, and formwork installation in C6-C8.

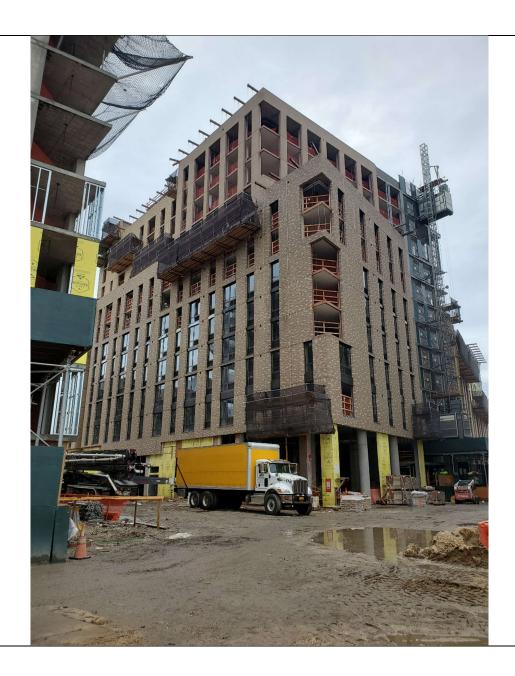
Photo 2- View of rebar, utility, and formwork installation in D3, D4, E3, and E4.

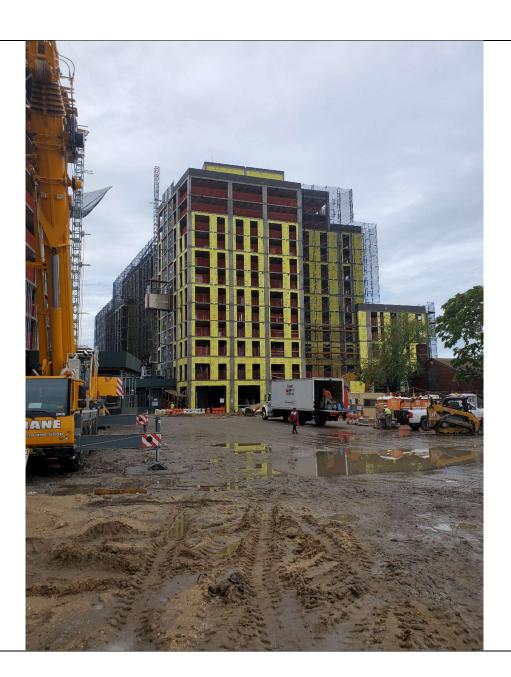
Photo 3- View of rebar, utility, and formwork installation in A3, A4, B3, and B4.

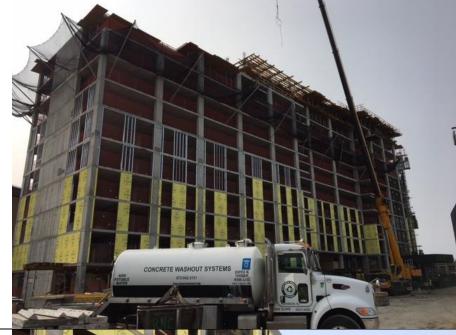
Photo 1- View of rebar, utility, and formwork installation in C6-C8.

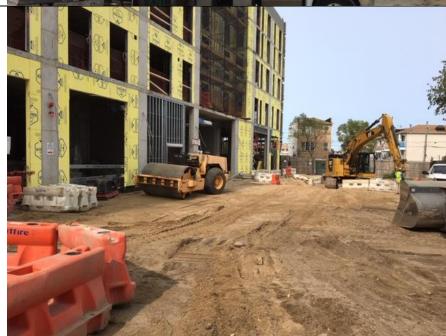
Photo 2- View of backfilling A5, B5, and C5 with clean fill.

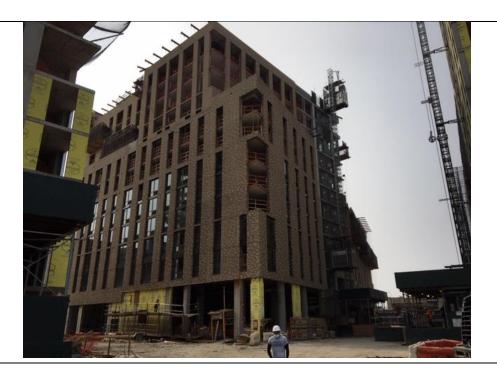
Photo 3- View of rebar, utility, and formwork installation in D4, D5, E4, and E5.

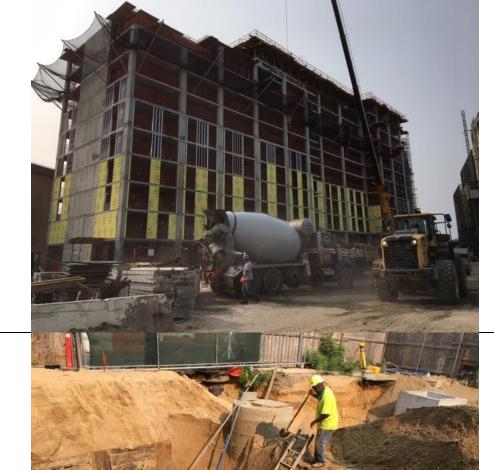
Photo 1- View of rebar, utility, and formwork installation in C6-C8.

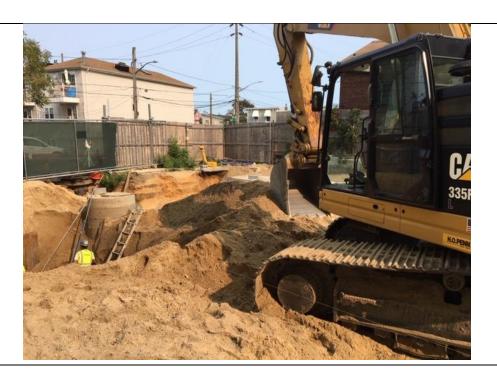
Photo 3- View of excavating clean fill in A5.

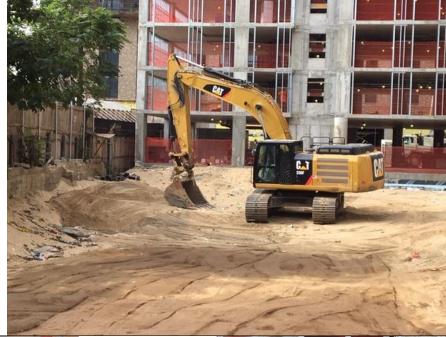
Photo 1- View of clean fill grading and compaction in D6-D8.

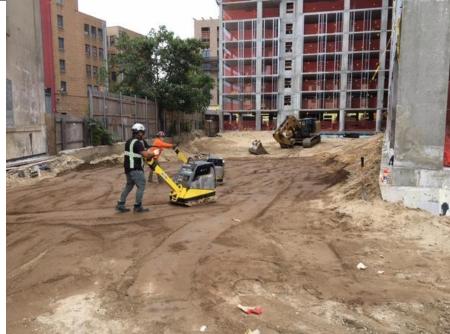
Photo 2- View of clean fill compaction in D6-D8.

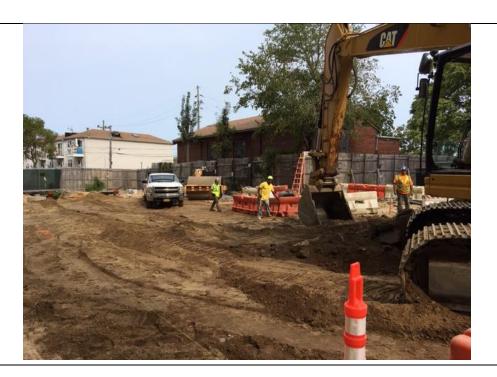
Photo 3- View of excavating in A5.

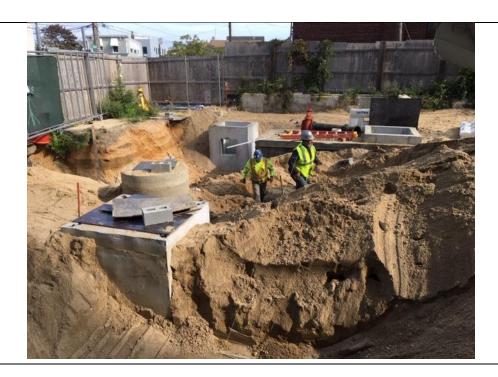
Photo 3- View of excavation and utility installation in A5.

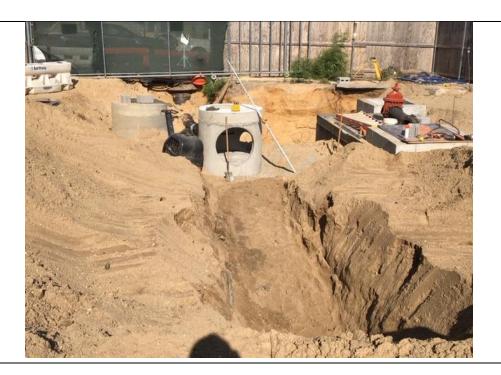
Photo 3- View of excavation and utility installation in A5.

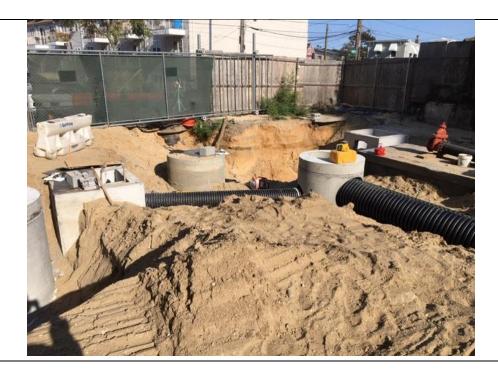
Photo 3- View of excavation and utility installation in A5.

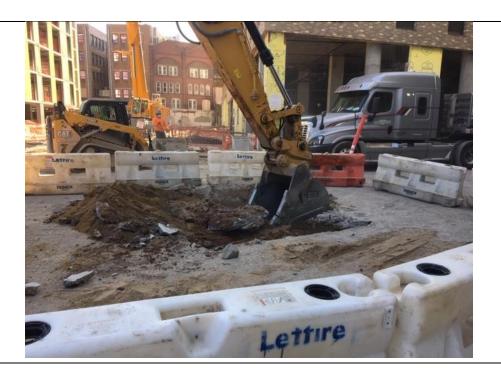
Photo 3- View of excavation and utility installation in B4.

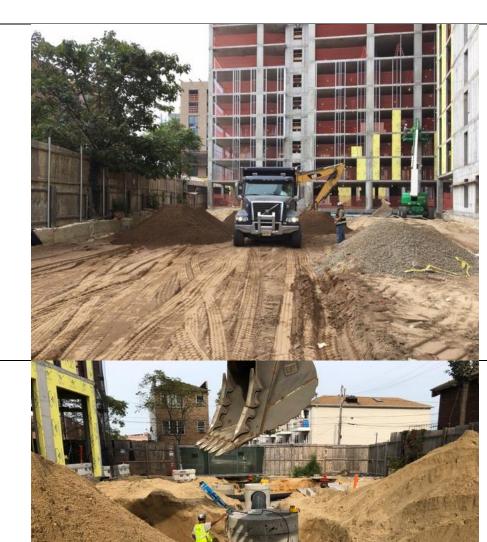
Photo 1- View of importing clean fill in D6-D8.

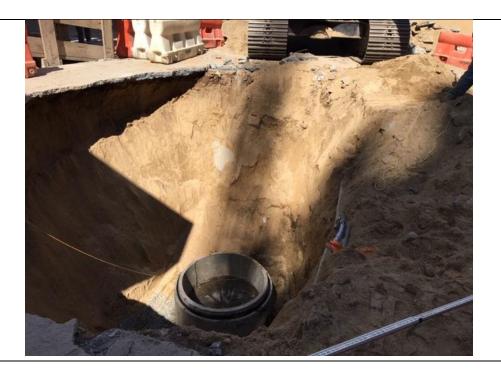
Photo 3- View of excavation and utility installation in B4.

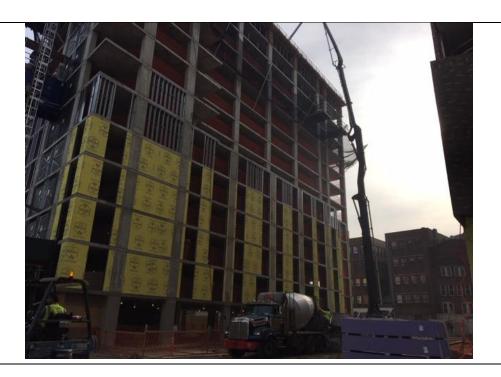
Photo 3- View of pouring concrete in C6-C8 and D5.

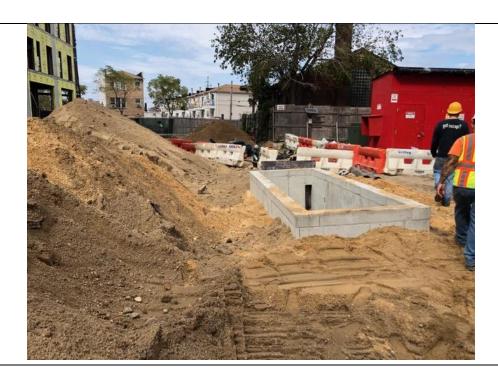
Photo 3- View of utility installation in B5.

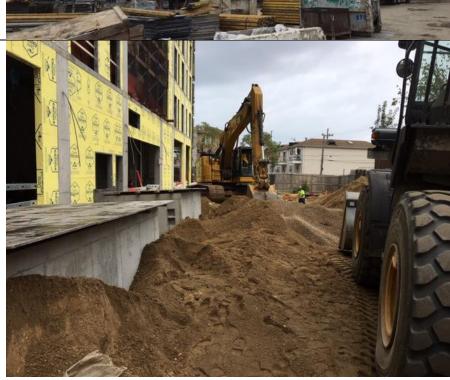
Photo 2- View of excavating soil and utility installation in A5 and B5.

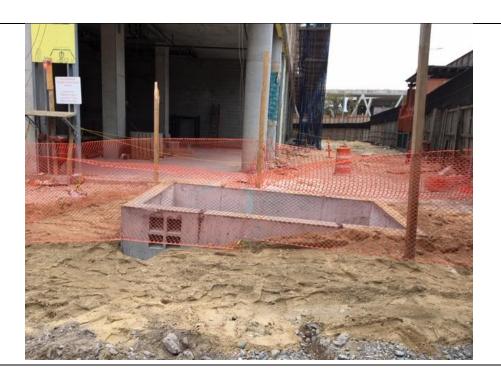
Photo 3- View of utility installation in C1.

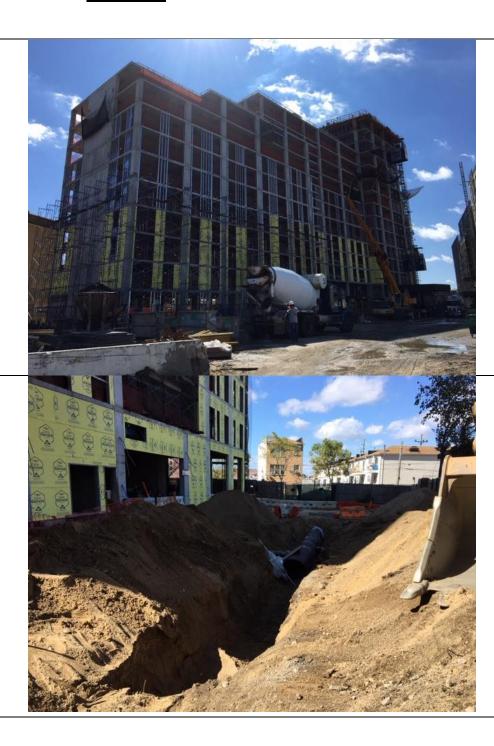
Photo 1- View of rebar, formwork, and utility installation in C6-C8.

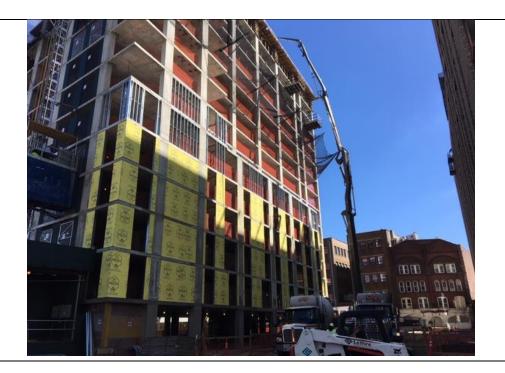
Photo 3- View of pouring concrete in C5-C8 and D5.
