## **Daily Report for December 1, 2020**

**Far Rockaway Project  
20-02 Mott Avenue  
Far Rockaway, NY  
BCP #C241224**

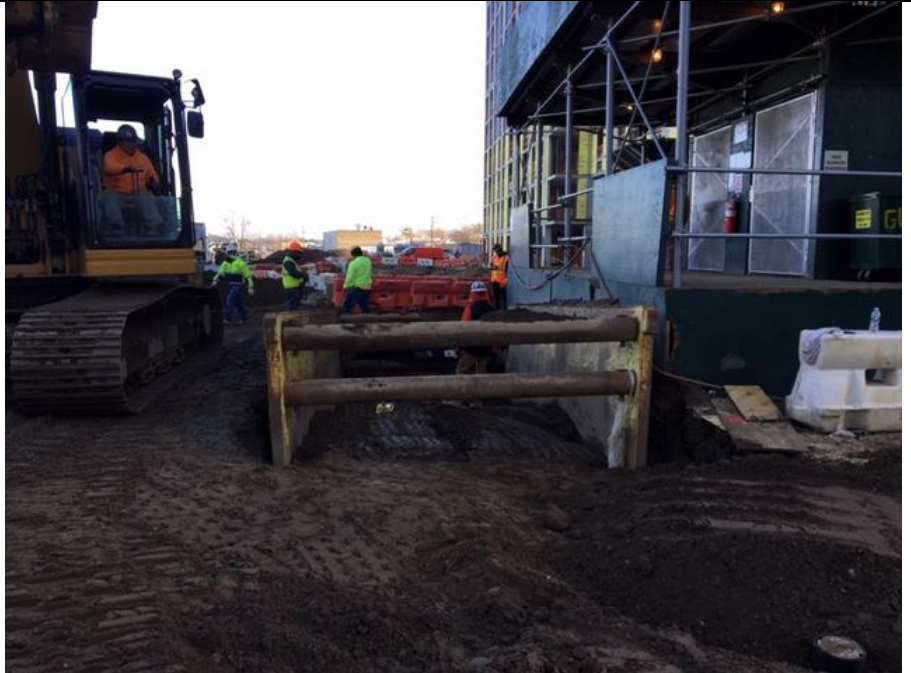
Photo 1- View of backfilling and compacting clean fill in B5 and C5.

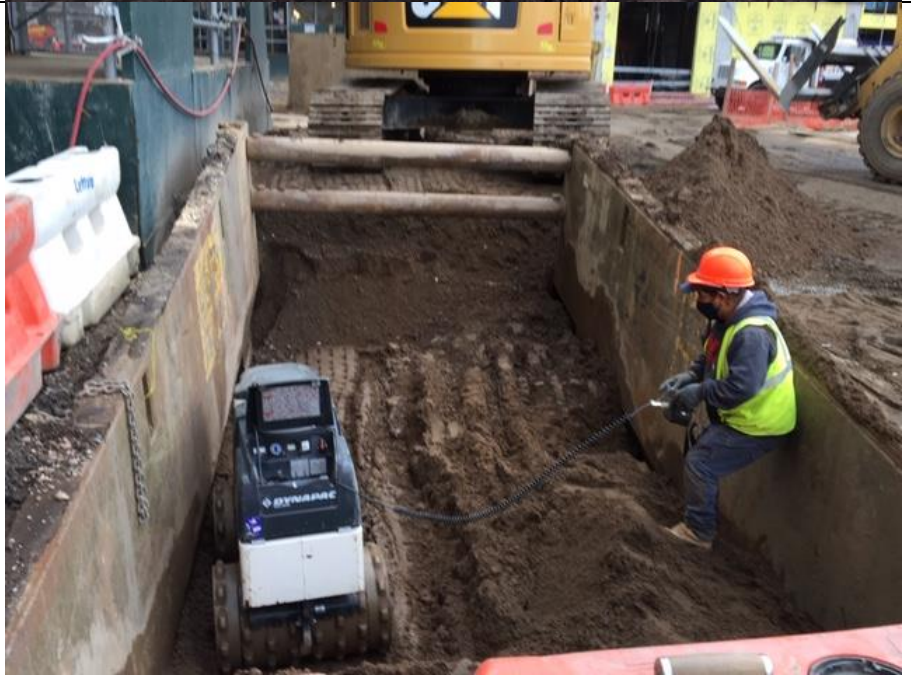
Photo 2- View of backfilling and compacting clean fill in B5 and C5.

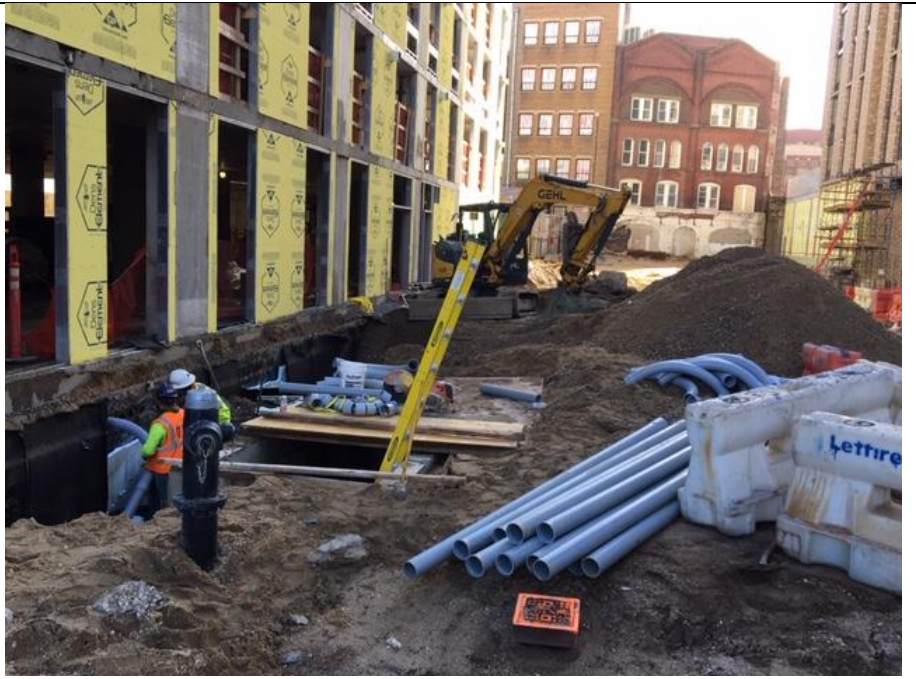
Photo 3- View  
of utility  
installation in  
C5.

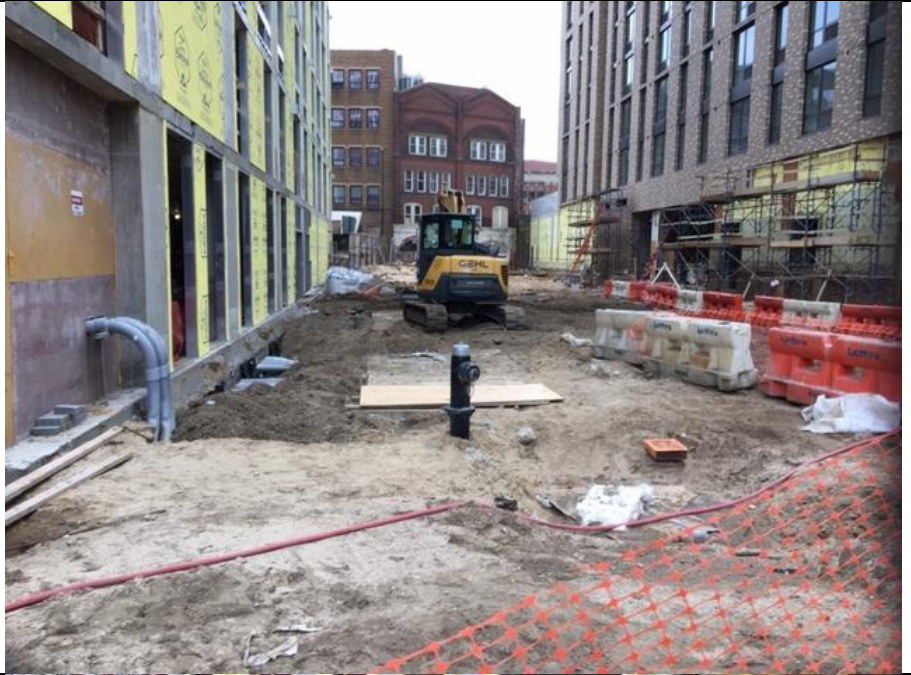
Photo 1- View of backfilling and compacting clean fill in B5.

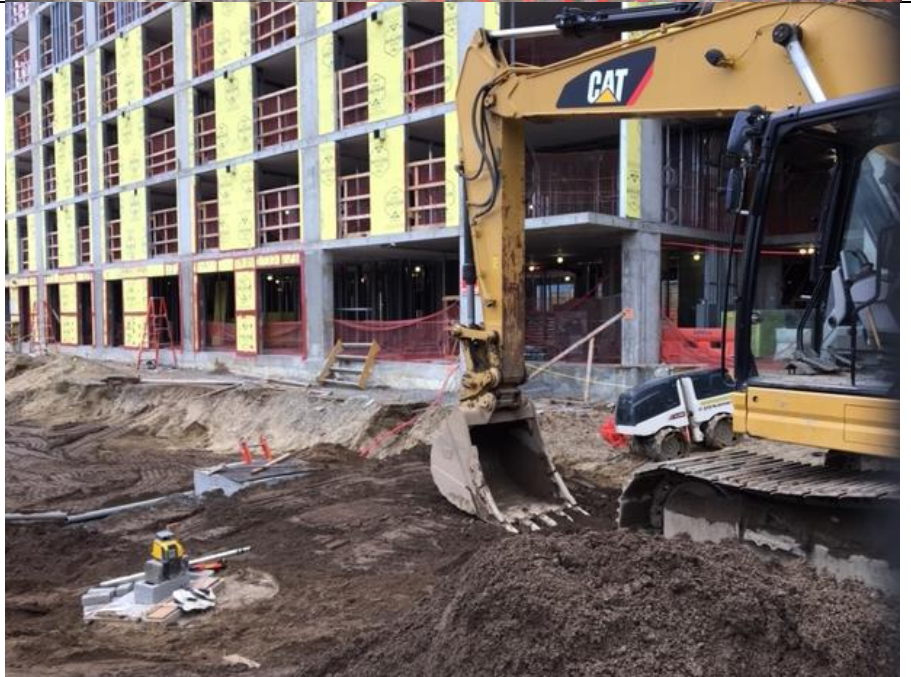
Photo 2- View of backfilling and compacting clean fill in B5 and C5.

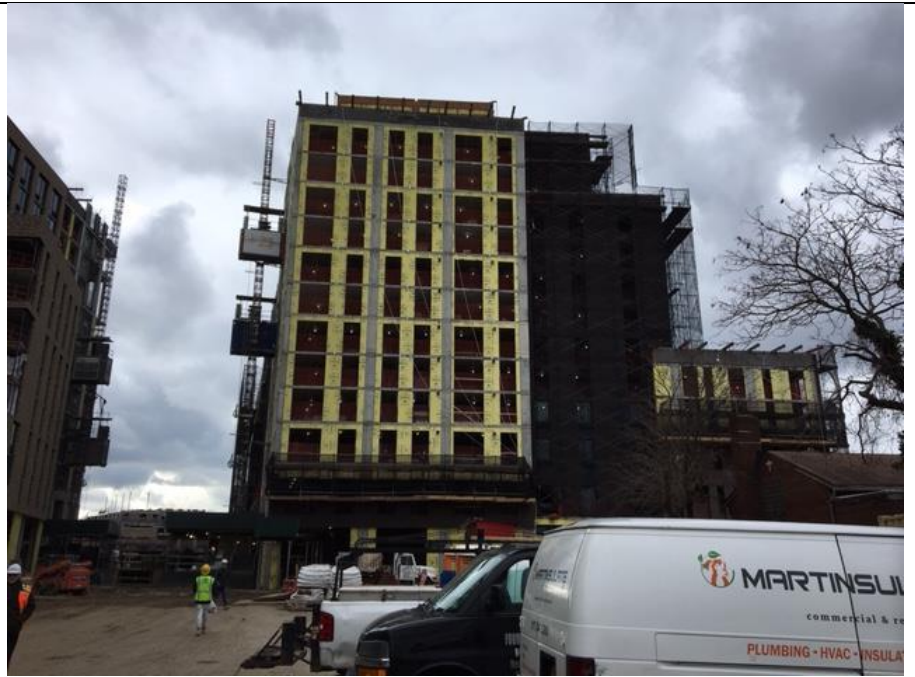
Photo 3- View of utility and formwork installation in A3, A4, B3, and B4.

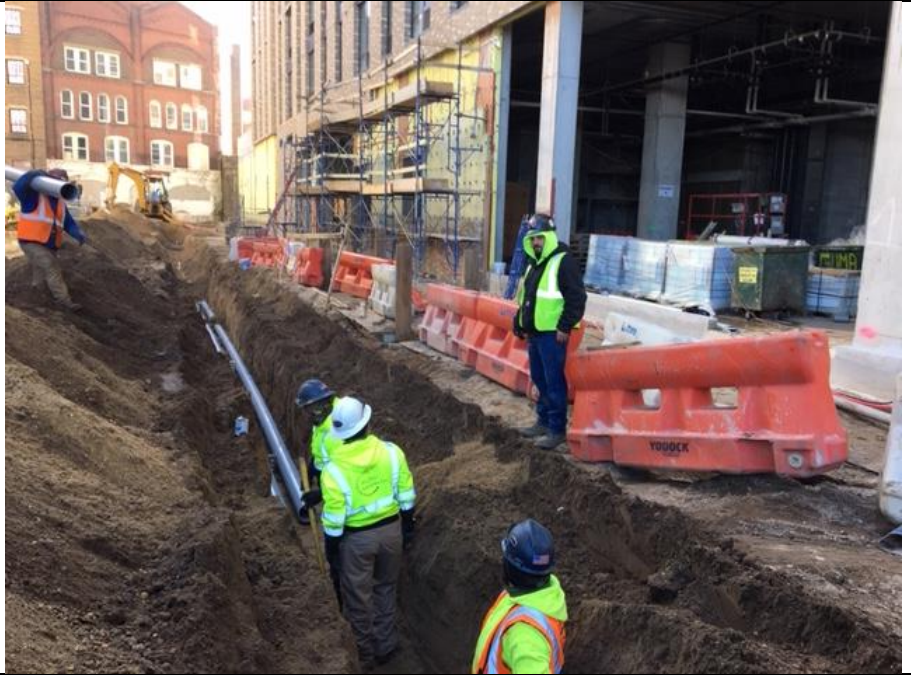
Photo 1- View of excavating clean fill and utility installation in C4 and D4.

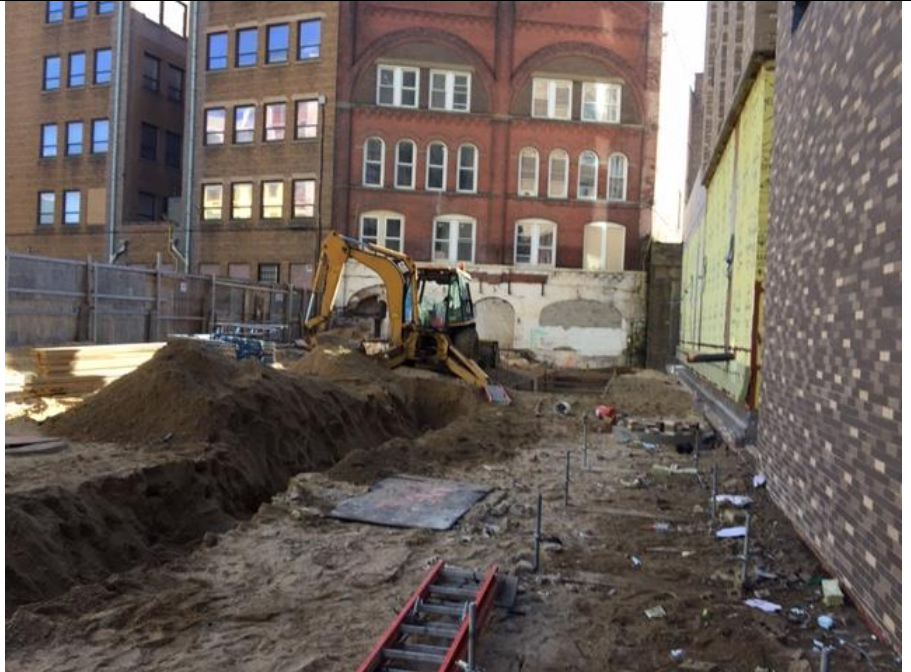
Photo 2- View of excavating clean fill and utility installation in D4 and E4.

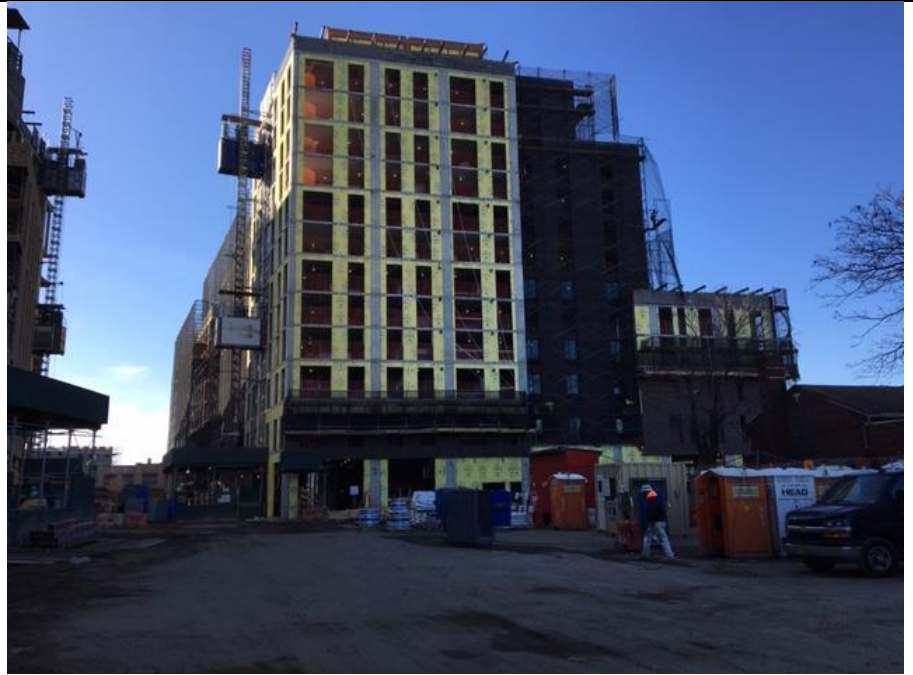
Photo 3- View of utility and formwork installation in A3, A4, B3, and B4.

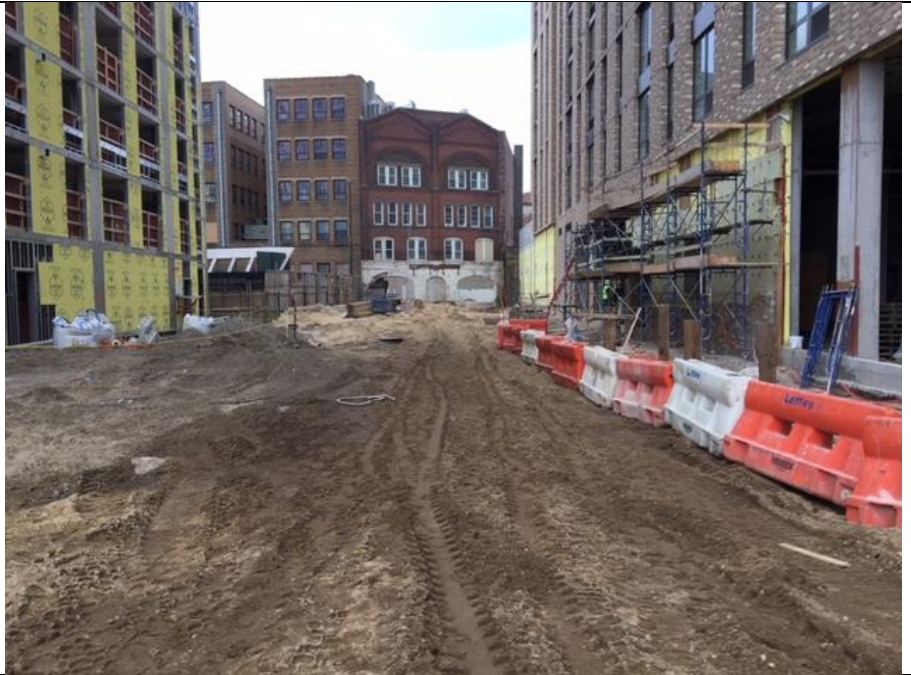
Photo 1- View of backfilled area in C4 and D4.

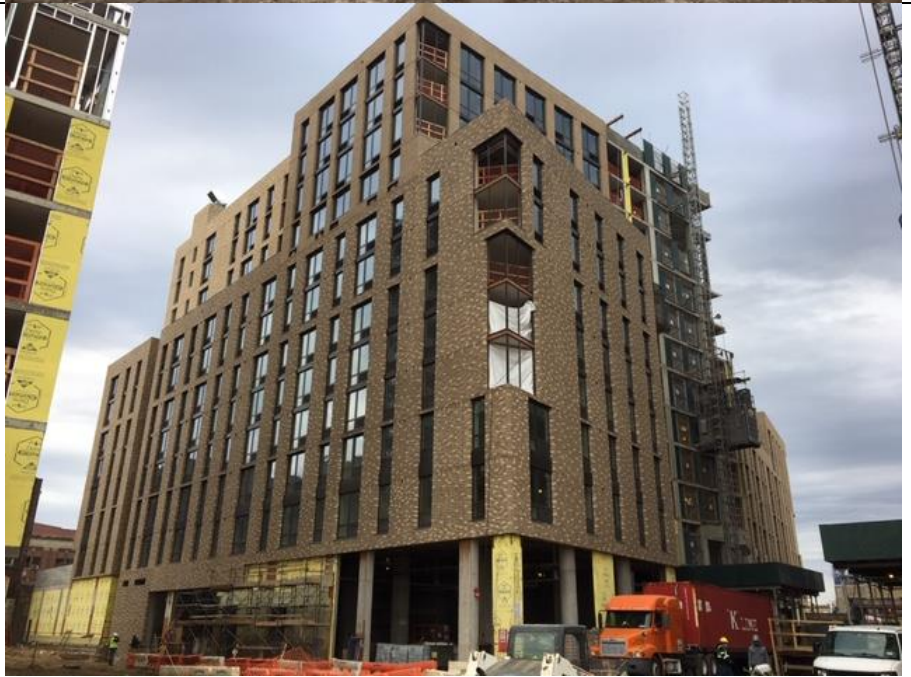
Photo 2- View of utility and formwork installation in D4, D5, E4, and E5.

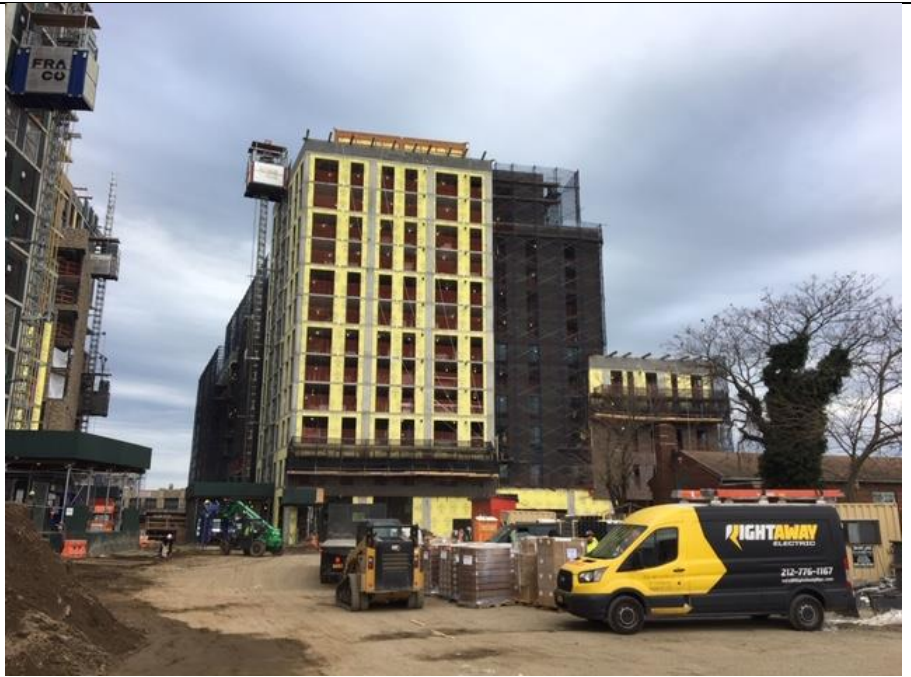
Photo 3- View of utility and formwork installation in A3, A4, B3, and B4.

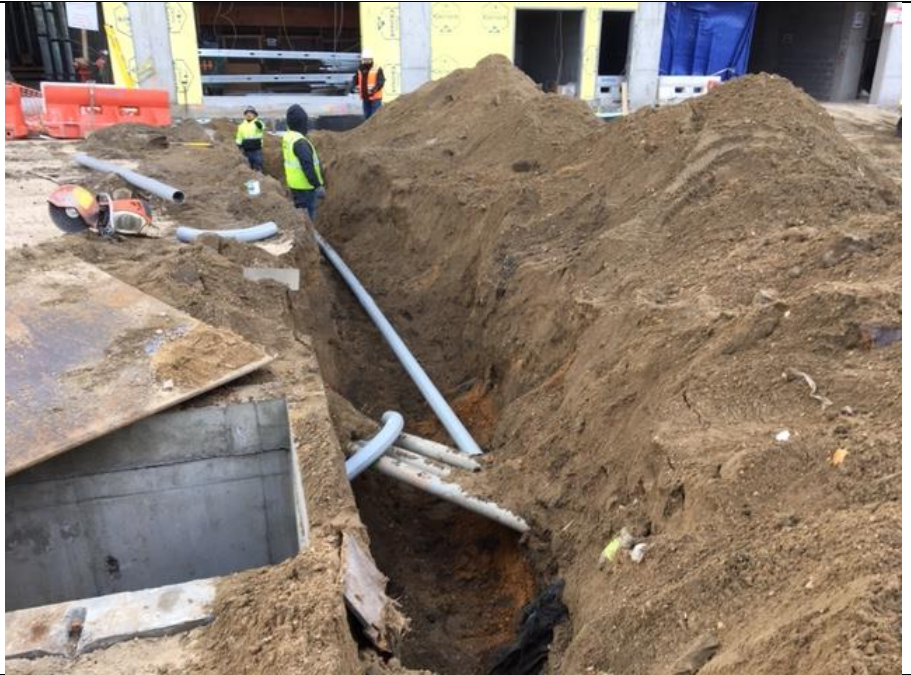
Photo 1- View of excavated clean fill and utility installation in B5.

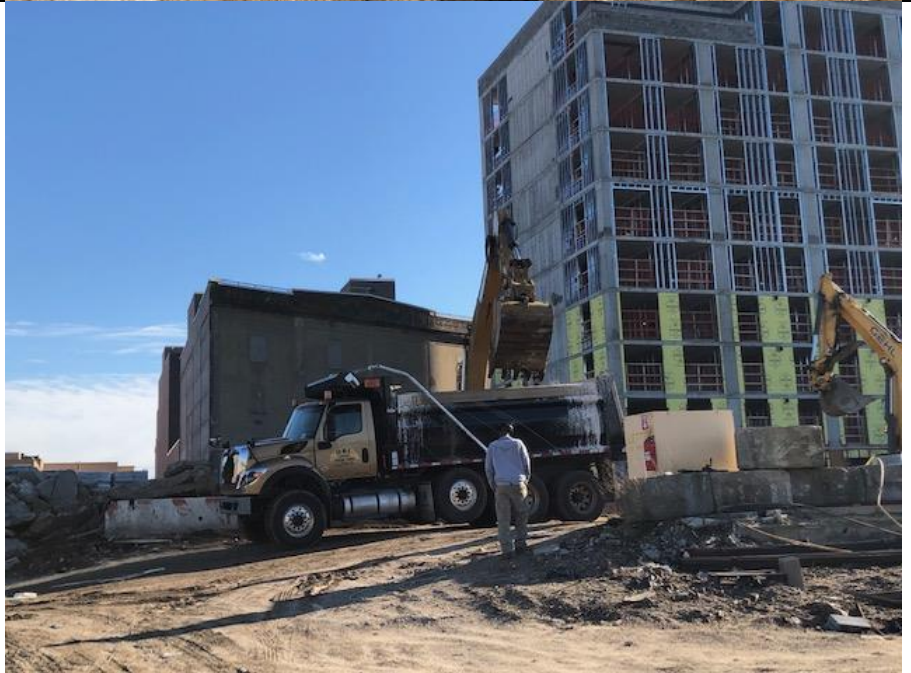
Photo 2- View of loading out of concrete and debris for export offsite.

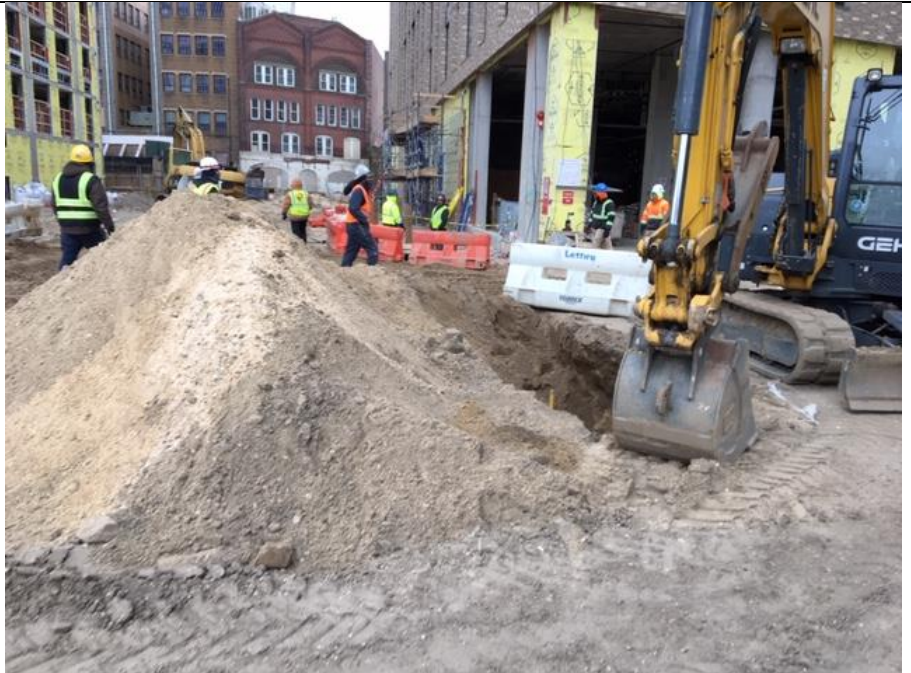
Photo 1- View of excavated clean fill and utility installation in B4 and B5.

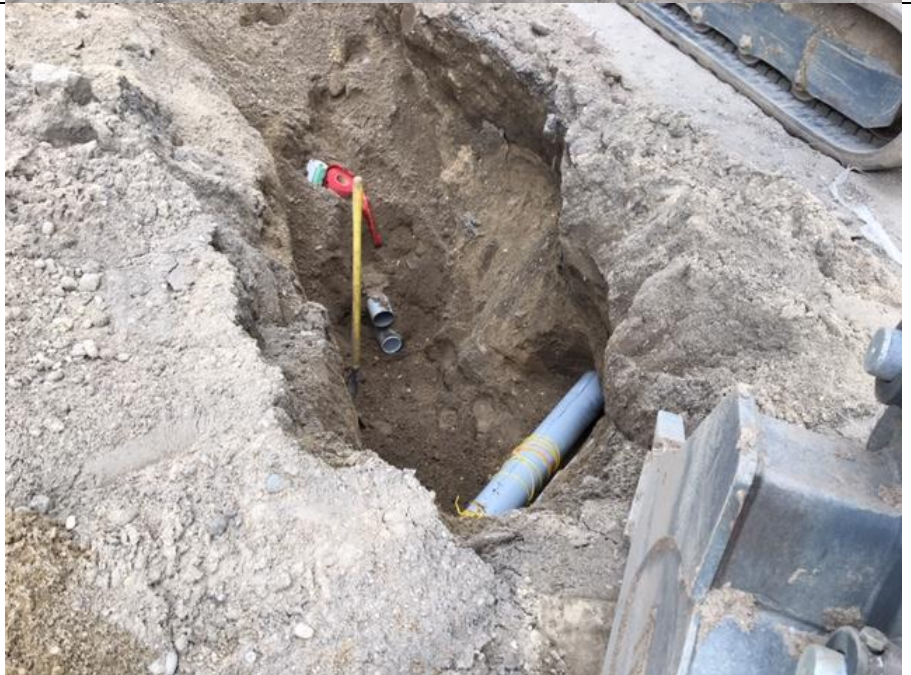
Photo 2- View of excavated clean fill and utility installation in B4 and B5.

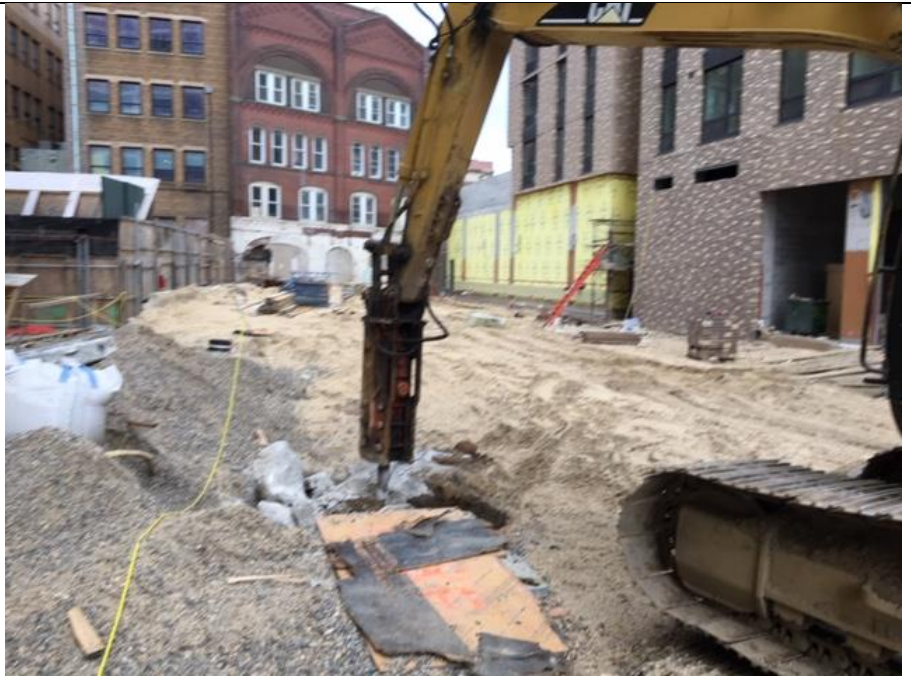
Photo 3- View  
of breaking up  
concrete in D5.

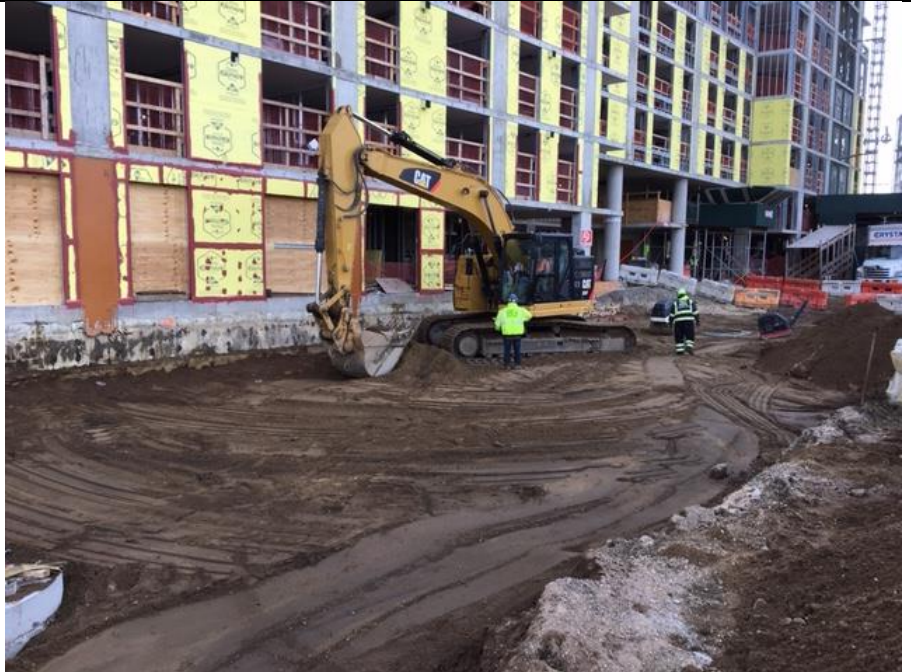
Photo 1- View  
of grading  
clean fill in C6.

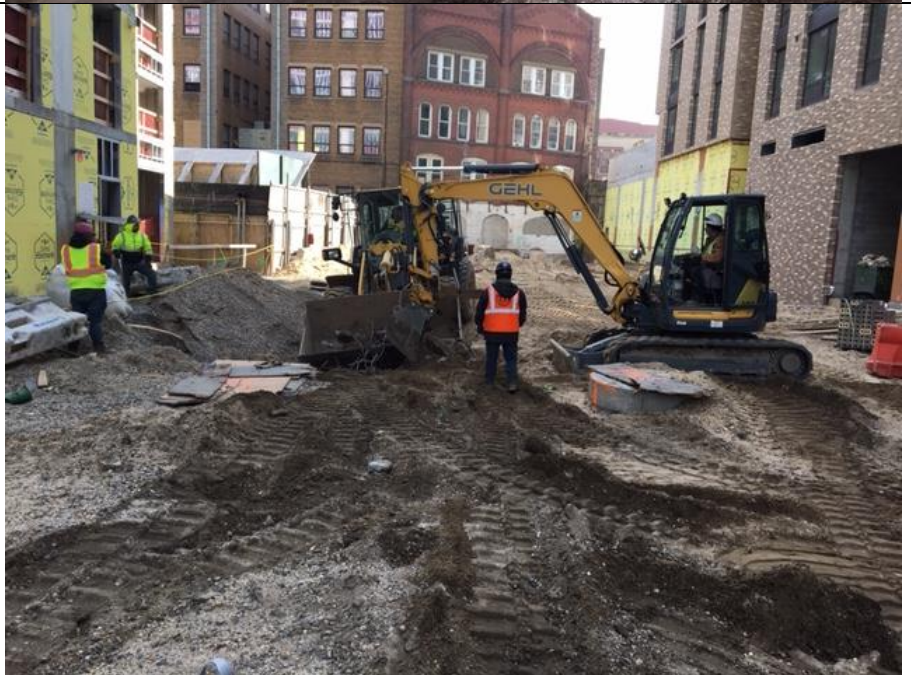
Photo 2- View  
of breaking up  
and stockpiling  
concrete in D5.

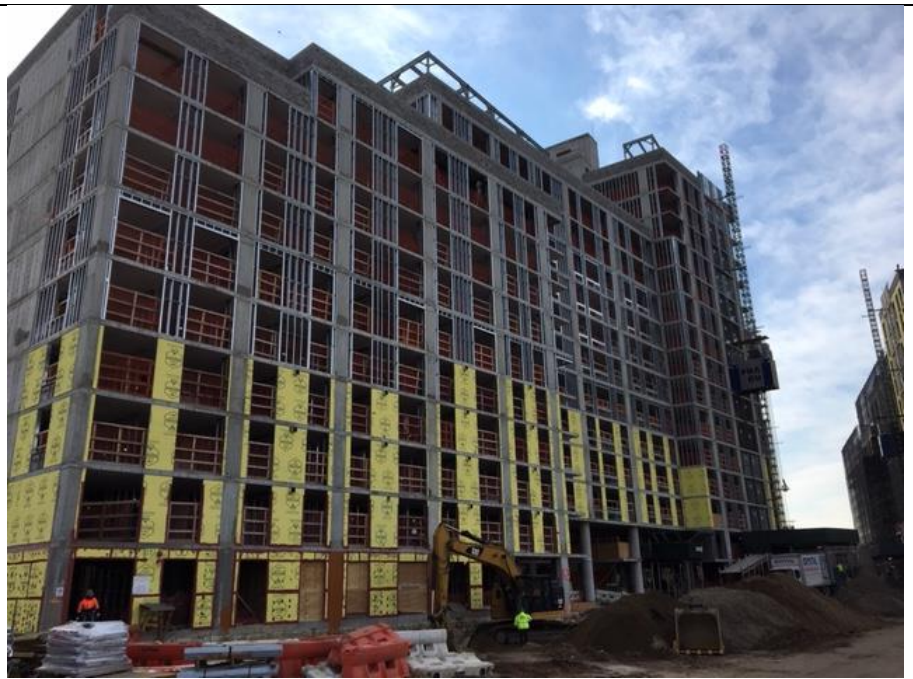
Photo 3- View of utility and formwork installation in C6-C8.

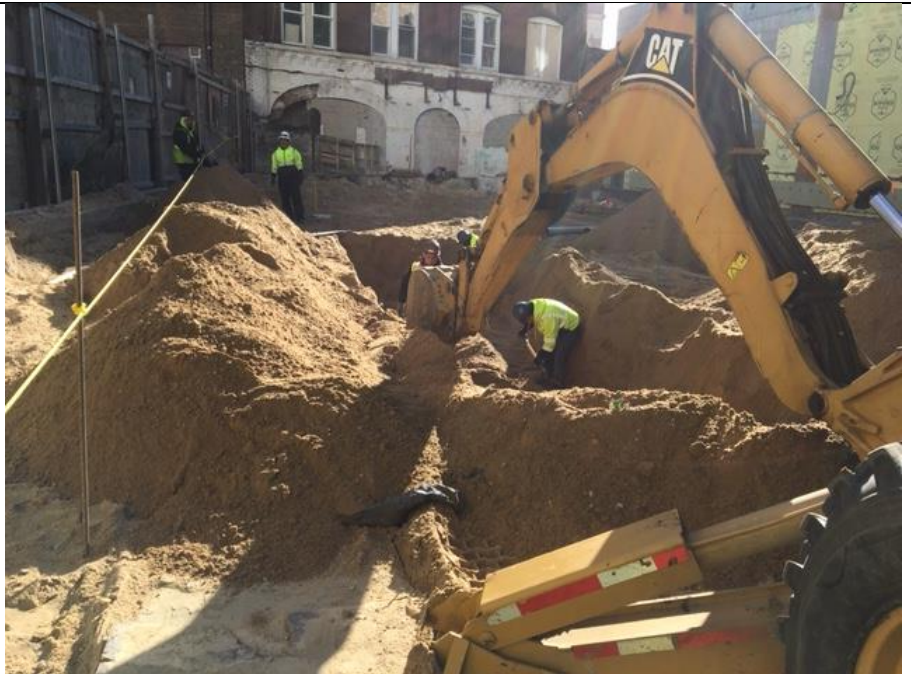
Photo 1- View of excavating clean fill and installing utilities in D5 and E5.

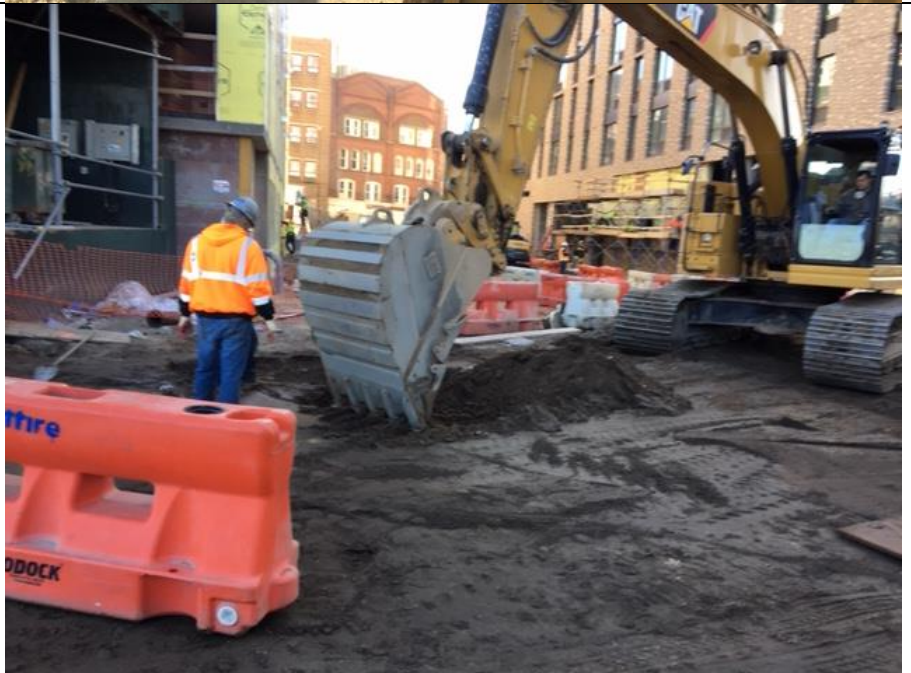
Photo 2- View of excavating clean fill in C5 for utility installation.

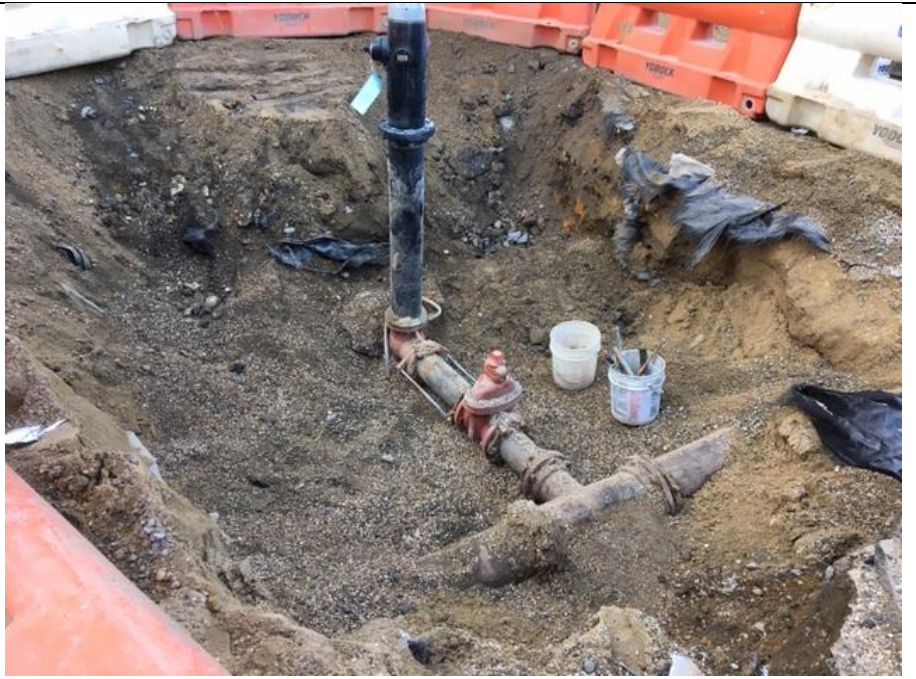
Photo 3- View  
of utility B5.

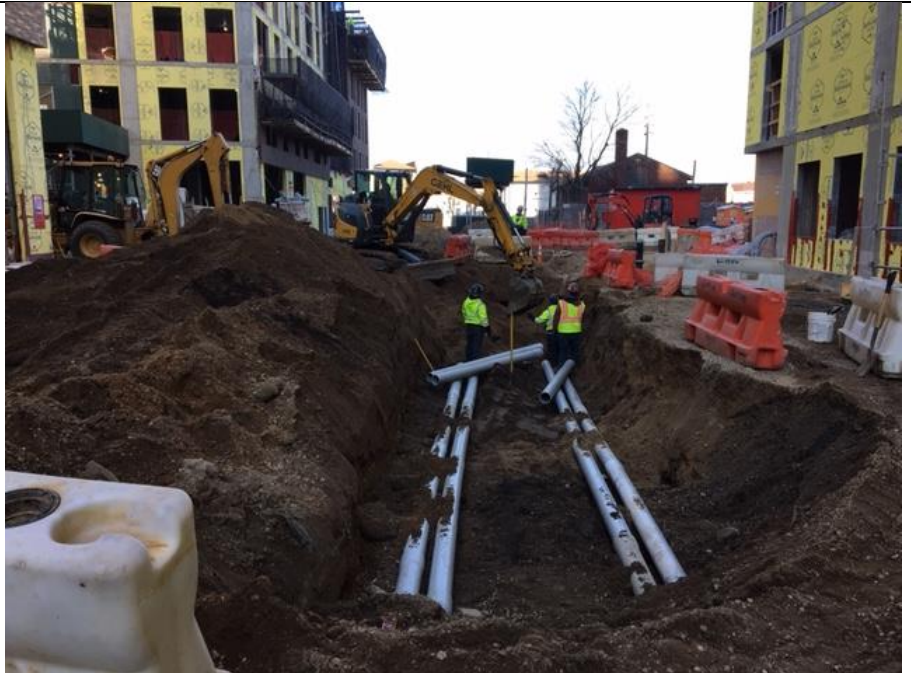
Photo 1- View of excavating clean fill and installing utilities in D5 and E5.

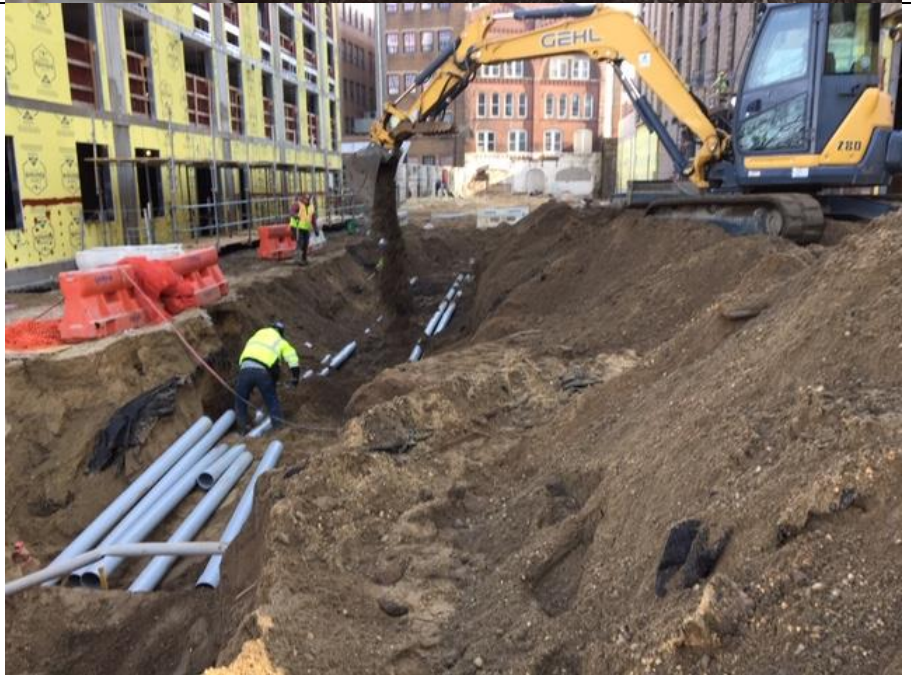
Photo 2- View of backfilling clean fill in C5 for utility installation.

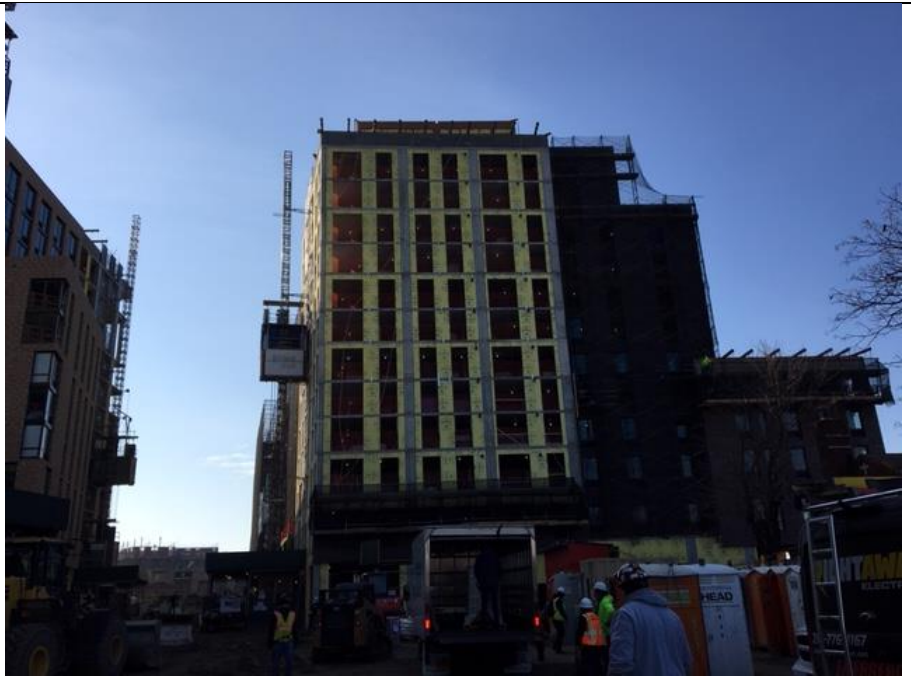
Photo 3- View of utility and formwork installation in A3, A4, B3, and B4.

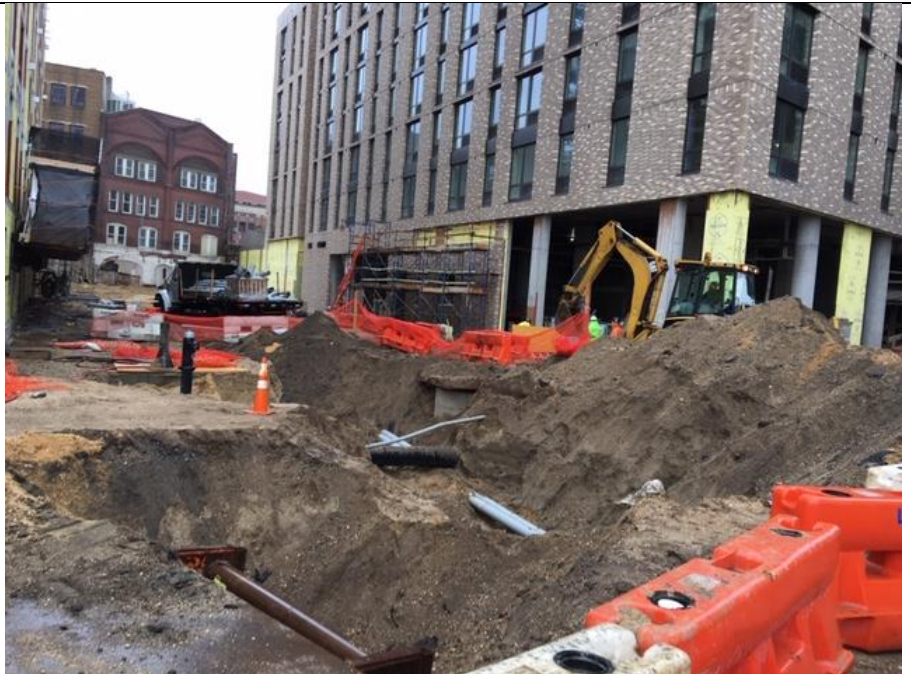
Photo 1- View of excavating clean fill and installing utilities in D5 and C5.

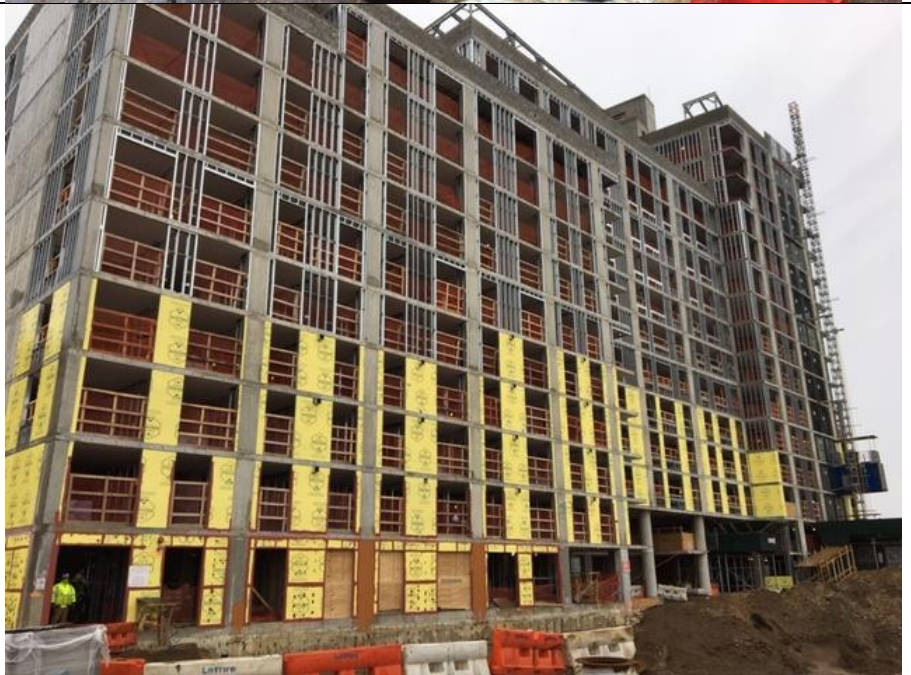
Photo 2- View of utility and formwork installation in C6-C8.

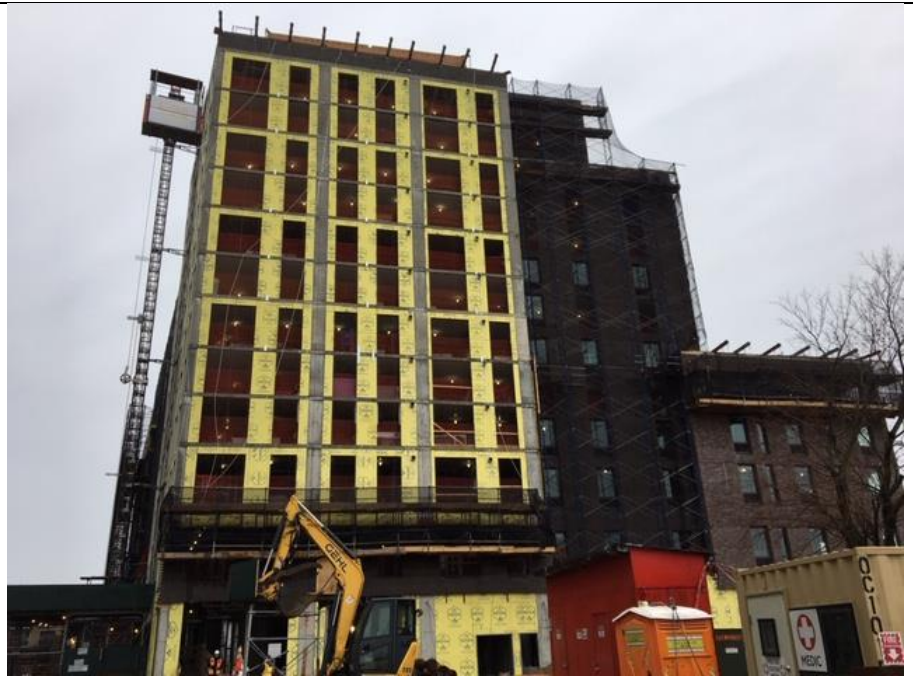
Photo 3- View of utility and formwork installation in A3, A4, B3, and B4.

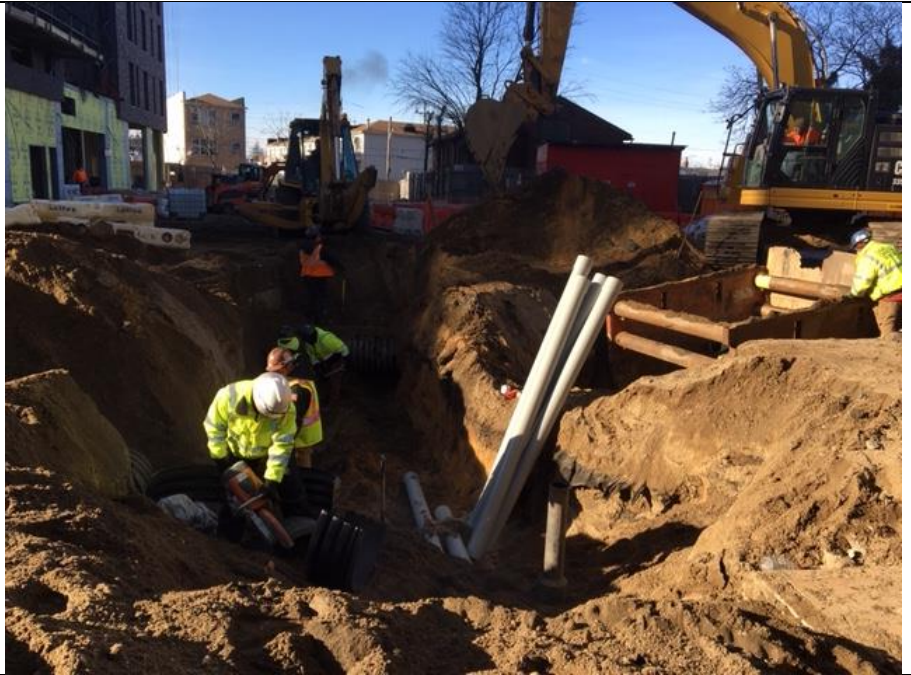
Photo 1- View of clean fill excavation and utilities installation in D5 and C5.

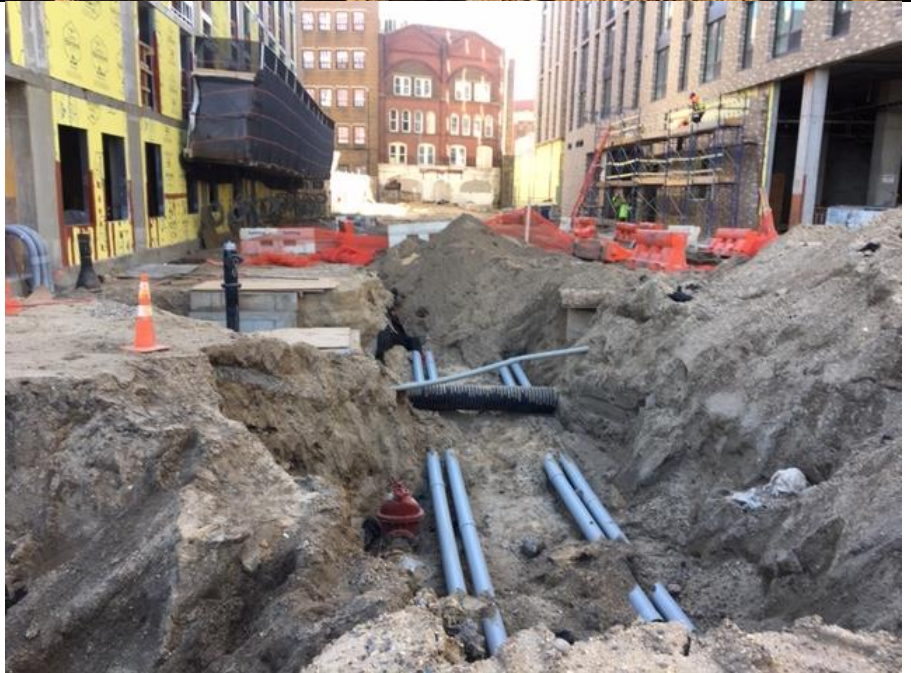
Photo 2- View of utility installation in C5 and D5.

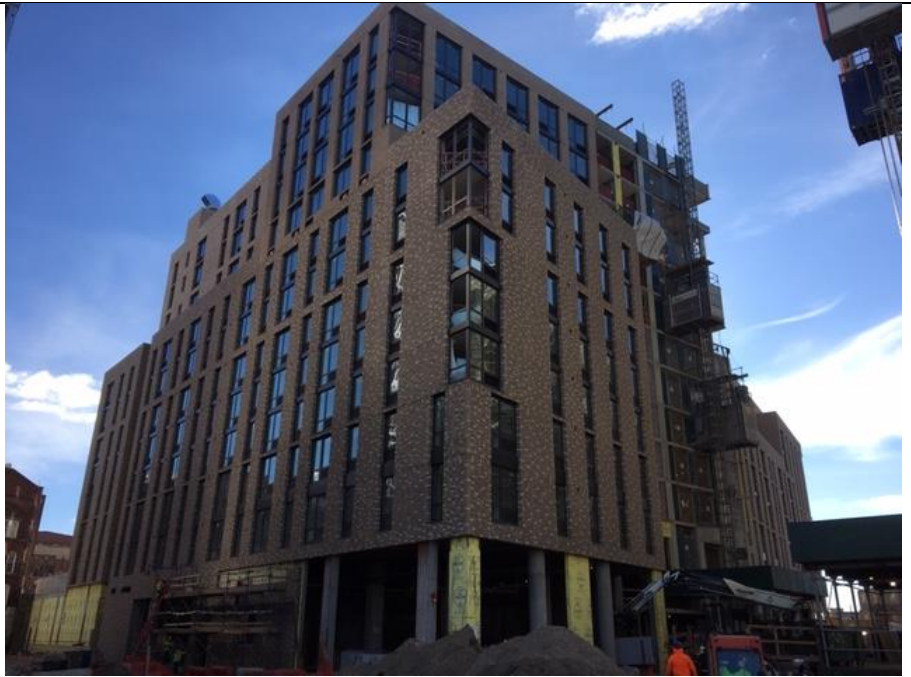
Photo 3- View of utility and formwork installation in D4, D5, E4, and E5.

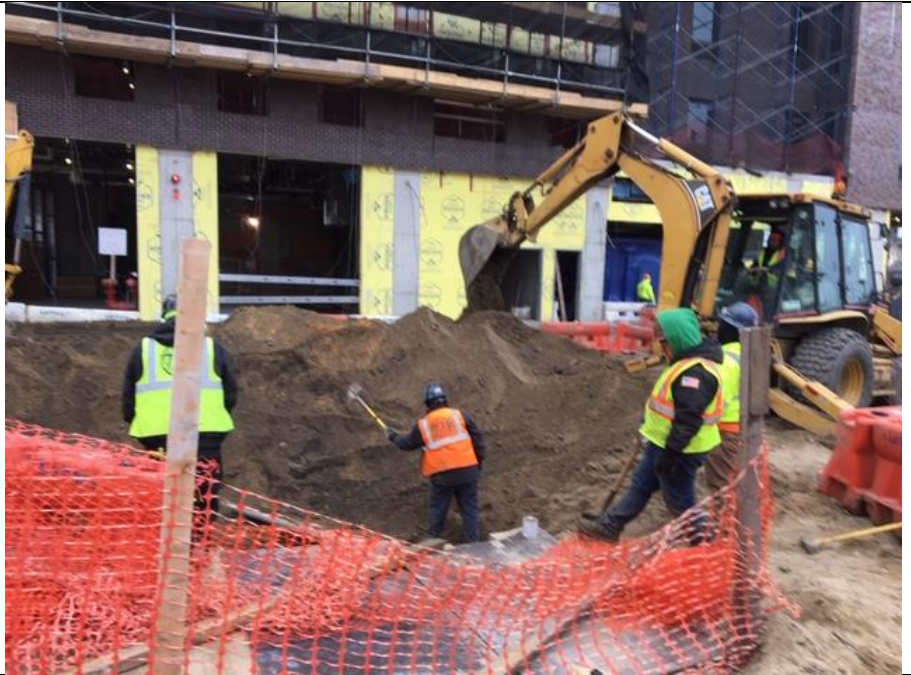
Photo 1- View of clean fill excavation and utilities installation in B5 and C5.

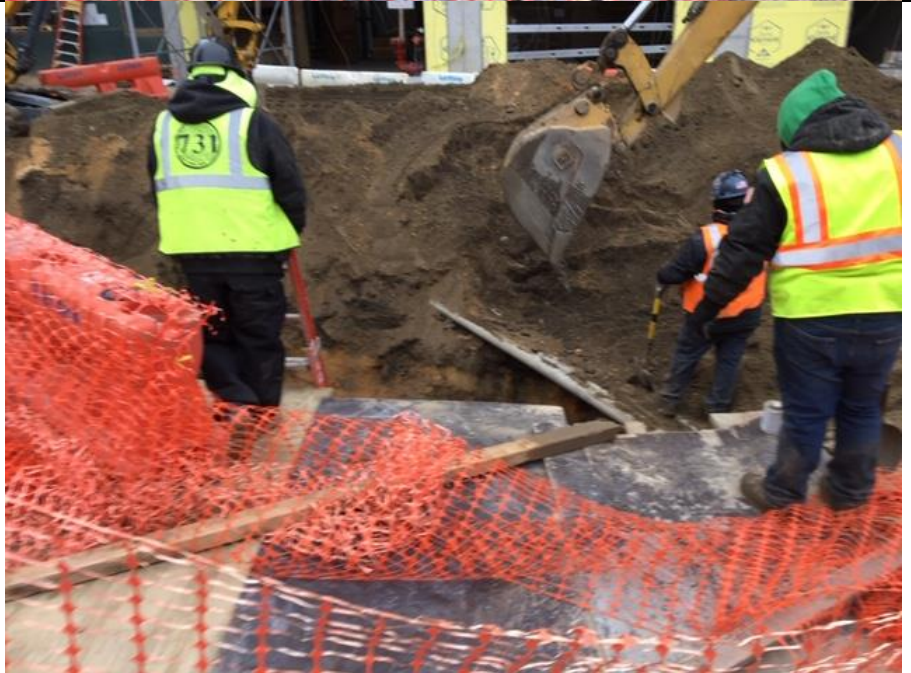
Photo 2- View of utility installation in B5 and C5.

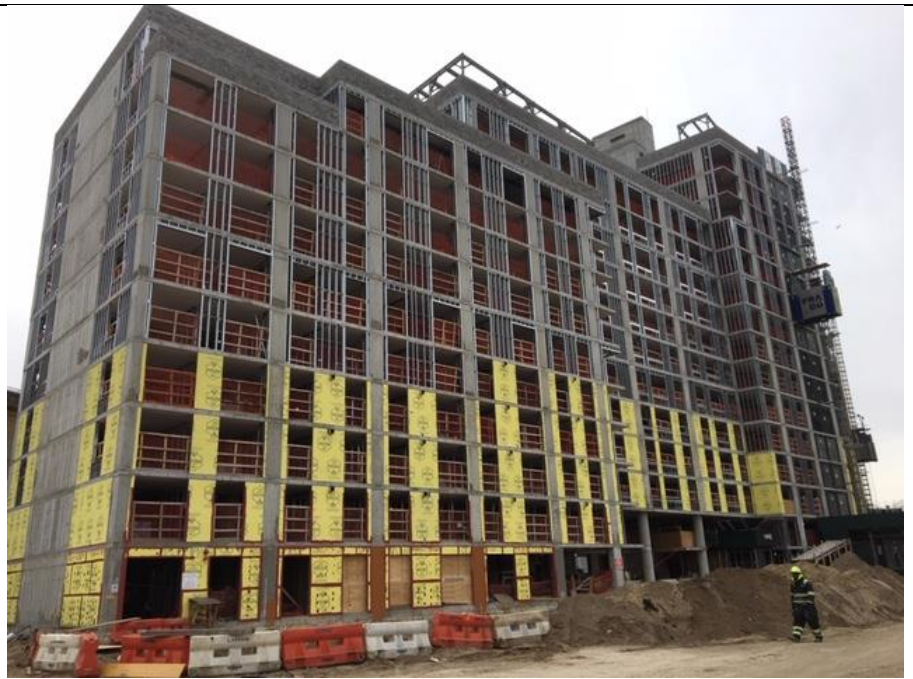
Photo 3- View  
of utility and  
formwork  
installation in  
C6-C8.

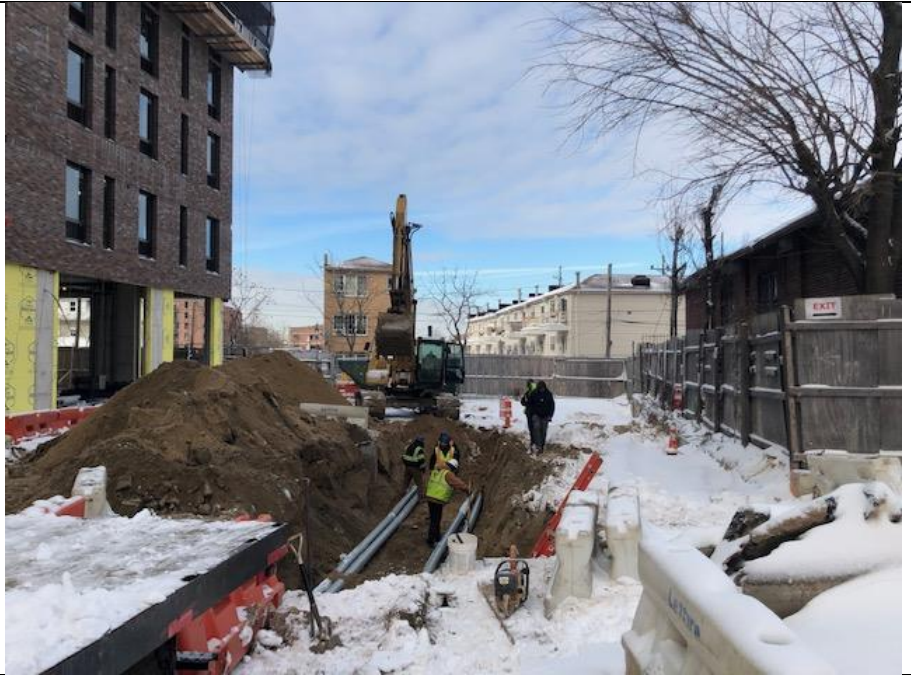
Photo 1- View of clean fill excavation and utilities installation in B5 and C5.
