## **Daily Report for December 1, 2020**

**Far Rockaway Project  
20-02 Mott Avenue  
Far Rockaway, NY  
BCP #C241224**

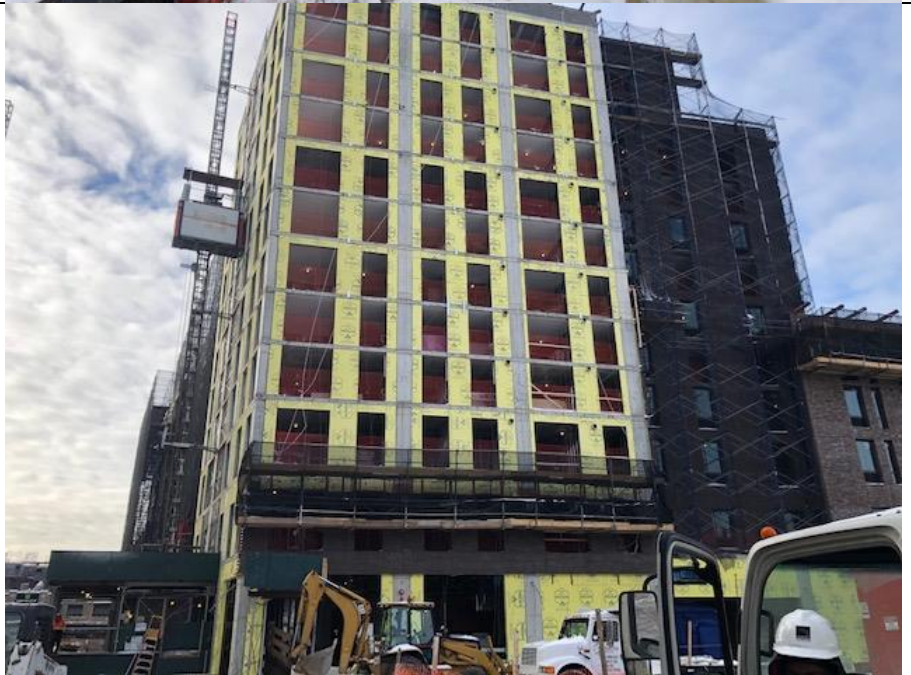
Photo 2- View of utility and formwork installation in A3, A4, B3, and B4.

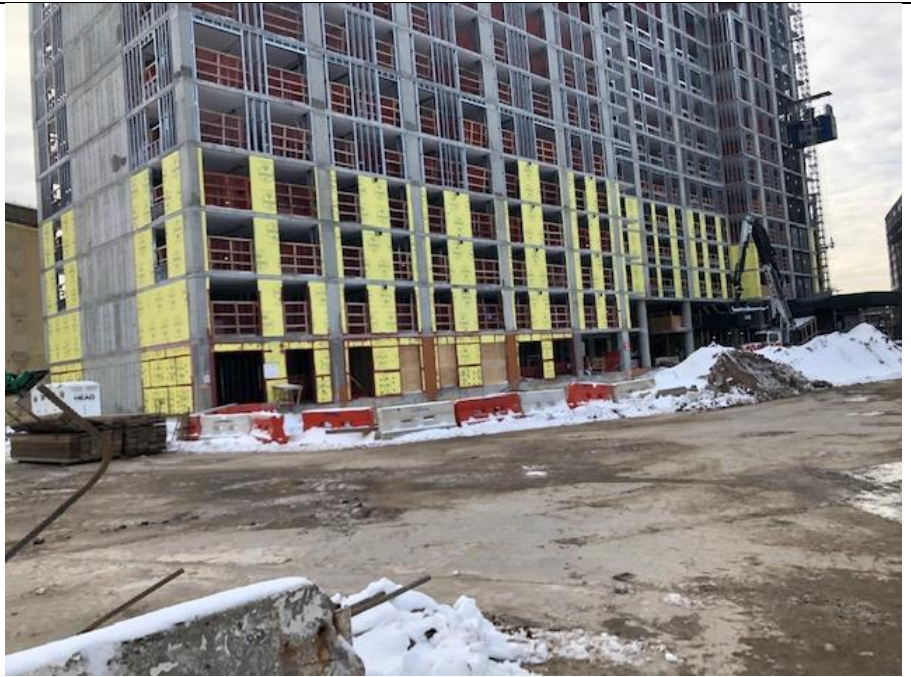
Photo 3- View  
of utility and  
formwork  
installation in  
C6-C8.

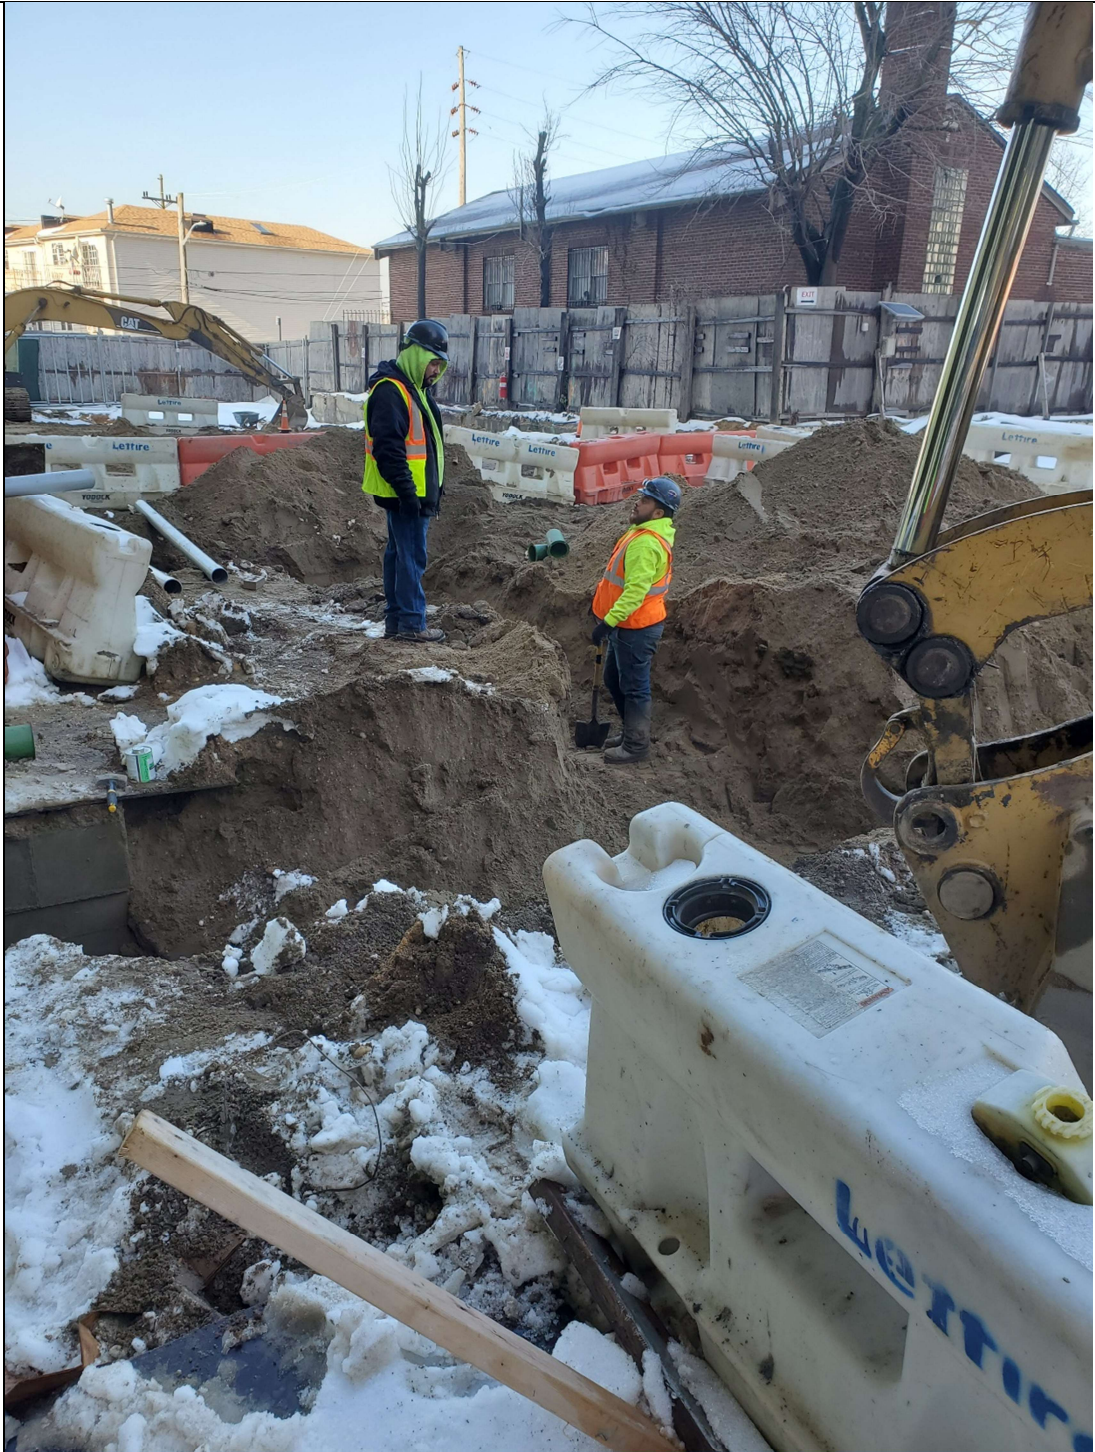
Photo 1-  
View of  
clean fill  
excavati  
on and  
utilities  
installati  
on A5  
and B5.

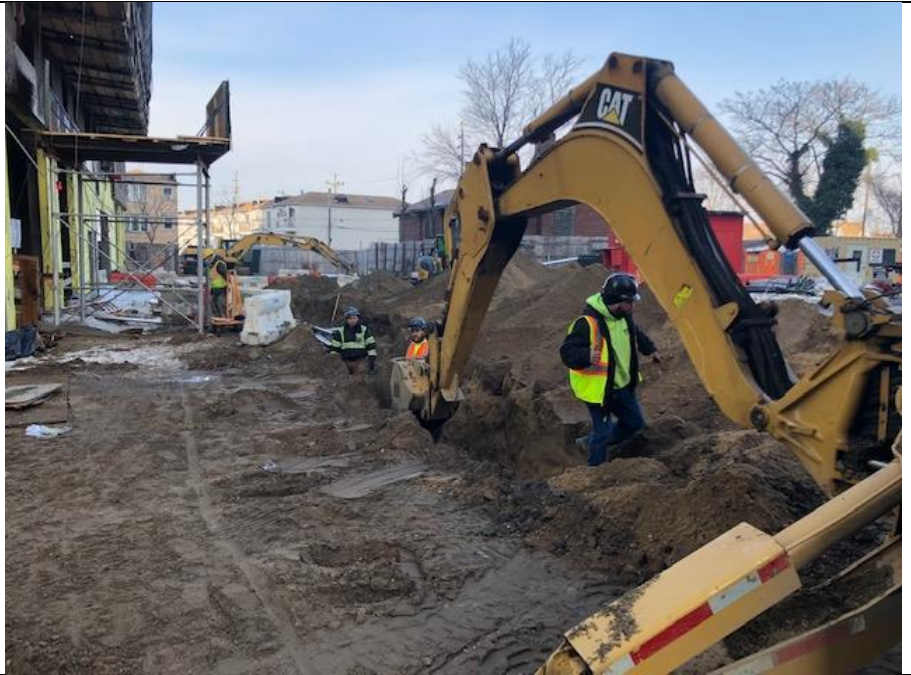
Photo 1- View of clean fill excavation and utilities installation in B5 and C5.

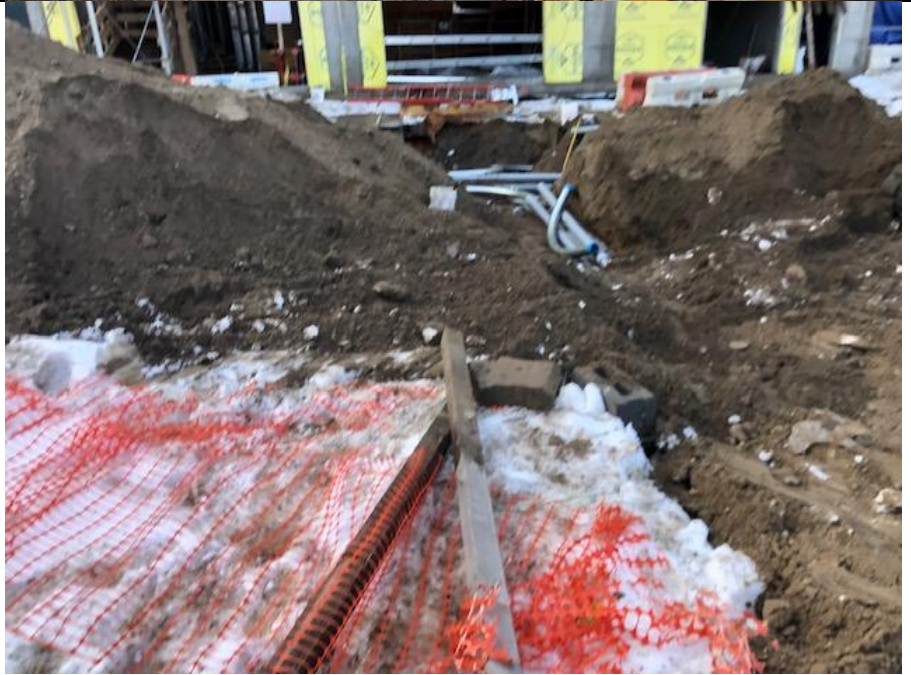
Photo 2- View of utility installation in B5.

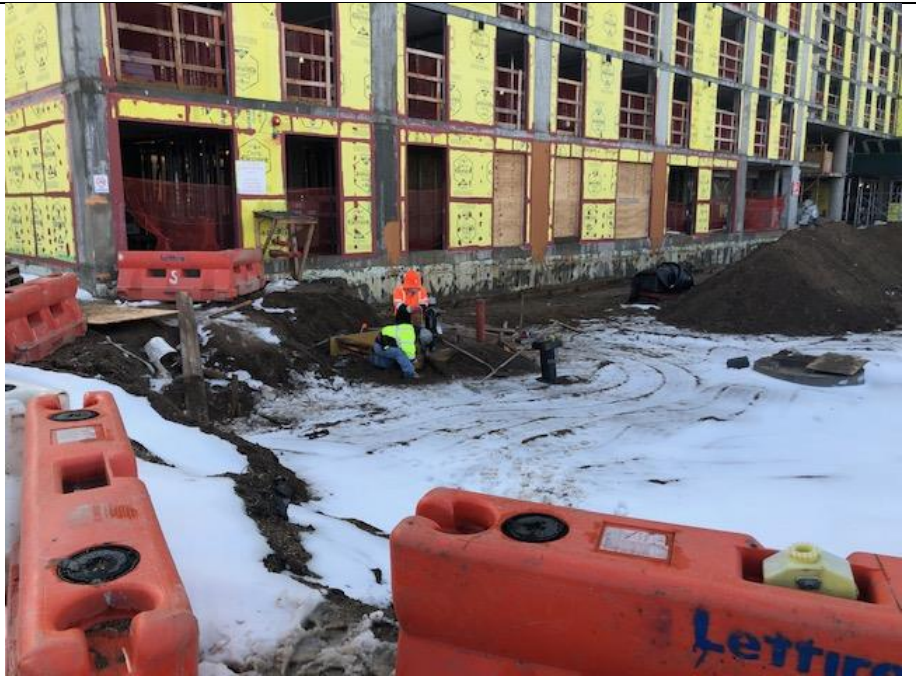
Photo 3- View  
of utility  
installation in  
C8.

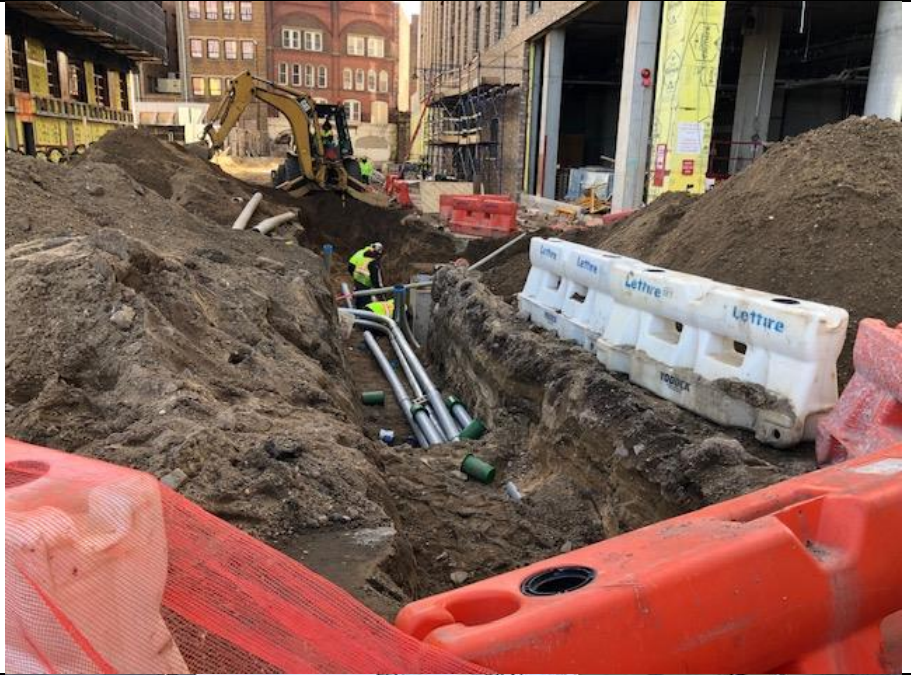
Photo 1- View of clean fill excavation and utilities installation in B5 and C5.

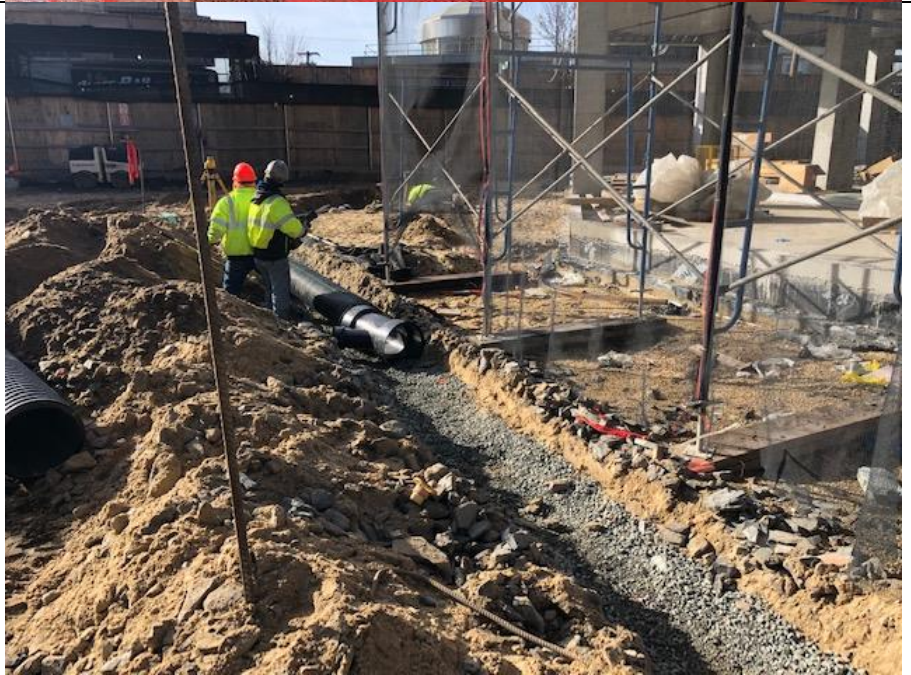
Photo 2- View of utility installation in B1 and B2.

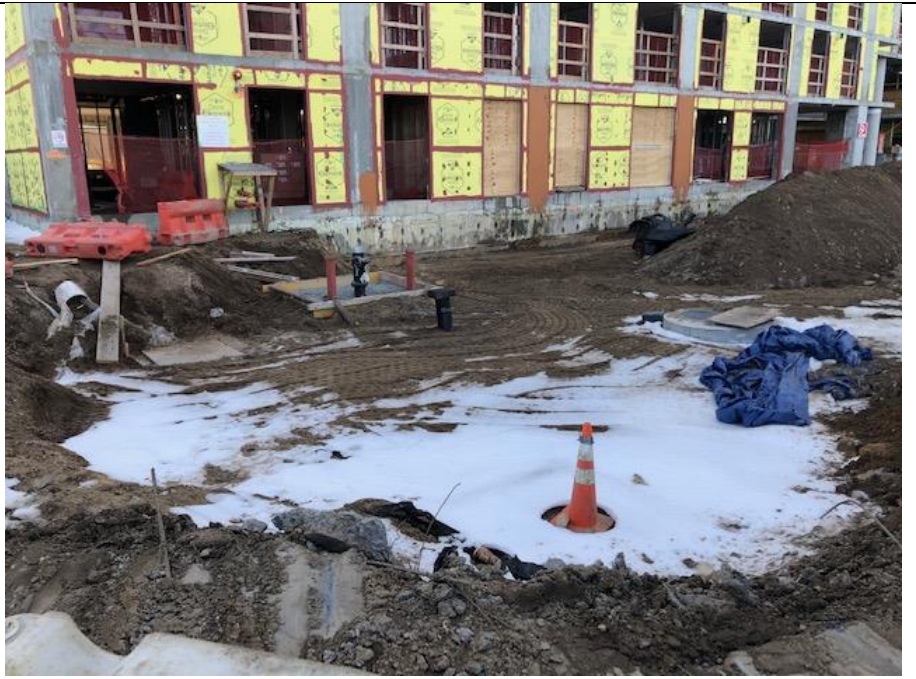
Photo 3- View  
of installed  
utility in C8.

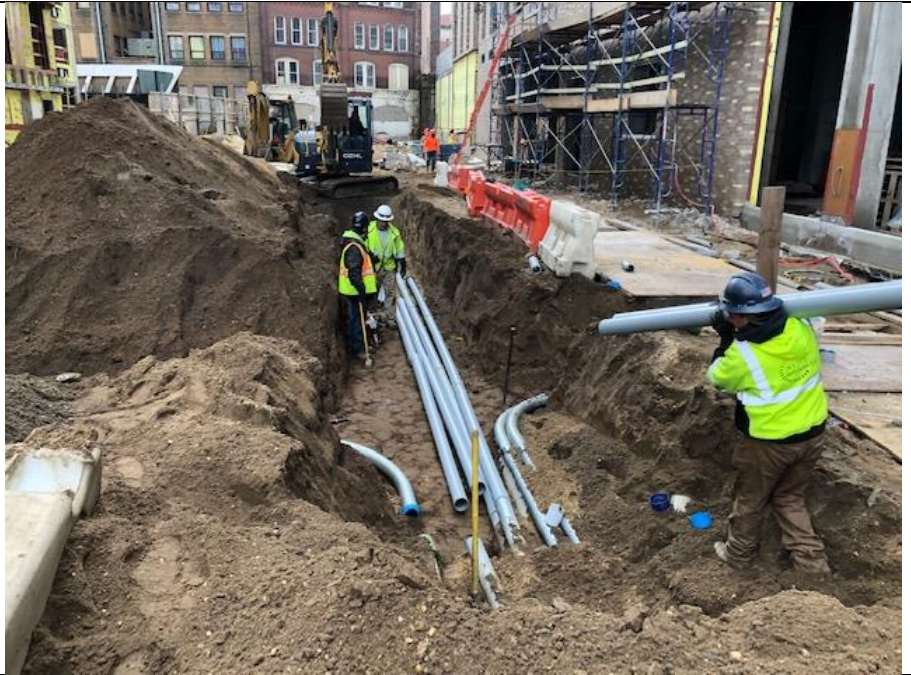
Photo 1- View of clean fill excavation and utilities installation in C5 and D5.

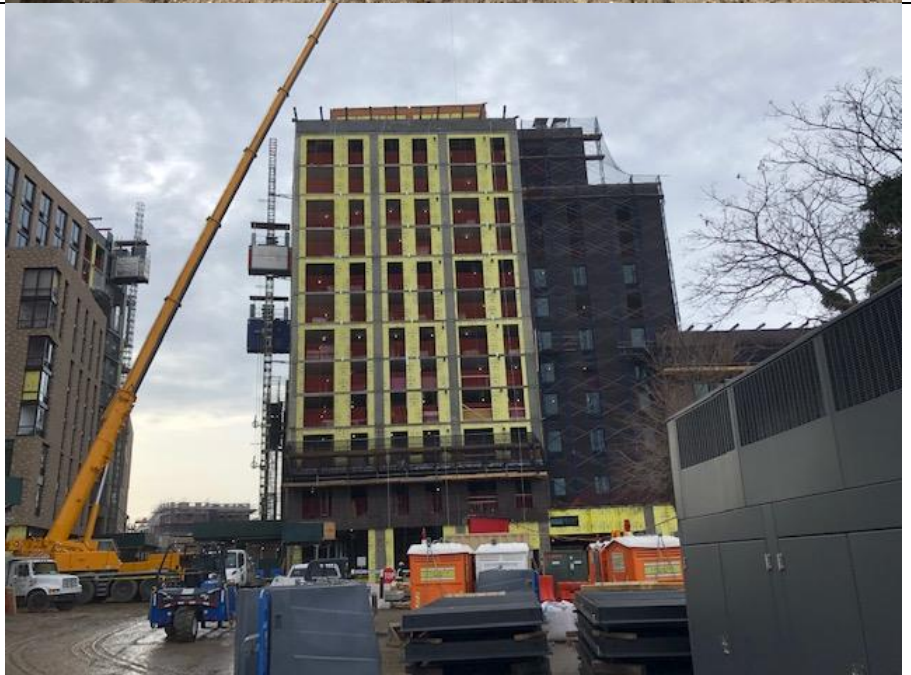
Photo 2- View of formwork and utility installation in A3, A4, B3, and B4.

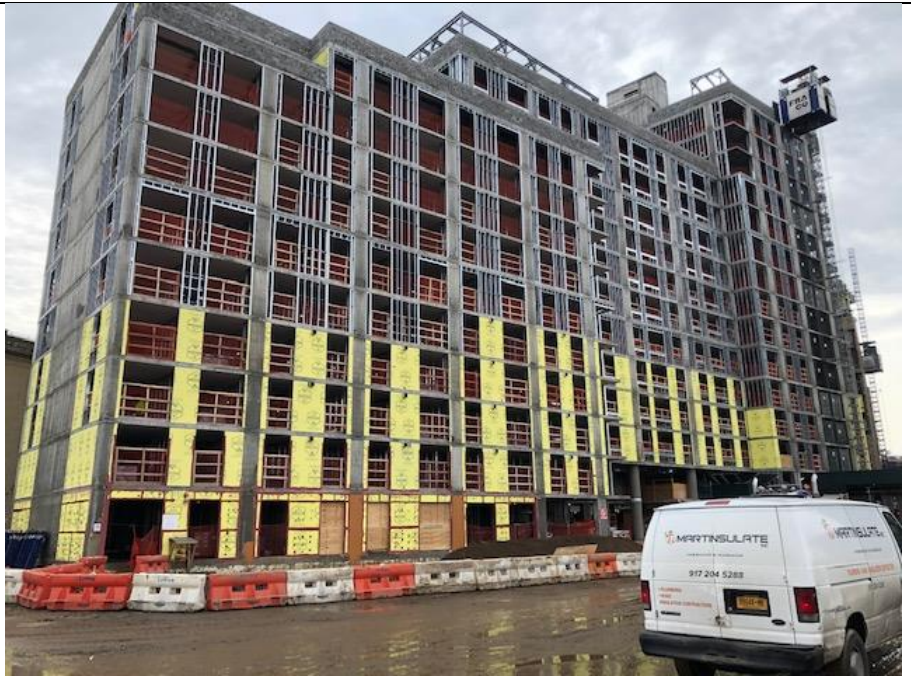
Photo 3- View of formwork and utility installation in C6 through C8.

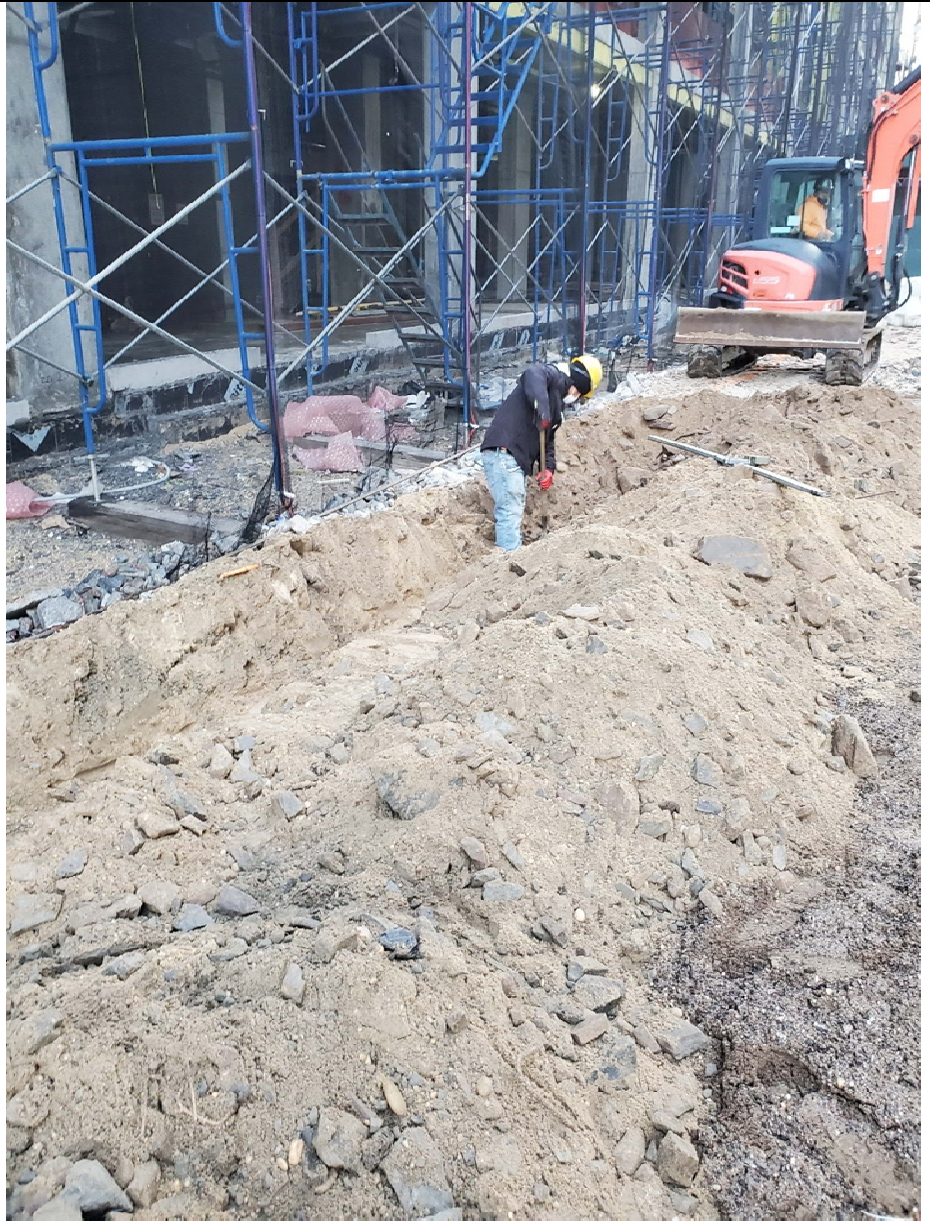
Photo 1- View of clean fill excavation and utilities installation in B1 and B4.

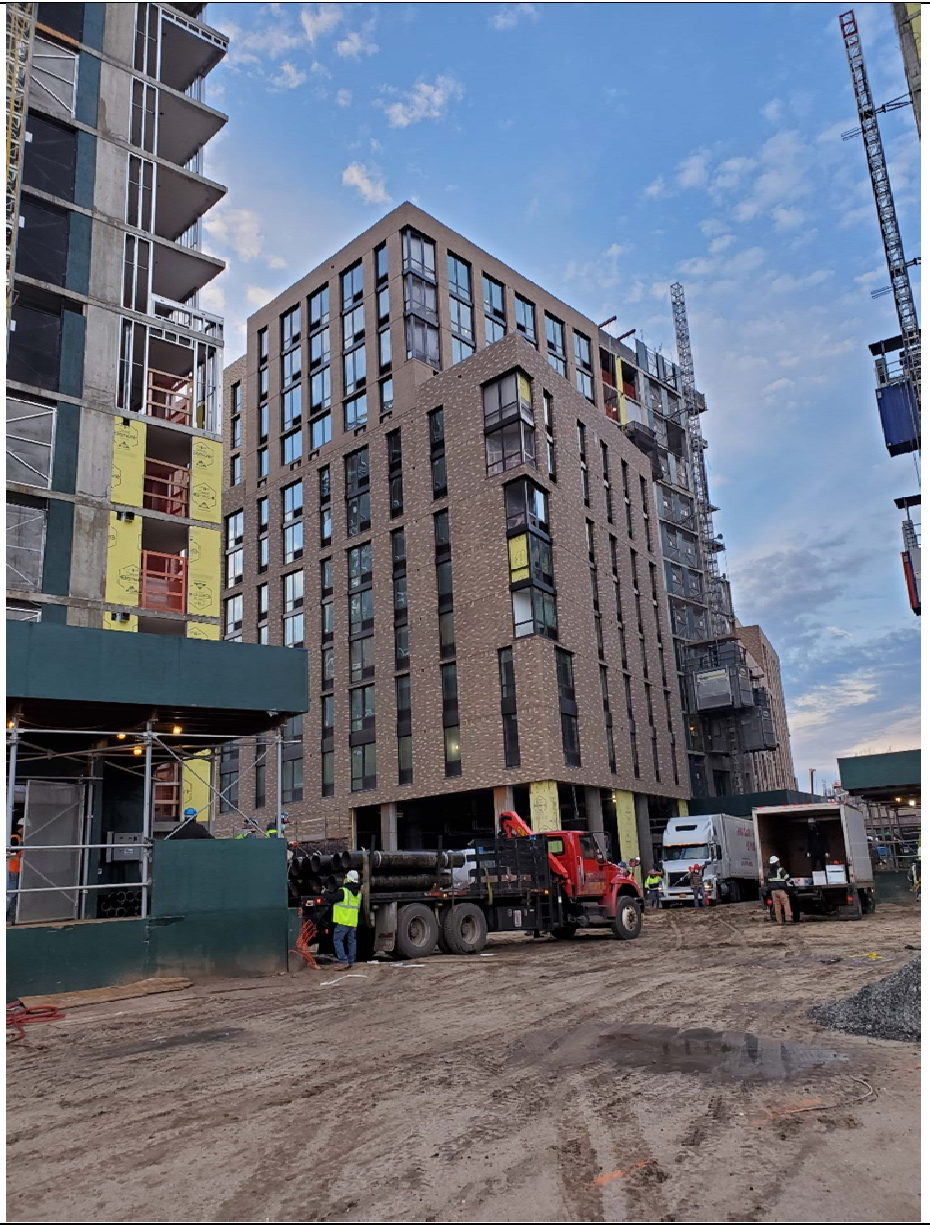
Photo 2- View of formwork and utility installation at Building B in C3, C4, and D4.

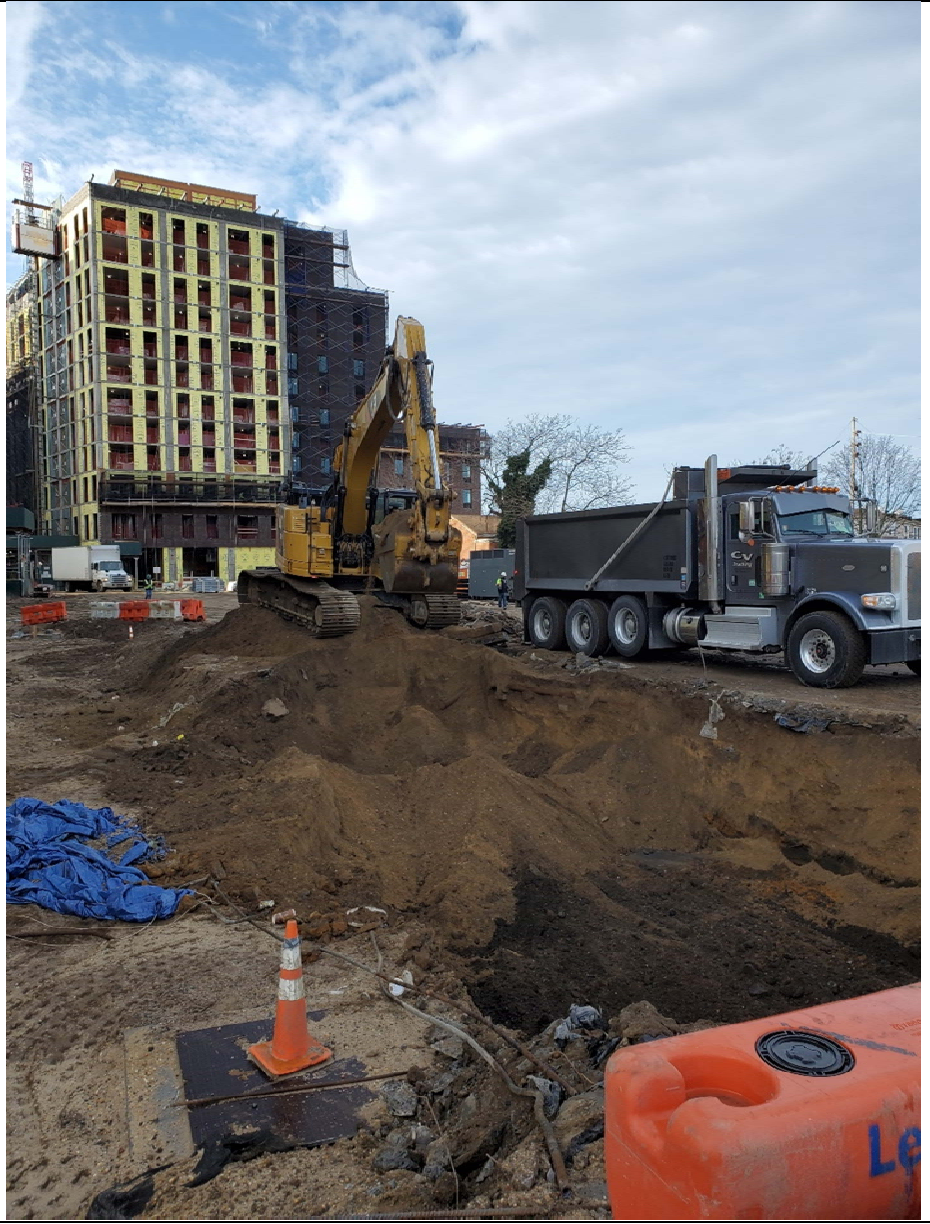
Photo 3- View of excavation and soil export from C6, C7, and C8.

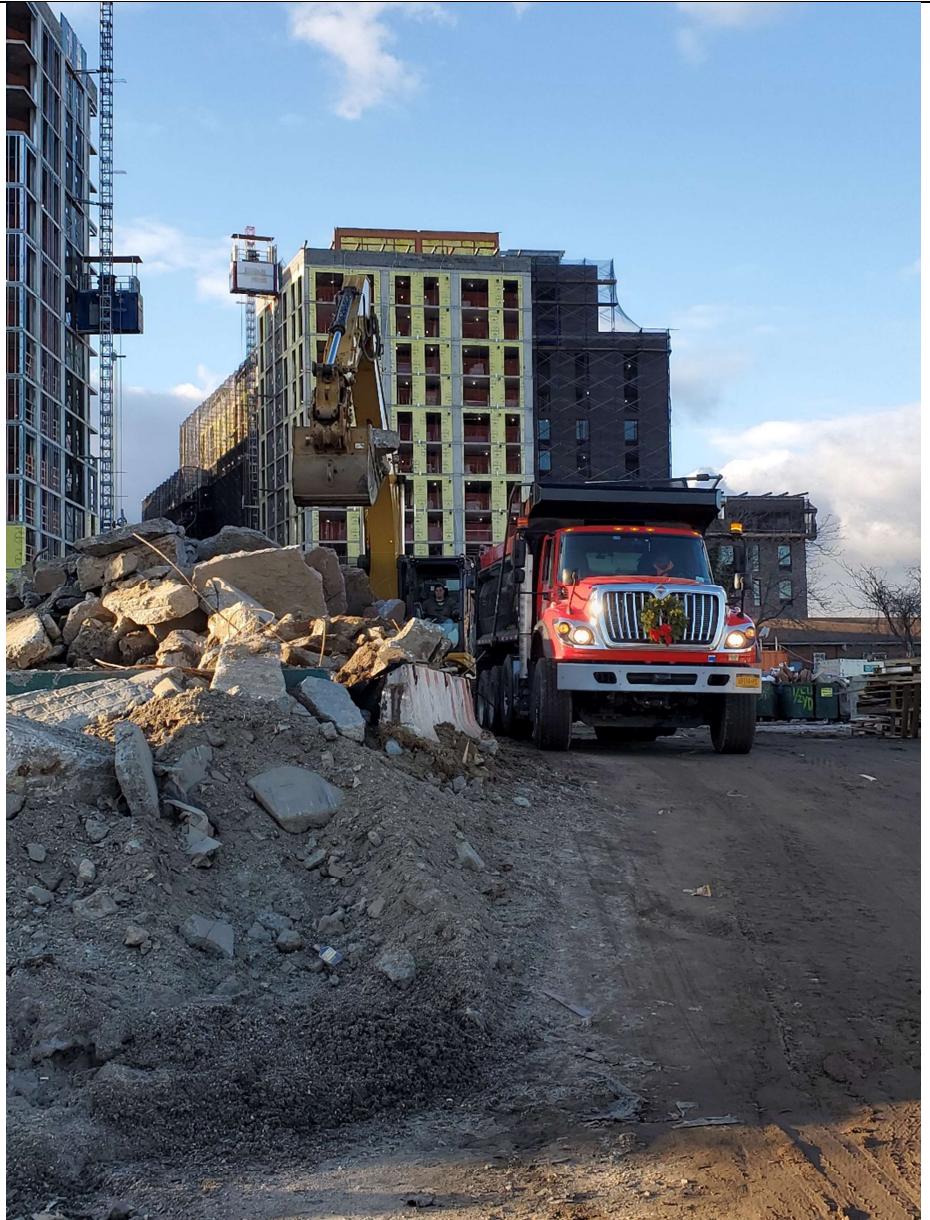
Photo 1- View  
of concrete  
removal.

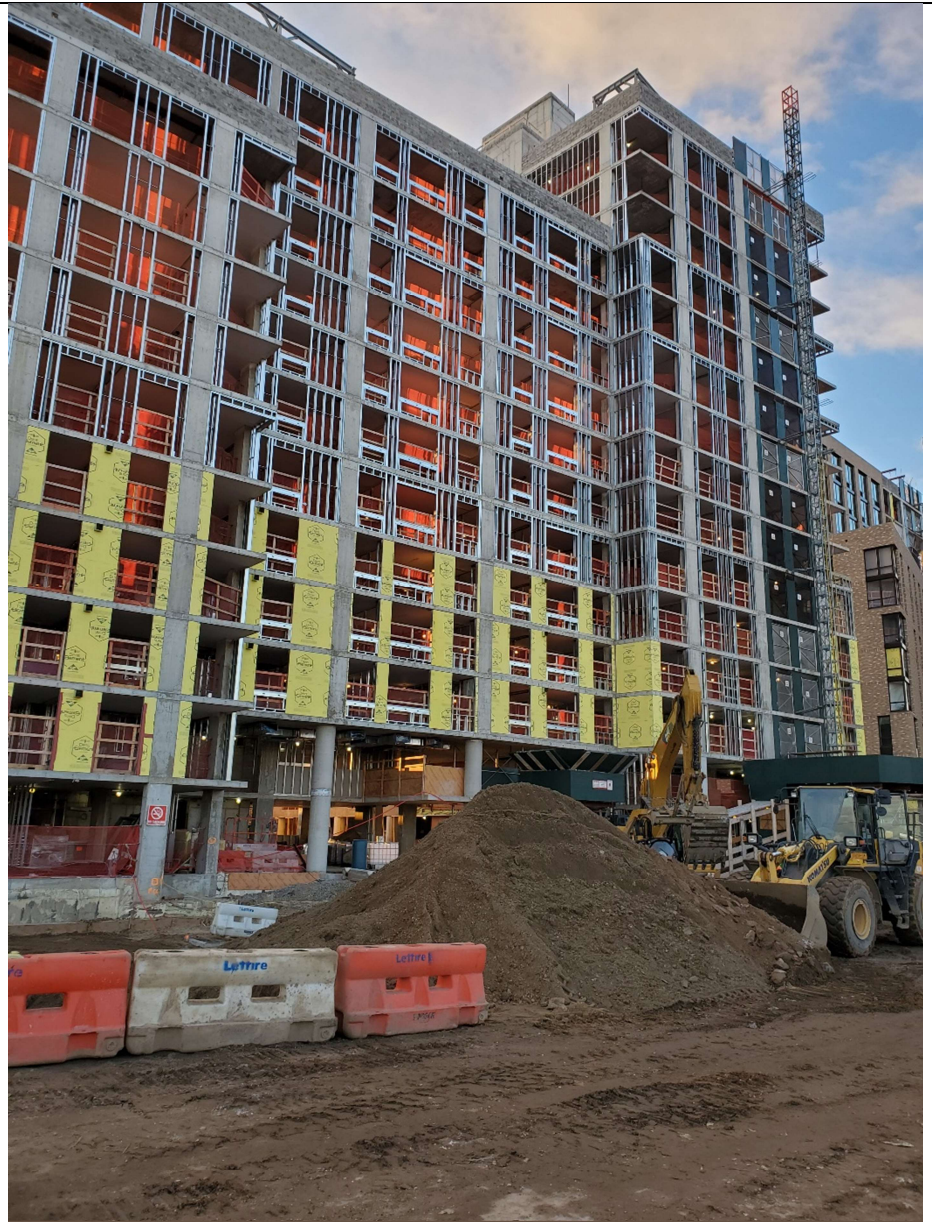
Photo 2- View of formwork and utility installation at Building H in C5, C6, and C7.

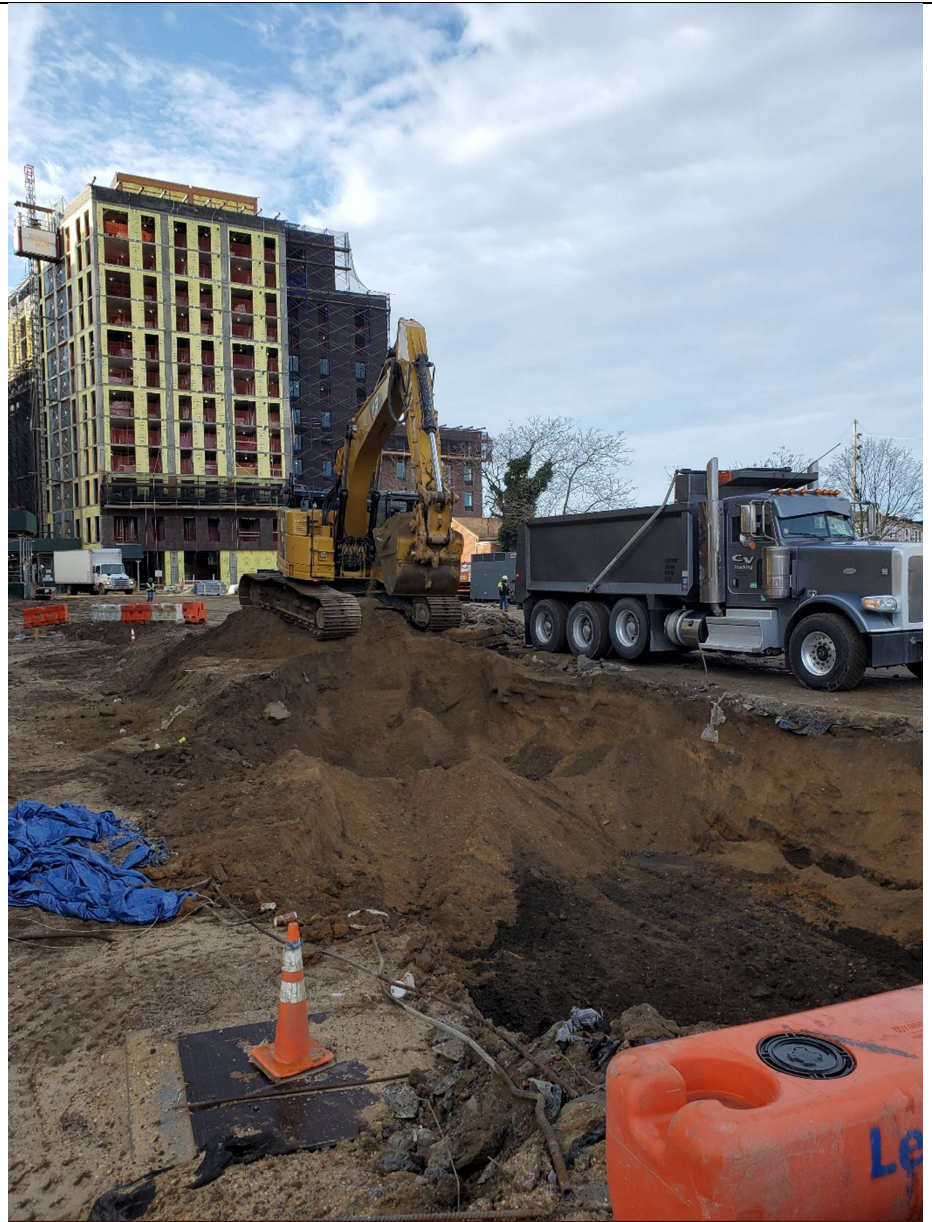
Photo 3- View of excavation and soil export from C6, C7, and C8.
