Daily Report for January 4, 2021

**Far Rockaway Project
20-02 Mott Avenue
Far Rockaway, NY
BCP #C241224**

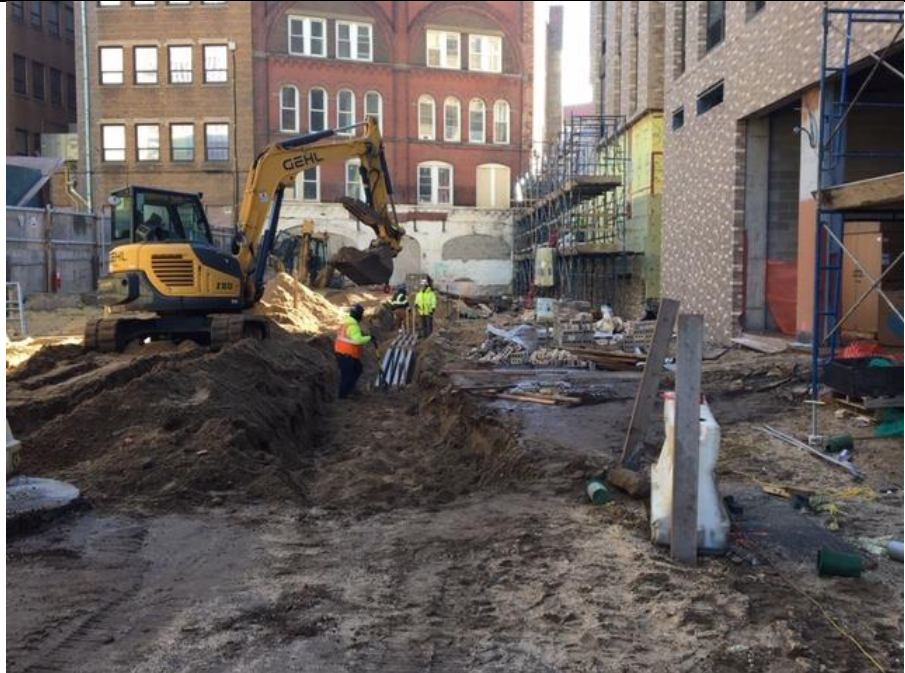
Photo 1- View of backfilling with clean fill in D5 and E5.

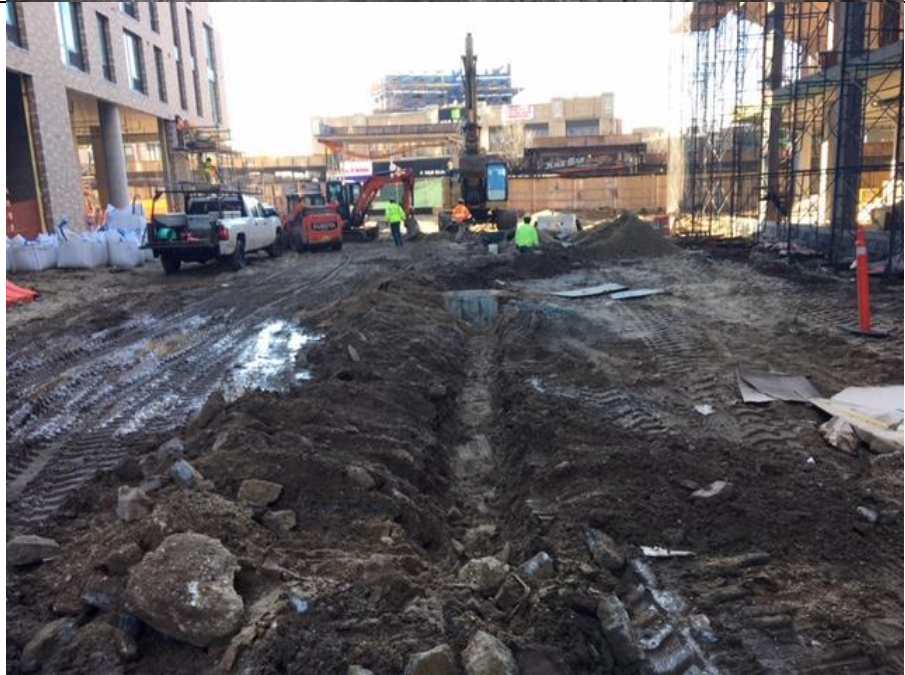
Photo 2- View of excavation for utility installation in B1 and B2.

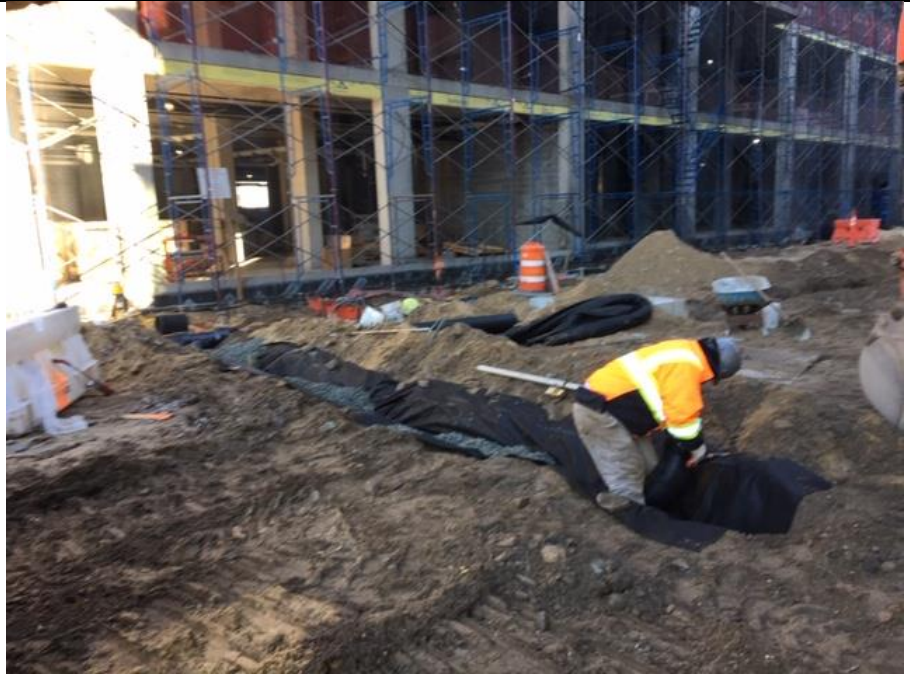
Photo 3- View
of utility
installation in
B1 and B2.

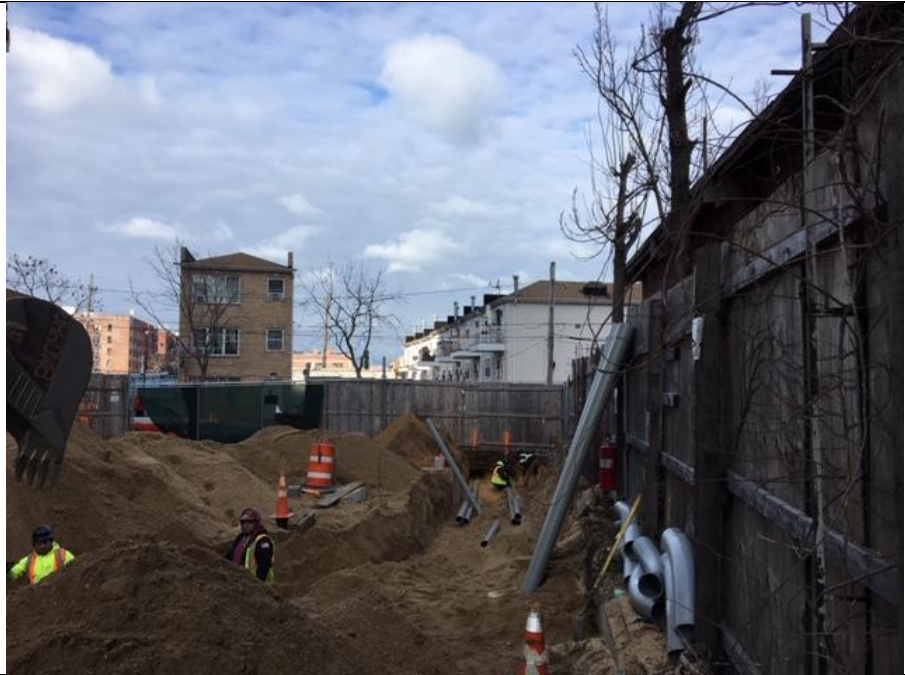
Photo 1- View of excavating clean fill in A5 and B5.

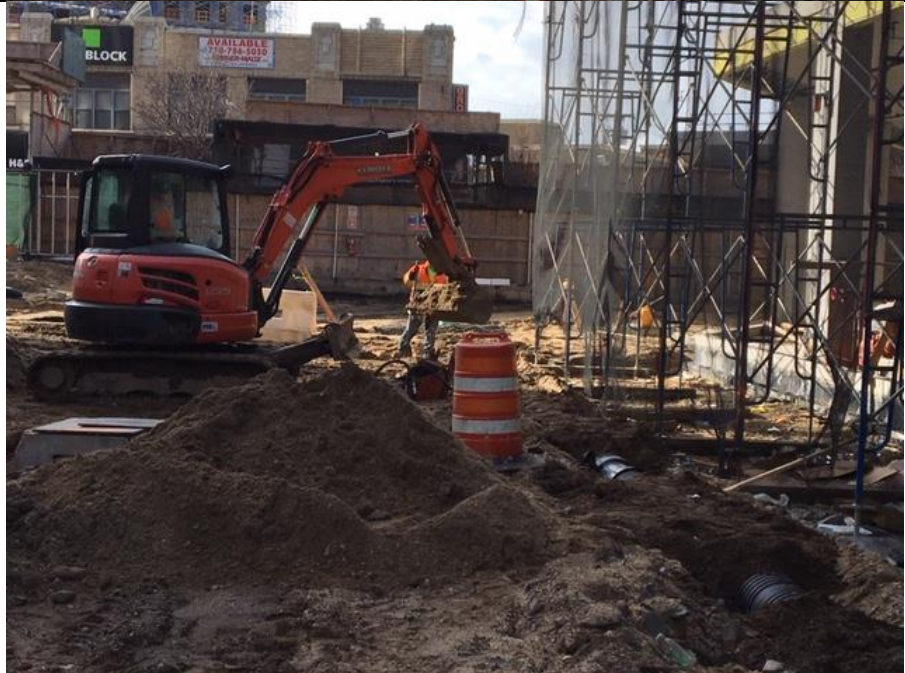
Photo 2- View of backfilling with clean fill in B1 and B2.

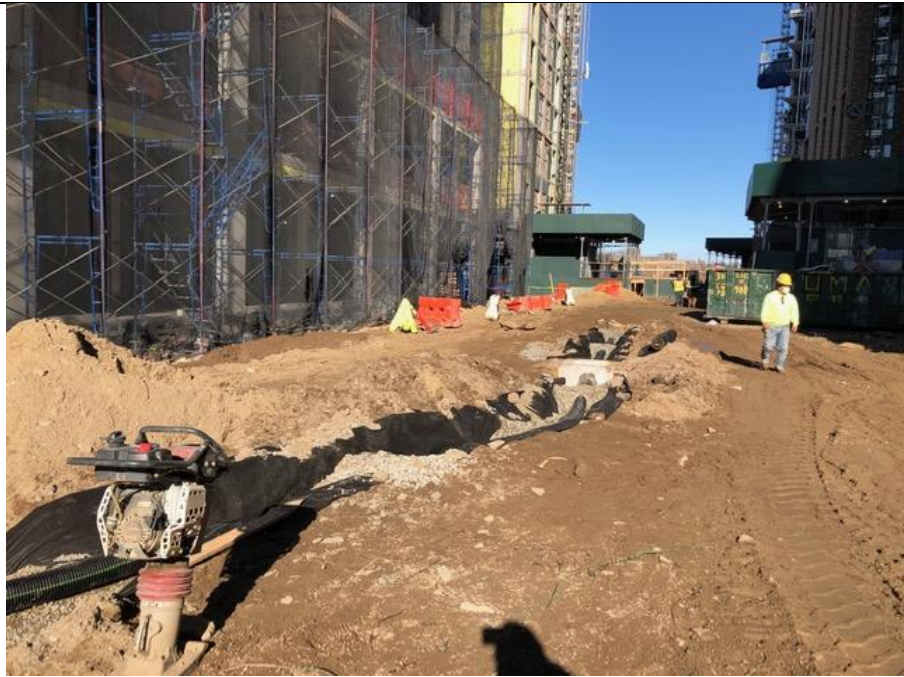
Photo 3- View
of utility
installation in
B1 and B2.

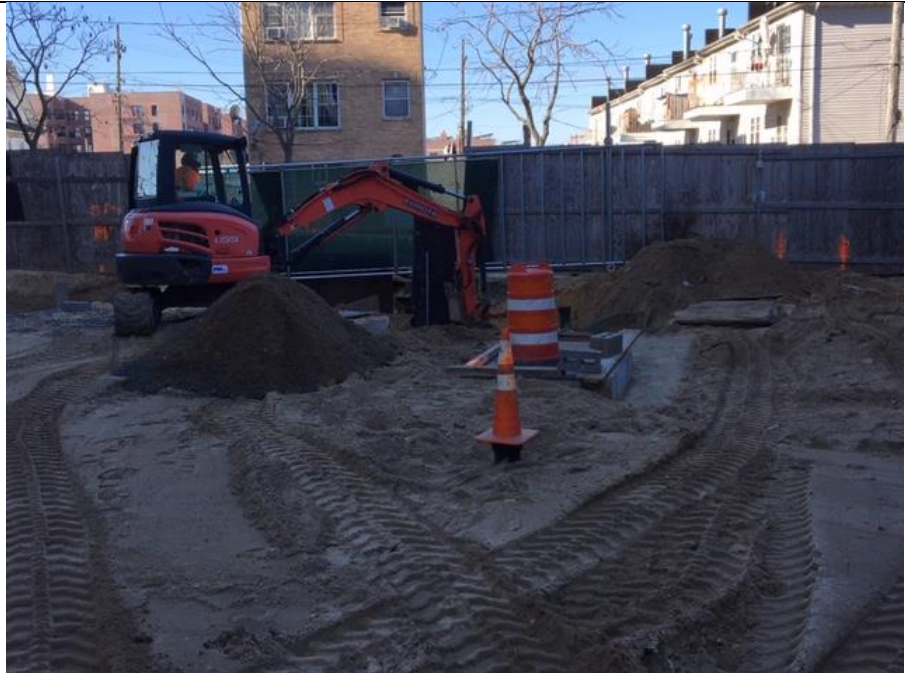
Photo 1- View
of excavating
clean fill in A5.

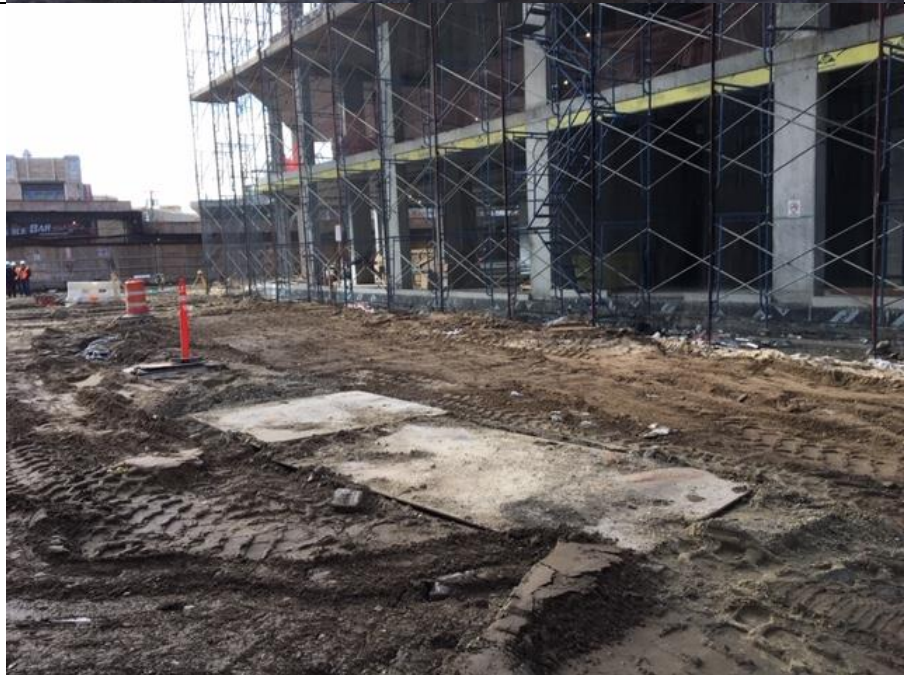
Photo 2- View
of graded clean
fill in B1 and
B2.

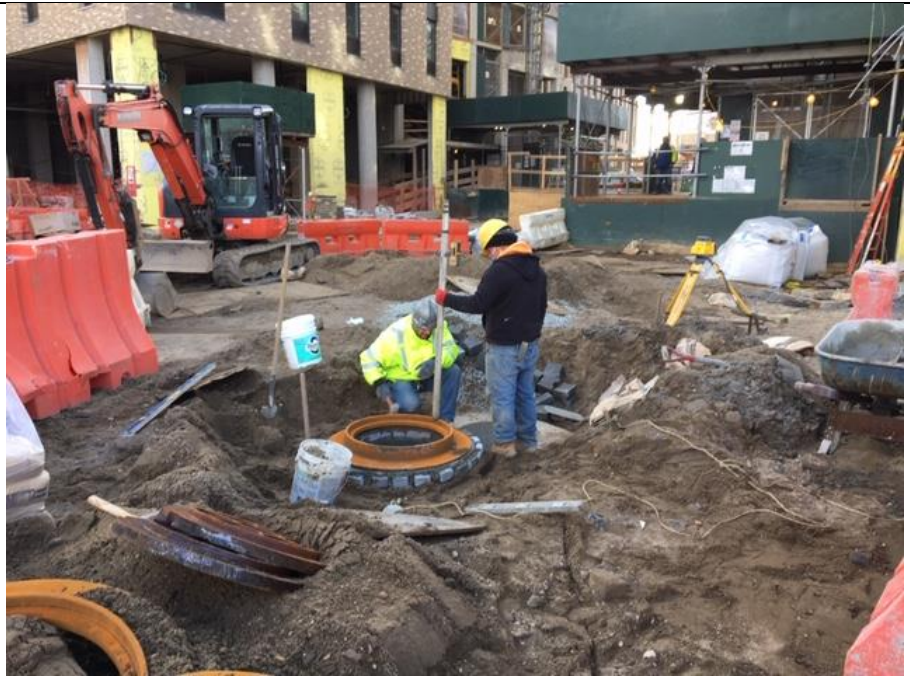
Photo 3- View
of utility
installation in
C5.

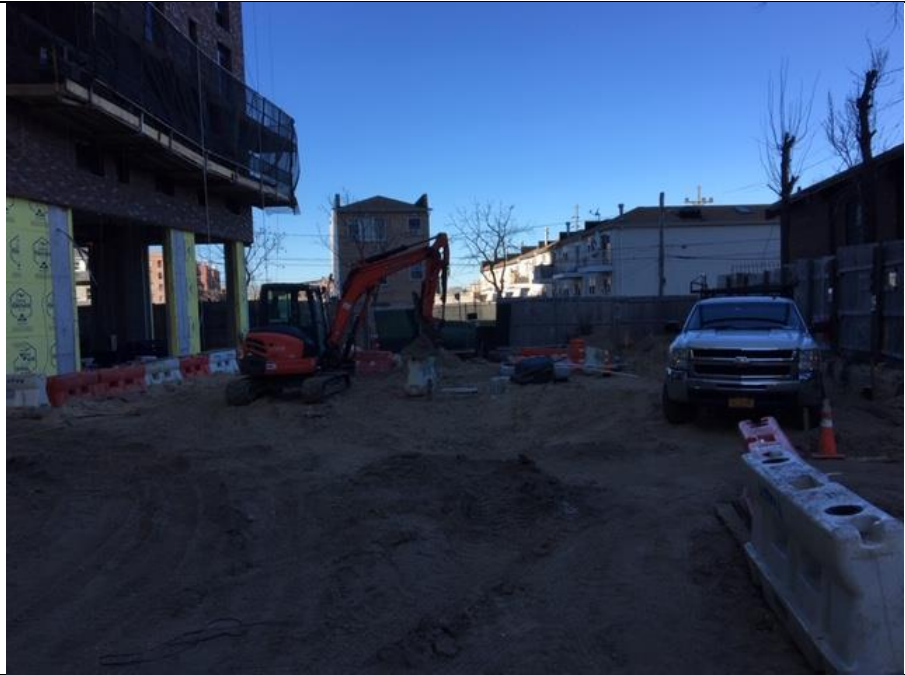
Photo 1- View of excavating clean fill in A5.

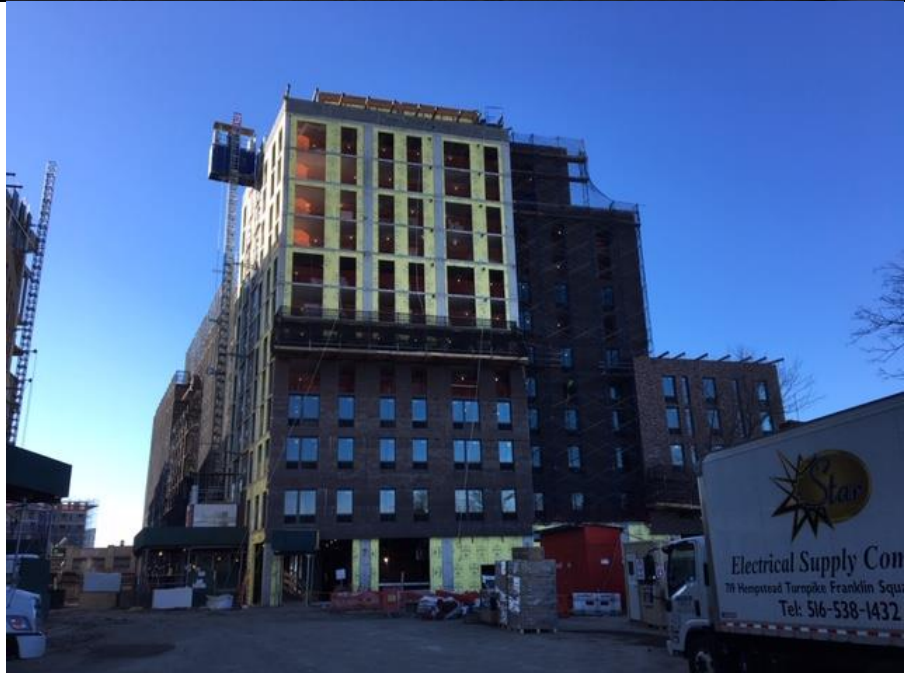
Photo 2- View of utility and formwork installation in A3, A4, B3, and B4.

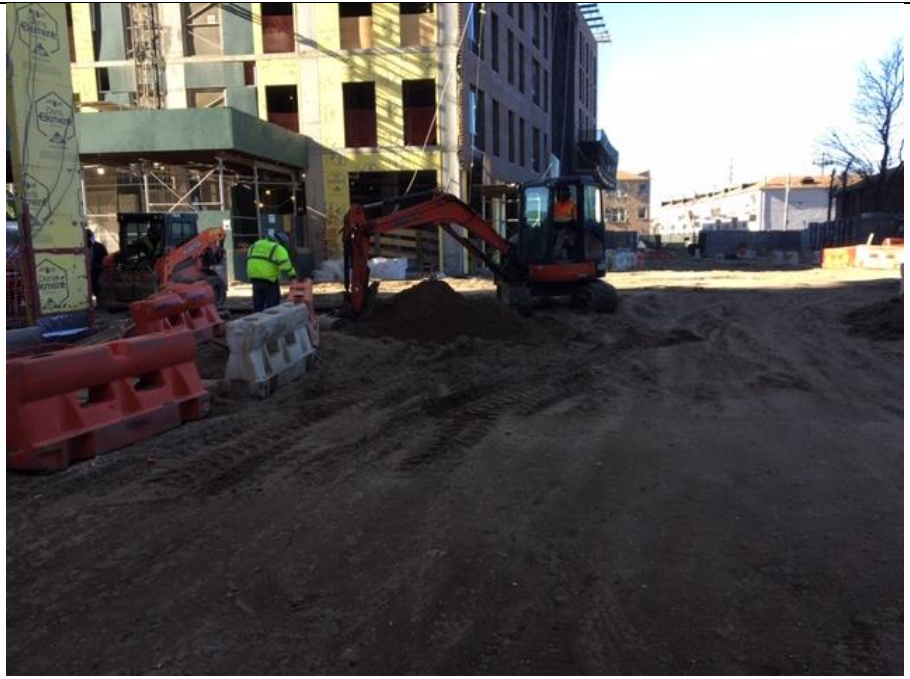
Photo 3- View
of utility
installation in
C5.

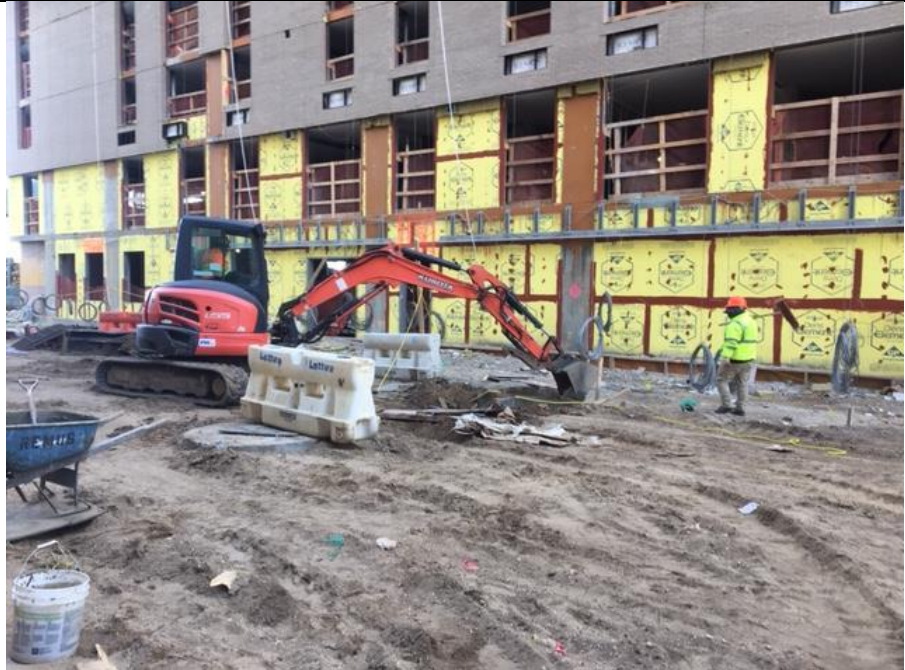
Photo 1- View of excavating clean fill in D5.

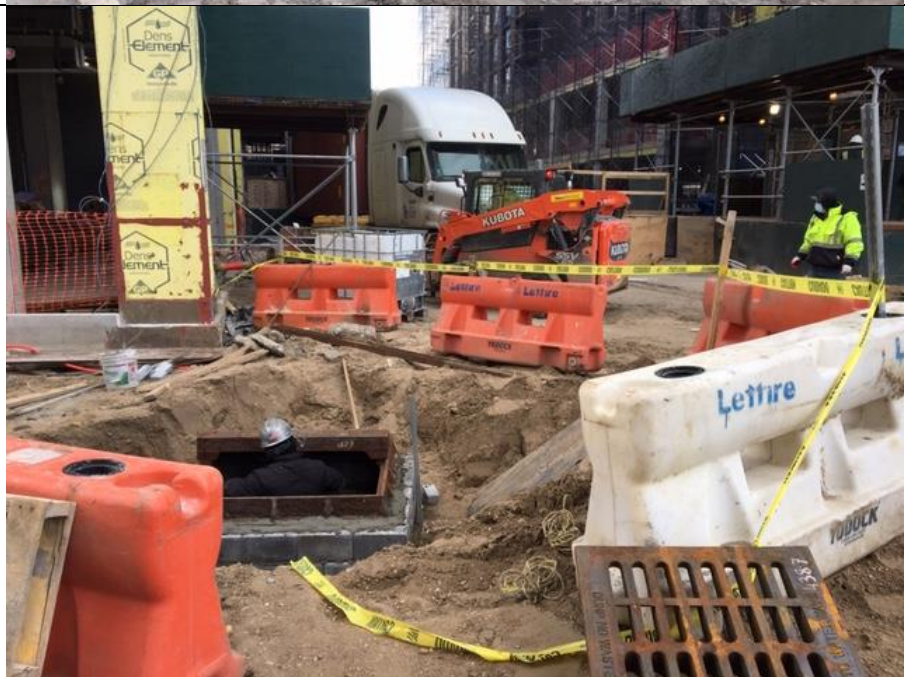
Photo 2- View of utility and formwork installation in C5.

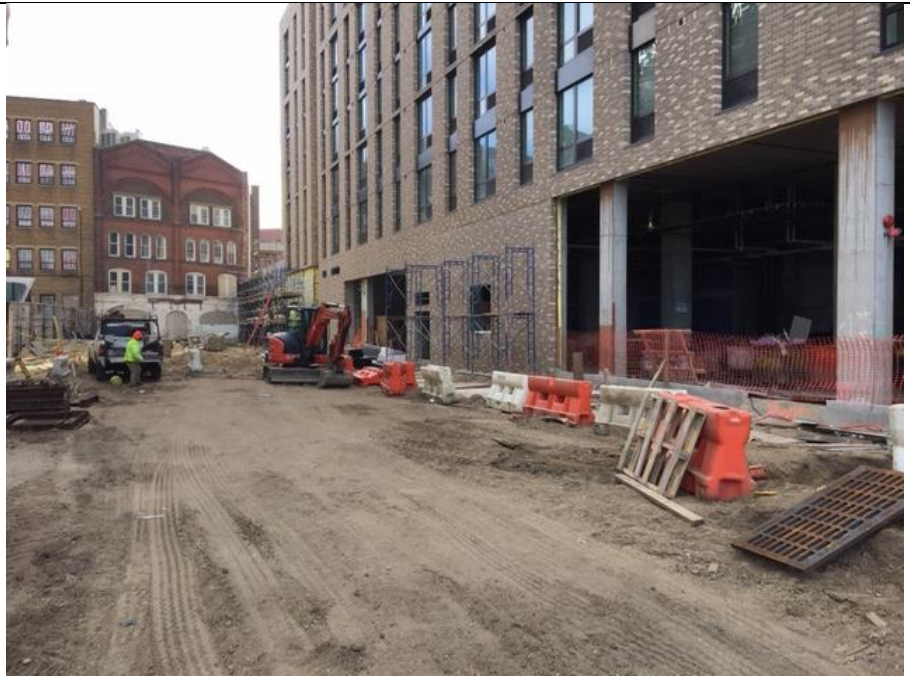
Photo 3- View
of grading
clean fill in E5.

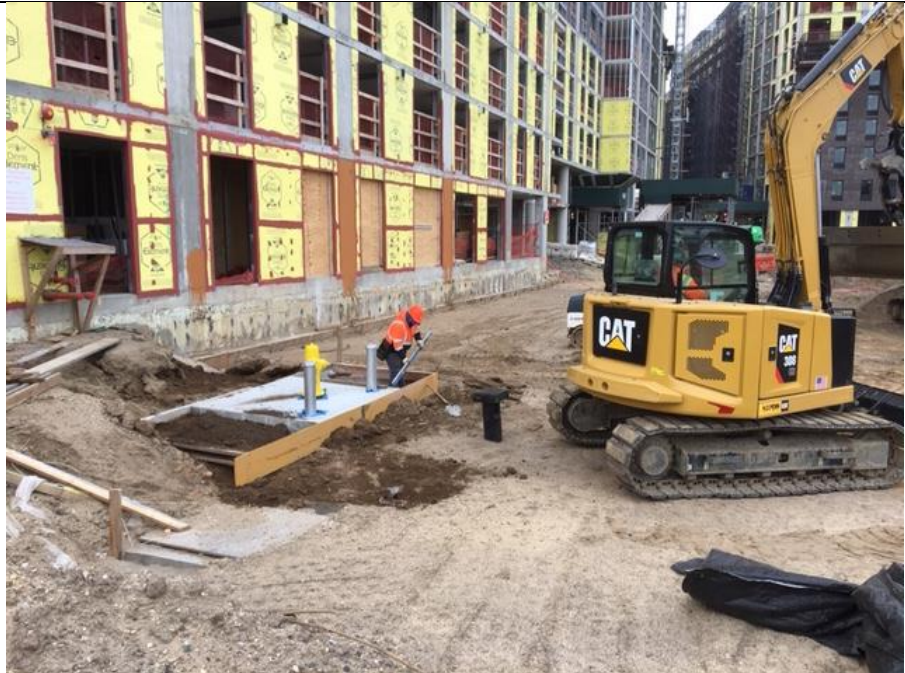
Photo 1- View of backfilling in C8.

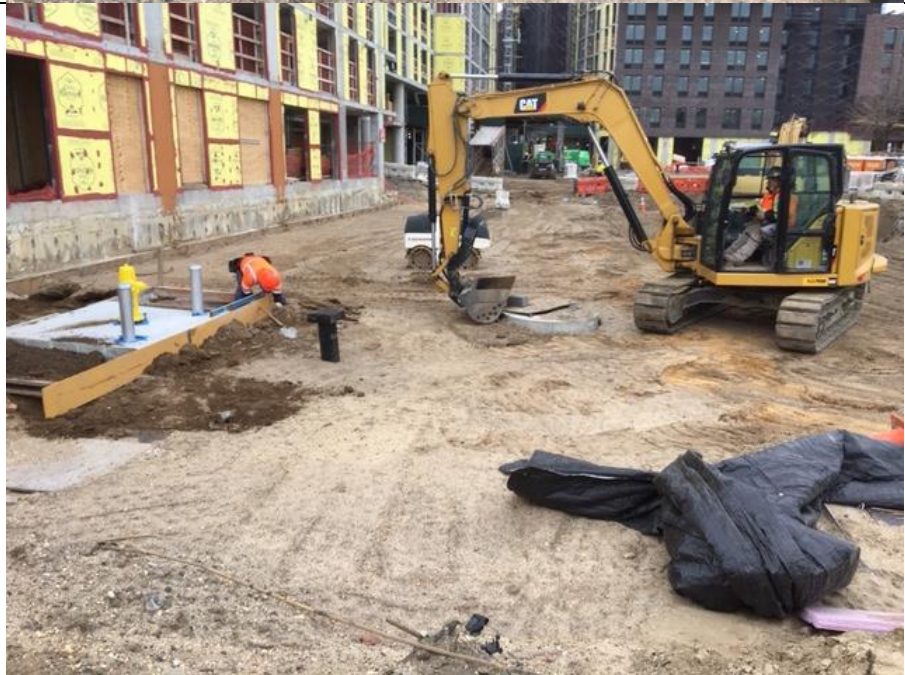
Photo 2- View of utility and formwork installation in C8.

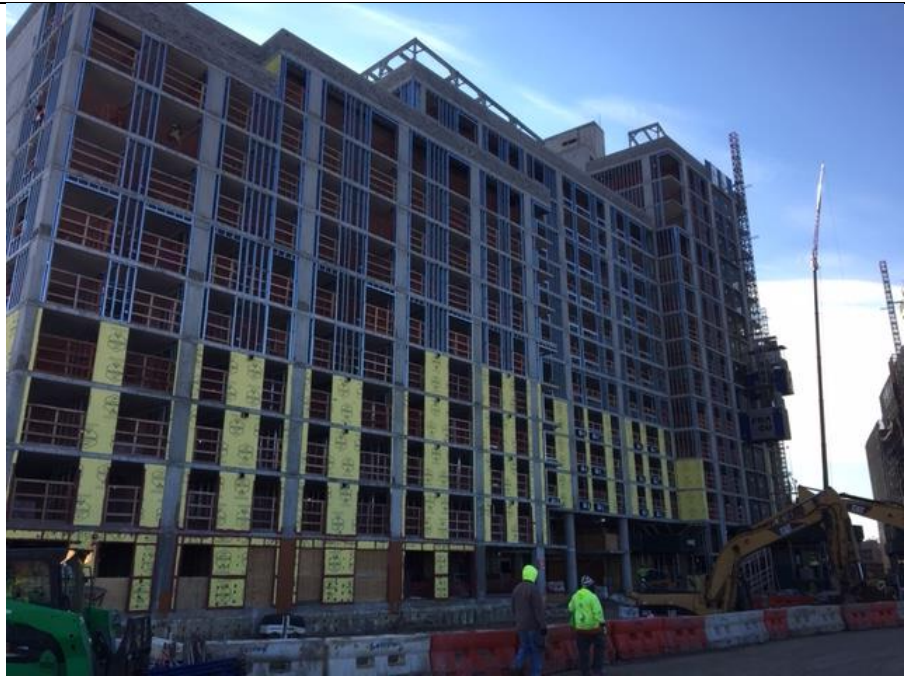
Photo 3- View of formwork and utility installation in C6-C8.

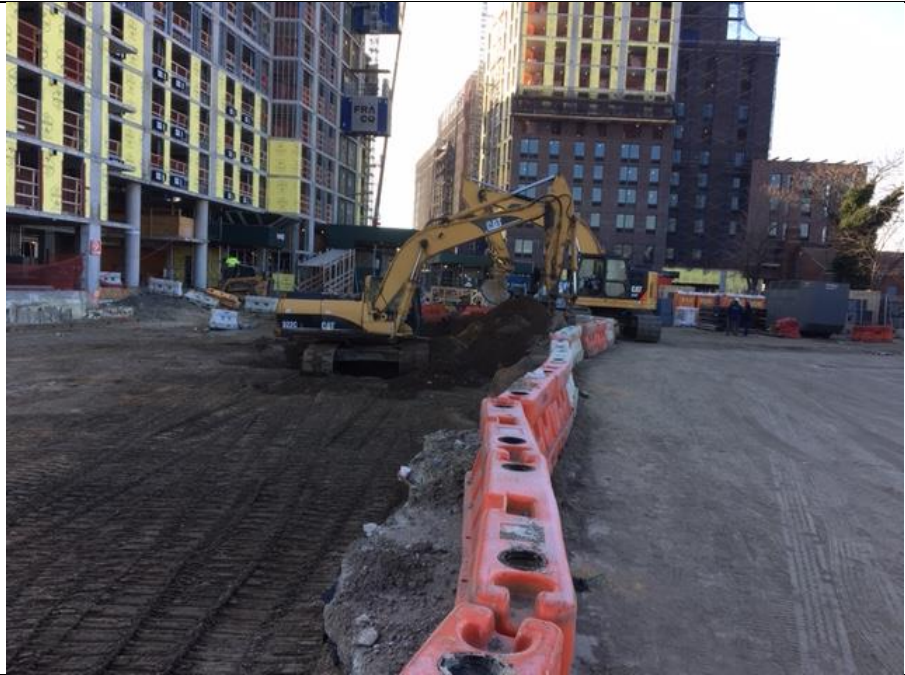
Photo 1- View of excavating in C7.

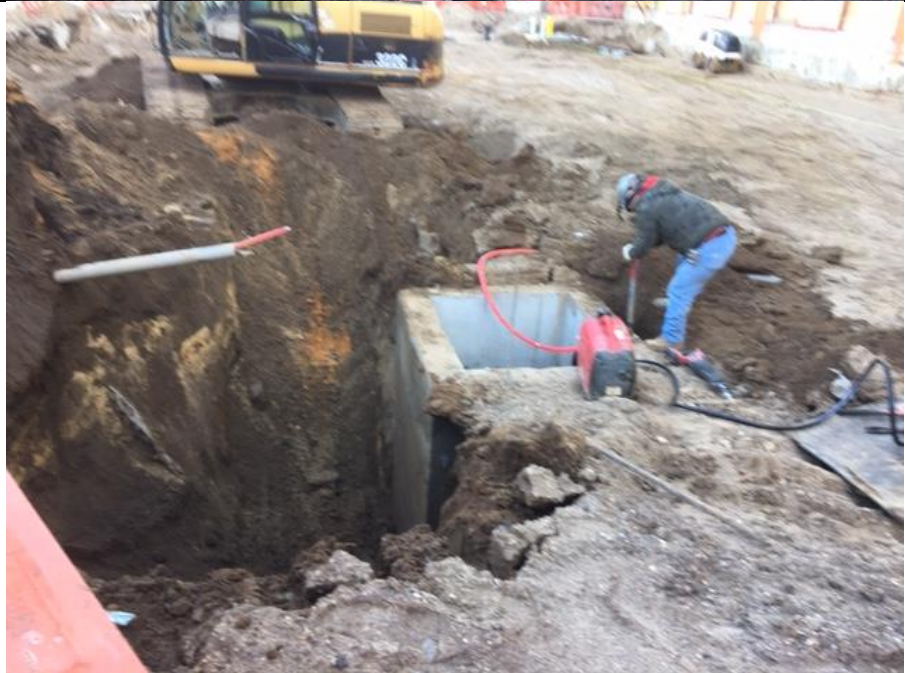
Photo 2- View of utility and formwork installation in C7.

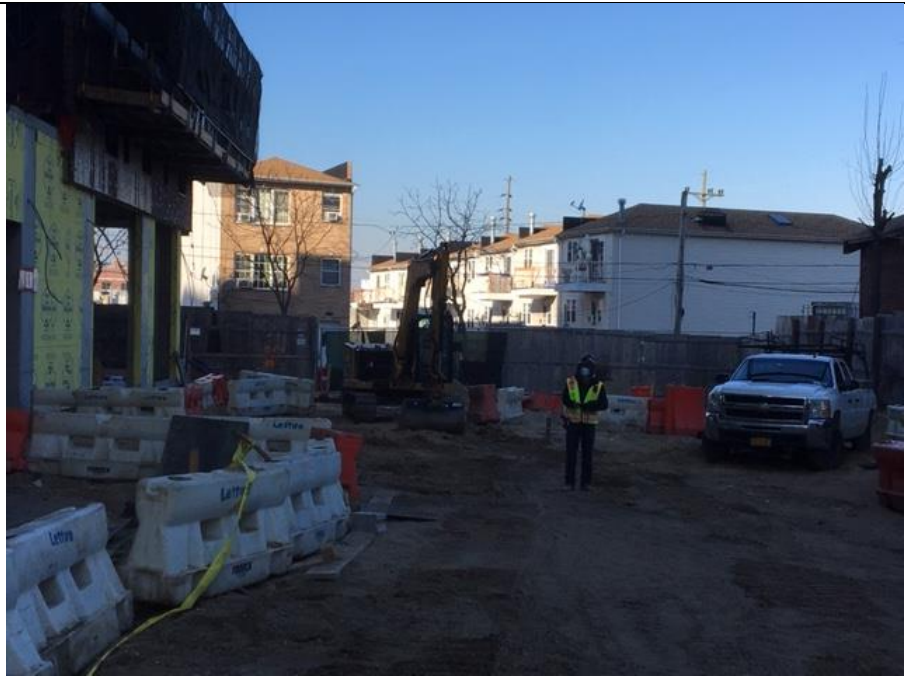
Photo 3- View
of grading
clean fill in A5.

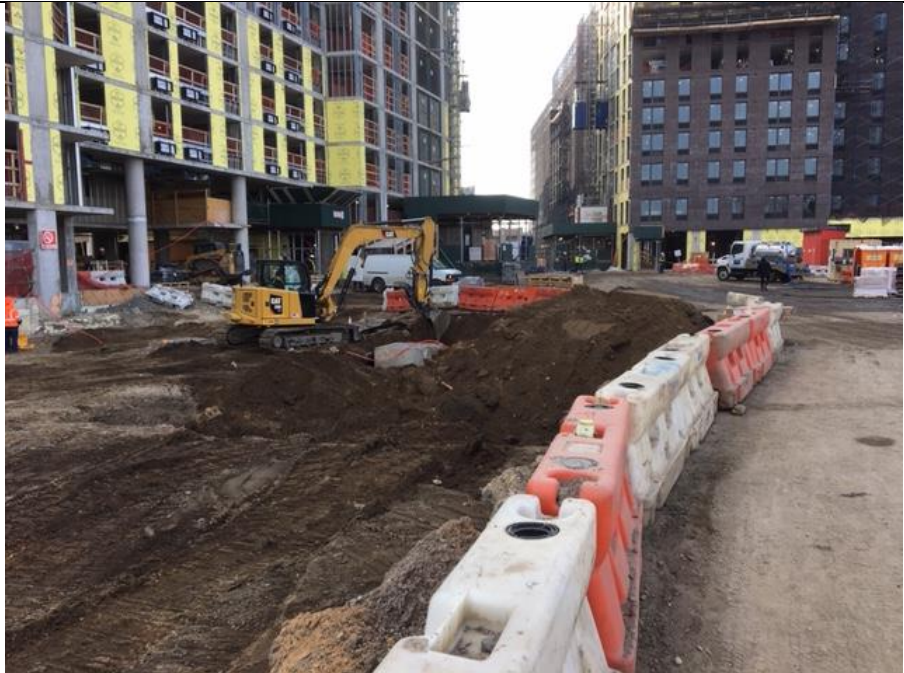
Photo 1- View of excavating in C7.

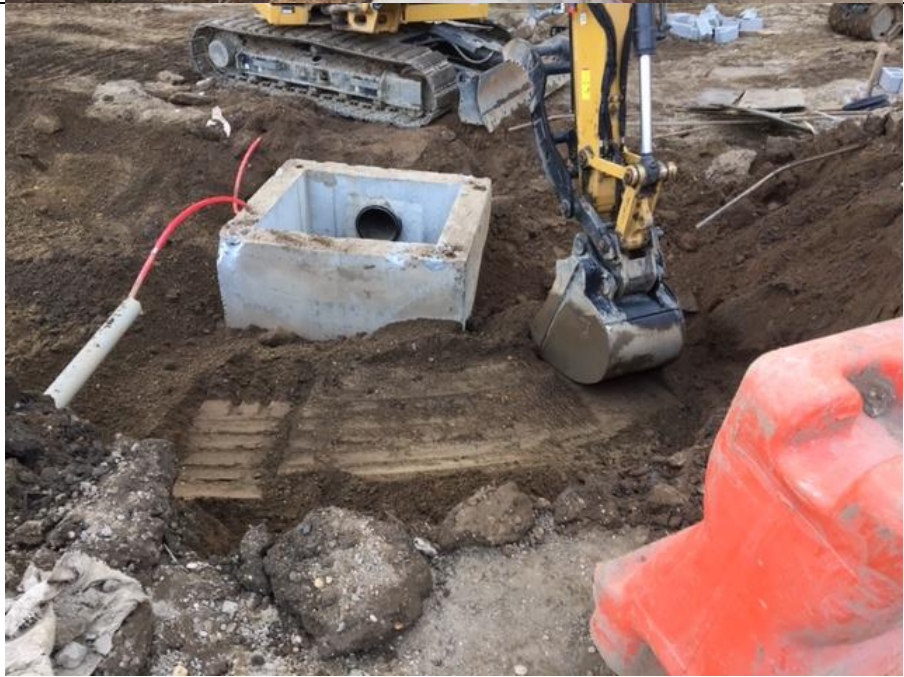
Photo 2- View of utility work and backfilling in C7.

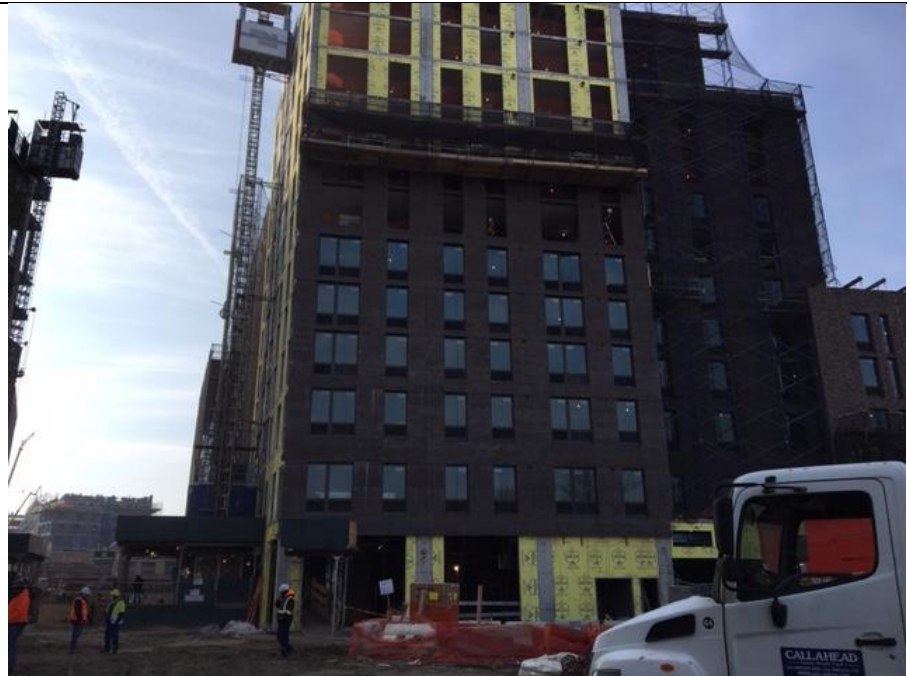
Photo 3- View of utility and formwork in A3, A4, B3, and B4.

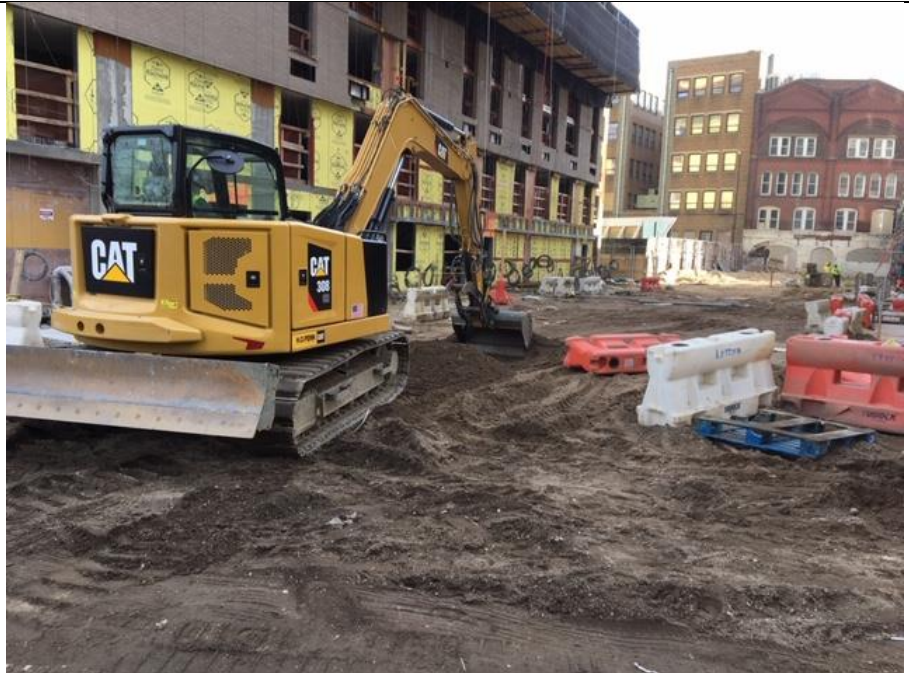
Photo 1- View of excavating in C5.

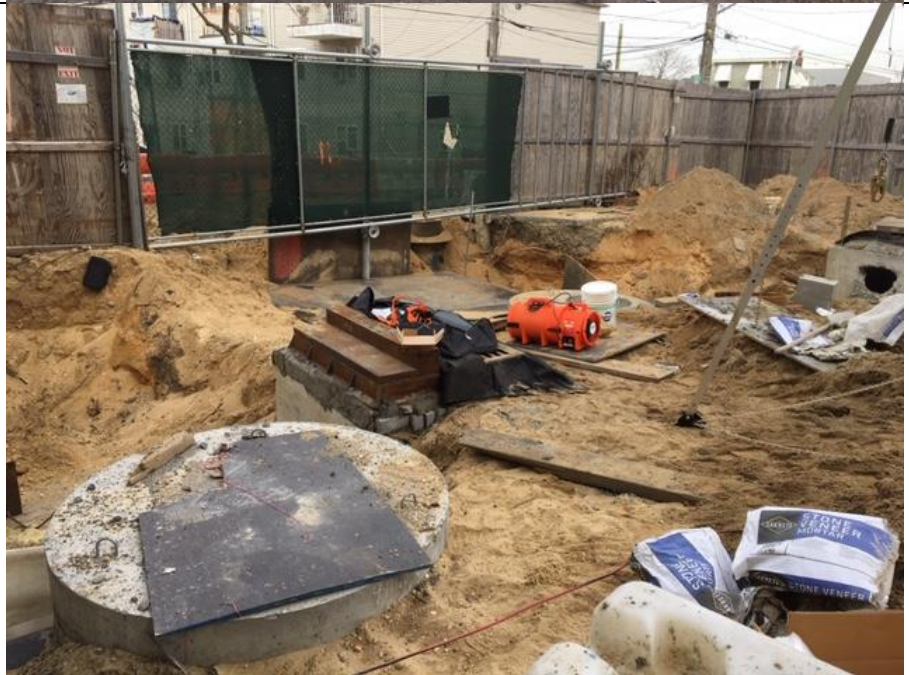
Photo 2- View of utility work in A5.

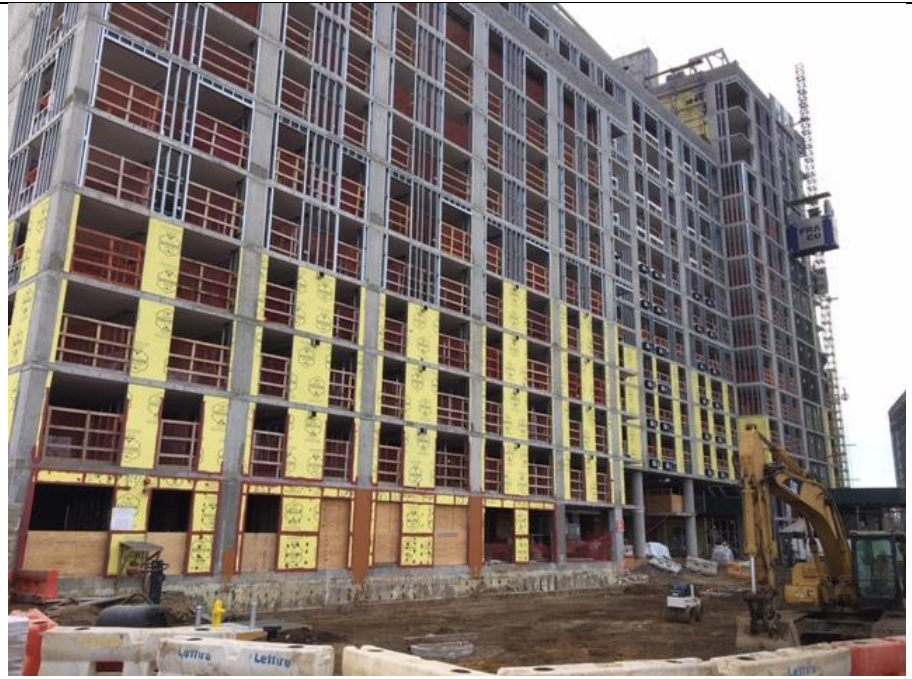
Photo 3- View
of utility and
formwork in
C6-C8.

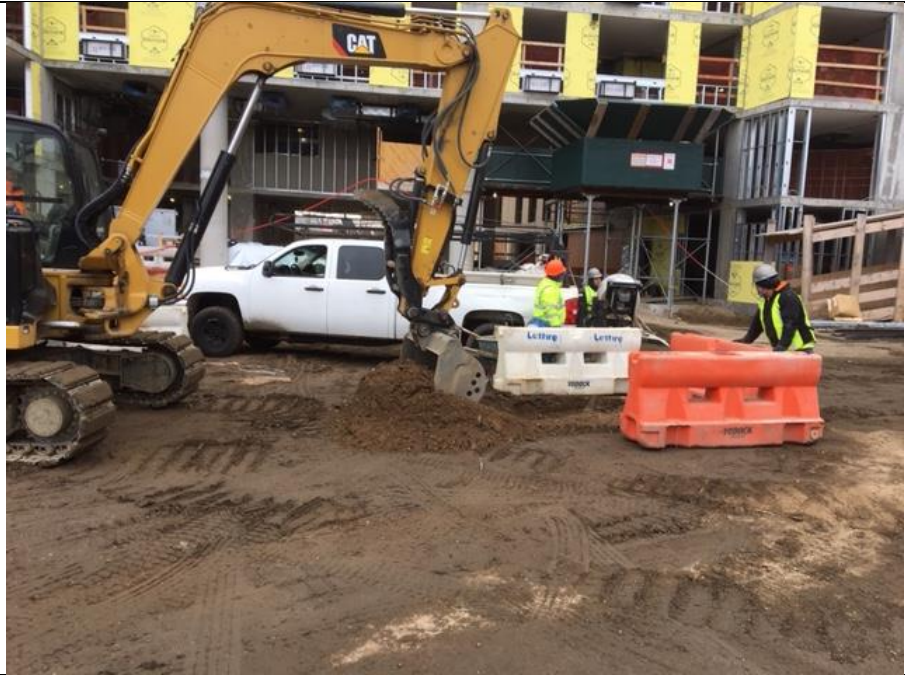
Photo 1- View of excavating in C7.

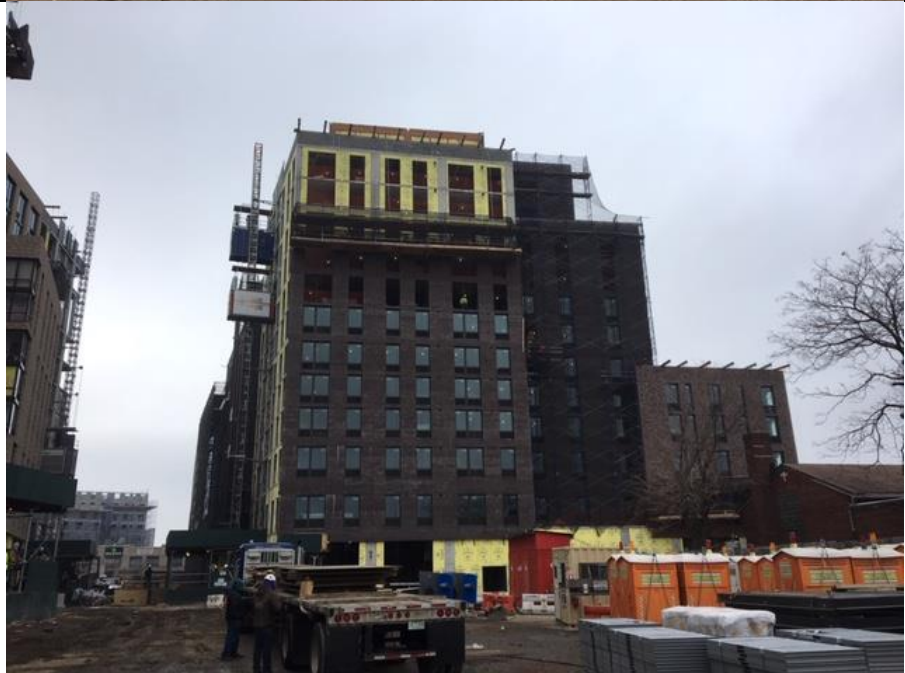
Photo 2- View of utility and formwork in A3, A4, B3, and B4.

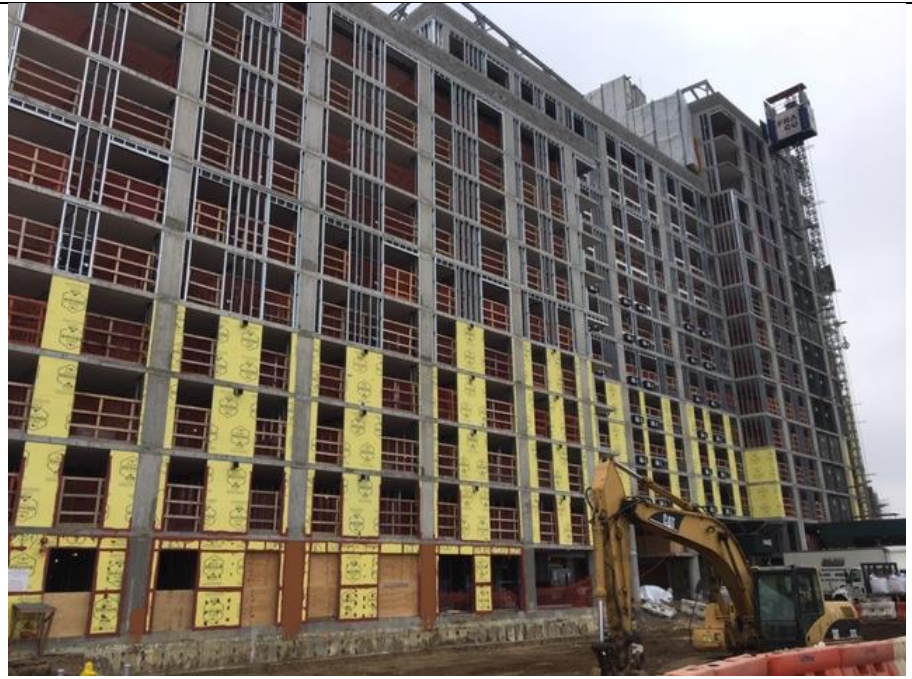
Photo 3- View
of utility and
formwork in
C6-C8.

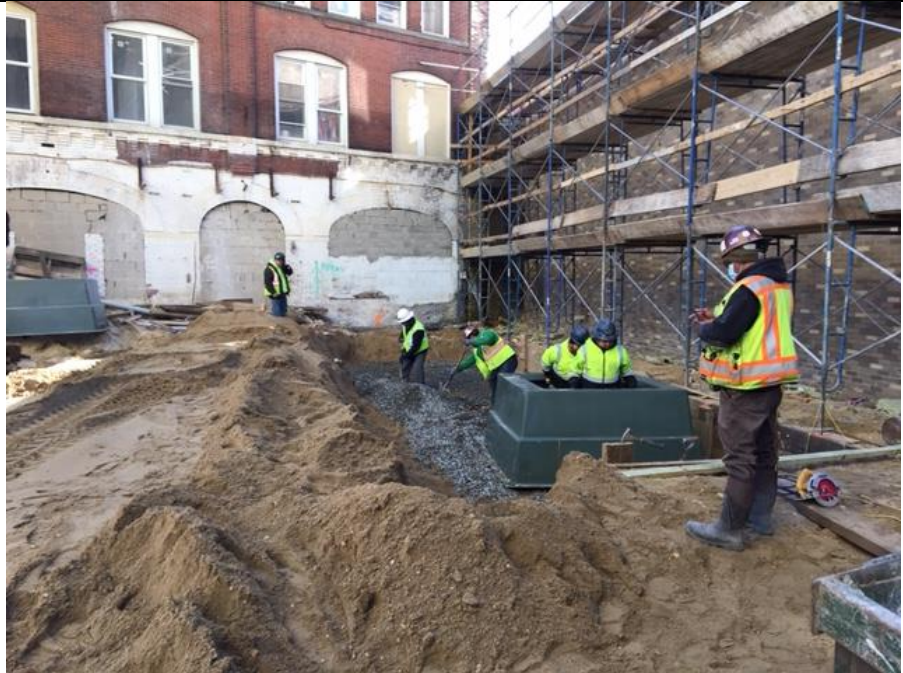
Photo 1- View of utility installation in E5 and F5.

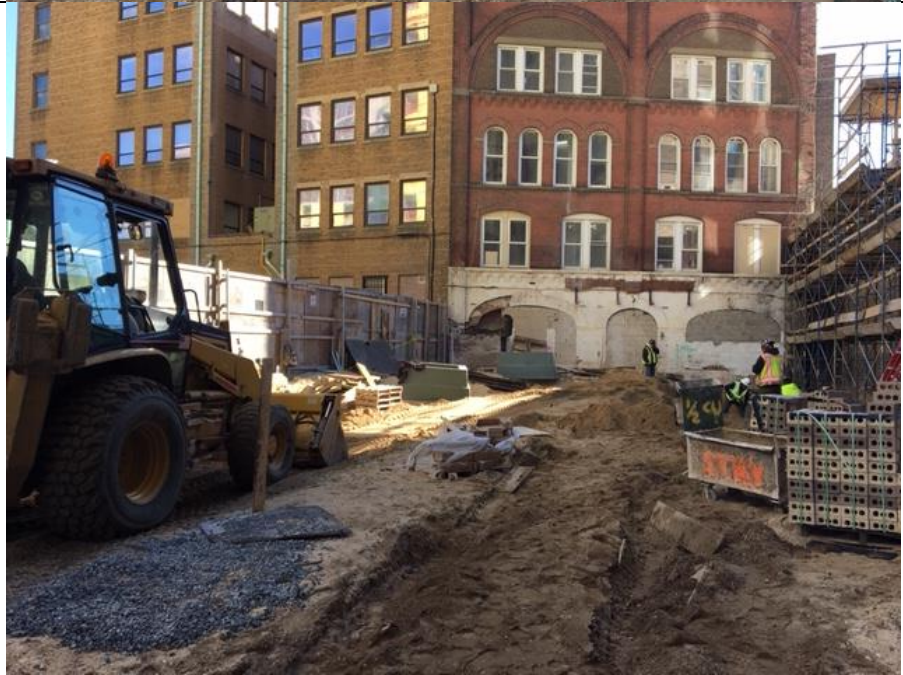
Photo 2- View of backfilling and grading clean fill in E5 and F5.

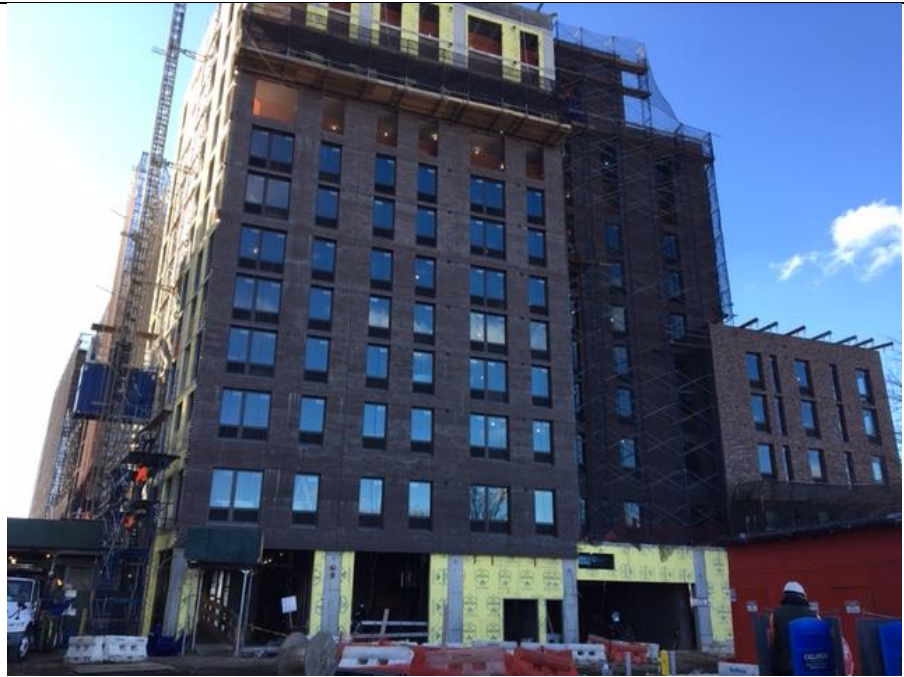
Photo 3- View of utility and formwork in A3, A4, B3, and B4.

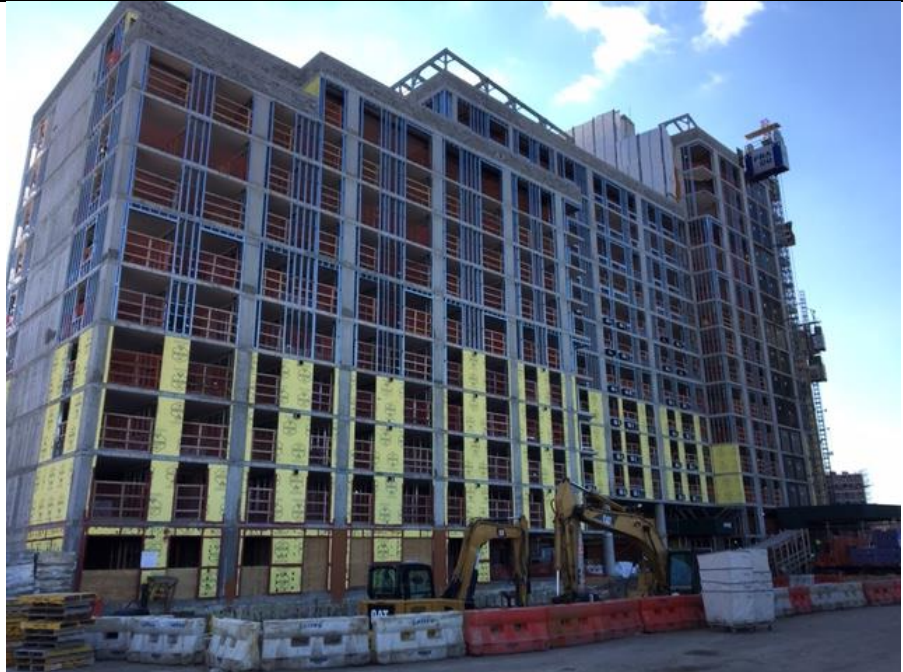
Photo 1- View of utility and formwork in C6-C8.

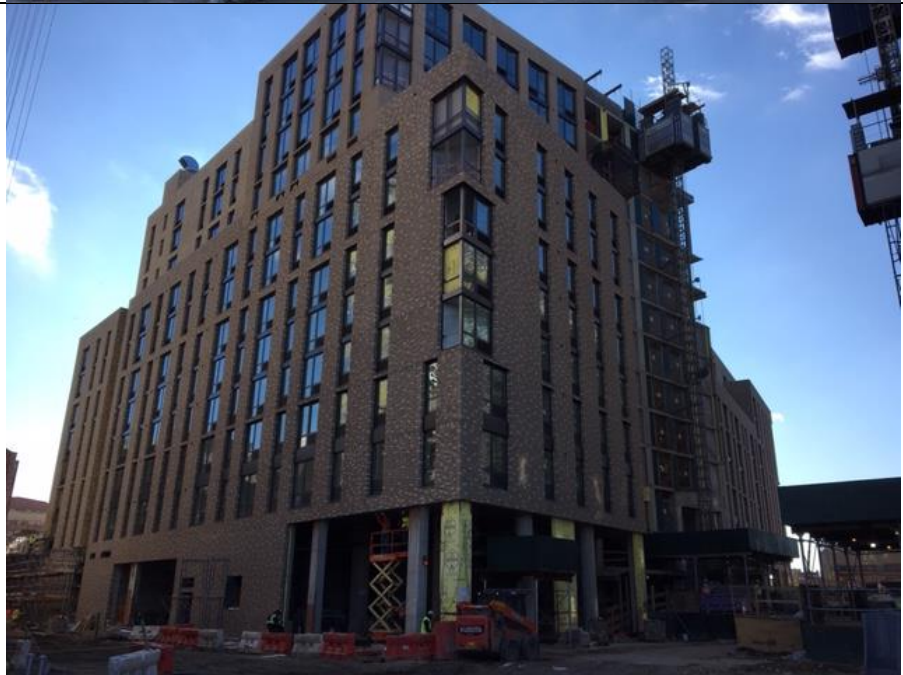
Photo 2- View of utility and formwork in D4, D5, E4, and E5.

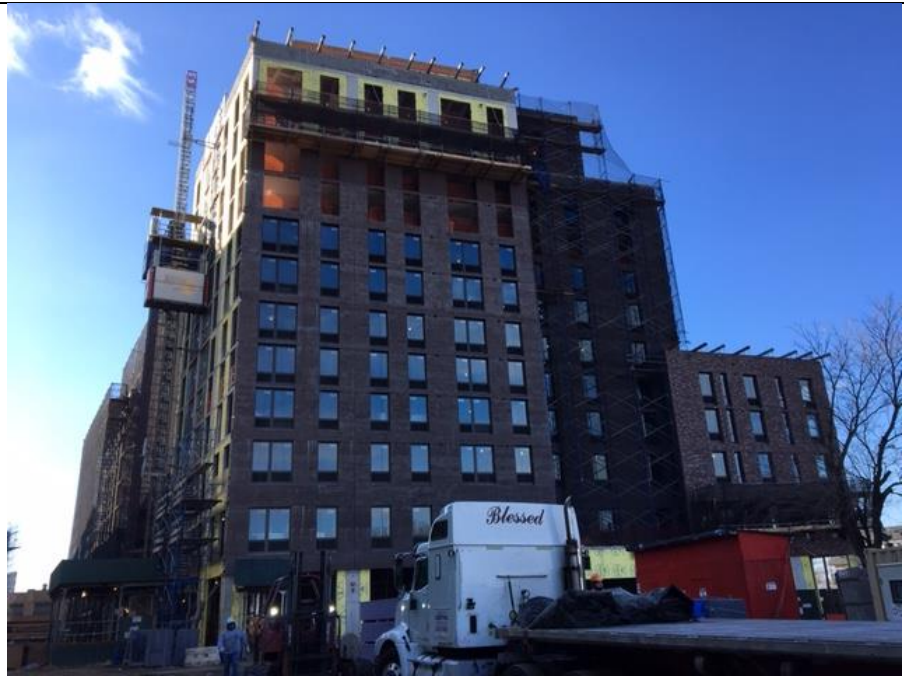
Photo 3- View of utility and formwork in A3, A4, B3, and B4.

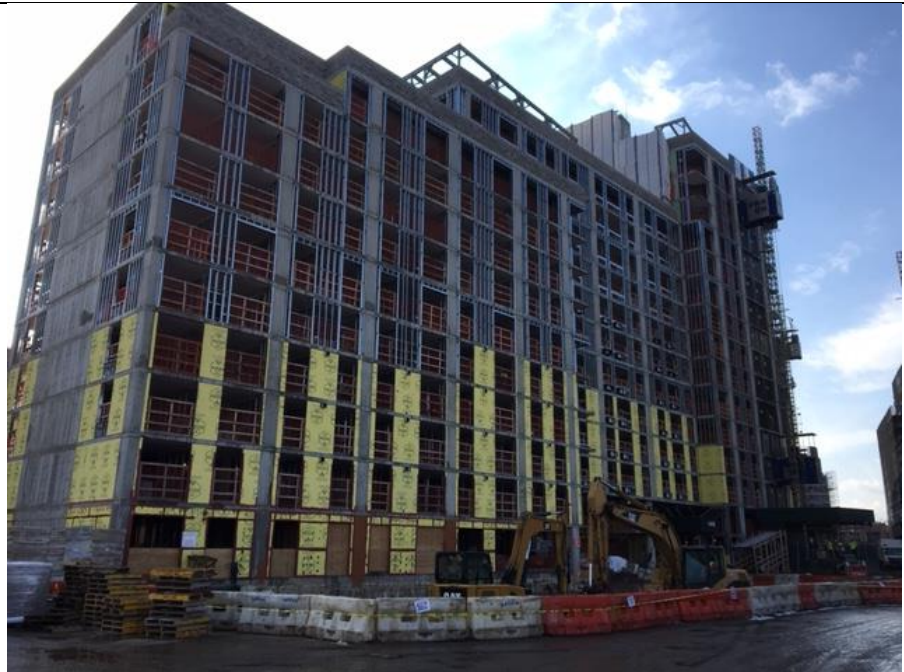
Photo 1- View of utility and formwork in C6-C8.
