Daily Report for January 4, 2021

**Far Rockaway Project
20-02 Mott Avenue
Far Rockaway, NY
BCP #C241224**

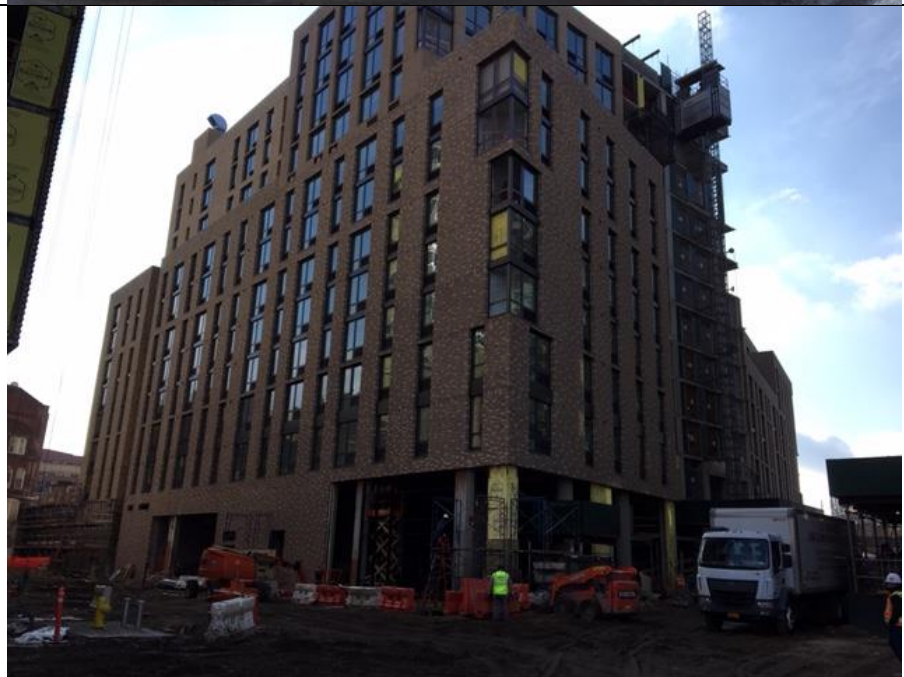
Photo 2- View of utility and formwork in D4, D5, E4, and E5.

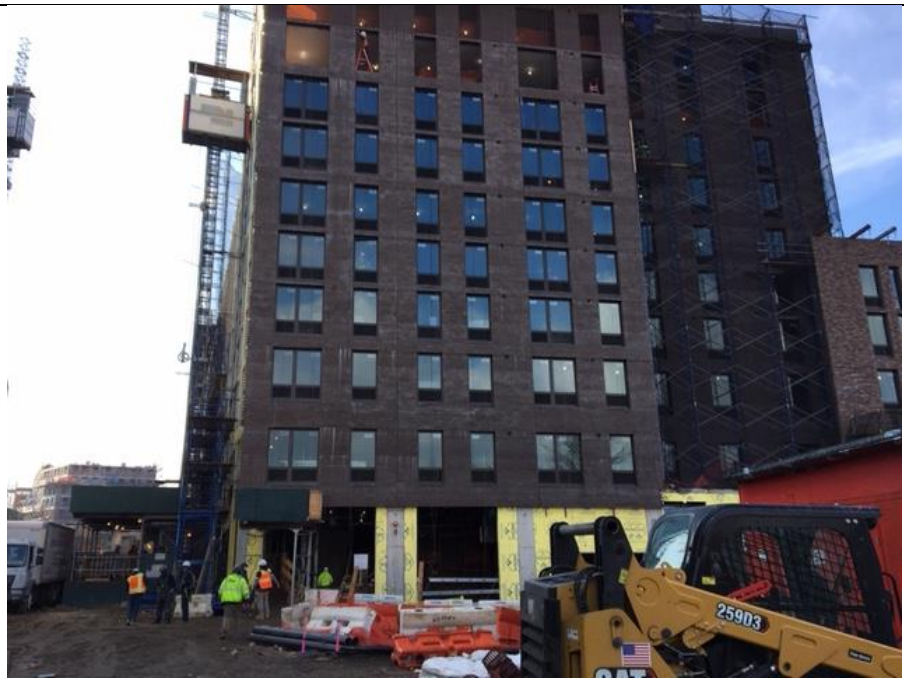
Photo 3- View of utility and formwork in A3, A4, B3, and B4.

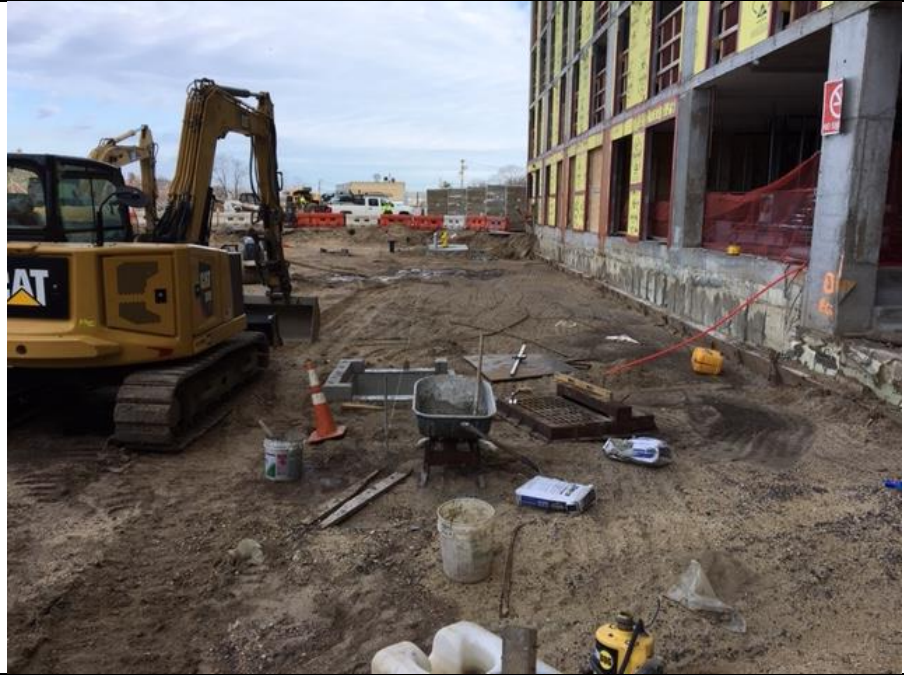
Photo 1- View of utility and formwork in C7.

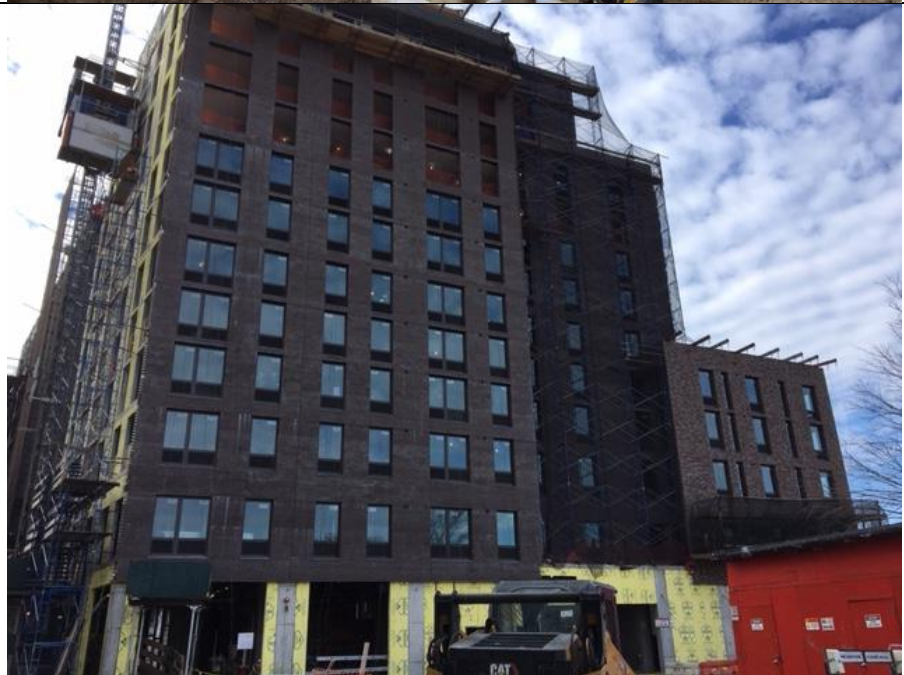
Photo 2- View of utility and formwork in A3, A4, B3, and B4.

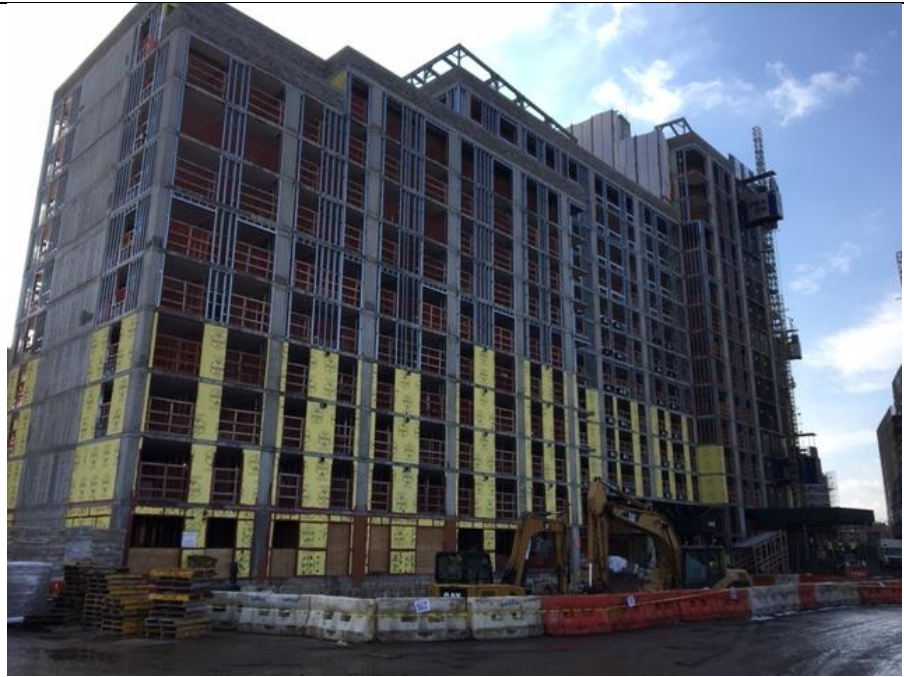
Photo 3- View
of utility and
formwork in
C6-C8.

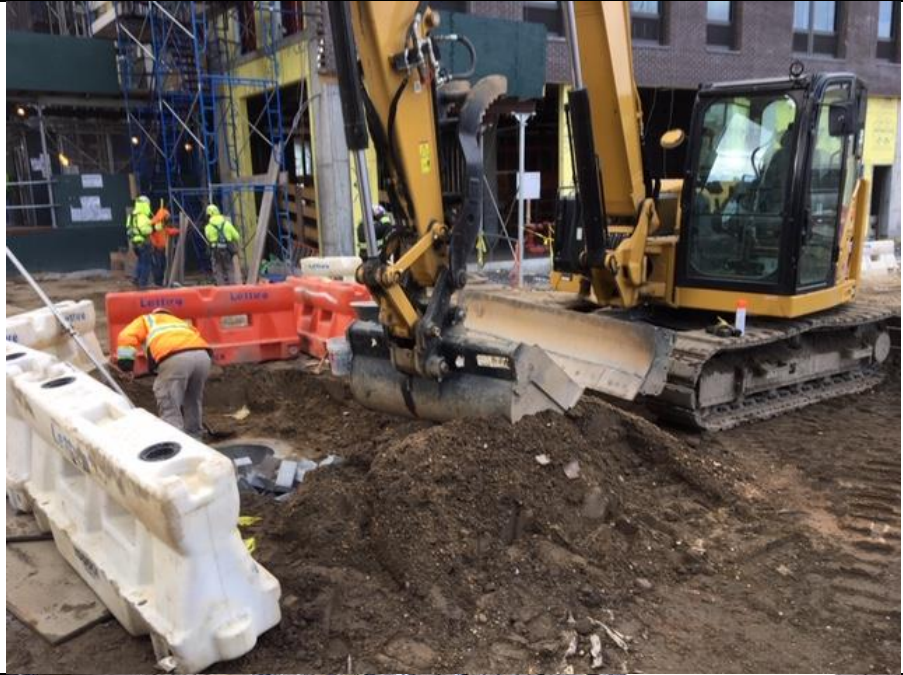
Photo 1- View of excavation and utility installation in C5.

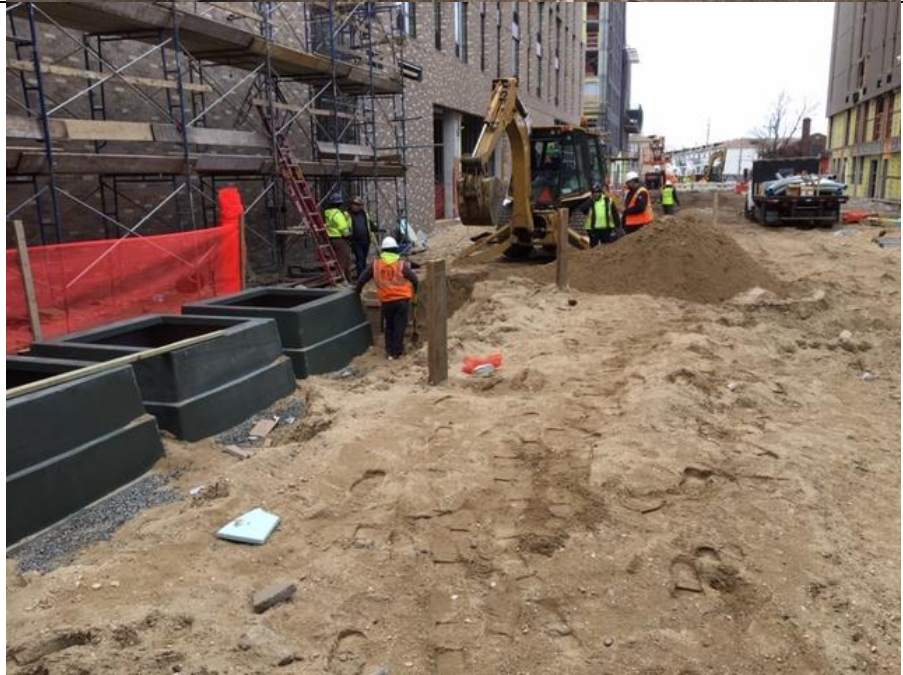
Photo 2- View of excavation and utility installation in E5 and F5.

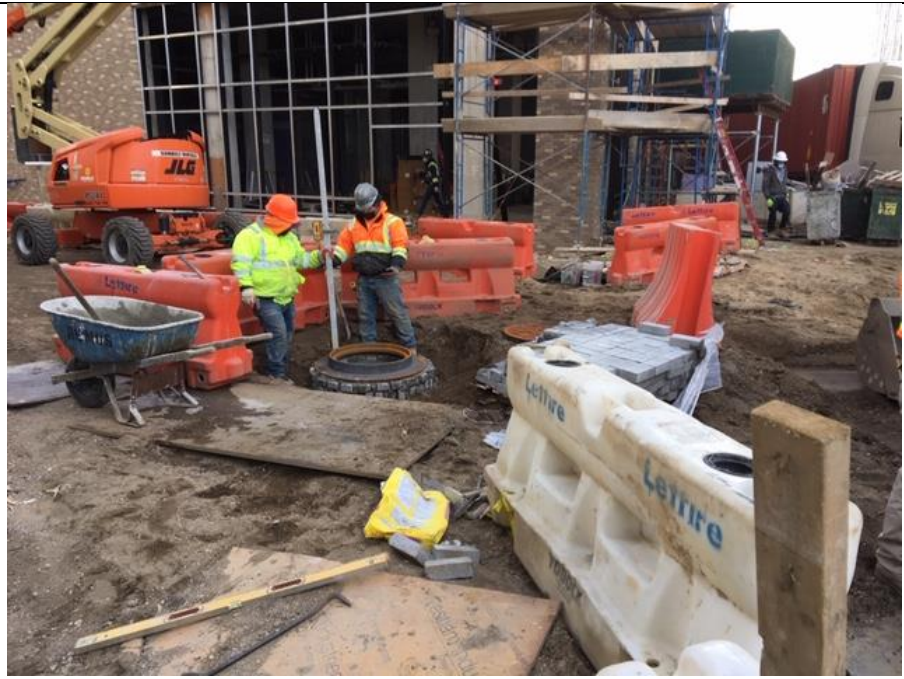
Photo 3- View
of utility
installation in
D5.

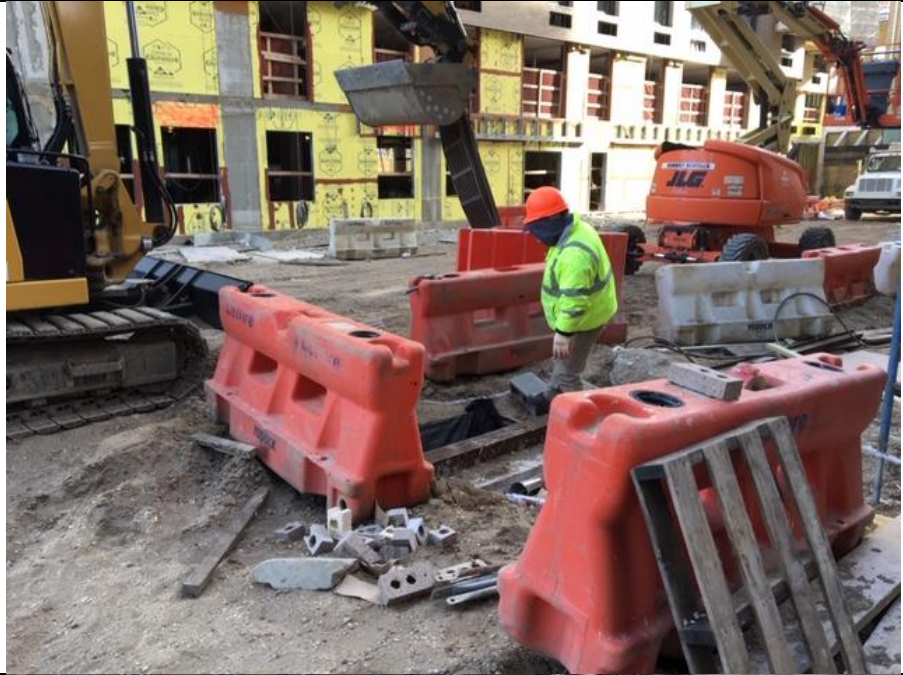
Photo 1- View of utility installation in C5.

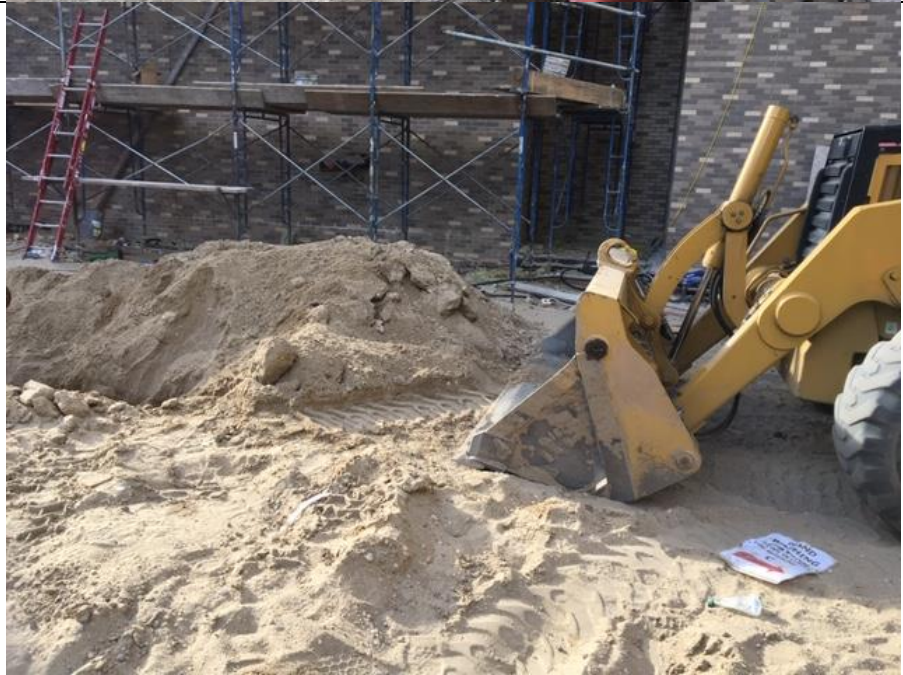
Photo 2- View of excavation and utility installation in E5 and F5.

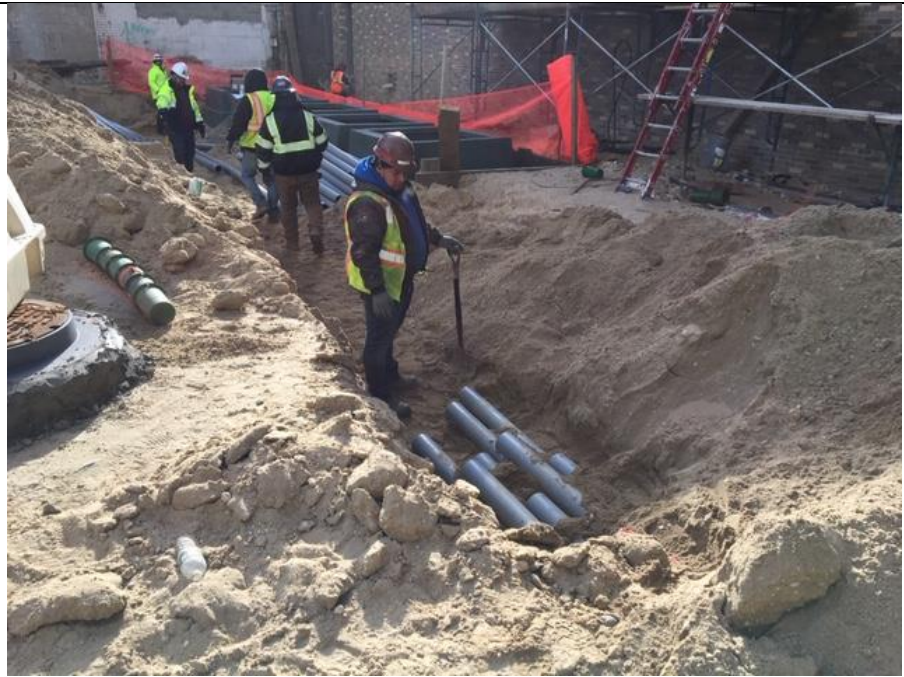
Photo 3- View
of utility
installation in
E5 and F5.

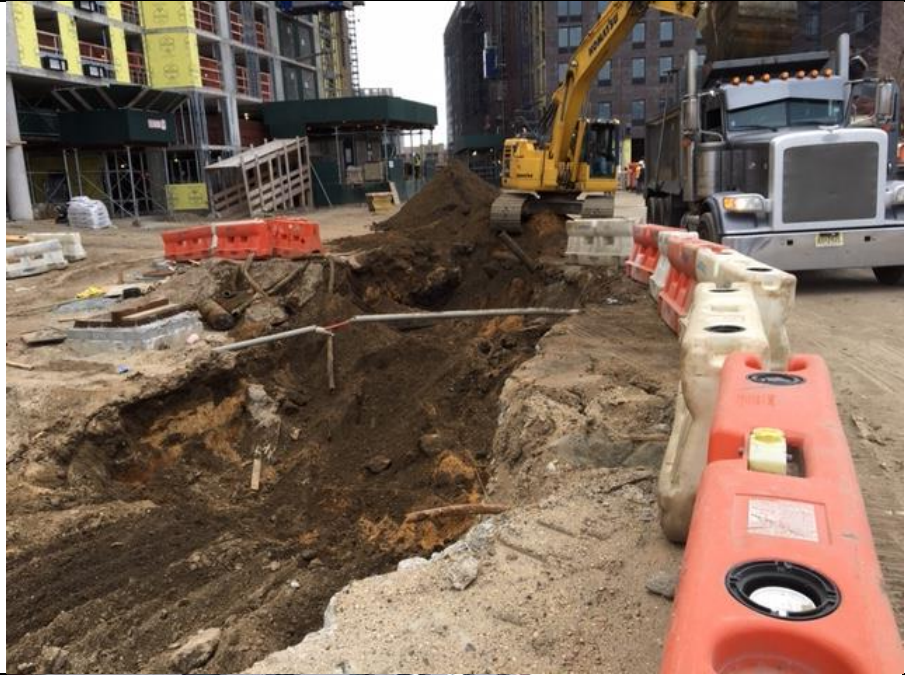
Photo 1- View of excavation in B6 and C6.

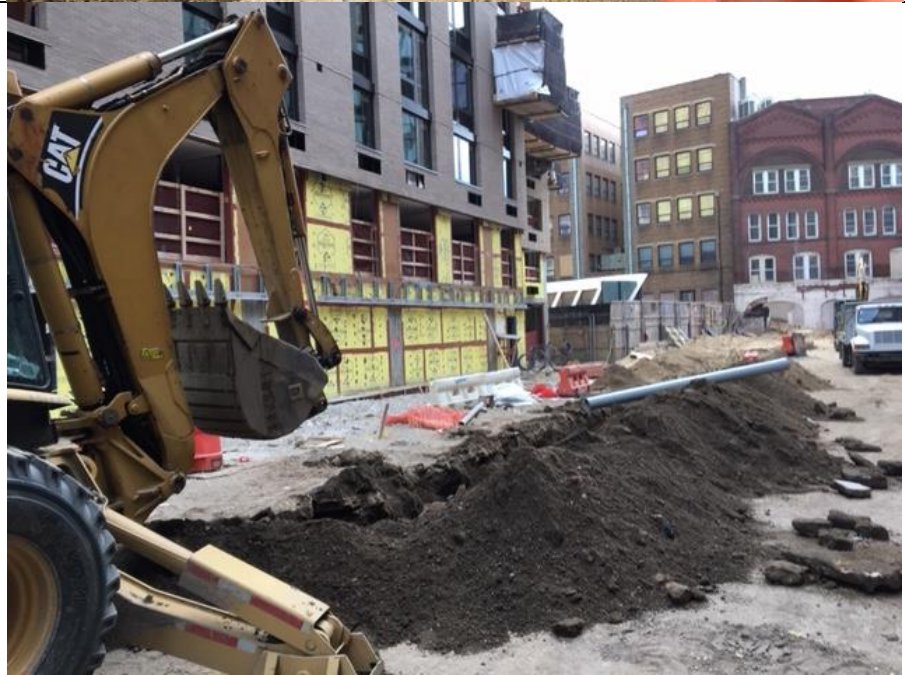
Photo 2- View of excavation and utility installation in E5 and F5.

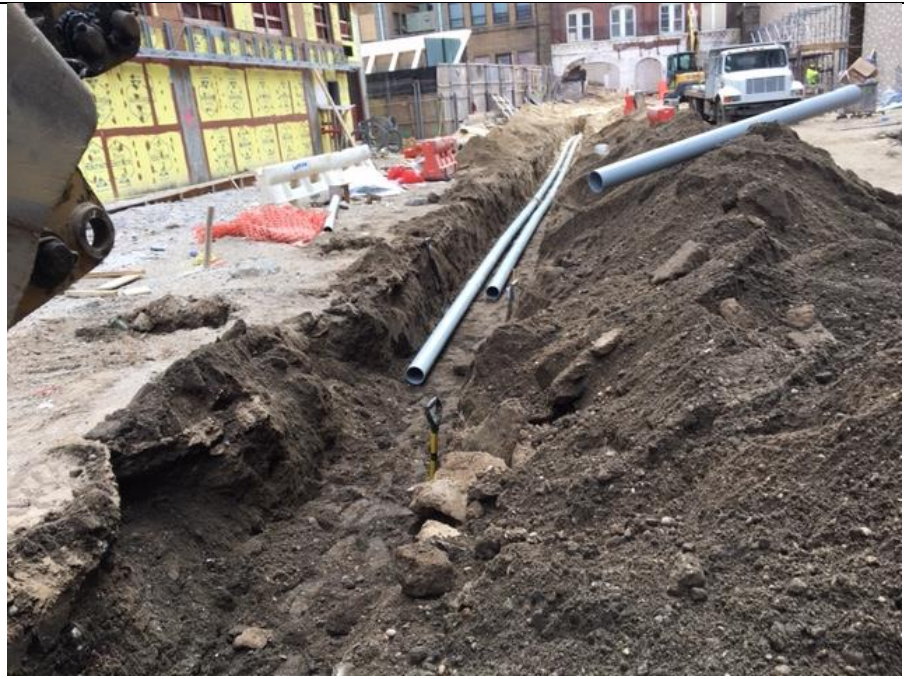
Photo 3- View
of utility
installation in
E5 and F5.

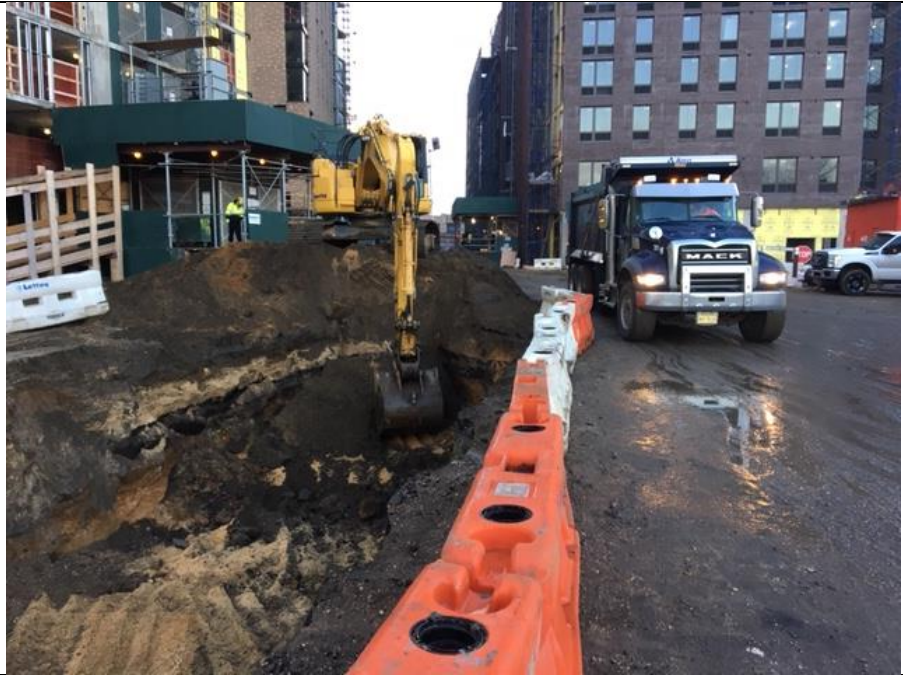
Photo 1- View of excavation in B6 and C6.

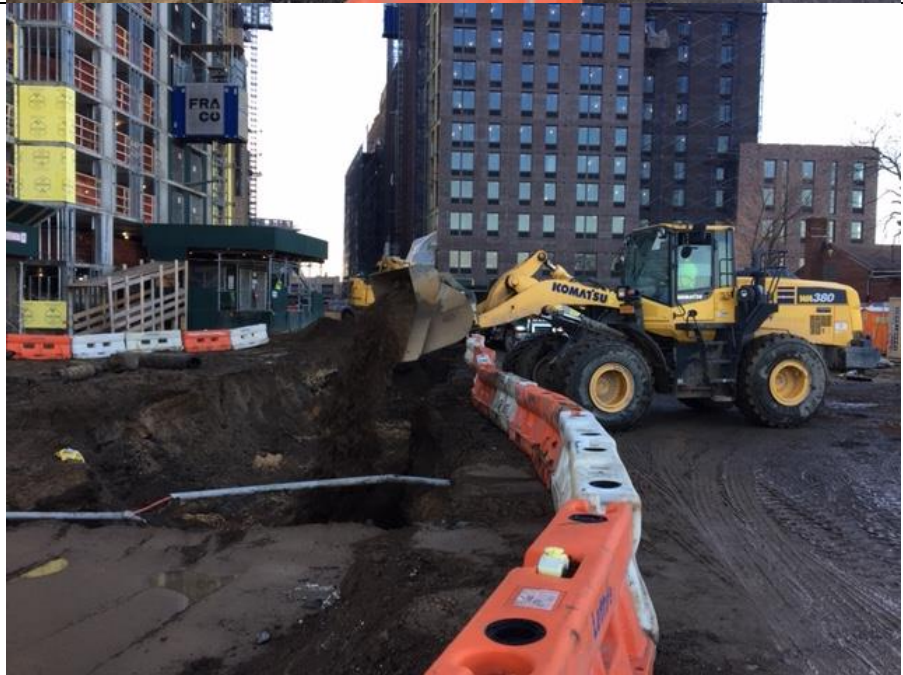
Photo 2- View of backfilling in C7.

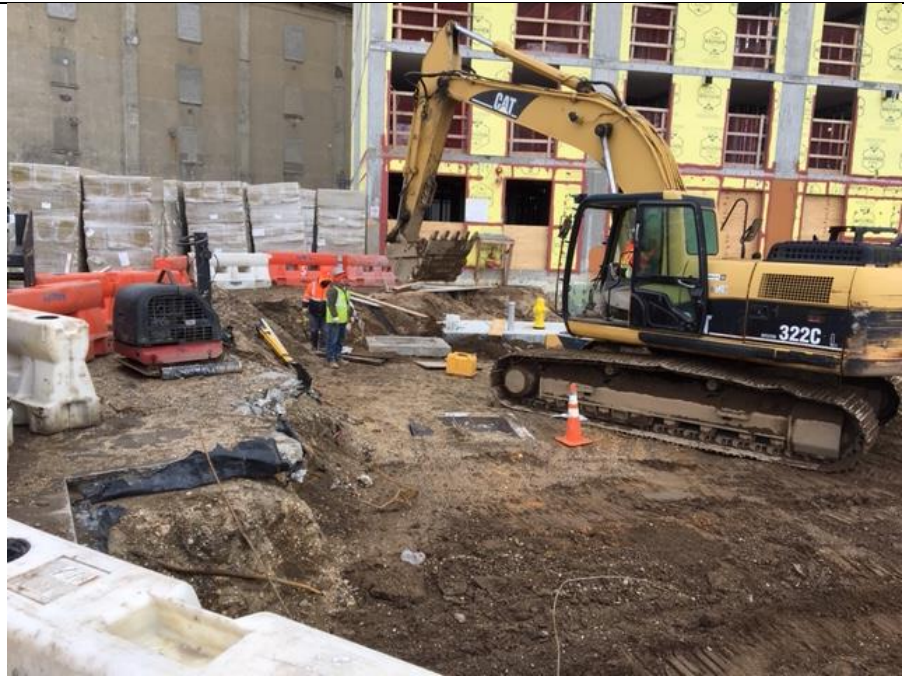
Photo 3- View
of utility
installation in
C8.

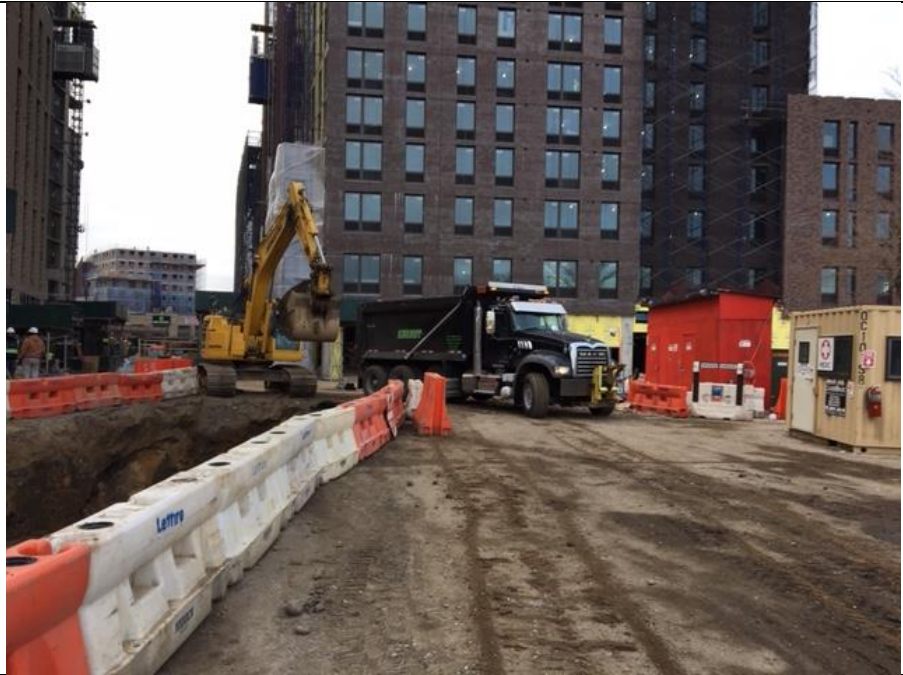
Photo 1- View of excavation in B6 and C6.

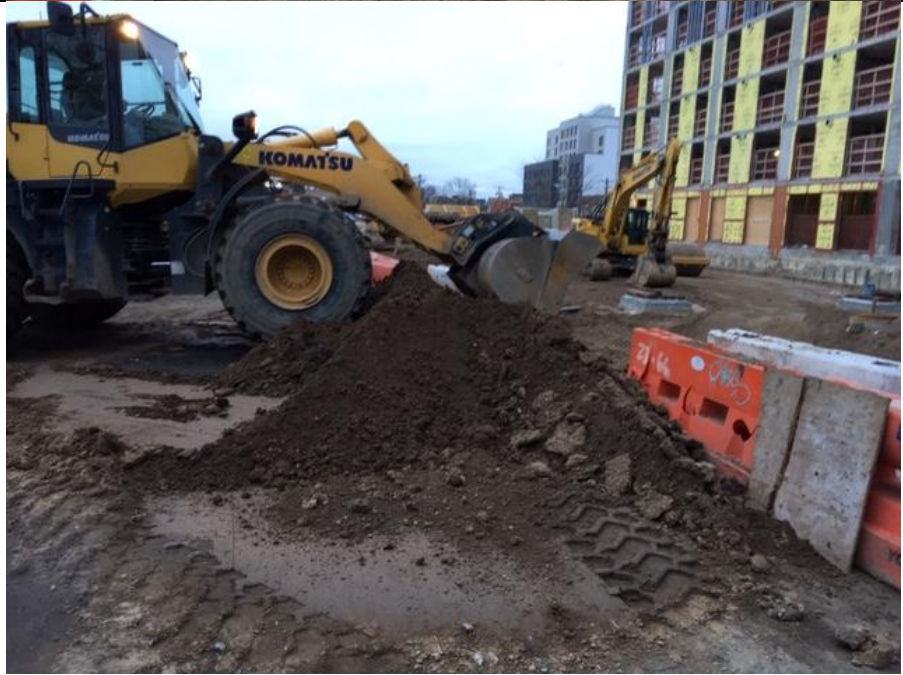
Photo 2- View of backfilling in C6.

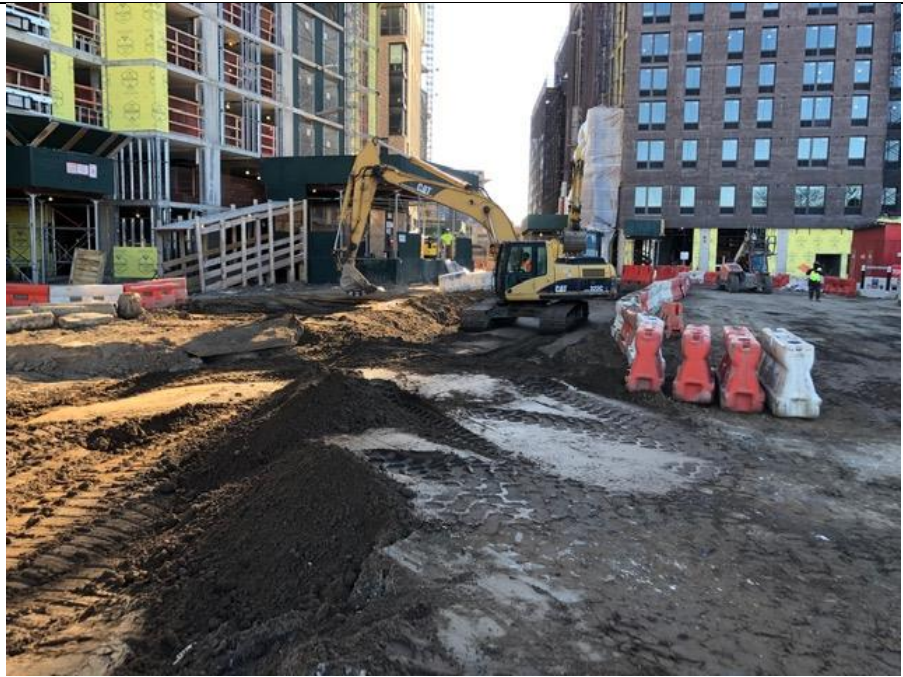
Photo 3- View
of backfilling in
C6.

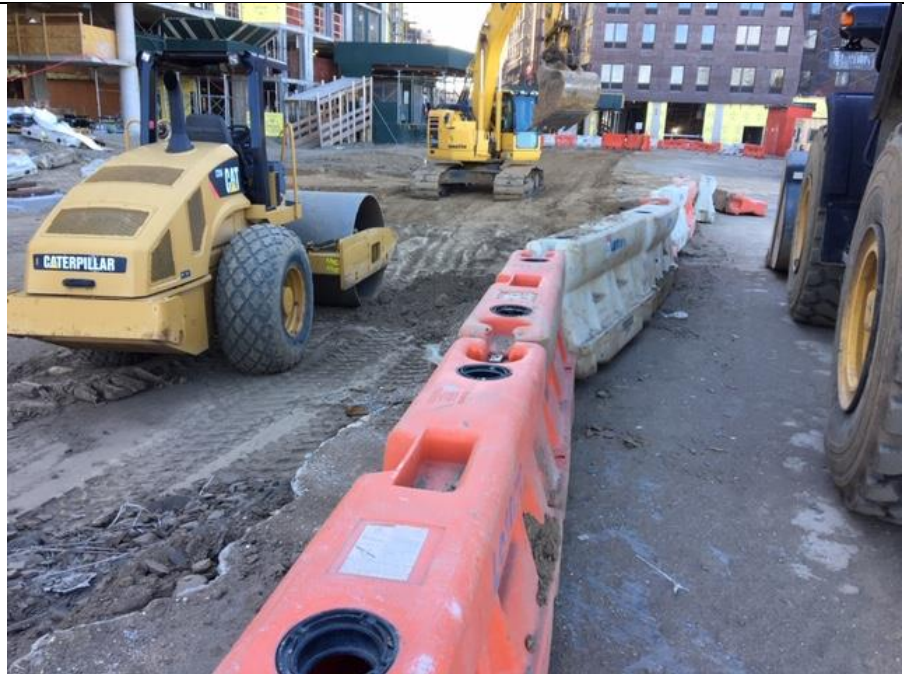
Photo 1- View of backfill compaction in C6 and C7.

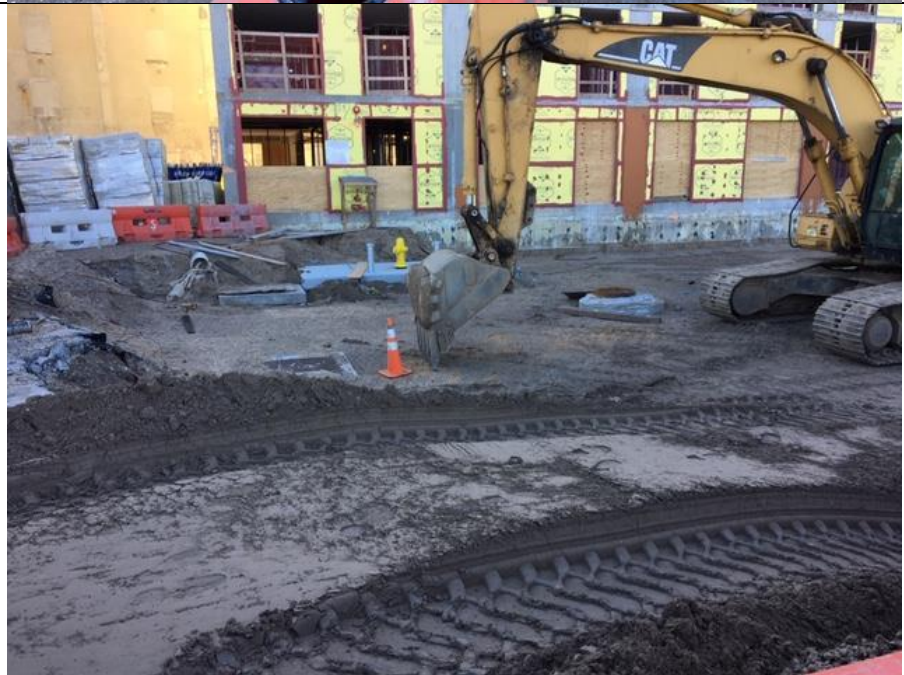
Photo 2- View of grading in C7 and C8.

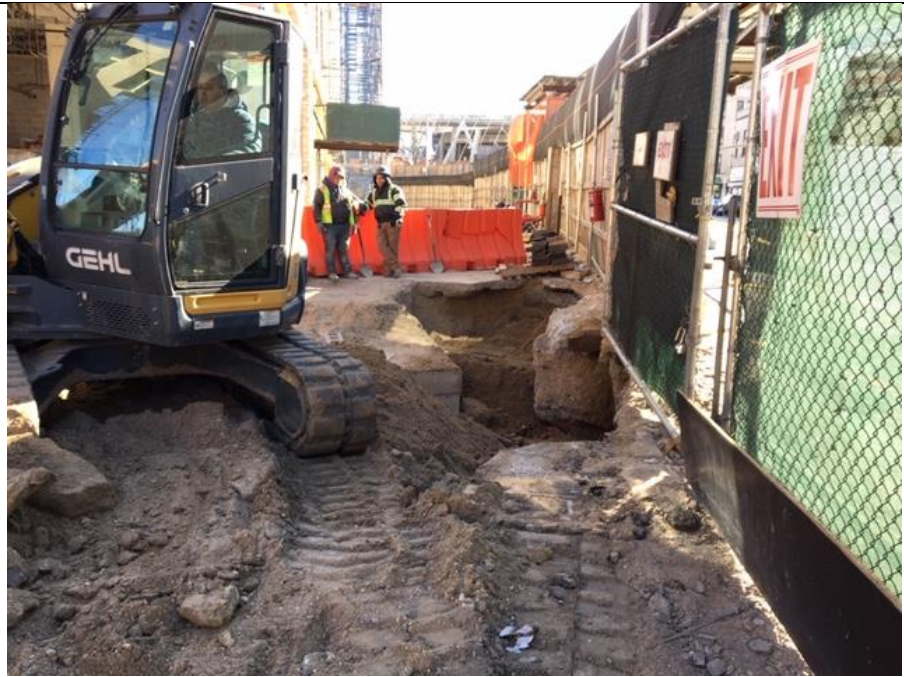
Photo 3- View
of backfilling in
B1.
