Re: Annual Inspection Report
HPS Parcel F, Site No. C241225
1-15 57th Avenue, Long Island City, New York

Site Inspection Checklist, HPS Parcel F, BCP C241225, Queens, NY

Date: 3/30/2023

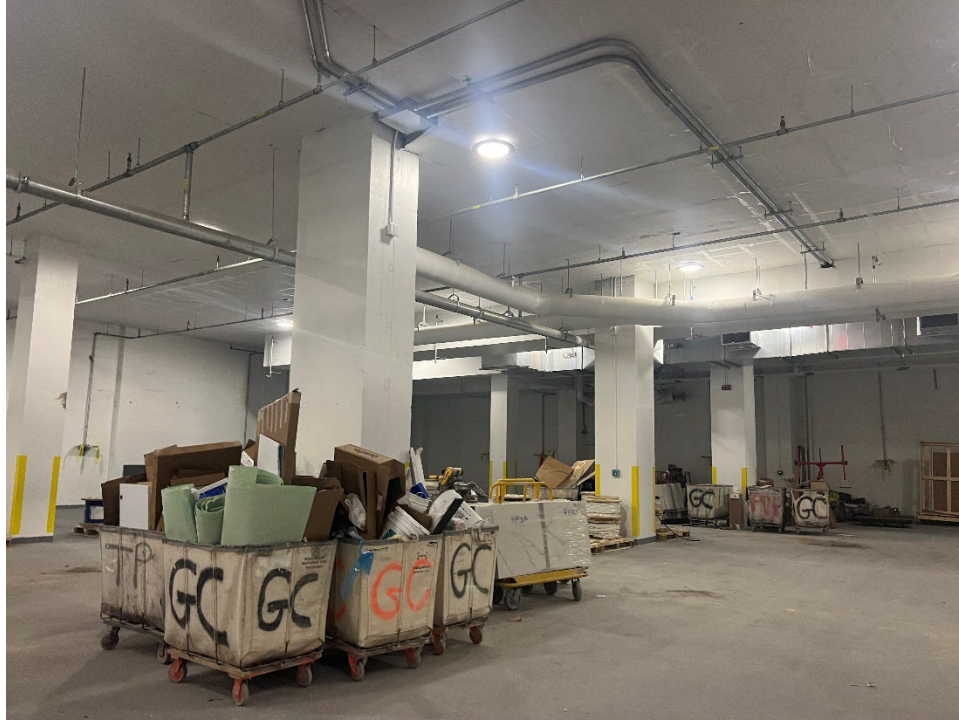
Photo 1: Cellar entrance from Second Street (looking southwest).

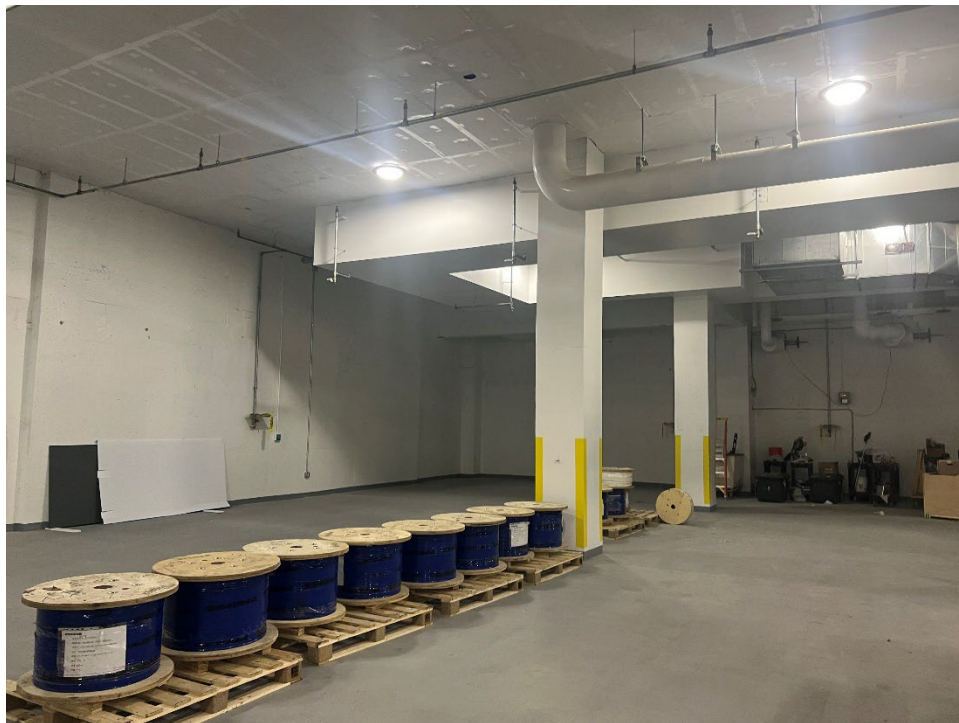
Photo 2: Cellar with building materials storage.

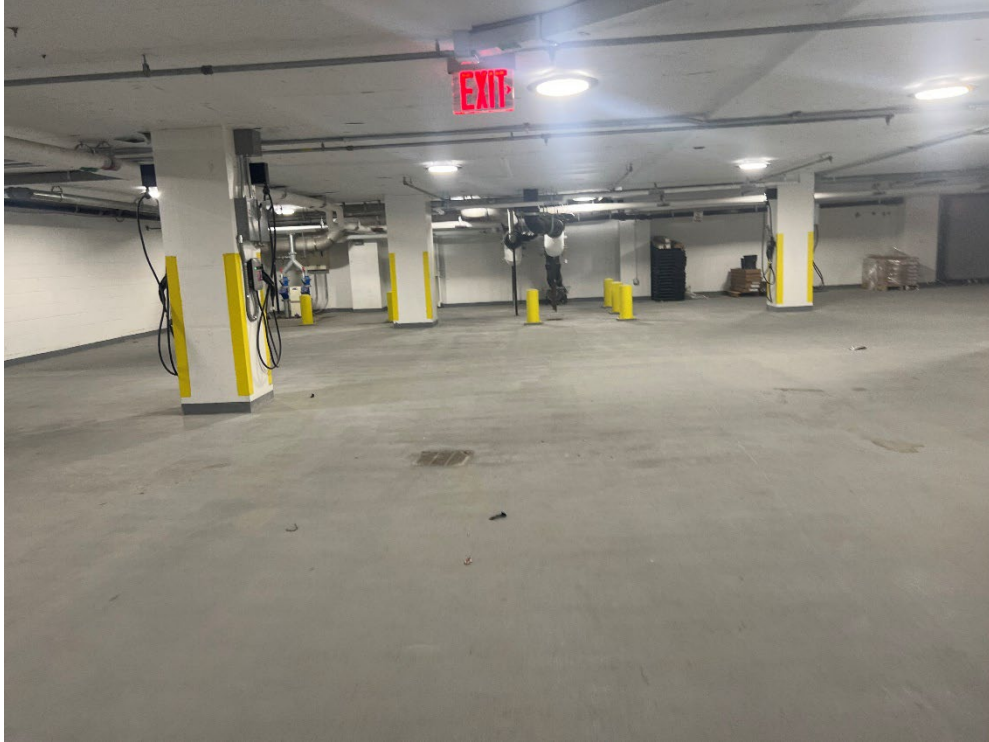
Photo 3: Cellar parking area with electric charging stations.

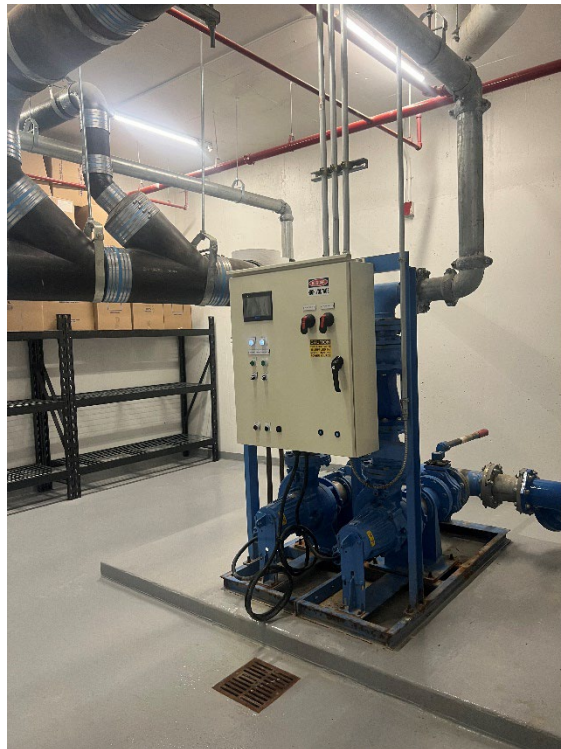
Photo 4: One of the Site's mechanical rooms in cellar.

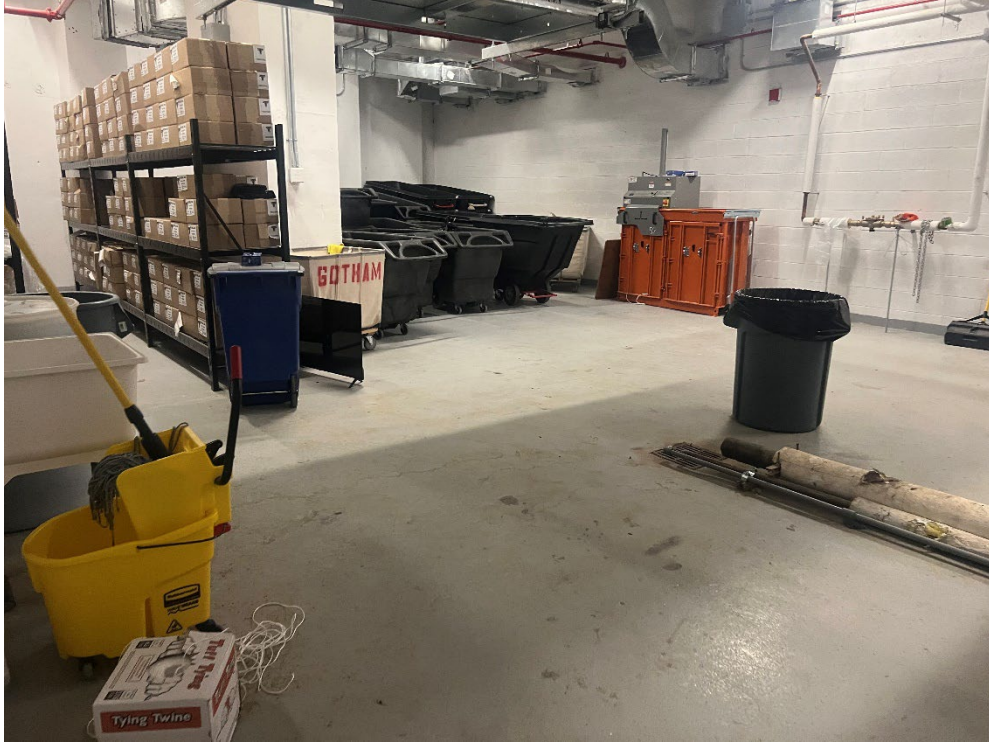
Photo 5: Trash compactor room in the cellar.

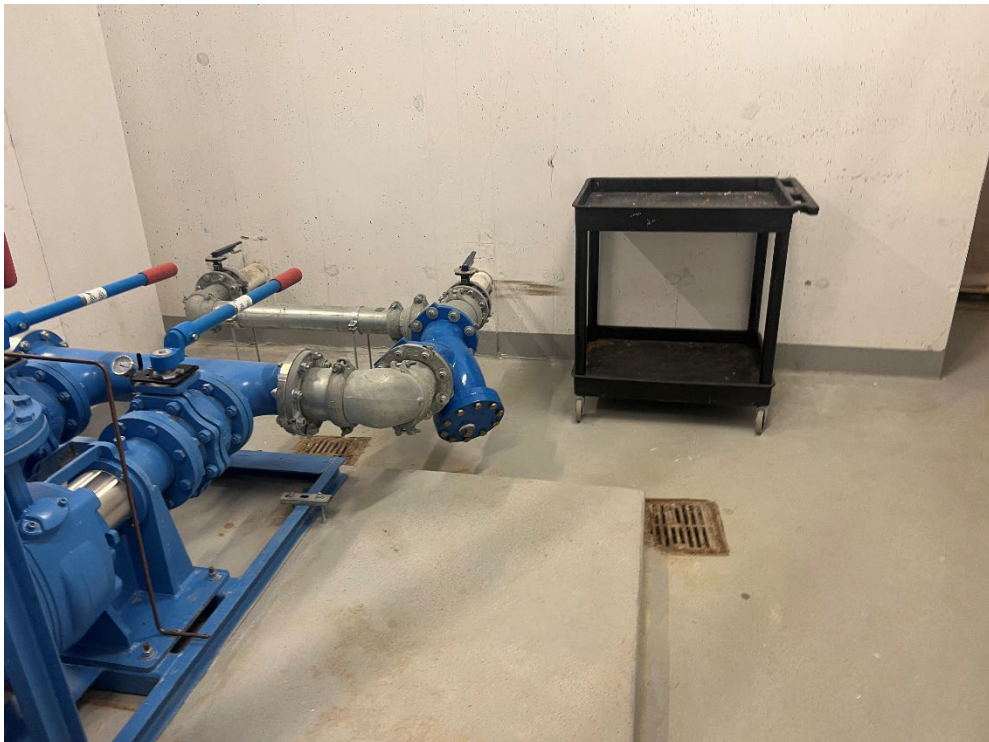
Photo 6: Mechanical room with floor drain in the cellar.

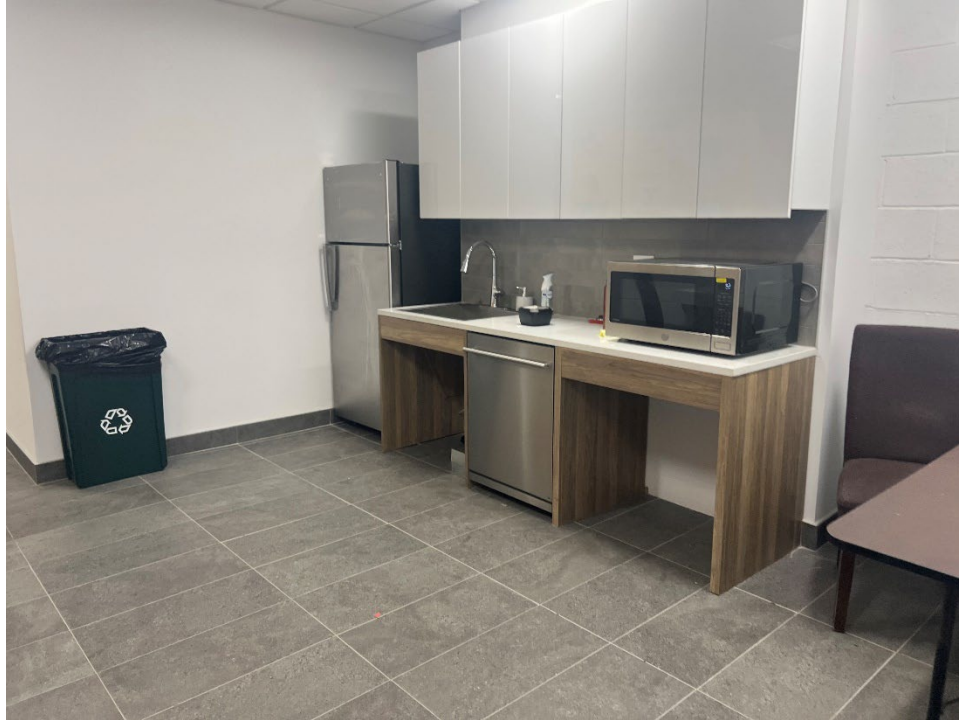
Photo 7: Staff break room in the Site's cellar.

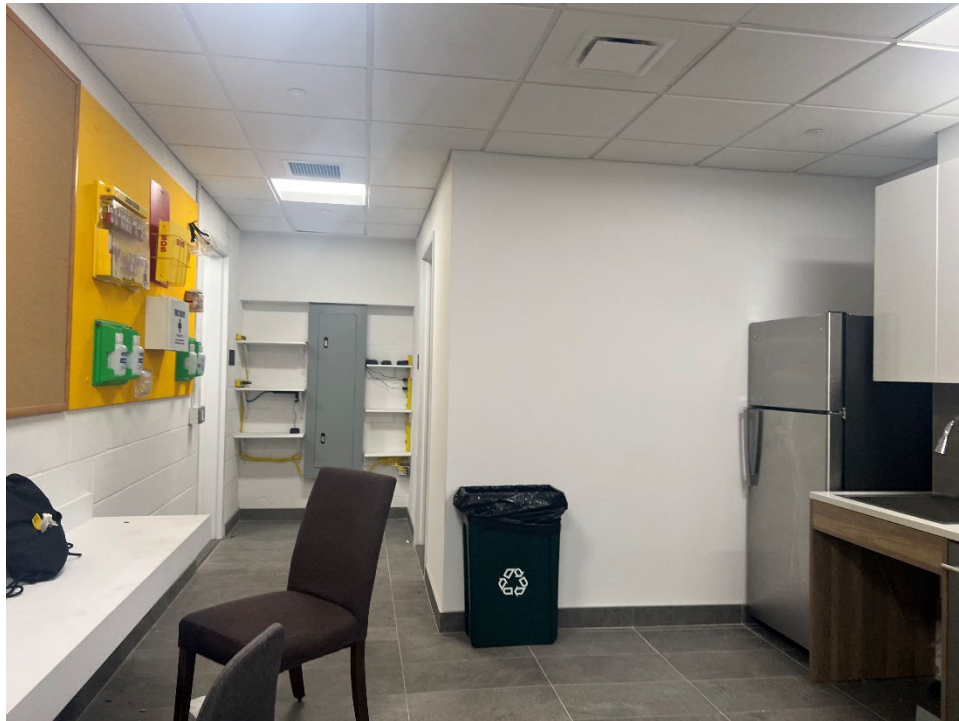
Photo 8: Staff break room in the Site's cellar.
