DAILY STATUS REPORT

Date: 1/04/2023

Project Name: 27-09 40th Avenue Site

Consultant: Scott Yanuck – Laurel Environmental
Safety Officer(s): Michael Avila, NY Preferred

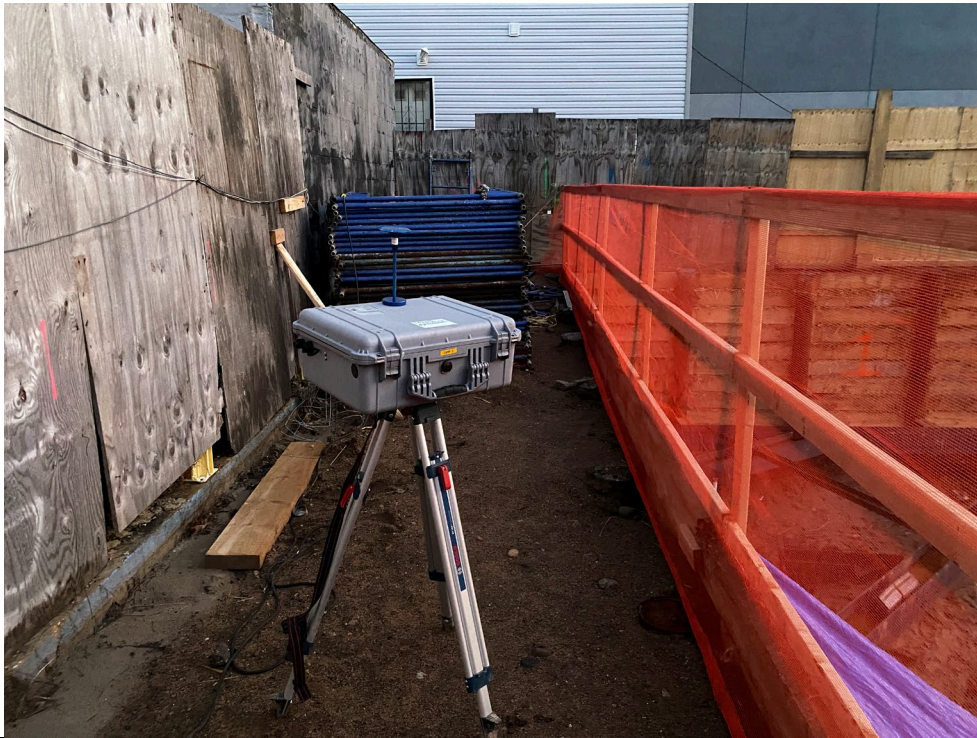
Photo 1 –
View of
the
Upwind
CAMP unit

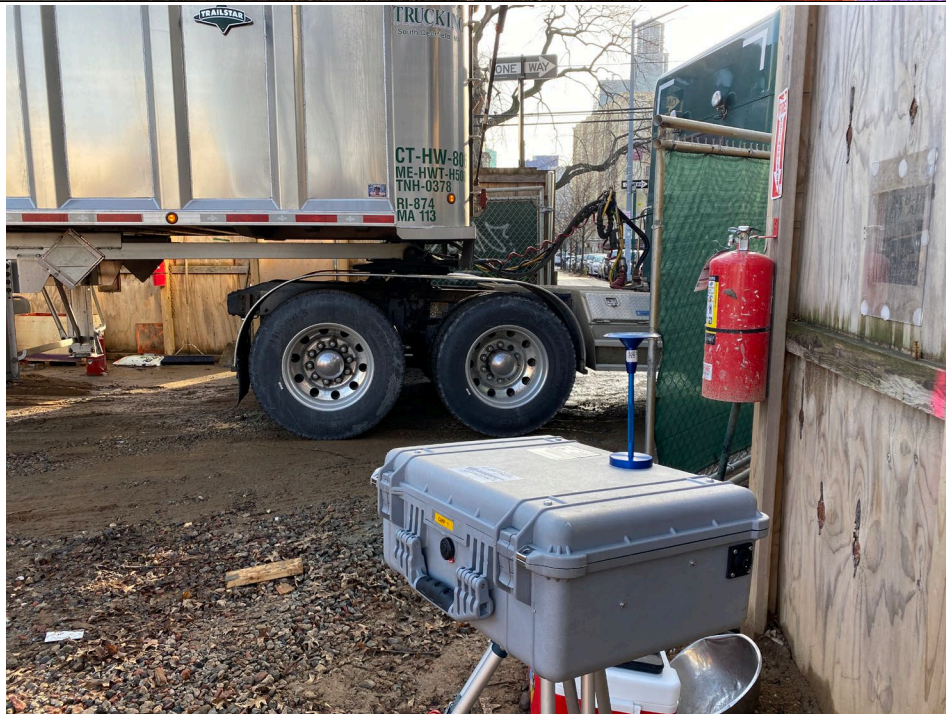
Air Monitoring:
CAMP units set up at the northwestern site boundary [Upwind] and in the work zone [Downwind].
The Upwind CAMP background readings were established at 0.065 mg/m³ for dust and 0 ppm for VOCs.
The Downwind CAMP background readings were established at 0.068 mg/m³ for dust and 0.181 ppm for VOCs.
Dust exceedances occurred in the Downwind and Upwind CAMP units several times between 7:00 AM and 8:00 AM, 9:00 AM and 11:00 AM, and between 2:00 PM and 3:00 PM. No visible dust emissions were noted during these time periods. The exceedances can be attributed to welding activities occurring in proximity of the CAMP units.

Photo 2 –
View of
the
Downwind
CAMP unit

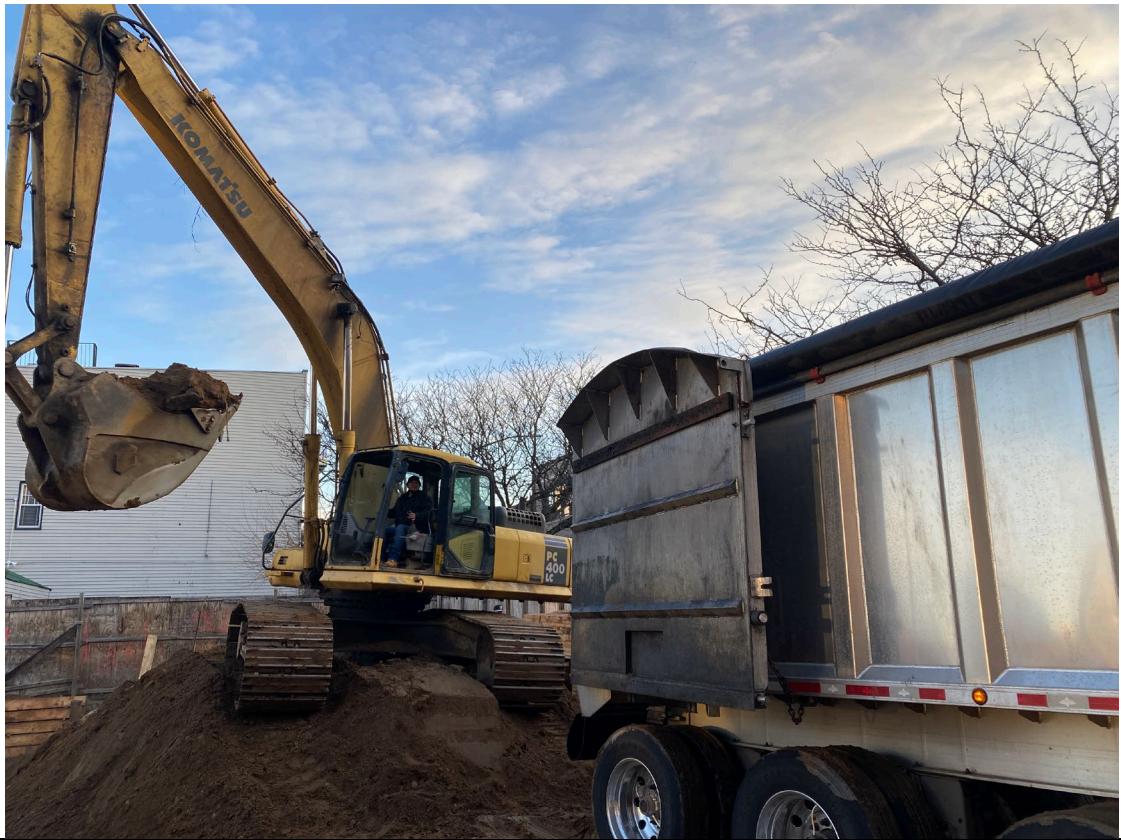
Photo 3 –
View of
soil being
excavated
and
loaded
from Grid
3

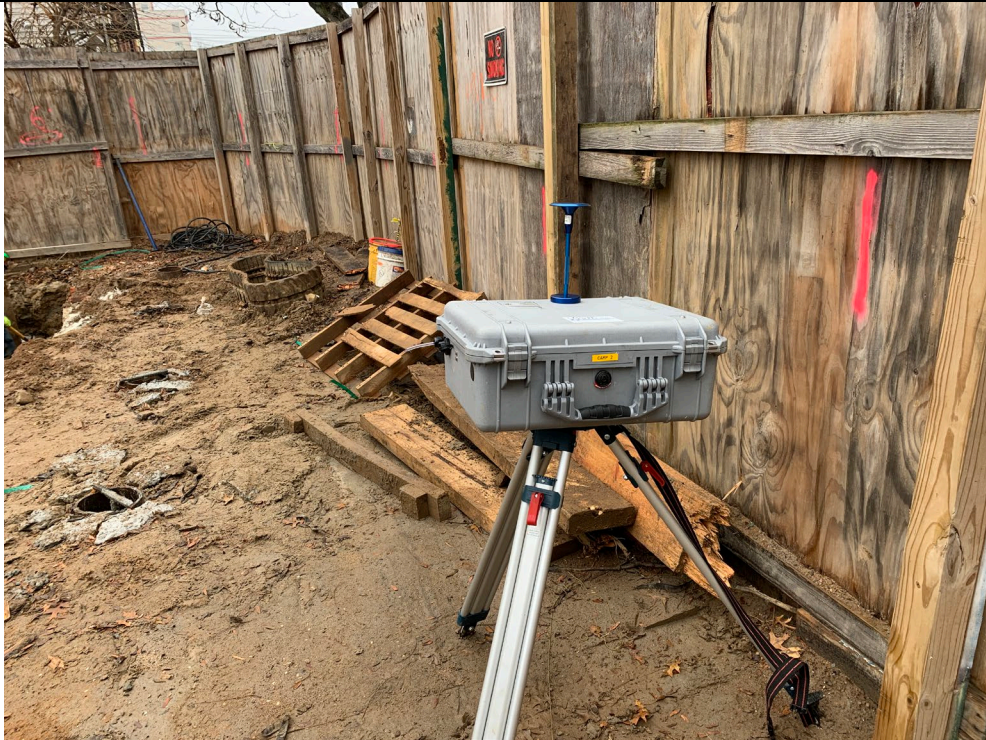
Photo 1 –
View of
the
Upwind
CAMP unit

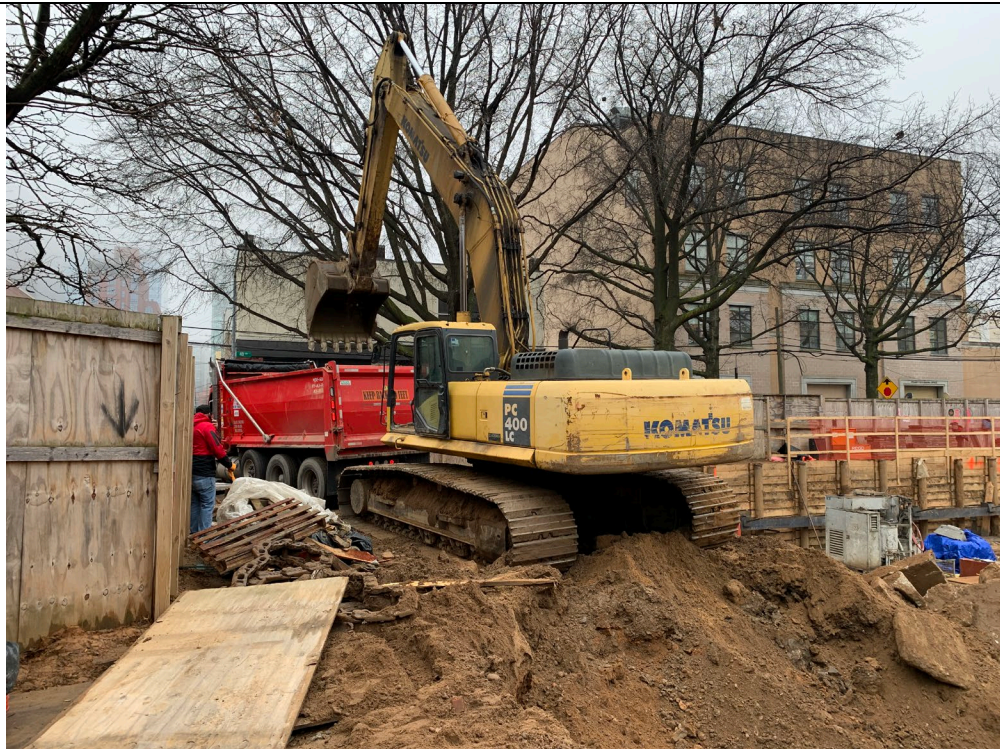
Photo 2 –
View of
truck
being
loaded
with non-
hazardous
waste

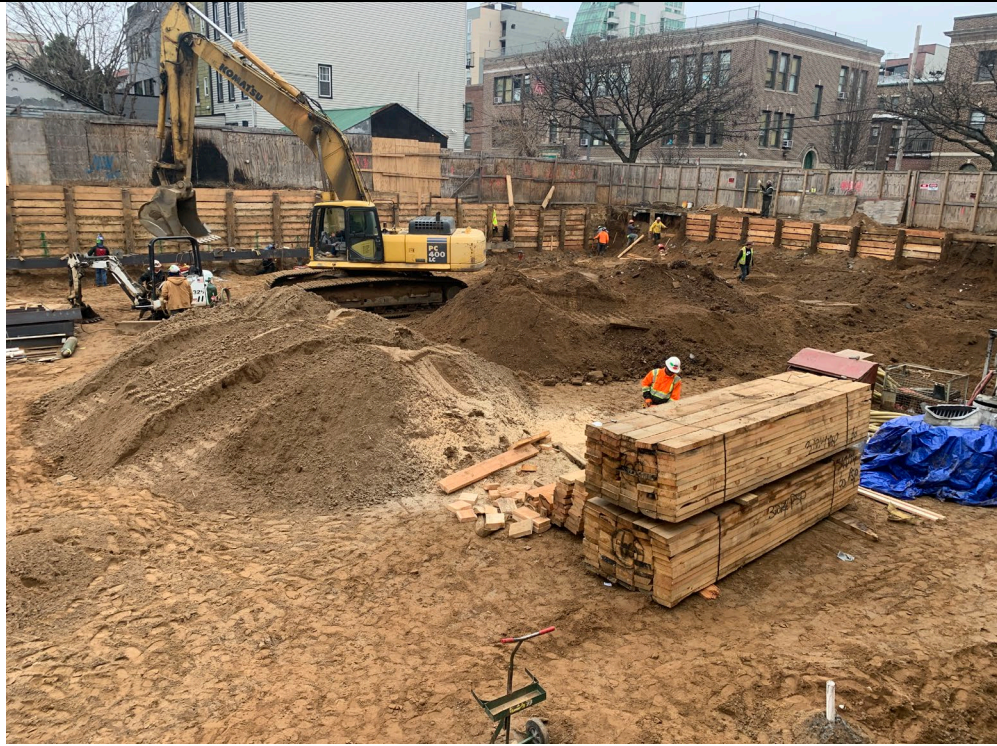
Photo 3 –
View of
site near
end of
day,
facing
north

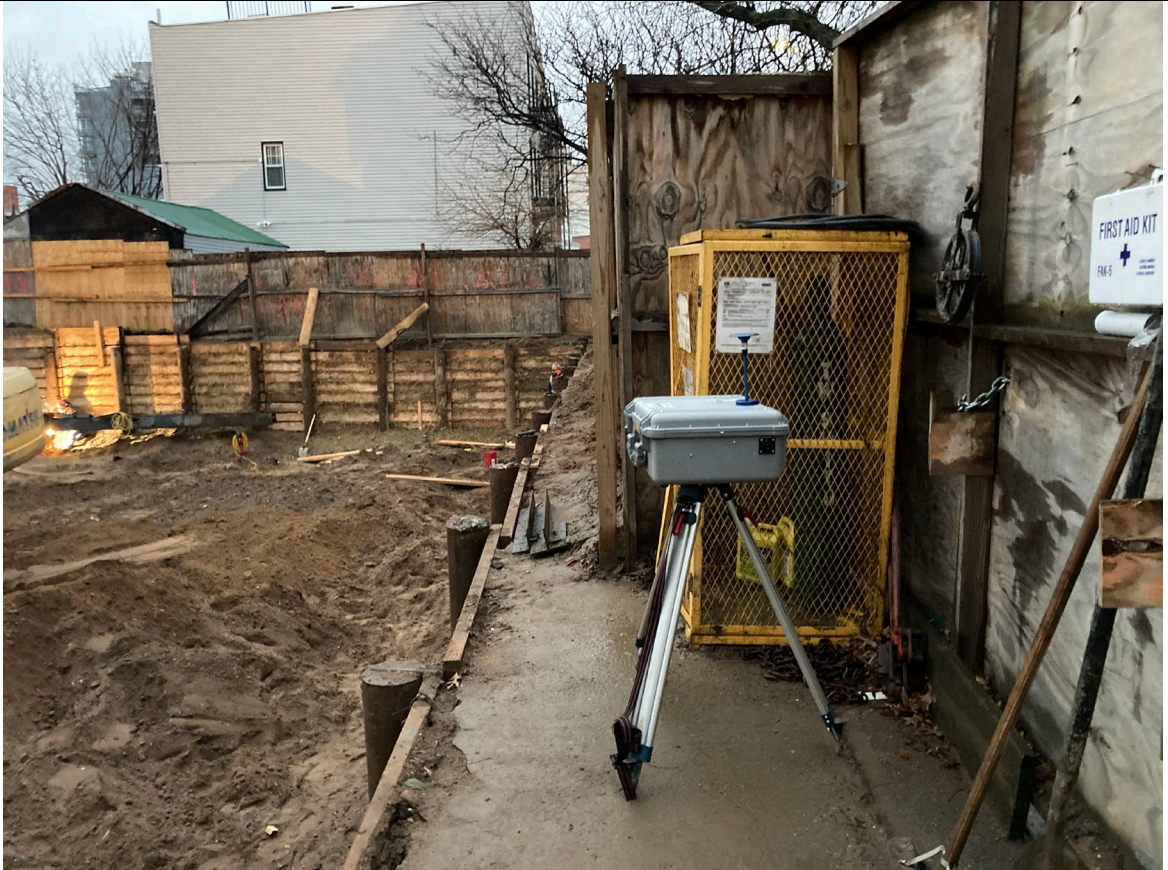
Photo 1 –
View of
welding
being
performed
near the
the
Downwind
CAMP unit

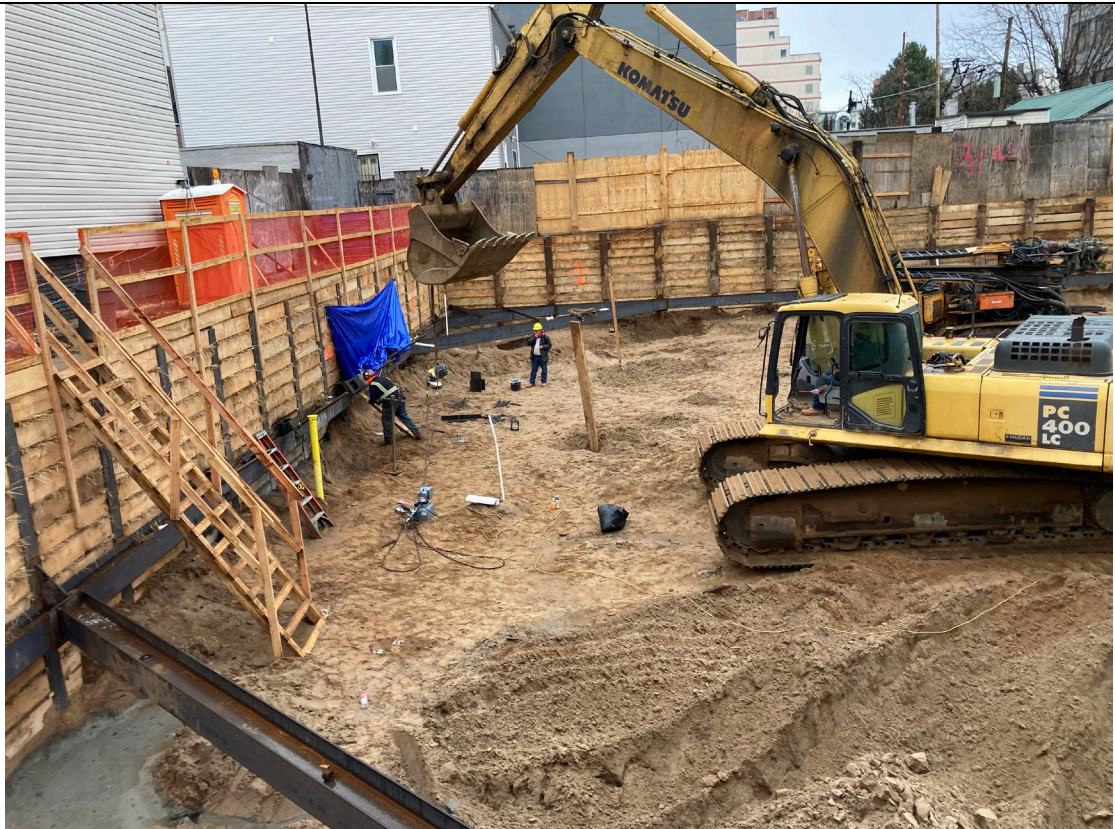
Work Activities Performed:
CG on-site at 6:45am. Wind noted as from the northeast.
No trucks were loaded today.
Lagging work was performed to further reinforce the sides of the excavation.
A tie-back test was done to determine if the stability of the subsurface allows for further safe excavation.
Welding was conducted across multiple areas of the site, as part of the SOE.
Site work was completed by 4:00pm.

Photo 2 –
View of
the
tieback
testing in
progress

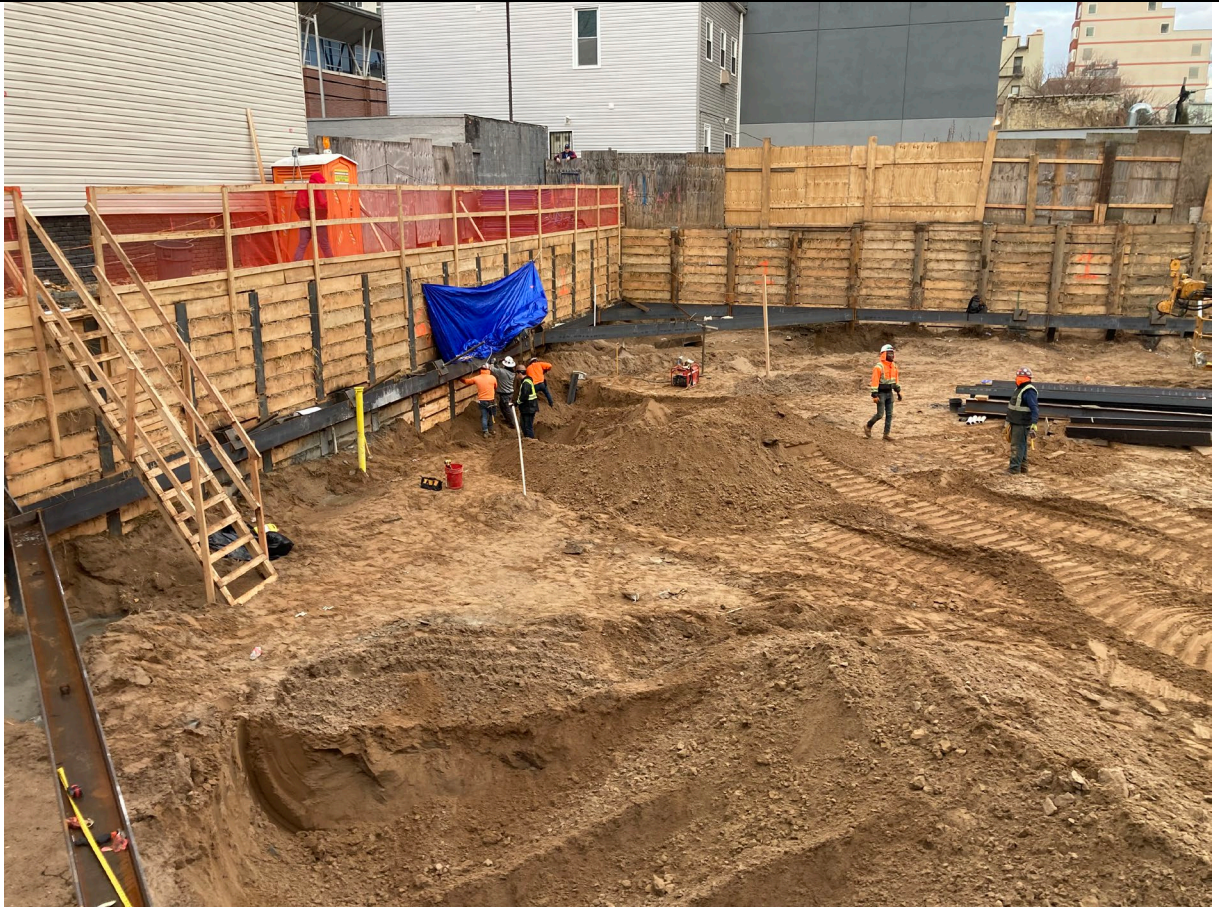
Photo 3 –
View of
soil
scraped to
allow
further
lagging
work to be
performed
in
Quadrant
1.
