# **Daily Activity Report**

Newtown Creek Bud Site - North Block 2-10 54th Avenue, Long Island City, New York

BCP No. C241248

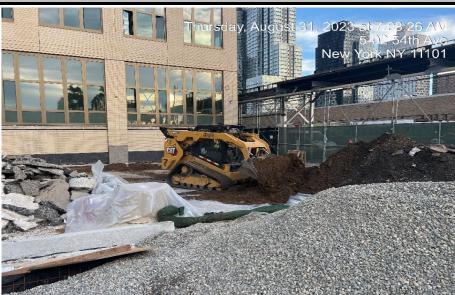
Photograph 1 -Exacavted material added to stockpile in WC-25, facing northwest.

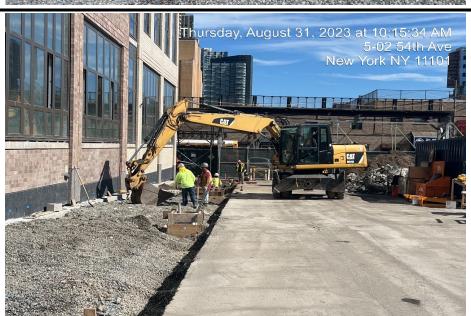
Photograph 2 -General view of the work zone in WC-24, facing north.

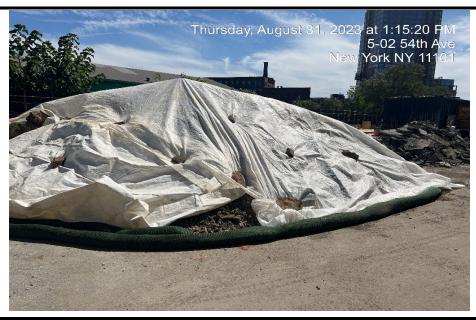
Photograph 3 -Stockpiled soil coved with poly sheeting, view facing southeast.
